# Happy Valley Stenness Orkney

## Archaeological Building Survey

November 2011

**Project No: 300**

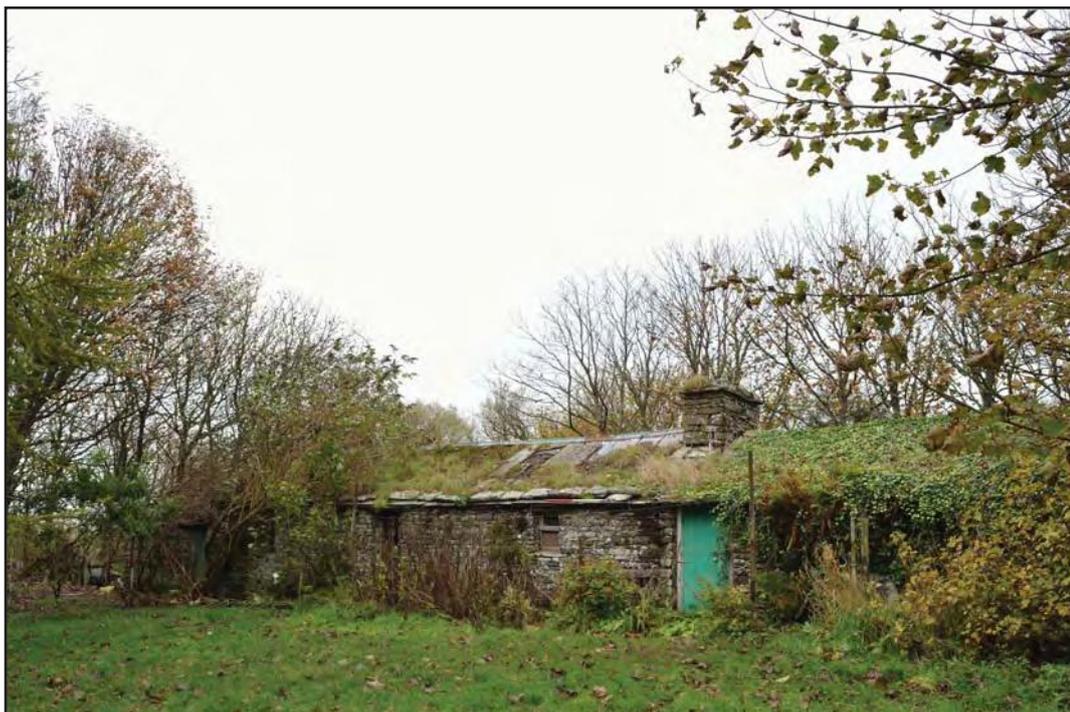
Plate 1: General view of B1, looking northwest.

The house is rectangular, measuring 20.00m by 4.93m externally, and orientated just a few degrees clockwise of east-west (Fig. 2, Plates 1 and 2). The surviving elements of the building can be divided into three main sections. The original later 19<sup>th</sup>-century farmhouse is contained between the two gable ends with chimneys (Phase 1A), now incorporated into later extensions. The roof has a central axis along the length of the building and is double pitched. The house was constructed on a slight west facing slope although the upper wall heads and roof are level. The main front door is located centrally in the original southern elevation with two small windows

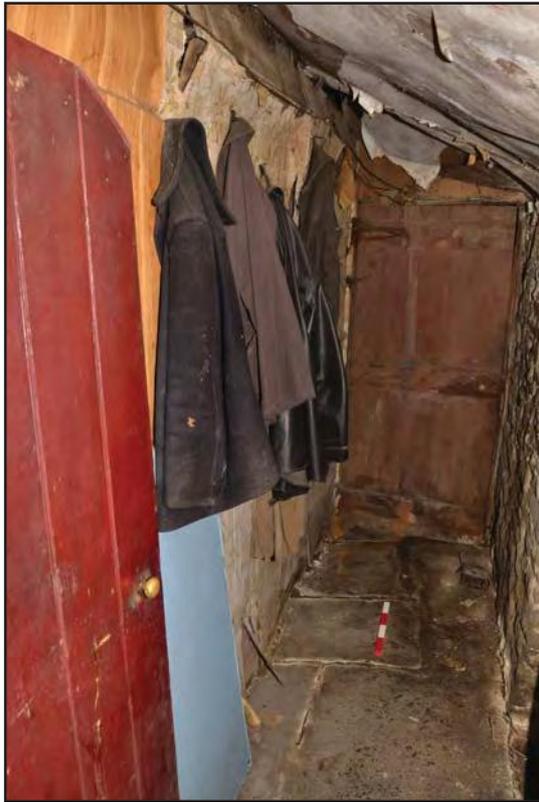
Plate 34: Room 8, looking east.

Generally, the fabric in Room 8 is in poor condition, especially the areas tongue and groove in the north elevation and the ceiling, although the stone wall is sound.

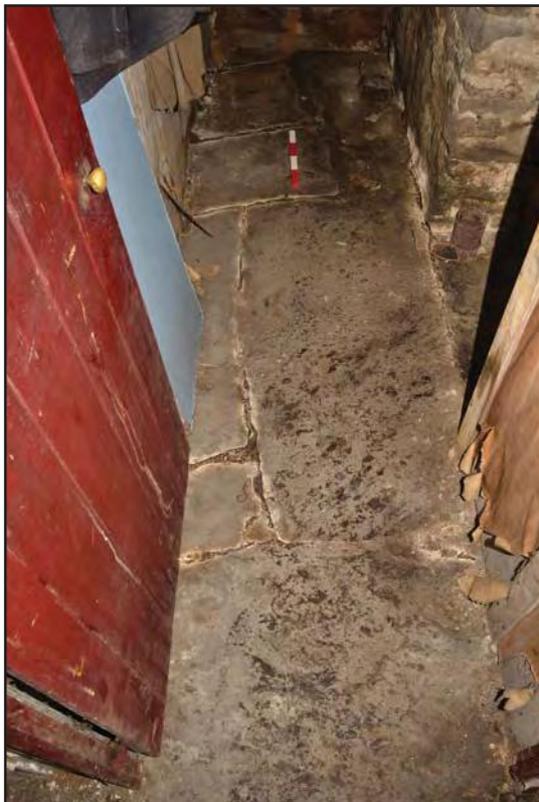
Plate 36: Floor 8.5, looking east.

The original flagstone floor (**8.5.001**) continues below the stud walls (Plate 36). The ceiling is covered with replacement fibreboard sheeting (**8.6.001**) which is in poor condition.

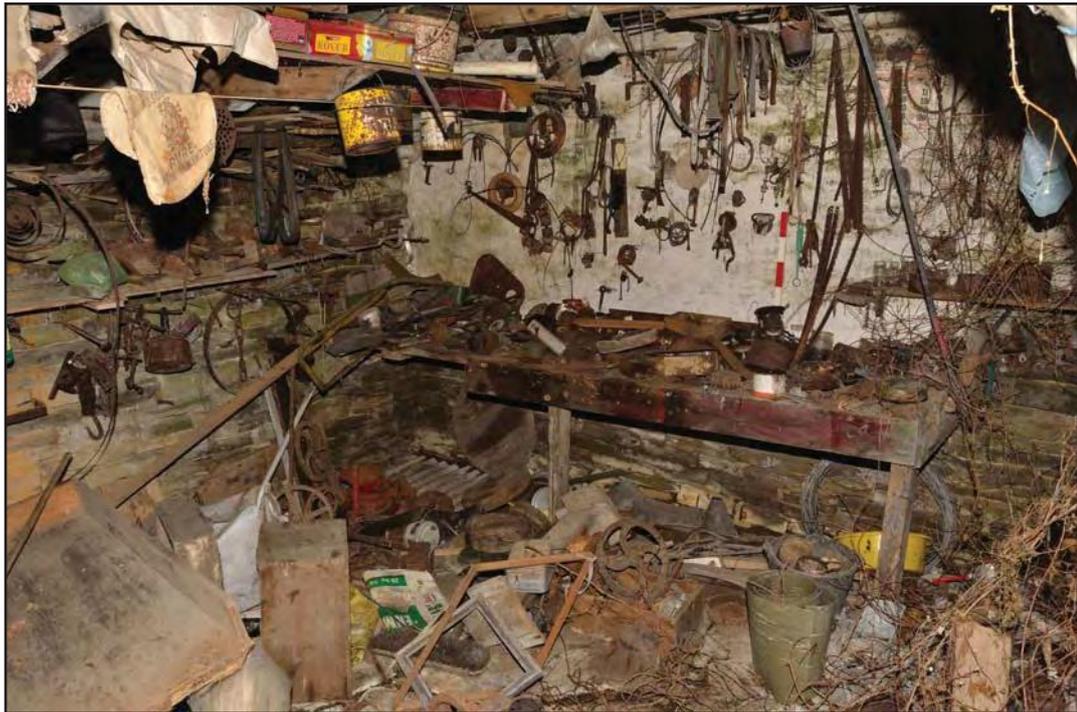
Plate 43: Elevation 10.3, looking southwest.

The south stone wall (**10.3.001**) supports four rafters (**10.3.002-005**) below which are several shelves and homemade shelf units constructed from reused timber (**10.3.009-011**, Plate 43). The doorway contains a replacement flush door (**10.3.008**). There is a 12V wire (**10.3.013**) which leads to the ceiling bench light and a Bakelite light switch (**10.3.012**). The west elevation contains two shelves with metal and wooden peg brackets (**10.4.004/005**) and numerous nails, pegs and hooks (**10.4.006**). The rafters are keyed into the gable end wall of the main house (**10.4.001/002**).

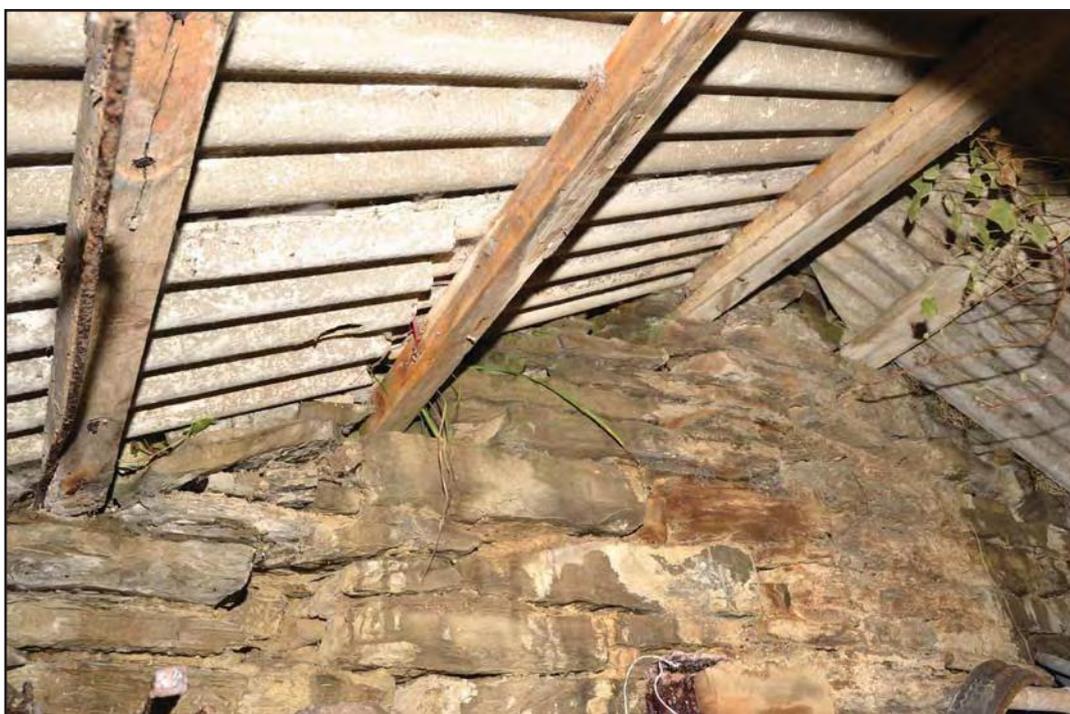
Plate 46: B1.1, west end, looking southeast.

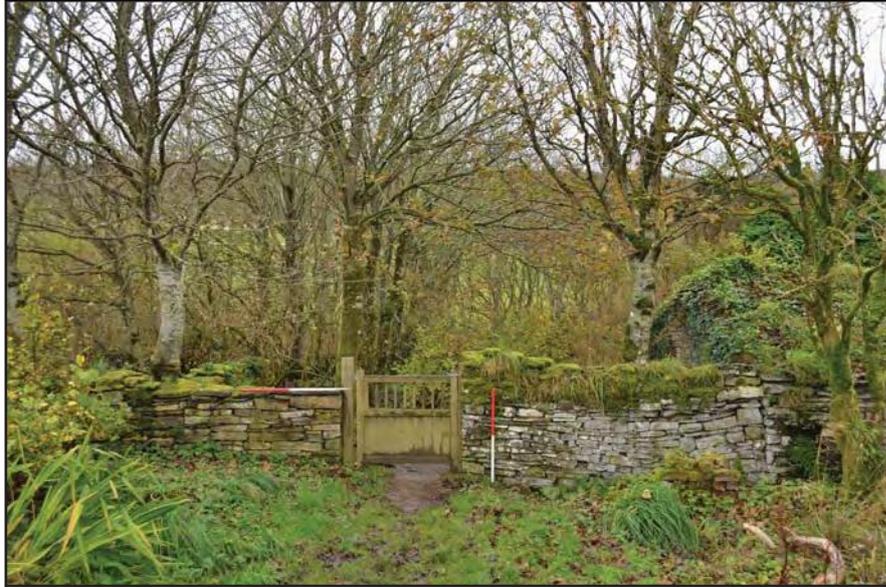
The gable end stone wall (2.50m high) of the east extension contains no features (**B1.2.001**, Plate 51). It is abutted by and an upright slab to the south (**B1.1.002**) and a boundary wall to the east (**B1.2.003**, Plate 48).

Plate 48: Boundary wall B1.2.003, looking south.

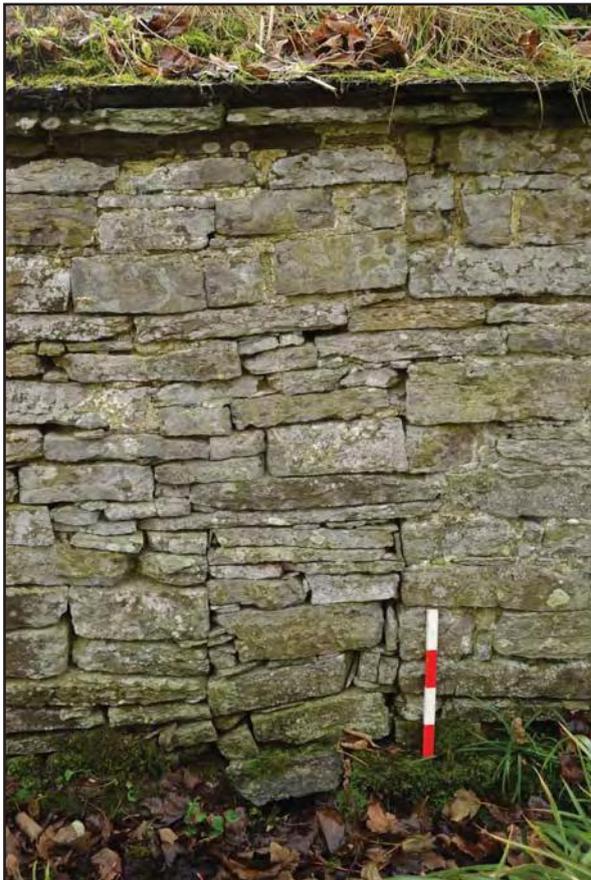
Plate 49: Change of build B1.1.001/005 and blocked aperture B1.1.006/007, looking south.

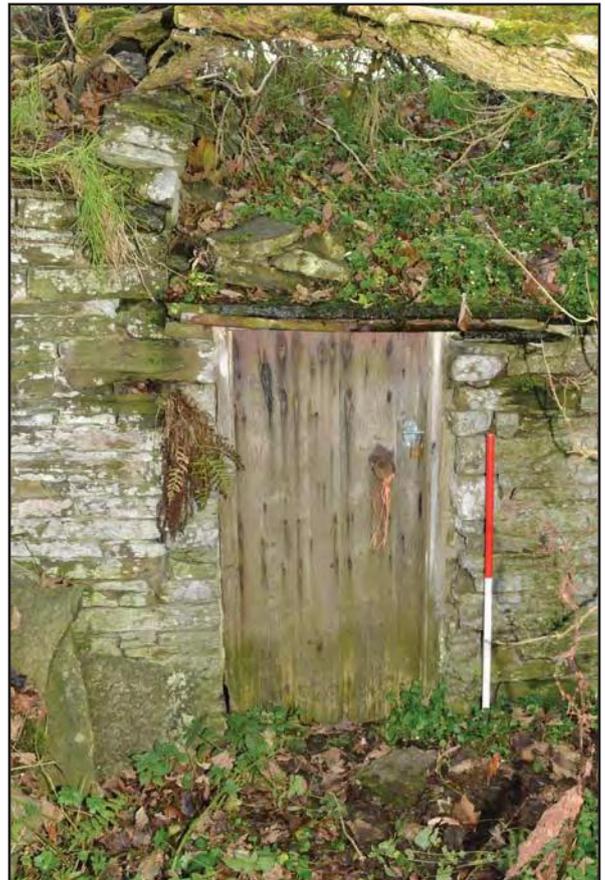
Plate 50: West limit of B1.1.001, doorway B1.1.010, north wall of west extension etc., looking south-southwest.

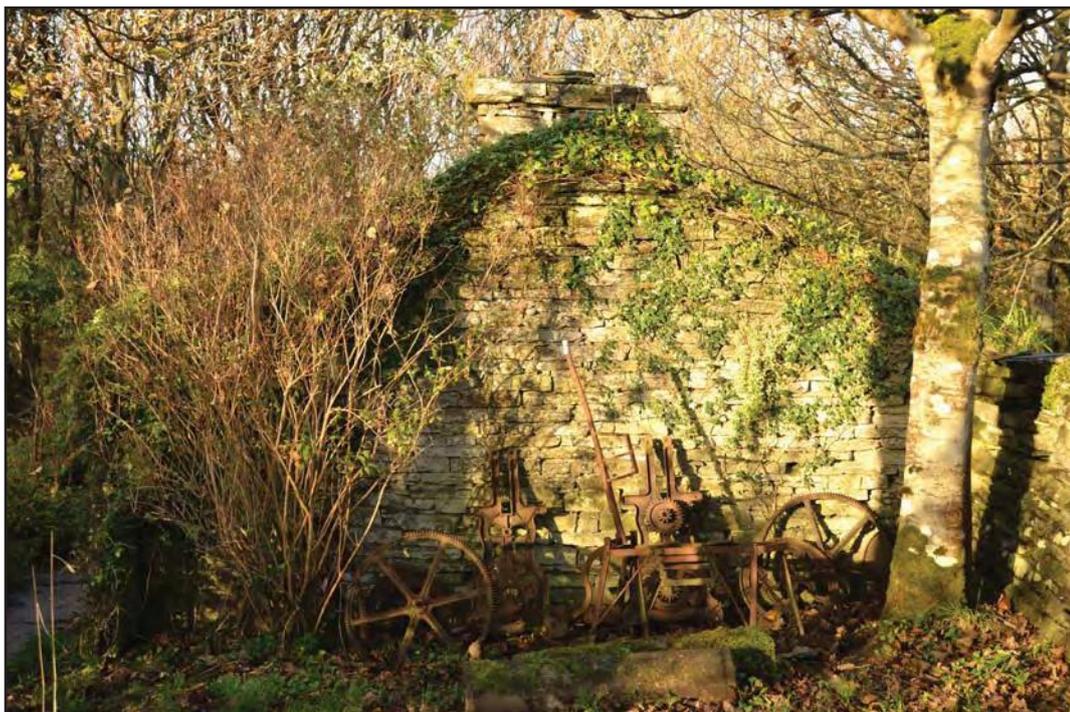
Plate 51: B1.2, looking west.

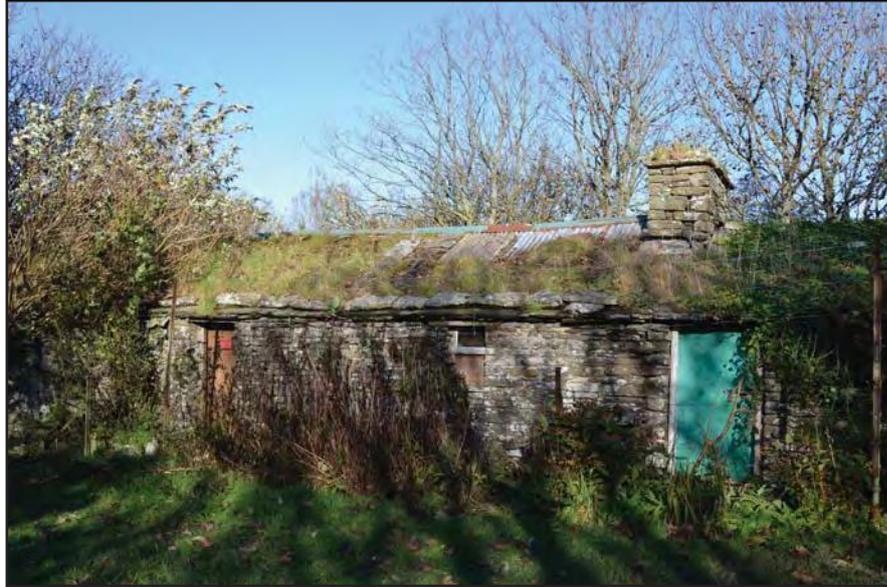
The original house (Phase 1A) is clearly visible in the south elevation with a central door and two small windows equidistant either side (Plate 53). There are two doors where east and west extensions abut the gable ends. The main central door (**B1.3.006**) has a sturdy external tongue and groove door (**B1.3.008**) with a wooden letterbox flap (**B1.3.009**, formerly weighted shut from the inside) a replacement brass door latch and escutcheon plate (**B1.3.010**, Plate 58). There is an iron drip gutter above the door (**B1.3.011**) that used to feed into a wooden barrel (now in Room 3) on a stone plinth. The two plastic buckets by the door were for growing neaps (Chris Gee pers comm.). The east window (**B1.3.004**, 0.48 x 0.66m) is the original size however the wooden framed two paned window is a replacement (**B1.3.005**). The west window aperture is higher, having been altered (**B1.3.002**, 0.47 x 0.94m) and also has a replacement wooden framed window with repaired panes (**B1.3.003**, Plate 60). There is a cable for a

Plate 53: B1.3, looking north-northwest.

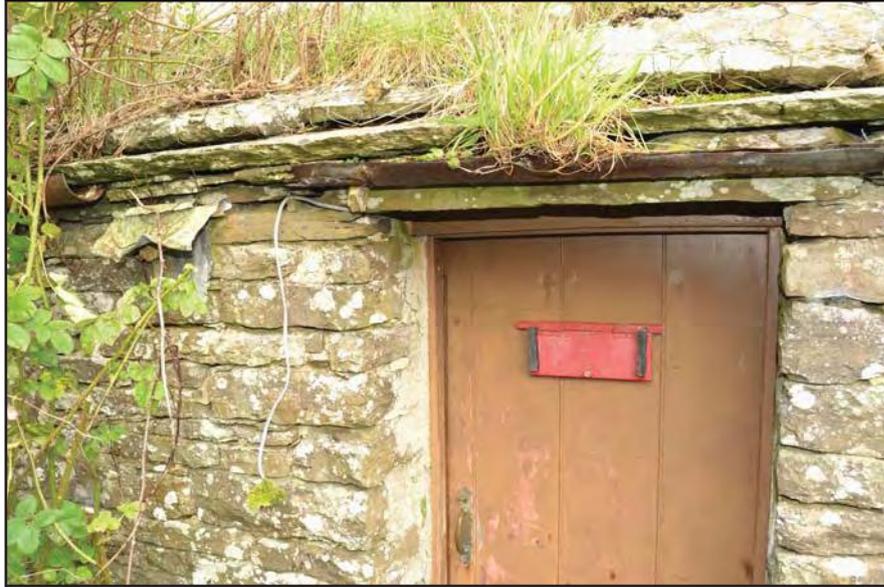
former 12V outside light and lead guard to the west of the door (**B1.3.024**, Plate 58).

Plate 58: Door B1.3.008 and light fitting B1.3.025, looking north-northwest.

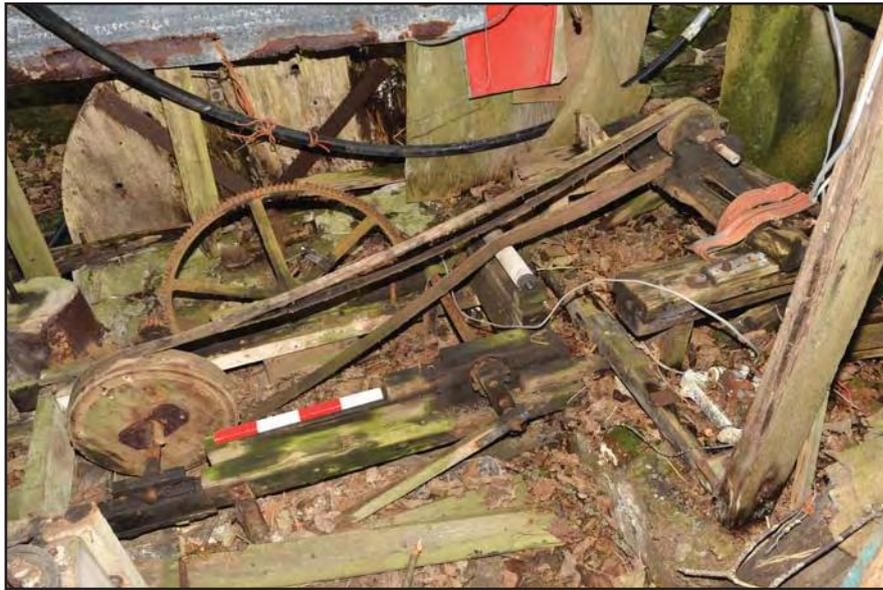
Plate 63: B2 interior, showing machinery, looking north.

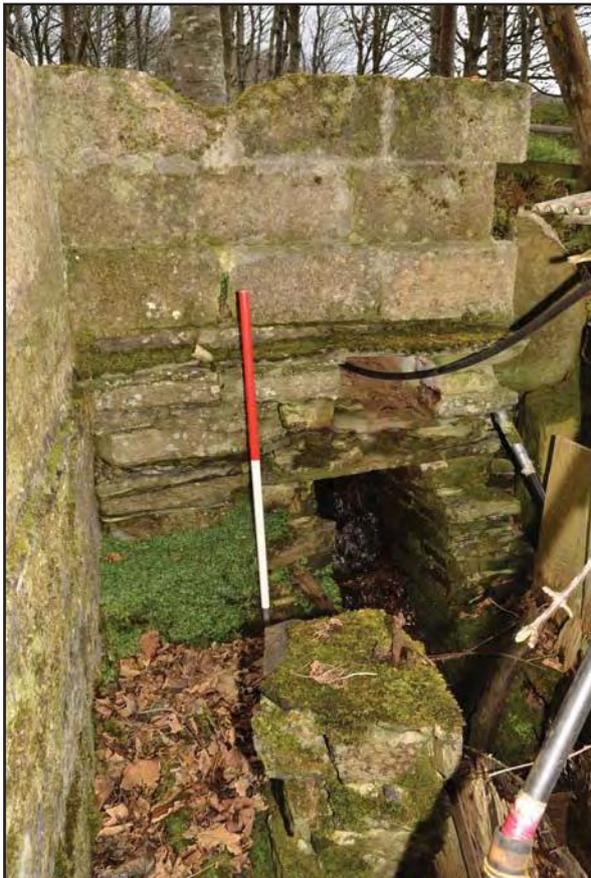
Plate 64: B2 interior, northeast corner, looking east.
