THE ALLIANCE AND LION SALT WORKS, MARSTON, NORTHWICH

THE FINAL REPORT:

VOLUME IV – HISTORIC BUILDING RECORDING

REPORT NO 2015-01

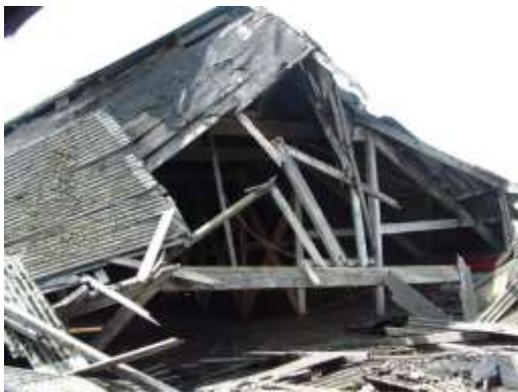
2.1: Collapse of Stove House 3, north gable, 1990s, south facing

Stove House 1 appears to have become structurally unsound in the 1990s and in the early 2000s the roof connected to Stove House 3 collapsed (2.1, 2.2). The collapse was almost certainly the result of the poor condition of the roof structure and the subsequent collapse of the southern wall which was shared with Stove House

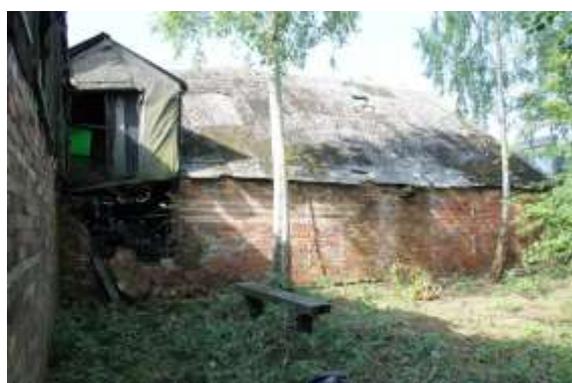
Pan House 1 abutted the northern long elevation. Originally the northern elevation continued to the east, but it was demolished when Stove House 2 was constructed. The northern elevation was a single storey high, plain and constructed in hand-made red brick in English Garden Wall bond (6505; 2.5). A second phase of rebuilt wall in machine pressed yellow bricks was visible on the eastern upper side of the wall (6928). The brick type corresponded closely with re-built areas of brickwork on Stove House 2 on its western and eastern elevations (see below). A single pier of machine-pressed red brick supported the structure on its north-western corner (6502).

2.5: Stove House 1, north facing elevation, south facing

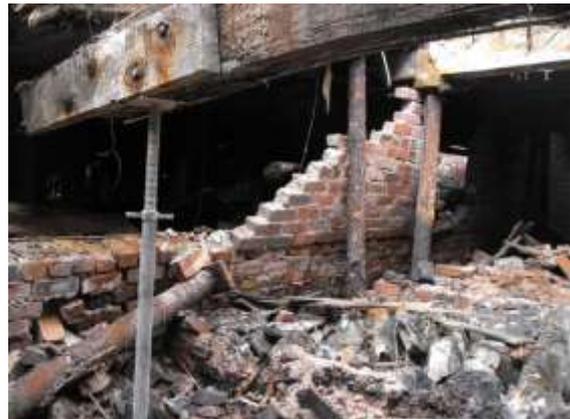
The southern elevation was almost entirely collapsed (Fig. BS070). It survived as a low line of machine-pressed red brick in English Garden Wall bond, with a single fragmentary upstanding wall (6194) continuing from the curve (6500) of the western gable wall. The single storey wall survived to the full height in one area (2.11). The whole of the first floor was formally open allowing direct

2.11: Stove House 1, southern elevation, remnant wall, south facing

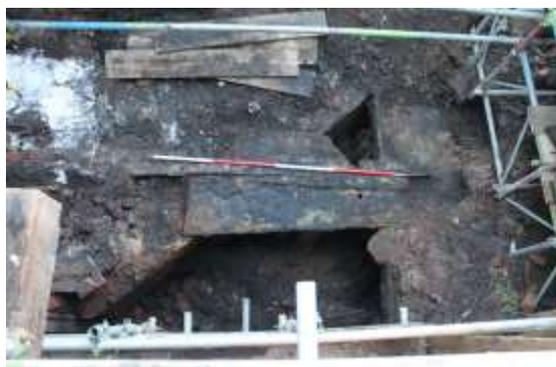
Both western and eastern walls were of hand-made red brick in English Garden Wall bond (6526, 6527). The entrance had a lintel made of two ferrous metal I-beams overlaid by a single sheet of ferrous metal (6525, see 2.19, 2.20). The roof of the tunnel was of sheets of ferrous metal, the main part of which formed a trough (6529). In the entrance this cover was a sheet of ferrous metal (6528), with a single small hole presumed to be for drainage. This had eroded and collapsed at the northern and southern ends. The tunnel presumably continued to the north and ran

2.19: Stove House 1, ferrous metal sheets over the tunnel entrance, west facing

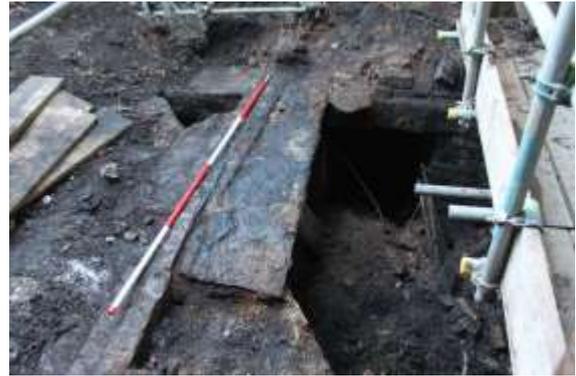
2.20: Stove House 1, ferrous metal sheets over the tunnel entrance, north facing

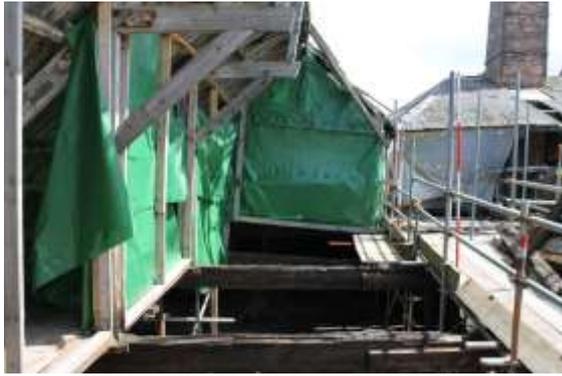
The interior warehouse level had almost entirely collapsed (Fig. BS048). The floor of the warehouse survived in 2009 more extensively but by 2012 it survived only three places. Large 3" thick floorboards were aligned east-west between each bay (defined by the transverse beams). These survived in the north-west corner (6535, see 2.29, 2.30, 2.31, 2.32); in front of the dormer gable in the northern elevation (6536, 2.33) and as floorboards where Stove House 1 and 2 (6607, 2.34) were combined. Trimmers (6604, 6605) had been added to strengthen this floor. A series of three salt hatches (6619, 6620, 6621) were located in the eastern surviving part of the floor. These were rectangular (0.90m x 1.00m) and supported by trimmers on east and west side. One these hatches (6621) had the salt hatch still in place.

2.32: Stove House 1, warehouse floor, in 2012, east facing

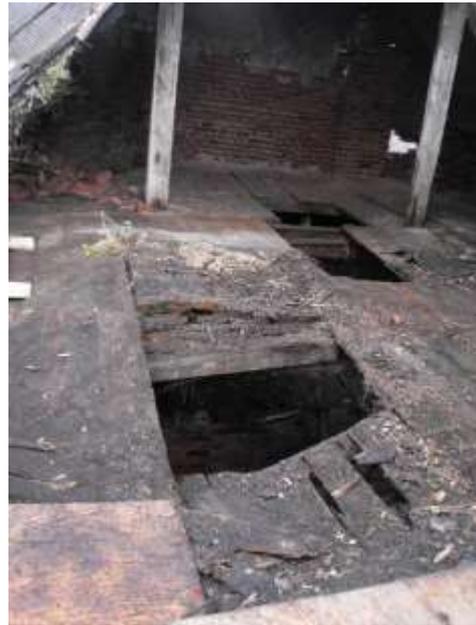
Originally in 2009 a much greater extent of floor existed throughout the warehouse. The roof collapse in the early 2000s resulted in water ingress and the majority of these timbers were rotten and were removed during the 2009 enabling works. The pattern of floorboards and salt hatches was however, still broadly visible (2.35, 2.36). This suggested that a combination of one or two hatches were spaced equidistant in each bay.

2.35: Stove House 1, pattern of salt hatches visible in 2009, west facing

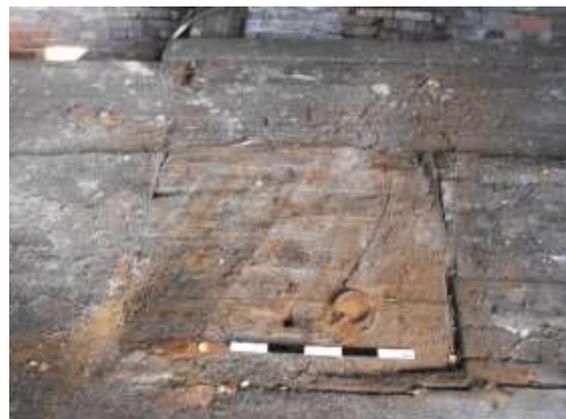
2.36: Stove House 1, surviving salt hatch in 2009, north facing

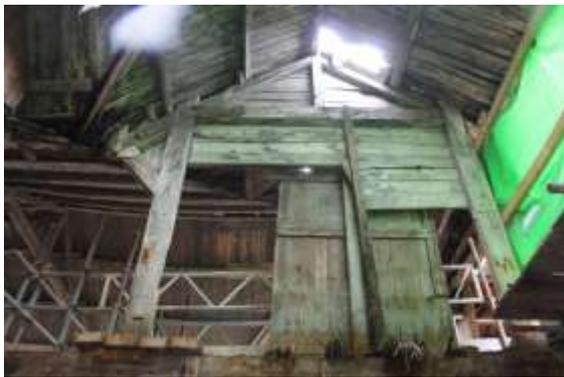
The roof structure survived poorly. Almost the entirety of the southern side of the roof structure had collapsed, been altered or been dismantled, meaning that the structure as a whole survived only fragmentarily. The roof structure consisted of

2.37: Stove House 1, Truss 6541, east facing

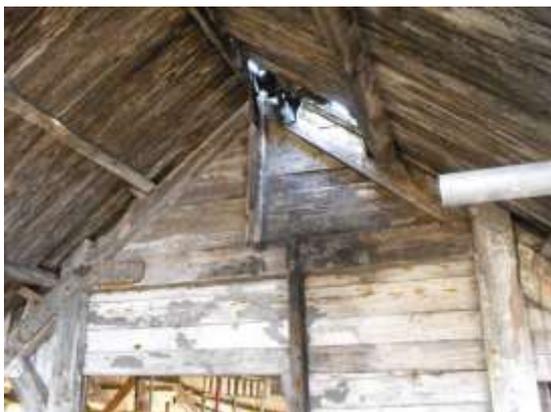
2.38: Stove House 1, Truss 6541, north-east facing

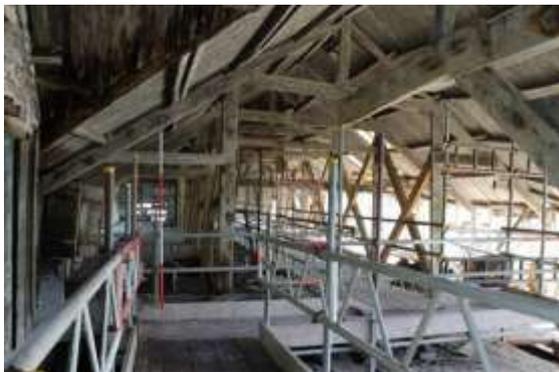
The addition of Stove House 2 had seen the loss of staggered purlins between the eastern bays (2.43). On the southern side two sets of purlins (6554; 2.44) only survived at the very eastern end.

2.43: Stove House 1 and 2, showing the removal of all remains of the trusses and purlins on the northern side, north facing

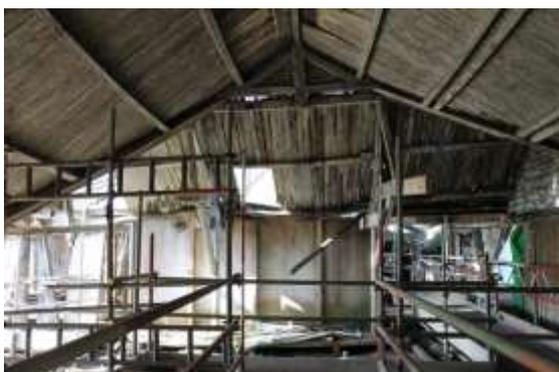
2.44: Stove House 1 and 2, showing the surviving extent of purlins on the southern side, south facing

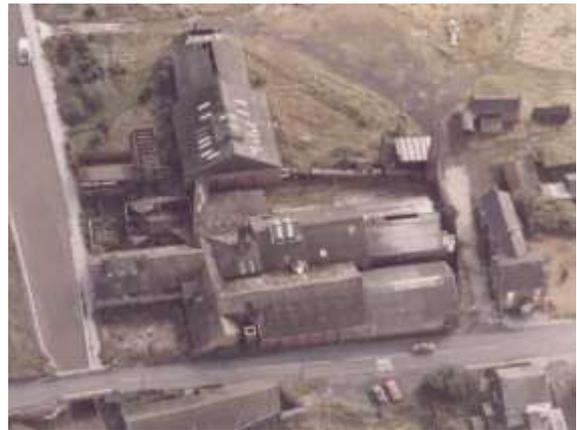
The pan house had entirely collapsed by the 1980s. The framework of the roof lay derelict within the pan itself as visible on aerial photographs dating to 1986-1990 (2.48, 2.51).

2.48: c. 1986 aerial photograph, Pan House 2 is visible as collapsed remains, east facing

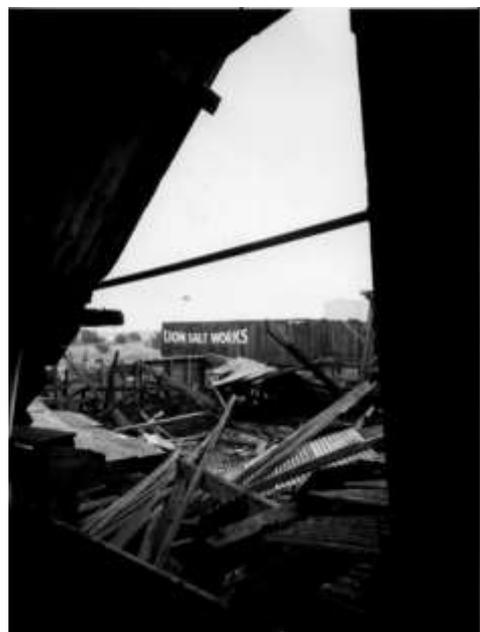
By 2009 the wooden structure of the pan house had almost entirely collapsed (2.49, 2.50). The roof was located within the pan as debris. The southern, northern and eastern sides of the pan house, survived but had partially collapsed.

2.49: Pan House 2, collapsed remains c. 1990, east facing

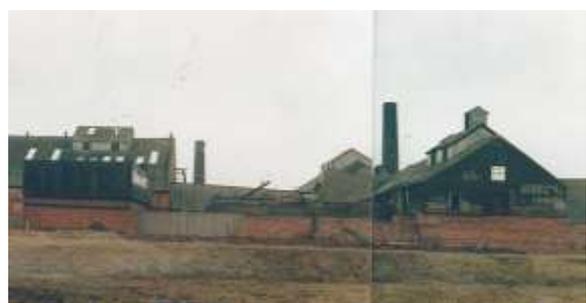
2.50: Pan House 2 and Stove House 2, c. 1990, pan house visible as collapsed timbers

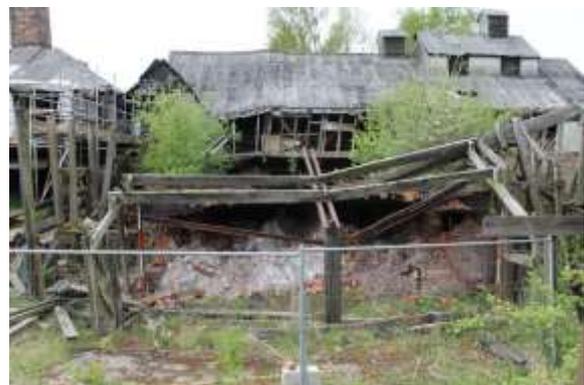
2.53: Pan House 2, in 2012, collapsed remains of the covered area at the front of the pan, west facing

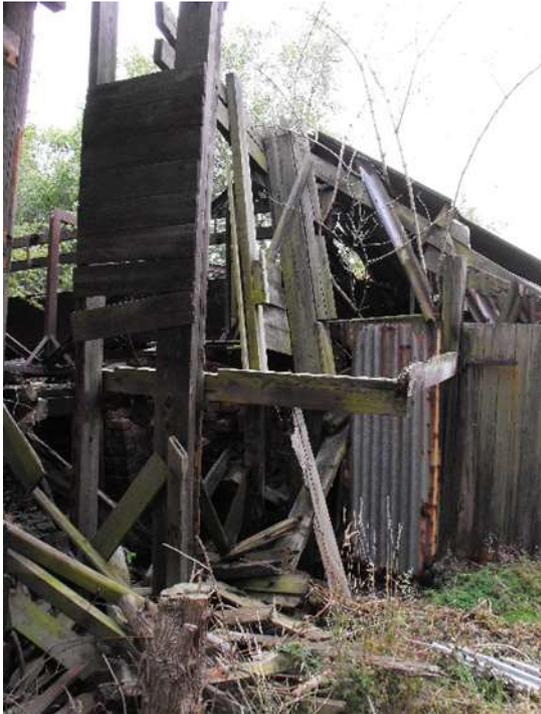
2.54: Pan House 2, in 2009, collapsed remains of the front of the pan, north facing

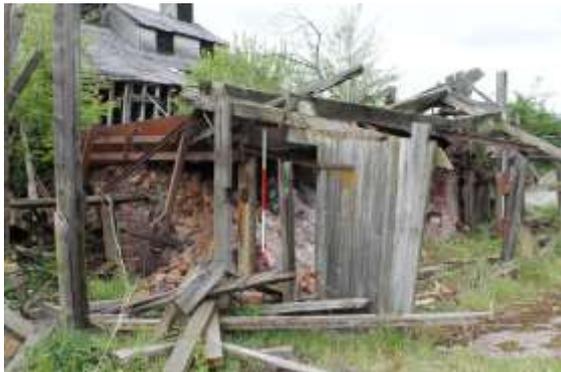
2.55: Pan House 2, in 2012, collapsed remains of the front of the pan, north facing

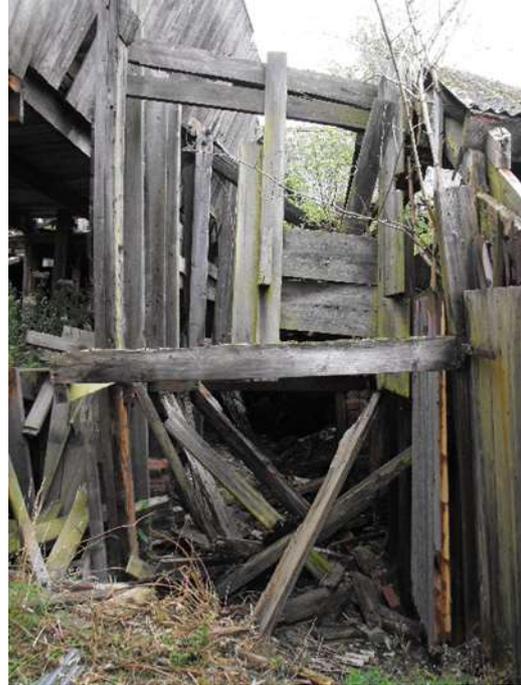
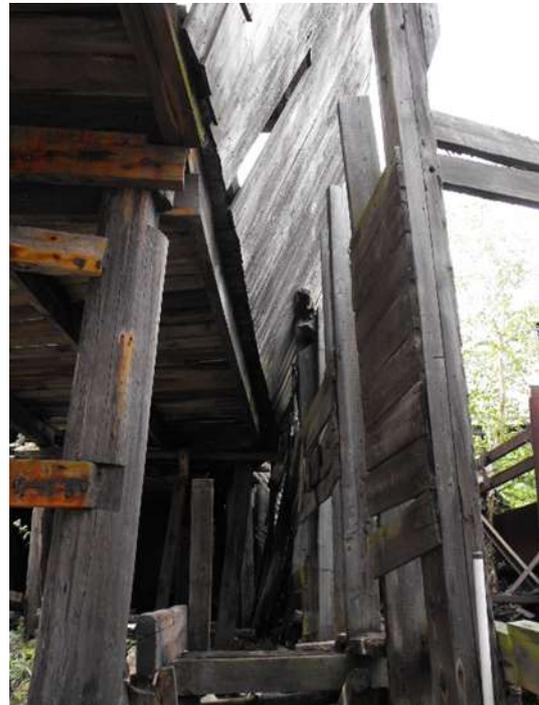
The southern side of the barricades was of stud-wall construction with horizontal planks throughout (BS061, 2.56, 2.57, 2.58, 2.59). The full-height vertical studs (5245, 5246, 5247, 5248, 5249, 5238, 6457) were supported on a sill-beam (5272) that rested on a hand-made red brick sill wall (6651). The hurdle walkway was supported on joists (5271) aligned north-south that in turn rested on an east-west rail at the southern side and rail (5261) and the stove house wall (6638) (see 2.60, 2.61). Few planks of the walkway survived but these were 2.5-3" thick (5236, 5243). The structure was almost entirely collapsed and appeared to have become worse since 2009. The

vertical studs had racked to the east and begun to collapse into the pan. Almost all the hurdle joists and rails had collapsed and the walkway survived predominantly as debris.

2.56: Pan House 2, in 2009, collapsed remains of the southern hurdles, west facing

2.57: Pan House 2, in 2009, collapsed remains of the southern hurdles, west facing

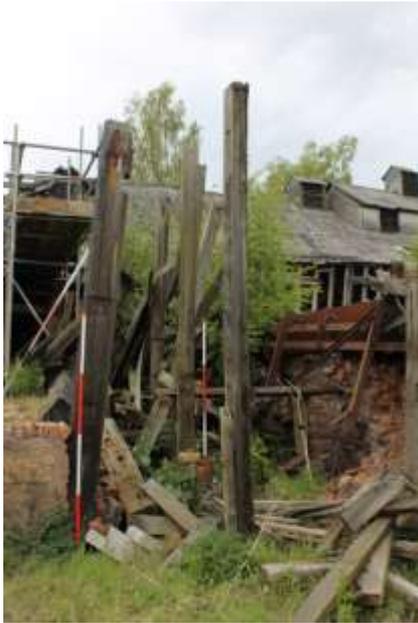
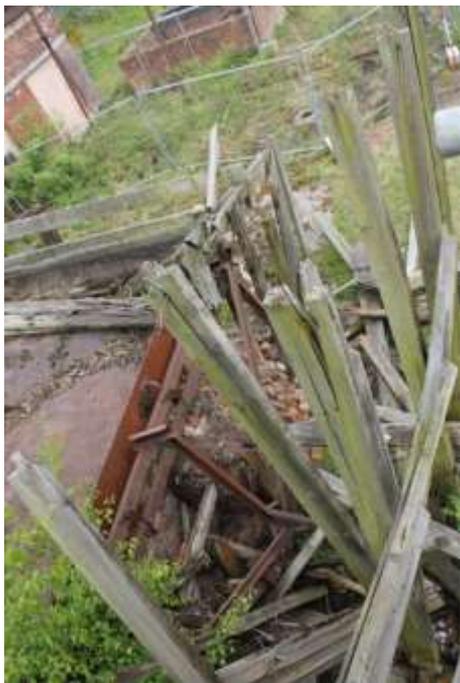
2.58: Pan House 2, collapsed remains of southern hurdles in 2012, west facing

2.59: Pan House 2, collapsed remains of the southern hurdles in 2012, north-east facing

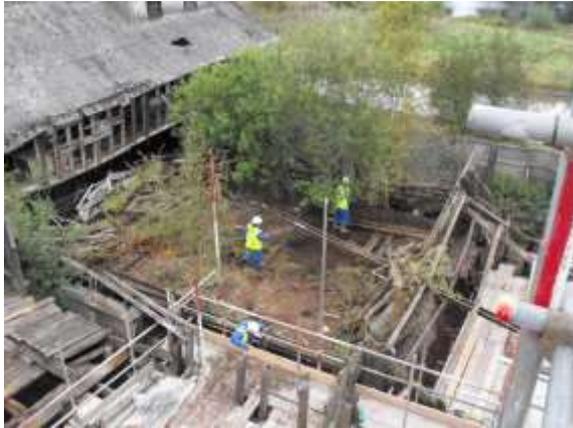
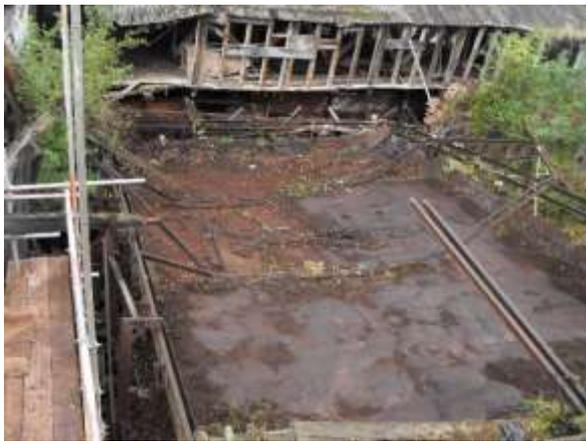
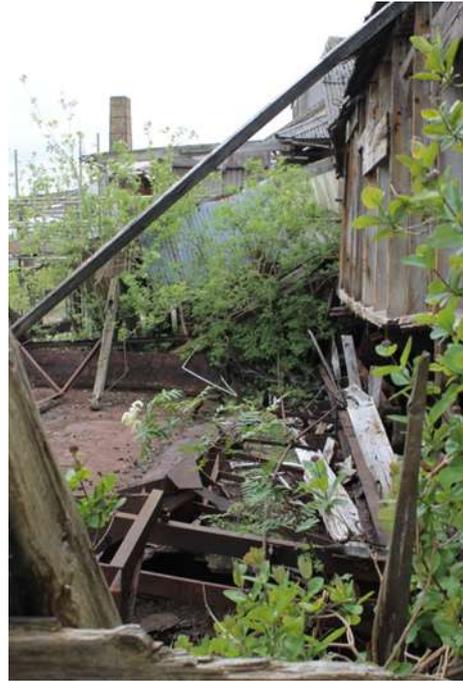
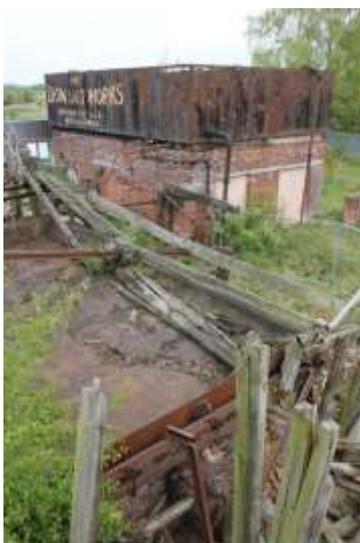
The pan (6652) was of ferrous metal, orientated east-west and survives in poor condition (BS057; 2.66, 2.67, 2.68, 2.69). It was 12.0m (east-west) x 7.20m (north-south), in size. The sides of the pan were of ferrous metal, but whilst the southern and northern sides were vertical, the eastern and

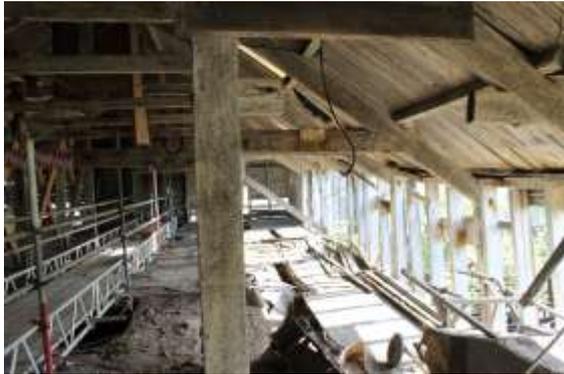
2.86: Stove House 2, warehouse floor, eastern side, north facing

floorboards supported the edge of these salt hatches. A large opening (6608) at the northern end of the warehouse floor allowed the vertical conveyor belt to pass through to the first floor (see above). This had a single trimmer supporting it that had fallen and lay on the floor. An opening (6613) on the eastern side of the floor may denote where belts to drive the crushing machine formerly passed through the floor surface. Throughout the remainder of the floor, decay and remediation work in 2009 had resulted in the loss of floor boards (see 2.86, 2.87, 2.88).

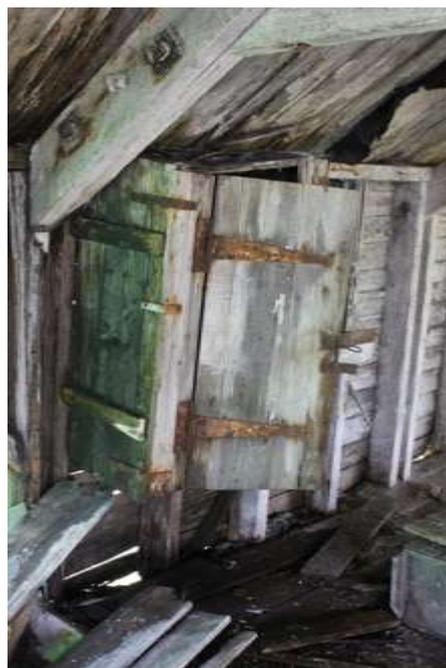
2.97: Stove House 2, electric fuse box, 6635, north-west facing

On the western interior elevation attached to the wall were a series of three wooden fuse boxes. The southern (6633) had mostly collapsed, but one of the northern pair (6635; 2.97) survived *in situ*. The other was collapsed on the floor (5148).

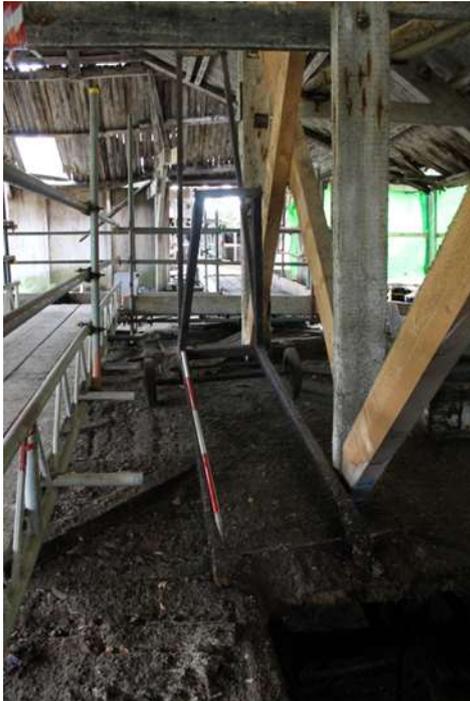
Housed within the building were the remains of a portable conveyor belt (5149, 2.98). This was a machine on two inflatable tyres with a metal frame, and a conveyor belt. The conveyor belt fabric was also found on the floor (5150, 5151). A small portable hopper also existed (5152, Plate 6.10.35). These appear to have allowed salt to be removed from the vertical conveyor belt during

2.98: Stove House 2, portable conveyor belt remains 5149, south facing

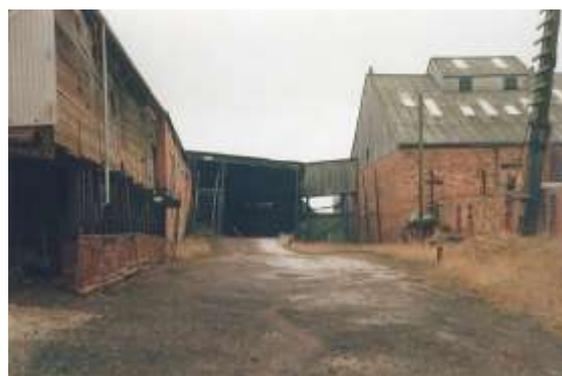
2.100: Loading bay and walkway, c. 1986, north facing

The complex was intact in the early 1990s (see 2.100, 2.101, 2.102, 2.103). The complex in common with many wooden elements of the Lion Salt Works began to decay rapidly once continuous maintenance ceased in 1986. This resulted in the partial collapse of the walkway in the 1990s and elements of the loading bay roof collapsing.

During the 2009 enabling works the walkway was dismantled and stored in the white building. The loading bay was dismantled up to the line of Stove House 4, with the exception of the large vertical timbers. Finally the sloping roof of the packing area was dismantled.

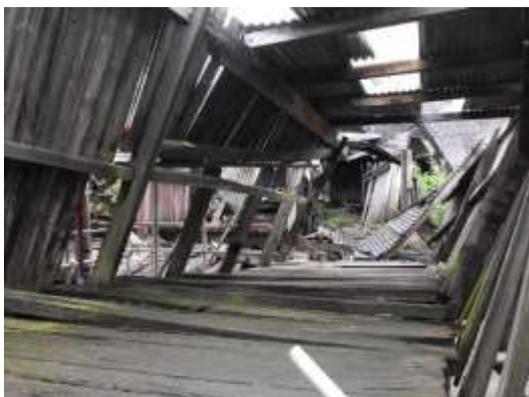
2.119: Walkway, viewed from Stove House 5, collapsed internally, west facing

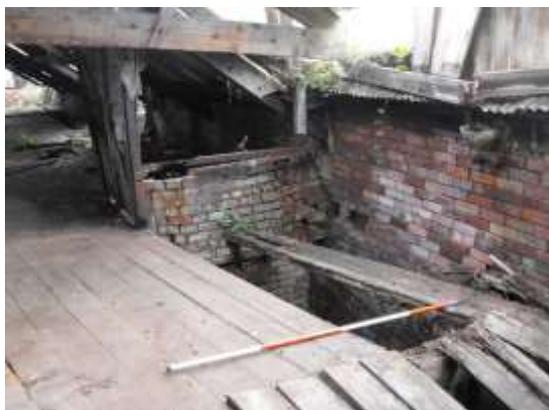
6637, 6484) supported longitudinal and transverse beams (6429, 6474, 2.122). These supported north-south floor boards (5228) that were removed in 2009 as part of the enabling works (2.123). On the eastern side it consisted of a series of square or rectangular cross-section posts (6440, 6442, 6443, 6444, 6445, 6446, 6447, 6449, 6451) supporting east-west transverse beams (6470, 6471) and a series of seven, large, north-south joists (6466). These in turn supported east-west floor boards of the Packing Area (6468). None of the sides of the packing area on the ground floor was enclosed except where it abutted an adjacent building (SH4, SH3, SH2; see 2.124, 2.125, 2.126).

2.123: Packing Area, floor removed in 2009, south-west facing

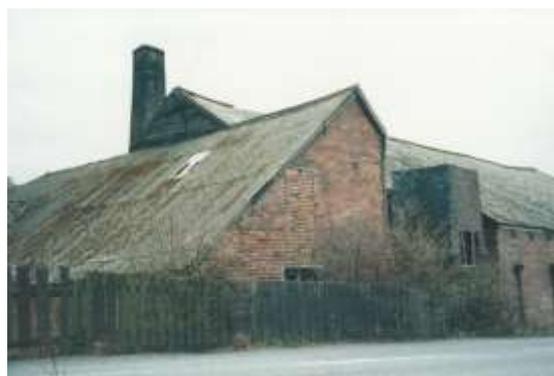
A photographs show its original height in the 1960s, in comparison with the other chimneys on site (2.133). In c. 1980 it was reduced in height, to the level of the eaves of the adjacent Stove House 3 when it became unsafe due to the proximity of Ollershaw Lane (2.134).

2.134: Chimney 1, in 1980s, after reduction in height, south-east facing

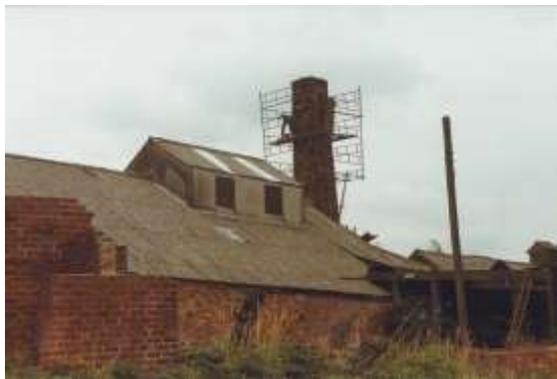
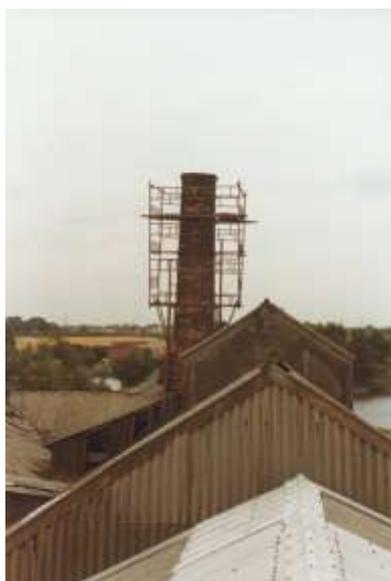
2.135: Chimney 2, taken in early 1990s during repair of upper portion of Chimney, north-west facing

2.136: Chimney 2, with original height visible during 1990s repair, north facing

Remediation work was undertaken in 1991 that saw the top three foot of the chimney removed, re-pointing and the capping of the chimney (2.135, 2.136).

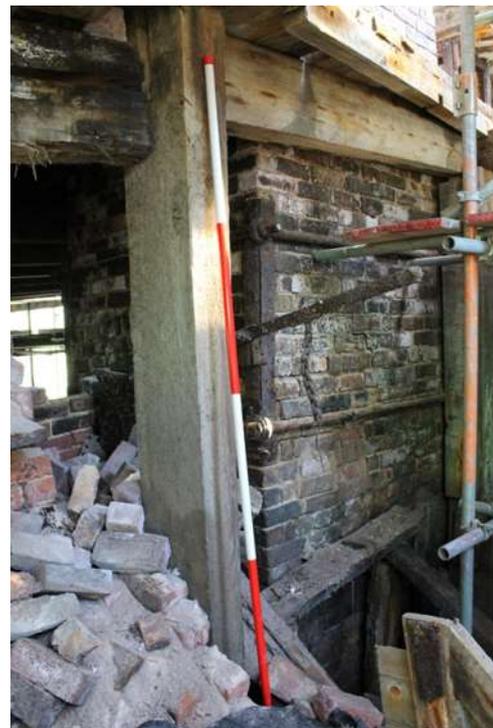
2.144: Chimney 2, note damper plate and arm 6432, south-east facing

The eastern and western sides of the chimney were plain. The excavated evidence from Test Pit 29 (see Volume III) revealed the foundations of the chimney to be corbelled at a depth of 22.20m AOD. The northern side of the chimney had a semi-circular arched opening for the flue. A ferrous metal damper plate and arm (6432) were attached

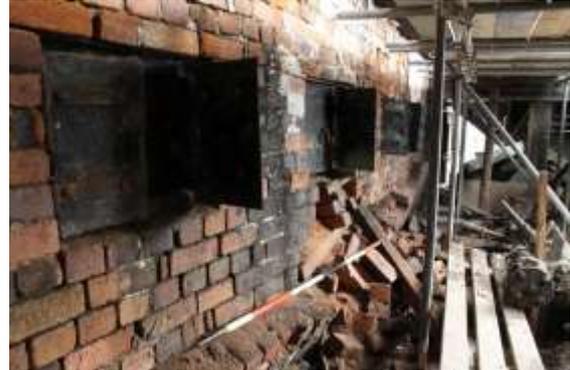
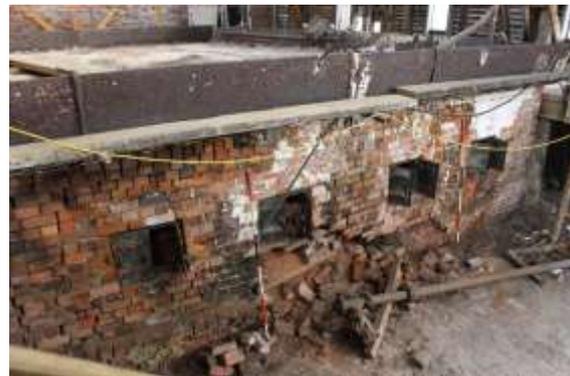
The central kiln consists of a large rectangular structure (c. 7.5m E-W, c. 13.5m in size), externally faced in hand-made red brick in English bond to a height of c. 2.2m. The principal façade of the kiln (6060; BS013) lies to the south with four ferrous metal doors at c. 0.85m from floor level (6061, 6062, 6063, 6064). These allow coal to be fed internally to the fire pans and flues that lie beneath the pan. The kiln contains six flues orientated north-south with narrow interior walls of a single skin of hand-made tallow refractory

style brick in English Garden Wall bond (6075-6081). These walls are in poor condition with no mortar surviving and in a state of collapse. Within each flue is a thick layer of brown-red clinker ash and sand.

2.155: Pan House 3 interior, southern stove elevation

2.156: Pan House 3 interior, southern stove elevation

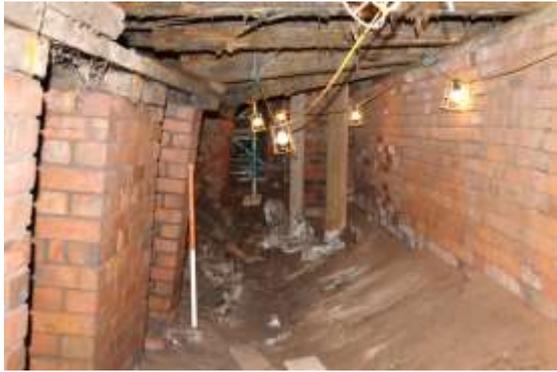
Either side of the kiln is in a state of collapse with repair visible to the brickwork (BS012, BS013). The lower brickwork consists of degraded hand-made red brick in English bond (west 6056, east 6059), on which, is directly constructed an upper, later, layer of hand-made red brick in English Garden Wall bond. The kiln wall is retained by a series of seven large brick piers on the western hurdles (6055, 2.157): three larger piers, 1.0m x 0.7m piers with narrower sets of three piers between, 1.0m x 0.2m. A further narrow pier lay beyond at the northern end. These are built directly on the brick floor of the ditch described below (6057). The eastern hurdles have an identical arrangement of brick piers (6059, 2.158). The largest piers at the southern end were both, on western and eastern sides in an advanced state of collapse.

2.157: Pan House 3, interior, western hurdles, south facing

Either side of the stove is the wooden framework of the hurdles and a brick ditch which served to drain excess brine from the gangway above. On the western side (BS001, BS002; 2.157) is a wide (c. 1.5m) ditch of machine-cut red brick laid on-side in Stretcher bond (6057). It gently slopes north-south and is sloped at an angle of 15-30° either side to a central gutter. This drains via a ceramic pipe to the south into a 1m square, 1.5m deep brick lined sump (6422). The hurdle walkway above is supported by a timber-framework of joists orientated east-west (6054). These are supported on the wall plate of the sill wall to the west and to the east by a longitudinal (north-south) beam lying between the brick piers of the hurdles. This supports a series of longitudinal floor boards that form the first floor walkway (6067, 2.159).

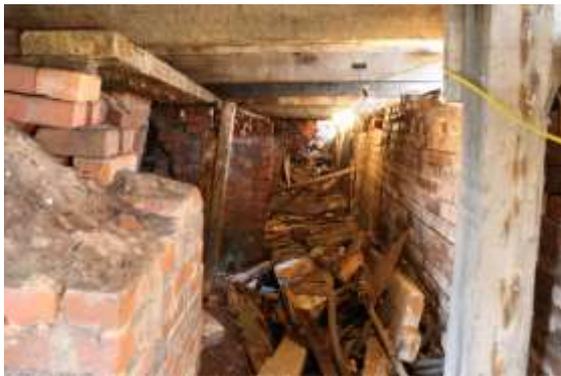
2.158: Pan House 3, interior, eastern hurdles, north facing

The eastern hurdles (BS001, BS002; 2.158) are similarly constructed but there does not appear to be any evidence of the brickwork of the drain at the current time, but a thick layer of humic brown silt rubble lines the floor. At the southern end a

framework of wooden timbers support the larger brick pier. This was partially exposed revealing a void beneath this pier and explaining the advanced state of collapse in which it was found. The wooden framework of joists of the eastern hurdles (6015), continue to the east to support a former walkway (see above). These support the plank boards of the eastern walkway (6068, 2.160).

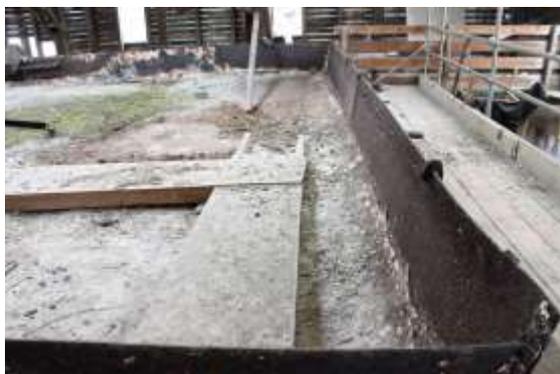
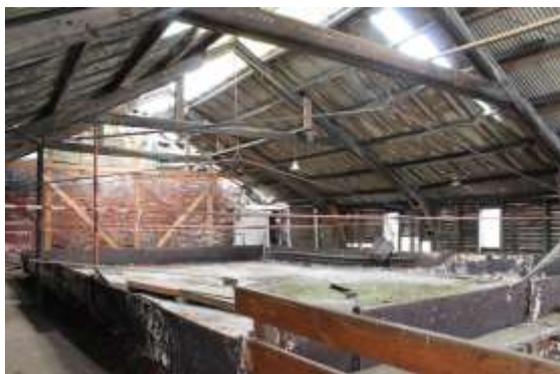
The pan (6046) is c. 11.3m x 7.3m in size, with a 0.6m rim above (BS003; 2.161, 2.162, 2.163, 2.164, 2.165). It is constructed of several sheets of ferrous metal riveted and welded together. At the north-western corner is a square hole known as the cotter hole) to allow the draining of the pan during work. Four large iron eyelets are set evenly on the edge of the pan just in from each corner designed to allow lifting of the pan and to allow access to the stove flues below. In the south-eastern corner of the pan was a wood and L-form steel jigger pillar designed to enable the lifting of the pan (6074, 2.165).

The pan is probably original with extensive repairs. It is doubtful whether any of the original plates survive as repair was a continual element of the job conducted by the 'pansmiths'. ⁴⁵ Details of specifications for the construction of the pan enable an understanding of its construction. The base of the pan was of Siemens Martin steel, the angles of the pan (ie. the corners prior to the sides) were to be of steel or brown iron and 100° obtuse angle and the sides were to be of brown iron. The base was formed of a large number of plates welded and bolted together. The specification and an associated plan shows the alignment of the plates as much thicker towards the front where the fires were placed and narrower to the rear. This meant that the size of the plates reduced but the quantity increased. The thickness of the plates was variable between 3/8" at the front to 5/16" in the middle to 1/4" at the rear. This was clearly designed to accommodate the heat of the fires that would be at its greatest at the southern end of the pan and less at the northern end. The plates were riveted together using 3/4" diameter rivets in the side of the pan and 5/8" diameter rivets in the base of the pan.

Phase 6: The pan may be original but will have been repaired several times.

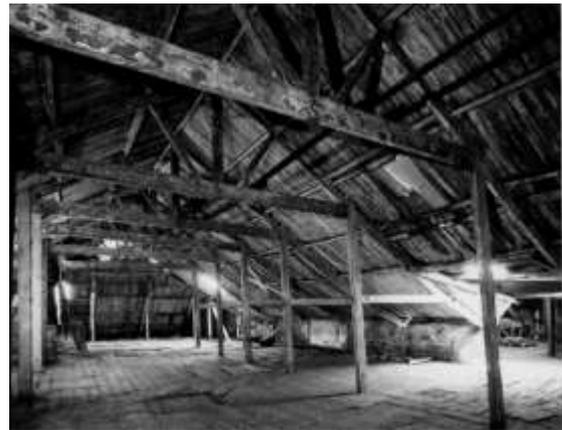
The northern bay of the stove house collapsed in the early 2000s. It was dismantled during the 2009 enabling works. Subsequently the northern wall of the stove house almost entirely collapsed and lies in a derelict state.

2.169: Stove House 3, warehouse level interior in 1989, prior to collapse

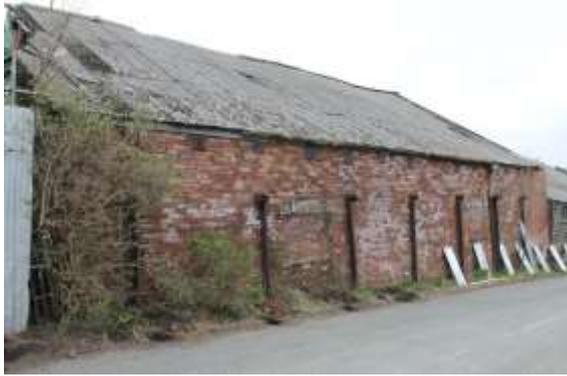
2.171: Stove House 3, northern gable collapsed

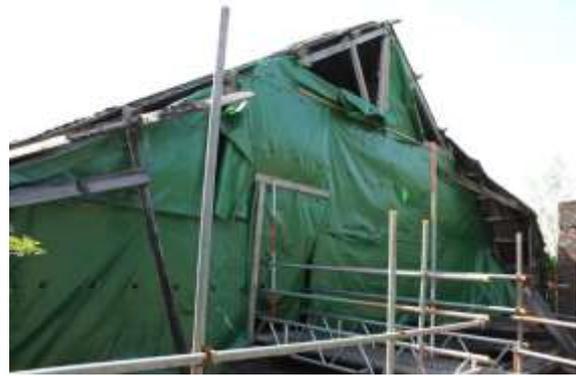
The northern gable elevation had almost entirely collapsed (BS070; 2.171). The remnants consisted of a small portion of curved exterior wall in hand-made red brick in English Garden Wall bond (6098) adjacent to Chimney No 1. A small section of the northern wall in hand-made red brick in English Garden Wall bond had almost entirely collapsed (6194). The remaining collapsed material was still present on site. This northern gable was originally constructed in hand-made red brick to the base of the warehouse level and then the valley roof structure was connected to the former pitched roof of the Link Block.

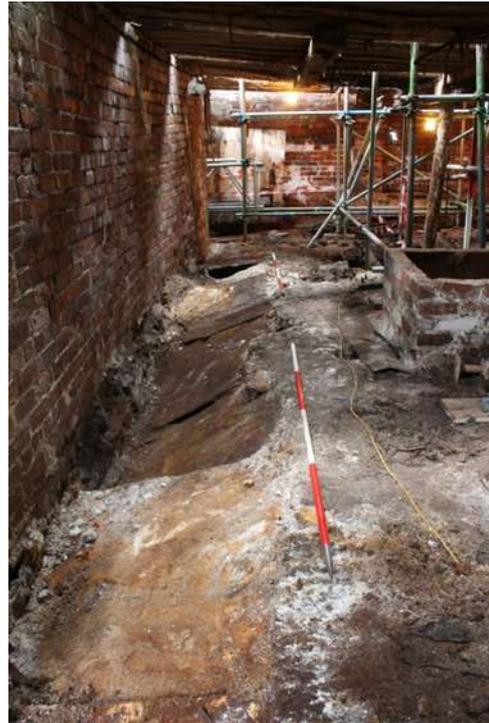
At the southern end, a single below-ground flue runs east-west (6140; c. 1m in width, 2.175), capped by a series of eighteen corroded rectangular ferrous metal plates, with smaller ridged rectangular ferrous metal spacers (6148). These have collapsed and form an uneven floor level. The northern end has a similar flue (6141, 2.176) which has almost entirely collapsed. The flues were fed from the flues beneath Pan 3 (6075-6081) into flue 6140. From their hot air was drawn through the north-south flues (6133-6139) via flue 6141 to Chimney 1 located in the north-west corner.

2.175: Stove House 3, below-ground flue, southern end, west facing

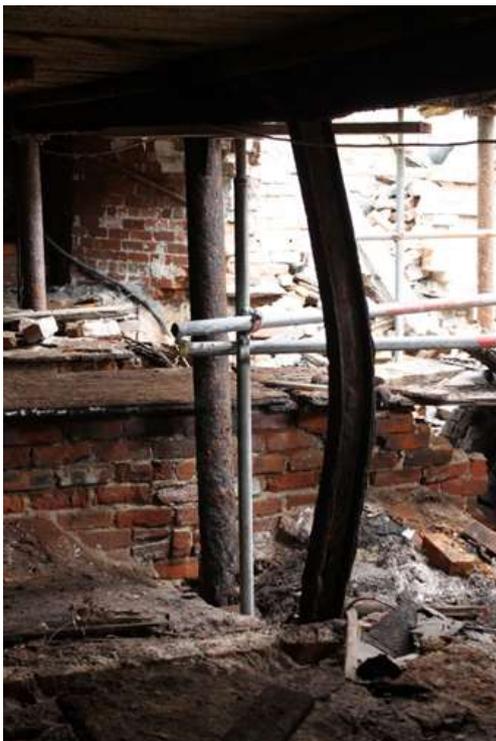
2.178: Stove House 3, interior flue level, column and I-beam support, north-west facing

Two vertical I-beams (6195, 6196) have been used to strengthen the support of I-beam 6131, of which 6196 is heavily bent (2.178). The integrity of the west and east walls were strengthened further by vertical iron rails on the exterior faces (6089-

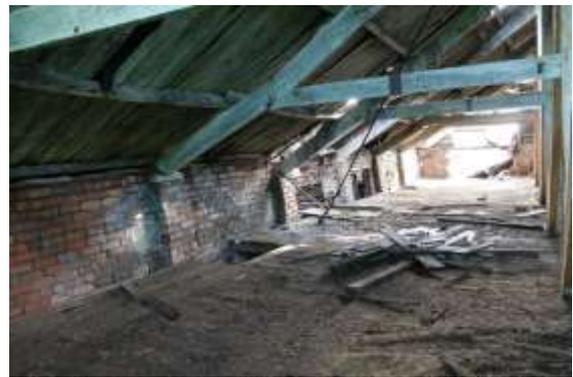
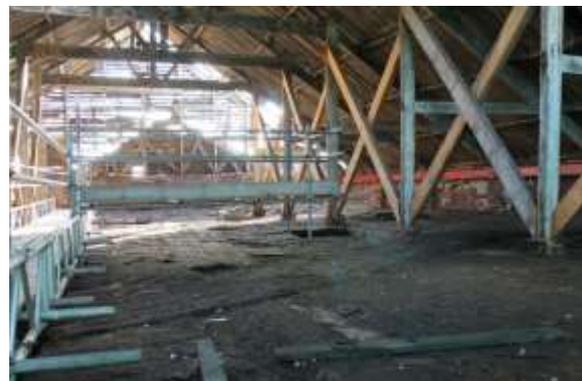
The floor boards of the warehouse level are aligned north-south, 2.5-3" thick and 6" wide (6176), declining to 4" on the outer six boards (6177, 6178). They are of softwood with a cast-iron fillet between the boards. Water damage has weakened the boards in areas. Patching using elm wood planks taken from dismantled salt tubs has been used on the upper surface of the floor boards (6197; BS016; 2.179, 2.180).

2.179: Stove House 3, warehouse level, elm wood floor boards, south-east facing

2.180: Stove House 3, warehouse level, elm wood floor boards, south facing

Phase 6-7: The collapse and decay of some of the floorboards on the warehouse floor resulted in piecemeal patching of the floorboards and strengthening using available material. In this instance it was a combination of discarded wood and the sides of elm salt tubs.

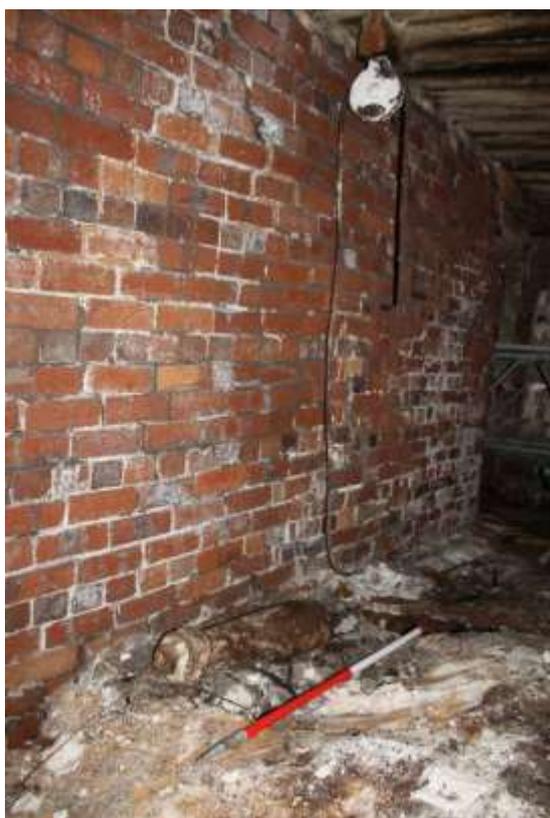
A system of weighted damper plates allowed the flow of hot air through the flues to be controlled from either Pan House 1 or 3. These were controlled by a series of cables along the underside of the beams attached by hooks and pulleys. A large teardrop weight that had collapsed at the southern end acted as a counter-weight for the damper plates (2.182).

2.182: Stove House 3, flue level, tear-drop counter-weight for damper plates and pulley

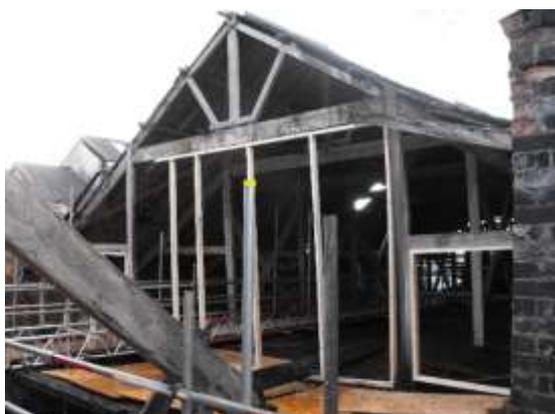
Originally eight aisled trusses (6106-6113; BS017, BS023; 2.185, 2.186) would have supported the roof structure (the northern had collapsed). The seven surviving trusses consist of two aisle posts supporting the principal rafters. The aisle posts rested on a pad that in turn rested on the I-beams of the floor structure. The truss had a tie-beam and central King post. This supported a series of five staggered purlins (6101), of seven members each connected to the principal rafters by clasp joints. The roof was lined with a series of softwood planks laid horizontally (6102). The trusses had been subsequently supported by a series of diagonal wind braces (6104) between the aisle posts as part of the 2009 remediation work. The work also involved the insertion of a large rigid steel joist (6105) to support the upper part of the western wall (6088).

2.186: Stove House 3, warehouse level, trusses of collapsed roof level in 2009, south-east facing

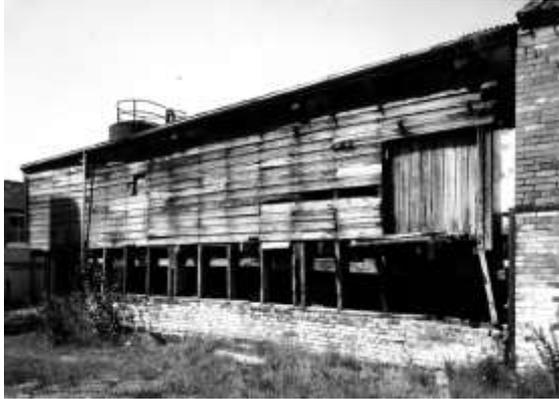
The roof was also altered but the dating is unclear. It has remained unchanged since the 1990s when plastic corrugated sheets covered the apex (2.189). The eastern elevation was originally clad with horizontal planks (see 2.190). It has been subsequently repaired in 1990 (see 2.191) but was again damaged by vandalism and now has only a

2.190: Pan House 4, eastern elevation in 1990, south-west facing

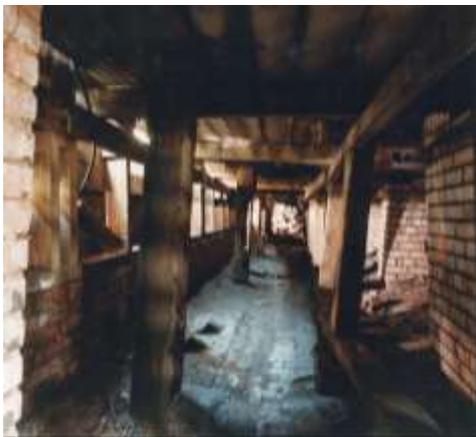
partial wooden cover. The western hurdles survived into the 1990s (see 2.192) but have subsequently collapsed. The interior of the pan house survives largely intact at pan level (see 2.193, 2.194). Collapse of the northern wall has been going on for a number of years and only partially survived during recording.

2.192: Pan House 4, western hurdles prior to collapse, north facing

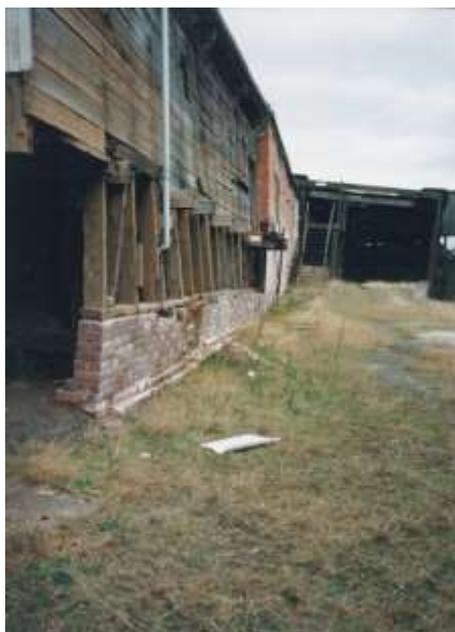
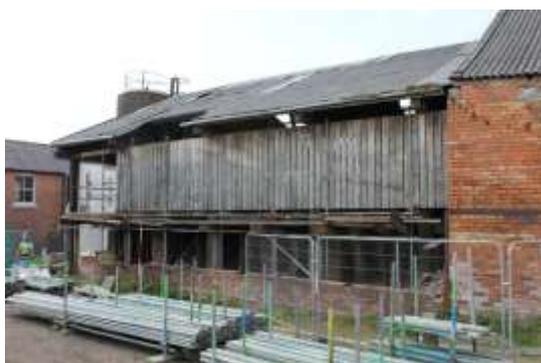
2.199: Pan House 4, eastern elevation, c. 1990, north-west facing

2.200: Pan House 4, eastern elevation, south-west facing

The eastern elevation has been heavily altered (BS029, BS033; 2.199, 2.200). The low hand-made red brick stud wall, again in English Garden Wall bond (6245) survives to a height of c. 1m. The stud wall has been entirely removed, and replaced at the first floor level by a soft wood timber panel wall (6246). The remainder is open.

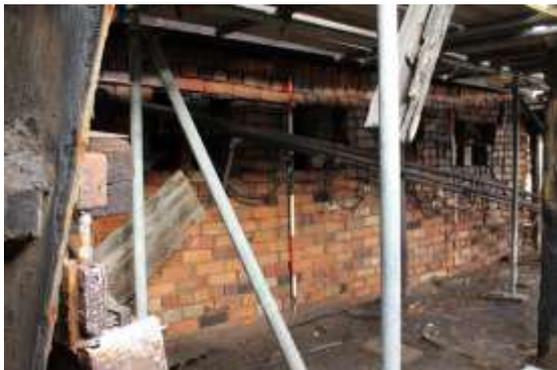
The ground floor is dominated by the rectangular kiln aligned north-south, 12.4m long by 6.2m wide (BS024; 2.201). The principal façade of the stove faced south (6292; BS036) and had four openings onto the firing flues (6293-6296). It is constructed in hand-made yellow-red brick in English Garden Wall bond (7 stretchers to one header). The doors to the stove had been removed and the coal-based system of firing had been replaced with an oil based system fed from the adjacent two-storey oil tank (2.202, 2.203, 2.204, 2.205, 2.206). This was achieved by a series of three ferrous metal pipes which are now highly corroded (6291), with

2.201: Pan House 4, stove southern elevation

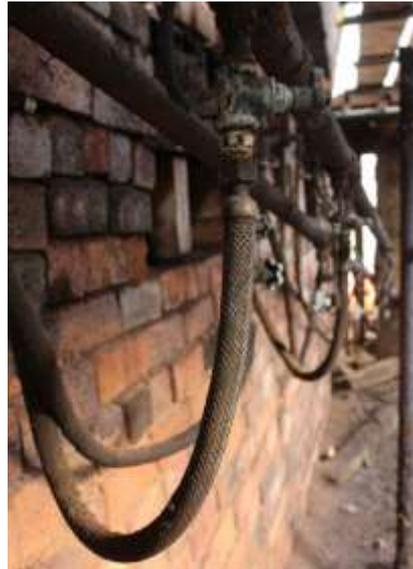
individual rubberised piping feeding to taps mounted at each opening to the firing flues. The three pipes continued horizontally to the south where they were fed by a compressor and regulator (6297) directly connected by a series of valves to the oil tank. The combination of oil under gravity-driven pressure supplemented by the compressor released the oil to spray into the flue thus creating a new fuel source. The remains of the electric fuse board (6298) from the compressor lay discarded to the south.

2.204: Pan House 4, stove, oil apparatus detail, east facing

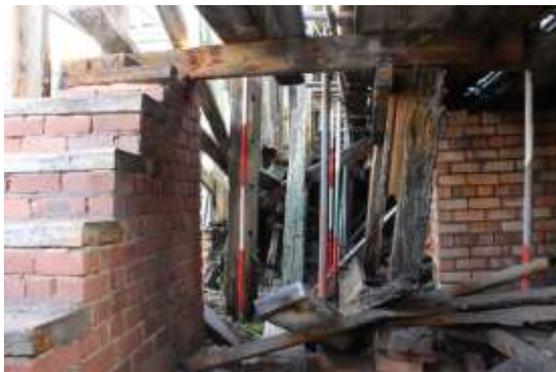
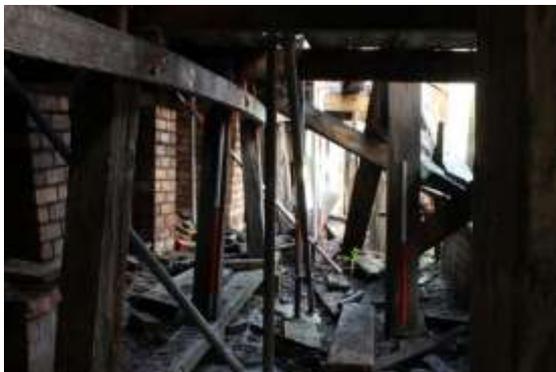
The western wall of the kiln has partially collapsed and two phases of brickwork are visible (BS035; 2.207, 2.208). The earlier consists of degraded hand-made red brick in English bond (6277). The stove has been rebuilt directly over this on the western side by a layer of hand-made yellow 'stock type' bricks in English Garden Wall bond (6282). A series of four rebuilt brick piers retain the kiln wall, forming five bays (6280) again of hand-made yellow brick in English Garden wall bond. The piers are of two sizes, the larger two on the outside, with the smaller two on the inside. All are built directly on the brick floor of the ditch (6221).

2.207: Pan House 4, western hurdles, north facing

2.208: Pan House 4, western hurdles, south facing

The timber-framework of the western hurdles (2.207, 2.208) is supported on the west by a large rail mounted on the studwork wall of two timbers, scarf jointed together (now removed, 5073); a central support consisting of a series of horizontal posts mounted on a sill beam with a beam above (6276) and on the east a long-beam running along the top of the brick piers. This framework supports a series of five horizontal joists, mounted in pairs or triplets that run east-west (originally seven joists, two have collapsed, with 11 timbers

surviving). These in turn support 9" wide, 3" thick floor boards of the hurdle walkway (6253; 2.211), which are orientated north-south. At the time of recording the western hurdles are badly damaged, with partial collapse centrally where rain infiltration from missing roof boards had caused decay and ultimately collapse (5071, 5072). This has been worsened at the northern end of the hurdles where the collapsing wall (see above) has led to the collapse of much of the very northern end of the hurdles.

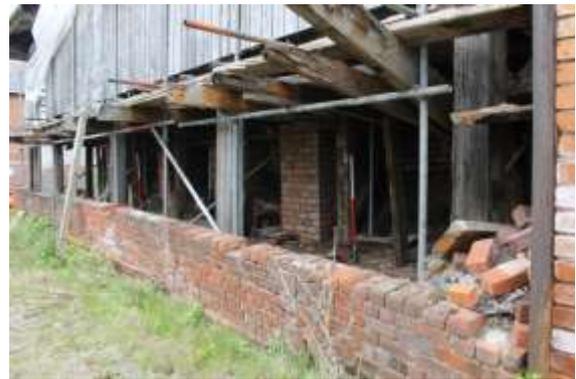
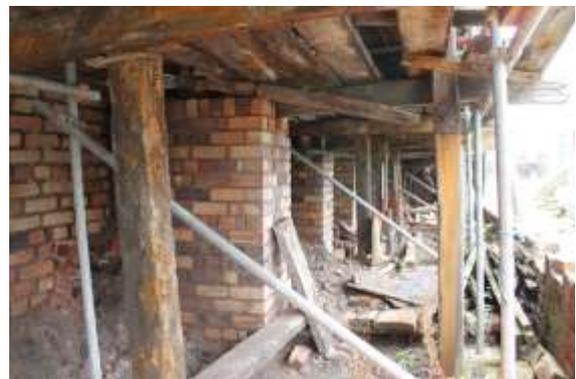
The eastern wall is similar to the western (BS033; 2.209, 2.210). The original kiln wall is again of two phases, the earlier hand-made red brick in English bond (6279) beneath a phase of yellow 'refractory type' bricks in English Garden Wall bond (6283). The brick piers are again of hand-made yellow-brick in English Garden Wall bond (6281), with again two larger brick piers either side of two smaller central ones.

2.209: Pan House 4, eastern hurdles, south-west facing

2.210: Pan House 4, eastern hurdles, north facing

The eastern hurdle (2.209, 2.210) supports are similar to the western side consisting of east-west horizontal joists (6259; 16 in total, in 9 sets)

supported on the edge of the stove wall and a row of central posts (6278). Vandalism to the outer stud wall means they were free-standing on this side. The joists have begun to collapse at the northern end where the partition wall has collapsed. These supported a series of 9" wide, 3" thick floor boards (6258, 2.212) that intermittently survive and form the eastern walkway adjacent to the pan. The ditch of the eastern hurdle (6260) is again of machine-cut red brick laid on-side. It slopes north to south, with sides sloping at an angle of 15-30°. At the southern end it drains into another brick-lined sump of hand-made red brick construction (6300).
