THE ALLIANCE AND LION SALT WORKS, MARSTON, NORTHWICH

THE FINAL REPORT:

VOLUME IV – HISTORIC BUILDING RECORDING

REPORT NO 2015-01

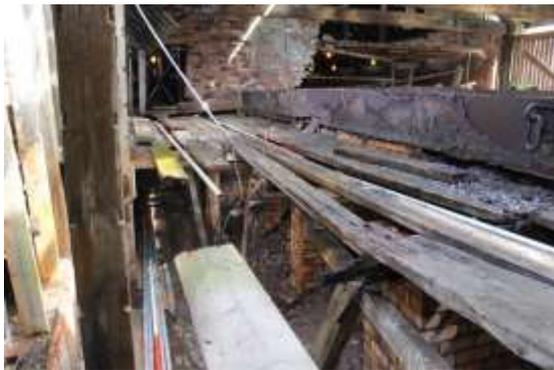
surviving). These in turn support 9" wide, 3" thick floor boards of the hurdle walkway (6253; 2.211), which are orientated north-south. At the time of recording the western hurdles are badly damaged, with partial collapse centrally where rain infiltration from missing roof boards had caused decay and ultimately collapse (5071, 5072). This has been worsened at the northern end of the hurdles where the collapsing wall (see above) has led to the collapse of much of the very northern end of the hurdles.

2.211: Pan House 4, western hurdle floorboards, north facing

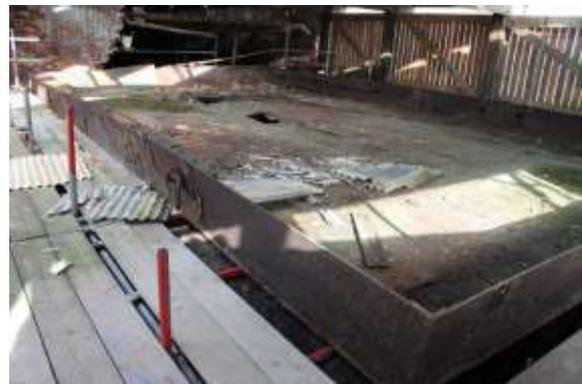
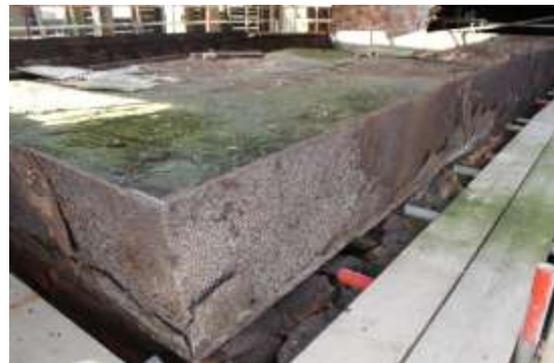
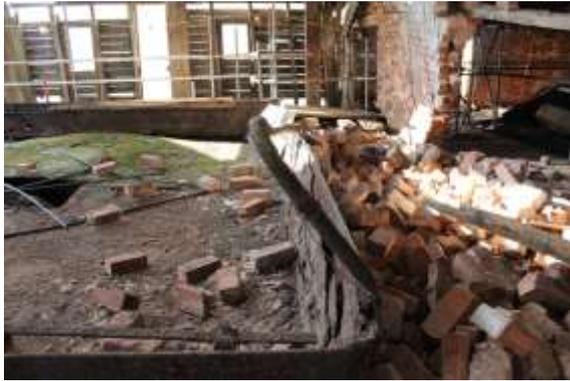
2.213: Pan House 4, pan, north-west facing

2.214: Pan House 4, pan, north-east facing

The pan (6250) is 10.7m by 6.2m in size of ferrous metal sheets welded and bolted together (2.213, 2.214, 2.215). It rests on top of the stove structure with an overhang above the stove at its southern end. A series of salt dogs, of ferrous metal hang on both the western and eastern sides. At the southern end the remains of the ferrous metal supports for the dodging planks survive. The remains of a ferrous metal brine pipe rise vertically from the floor before emptying into the pan (2.216). Damage has been caused to the pan base

where the wall has collapsed southward at a number of times over the years.

2.215: Pan House 4, pan east facing and wall collapse

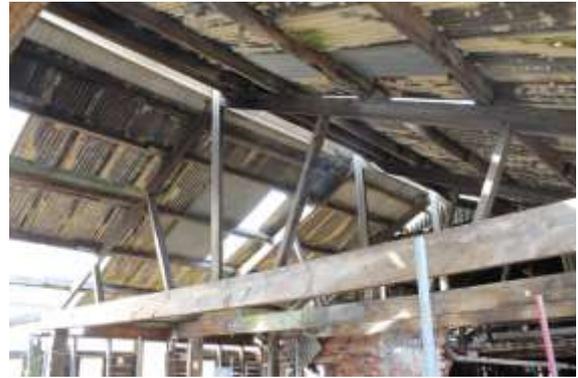
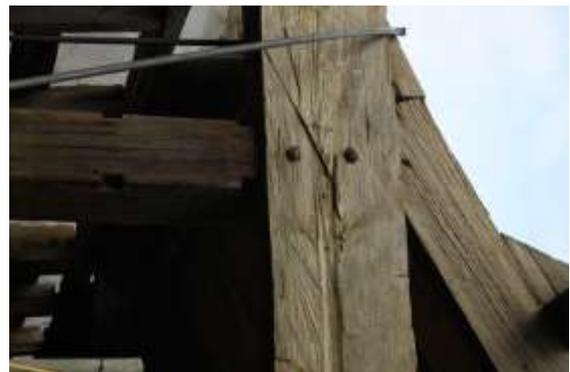
The roof trusses all replace earlier hipped roof. A series of ten large posts support five roof trusses (west 6213-6217, east 6212, 6241-6244; BS034, 2.217, 2.218). The posts display carpenters marks and are cut with joist sockets along their length suggesting that they are re-used longitudinal beams. The five trusses (6230-6234) are of King post design with raking struts to the principal rafters. The tie-beams are likewise re-used but have been cut to size using a chain-saw, as the

2.217: Pan House 4, trusses, north-west facing

2.218: Pan House 4, truss detail, north facing

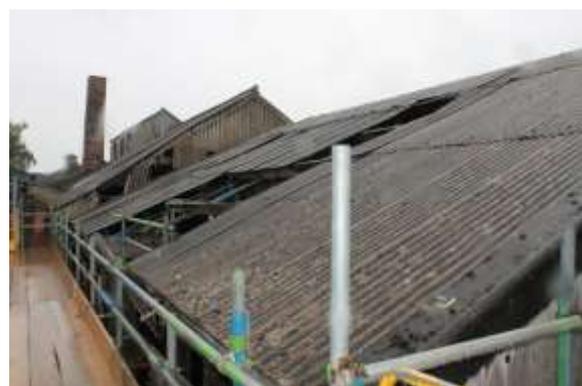
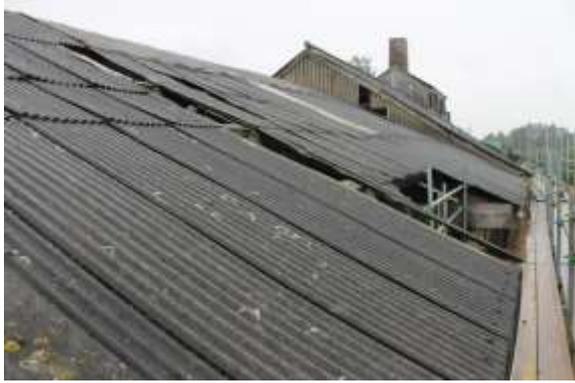
marks are clearly visible on the faces. The trusses support a series of five staggered purlins on either side (west 6249, east 6256) each purlin consisting of five members. The purlins are clasp jointed to the principal rafters. The roof is covered with corrugated cement asbestos sheets (6239, 6248; 2.219, 2.220).

2.219: Pan House 4, roof, western elevation, north facing

2.220: Pan House 4, roof, eastern elevation, north facing

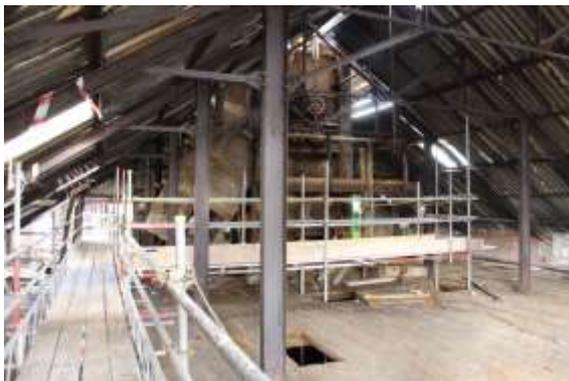
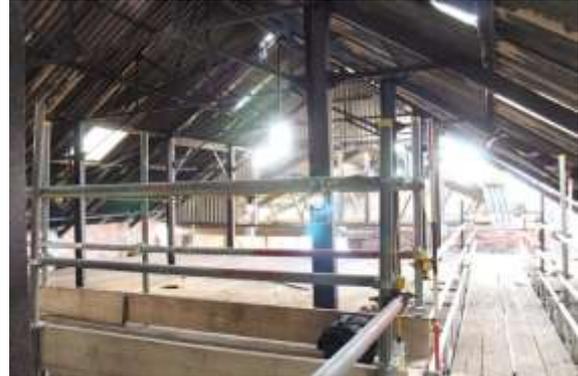
The floor boards of the warehouse level (6332; 2.233, 2.234) were of soft wood, 9" wide and 2.5-3" thick, with a ferrous metal fillet in-between each board. They narrowed to 6" wide on the outer six to seven boards (like Stove House 3) but most of these had decayed or been removed. Within the floor boards were a series of twelve salt-traps (6360-6371; e.g. 2.235), designed for 'lumping' the salt to the warehouse floor above. These were open rectangular holes, c. 1.0 x 1.1m in size, supported by trimmers on northern and southern sides. Each salt-trap had either two thick plank hatches or a series of five or six planks by which they were covered and closed. These have been largely removed or are labelled and stored (e.g. 5120-5127).

2.233: Stove House 4, interior warehouse level, north facing

2.234: Stove House 4, interior warehouse level, south facing

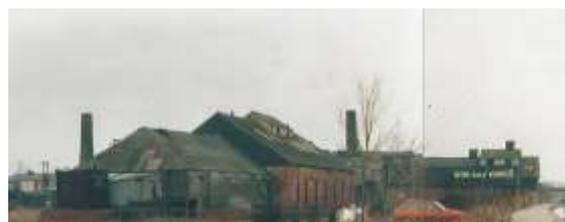
3.3: Pan House 5, 1986, south-west facing

The southern (see 3.2) and northern (see 3.3) elevations were similar and were made of a low hand-made red brick stud wall (described below, surviving in 2009 but now removed). Above this the barricade was constructed of vertical studs running the full height of the building. These were covered with horizontal planks in common with the design of other pan houses on the site. The southern elevation had a single doorway at ground floor level, a second doorway at first floor level and two plain windows. The northern elevation had a single doorway opening at ground floor level. A doorway at the western end at first floor level and partially constructed steps for access are also visible. No windows are visible.

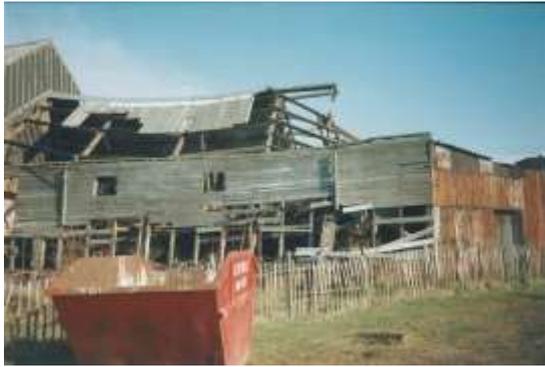
3.4: Pan House 5, during collapse in 1995, north facing

The structure began to collapse in the 1990s. It was intact in 1990 (see 3.2) but was poorly preserved by 1995 with the structure only partially surviving (see 3.4).

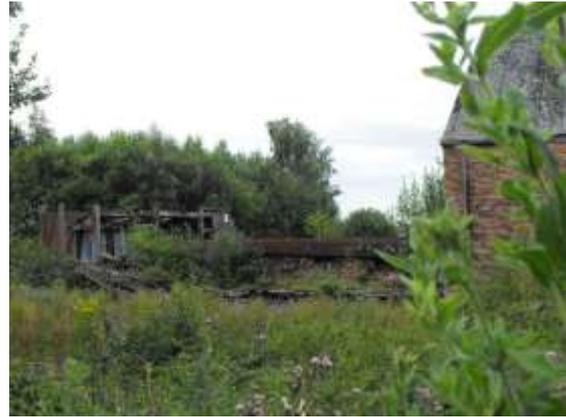
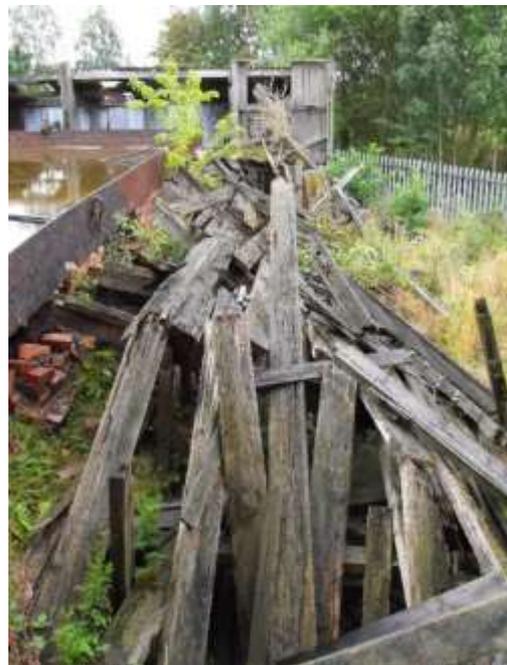
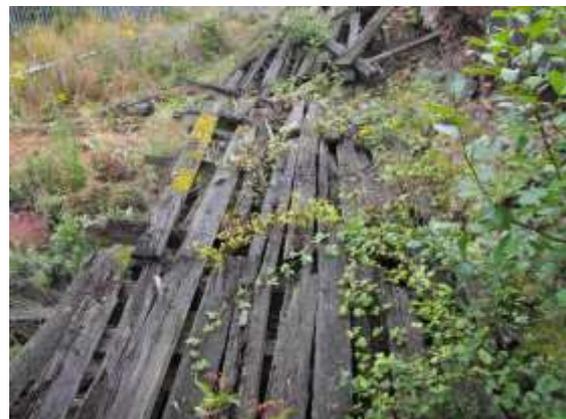
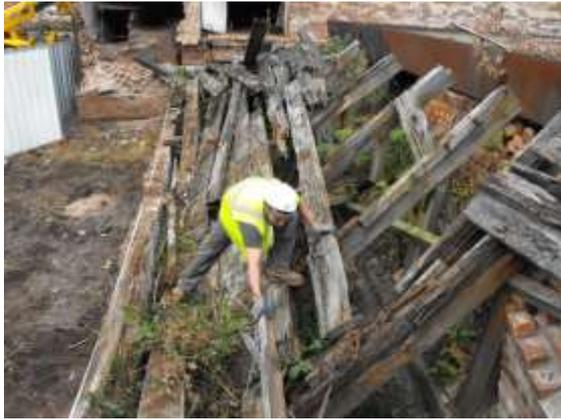
It was dismantled as part of the 2009 enabling works and this report forms a description of the pan complex prior to its dismantling (see 3.7, 3.8, 3.9, 3.10 for images of the state of decay by 2009).

The timber structure of the southern hurdles only partially survived. The majority was removed during enabling works. This included the hurdle walkway of 3" thick timber boards (see 3.10). The scantling and framework of north-south joists had collapsed and was laid at an angle (3.17). In turn a wooden framework supported this. It consisted of two east-west aligned sill beams and a series of vertical posts mortice and tenon jointed into them (see 3.15, 3.16, 3.18). To the west (beyond the first brick pier) were four posts, centrally (between the two brick piers) were a further five posts and to the east were a further two posts (east of the final brick pier).

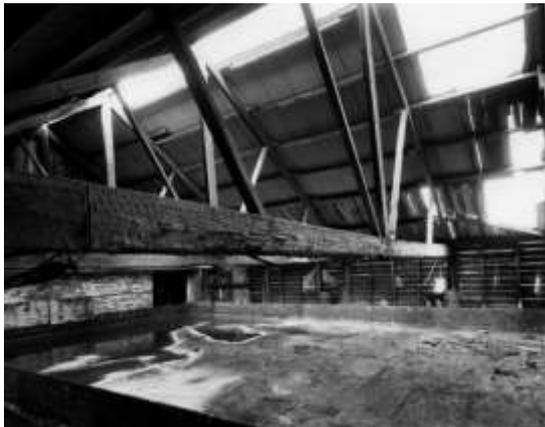
3.5: Pan House 5, interior 1990s, north-west facing

The roof structure was hipped at the eastern end and covered in corrugated ferrous metal. The upper element to the apex of the roof was open to allow steam to escape. Internal images (3.5) reveal that the roof was supported on a series of wood roof trusses of king post design with a series of two raking struts either side. On either side these supported six sets of staggered purlins (three to each set minimum).

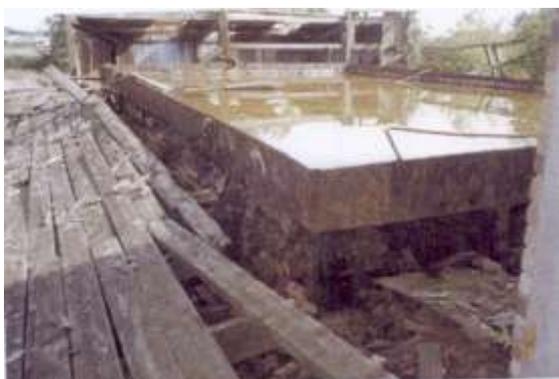
3.6: Pan House 4, after collapse in 1997, south-east facing

The pan was placed centrally and is described below. Either side were a series of wooden walkways above the hurdles. An image from the 1990s shows the collapsed state of the walkway and caboose (3.6).

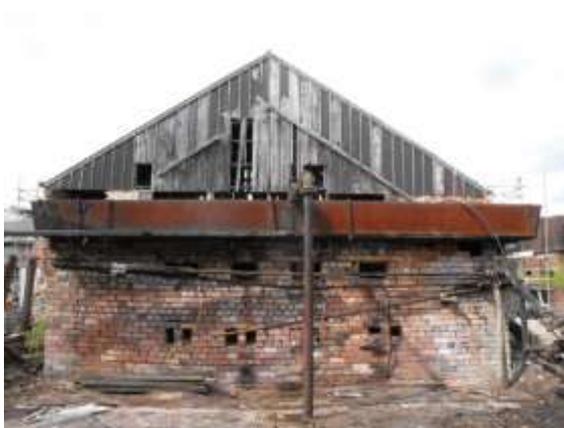
3.11: Pan House 5, stove, eastern elevation

The stove survived in a poor condition. The principal eastern elevation was constructed in hand-made red brick in English Garden Wall bond, the absence of mortar suggesting it was salt or clinker based and had decayed (BS080, 3.11). A series of four openings without stove doors allowed access to the flues beneath the pan. Each of the openings was oil fired as part of the latest phase of fuel development (3.12, 3.13). These were served by a series of three ferrous metal pipes which attached to valves at the openings. The cast-iron brine pipe to feed the pan survived in situ (3.14). It was vertical, about 7" in diameter and turned level with the pan to empty over it. At the time of recording it was free-standing positioned c. 0.5m from the pan and the upper edge was resting against the edge of the pan.

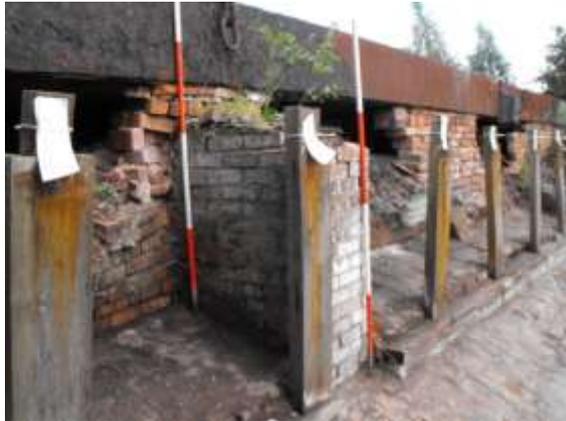
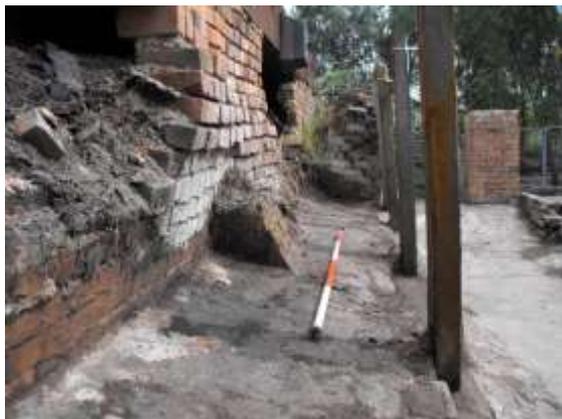
The southern elevation of the stove (BS079, 3.15, 3.16) was collapsed or partially collapsed hand-

made red brick bonded with a mix of headers and stretchers that had no pattern. No mortar was discernible between the bricks and had clearly corroded away due to exposure to salt. Two large brick piers retained the wall and were built over the remains of a wide machine-cut brick lined drain that ran down the eastern edge of the stove.

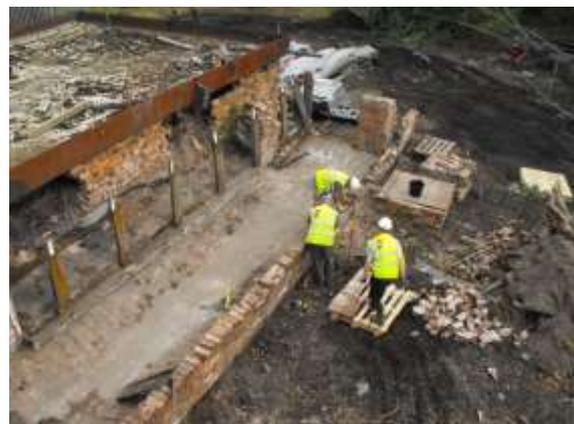
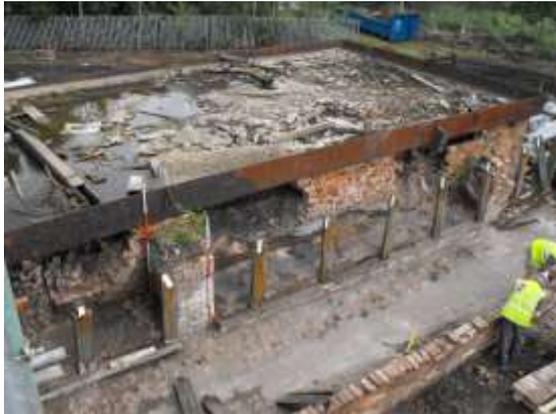
The archaeological remains of the barricades on the southern side were represented by the sill wall of hand-made red brick in English Garden Wall bond (3.19, 3.20). This survived to a height of c. 0.8m in height. A series of steps built in hand-made red brick ran east-west and would originally

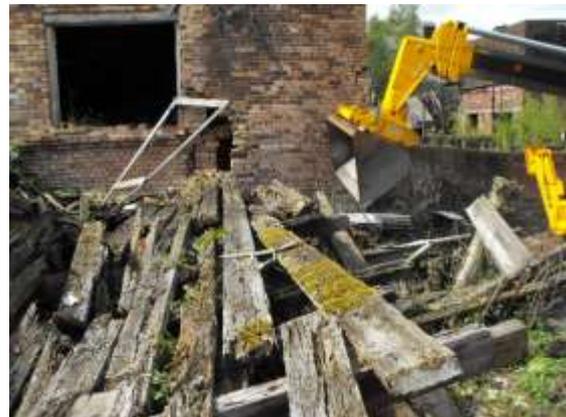
3.28: Pan House 5, northern hurdles and walkway during dismantling, west facing

The sill wall of the barricades survived to its full height of c. 0.6-0.8m, but had collapsed elsewhere (see 3.25, 3.26, 3.27). The timber structural elements of the northern hurdle survived collapsed in situ. These were removed during enabling works (3.28). They consisted of 3" thick timber planks of the walkway and the north-south joists of the underlying walkway. They were

supported by the collapsed element of the western central sill beam and a series of posts that had collapsed.

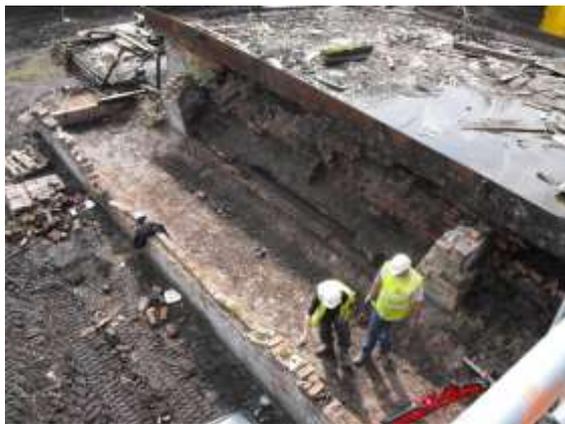
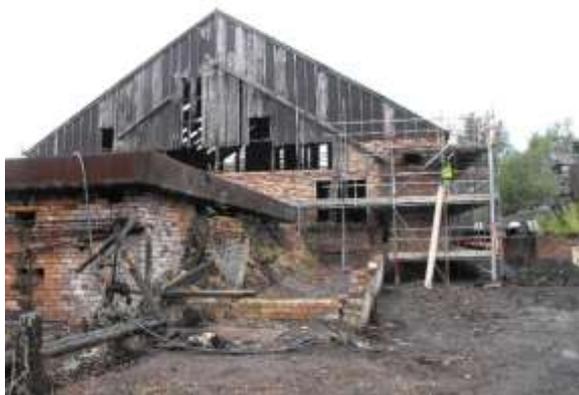
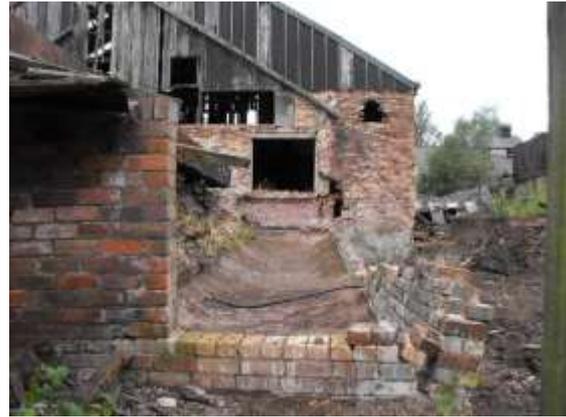
The northern elevation of the stove was in much poorer condition than the southern (BS081, 3.25, 3.26). It survived best at the front of the pan where it was visible constructed in hand-made red brick in Stretcher bond. The central and western section had almost entirely degraded or collapsed and was visible only as fragmentary bricks with no discernible mortar. The northern side of the stove, was retained by two large brick piers like the southern side. This overlay the remains of a wide brick drain, skimmed with concrete as before (3.27). It likewise sloped west to east and drained via a ceramic drain to the east. It is not clear where this drain passed from here but it is anticipated that it turned to the south to exit into the sump described above.

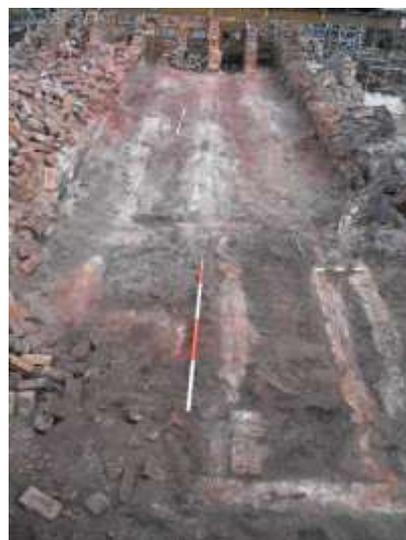
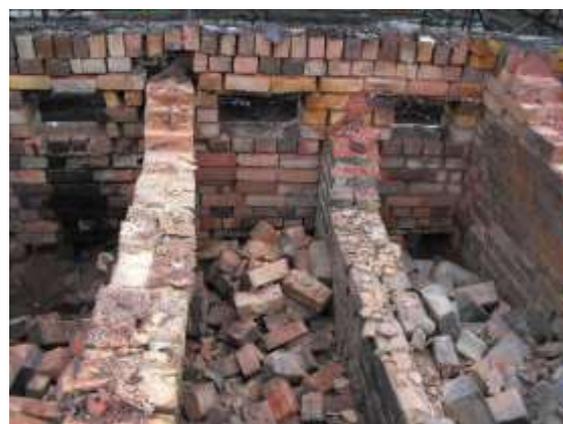
of flues were two skins thick and constructed of hand-made yellow 'refractory style' brick in English Garden Wall bond (3.32, 3.33). The space between the outer flues and the stove wall, the dead draft, was filled with a mix of ash and clinker visible in the collapsing sections of the outer wall.

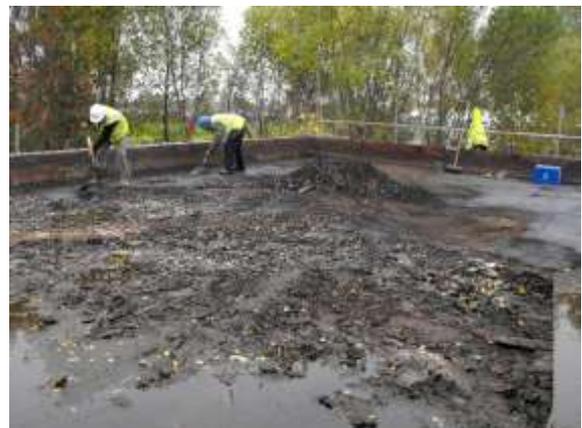
3.43: Pan 5, on scaffold during cleaning of interior salt residues, north facing

During the restoration process the pan was lifted into its current location (2009-2014). The salt scale was cleaned from the interior of the pan and the pan was treated to prevent decay (3.43, 3.44).

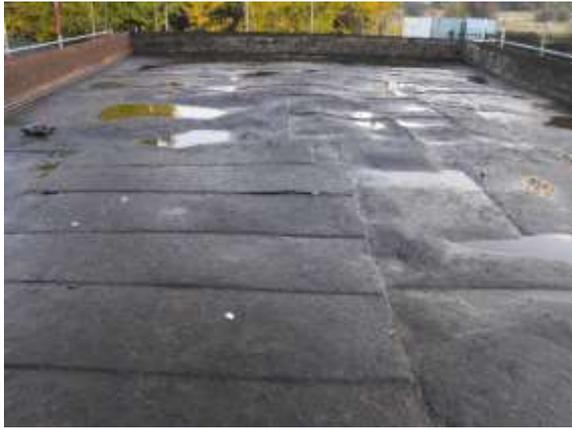
3.44: Pan 5, after cleaning, north facing

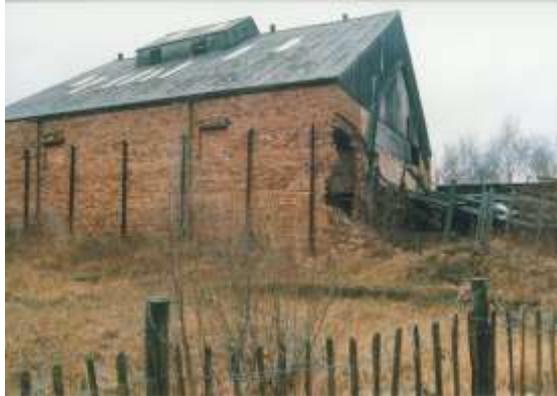
3.47: Stove House 5, after the collapse of Pan House 5 in 1997, north facing

The stove house began to deteriorate around the same time as Pan House 5. Notably a large collapse of the south-eastern corner of the stove house occurred prior to 1997 (see 3.47).

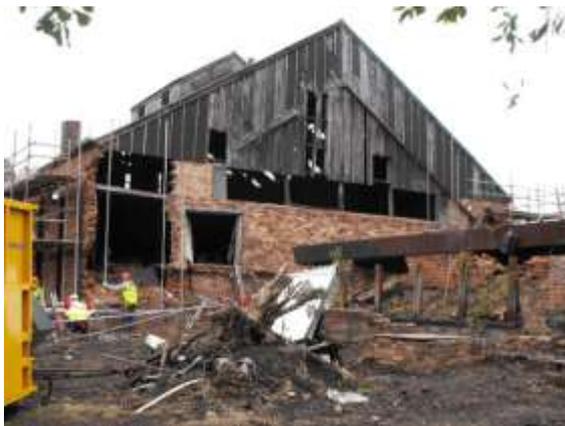
The principal elevation faced east towards the pan house (BS091; 3.52). It was gabled and built in hand-made red/ yellow brick in the English Garden Wall bond to above the second floor level (about c. 1m above the level of the warehouse floor). This was carried up through the gable in a wooden stud wall clad in vertical planks that had been felted underneath. The remnants of the gable of Pan House 5 were visible against the exterior wall as a line of surviving rafters. Two openings survived from the original access between Pan and Stove House 5 at first floor level. These were located equidistant apart at first floor level in line with the original location of Pan House 5 hurdles. They had substantial wooden posts and wooden lintels above. The doors had been removed. Two further openings to allow light existed in the warehouse level of the wooden gable. The south-eastern corner of the Stove House had collapsed and a large fissure existed on the eastern elevation.

3.52: Stove House 5, eastern elevation

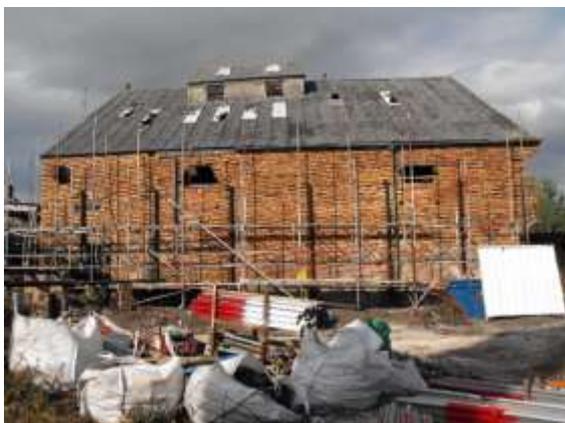
3.53: Stove House 5, southern elevation, north-west facing

The southern elevation was entirely built in hand-made yellow/ red brick as above (BS090; 3.53). It was reinforced by a series of six vertical ferrous metal I-beams reused from railway lines that tied into the horizontal beams that supported the warehouse level floor. The joint was made via a bolt through both members at their end. The elevation had a single central window opening. This was originally a wooden casement window (visible on historic photos) but had subsequently been bricked up.

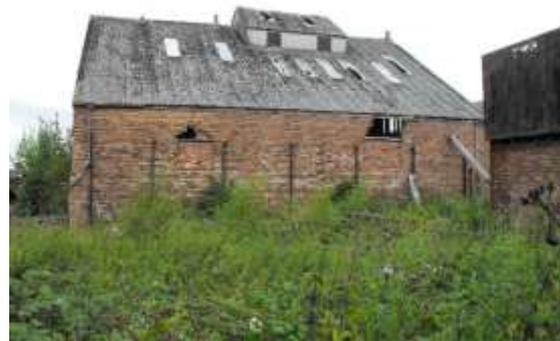
The northern elevation (BS092; 3.54) was almost identical to the southern elevation and again adopted the system of six vertical I-beams to reinforce the wall, whilst tying the horizontal beams into the structure as a whole. Two windows were located in the northern elevation.

3.54: Stove House 5, northern elevation

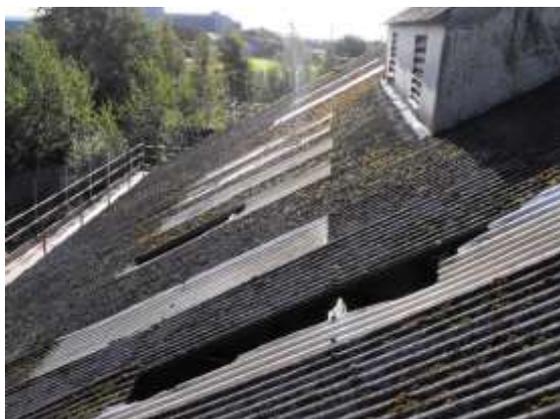
3.57: Stove House 5, roof, east facing

The roof was pitched, with wooden panels underneath and covered in corrugated cement asbestos. Cement asbestos and wood weather boards covered either gable (BS084; 3.57, 3.58, 3.59). The roof had been altered and a series of eight corrugated plastic sheets had been inserted to act as skylights. Set in the apex of the roof was a louver c. 1m in height with wooden sides and a corrugated cement asbestos roof. Rising from both the eastern and western apex was a square cross-

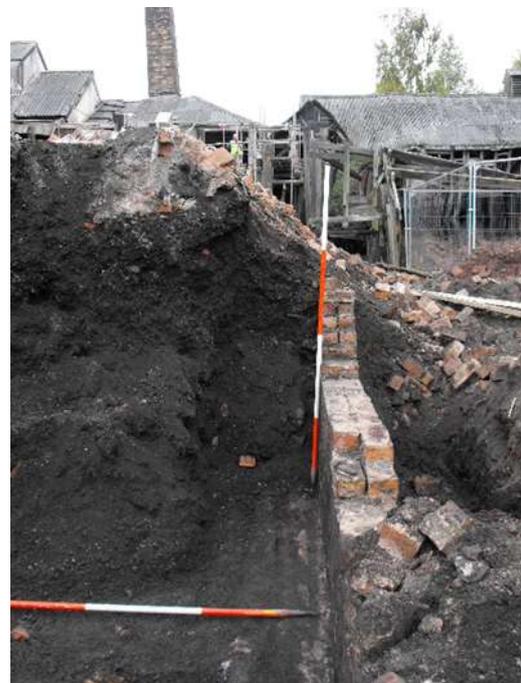
below, see 3.63) to below ground level. The beams were set in concrete plinths at their bases. The interior space between the foundations was subsequently filled with a thick layer of black clinker ash material to a depth of c. 1.75m (see 3.64). Occasional longitudinal-walls were visible uncovered during the watching brief when the layer was machine-excavated. These may have supported the flue walls or more probably the line of columns above.

3.64: Stove House 5, remains of the northern wall and foundation base, build-up of ash in interior, west facing

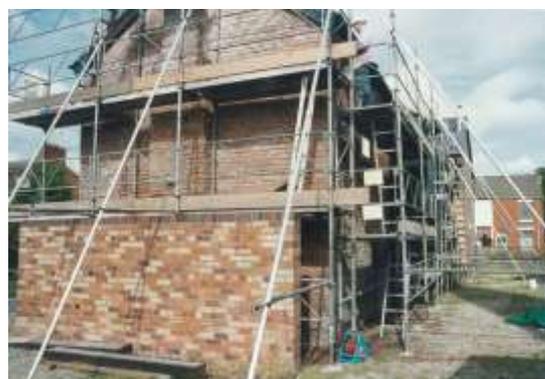
Between 1987 and 1989 it was refurbished by Vale Royal Borough Council and the Groundwork Trust. The refurbished buildings can be seen in 4.1, 4.2, 4.3, 4.4.

4.4: Red Lion Inn, repairs in the 1980s, east facing

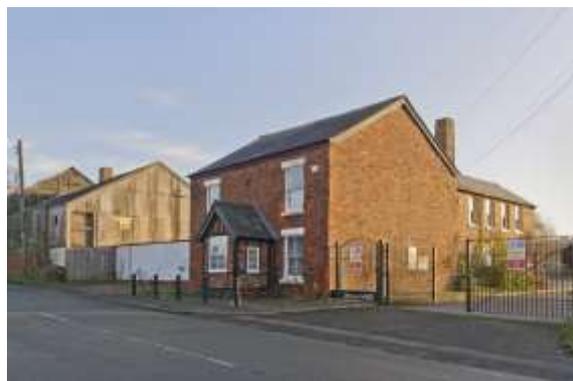
4.5: Red Lion Inn, north-east facing

The southern and northern elevations are gabled. The southern elevation (5000; BS130; 4.5) is built in hand-made red brick in a mixed bond of English Garden Wall style. The brick quality is poor, heavily degraded and cracked and consists of seconds with repointed cement mortar. The eaves are plain. The northern elevation (5007, BS130; 4.6) is constructed of hand-made red brick in English Garden Wall bond. Two small central windows are located at ground and first floor with segmental heads and plain wooden casement windows. A single inserted doorway has been placed on the ground floor, with a plain soldier head in brick and a plank and baton door.

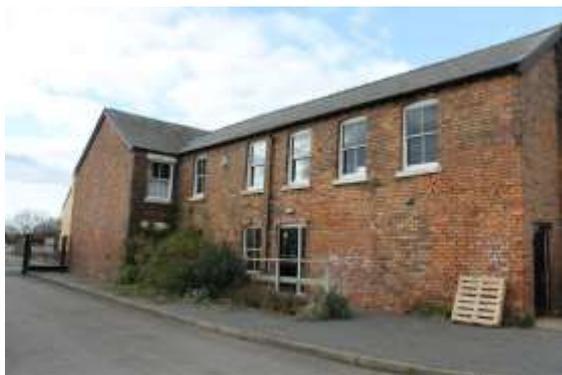
The two-storey rear range consisted of five bays extending to the east (BS130, BS131, BS132; 4.7, 4.8, 4.9). It was constructed in hand-made red brick in English Garden Wall bond, originally with lime mortar but largely replaced with cement resulting in intermittent water damage. The southern elevation (5002, Plate 6.7.8) had five bays, arranged in a pattern of a single bay to the west and four to the east reflecting the internal plan layout. The single bay to the west has windows on ground and first floor; the bays to the east had a single window and doorway at ground level with four evenly spaced windows on the first floor. The single door with fire-glass surround was a later replacement of a possible earlier double door. All the windows have segmental arched heads, plain sills and four-pane sashes.

4.7: Red Lion Inn, southern elevation, rear wing, north-west facing

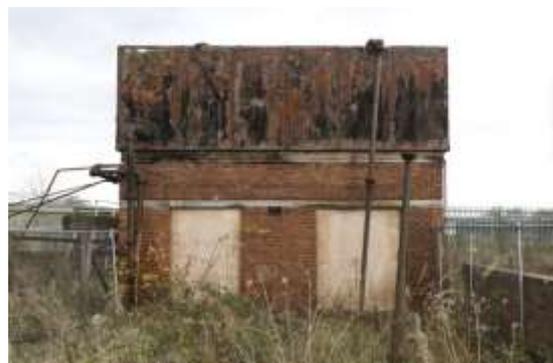
4.25: Engine House and Brine Tank, 2012, north facing

The lower part of the structure is constructed of two distinct phases of brickwork, along with patching and minor repair throughout. The earliest phase of brickwork reveals that the building has slumped north-south. It is of hand-made red brick in English Garden Wall bond with a lime based mortar (6691, 6699, 6716, 6722). Subsequently the building has been rebuilt and the brickwork levelled using a second later phase of machine-pressed red brick in English Garden Wall bond (6692, 6700, 6717, 6723).

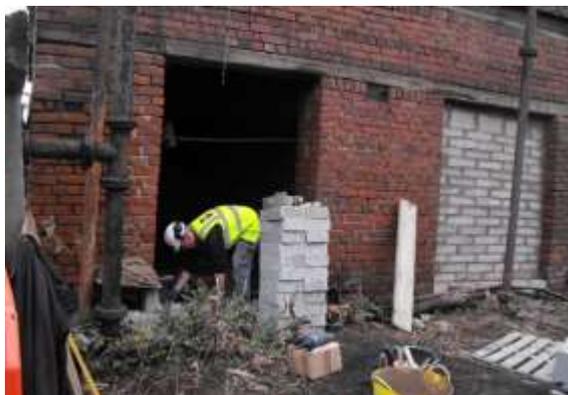
The principal façade to the south has two large doorway bays with eroded sandstone sills (6693, 6694; 4.25) with a continuous wood lintel above (6695). A cross-member can be seen end on above this (6696). The bays have been breeze-blocked in-filled and rendered in 2009 (see 4.26).

4.26: Southern Façade during remediation work in 2009, north-east facing

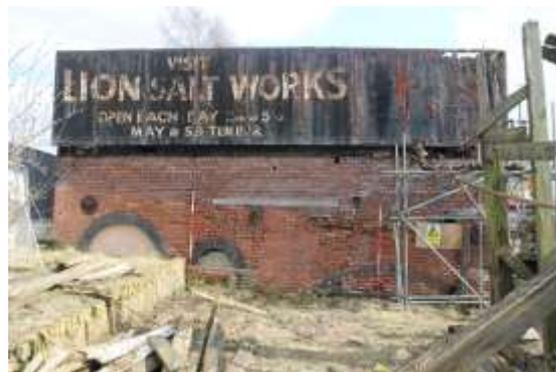
The western façade shows clear evidence of the slumping of the earlier brickwork (6699) north-south (4.27). A single beam (6721) acts as a tie-beam on top of the brickwork that has subsided. The later upper phase of brickwork (6700) is clearly designed to level the building. Two inserted ties (6715) and a series of three wall plates, one octagonal (6707) and two circular (6706, 6708) have been used to reinforce the wall. There are three segmental brick arches on the western façade. One is a low structural arch (on the southern end, 6703). This overlies a large ferrous metal frame c. 3.20m wide, extending below ground (6704). The other two are semi-circular arched openings that have been rebuilt in 2009 with blue engineering brick and breeze-block in-filled (6701, 6702; 4.28). A series of steam pipes (6710, 6711, 6712, 6713, 6714) extend from the upper part of the wall in various locations at the southern end. They appear to pass in the direction of the engine base (6643, 6644, 6645).

4.27: Engine House and Brine Tank, 2013, east facing

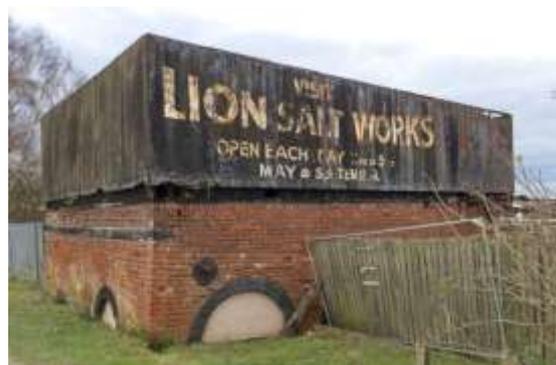
The earlier brickwork (6716) on the northern façade extends half-way up the wall on top of which is a large timber beam (6718). Later brickwork (6717) is constructed on top of this. Two plain low segmental brick arches (6719, 6720; 4.29). Both now lie below the level of the canal.

They have been rebuilt with blue engineering brick and then breeze block in-filled in 2009.

4.29: Engine House and Brine Tank, 2012, south-east facing, photo courtesy of English Heritage

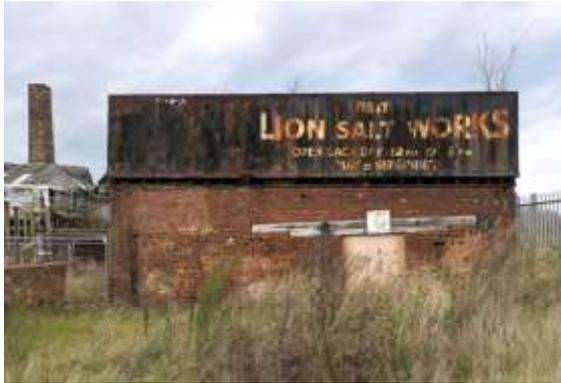
The eastern façade has lower brickwork as previously described (6722) that like the western façade has subsided from north-south. The earlier brickwork dramatically bulges at the base. Two large beams in the centre (6726) rest on top of this brickwork. Above this is later brickwork (6723) is built above this. The beams also act as the wood

lintel for a single opening (6725; 4.30, 4.31). It has a plain sandstone sill, badly eroded and in-filled by breeze-blocks in 2009. Originally it was larger but has been in-filled on the southern side with later brick (6724). Two wall plates, one octagonal (6727) and one circular (6728) correspond with those on the western side (the third is missing, found located on the floor). Two vertical I-beams (6729) that are almost entirely corroded retain the wall at the southern end. A water or steam pipe (6730) runs vertically up the face at the southern end and enters the eastern room (the boiler house).

4.30: Engine House and Brine Tank, 2012, west facing, photo courtesy of English Heritage

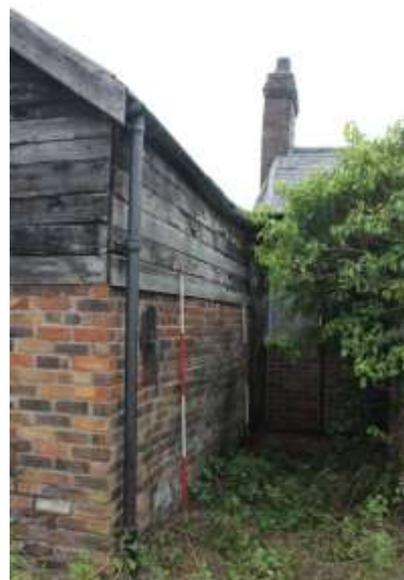
The boiler house was built of hand-made red brick in English Garden Wall bond to a height of 1.8m (6789, 6794, 6800). On the western gable end (4.67) the remains of a segmental arched flue (6796) that continued to the north-west where it entered Chimney 3 as flue (6768). Also visible on this face were the words 'SHOP' in faint whitewashed letters. The wall has bulged on the southern side (4.68, 4.69) and is retained by an

4.68: Boiler House, east facing, in 2013

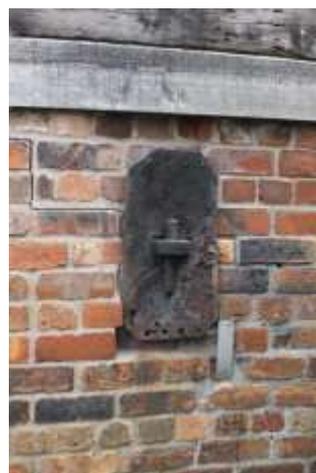
octagonal wall plate (6801) and seven wall braces (6802). Above the brick base it was constructed of a wooden frame with horizontal panels (6790, 6795, 6803). In the northern face (4.70) was a central opening now nailed shut (6791). Against the western gable end was a wooden panel (6797) that covered the remains of a damper plate. The damper plate was raised via a pulley (6798) attached to a wooden brace housed in the apex of the gable. The roof was pitched and covered in felt with wood braces (6792). Metal gutters and down pipes were located on northern and southern sides (6793, 6804).

4.69: Boiler House, wall plate, south face, in 2013

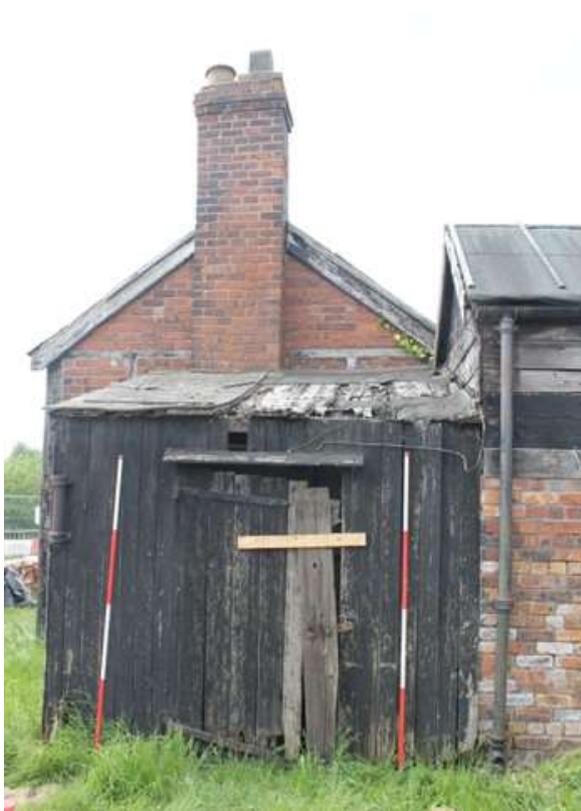
damaged plank and baton door, with plain straps and gudgeons (6806) opens to the north. On the eastern side a single wooden casement window is now boarded with chipboard (6808). The whole structure has been fire damaged by vandals in 2003.

4.71: Coal Shed, south facing, in 2013

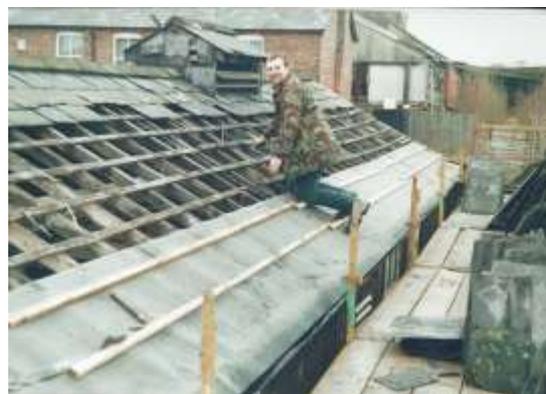
In the early 1990s the buildings north of the smithy were demolished to make way for new access road to the site (replacing the existing road between Pan House 3 and 4 and the Red Lion Inn). The remainder of the smithy was repaired in 1996 (4.99, 4.100). At this time corrugated iron sheeting covering the Smithy was replaced by new sawn boarding. The north-west corner post had rotted

through and was replaced with a new oak post. The roof was recovered in a combination of original and new Welsh Grey slate. A replacement canopy was built over the circular saw.

4.100: Repairing the Smithy roof, in 1996

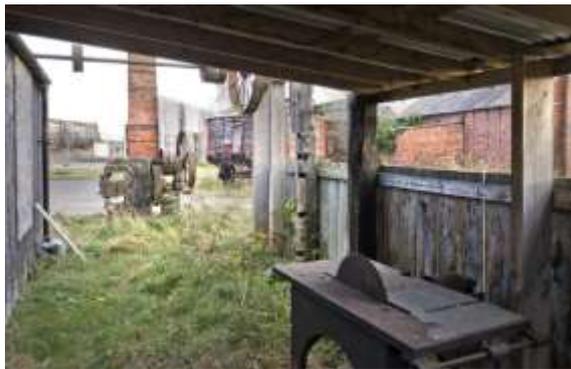
5.116: The layout of the Guillotine Punch, Bench Saw and Line Shafting, north facing

characteristic of Henry Thompson's final tenure. Elsewhere on site the use of electric motors is common. One photograph shows the guillotine at an angle to the line shafting. This strongly suggests that it was never powered by the line shafting. It would appear more likely that an electric or petrol driven solution was adopted. In Store 2 of the Smithy, a stand-mounted, Stuart Turner style, petrol-driven motor (5571) was found that appeared to belong to the 1970s period of the work. It is probable that this was used either to power the bench saw or the guillotine punch. The machines were realigned for display purposes in the early 1980s as part of the Thompson's working museum. It is probable that the line shafting dates to this period but without good photographic evidence for the earlier phases of the Smithy it is difficult to tell.

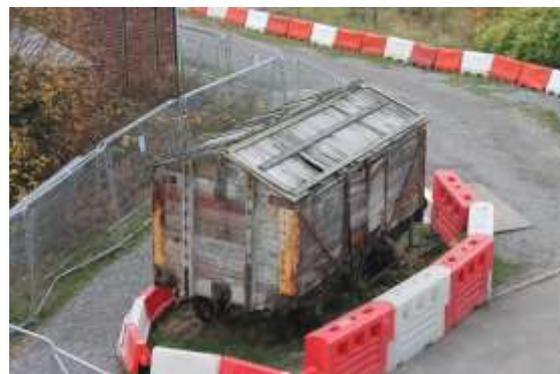
5.120: The Salt Van, south-east facing, in 2013

External Diagonal Strapping and Corner Angles - The diagonal iron straps turn at the bottom to run along the side of the floor strips. The upper end of the straps, which terminate at the 6th plank, indicate that the original corner angles were narrower and thicker (7 inch x 7 inch x 3/8 inch; 178mm x 178mm x 9.5mm), than those now fitted (8 1/4 inch x 8 1/4 inch x 1/8 inch; 210mm x 210mm x 3mm). Battens which should have covered bolt heads inside the van are missing. The metal corner angles terminate at the 6th plank, with a separate corner bracket fitted horizontally around the 7th plank.

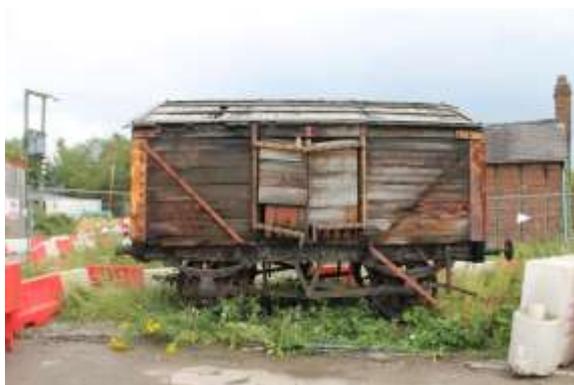
5.121: The Salt Van, east facing

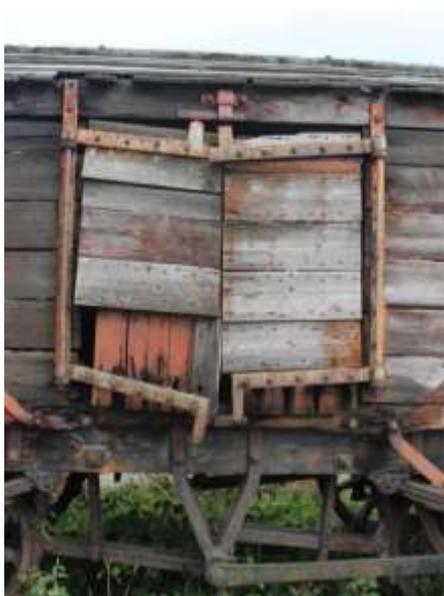
5.122: The Salt Van, detail of surviving door

Side Doors - The door openings are 4 feet (1219mm) wide. The hinges are fitted to vertical straps which brace the side planking, rather than being hung on their own separate straps. One door has been extensively replaced using modern timber and screws. The three original iron hooks and rings for fastening the doors survive.

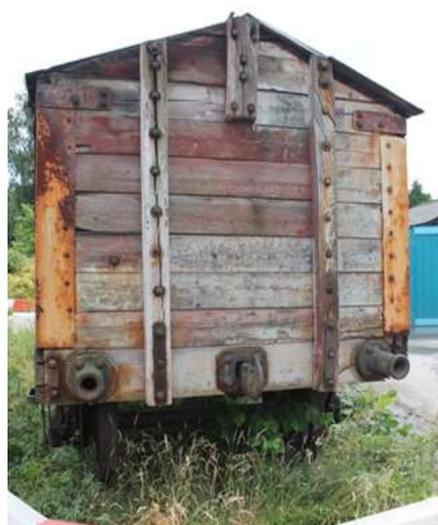
Side Sheeting and End Planking - The side sheets have a 6 inch x 2 inch (152 x 51mm) cross-section. The side and end planking indicates that a new roof had been added to the van. The condition of the internal surfaces is quite distinctive between the two construction phases. This is caused by a general lack of paint over the internal surfaces and a general lack of weathering on the protected internal timber. There is a slight variation in plank width between the sides and ends of the van.

5.123: The Salt Van, south facing

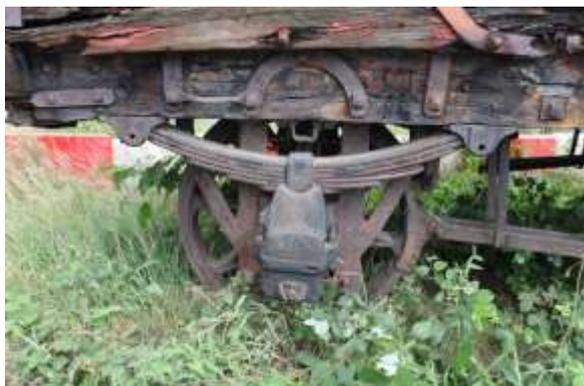
Wheels and Axles - The wheels (5.125) have centres at 8 feet 7 inches (2616mm), rather than the 9 feet (2743mm) indicated on Tracing No. K38. The journals are 8 feet (2438mm) long and 3¼ inch (95mm) diameter. Each of the four oil axle boxes are different, two were supplied by Charles Robert & Co. A third box was supplied by Wagon Repair Ltd and the fourth by ICI wagon repair workshop.

5.125: The Salt Van, the wheels and axles

The 'W' frames which hold and guide the axle boxes are of different design on each side of the wagon. The centres on one side are at 3 feet (914mm), as shown on Tracing No K38. The other side has tracing at 2 feet 6 inch (762mm) centres. The effect of the different frame widths is to position the brake level guides inside the two frames on one side, and outside the frames on the other side. The pins securing the axle springs in position have been removed in the past and are now lost.

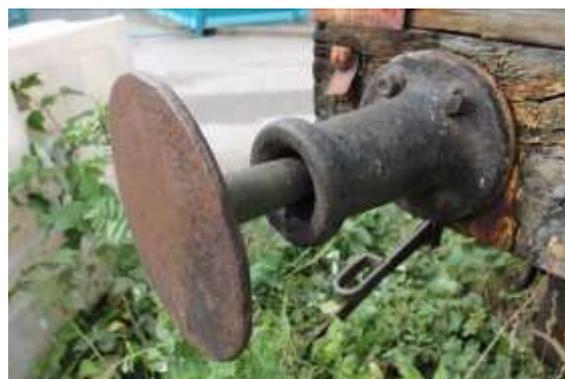
Buffers and Brakes - One pair of buffers (5.126) is original. Looking at the other set of buffers indicates that the whole buffer bar has been replaced and that the buffer housings themselves have been replaced with a pair of smaller diameter. The coupling hooks, bar and buffer springs are all original. Brakes are fitted to both sides of the wagon. One inner strap support for the brake rods still survives, though the other has corroded away.

5.126: The Salt Van, buffers

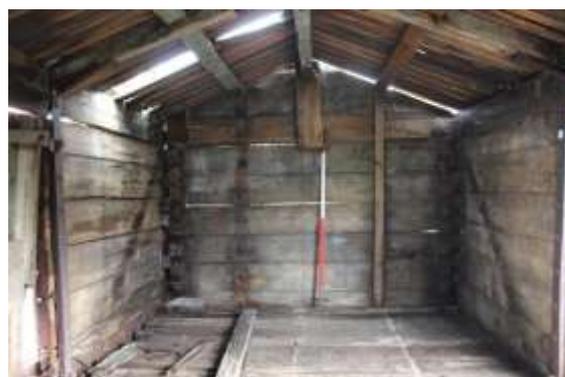
Interior Floor - The interior floor (5.127) consists of a series of 23 or 24 cross planks loosely attached. These have a 6 ½ x 2" cross-section and are 82" long. They have been patched with plywood in places.

5.127: The Salt Van, Interior

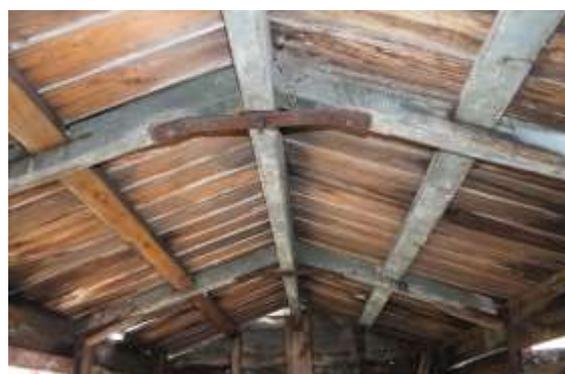
5.128: The Salt Van, roof structure

Pitched Roof - The roof structure (5.128) consists of two trusses of plain principals, 4 inch x 2½ inch (102 x 63.5mm) cross-section. A ridge-beam, 6 inch x 3 inch (152 x 76mm) cross-section and two purlins, 4 inch x 2 (102 x 51mm) inch cross-section, support the roof. The roof is double skinned with over-lapping tongue and groove, 5½ inch x ¾ inch (140 x 19mm) cross-section.

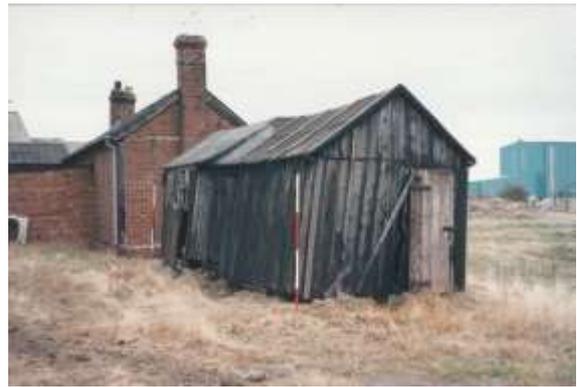
The building was a small pitched roof shed. It was two-room plan, aligned north-south. Internally it was timber-framed, with mortice and tenon stud construction throughout. The exterior was clad with vertical boarding. The roof was clad with boarding and felted over the top of this (6.9, 6.10).

6.9: Waller's Hut, early 1990s, north east facing

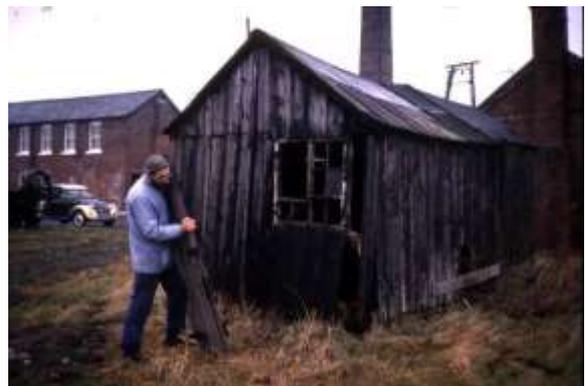
6.10: Waller's Hut, early 1990s, north west facing

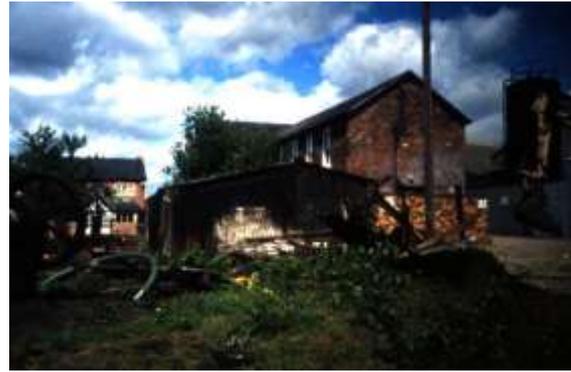
6.11: Remains of the cart shed, early 1990s, west facing

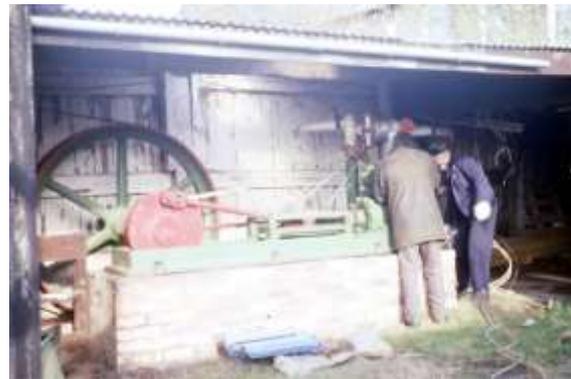
To the south was a later lean-to roof that formed a covered space over the Abraham Lord (Smithy) Engine (see above, 6.12; BS166). The lean-to cover over the engine rested on the roof of the original shed and had broken the purlins of the cart shed.

6.12: Remains of the lean-to containing the Abraham Lord steam engine, early 1990s, west facing
