Condition Survey and Emergency Conservation Treatment

PETERBOROUGH CATHEDRAL

THE NAVE CEILING ST PETER, ST PAUL AND PSALTERY PLAYER LOZENGES

October 1997

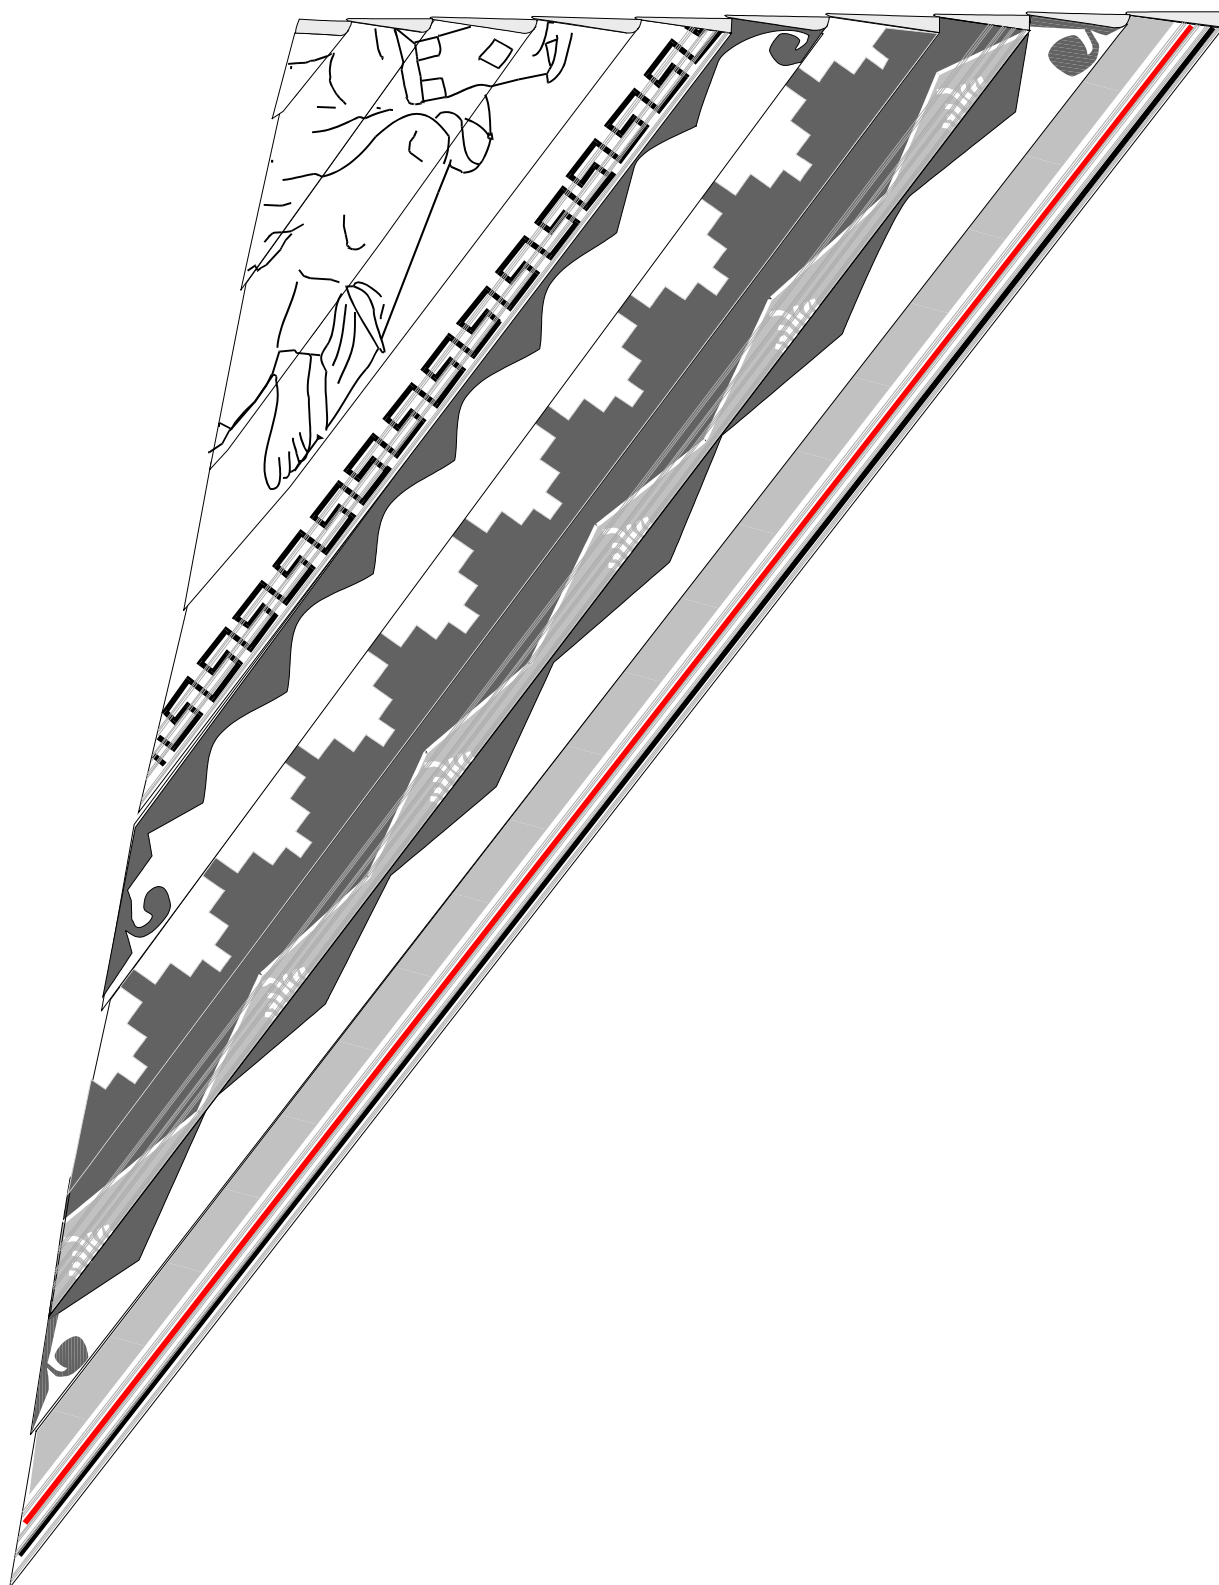
Another design feature is the series of parallel grooves within the thicker, outer halves of each key pattern, coloured bands, and grey chevron board. The grooved effect is achieved as much by the surface texture as by the indentations which are extremely shallow. The three grooves are smooth whereas the slightly raised bands either side and between are roughly finished (*see Figure 3 on next page*). None of the many replacement boards have either the half-rounded edge or parallel grooves, presumably the restorers thought these omissions would not be noticed from floor level.

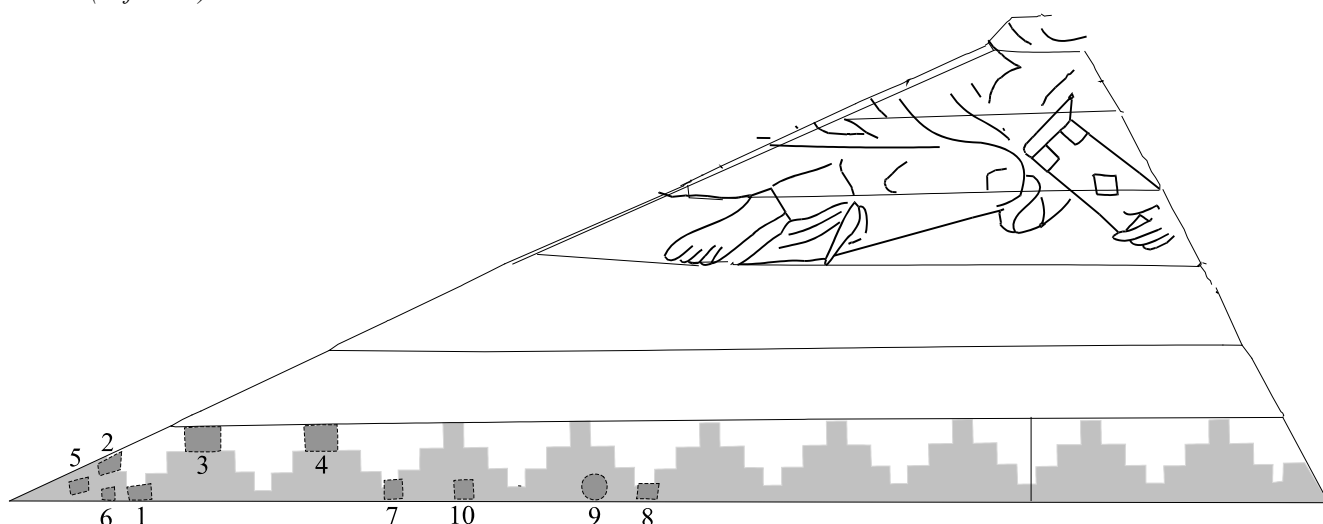
St Peter (Ref. 31/II)

Test	Materials & Methods	Results
1	Deionised water on a cotton wool swab	Removes surface dirt, some initial agitation required
2	IMS/deionised water 1:1 swab	As 1, but acts quicker & needs less agitation
3	Wischab sponge	Removes surface dirt well with minimal rubbing; good for stable areas
4	Deionised water sponged through Japanese tissue	Minimal surface dirt removal

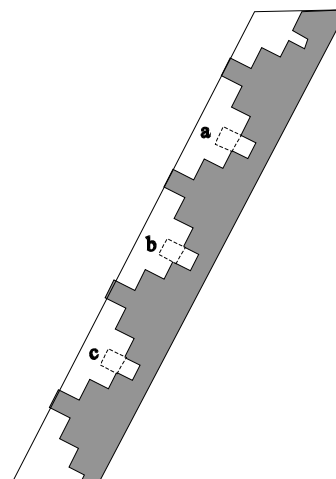
To test the effects of any residual consolidant on the ability to clean subsequently and the appearance of the treated area. The paint layer here was stable.

Test	Materials & Methods	Results
a	Areas treated similarly to flaking paint i.e. pre-wetted with PP 40°C (mist 1) for 2 mins; 5% solution Plextol B500 injected & left in place for 1 min. then area pressed with damp swab through tissue to remove excess. Each area has its own control, as cleaning takes place <i>across</i> each test. When dry half the test area and surround was wiped over with a damp Slurpex sponge.	Significant surface dirt was removed from the area when wiped with the sponge. The 'consolidated' and subsequently 'cleaned' area appeared <i>cleaner</i> than surrounding 'un-consolidated', but cleaned area. The result suggests that using this solution and method of application and will not inhibit the removal of the surface dirt from the re-attached paint.
b	As (a) but using 10% solution Plextol B500	As (a)
c	As (a) but using 15% solution Plextol B500	As (a)
