**PETERBOROUGH CATHEDRAL: THE NAVE CEILING**

**PHASE 1: ROWS 36 - 40**

**CONDITION SURVEY AND CONSERVATION TREATMENT**

**JANUARY - JUNE 1998**

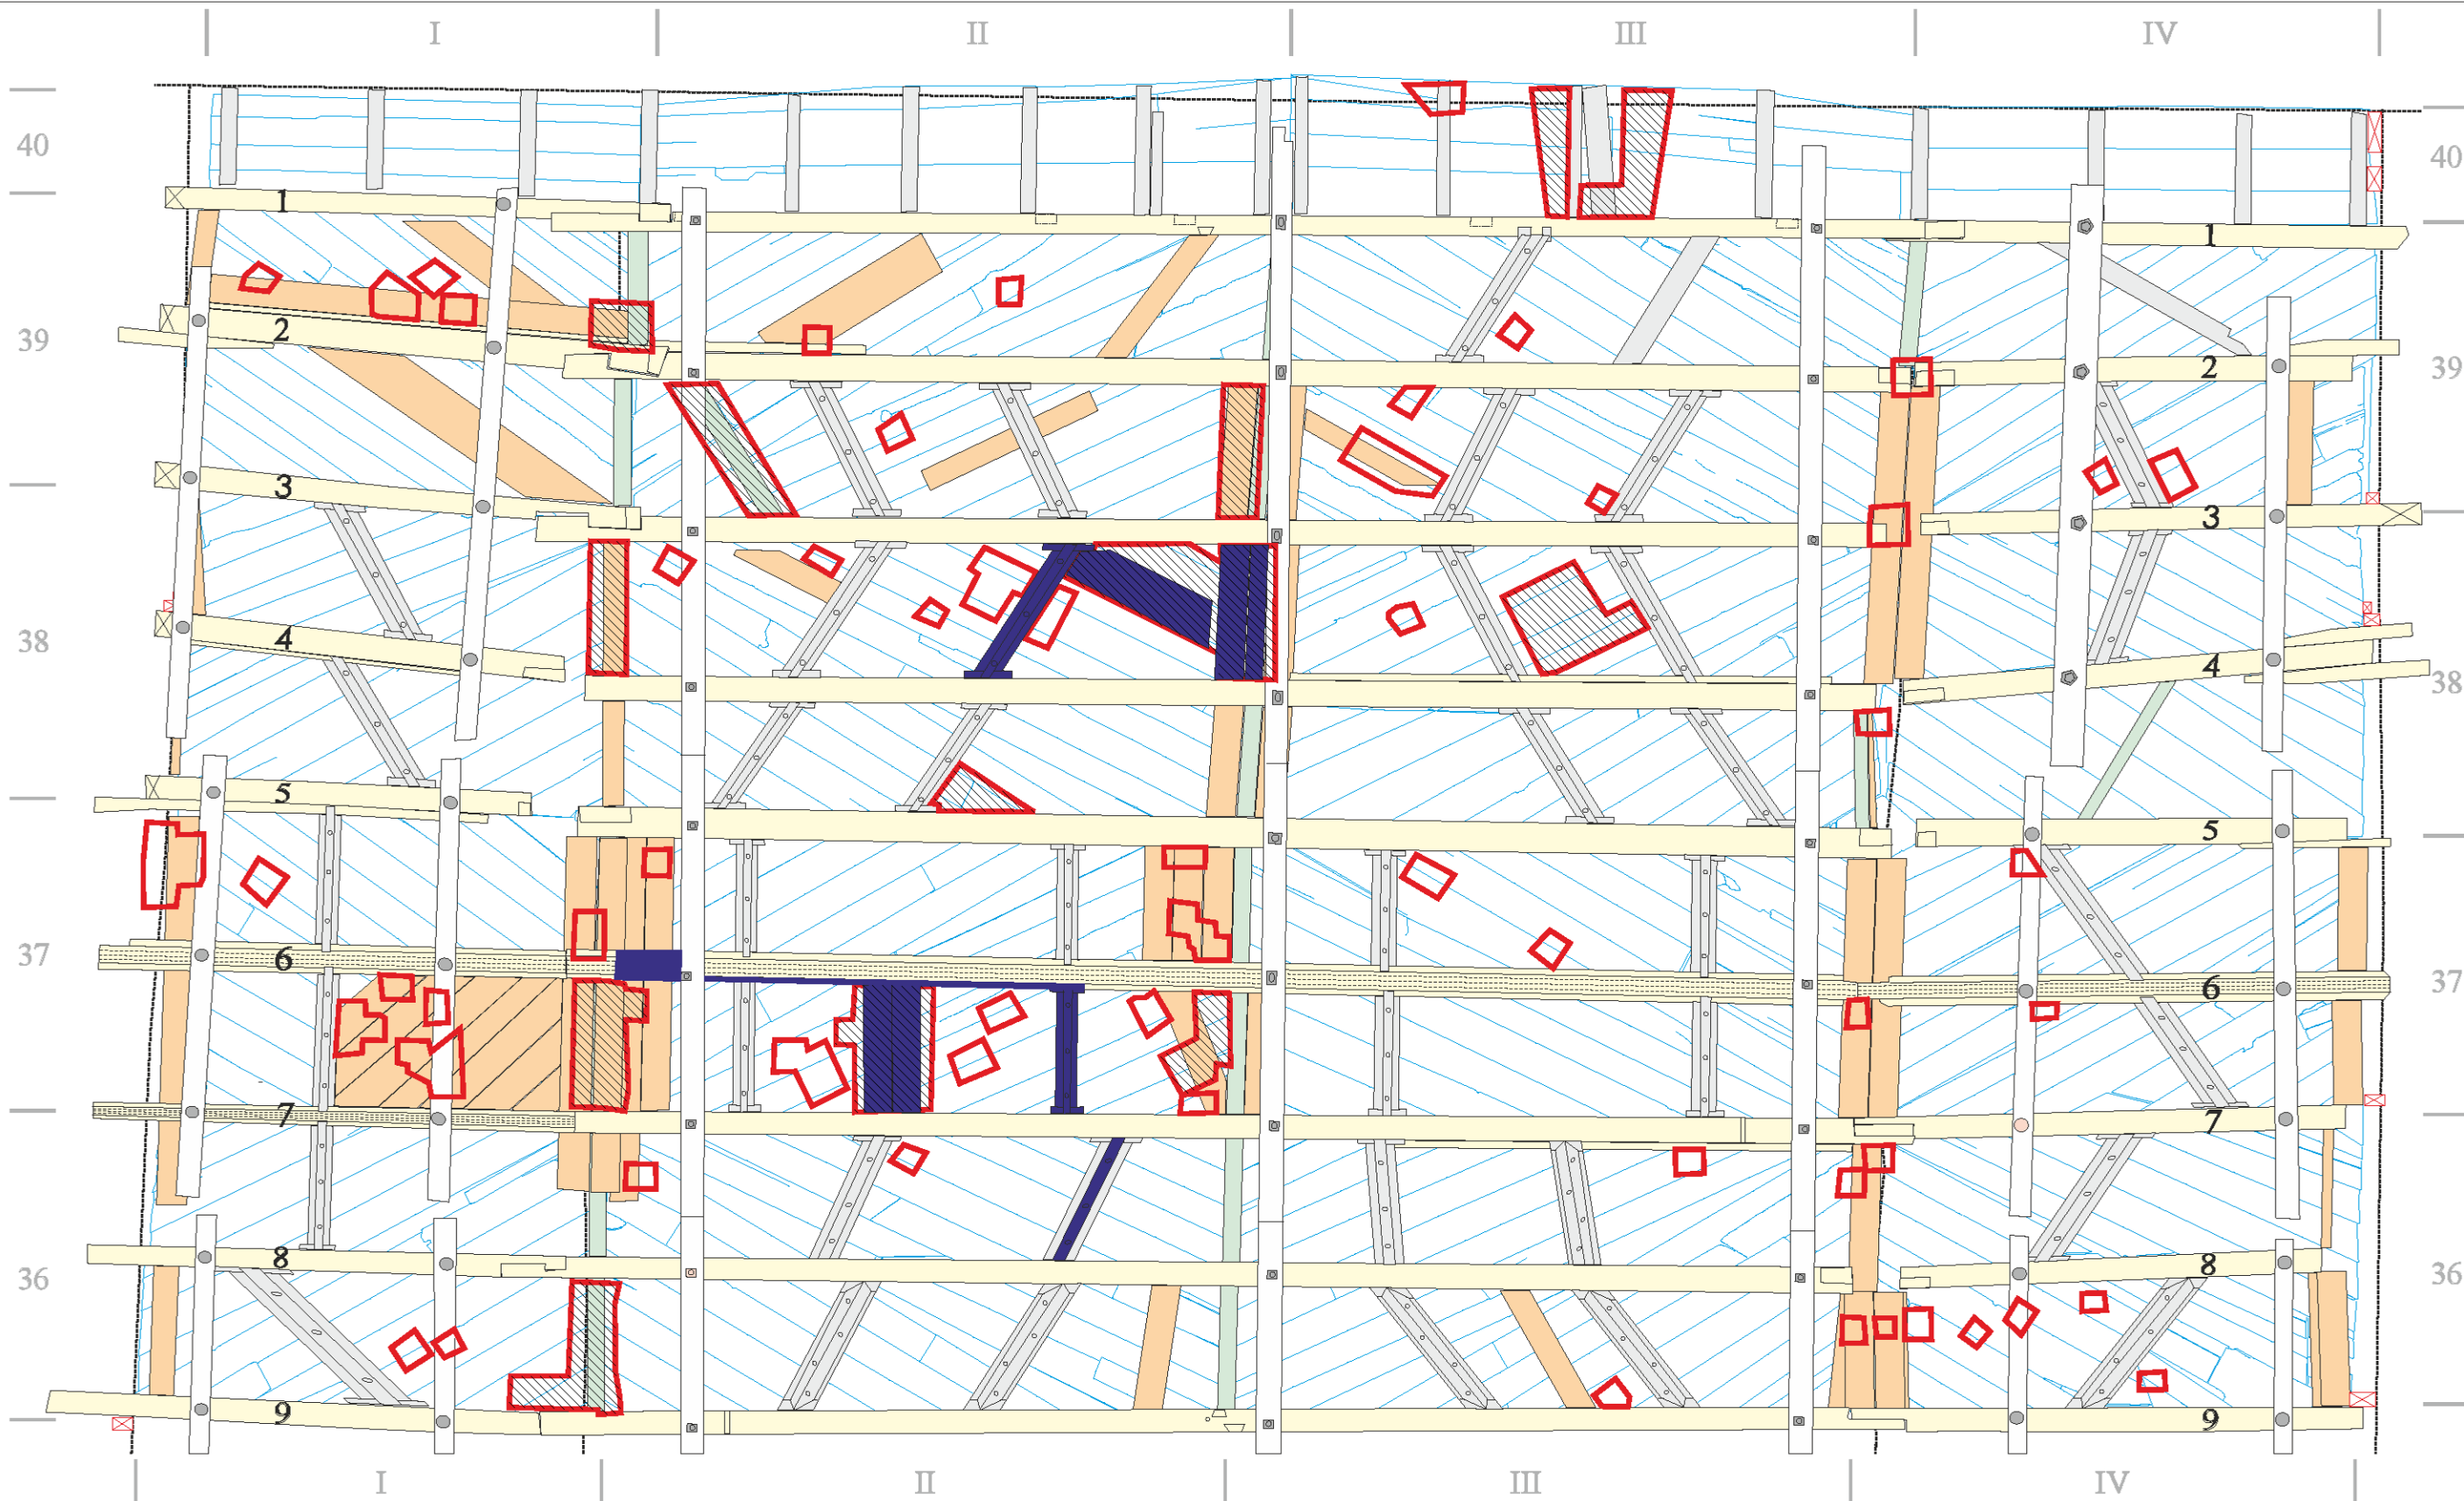
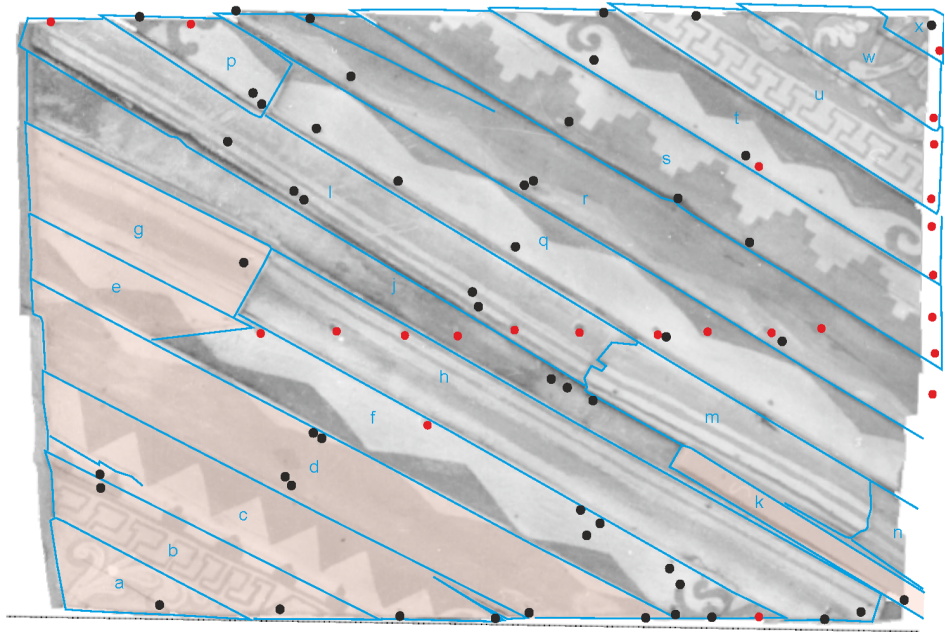
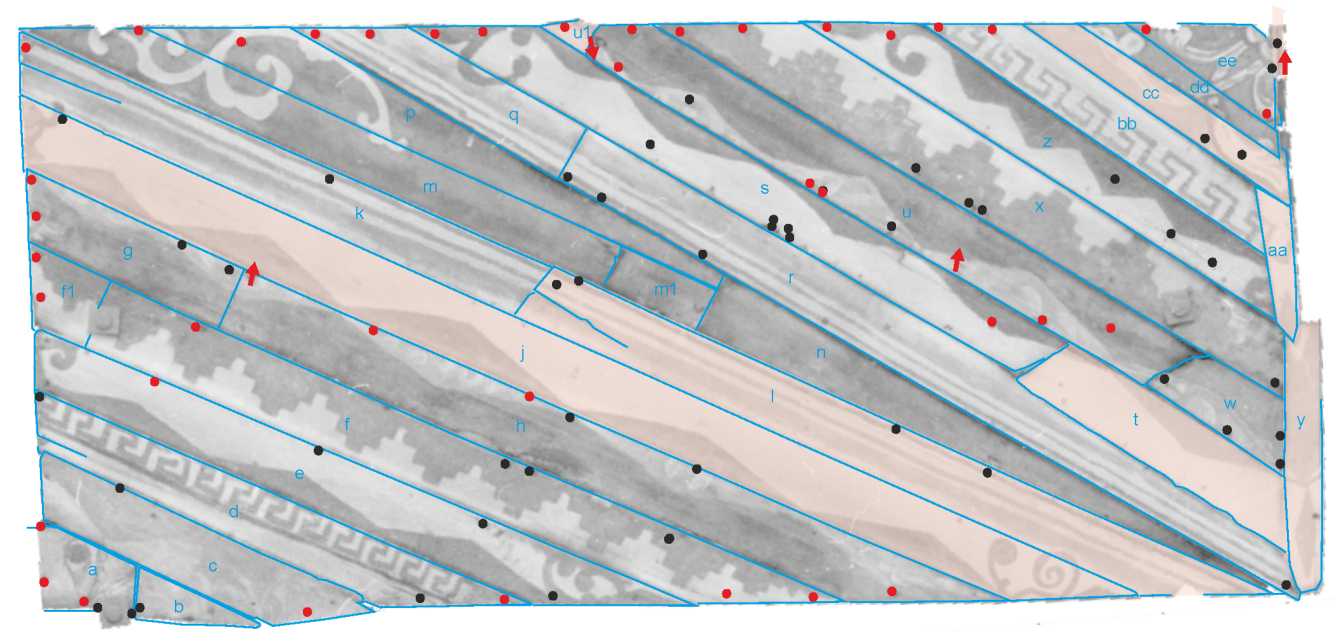
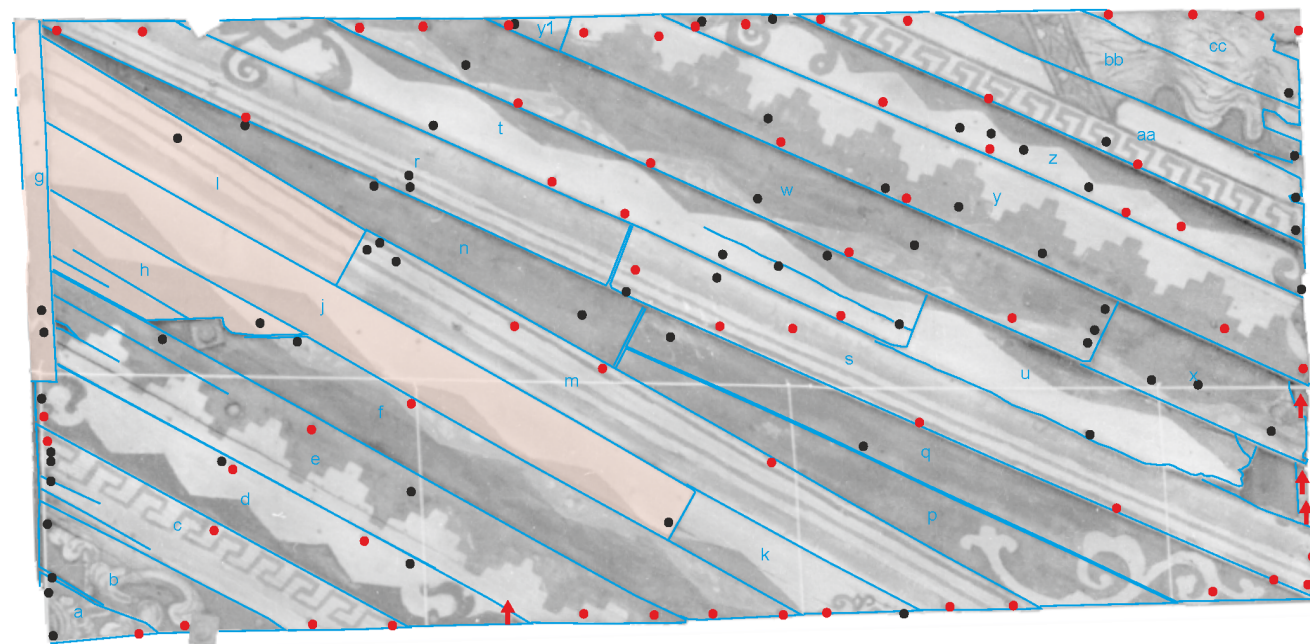
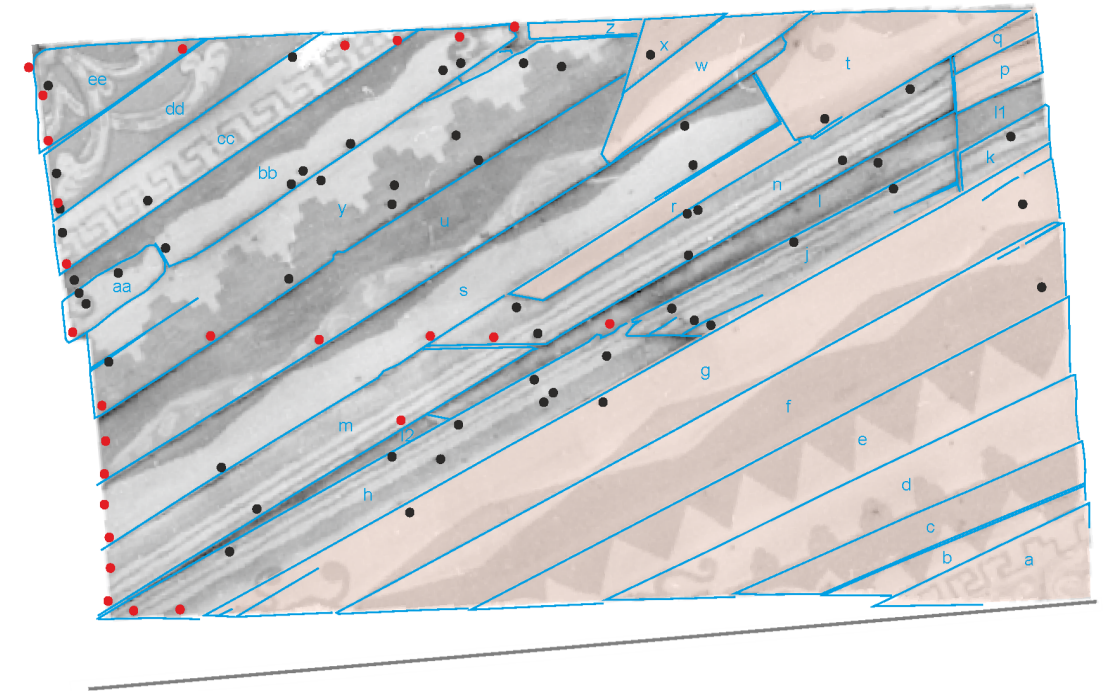
It is noticeable that consolidation by Paraloid B72 and fillings has been used in areas of insect damage and fungal decay.

Stainless steel fixings have been used to secure unstable splinters and fragments of the ceiling boards.

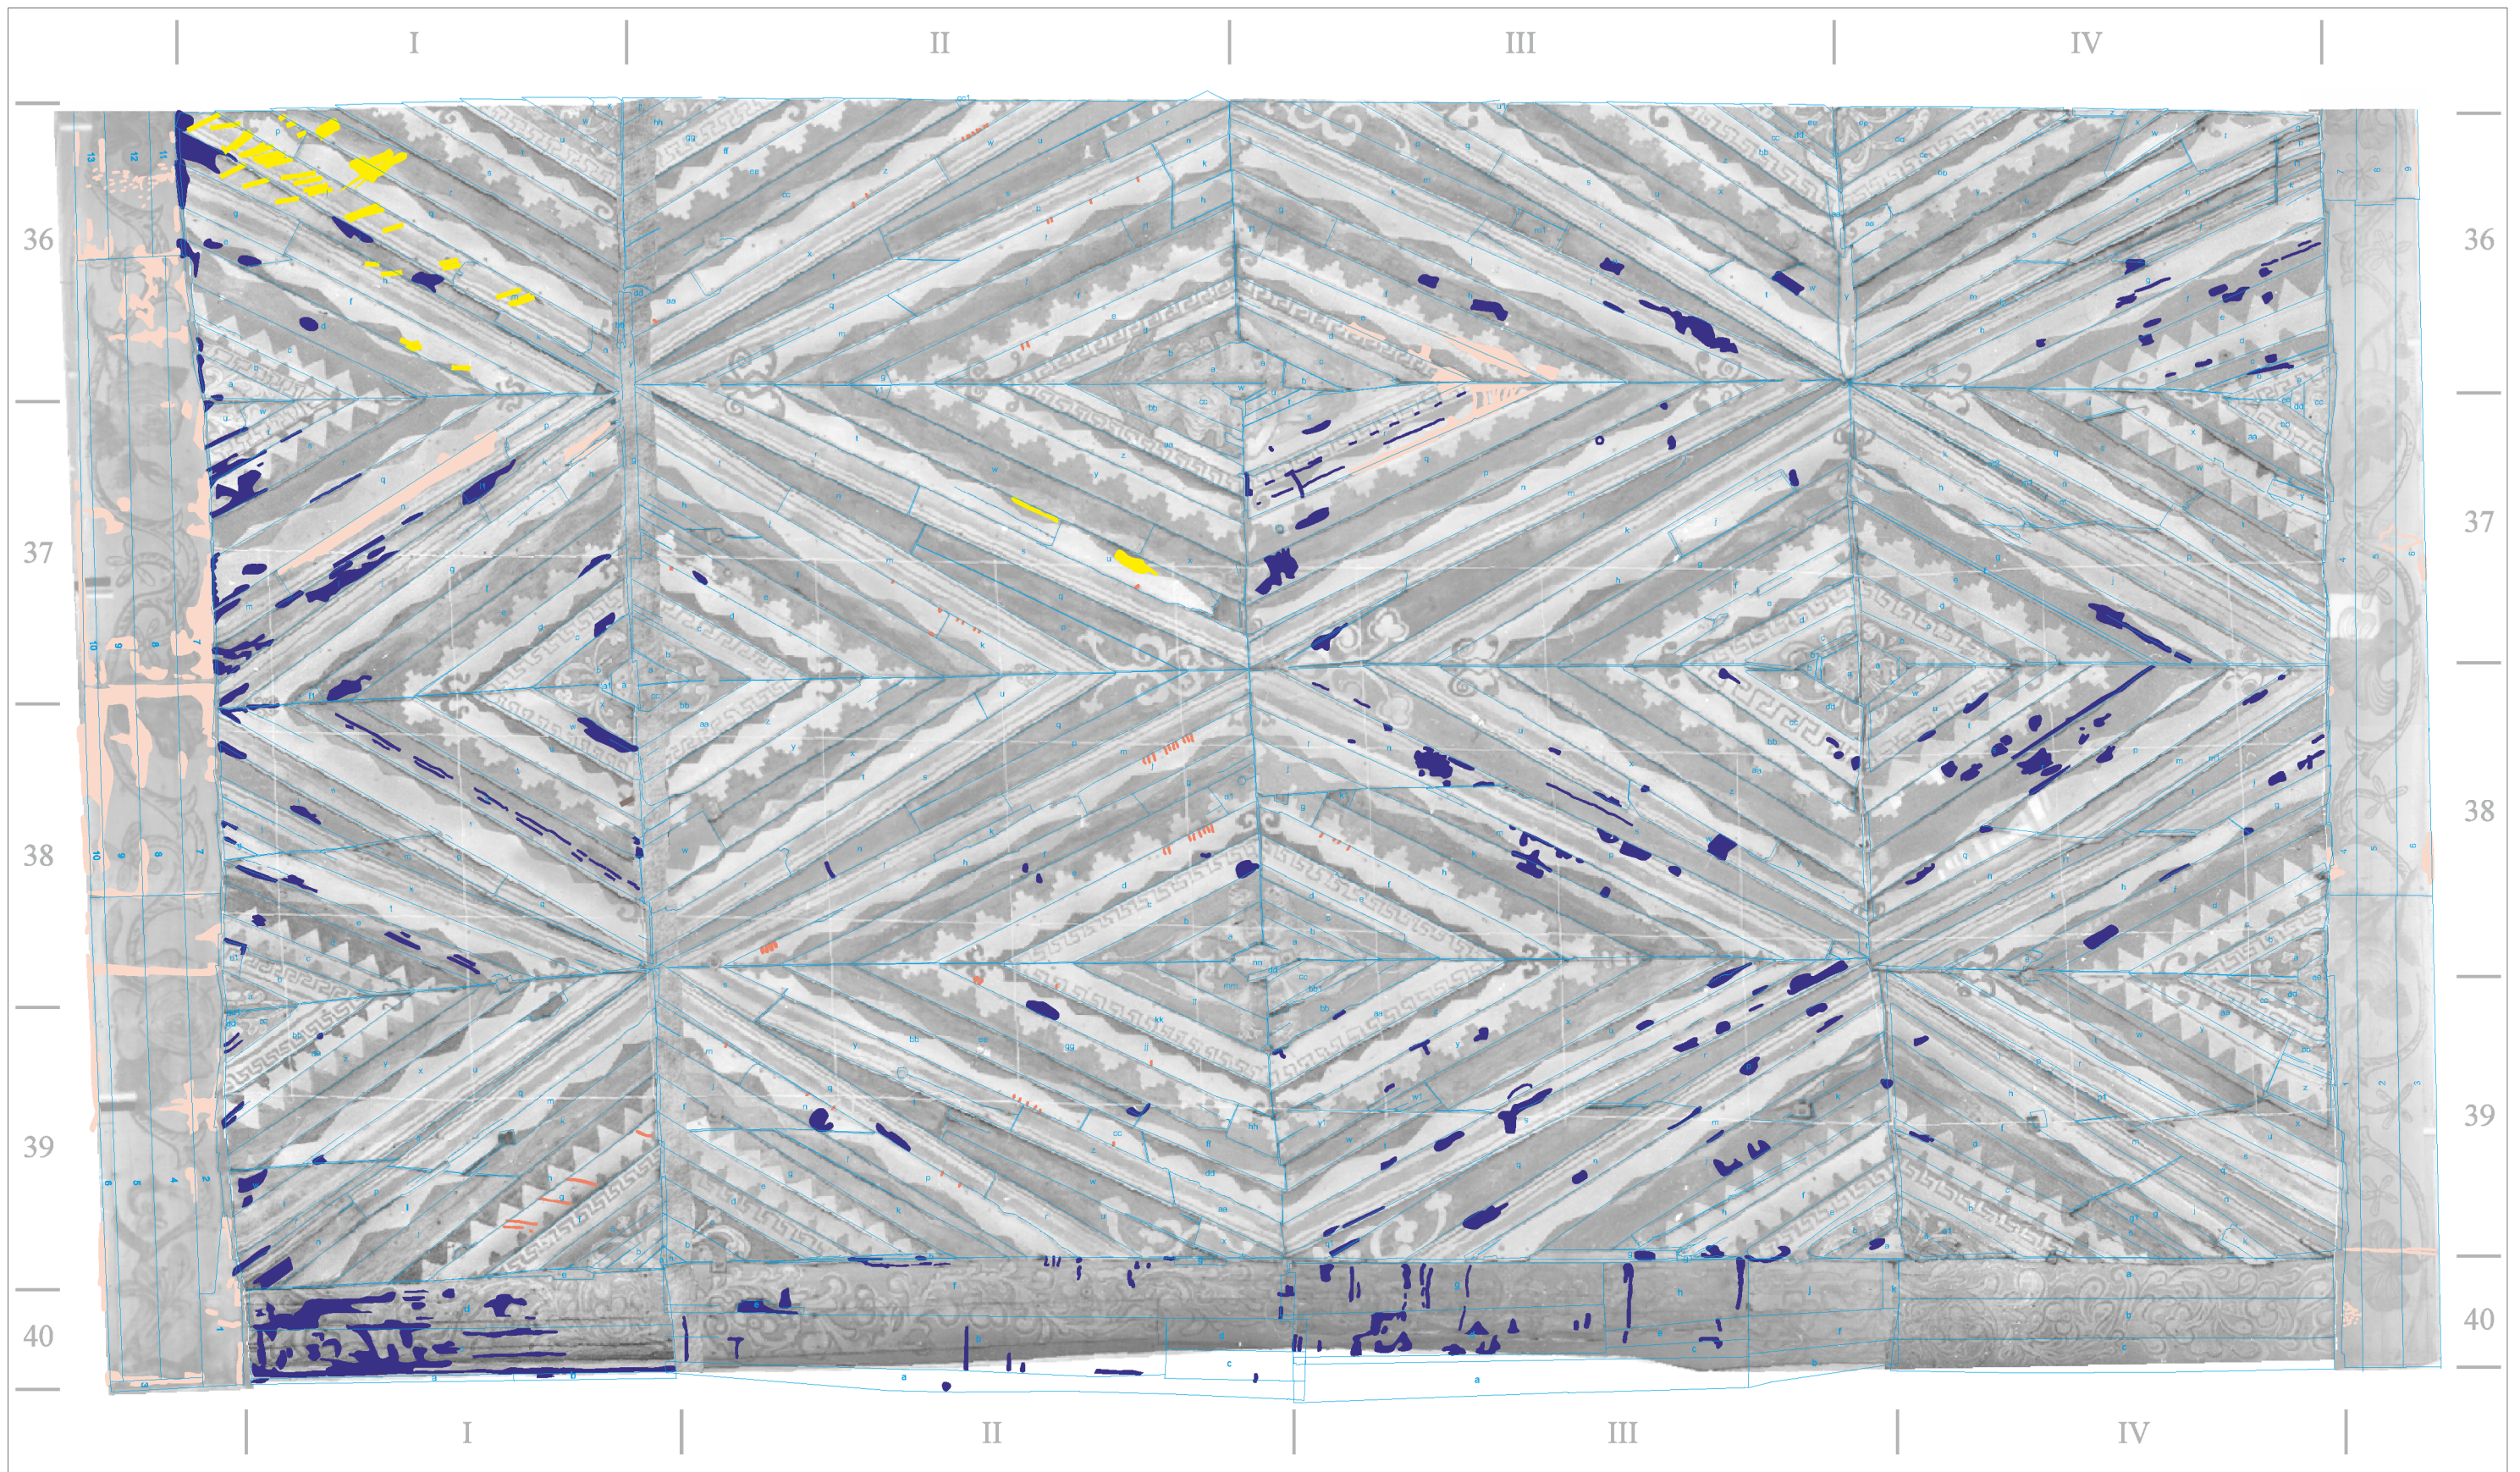
**Microbiological Growth** - Residues of what may be three forms of microbiological growth were found on the paint surface. These were removed as far as possible during the surface cleaning process. These residues are widespread across the Ceiling and will be analysed as part of the Phase 2 investigations. The three forms of residue are: a spattering of light brown powdery flecks ( faint traces of this remain after cleaning with a Wishab) sponge; a purplish powder residue; a white bloom or stain on the paint not removed by Wishab cleaning (the fine tendrils suggest this results from microbiological growth).
