PETERBOROUGH CATHEDRAL: THE NAVE CEILING

PHASE 2: ROWS 28 - 35

CONDITION SURVEY AND CONSERVATION TREATMENT

MAY - JULY 1999

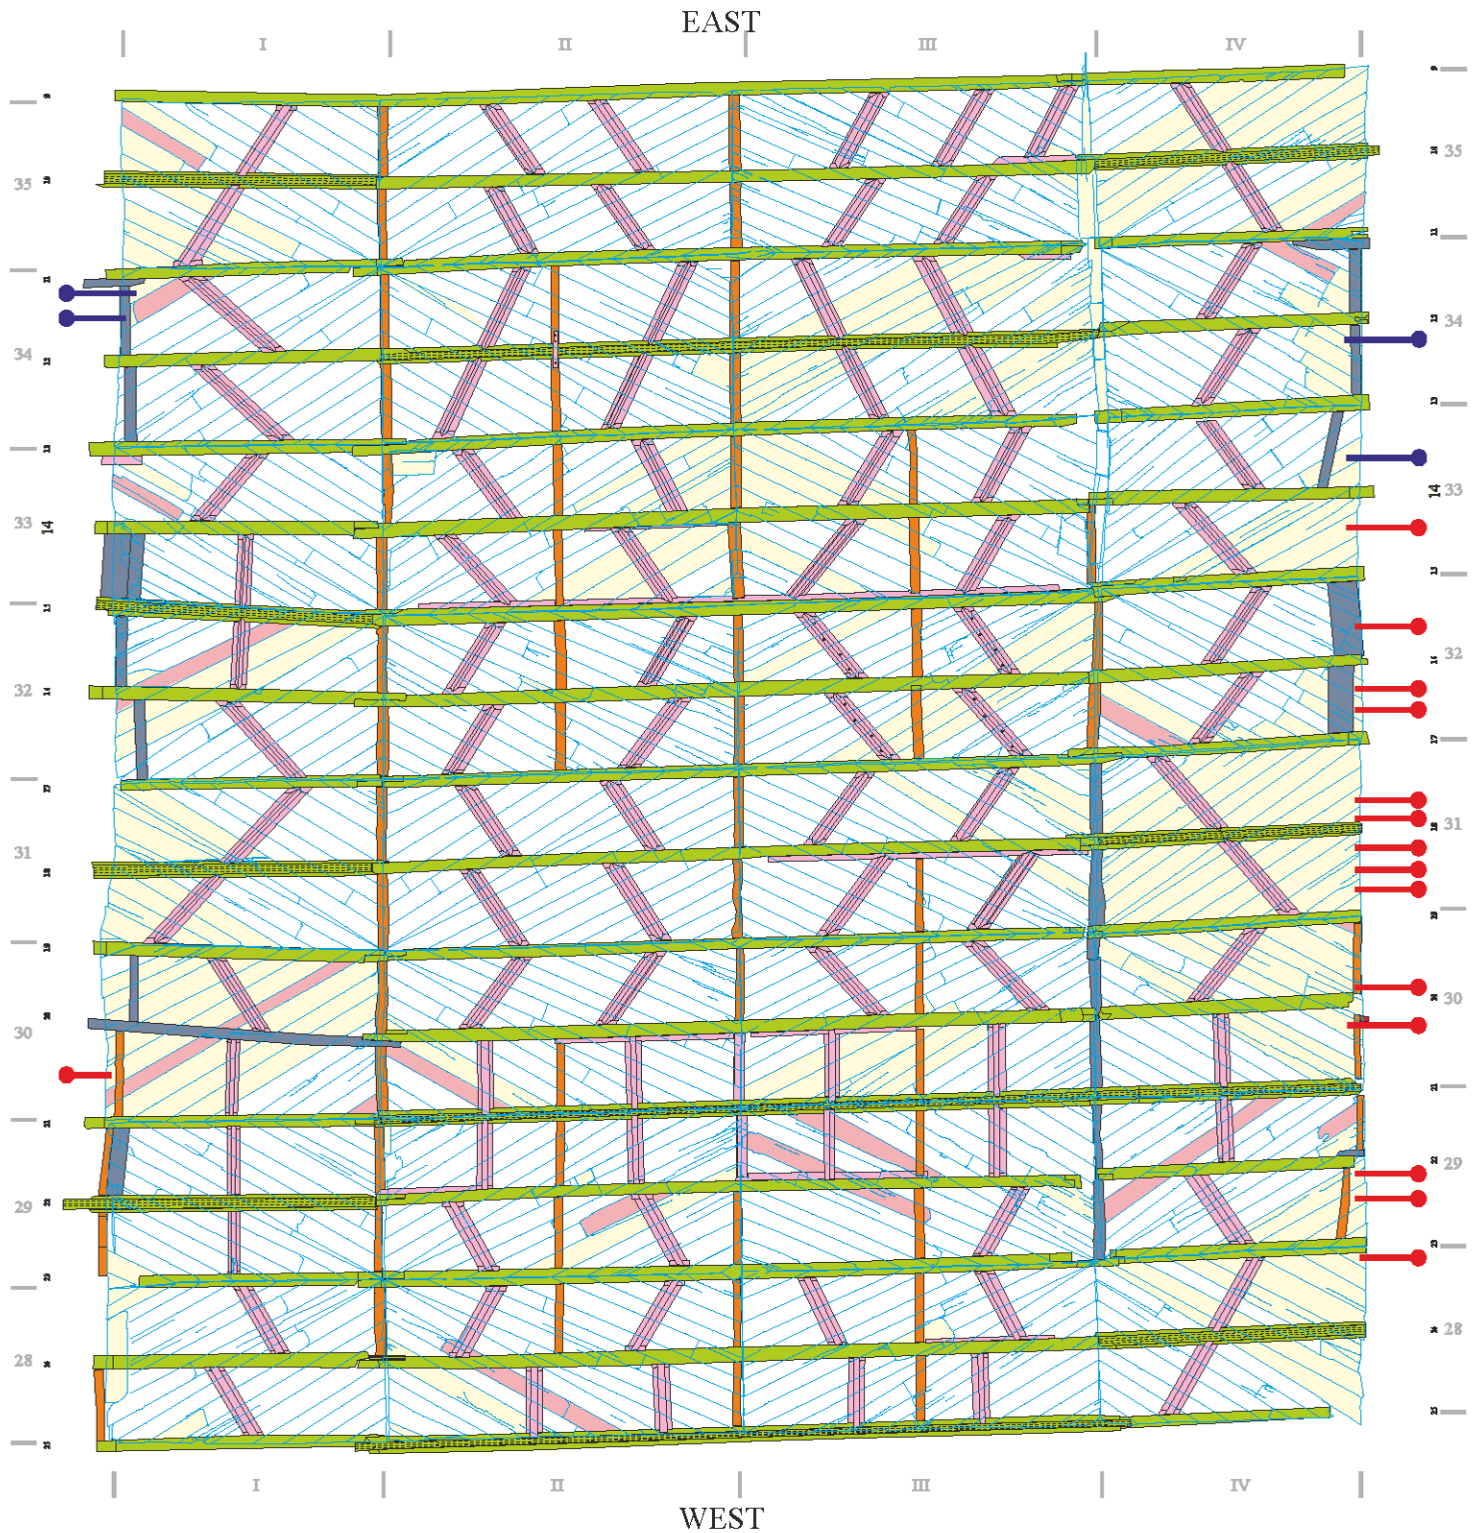
Figure 10. Plan from above showing Bays 2 and 3 and the location of sampled softwood boards.

Groves analysed 19 samples of softwood from the ends of the sloping boards which overhang the Ashlar boards see **Plate 99**. The position of these boards is shown on **Figure 10**. Of the 19 samples, two genus types were identified, 15 samples being of the *Pinus sylvestris* group (Type A in her Report), and 4 samples being the *Picea/Larix* group (Type B in her Report). The four Type B samples were all found east of Joist 14 which also marks position where several other changes in painting/repainting technique are found and described later in this report in Item 8.3.2.4. It may or may not be coincidental that 3 of the Type B samples had a very similar thickness of 10mm or 10.5mm. The Type A varied over the full range of thickness from 10mm to 18.5mm.

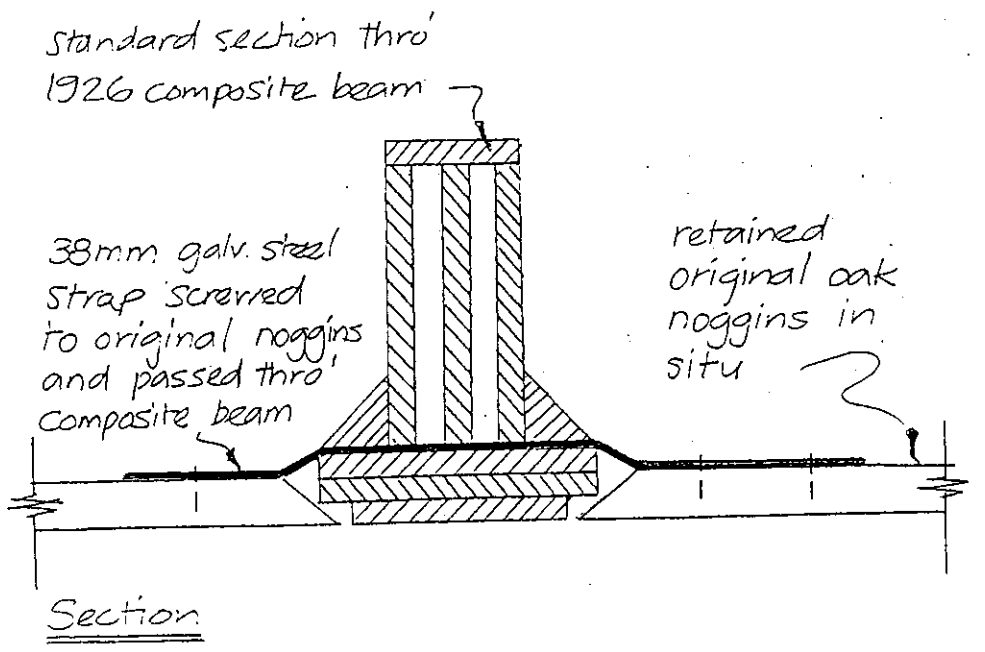
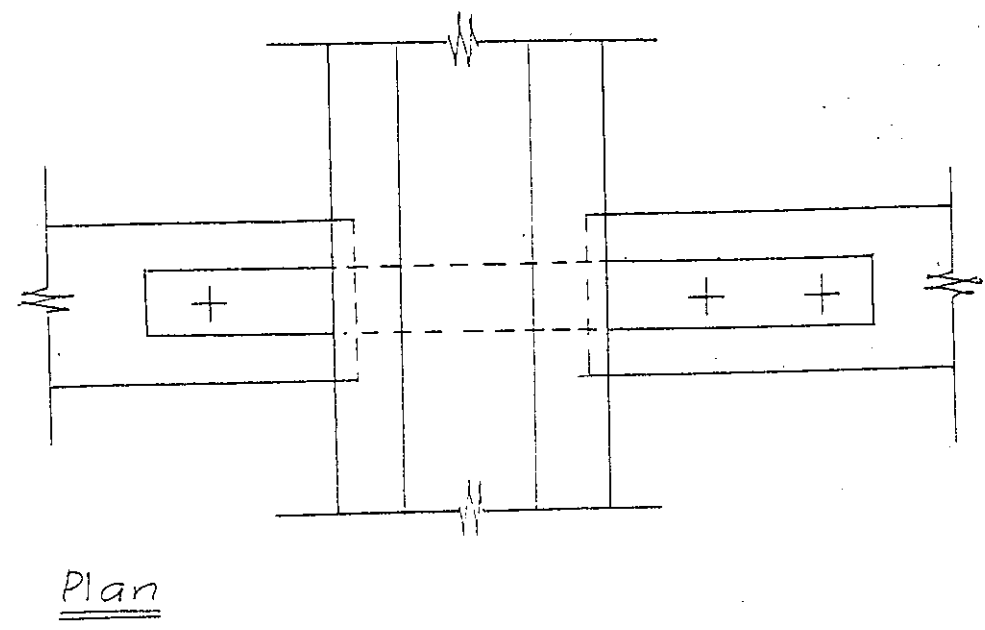
Bay 34 II North, Ceiling Joist 12 method of supporting original oak intermediate noggins.

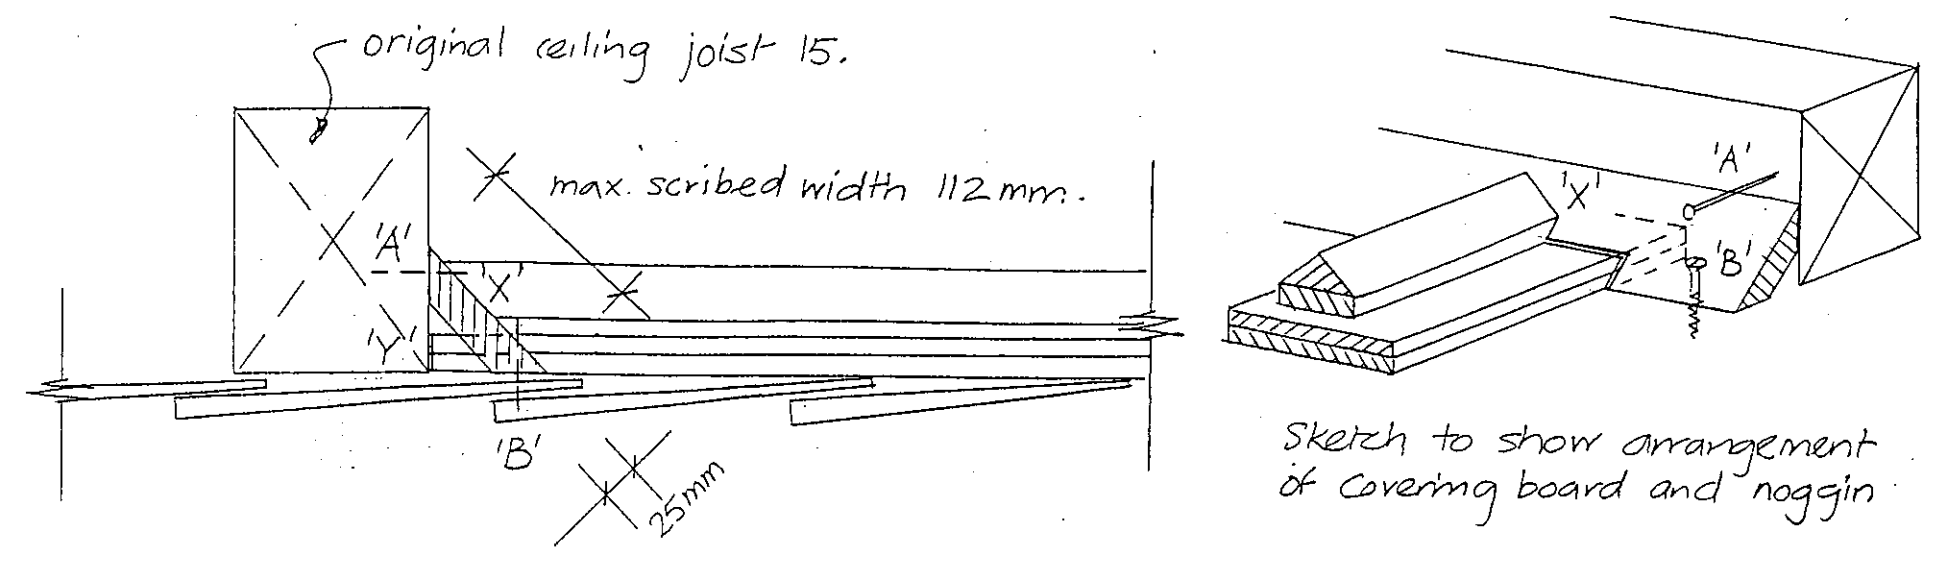
Method of Supporting Type 3 1926 Noggin Construction on East Side of Ceiling Joist 15.

Continuous ex. 25 x 150mm covering board scribed to diagonal boarding profile and notched over 2 no. 150 x 12mm 1926 Noggin lower boards, covering board horizontally nailed to original oak ceiling joist 15 east side 'A' and vertically screwed down to diagonal boarding 'B' top two sections of 1926 Noggin rest on covering board at 'X', lower boards stop at east side of joist 15 at 'Y'

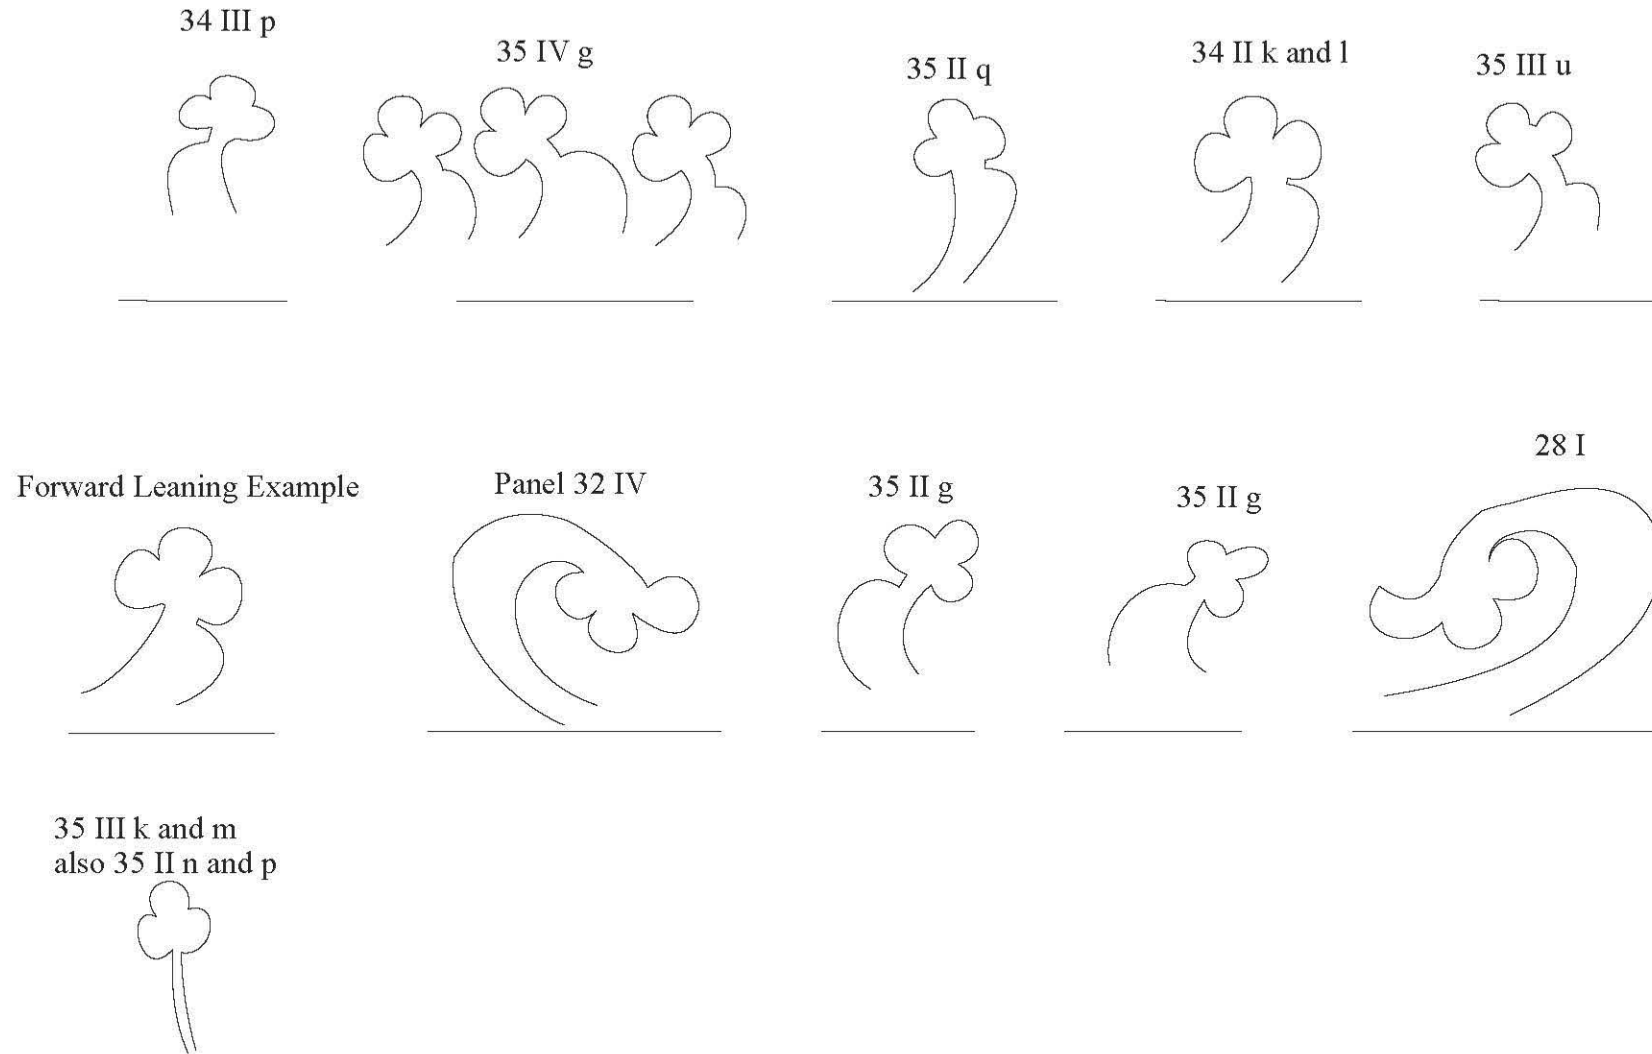
Figure 14. Tracings of typical trefoil shape (Scale 5:1).

- A grooved board with the alternating red (red and white lead)⁵⁵ and black bands intersected at the corners by an elaborate black scroll with trefoil ornament. No pigment was found on the sample taken to identify the black paint⁵⁶.

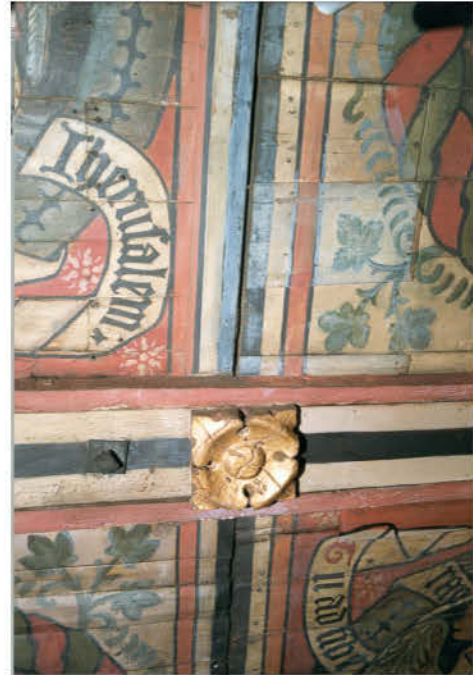
Figure 15. *St Albans Cathedral, C15th Choir Ceiling: Detail showing the apparently receded wood surface where original background paint had been lost. The same phenomenon has occurred on the nave ceiling at Peterborough Cathedral.*

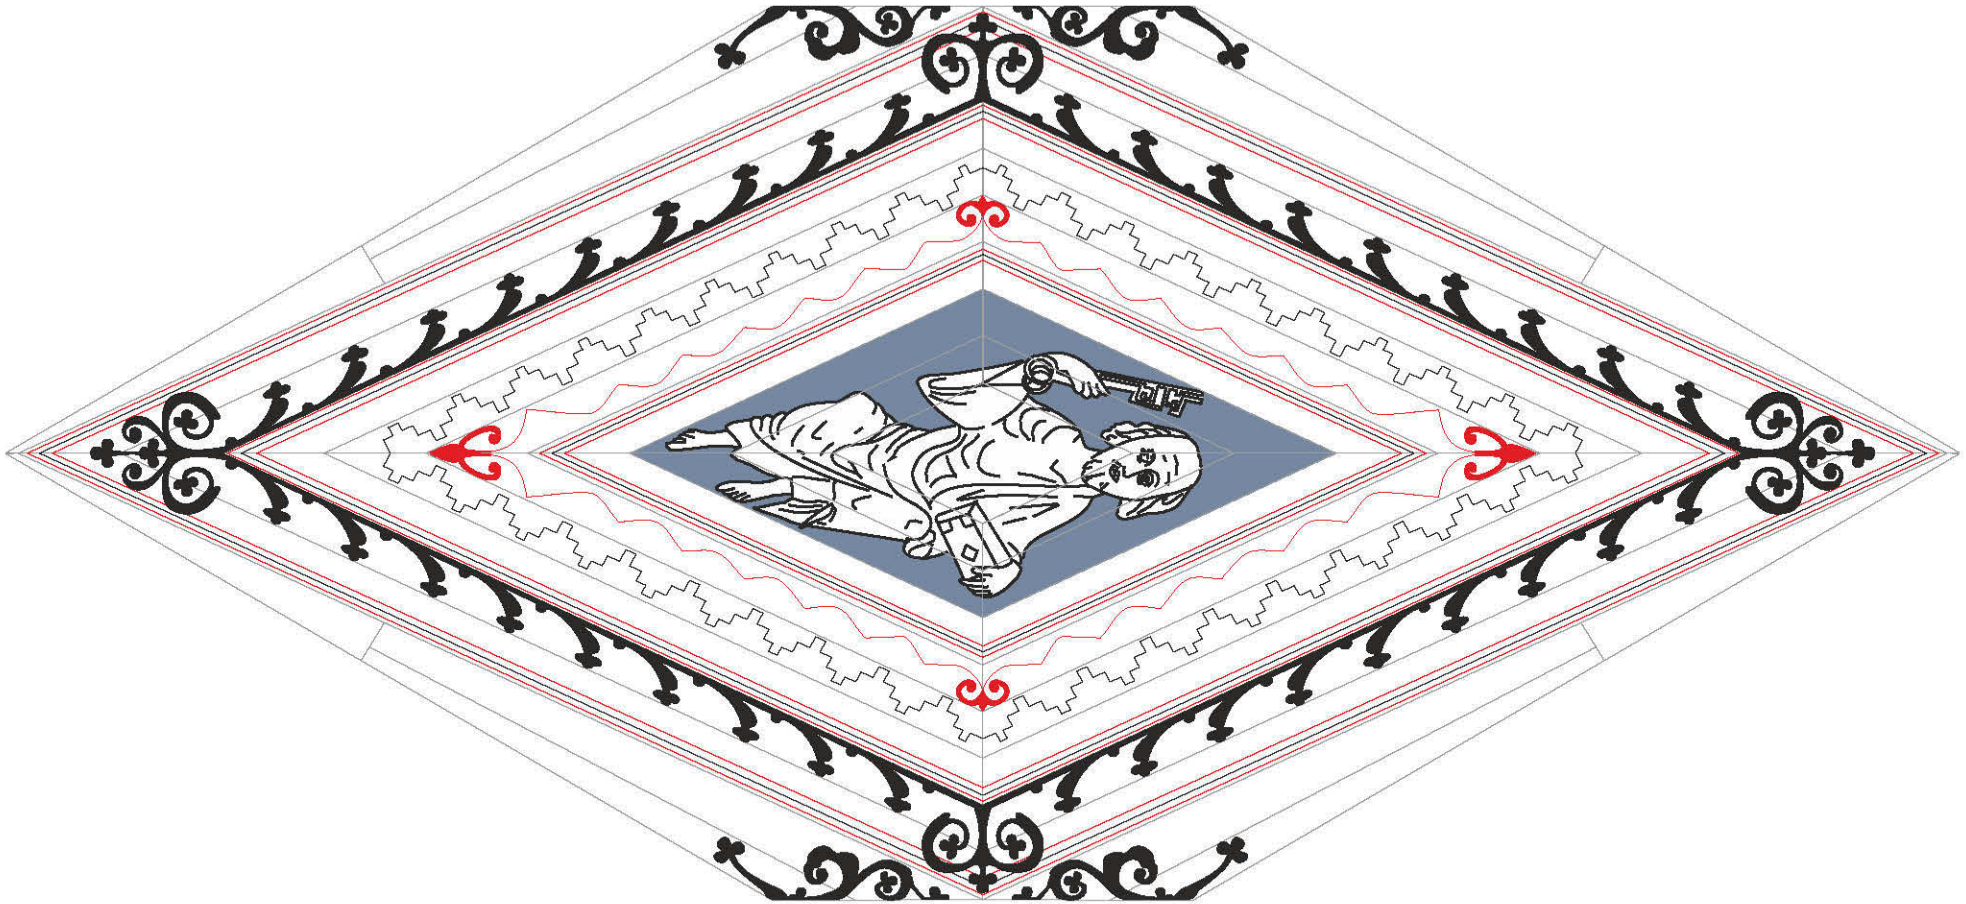
Figure 16. *Reconstruction of probable original medieval lozenge border decorations.*

The original lozenge border designs differed significantly from their present appearance. During Phase 1 it was noted that a trefoil pattern terminating in an elaborate scroll design existed under the extended chevron pattern on many original oak boards. Other examples of underpaint showing the outlines of border designs in relief on boards with otherwise 'weathered' surfaces were also noted. In Phase 2, as a consequence of the detailed examination required to accurately record the visible underpaint and with the results or extensive paint sample analysis we have a greater understanding of how the essentially linear border designs evolved through at least two restorations. **Figure 16** (see page 60) is a reconstruction of what is now considered to be the 13th century lozenge border decoration; although, further investigations are required to confirm this interpretation. Starting from the outside the original decorative pattern sequence was as follows:

Lozenge border decoration - Further investigations are required to confirm what is now considered to be the 13th century lozenge border decoration (see **Figure 16**). Investigations should include:

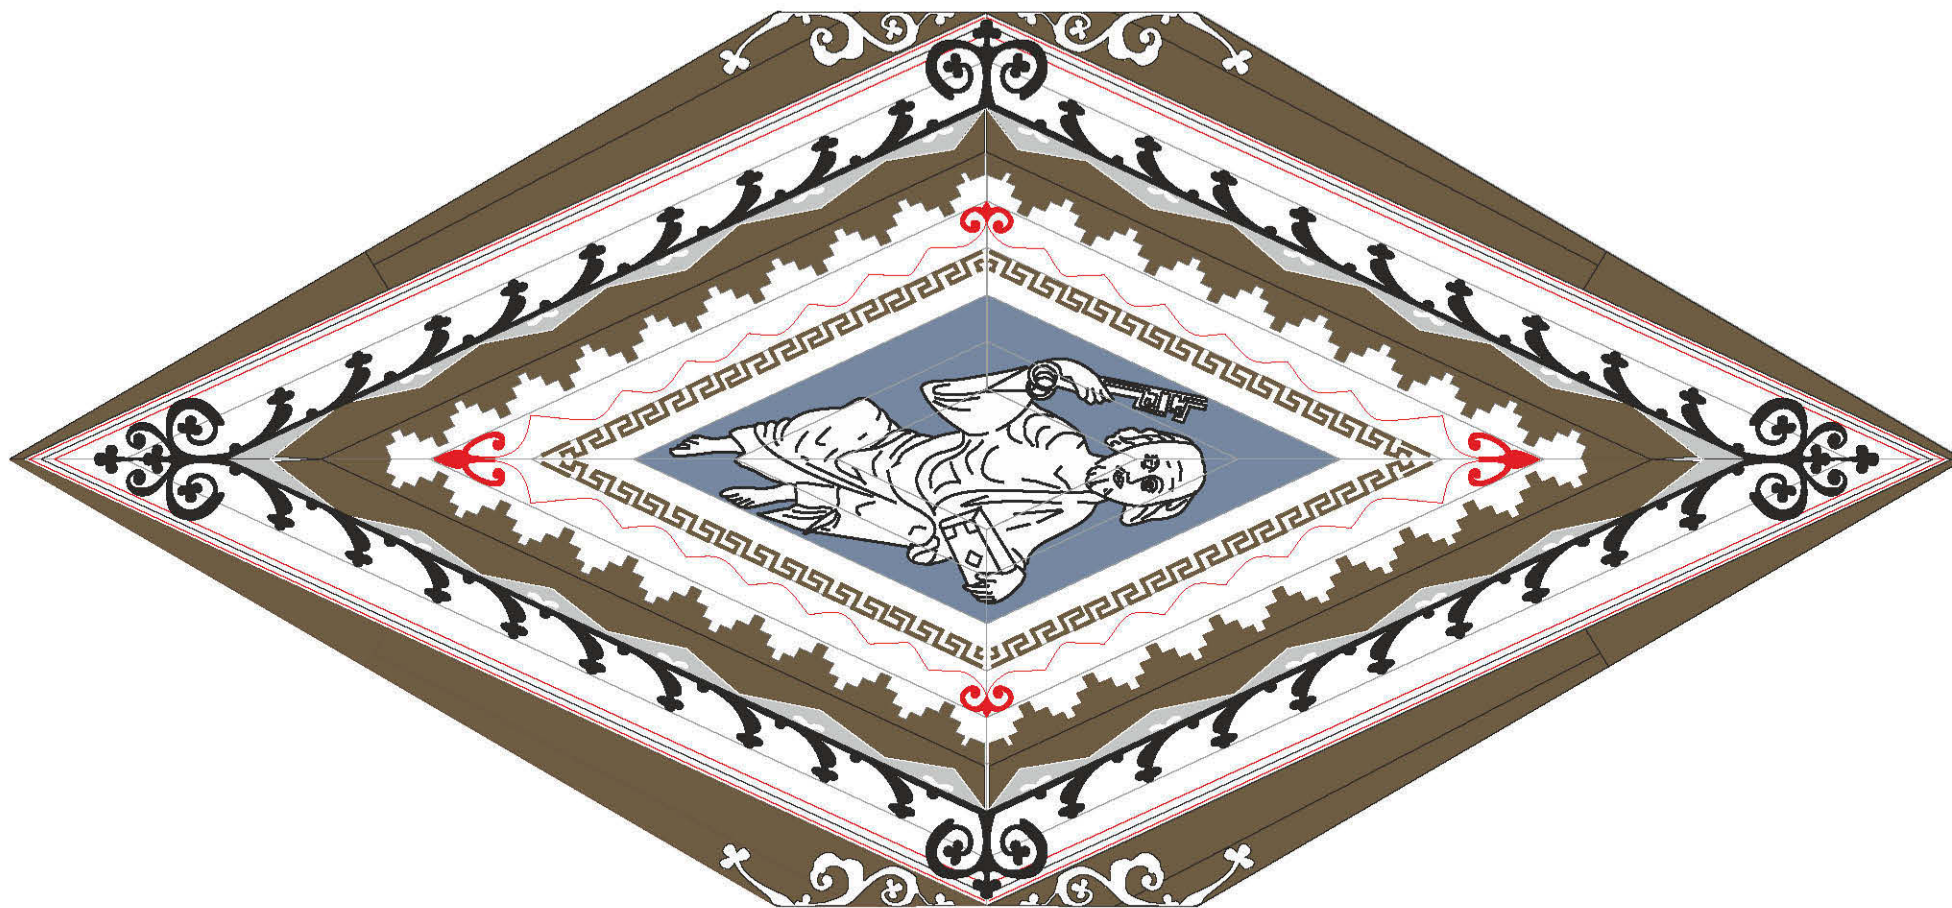
Figure 17. Reconstruction of probable lozenge border decorations as painted in the 1740s.

8.3.1.1 Lozenge border patterns – Analysis of a limited number of paint samples, obtained during the Emergency phase and Phase 1, from boards with the lozenge border designs led us to assume all these boards had been entirely repainted in the 1740s. Kakoulli's 1999 findings and subsequent visual observation indicate this assumption was incorrect. **Figure 17** is a reconstruction of what we now consider to be the 1740s lozenge border decoration. Starting from the outside the 1740s decorative pattern sequence was as follows:

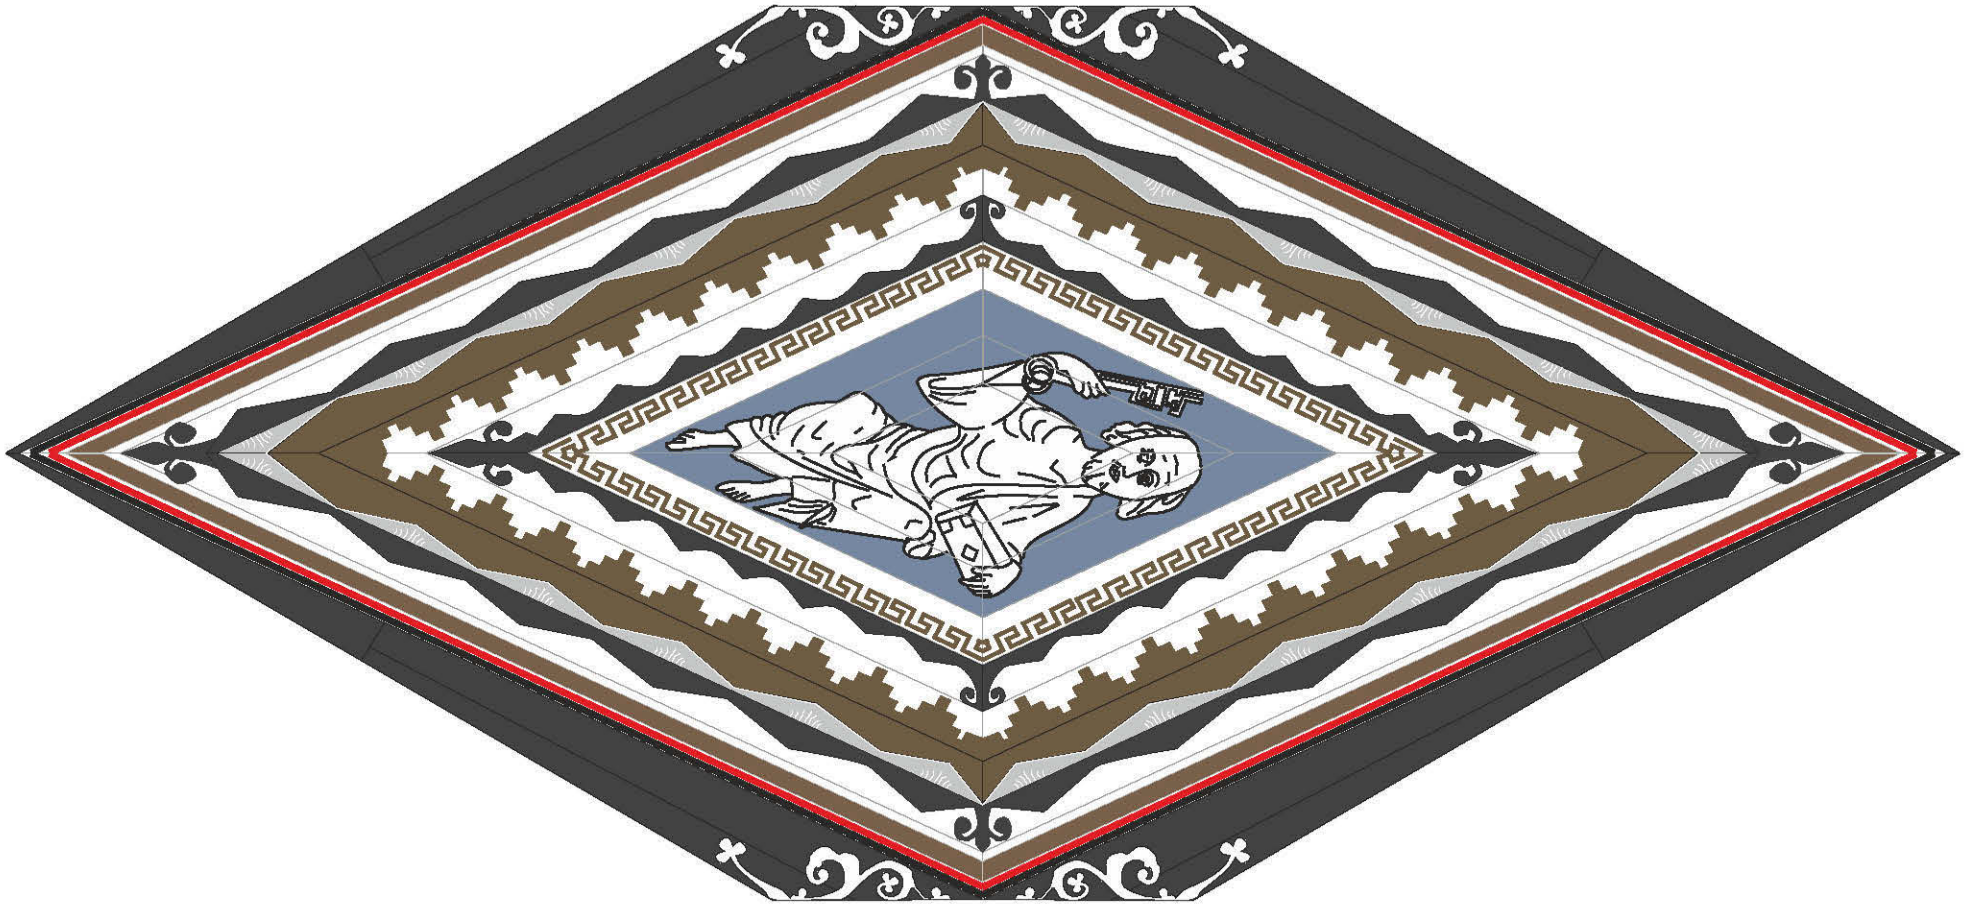
Figure 18. Lozenge border decorations as painted in the 1830s.

8.3.2.2 Lozenge border patterns – **Figure 18** is a reconstruction of the lozenge border decoration as painted in the 1830s and therefore as it appears now. Starting from the outside the 1830s decorative pattern sequence is as follows:

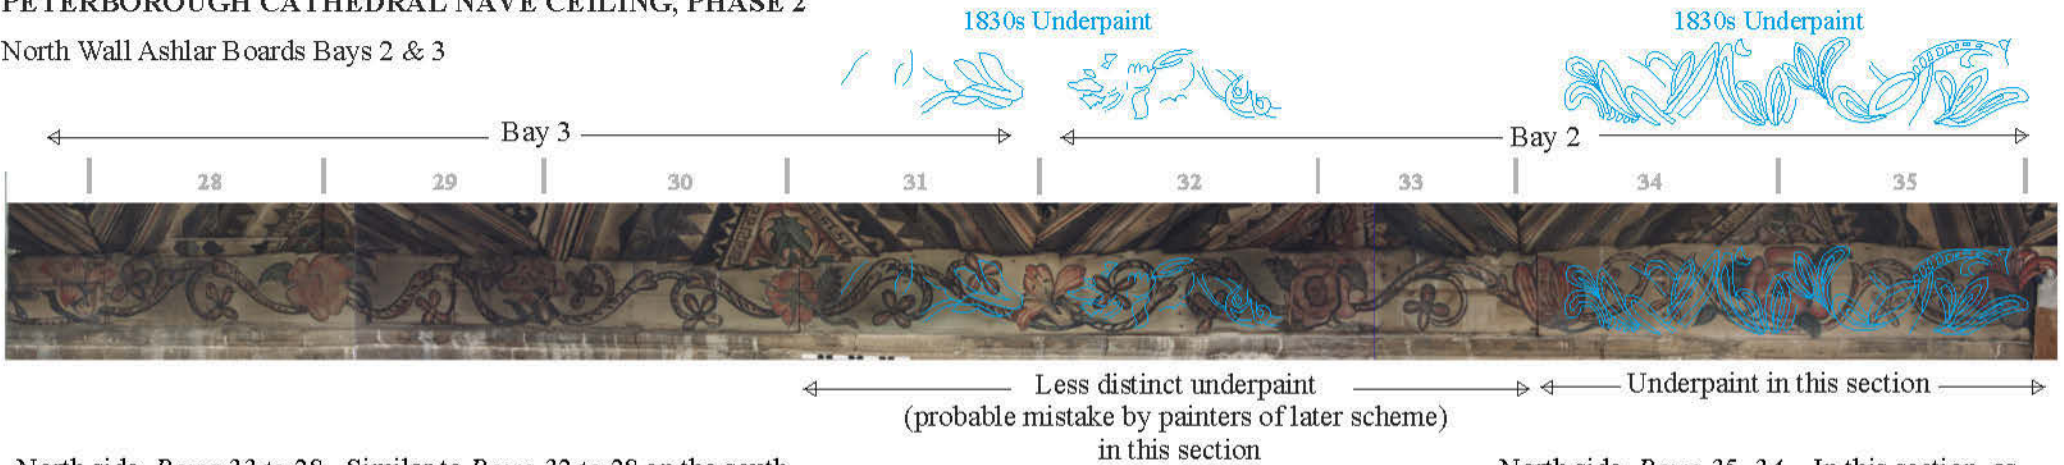
North Wall Ashlar Boards Bays 2 & 3

North side, *Rows 33 to 28* - Similar to *Rows 32 to 28* on the south side although with subtle differences that are difficult to define. Probably executed by a different painter: i.e. one restorer painted the south Ashlar boards while another painted the north frieze.

North side, *Rows 33 to 31* - A mistake was painted out with the white background colour while still wet. It is possible to see a misplaced flower through the background. The covering background paint has a distinct greenish tinge suggesting the still wet green paint in the layer below was redistributed in the process.

North side, *Rows 35, 34* - In this section, as well as the whole of Bay 1, the reds and greens are deeper and the blacks more intense. These areas appear to have been painted with more care than what follows to the west.

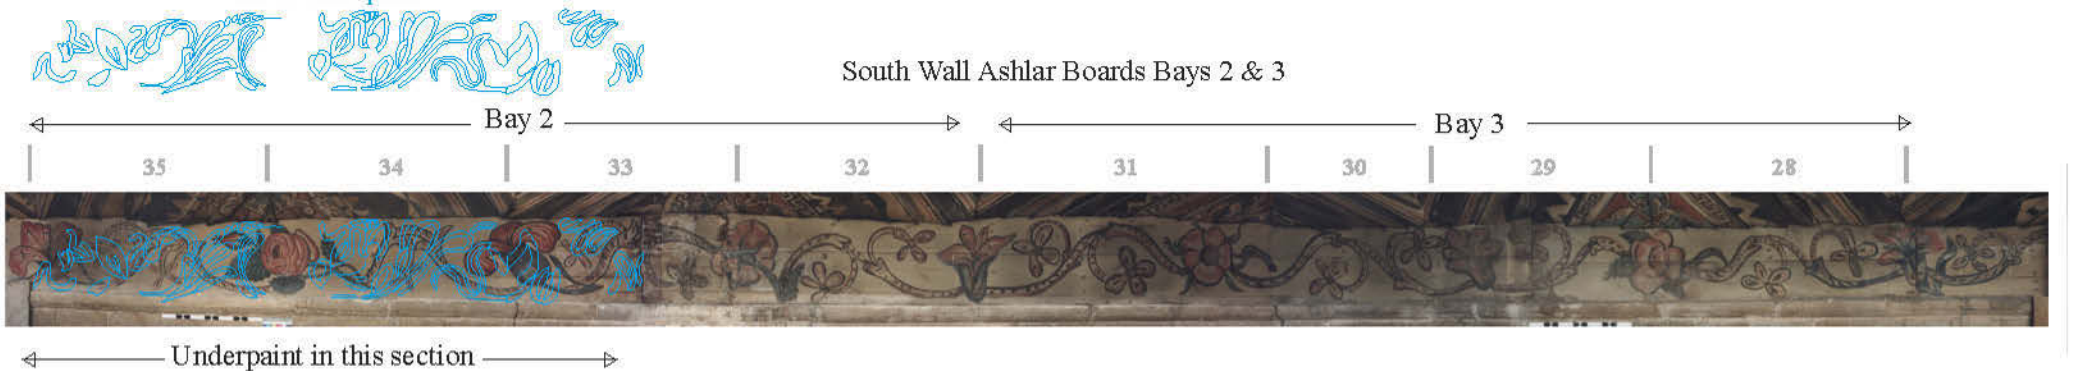
1830s Underpaint

South side, *Rows 35, 34* and half of *33* - In this section, as well as the whole of Bay 1, the reds and greens are deeper and the blacks more intense. These areas appear to have been painted with more care than what follows to the west.

South side, *Rows 32 to 28* and beyond - The blacks are more resinous in this area and the colours generally less intense. There is more use of brown rather than black in the stem decoration.

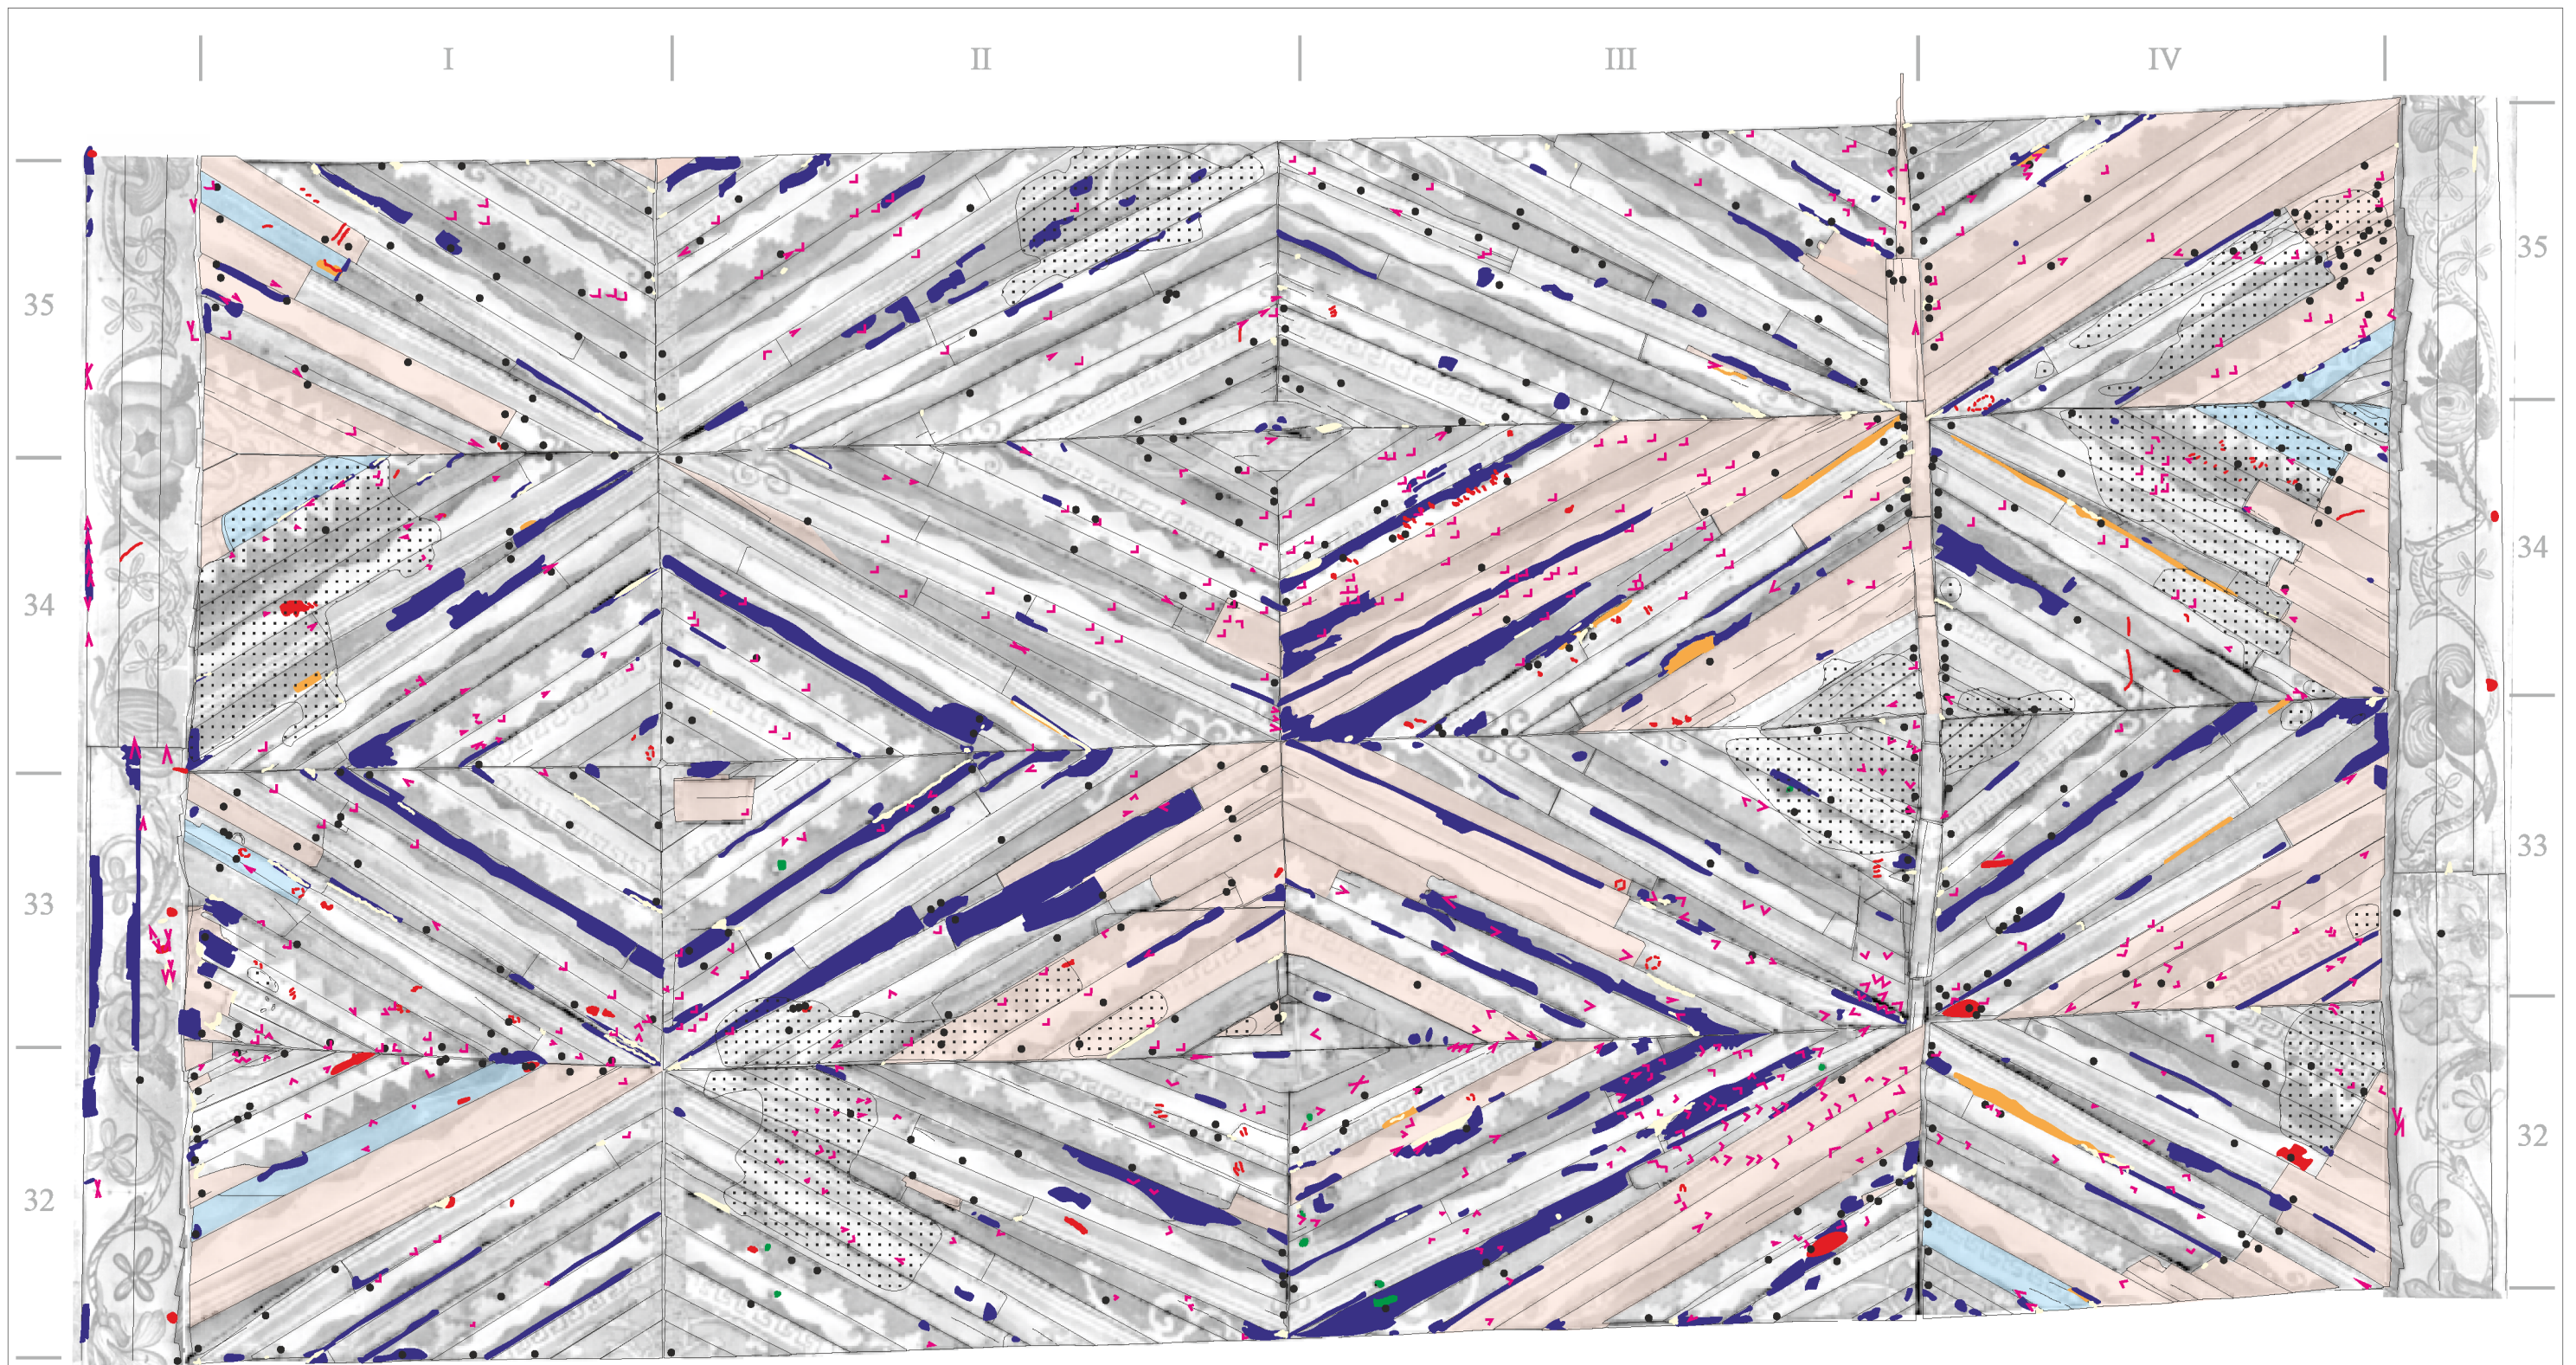
Wood loss - Note the holes etc. cut in the ceiling boards marked as Intended wood losses.

Repositioned oak boards - Note the number of original boards that have been reused, marked in light blue as Repositioned oak boards.

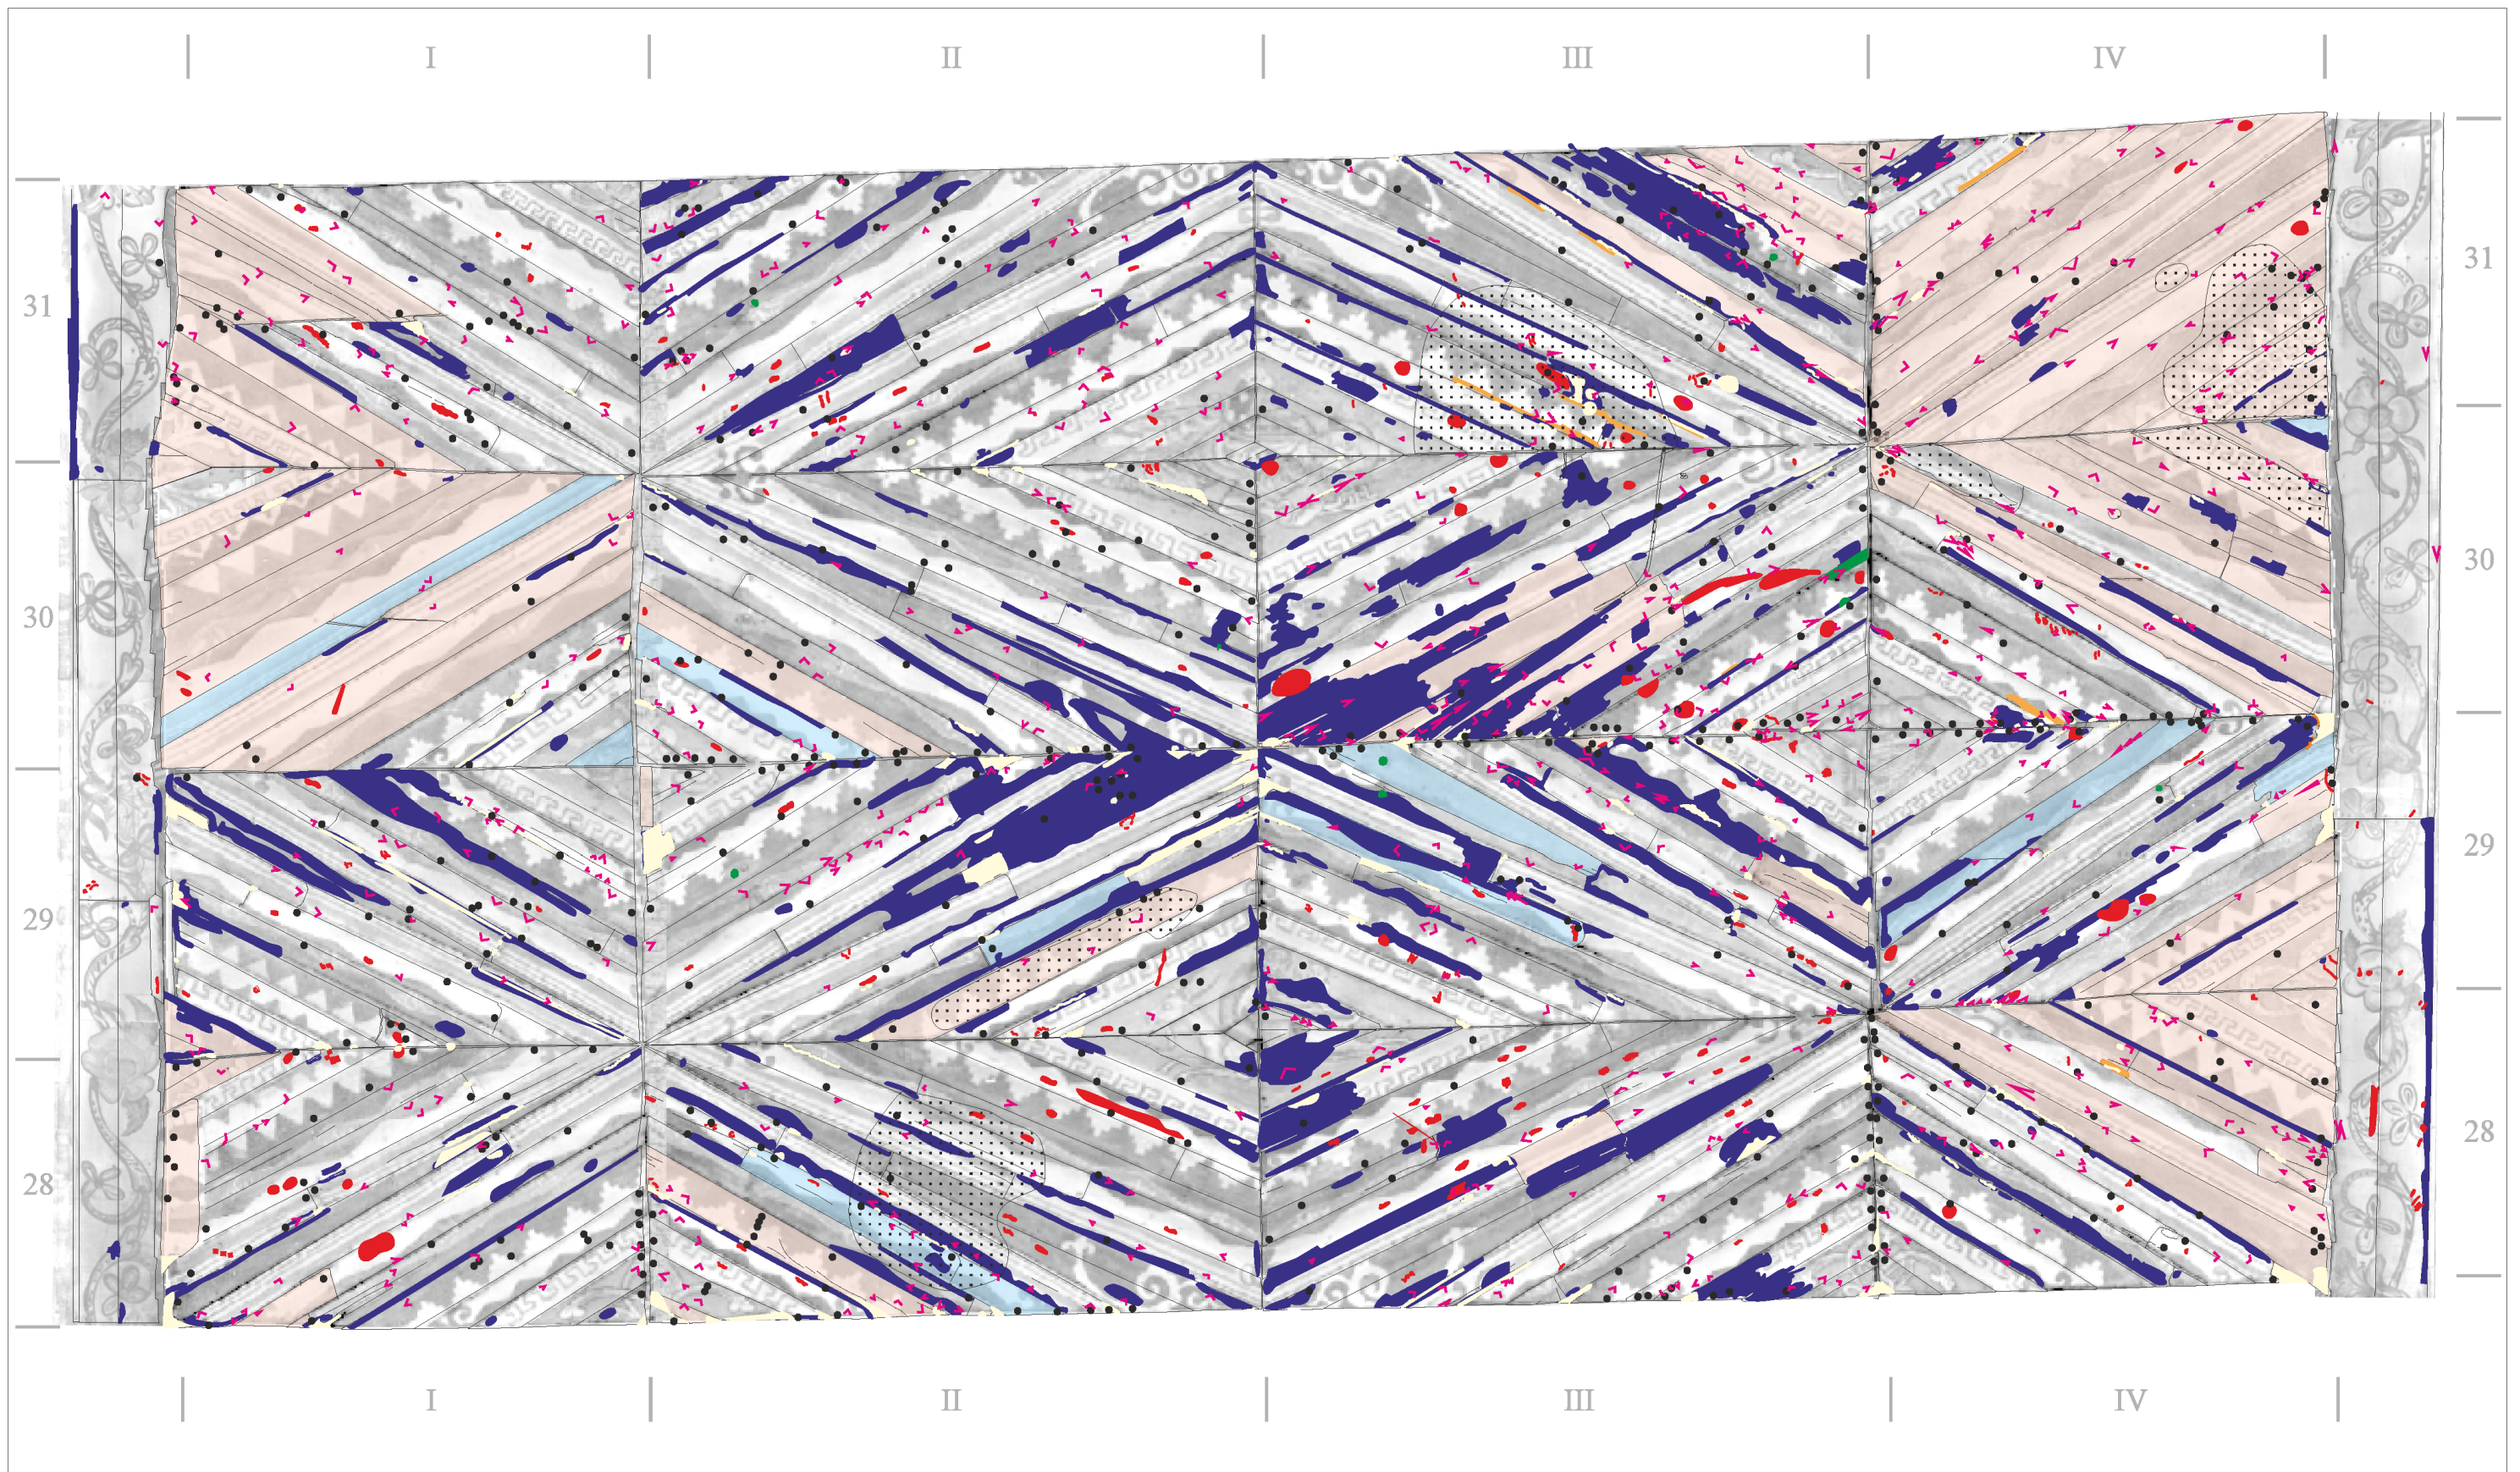
STAGE **CONDITION SURVEY
 AND TREATMENT** DESCRIPTION
Damage to Ceiling Boards

Decay - The pattern of decay remains similar to that found in Phase 1, with a greater retention of original boards in the flat section of ceiling, and with a corresponding increase in insect damage. It should be noted how few original boards survive at the base of the sloping panels.

Wood loss - Note the holes etc. cut in the ceiling boards marked as Intended wood losses.

Repositioned oak boards - Note the number of original boards that have been reused, marked in light blue as Repositioned oak boards.
