PETERBOROUGH CATHEDRAL: THE NAVE CEILING

PHASE 2: ROWS 28 - 35

CONDITION SURVEY AND CONSERVATION TREATMENT

MAY - JULY 1999

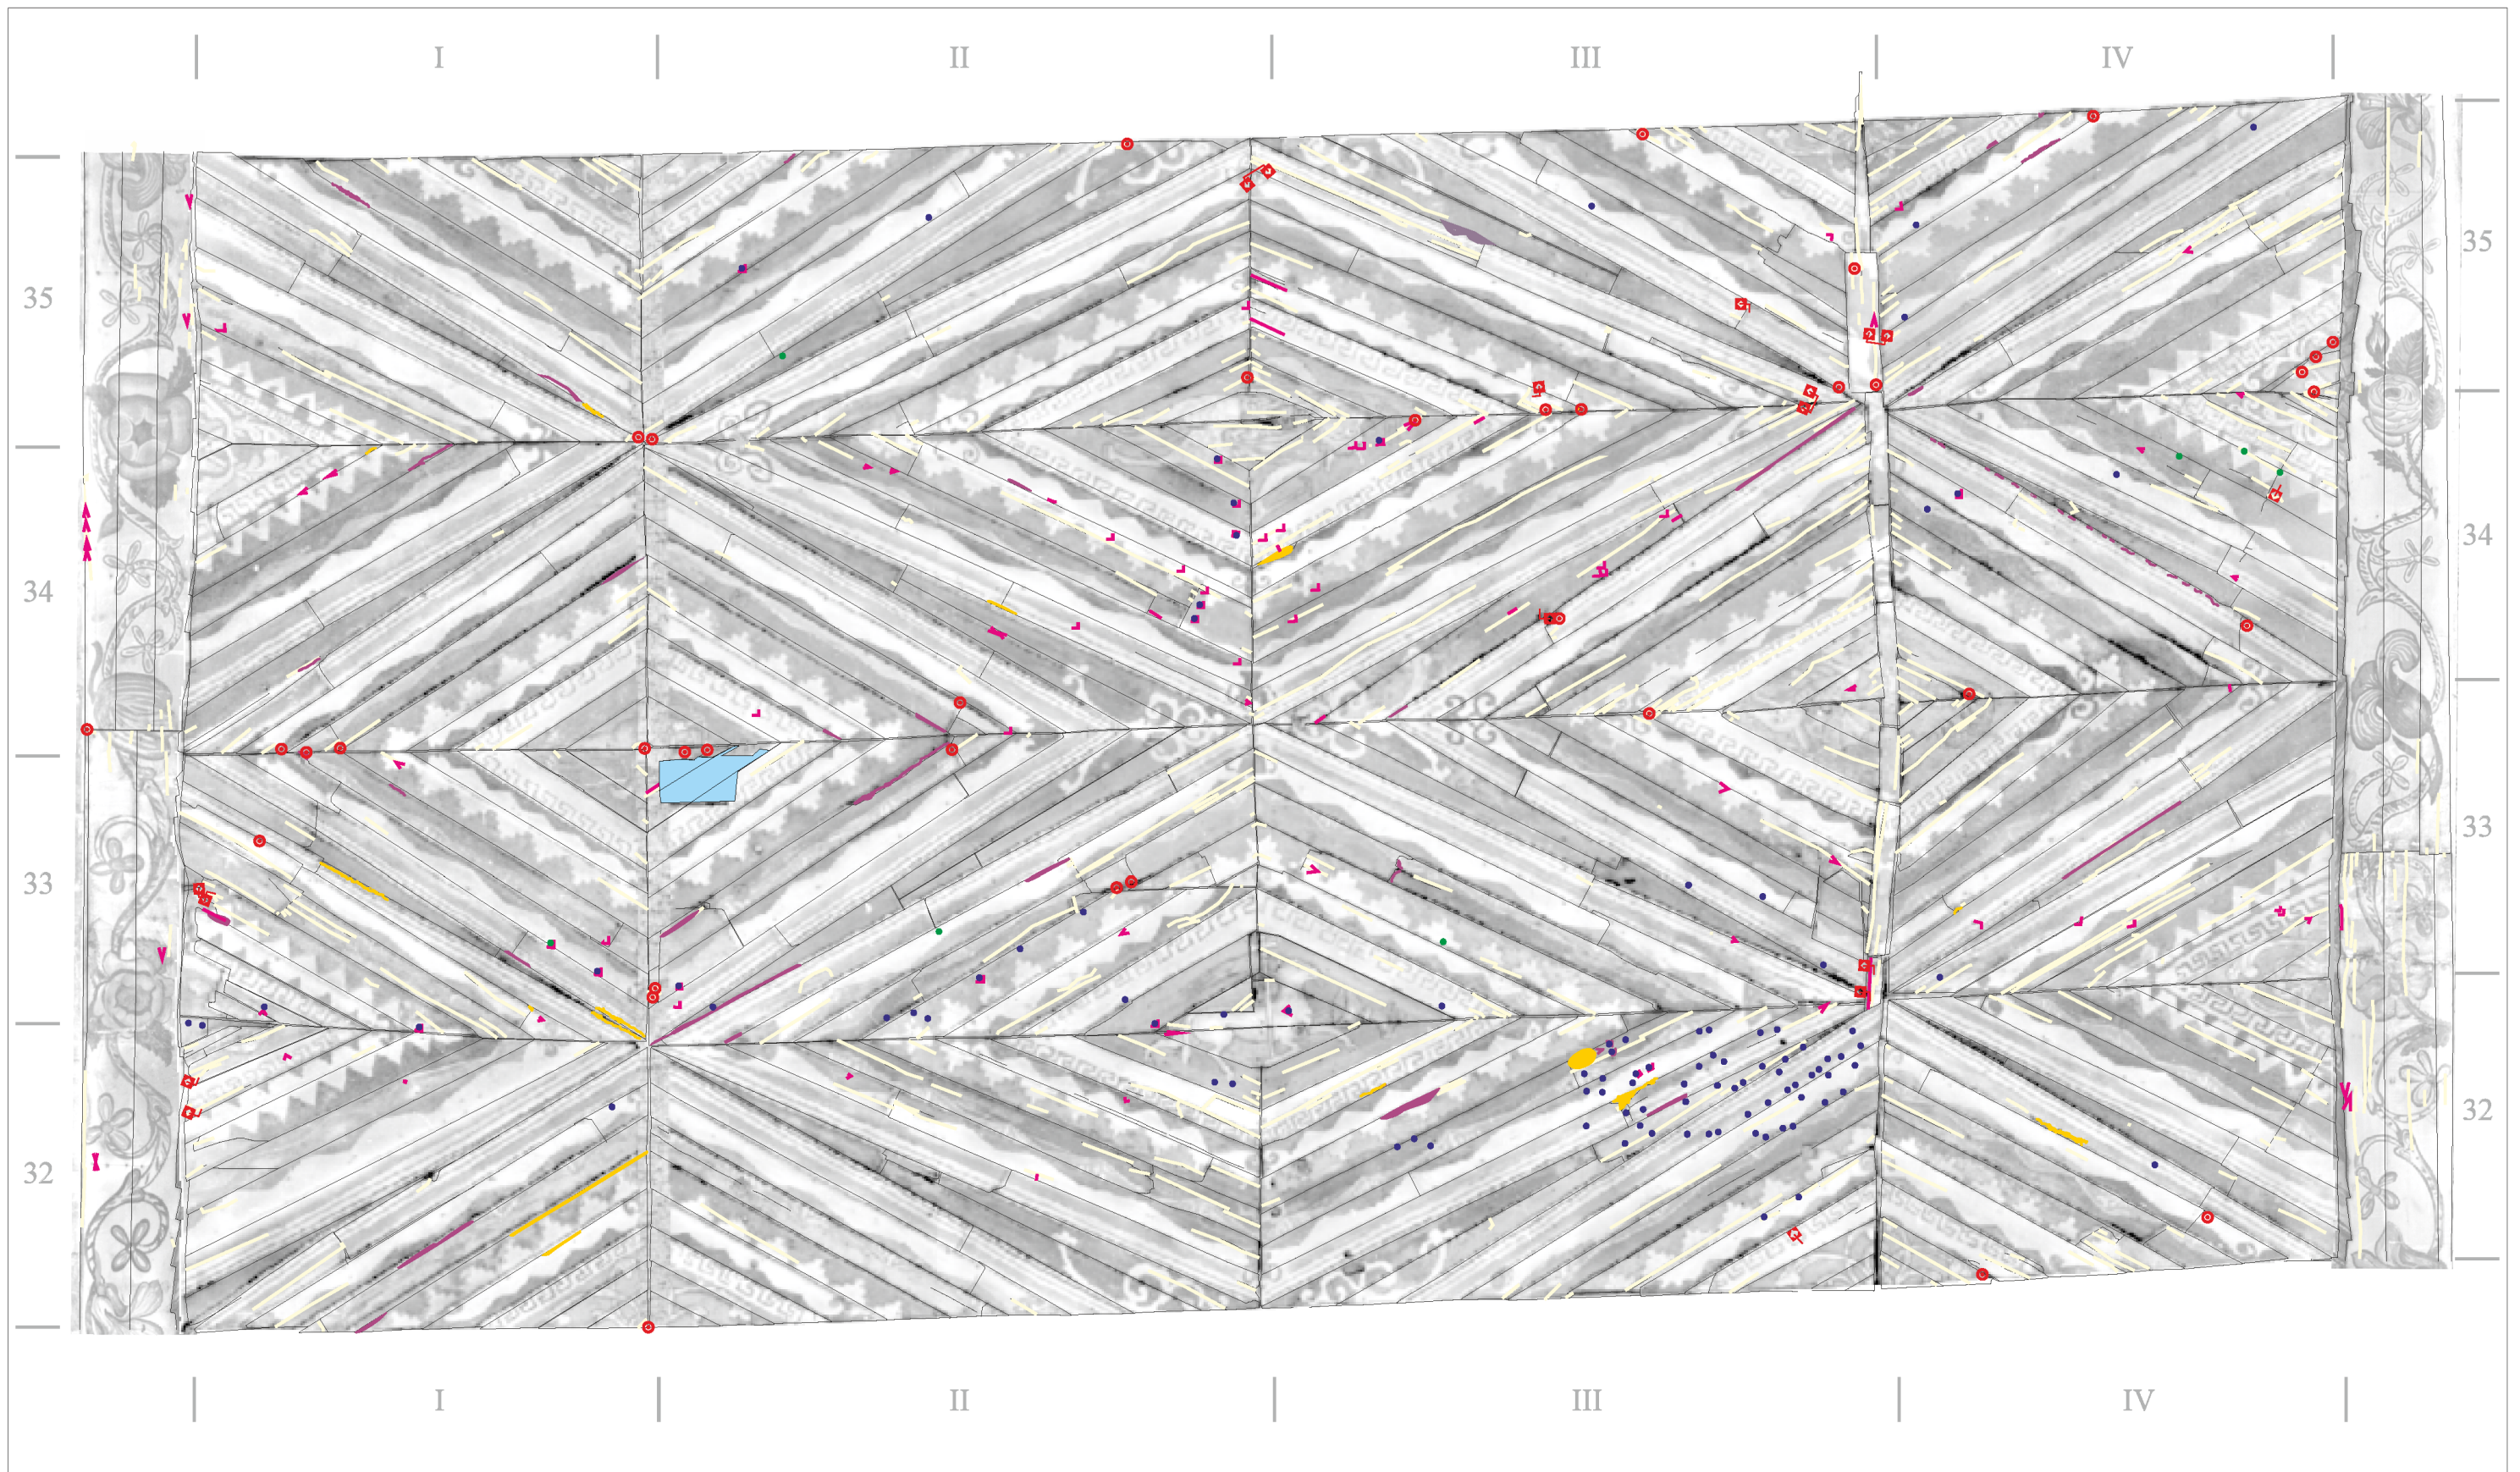
Timber inserts - The location of the new oak inserts is shown here in blue.

Replaced screws - Where protruding 1926 screws can be accessed from above simply by peeling away the hessian above the screw head, these were removed and replaced with shorter stainless steel screws.

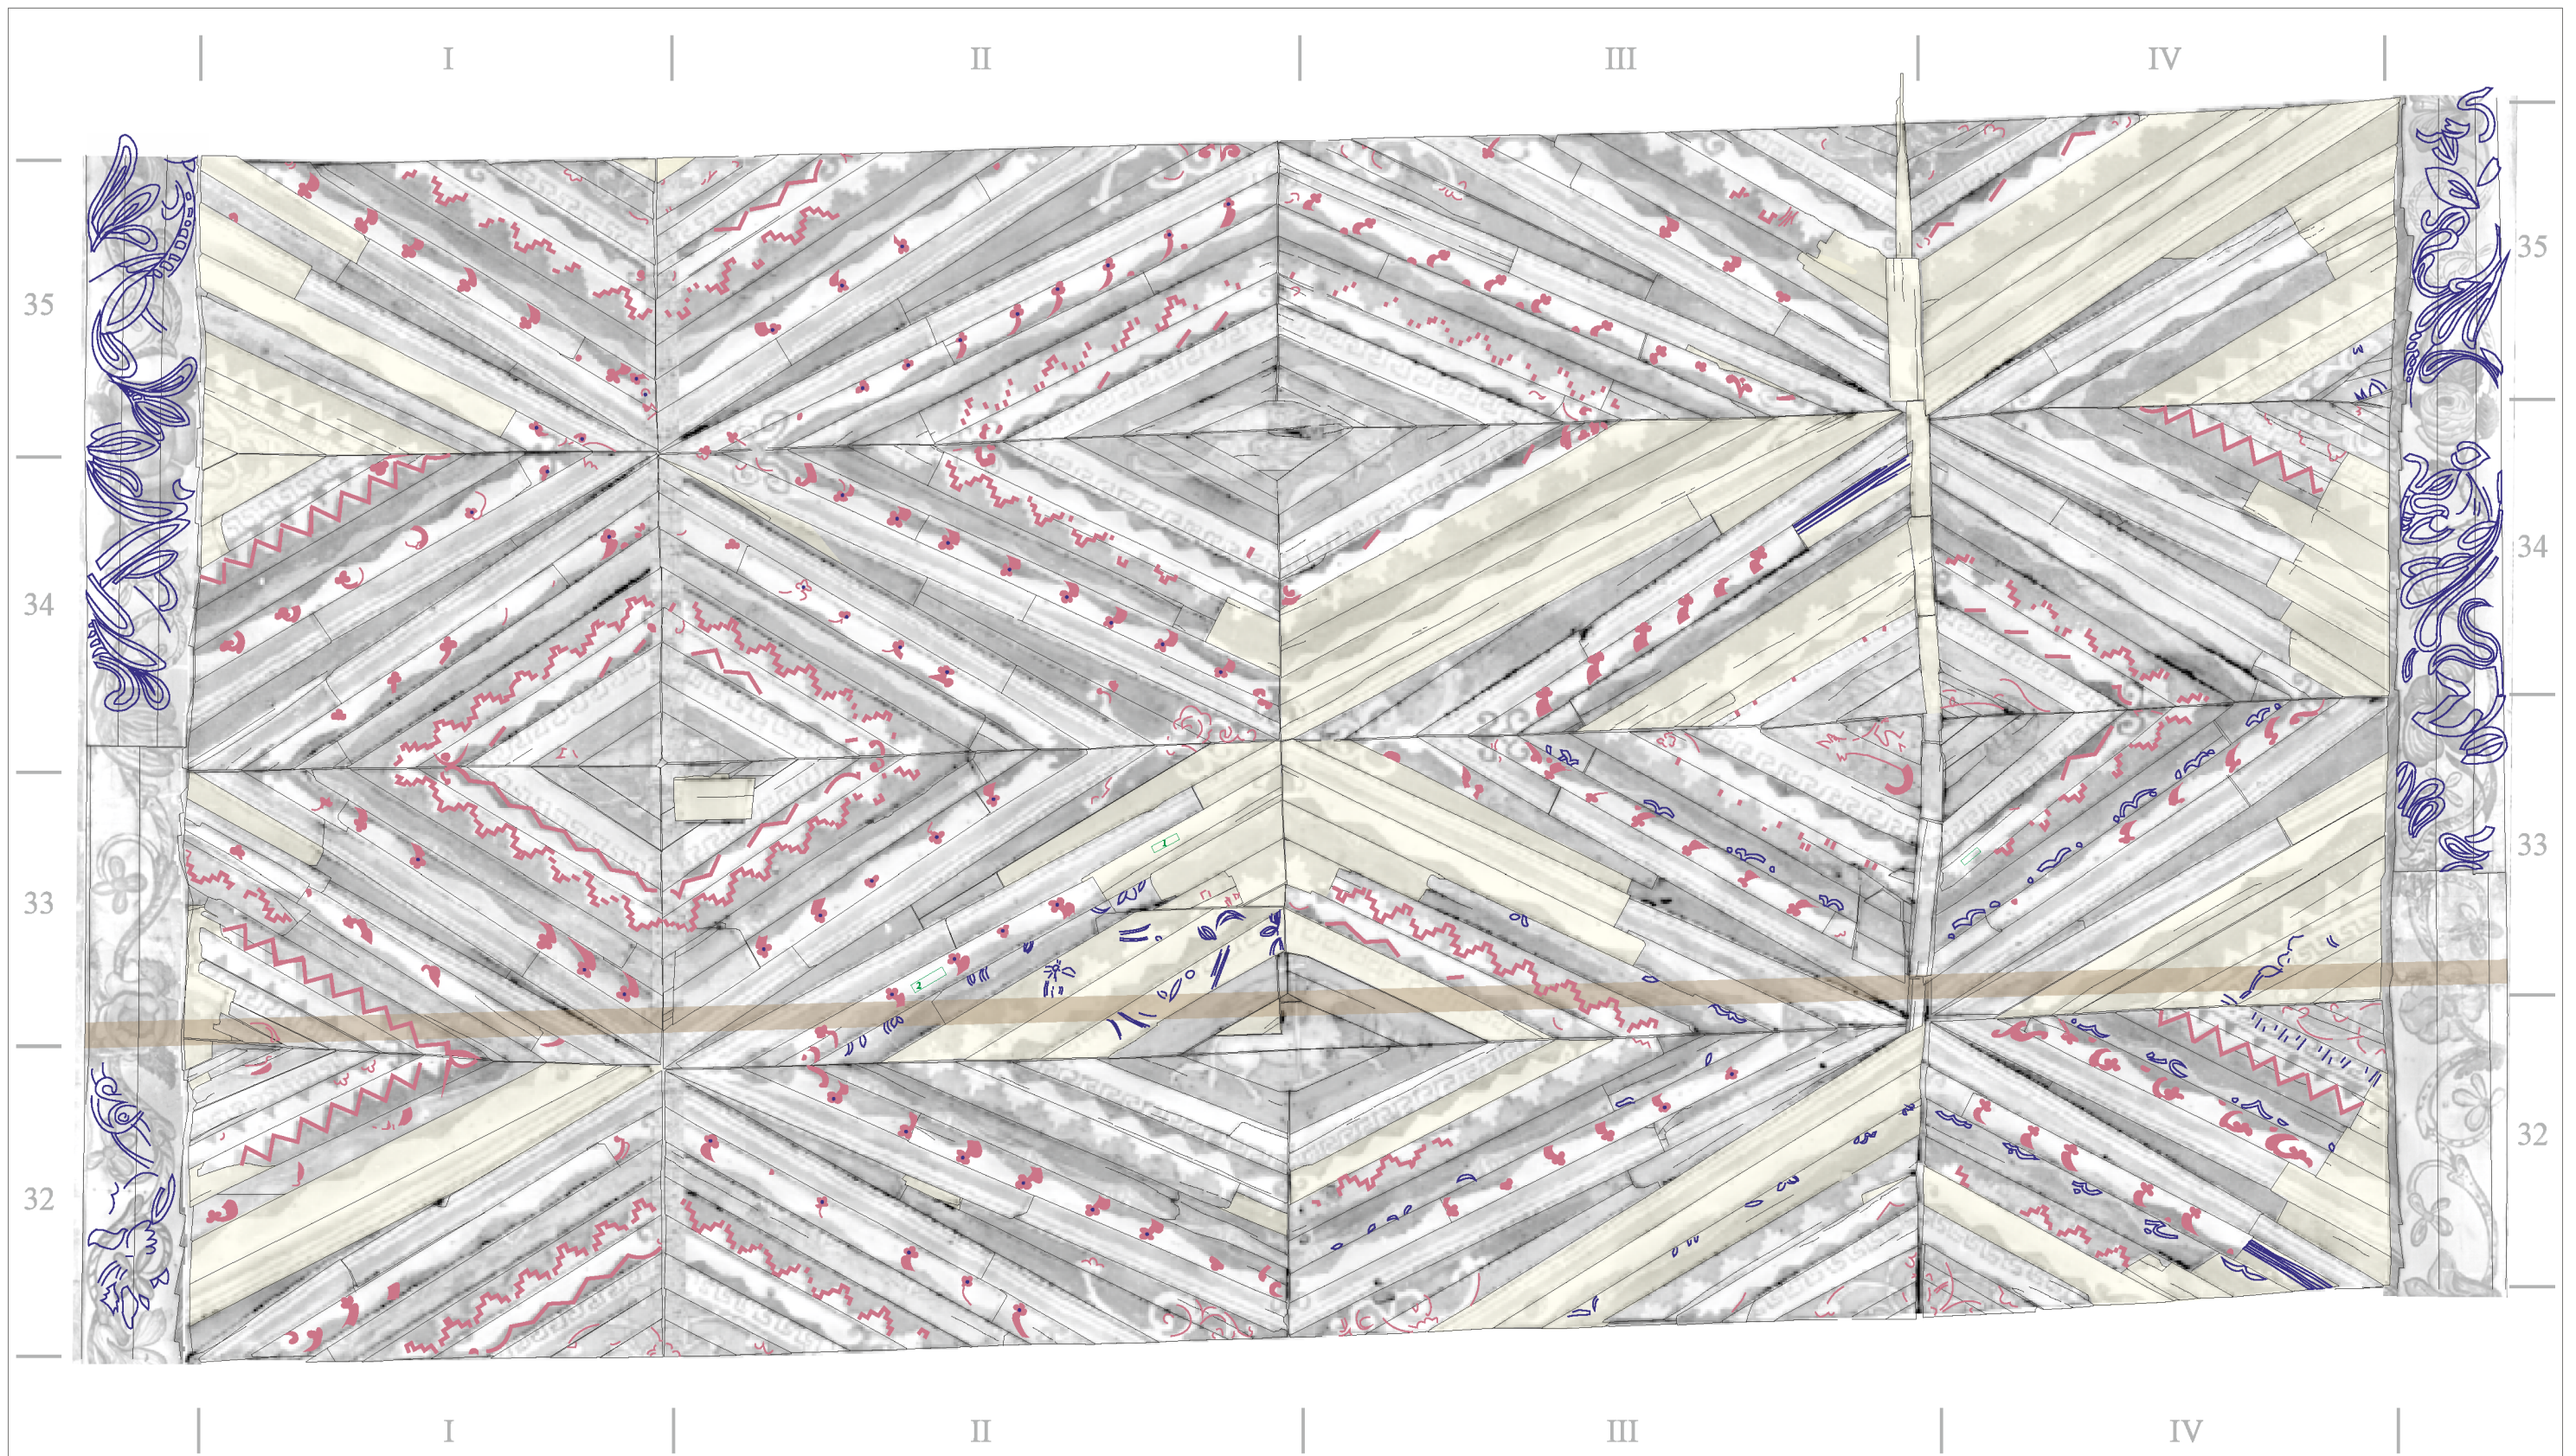
Graffiti - Some 1880s pencilled graffiti exists on the ceiling boards to the west of the 1880s screening. On the Ashlar boards in Bays 1, 2 and 3 there are a number of examples recording that limewash was scraped from the nave walls during 1890.

Visible Underpaint - All evidence of the original and 1740s painted scheme visible in raking light beneath the 1830s repaint is plotted on this graphic, including 1830s underpaint on the Ashlar boards west of Row 33 and the frieze scheme visible as underpainting on a number of softwood replacement ceiling boards.

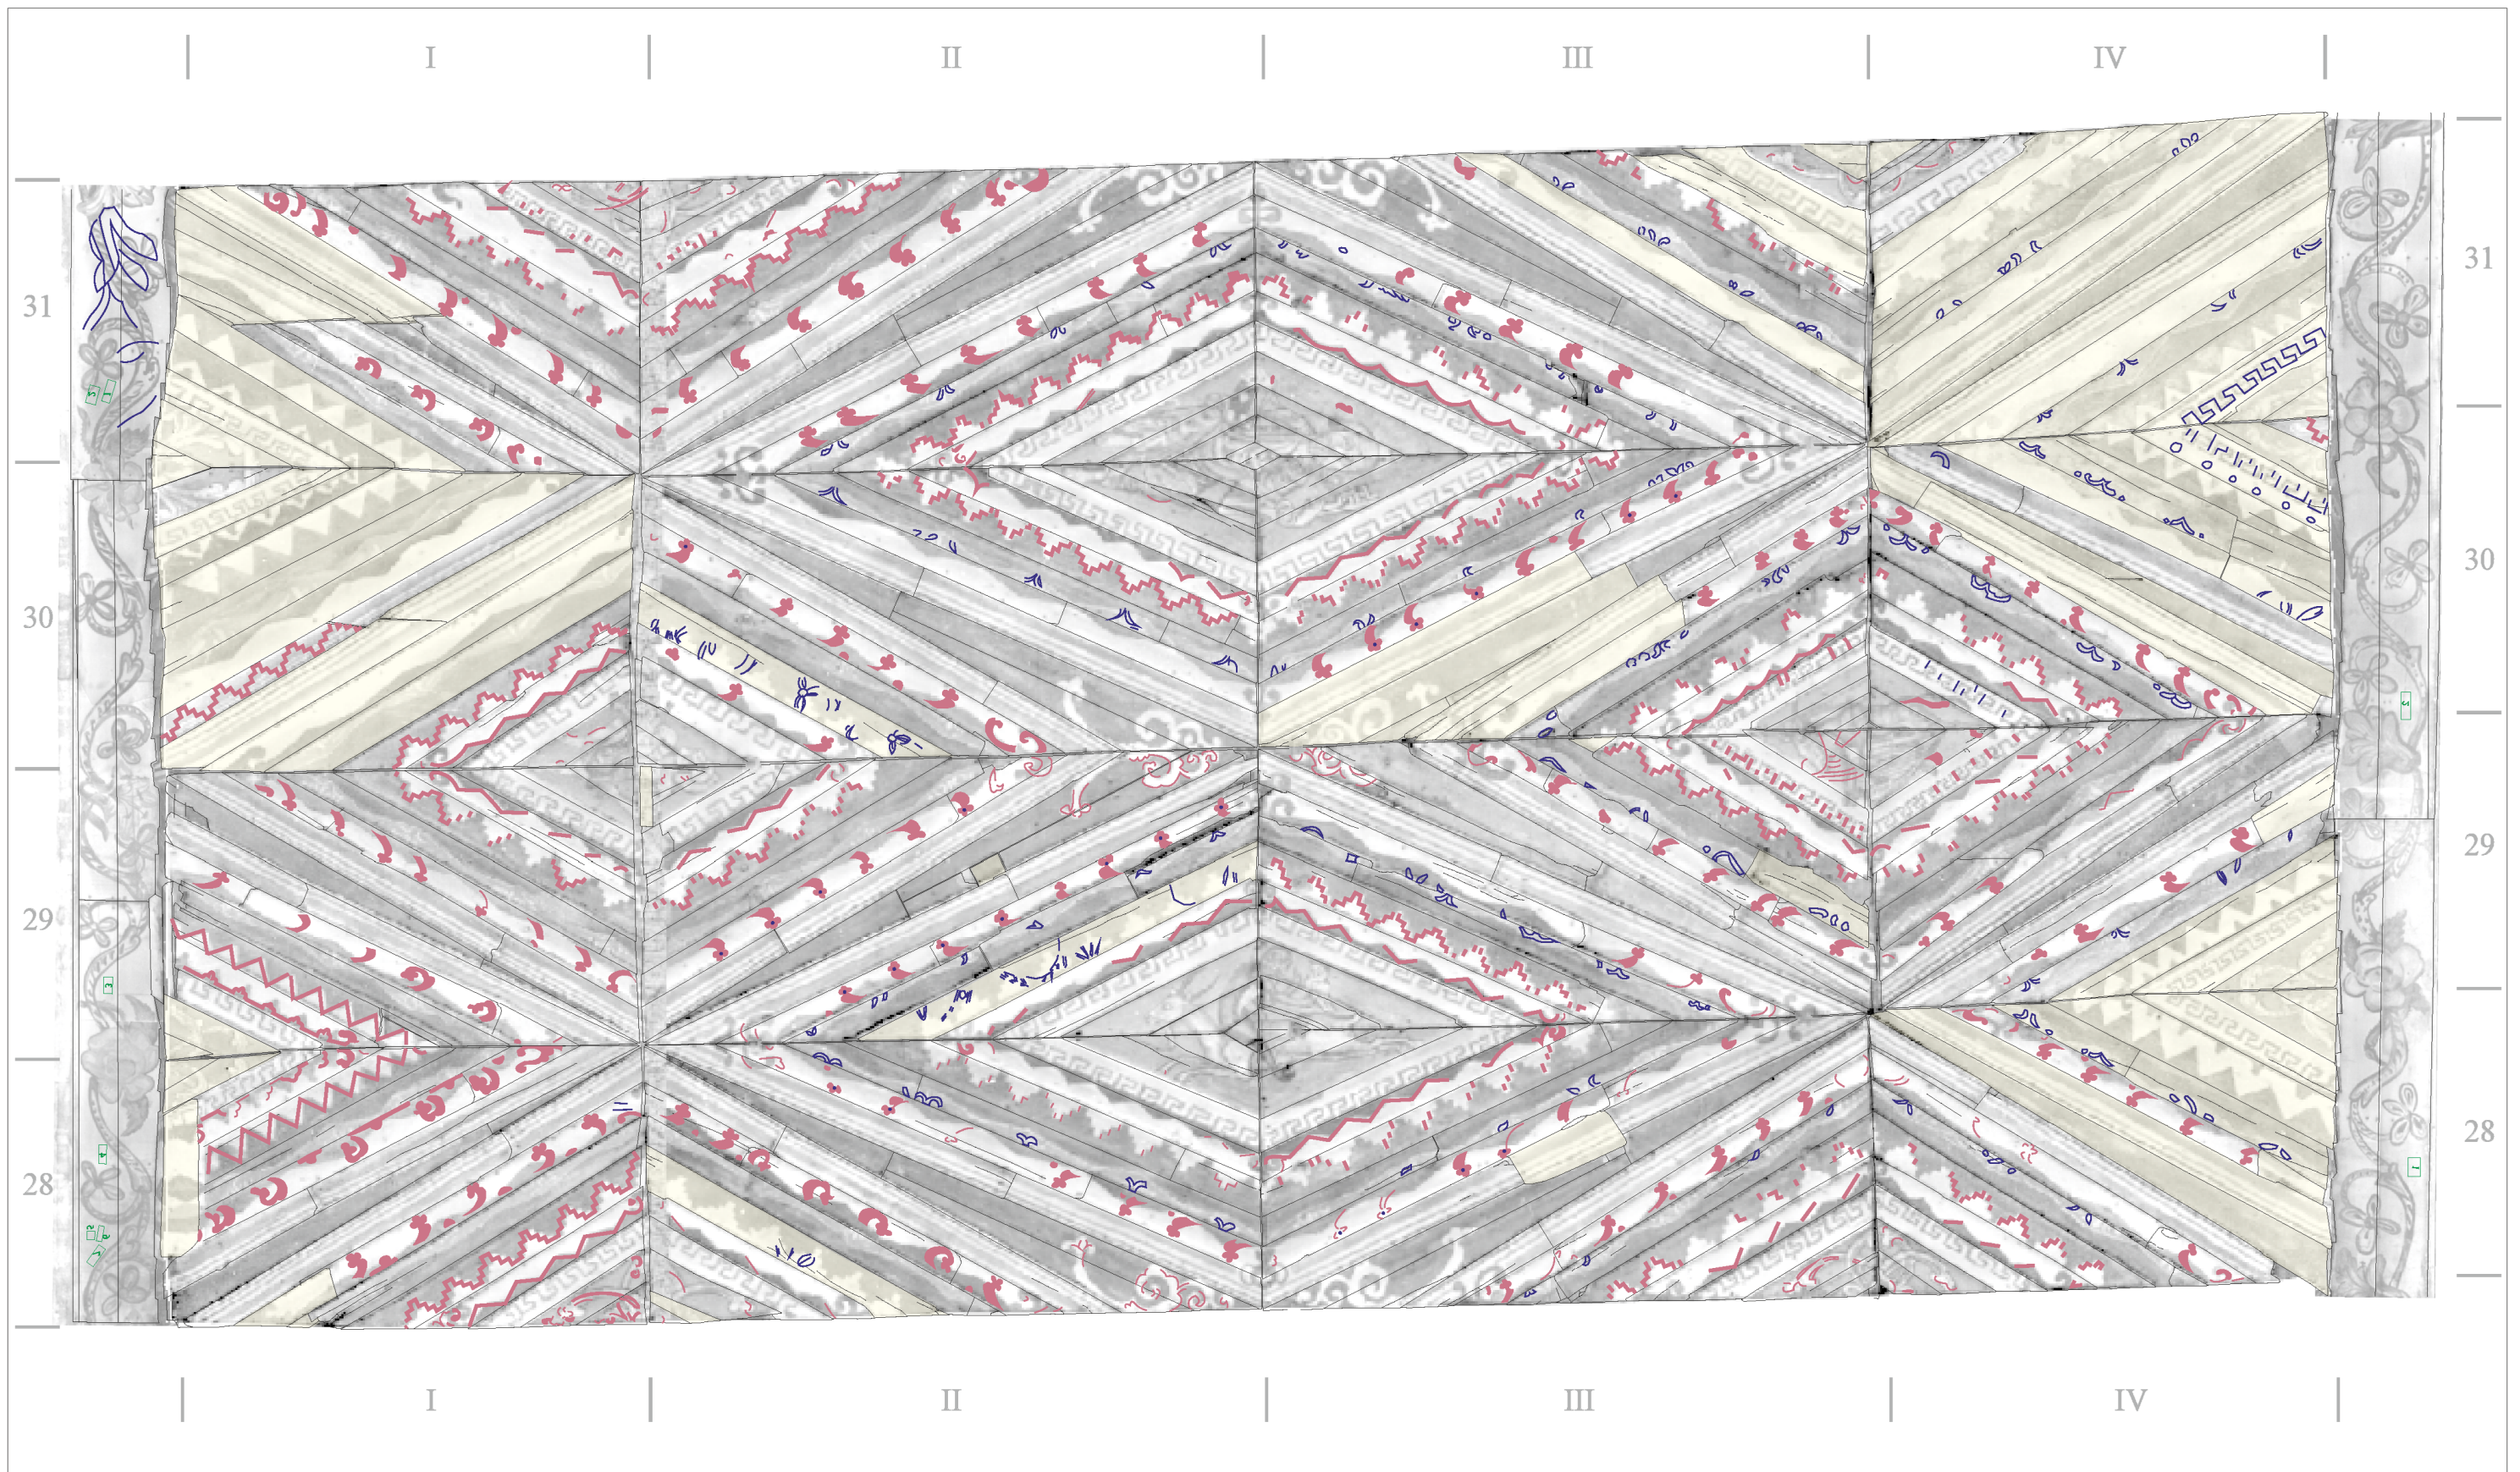
Graffiti - Some 1880s pencilled graffiti exists on the ceiling boards to the west of the 1880s screening. On the Ashlar boards in Bays 1, 2 and 3 there are a number of examples recording that limewash was scraped from the nave walls during 1890.

Visible Underpaint - All evidence of the original and 1740s painted scheme visible in raking light beneath the 1830s repaint is plotted on this graphic, including 1830s underpaint on the Ashlar boards west of Row 33 and the frieze scheme visible as underpainting on a number of softwood replacement ceiling boards.

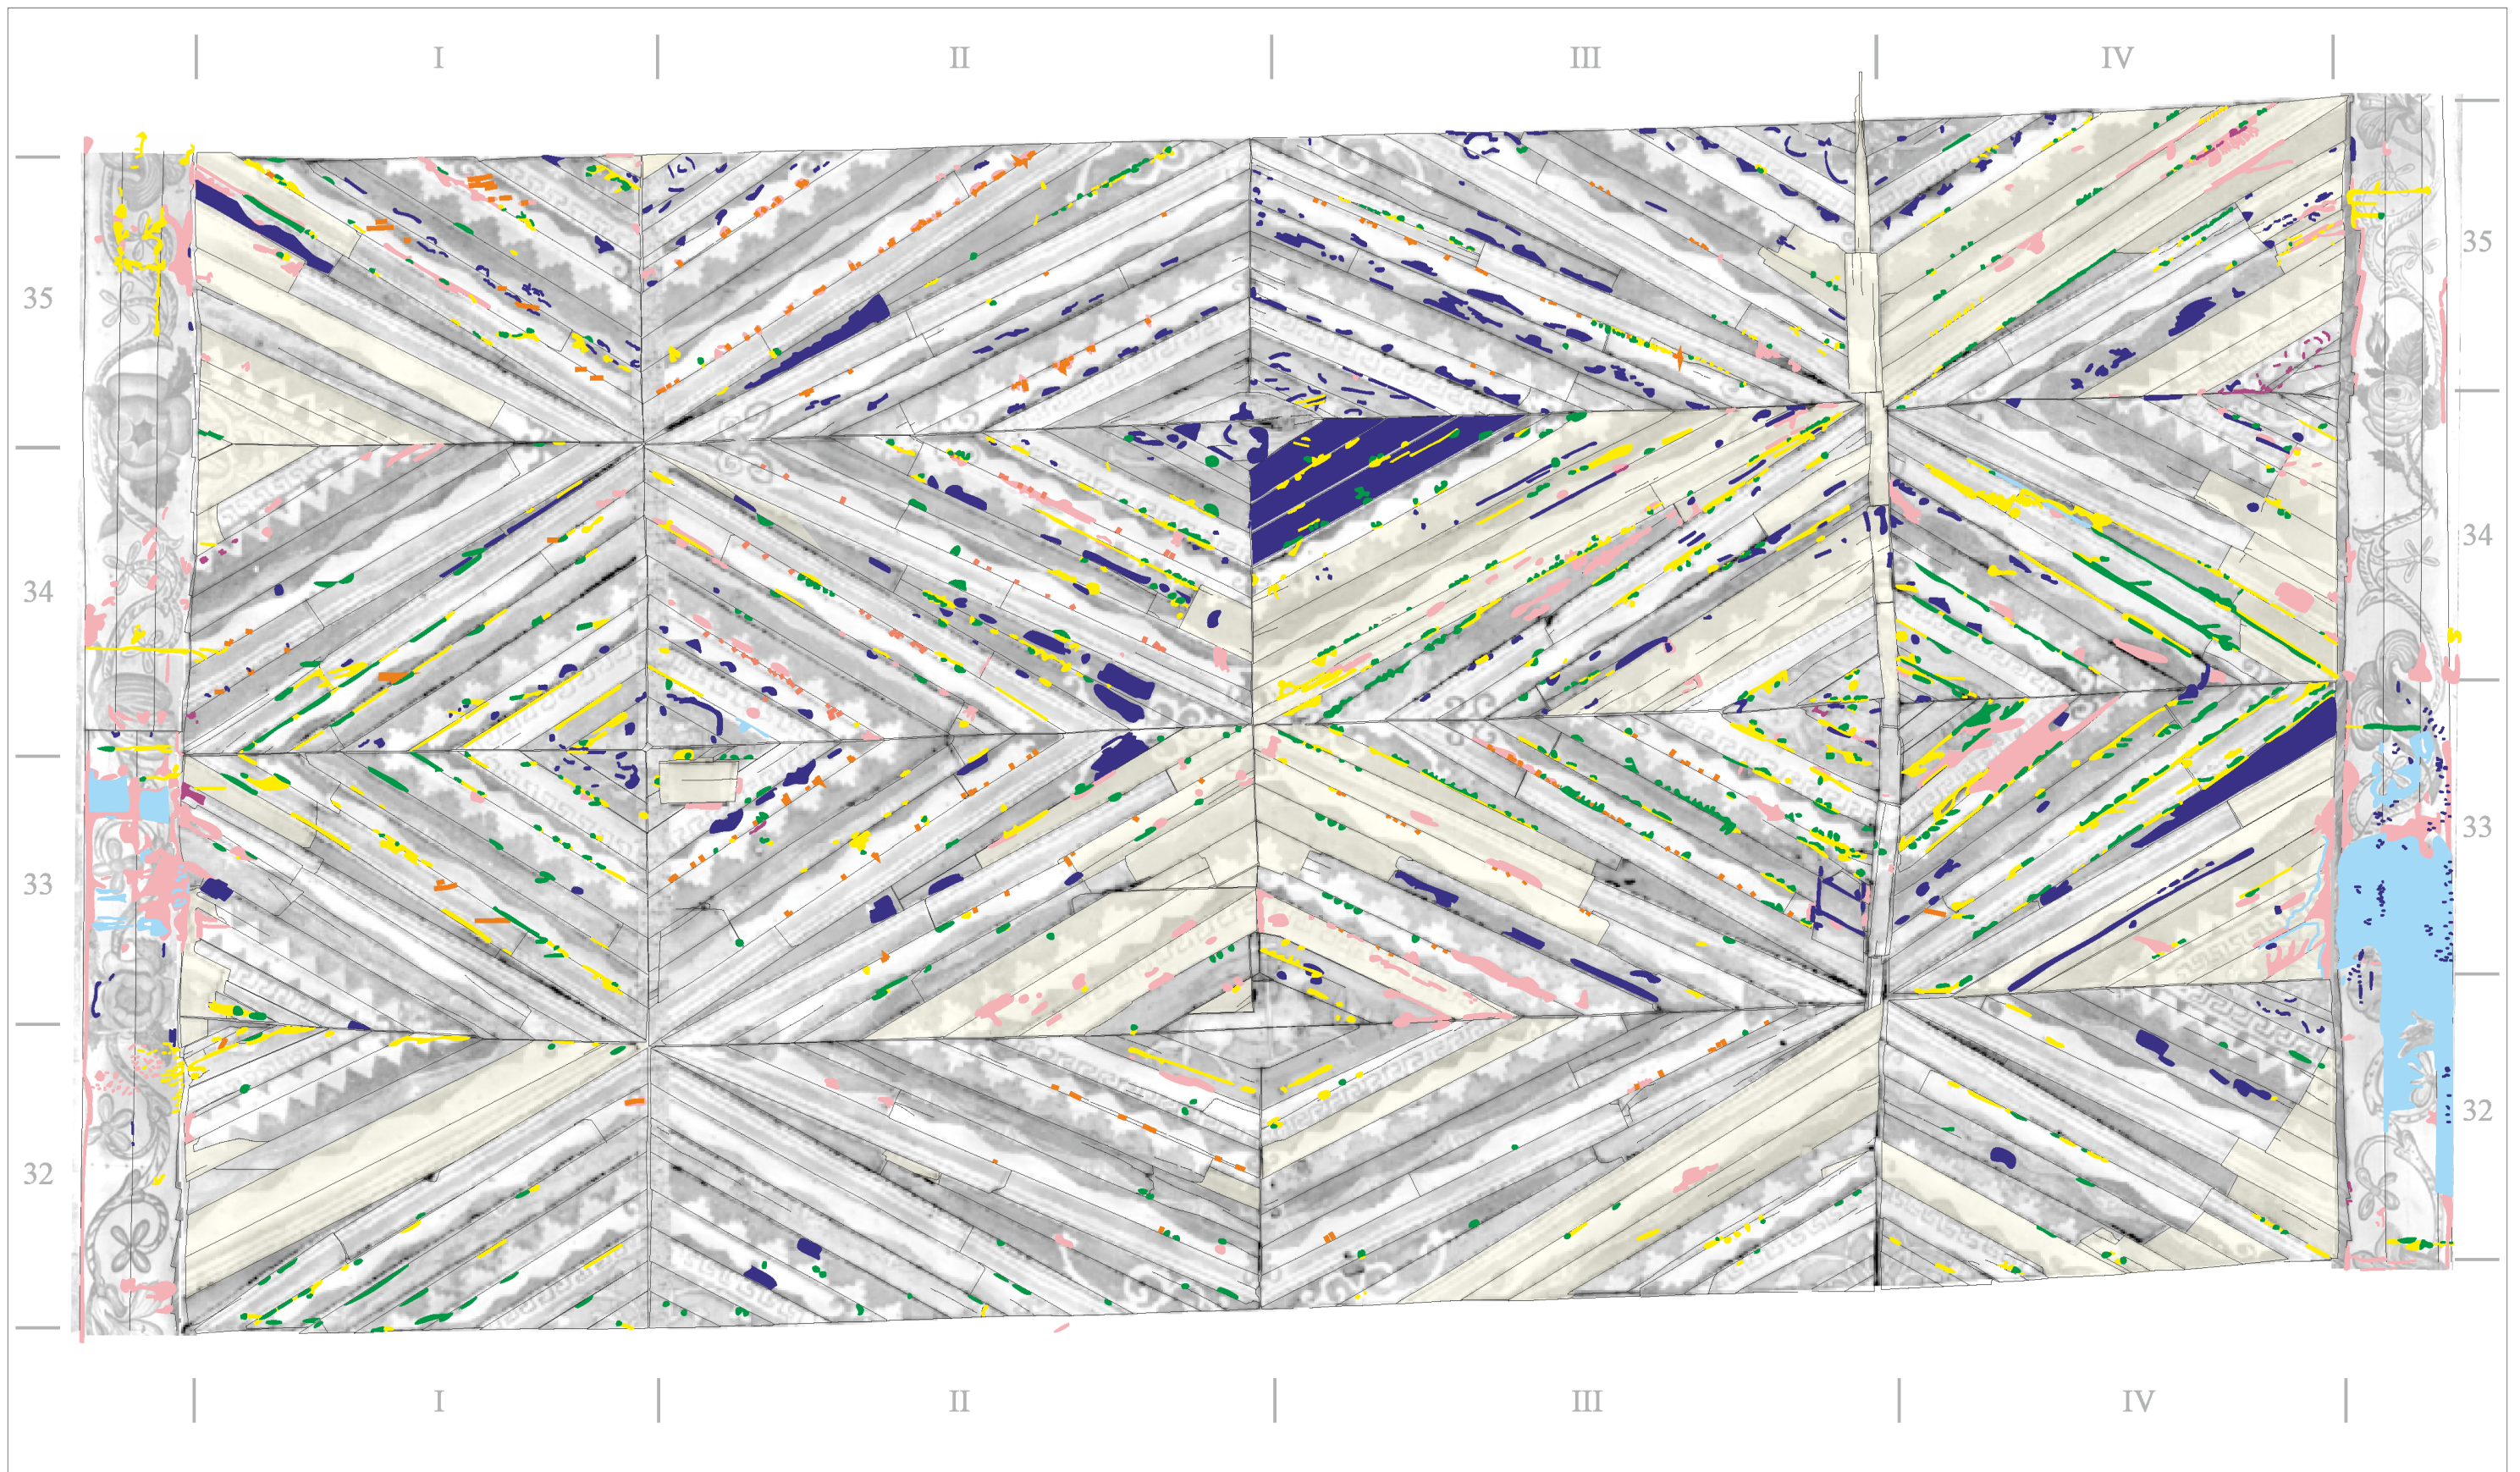
Staining - All stains on the painted decoration result from liquid material penetrating down between the boards or through cracks in deteriorated boards.

Efflorescence - Most characteristic is the 'white chalk line' on a number of original, wave pattern boards with the mat, saturated, black paint: at least two different salts are present, chloride and sulphate. All efflorescence was removed.

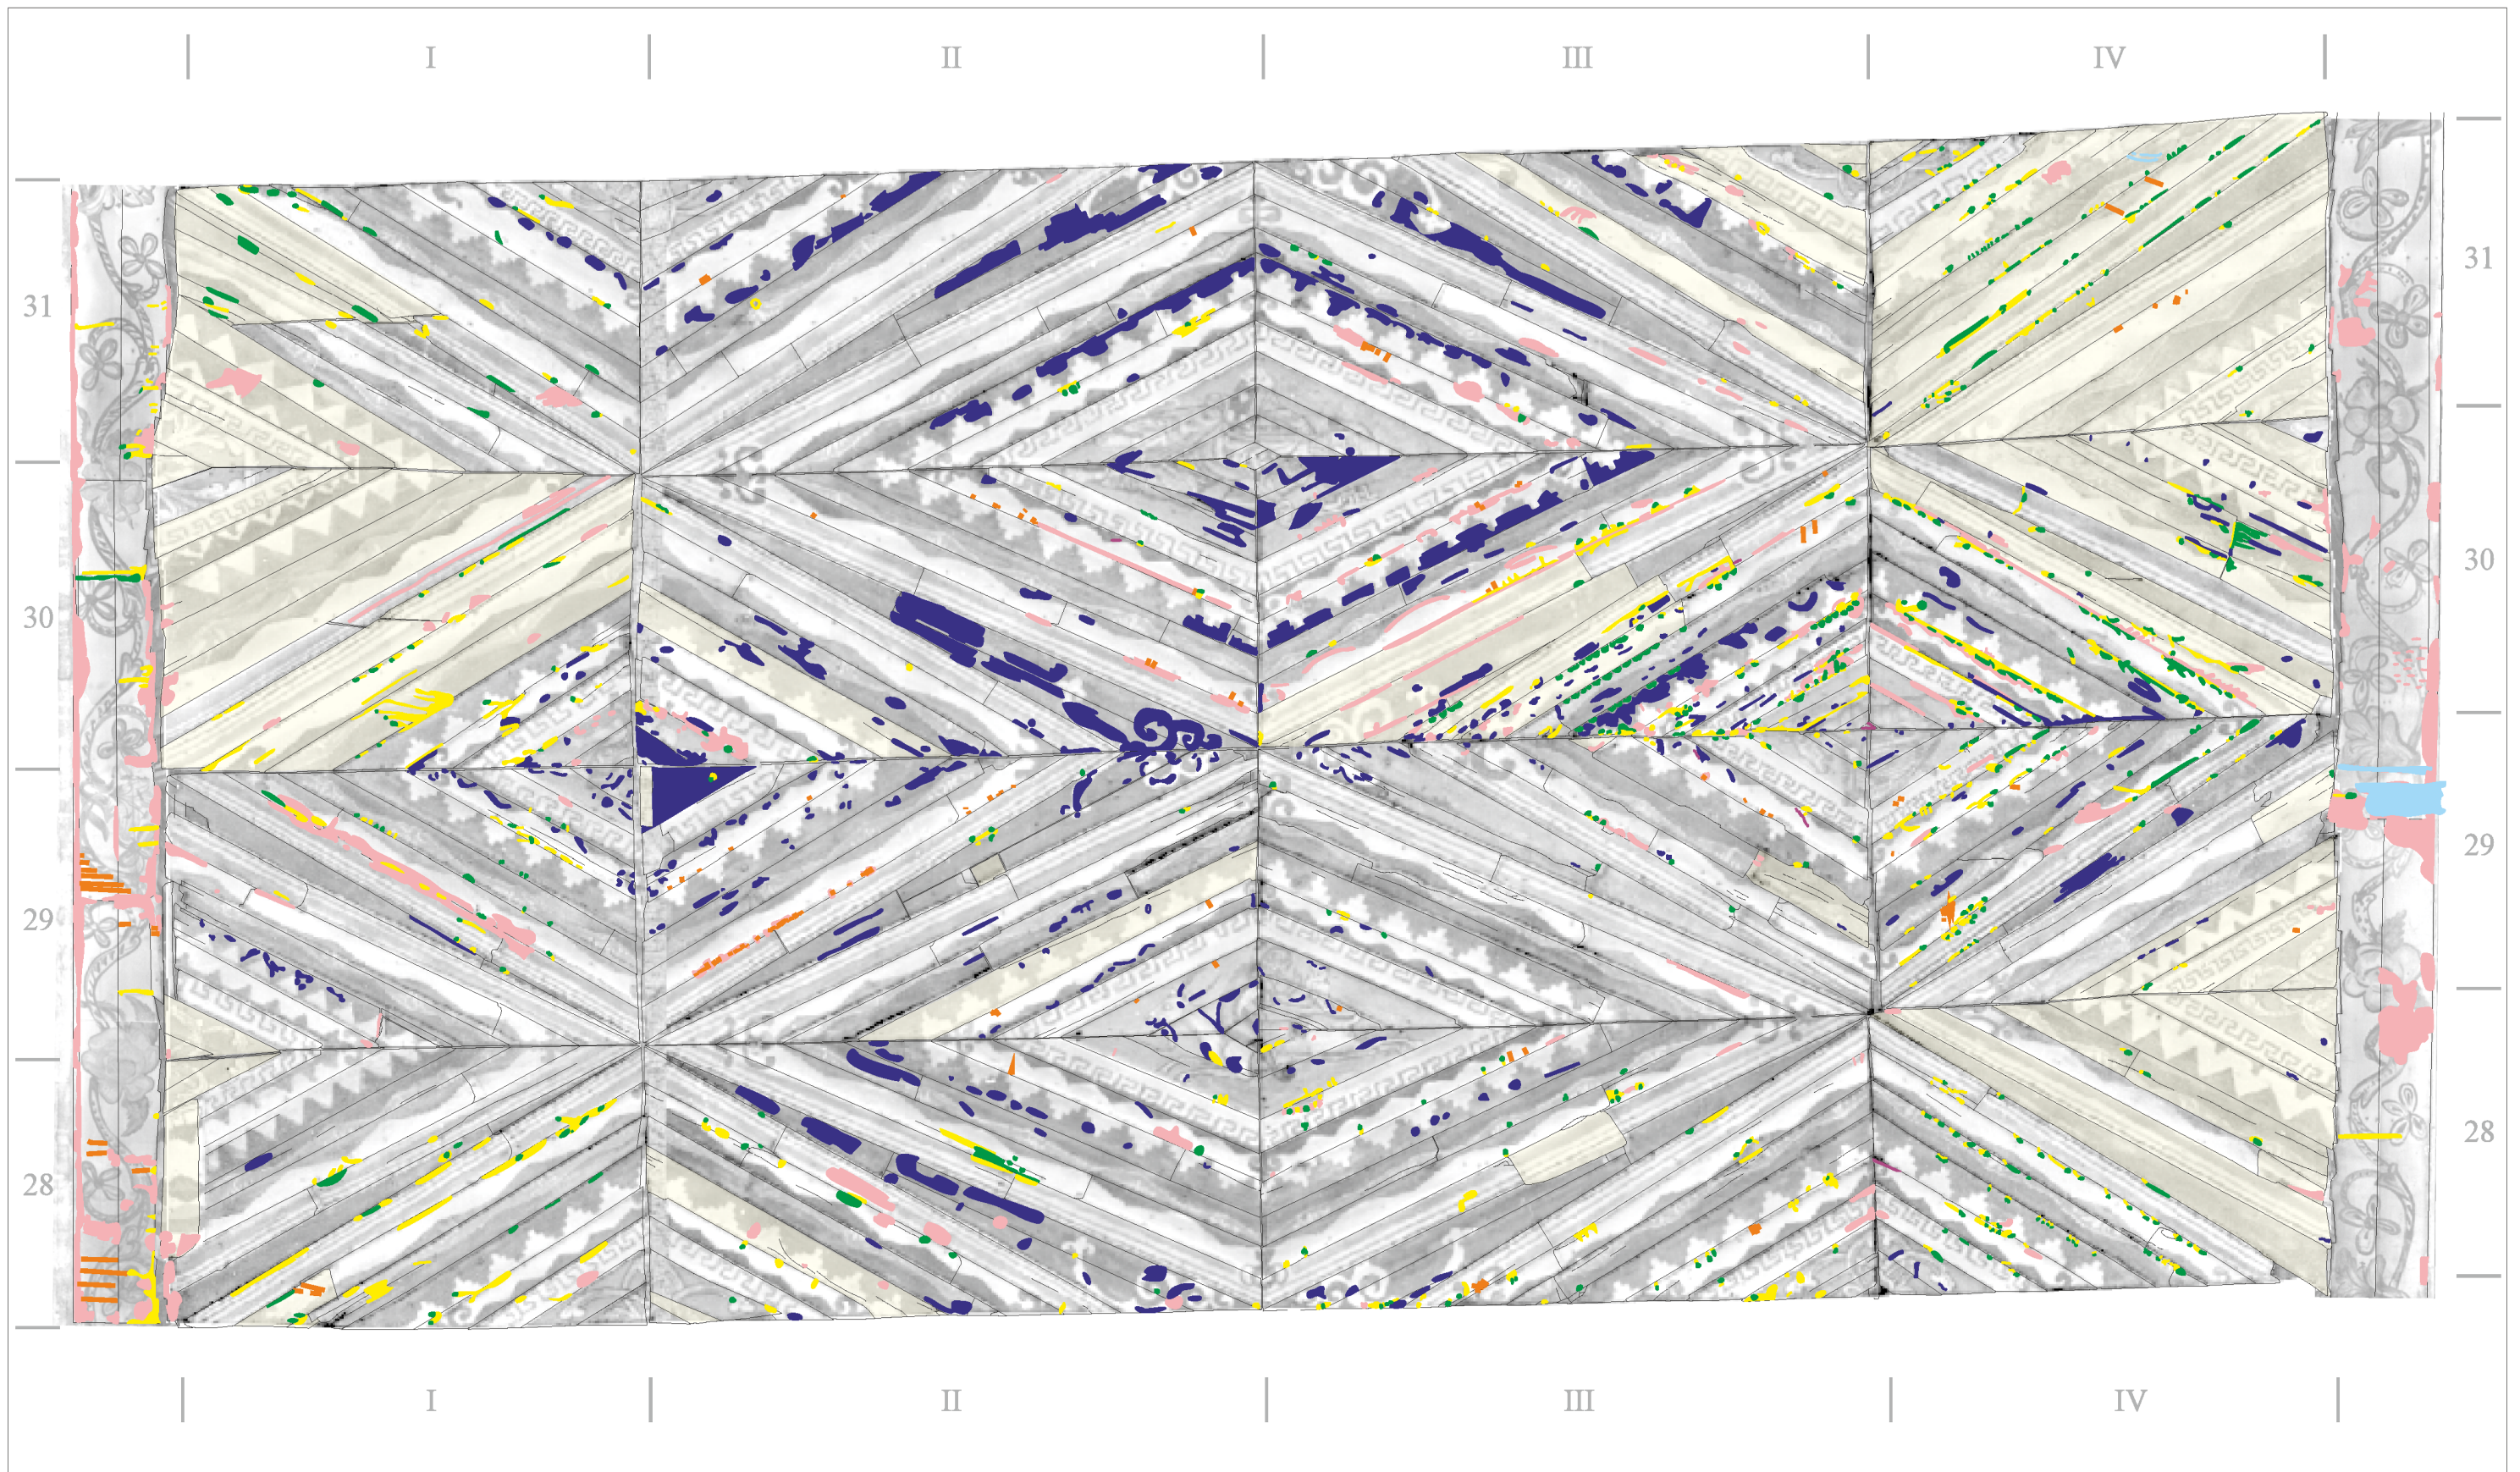
STAGE **CONDITION SURVEY AND TREATMENT** DESCRIPTION **Paint & Surface Accretions**

Flaking Paint - The primary cause of flaking paint on the Nave Ceiling is long term water infiltration leading to deterioration of the wood support and subsequent loss of adhesion. All flaking paint was re-attached during treatment.
