PETERBOROUGH CATHEDRAL: THE NAVE CEILING

PHASE 5: ROWS 0 - 7

MAY - OCTOBER 2003

CONDITION SURVEY AND CONSERVATION TREATMENT

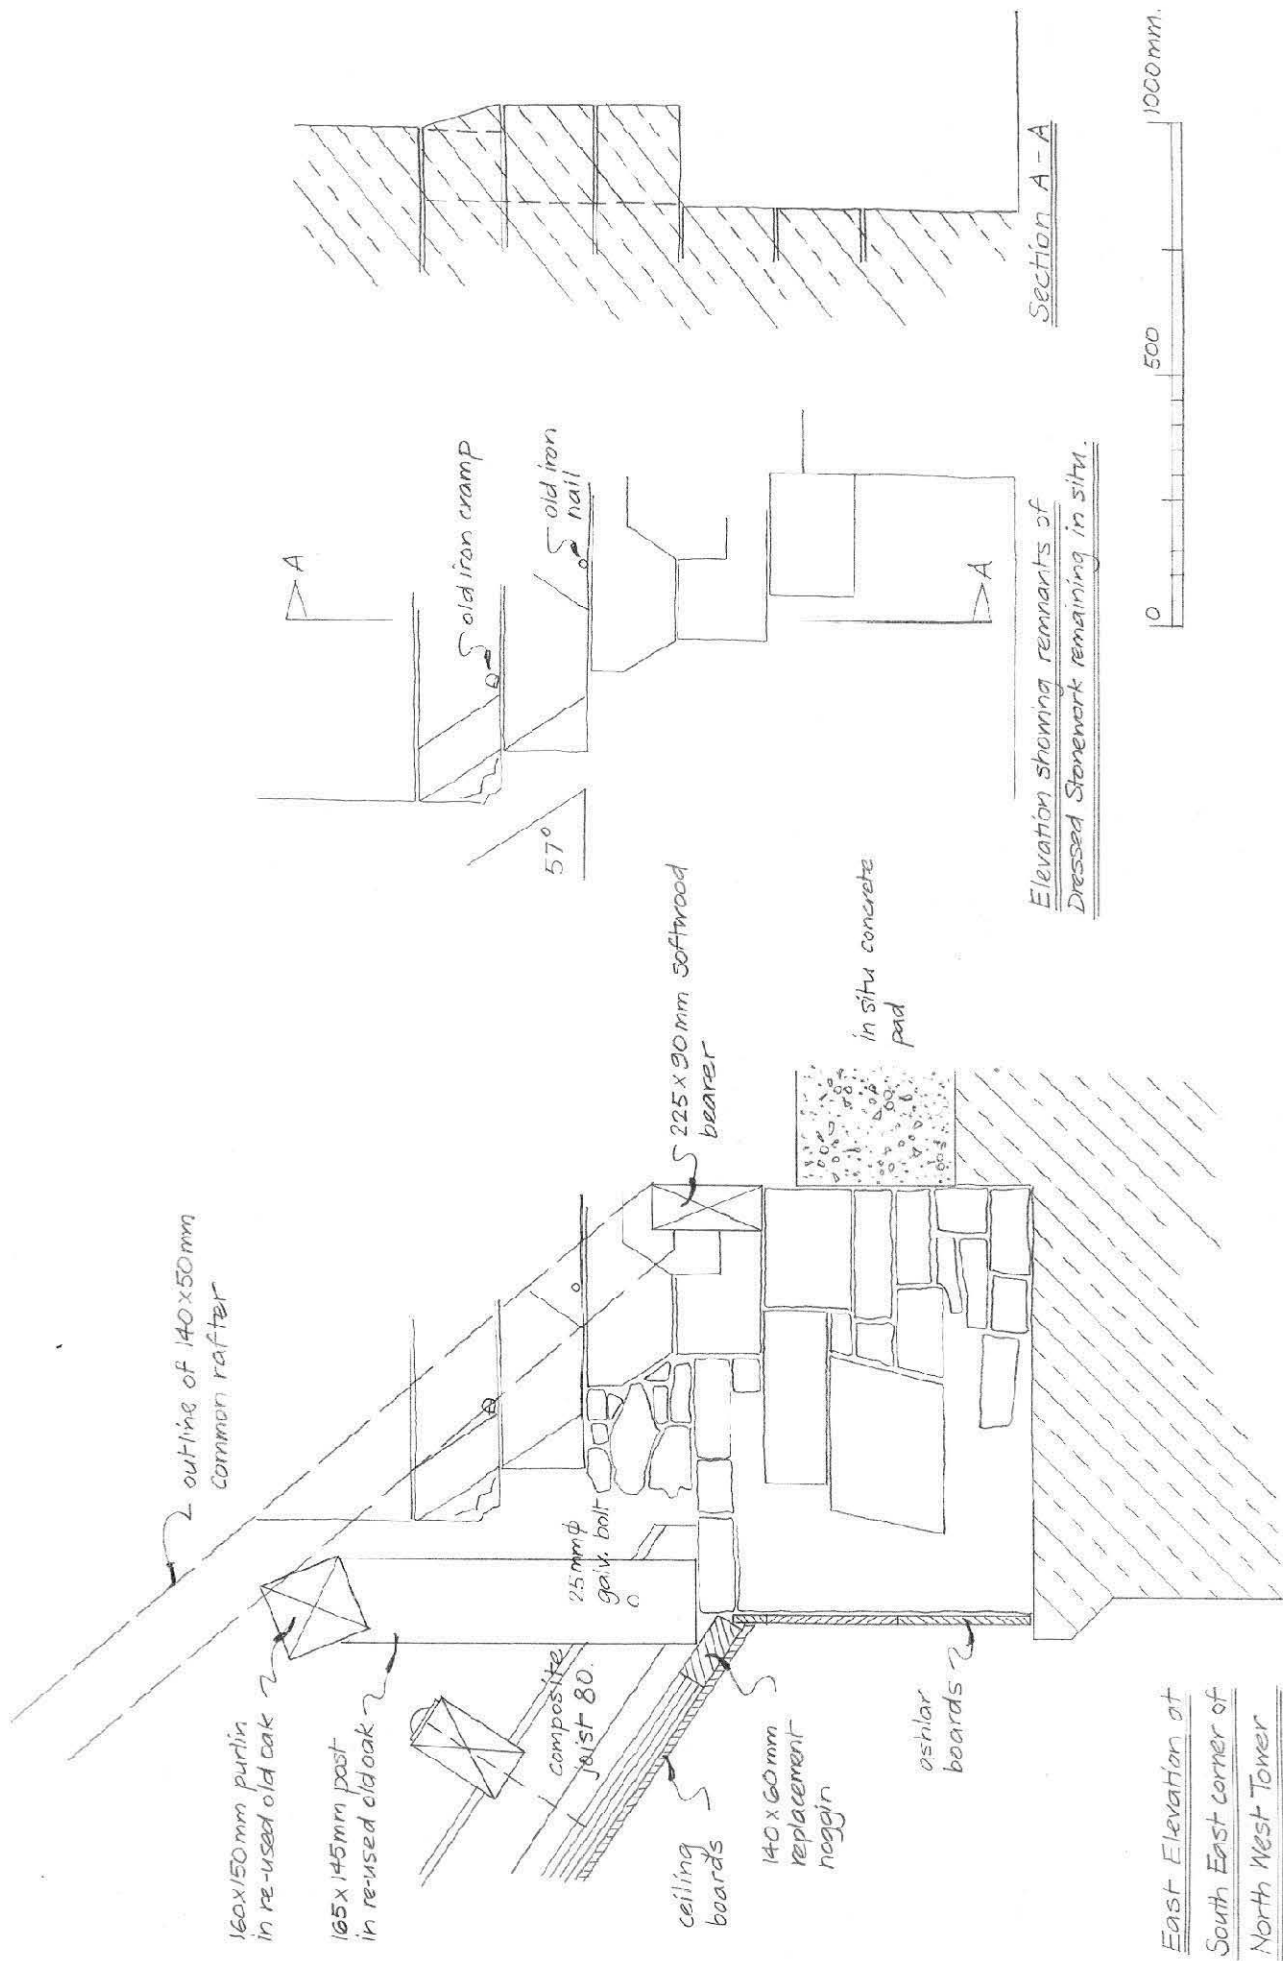
Figure 4

None of the original roof survives other than as individual components reused in later reconstructions. The discovery in this phase of stones in the east wall of the north west tower showing the angle of (presumably) the original roof is interesting, (see **Plates 26, 27**), and these have been recorded in **Figure 4**.

PETERBOROUGH CATHEDRAL detail of sloping joist 80 north showing fragments of original roof sloping string course embedded in west wall masonry.

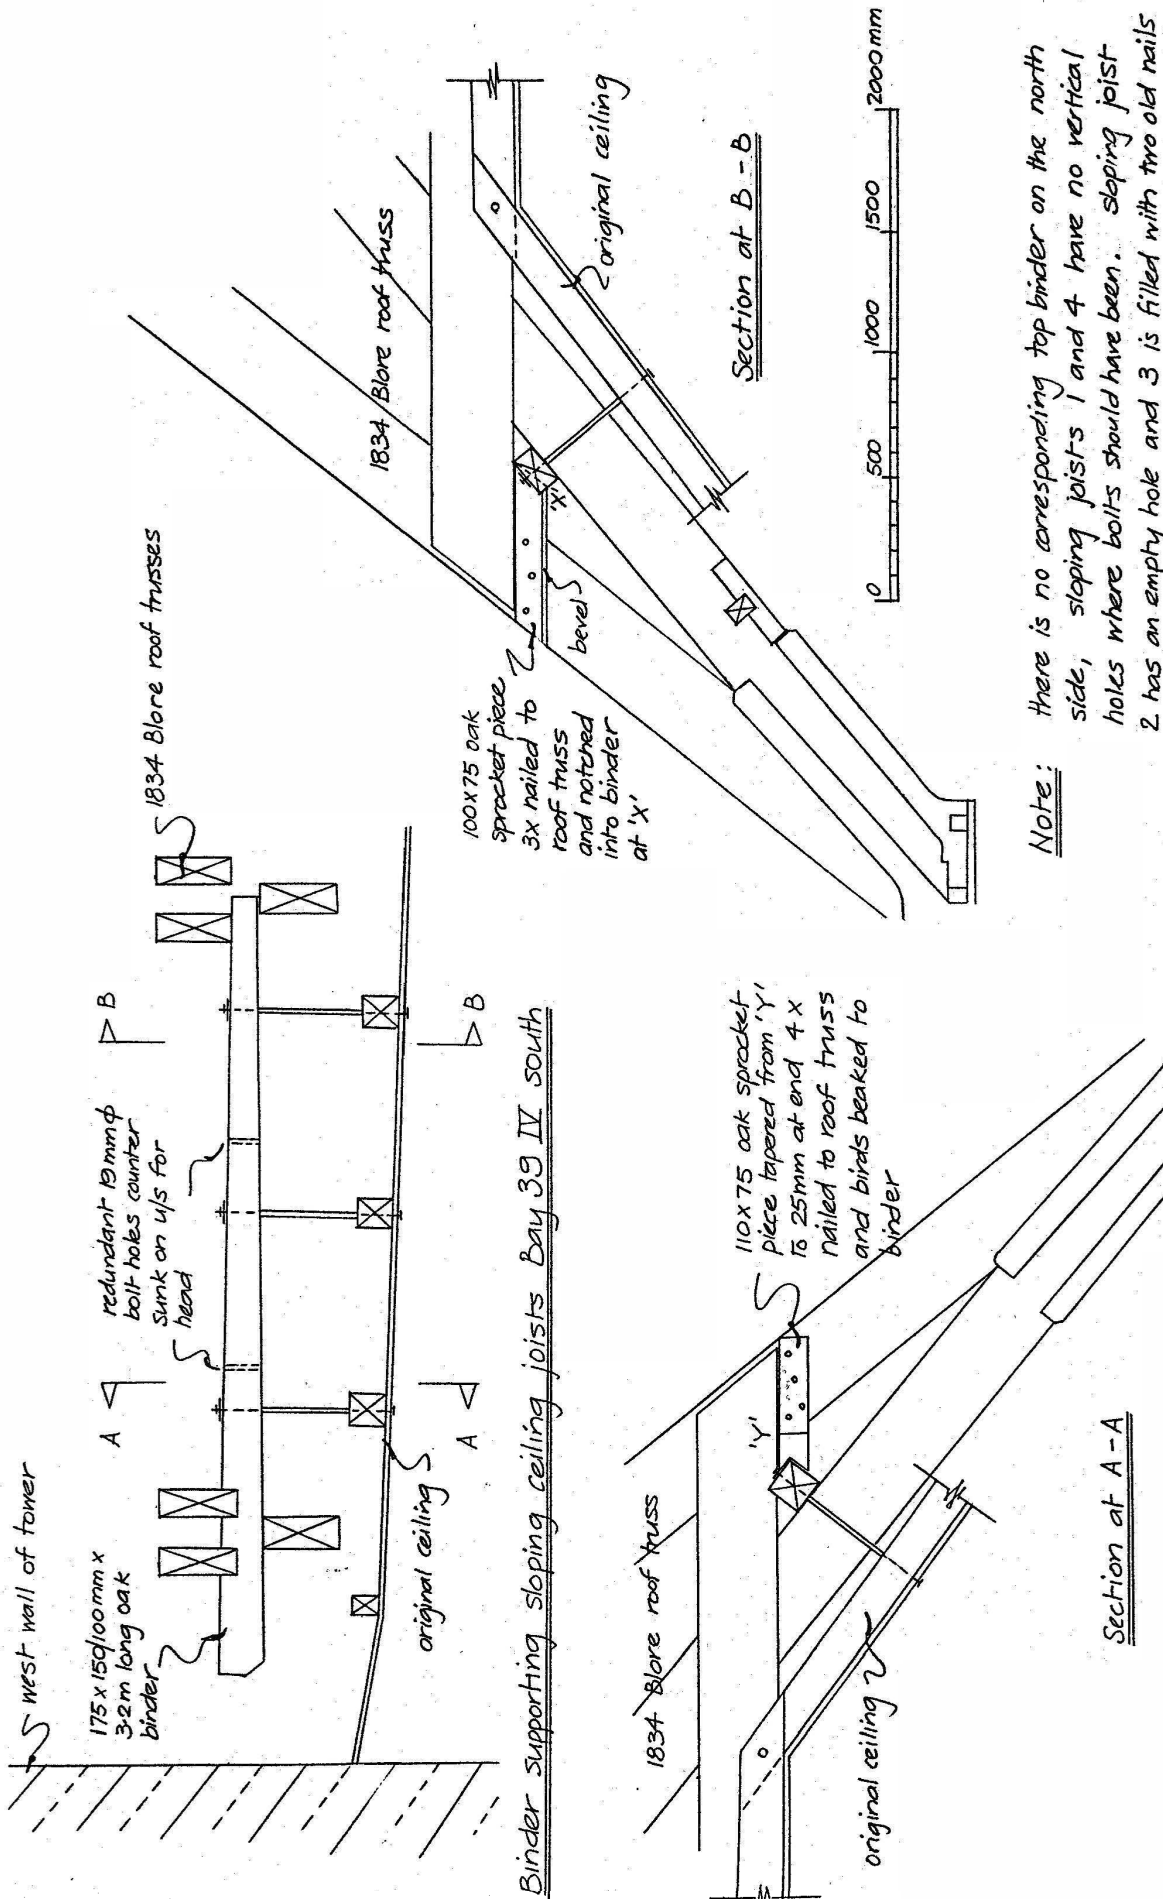
Note: there is no corresponding top binder on the north side, sloping joists 1 and 4 have no vertical holes where bolts should have been. sloping joist 2 has an empty hole and 3 is filled with two old nails and wood fragments. there is no evidence on other roof timbers of any binders having once been fitted however on u/s of painted ceiling, positions are occupied by bolts/wedges.

PETERBOROUGH CATHEDRAL Top binder details Bay 39 II south side
 YUCH HARRISON CONSERVATION drawn Peter Ferguson June 2002

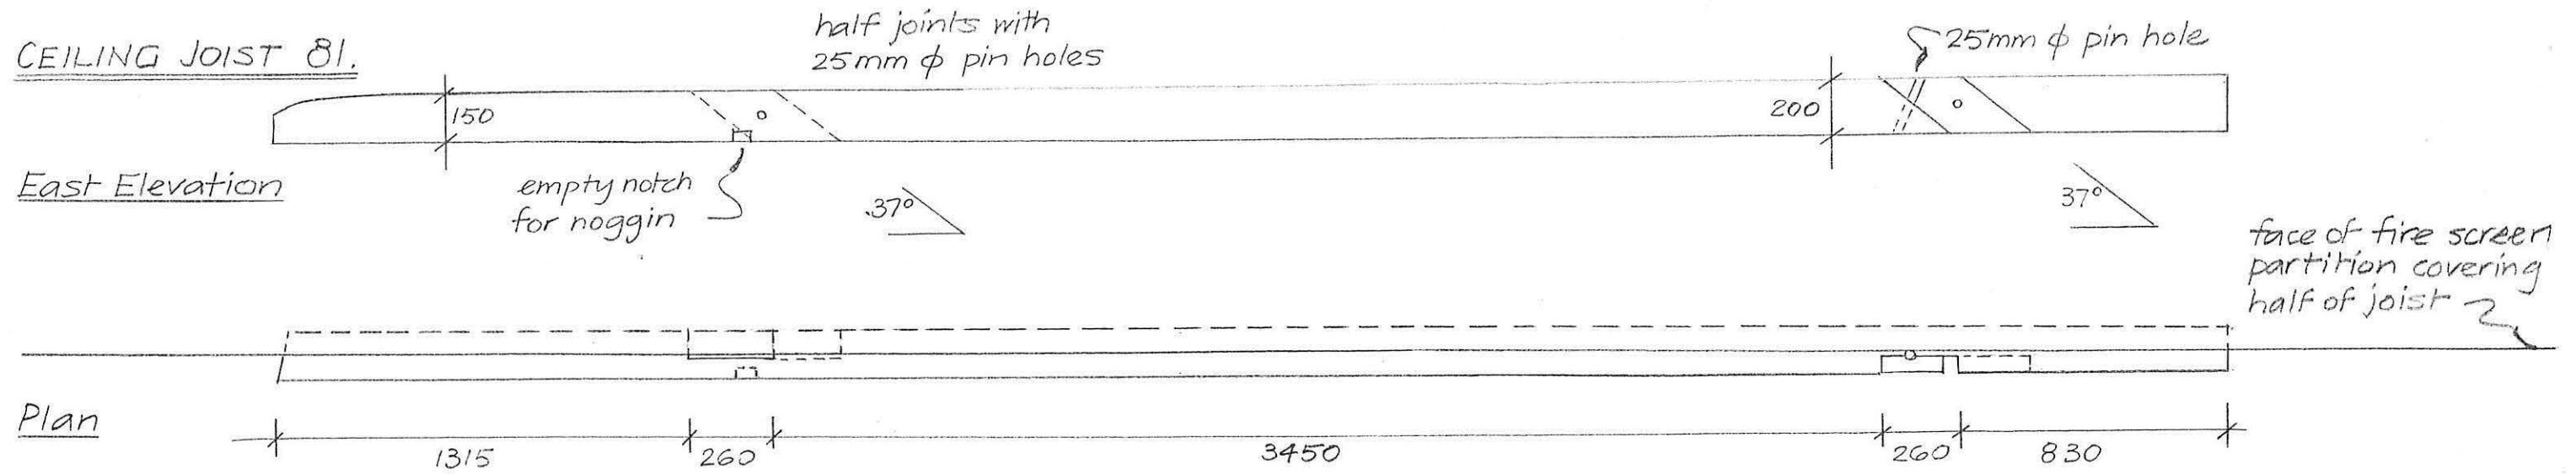
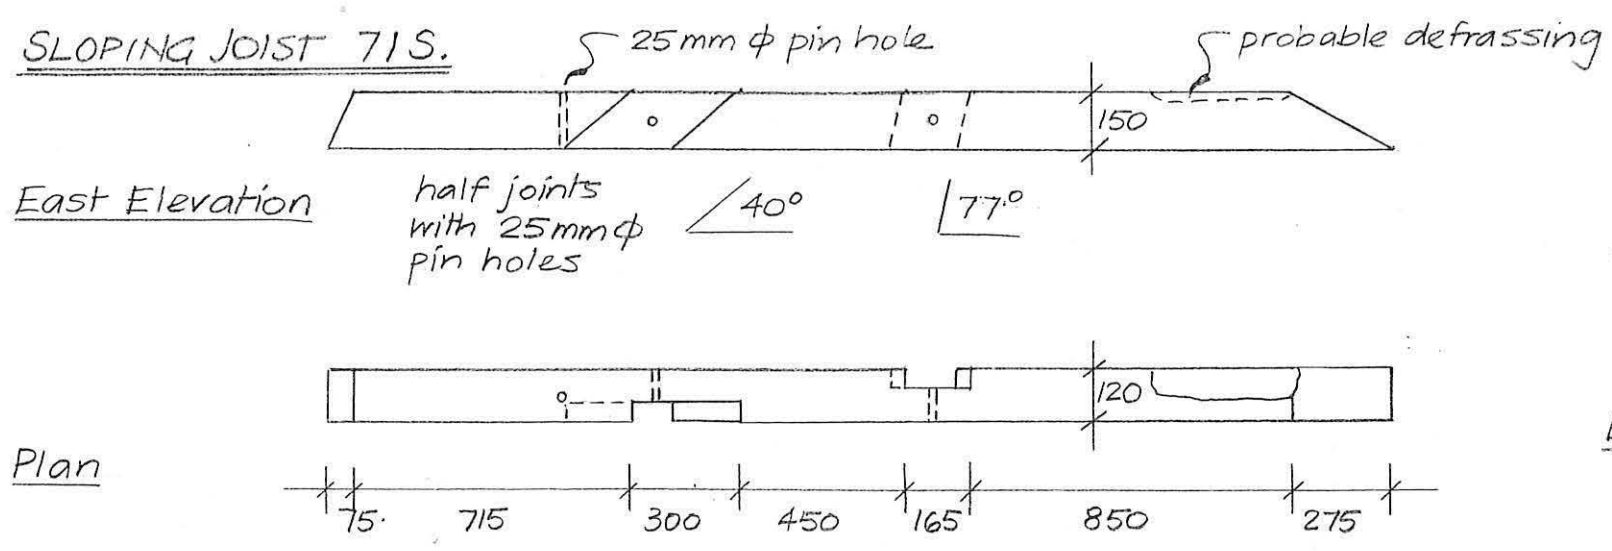
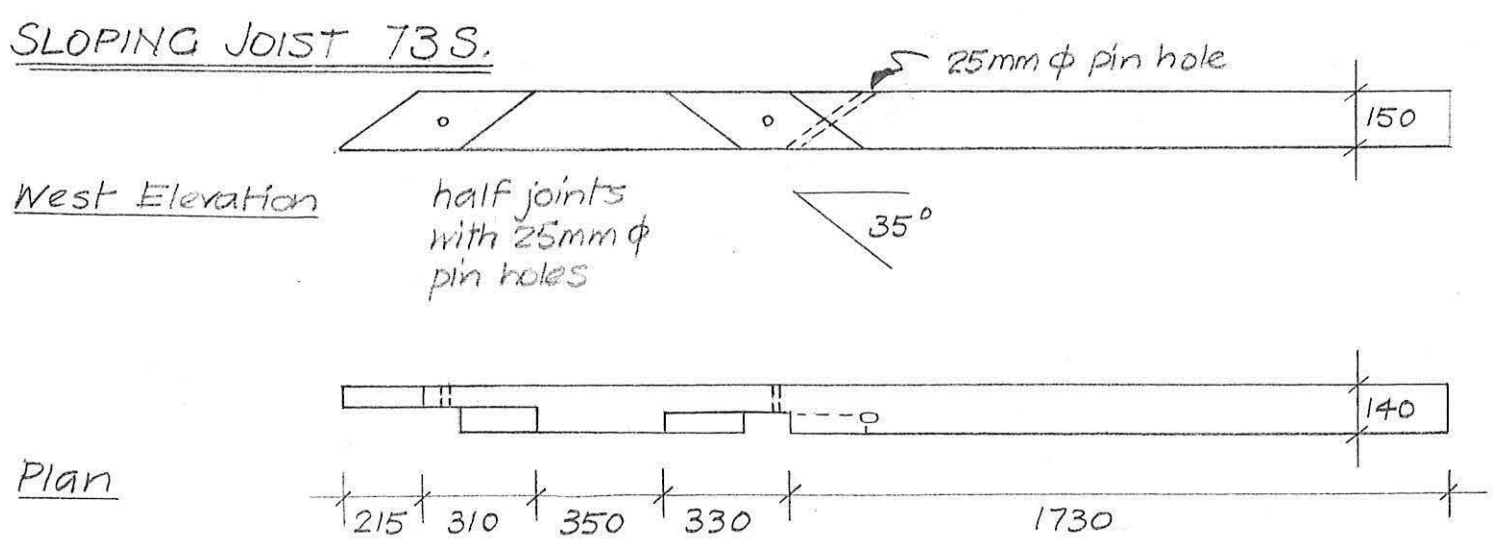
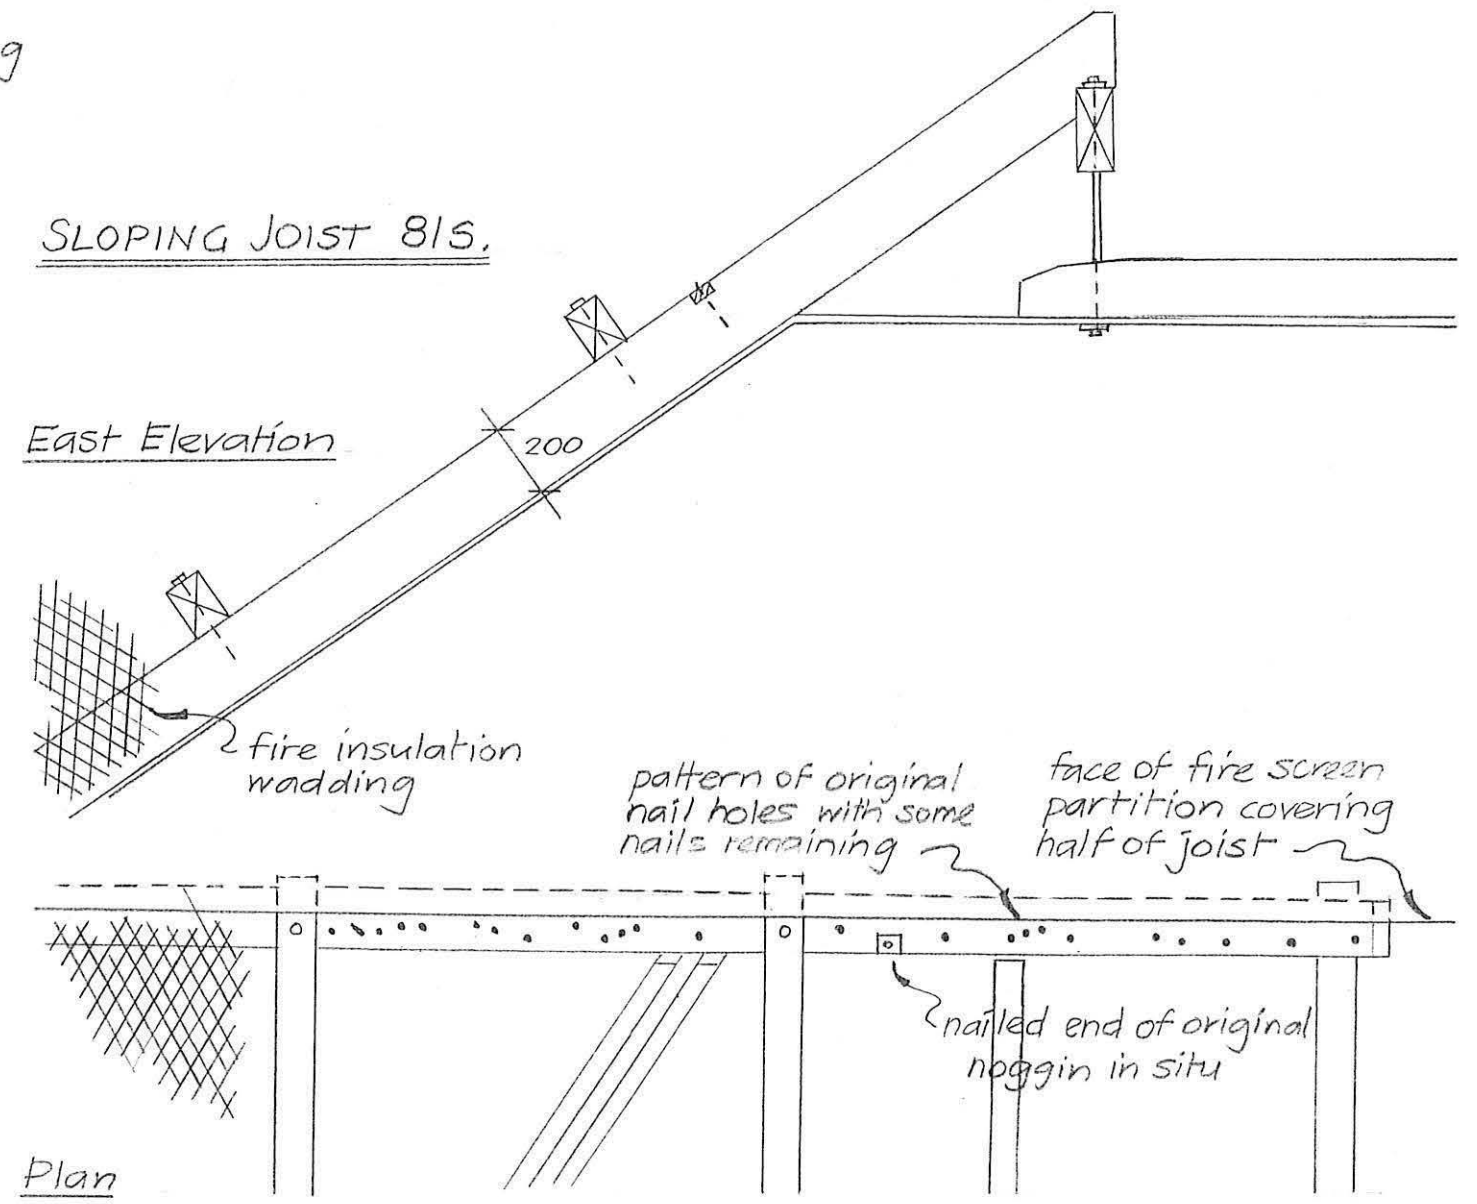
DRAWING 2

Throughout the roof a substantial number of reused timbers are found, presumably from the original roof¹⁴, some with carpenters' numbers. The re-used timbers were measured and those with sufficient constructional details have been recorded on **Drawing 2**. These timbers were also carefully projected onto the reconstruction study (**Drawing 1**) for the original roof, allowing also for the adjusted pitch measured from the surviving sloping string course discovered embedded in the S.E. corner of the N.W. Transept Tower wall. Results obtained were inconclusive for replacement sloping joist 73 south and ceiling joist 81, but an excellent match was obtained for sloping joist 71 south, and this is shown on **Drawing 1**. However, this must remain tentative.

PETERBOROUGH CATHEDRAL 1830s replacement ceiling timbers using re-used material from original roof.

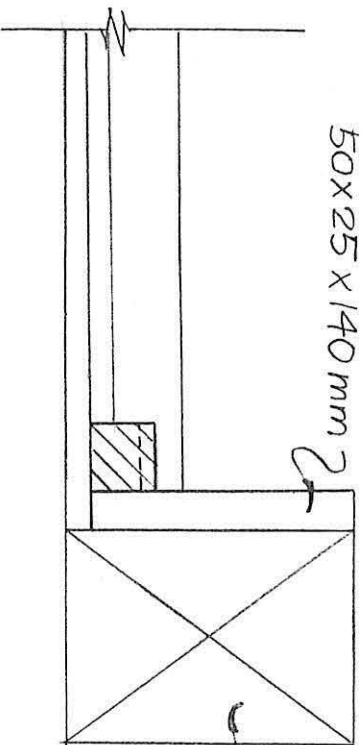
DRAWING 6

with Types 16 and 17 new in this phase, overall there is less variation in Phase 5 than for Phase 4 with Types 1 and 3 being the most commonly used, no particular pattern of use is suggested and where sagging of the board panel probably accounts for variation 16, no satisfactory explanation is apparent for variation 17.

PETERBOROUGH CATHEDRAL 1926 Ceiling Noggin Details
HUGH HARRISON CONSERVATION drawn Peter Ferguson November 2004.

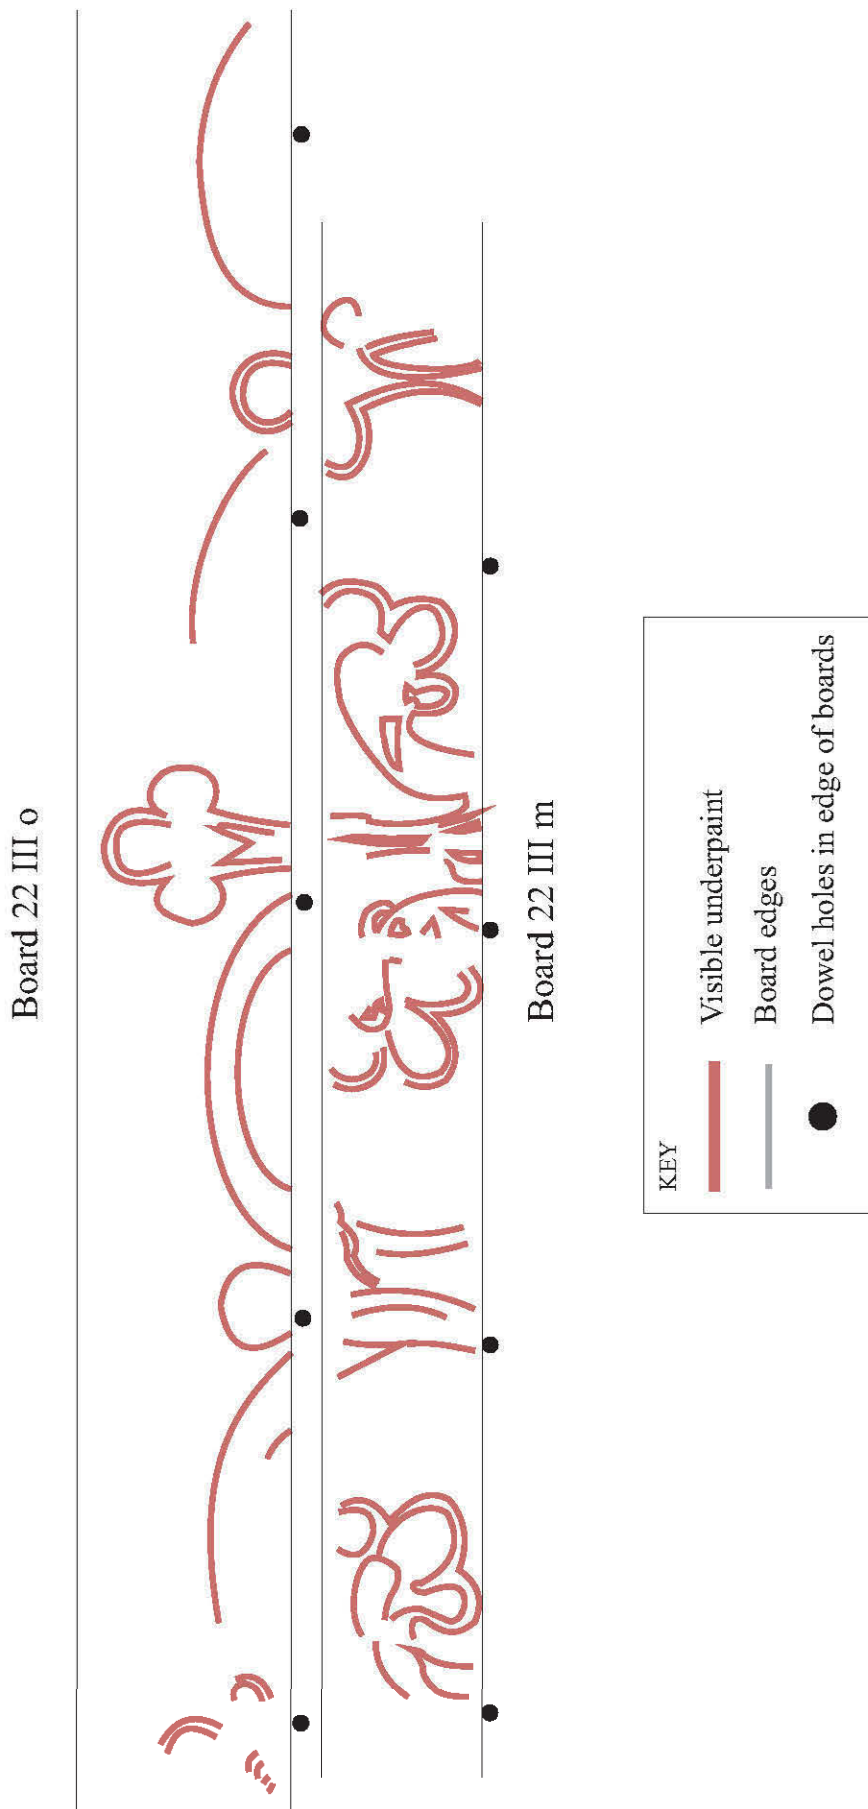
Figure 15. Tracing of linear visible underpaint on repositioned oak boards found in Bay 7 considered to be original Ashlar boards (Scale

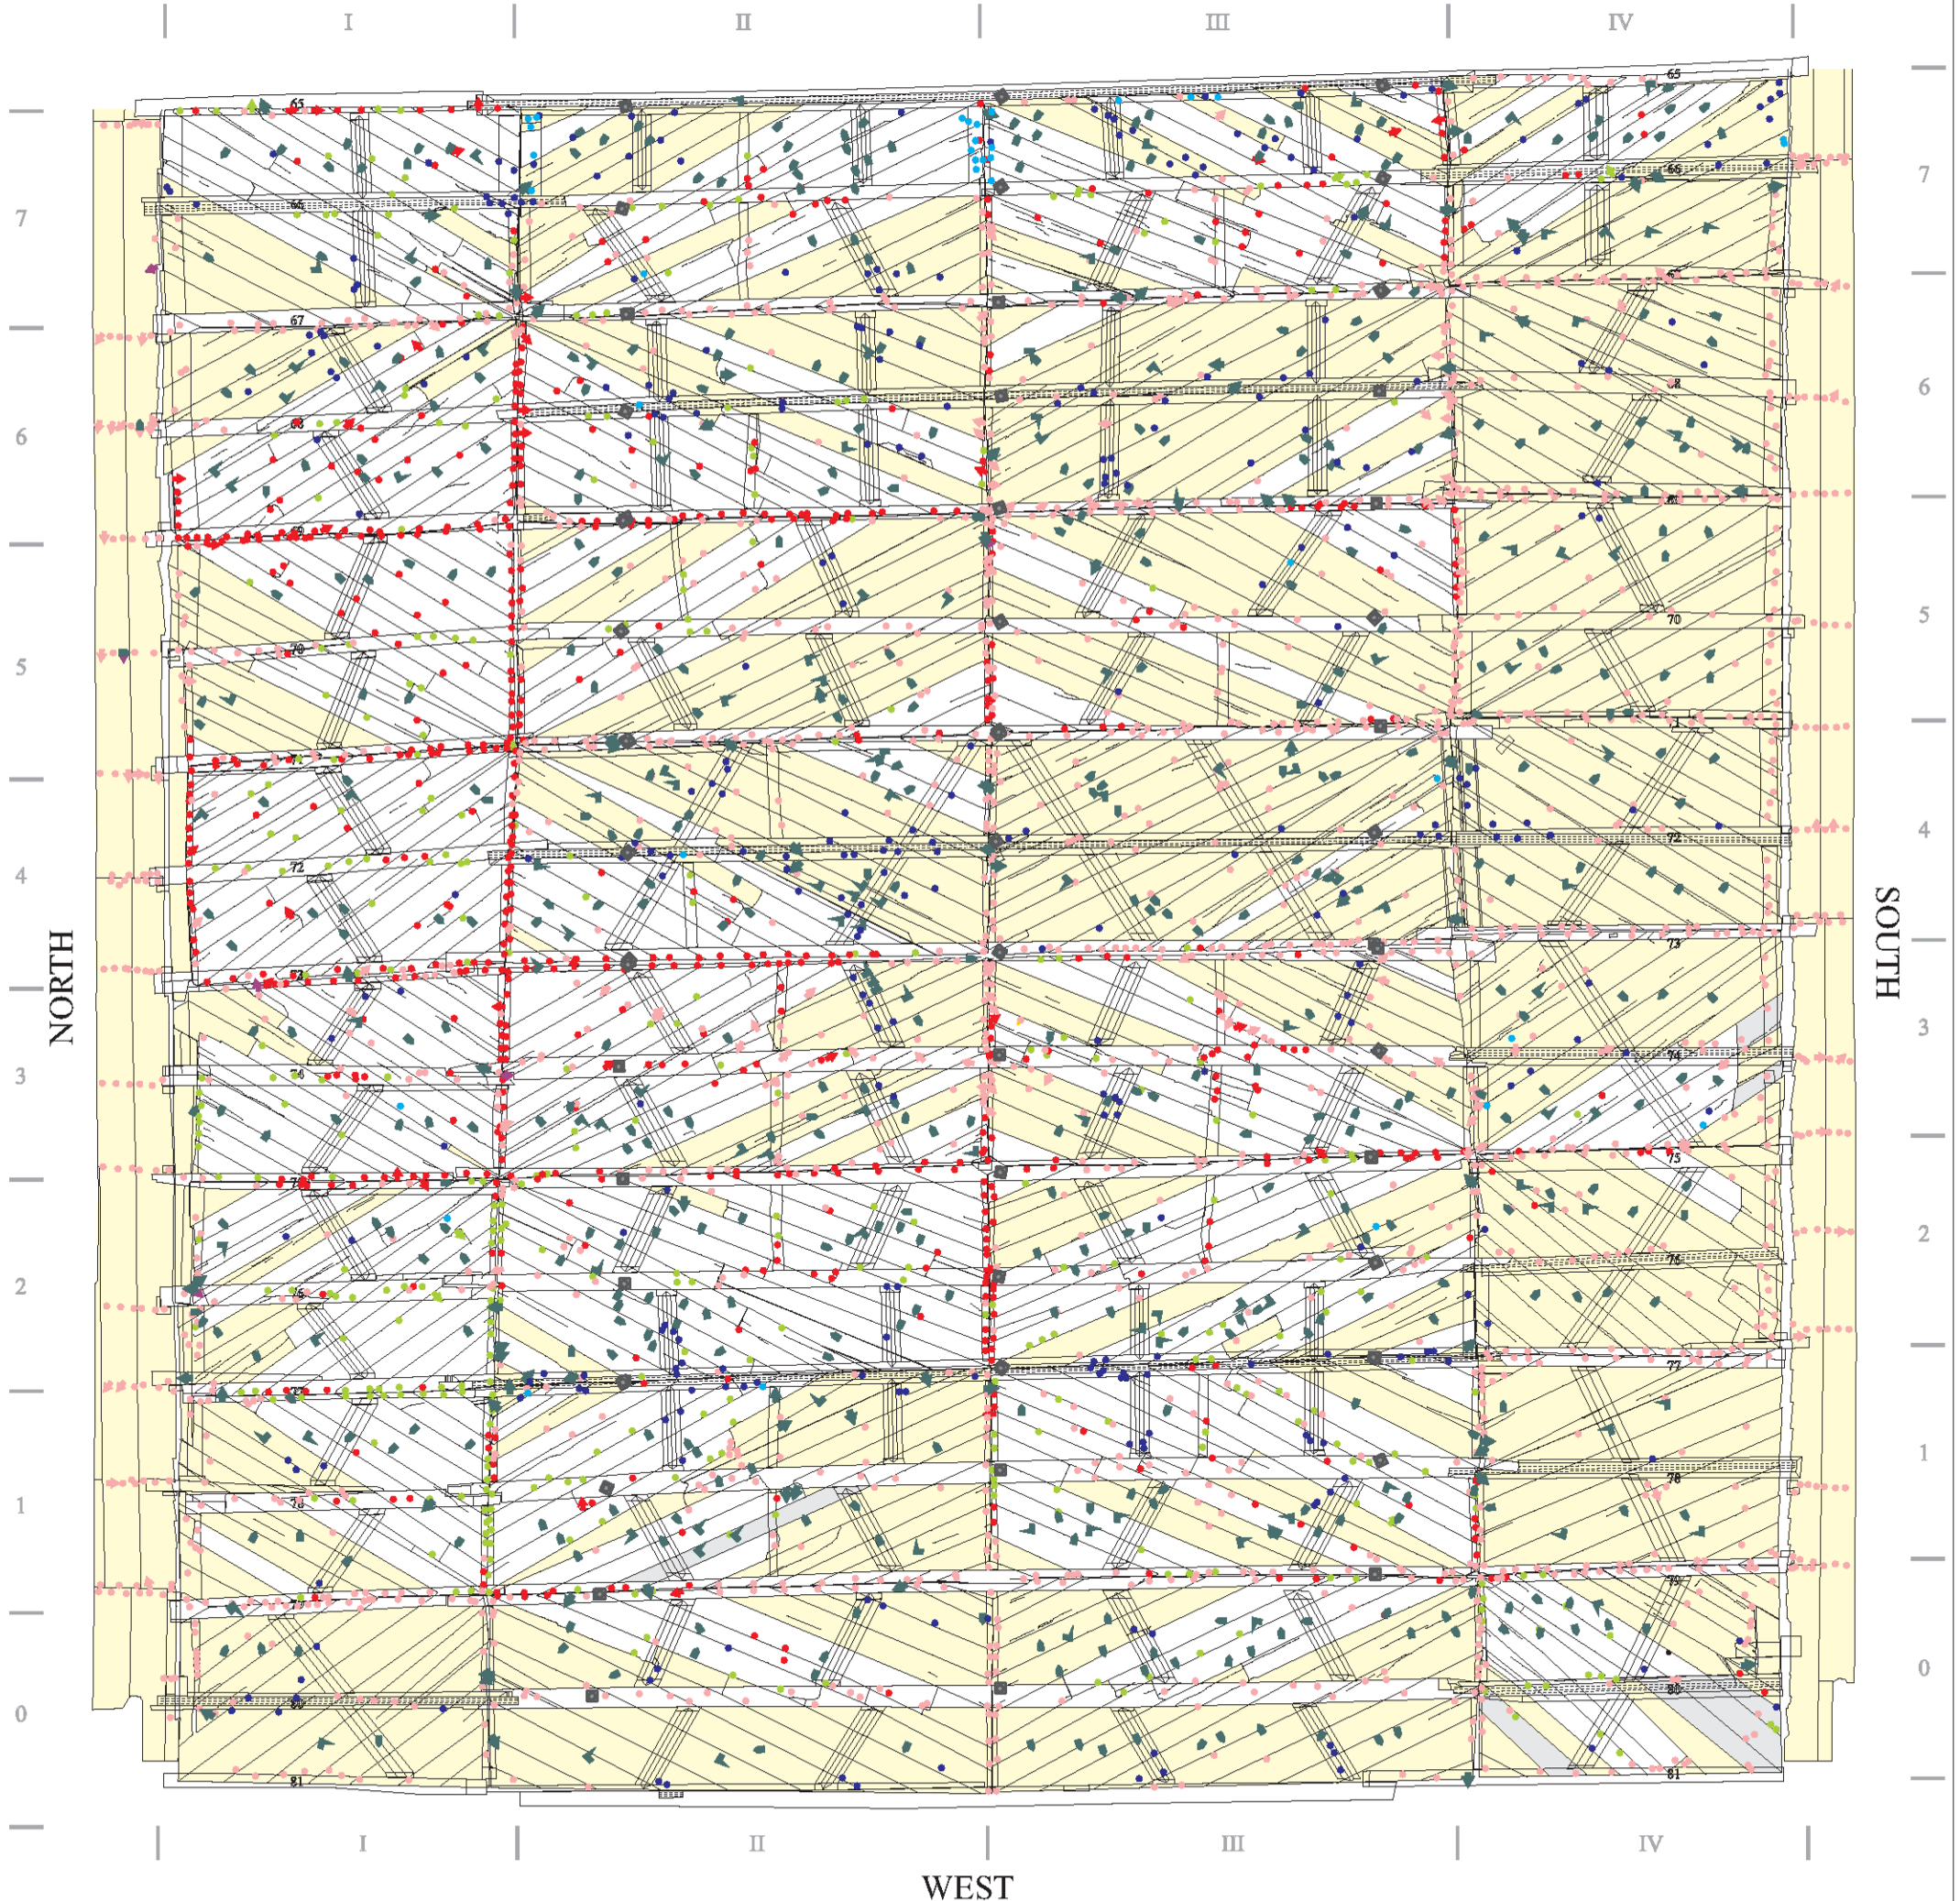
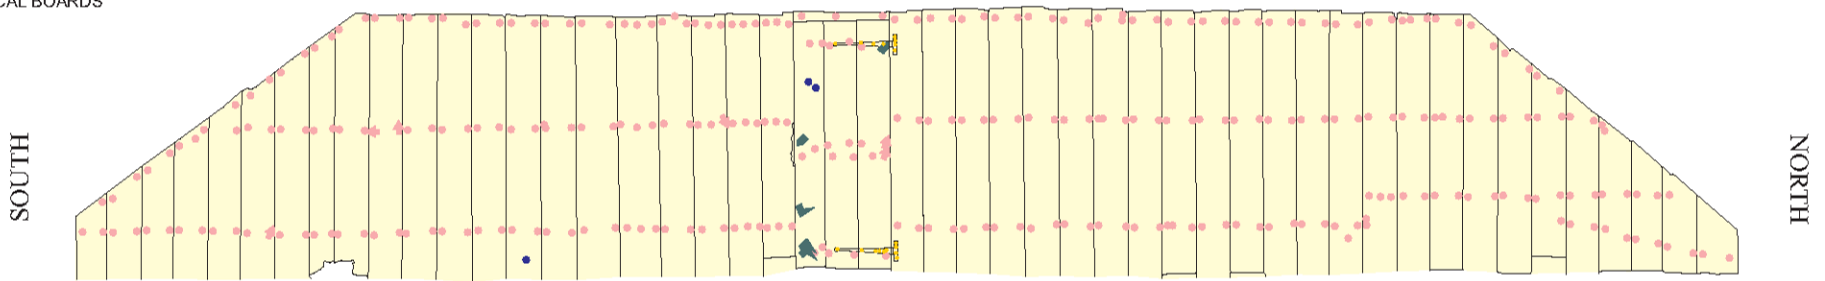
Decay - Very little decay has been found in this phase of work, and the pattern of insect damage is similar to Phase 4 and is split with a greater concentration in the north half of the ceiling than the south. Note the low survival of original boards on the south side of the ceiling.

Shot - The shot damage has been assessed as pre- or post the 1830s restoration depending on whether there is paint in the shot holes. As in Phase 4 there is no shot in the ashlar boards and virtually none in any post 1830s board. This shows that the predominance of shooting occurred in the 18th century or earlier.

Repositioned oak boards - Not many of these boards are found in this phase.

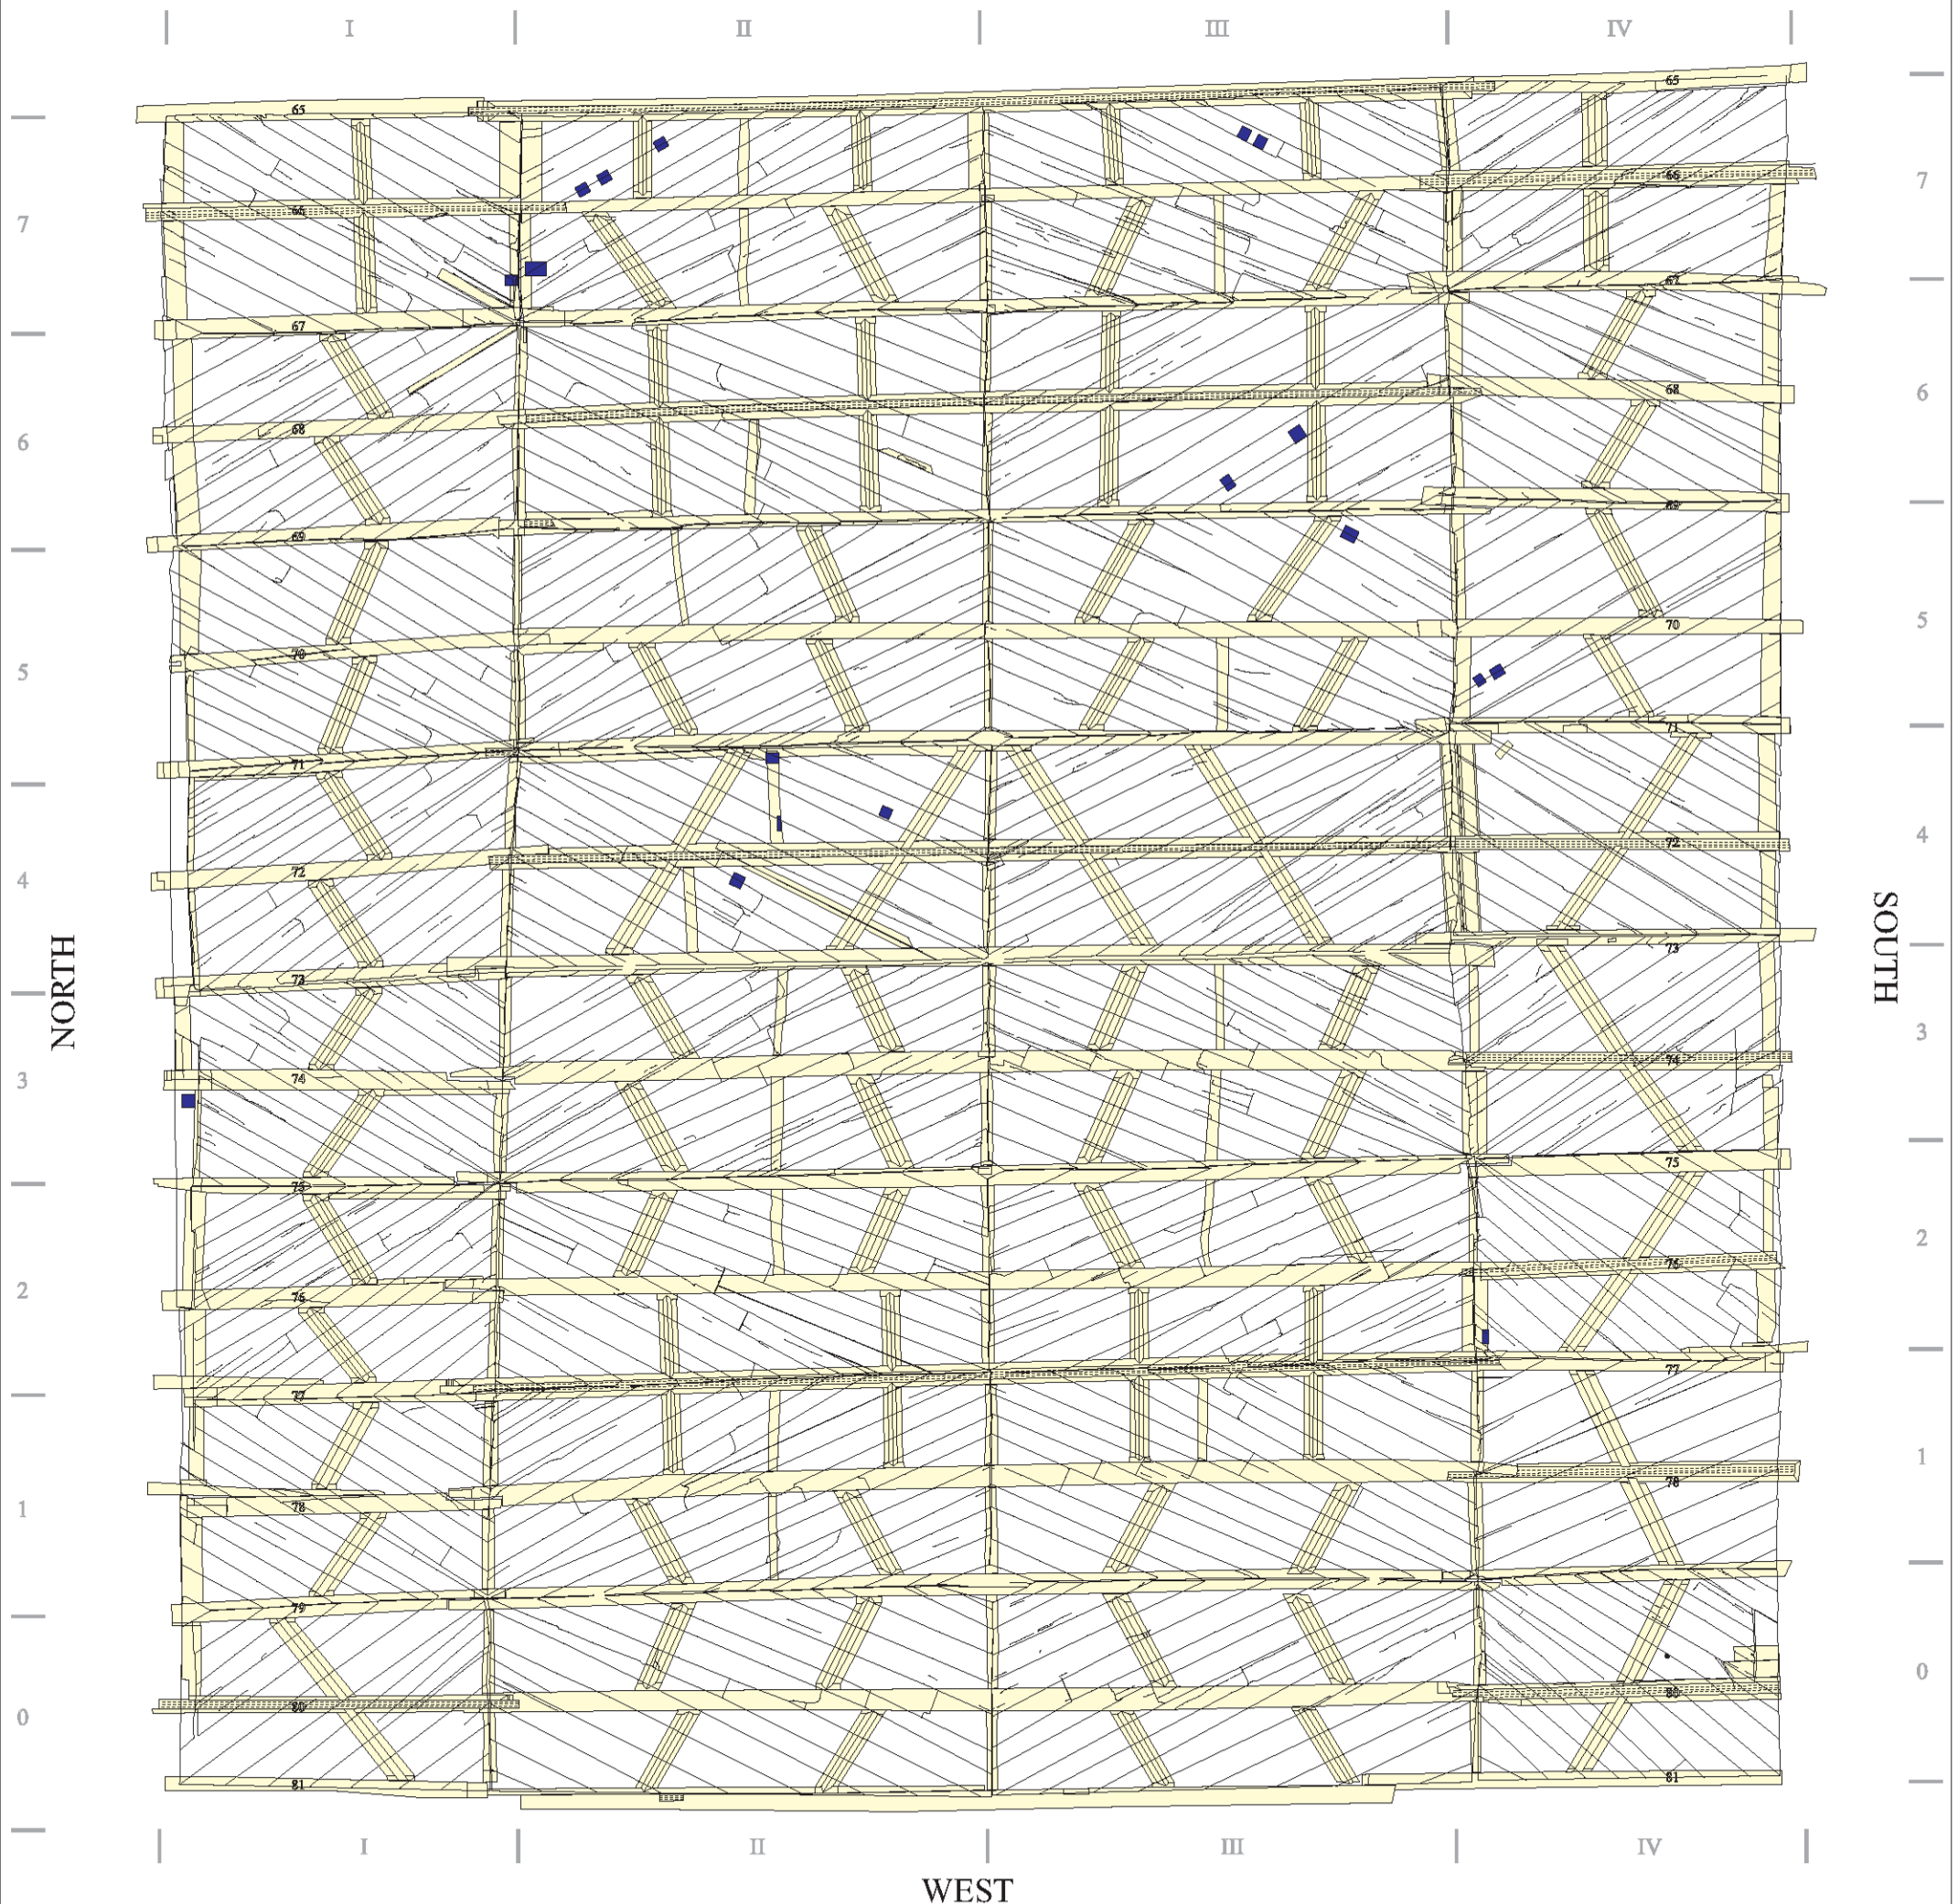
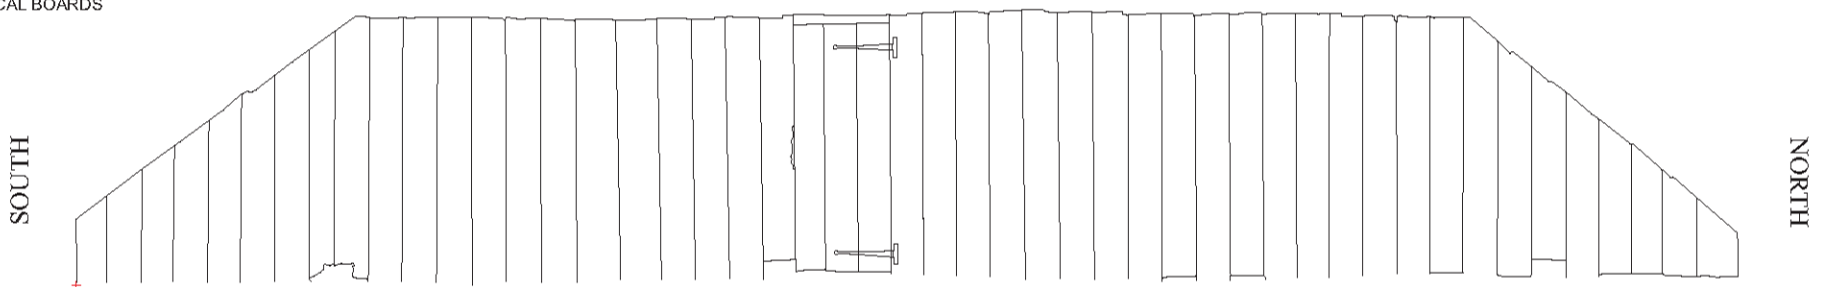
Consolidation - Consolidation by Paraloid B72 with associated fillings has been used in areas of insect damage and fungal decay. No consolidation with Bencon 19 was required in this phase of work.

Stainless steel fixings and screws - As for previous Phases these were used to secure loose fragments of the ceiling boards.

Softwood patches removed - This category denotes softwood cover boards which serve no purpose and were visually distracting, so they were removed.

Replaced screws - Where protruding 1926 screws can be accessed from above simply by peeling away the hessian above the screw head, these were removed and replaced with shorter stainless steel screws.
