PETERBOROUGH CATHEDRAL: THE NAVE CEILING

PHASE 5: ROWS 0 - 7

MAY - OCTOBER 2003

CONDITION SURVEY AND CONSERVATION TREATMENT

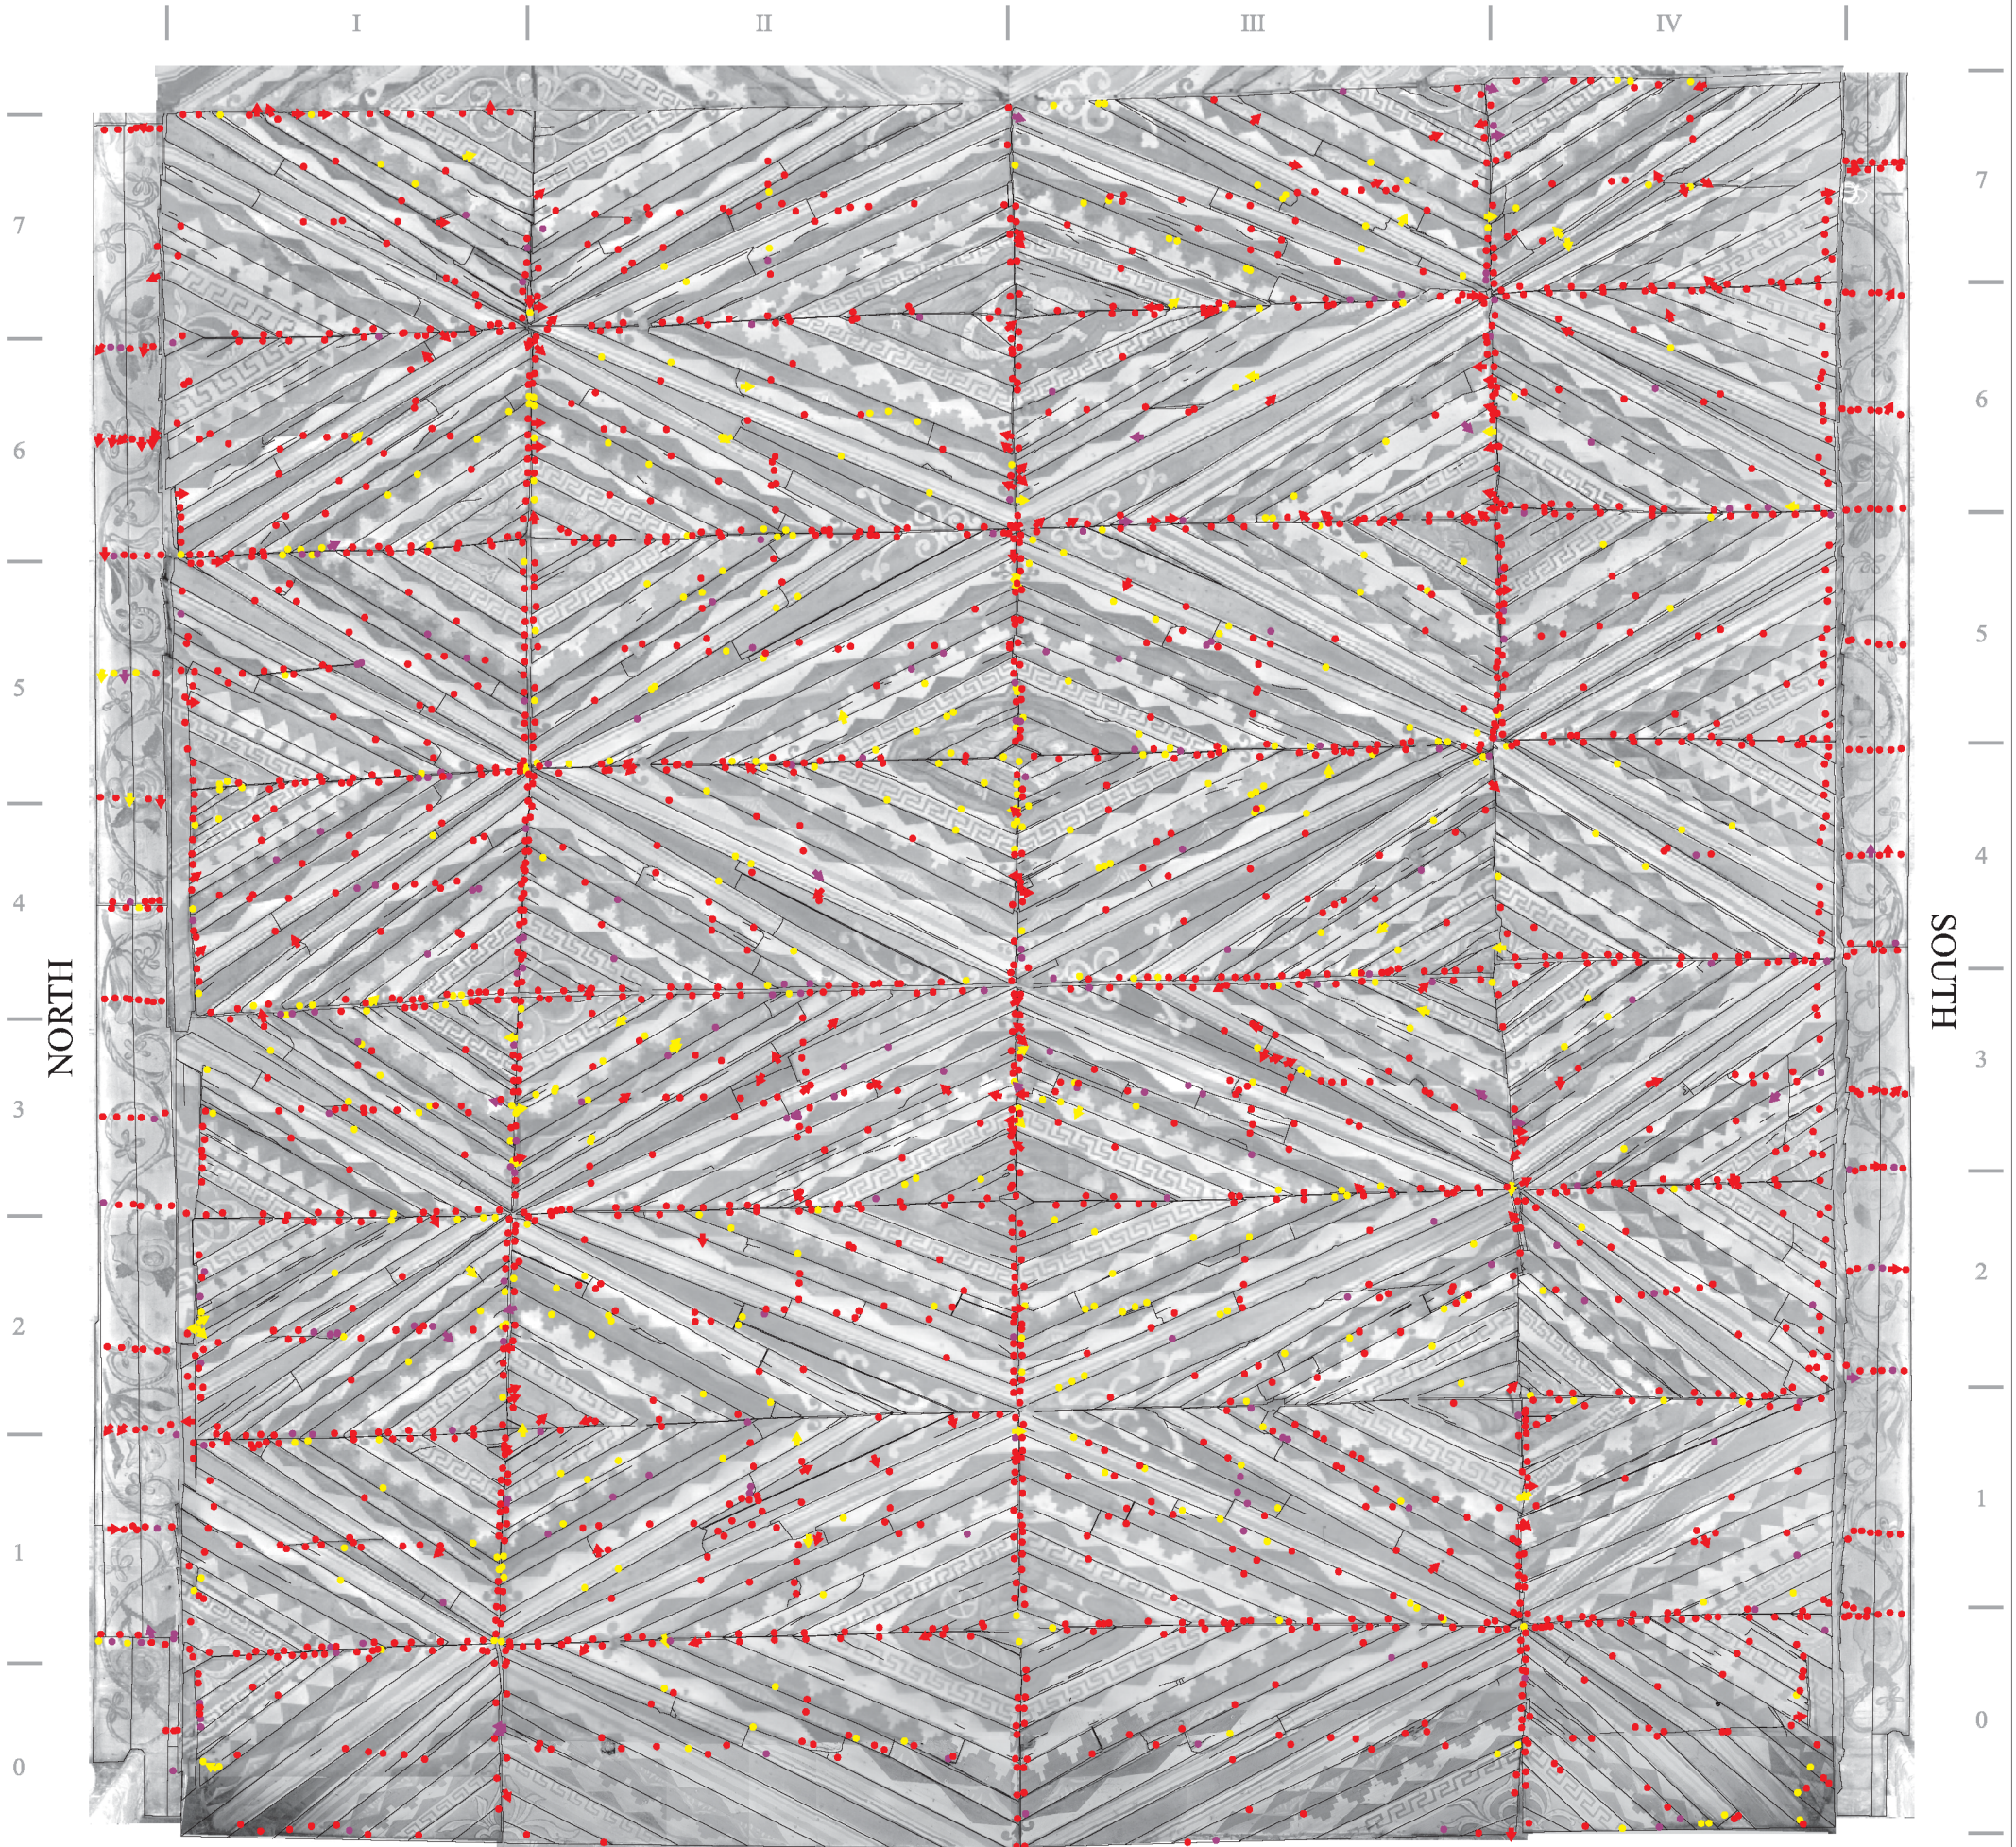
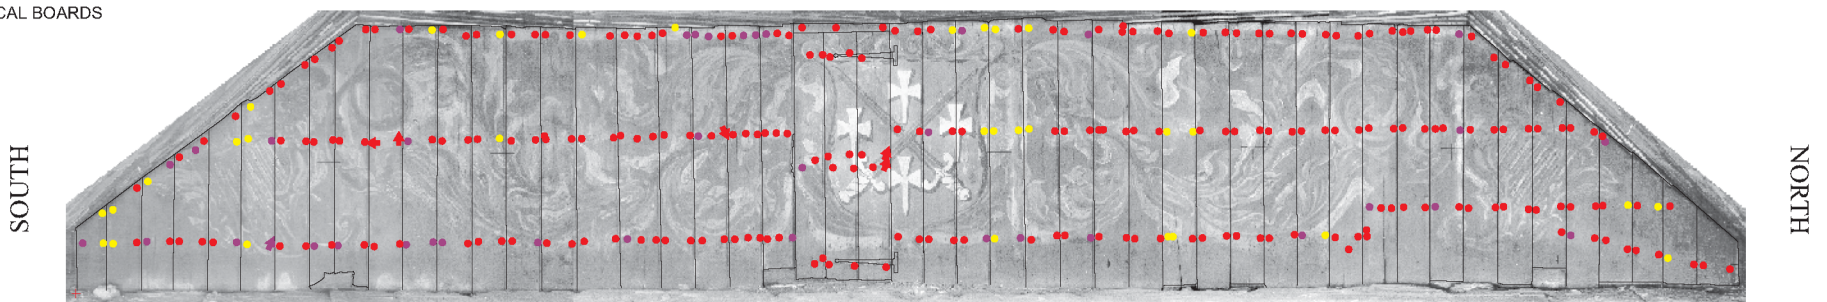
GRAPHIC No: 11

NOTES **Paint Surviving on Nail Heads** - The nail heads are shown here as oversized to aid visibility. The groupings signify the percentage of paint remaining on each nail but do not indicate whether the surviving paint was flaking. The same material in the same solution (Paraloid B72: 10% in acetone) was used both to re-attach flaking paint on nail heads and to coat exposed metal. In Phase 3 we observed for the first time that all nail heads and ceiling bolts covered by this paint without an intervening white lead ground have corroded to the extent that little or none of the covering paint survives. Whereas many of the nail heads with the 1740s red and green paints are similarly corroded, with the 1740s brown/black paint it occurs in every case.

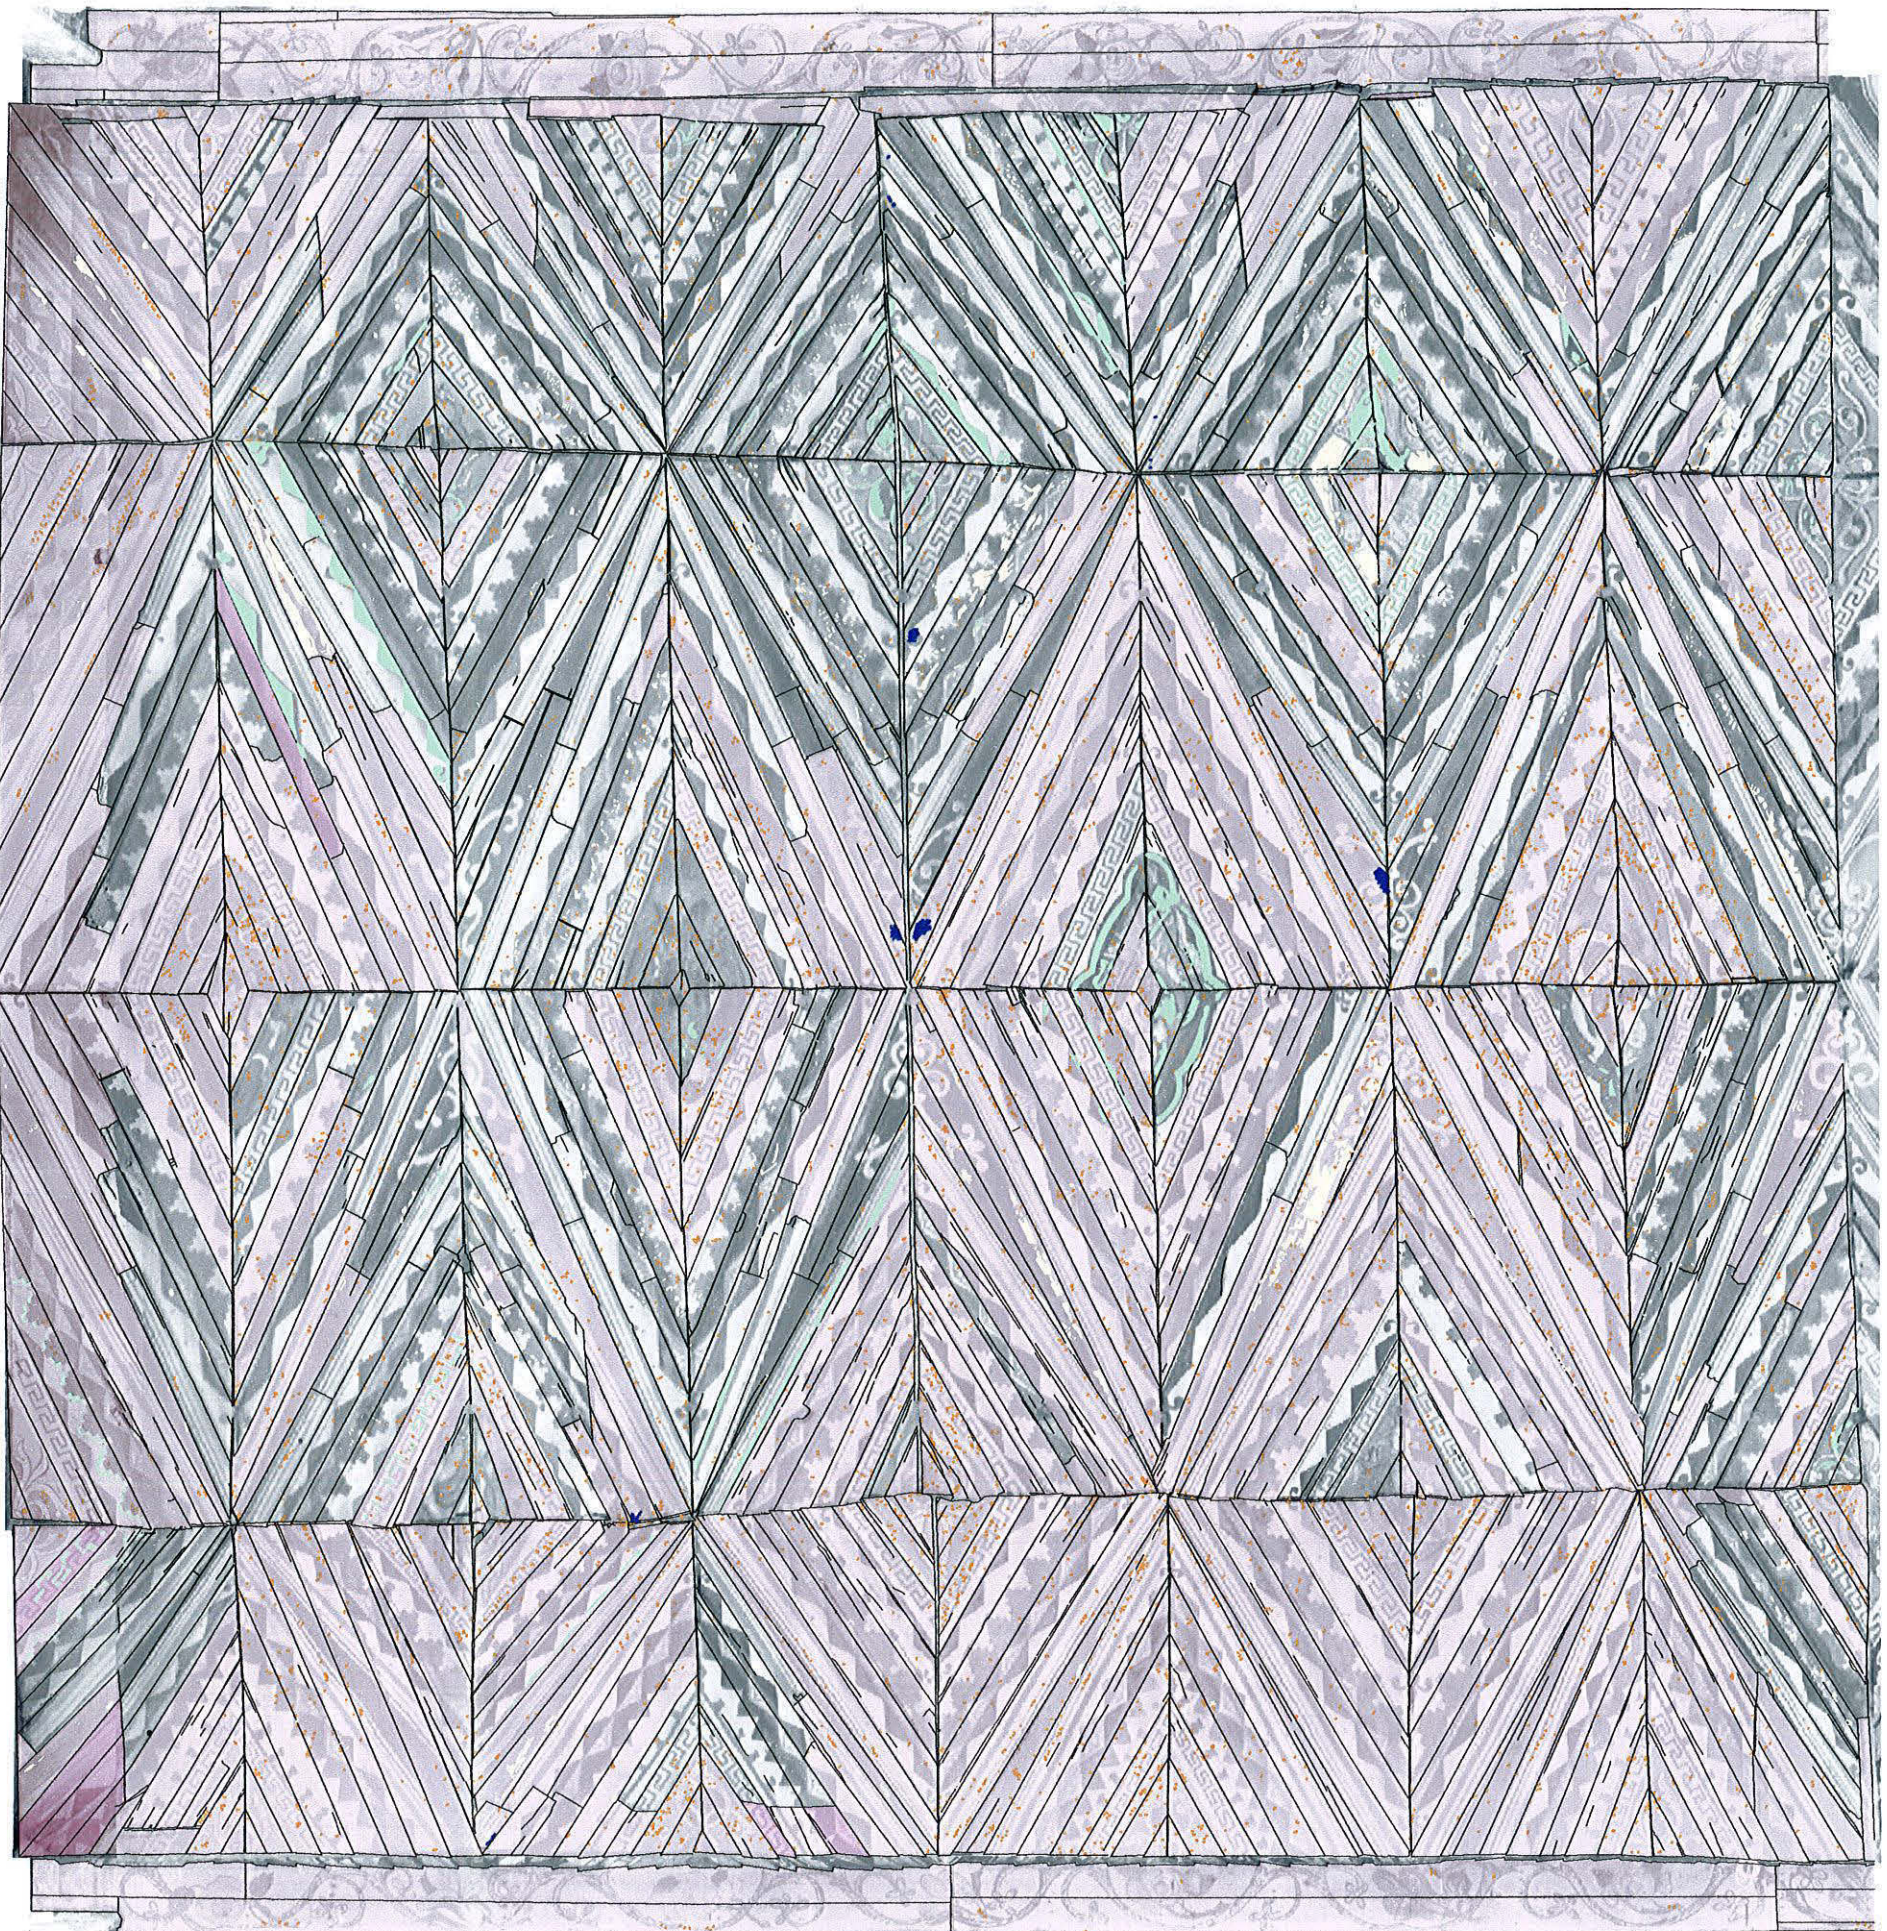
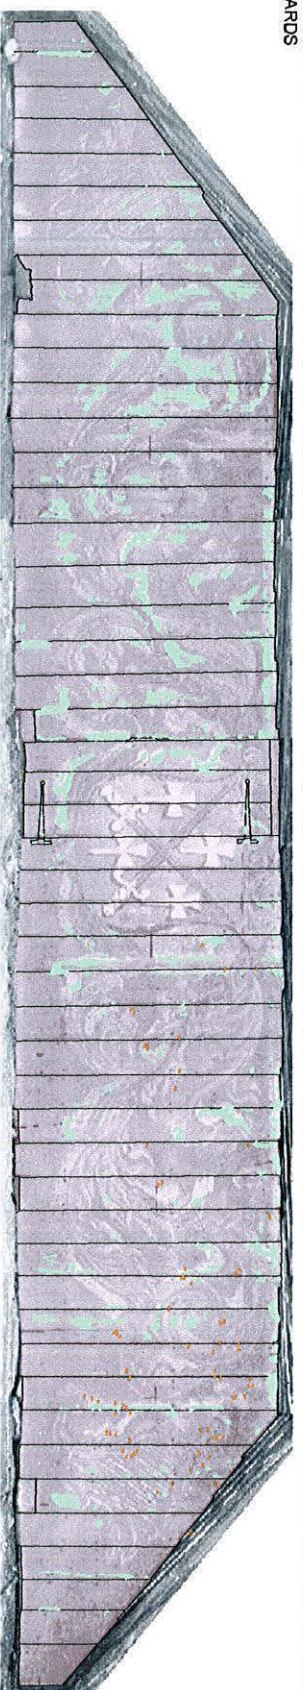
Patchy white deposits - Associated with the thick resinous 1830s black paint/coating remain unidentified initially they were considered to be some form of microbiological growth (MIBG) but analysis indicates they are accumulations of irregularly shaped, translucent, plate-like crystals. The recent discovery of a list of materials used by the 1830s restorers would suggest that the inclusion of sugar of lead (lead acetate) in the paint may be a factor. *Matt white patches* - These have a grey/white, powdery, matt surface and are generally found on the black of the wave and extended chevron boards. Often associated with the application of other paint layers. It can usually be removed or reduced with a Wisbuh. *Tendrill deposits* - These resemble miniature spider web, joining larger elements together. This type of deposit may have originated through microbiological action: analysis found some collapsed strand material. *Brown/white blotches* - These accretions were widespread across the Ceiling. They are irregularly shaped, translucent granules. The spots were generally brown and at the centre there appears to be a dark brown particle, like a grain of sand, around it was a lighter brown or off-white halo with a fuzzy edge. As with the patchy white deposits, it may be the inclusion of sugar of lead in the 1830s paint is responsible. *Surface Bloom* - From Phase 2 onwards this has been re-defined to exclude the overall milky veil on some softwood replacement boards. *Surface bloom* occurs generally but is particularly evident on repainted backgrounds of the lozenge boards, where the 1830s red and blue has been laid over the olive green or red of the 1740s. It is patchy, white and matt. It can be reduced with a Wisbuh.

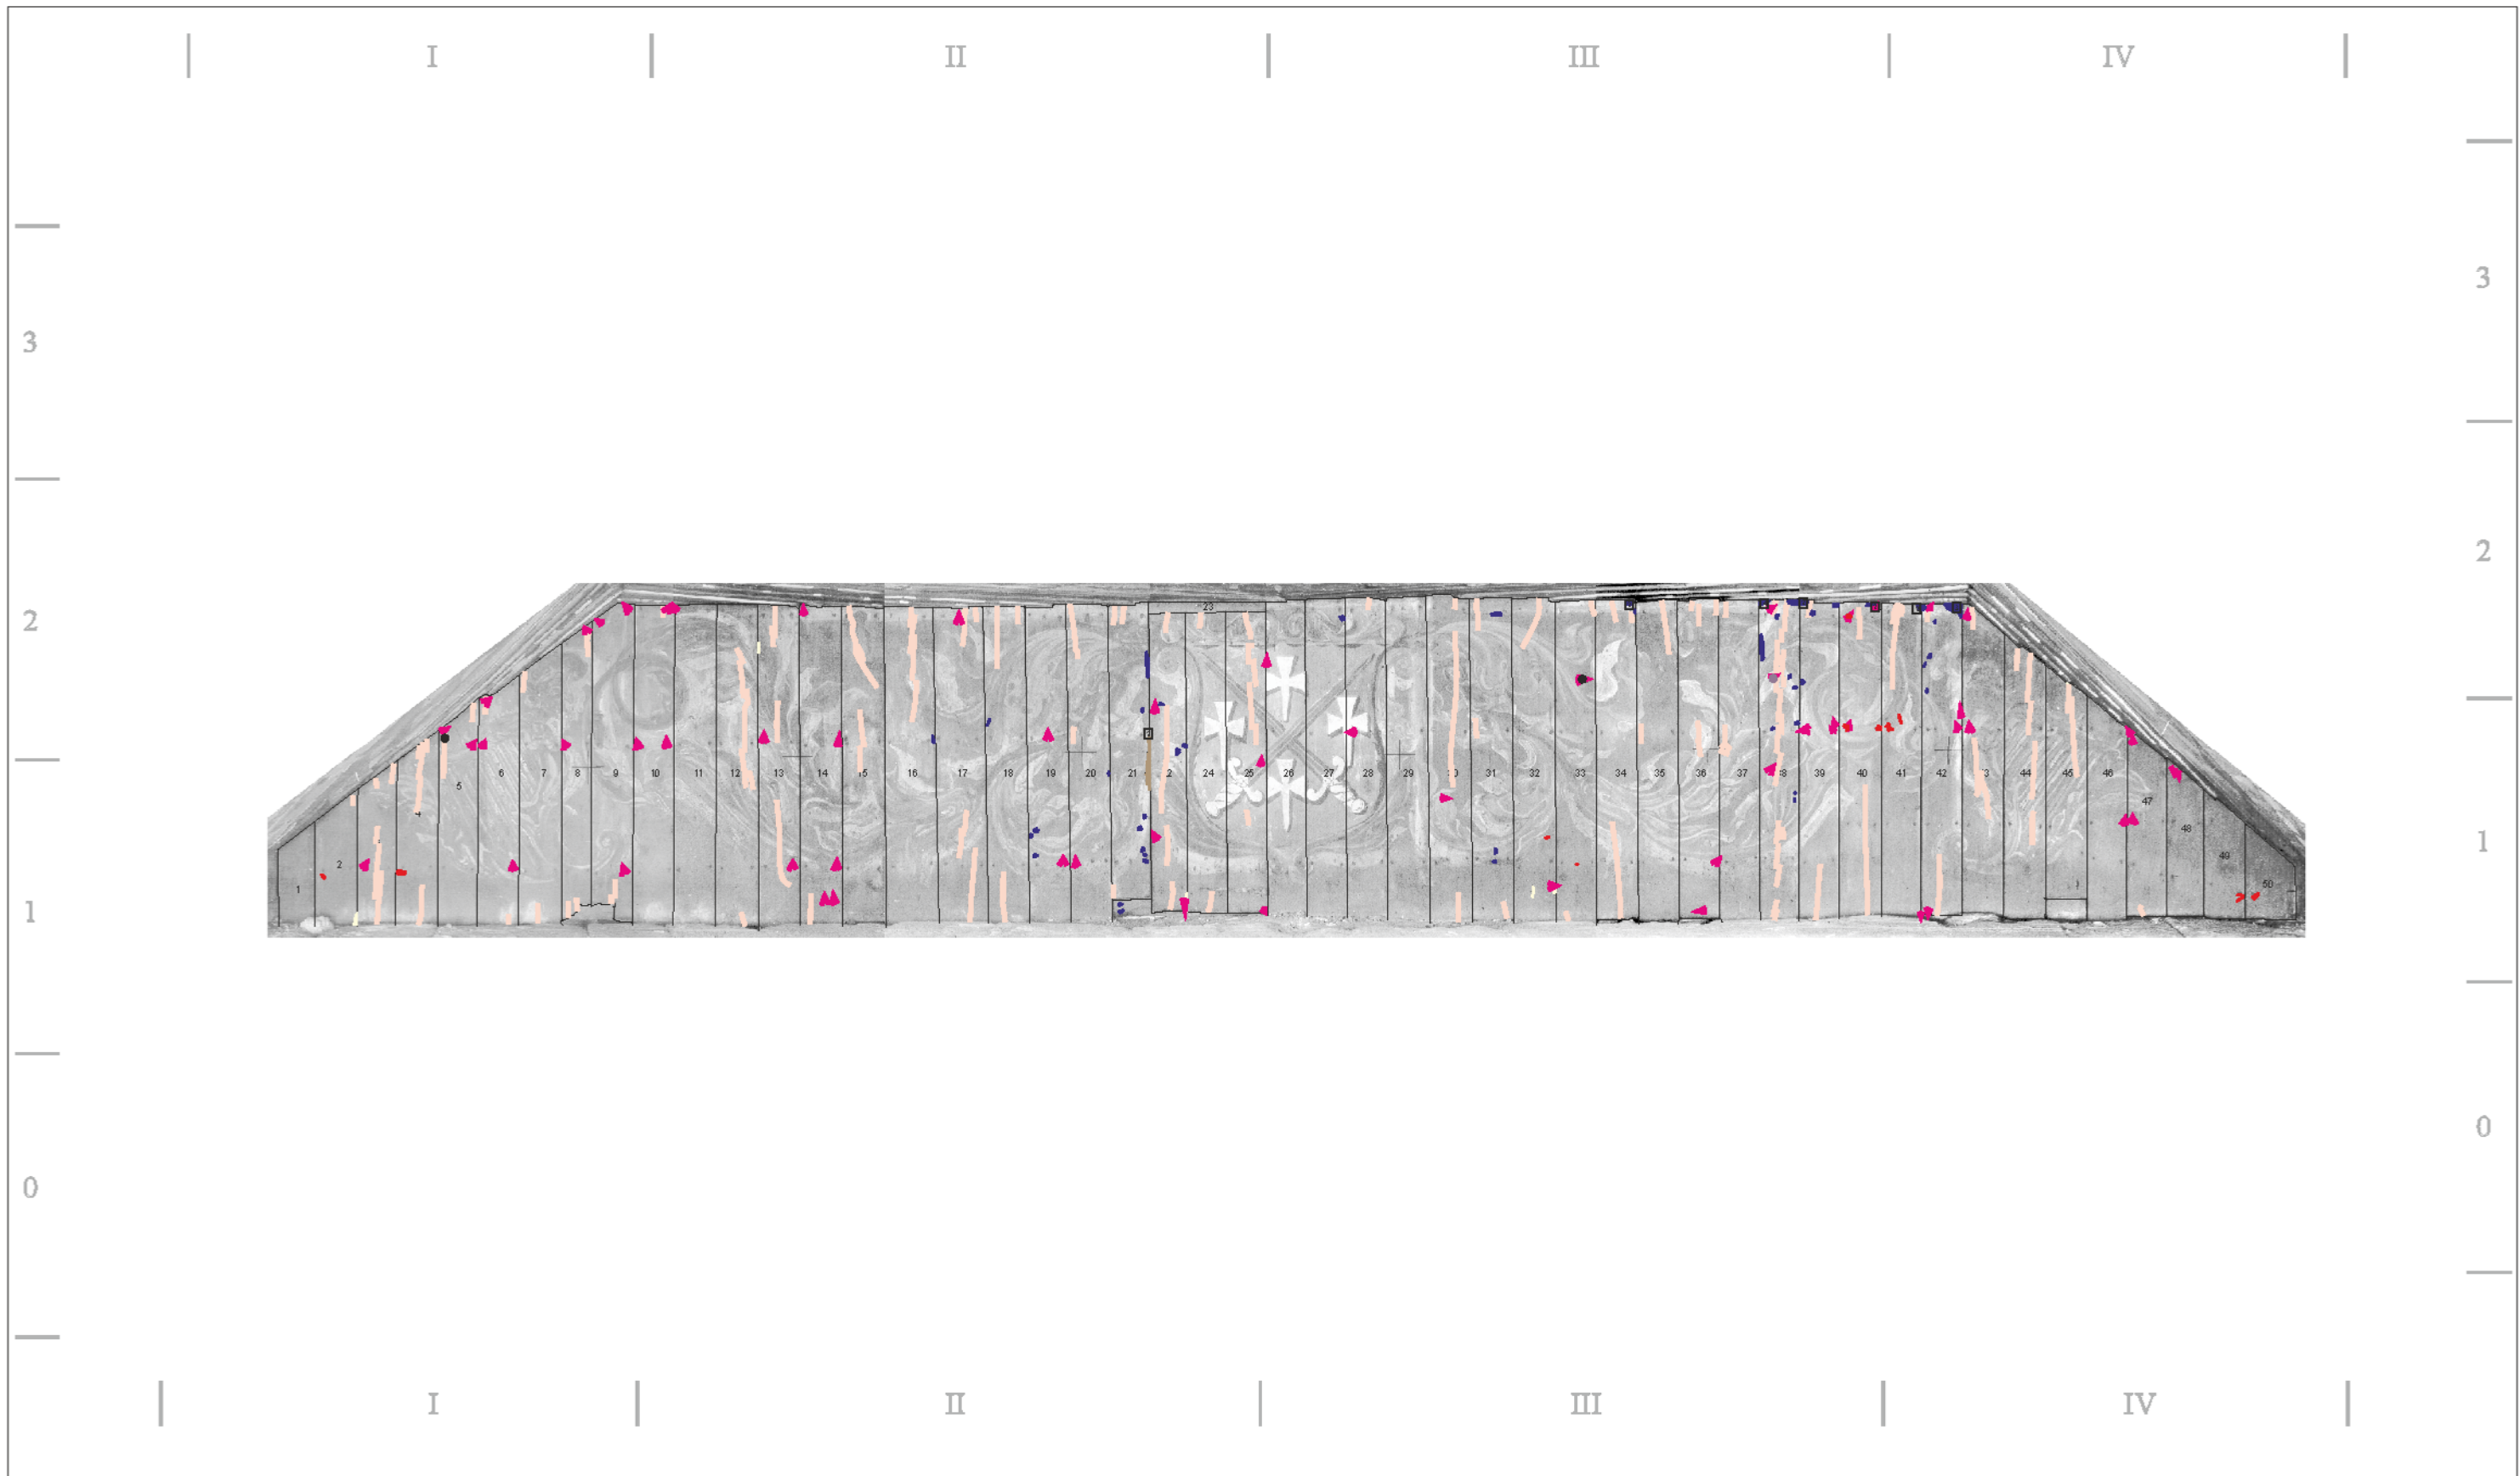
GRAPHIC No: 14

NOTES **Graffiti** - The most interesting graffiti on the West End Vertical boards is an indistinct white painted inscription "...Cobley Painter 1835" within a small foliate cartouche, also painted in white.

Flaking Paint - The primary cause of flaking paint on the Nave Ceiling is long term water infiltration leading to deterioration of the wood support and subsequent loss of adhesion. All flaking paint was re-attached during treatment.

Staining - All stains on the painted decoration result from liquid material penetrating down between the boards or through cracks in deteriorated boards.
