PETERBOROUGH CATHEDRAL

ENVIRONMENTAL MONITORING OF THE NAVE CEILING

JUNE 2001 – MAY 2002

Report No: PTB01.2

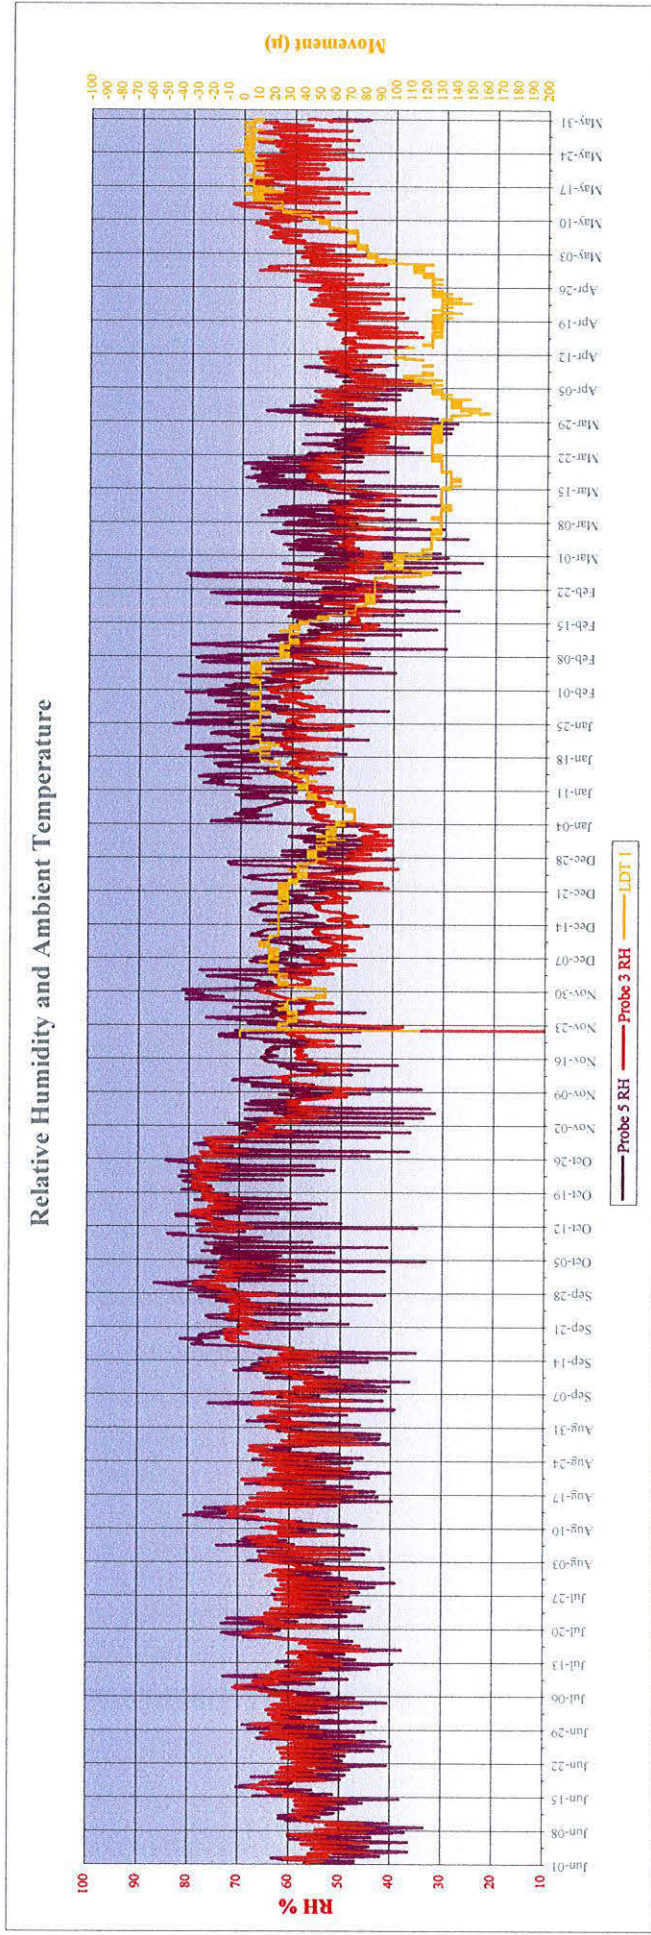
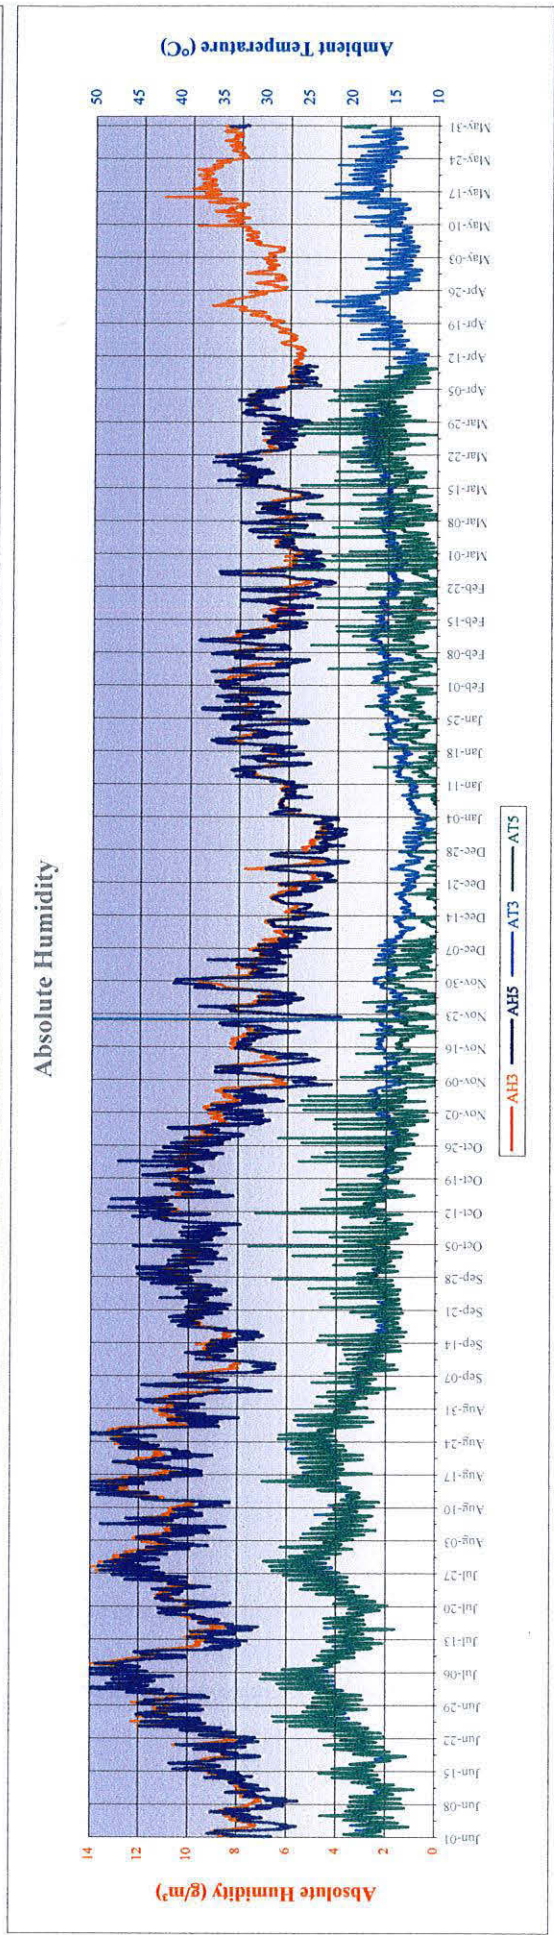
LDT movement with RH and AT for Probes 3 & 5 (Bay 33 IV lower upper side: sun)

The variations between the above and below ceiling conditions often result in extreme hygro-thermal gradients across the boards, raising concerns about their dimensional response and the implication for the paint layer. It was in order to measure their *actual* movement that Linear Displacement Transducers were installed on three separate boards (two original oak and one later pine). The data showed that in all three cases, movement took place in response to changes in Relative Humidity.

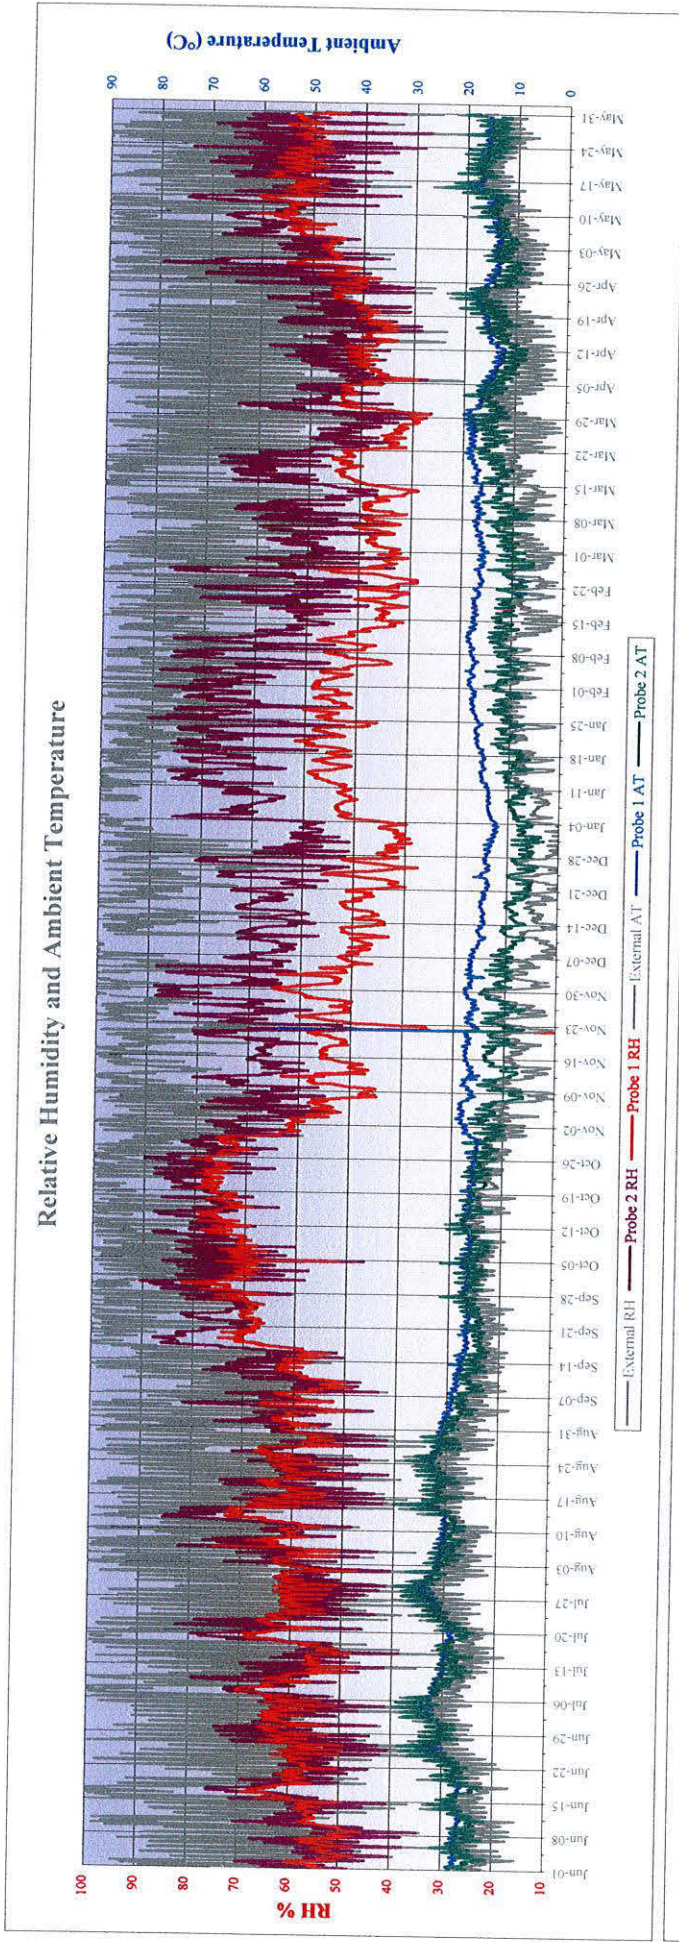
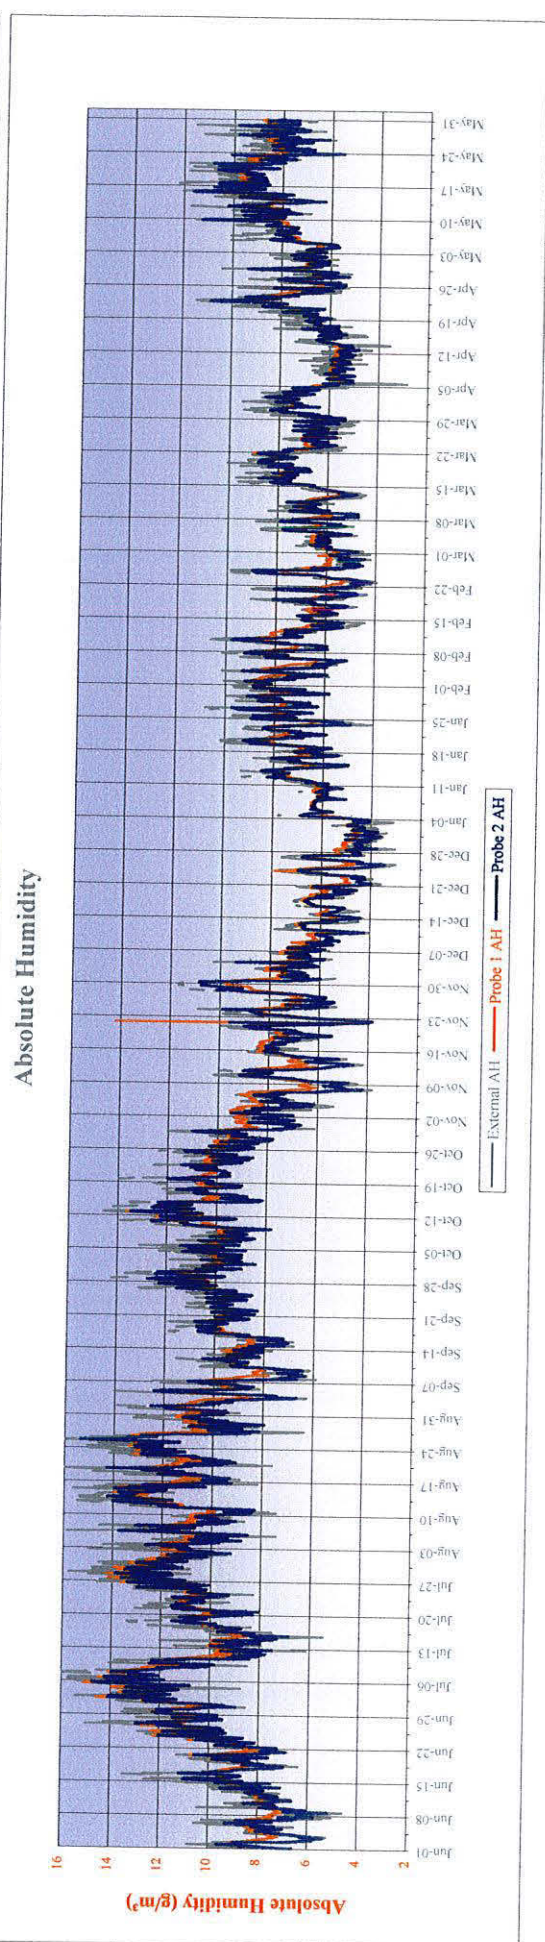
Probe 1: Bay 36 III lower side & Probe 2: Bay 36 III upper side (shade)

The microclimatic data collected during the current period of monitoring was similar to that recorded in previous years. On the lower side of the ceiling the annual average values for RH and AT were 56.6% and 17.1°C (in the shade). The extremes for RH were 82% and 33% while those for AT were 11°C and 29°C. (Excluding fire conditions). Summer averages were 61% and 21°C with diurnal fluctuations of 8% and 3°C. Winter averages were 53.3% and 15.2°C with diurnal fluctuations of 4% and 1.5°C.⁹

The equivalent annual conditions in the roof space were 65% and 14°C. Extremes for RH were 91% and 32% while those for AT were 32°C and 3.5°C. Summer averages were 58.7% and 20.9°C with diurnal fluctuations of 18% and 6°C. Winter averages were 66.4% and 10.5°C with diurnal fluctuations of 9% and 3°C.

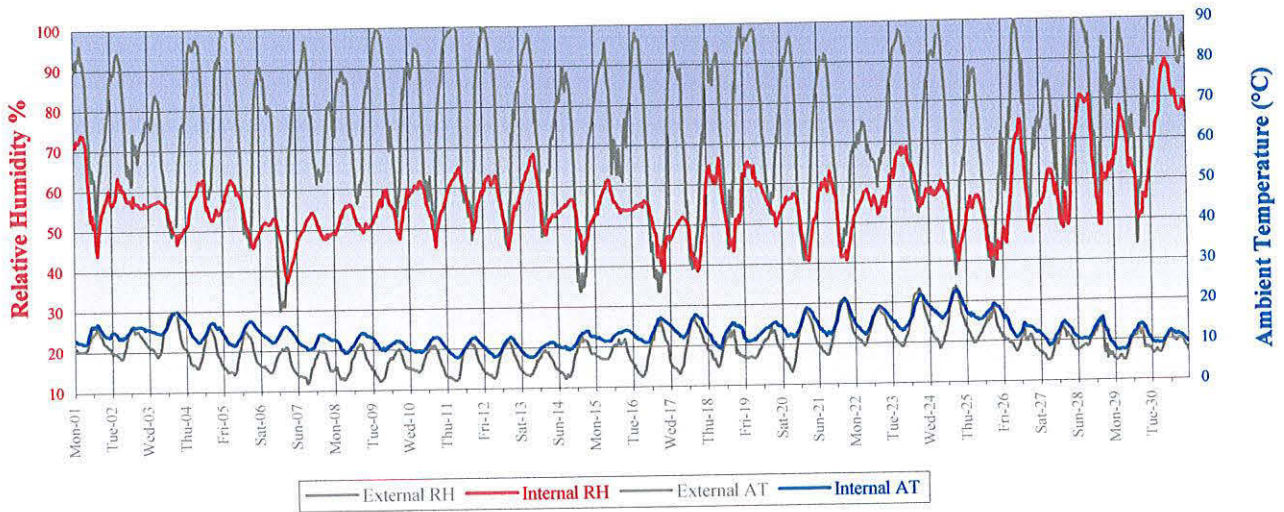
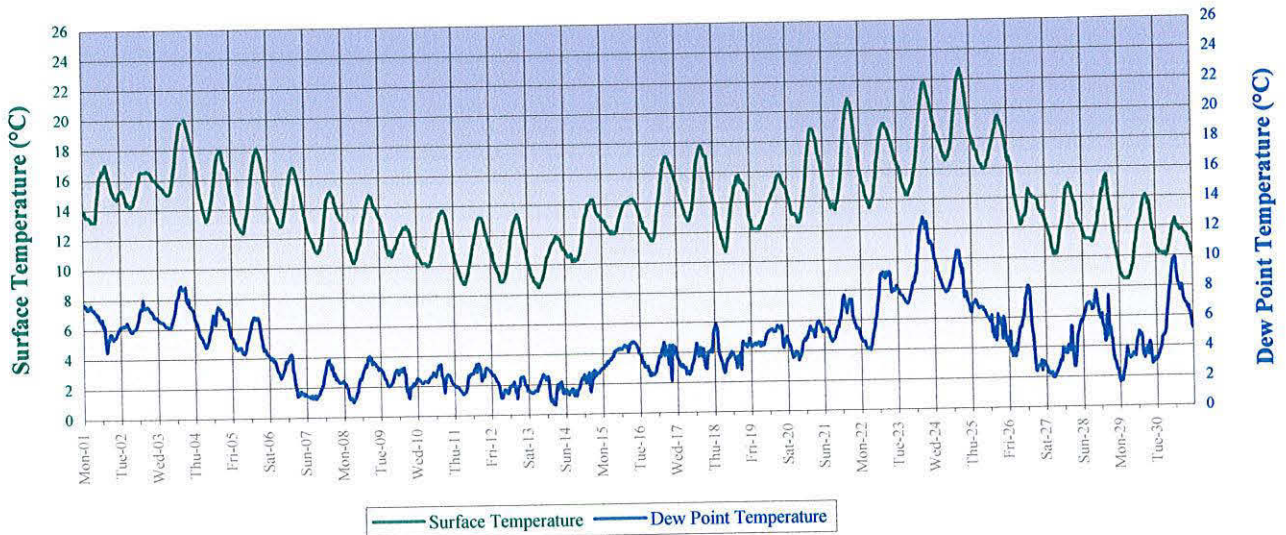
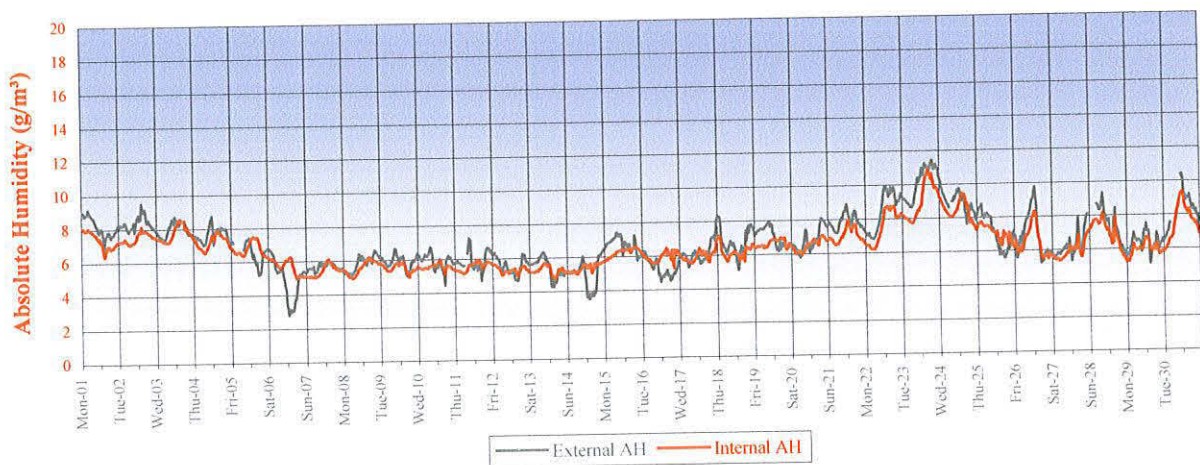
Relative Humidity and Ambient Temperature

Surface and Dew Point Temperature

Absolute Humidity
