## PETERBOROUGH CATHEDRAL

### ENVIRONMENTAL MONITORING OF THE NAVE CEILING

*JUNE 2002 – OCTOBER 2003*

**Report No:** PTB01.2

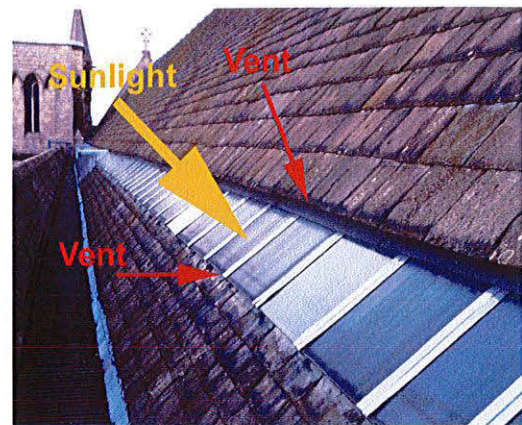
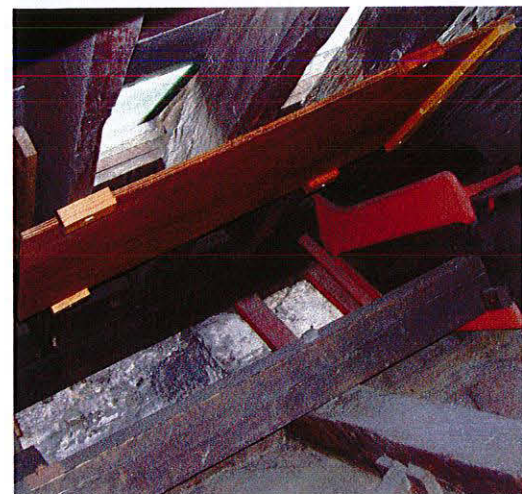
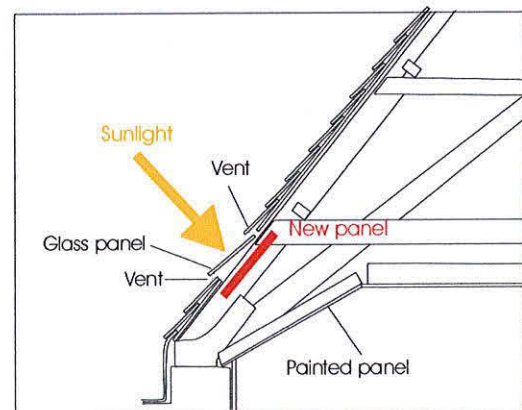
In previous years, the conditions on both sides of the ceiling had been effected by sunlight coming through the glass panels on the south side of the roof. This had caused fluctuations in ST of up to 38°C with corresponding

Figures 5, 6 & 7. Panels above the windows on the south side of the nave roof (Photo: TCA 2003).

short term falls in the RH. However, as a result of the panels inserted in July 2002 and October 2003, this effect has been almost entirely eliminated.

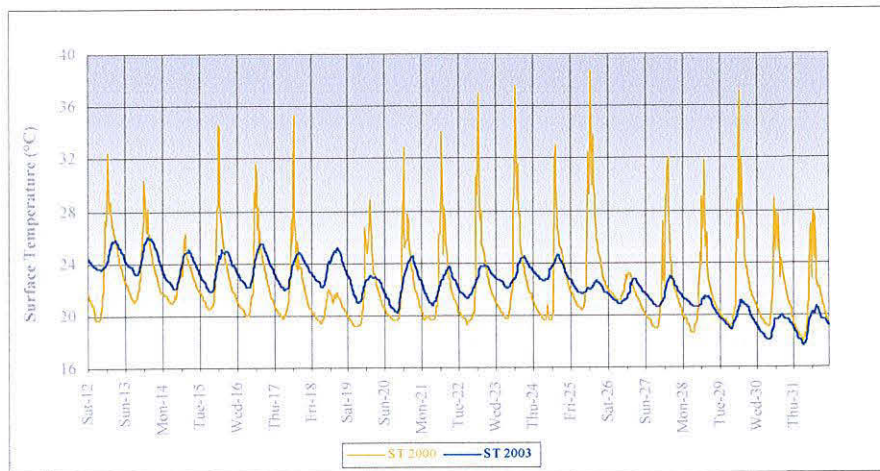
**Chart 1.** Surface temperature at Probe 3 in August 2000 and in August 2003, after the insertion of the window boards.

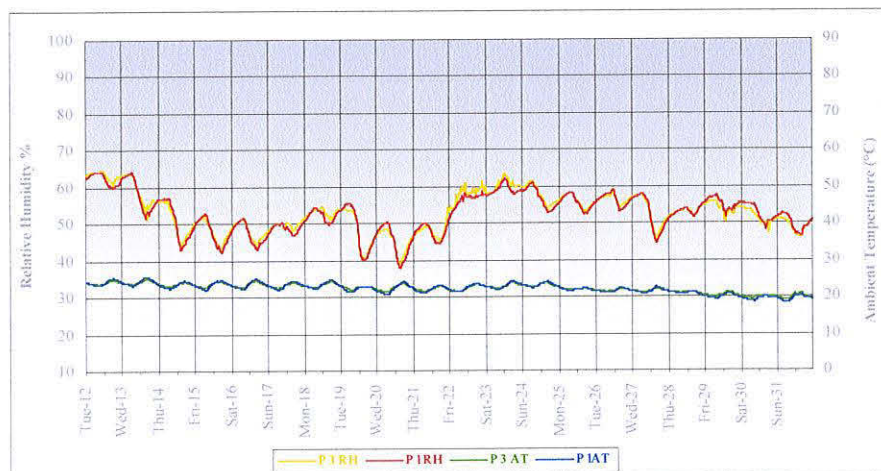
However, although the ST on the boards is no longer effected, the AT in the vicinity still shows a significant influence of solar radiation. The effect of the sunlight falling on the boards, is to heat them thus causing a warming of the surrounding air. This has an effect on the RH as would be the case with an increase in AT from any other source.

The fluctuation of the AT is not solely associated with the heating of the boards. The solar radiation on the tiled roof would also cause a significant increase in the internal AT due to the low level of thermal insulation. If one were to measure the ST of the interior face of the roof, short temperature peaks would be observed

**Chart 2.** Following the insertion of the boards, the August relative humidity and ambient temperature at Probe 3 (previously in sunlight) are almost identical to those of Probe 1 (shade). Solar radiation on the uninsulated roof still causes significant fluctuations.

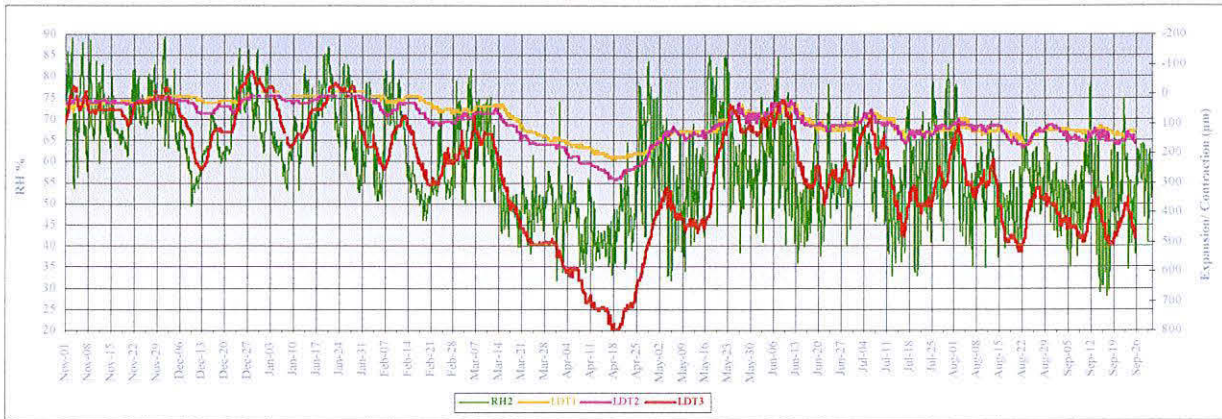
As had been demonstrated in 2001/2002, the movement was proportionate and opposite to the change in RH. In other words, when the RH decreased, the boards expanded, and when it increased they contracted. This was far clearer in the current period than in the previous year. While the RH above and below the ceiling varies in level and short term patterns, the longer term patterns are similar. The upper, unpainted, sides of the boards, with their hessian and glue backing, are also far more porous and hygroscopic than the lower painted side. It is possible therefore that an increase in RH disproportionately effects the upper sides of the boards, causing a greater level of expansion as the RH increases, and thus creating a concave deformation on the lower sides. This may also be exacerbated by the methods of fixing from above.

**Chart 3.** Movement in the boards plotted (in reverse) against the relative humidity in the roof space. A decrease in relative humidity can be seen to induce expansion in the boards.

As had been seen in the previous year, the level of movement in probes 1 and 2 (mounted on a pine and an oak board, respectively) were very similar, with a movement range of <300µm. Although the pattern of movement for probe 3 (mounted on an oak board), was similar, the range was far higher at <1000µm. No obvious difference between the two oak boards was observed and so it appears probable that the variation in movement levels is associated with the methods in which the boards are fixed.

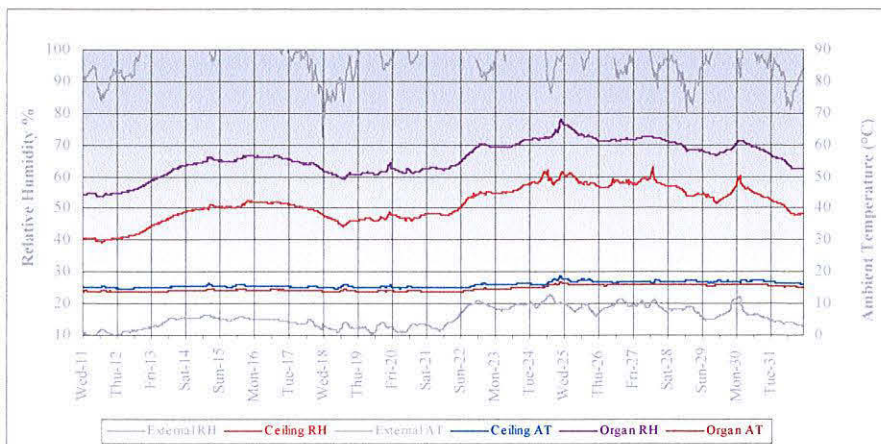
Data collected from the area in the north triforium gallery by the organ pipes showed that the RH was significantly higher than at ceiling level. However, the AH level was similar (due to the similarly low level of internal/ external air exchange) and it was principally the fact that the AT was lower, which was responsible for the increase in the RH. The lower AT is presumably due to the passage of warm air from the stoves, which bypasses the gallery, and the cooling effects of the large north windows. The pattern of movement is extremely similar in the gallery and at the ceiling, and both areas show a relatively high degree of stability in the winter months (when the heating is in use). In the summer, there is a greater level of diurnal heating and cooling, which is reflected in a more unstable RH. However, the fluctuations in AT in the gallery are less than at ceiling level and therefore the RH is more stable at the level of the organ pipes than by the painting.

**Chart 4.** Conditions at the organ pipes (purple and brown) and on the ceiling (red and blue) in December 2003. Although the levels differ, the patterns are very similar
