JANE DAVIES CONSERVATION

PETERBOROUGH CATHEDRAL, NAVE CEILING ROOF SPACE

INVESTIGATION OF PAINT MATERIALS AND TECHNIQUES

May 2003

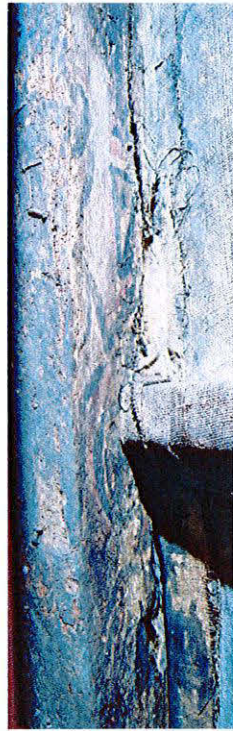
Sample location photograph (*below*):

Sample 32 (3101, P4a:1) was taken from the east side of the easternmost joist of the Nave ceiling, from an area of black paint.

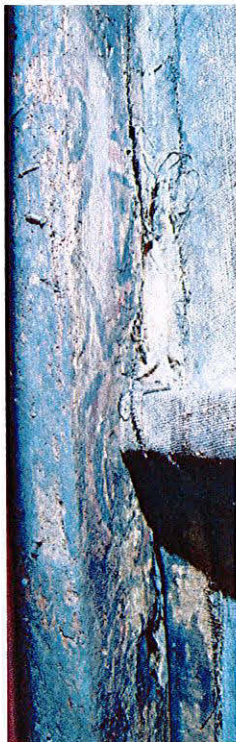
Sample location photograph (below):

Sample 33 (3102, P4a:2) was taken from the east side of the easternmost joist of the Nave ceiling, from an area of white paint.

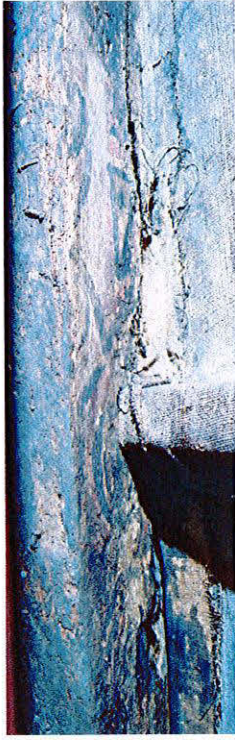
Sample location photograph (below):

Sample 34 (3103, P4a:3) was taken from the east side of the easternmost joist of the Nave ceiling, from an area of white paint, where red ground appeared to be present below when sampling.

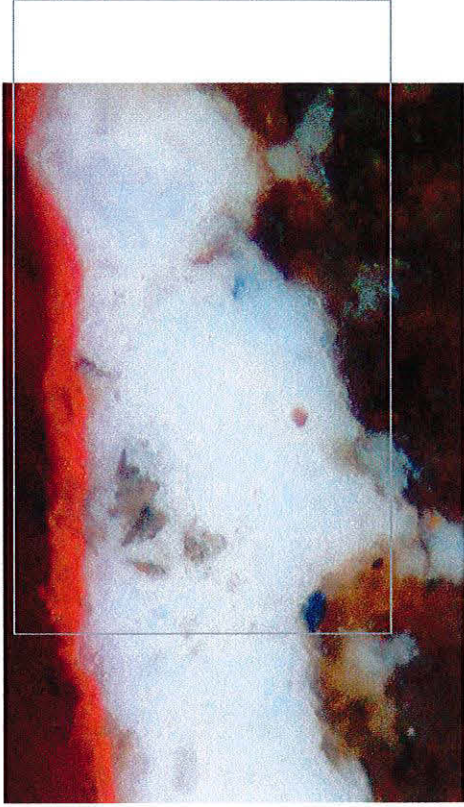
Image above: Box shows approximate location of SEM Backscattered image on sample cross-section.

Image above right: SEM.EDX backscattered image of the sample showing points at which EDX spectra were made.

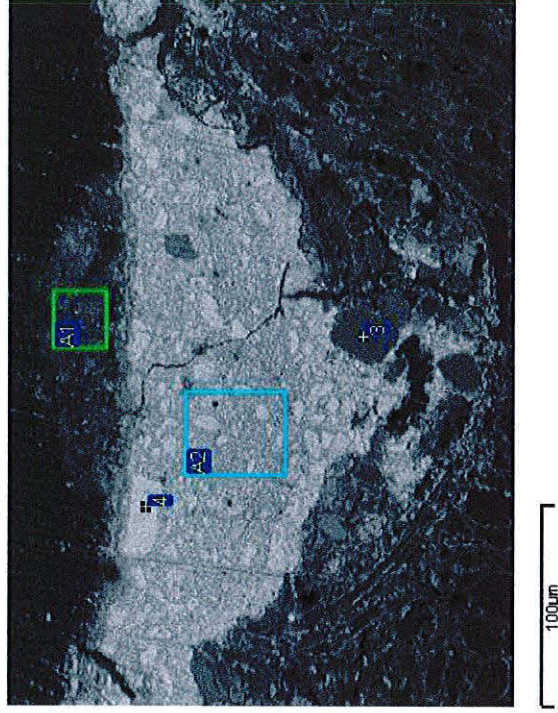
interface and on the surface of the sample. Previous research (Howard 1997) identified calcium sulphate and a clay-rich material at the wood/paint interface which was attributed to previous conservation treatment of the ceiling. Given the proximity of the sample location to areas of hessian and glue applied during previous conservation it appears likely that the clay-rich material may not be original to the painting, but a later introduction.

Spectra A2 and Spectra point 4 both show peaks for lead, carbon and oxygen.

Image above: Box shows approximate location of SEM Backscattered image on sample cross-section.

Image right: SEM.EDX backscattered image of the sample showing points at which EDX spectra were made.
