PETERBOROUGH CATHEDRAL
ENVIRONMENTAL MONITORING
FOURTH PERIOD
20th SEPTEMBER TO 1st NOVEMBER 1995

Monitoring is continuing to establish the environmental conditions within the cathedral so that an assessment can be made as to whether the medieval painted ceiling is being adversely affected by the heating system.

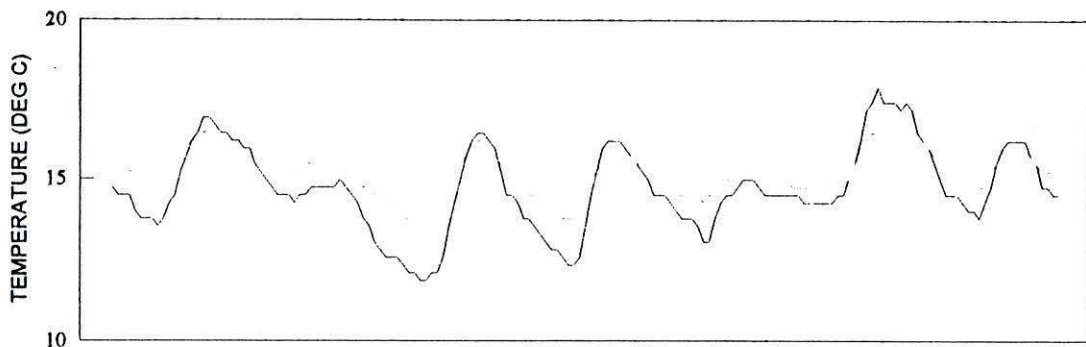
SURFACE TEMPERATURES EITHER SIDE OF PAINTED CEILING
GRAPH 2

Conditions within the roof void varied by a greater amount than those in the cathedral, appendix C, graph 1 shows how the ceiling surface temperatures varied and graph 3 shows the temperature difference across the ceiling. It is inevitable that with an unheated roof space, there will be some temperature differential across the ceiling. Graph 2 shows an expanded portion of the data and indicates a maximum difference of 2 degrees. Given the heavyweight building structure, any flexing due to this deviation should be minimal.

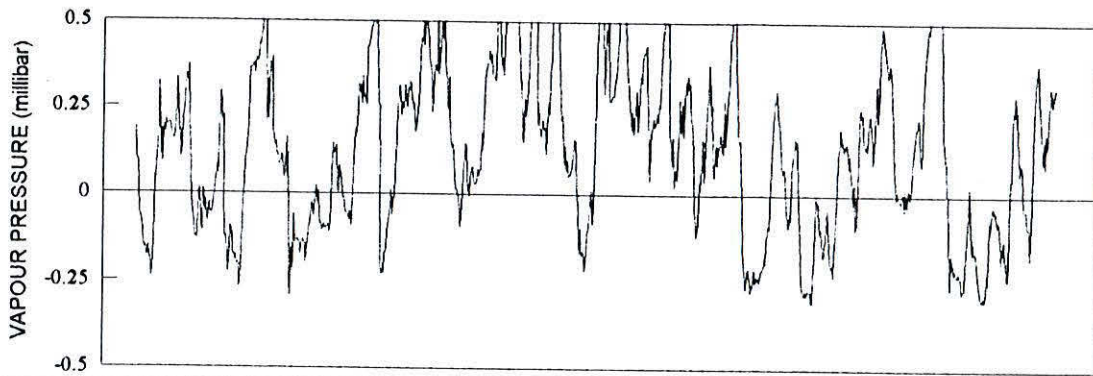
POSITIVE INDICATES MOVEMENT OUTSIDE TO INSIDE
GRAPH 1

The vapour pressure graphs show that the moisture movement is predominantly from outside to inside but the conditions across the painted ceiling are relatively stable (see graph 3 of appendix F). The moisture content graphs also show that the conditions across the ceiling are

From the calculations of vapour pressure and moisture content it can be seen that whilst moisture tends to move from outside to inside the building, moisture is moving fairly constantly in either direction across the ceiling. This should not lead to a situation where warping could occur through one side having a greater moisture content than the other.
