**PETERBOROUGH CATHEDRAL  
ENVIRONMENTAL MONITORING  
2nd NOV 1995 TO 31st JAN 1996.**

**PETERBOROUGH CATHEDRAL  
ENVIRONMENTAL MONITORING  
FIFTH PERIOD  
2nd NOVEMBER 1995 TO 31st JANUARY 1996**

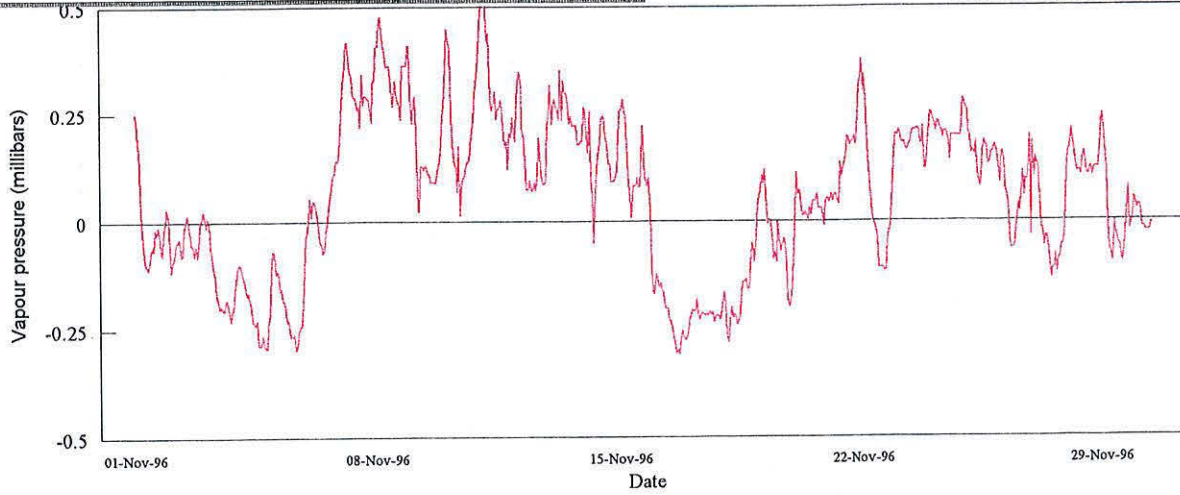
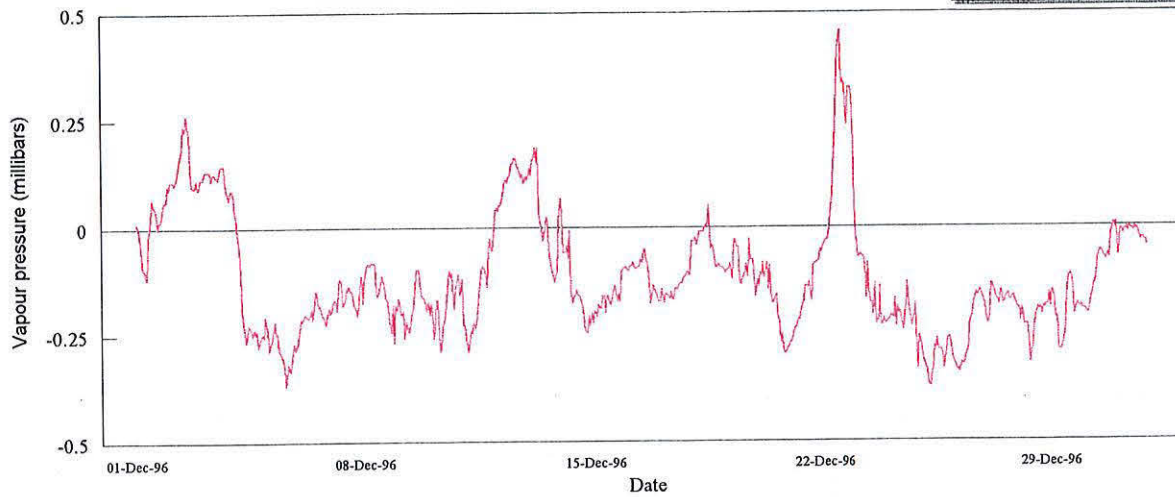
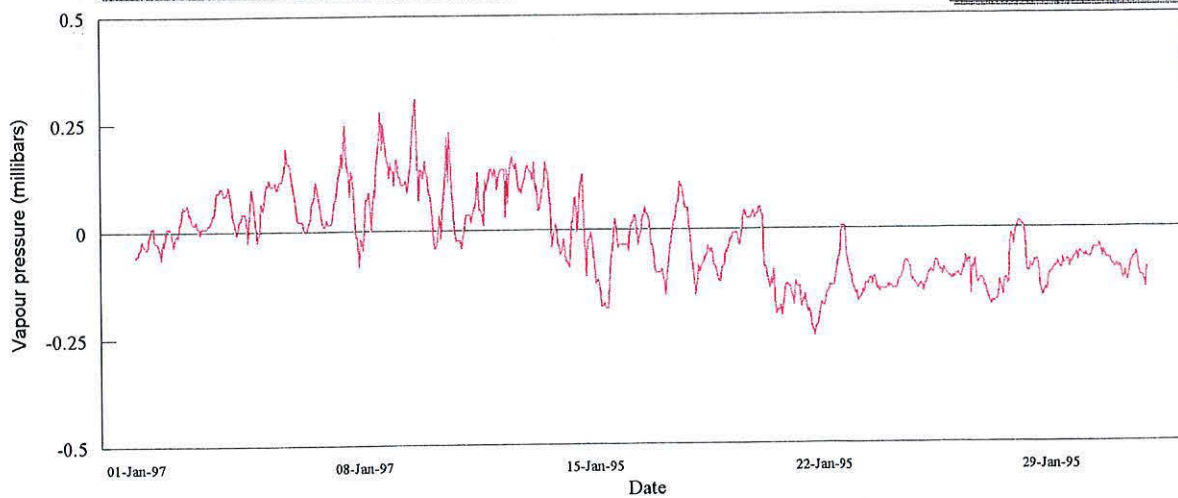
These are shown in graphs 12 to 29, results indicate that during November and January effects were broadly neutral with moisture moving from inside to outside and vice versa. During December there was a tendency for moisture to move predominantly from inside to outside which was counteracted by the humidification effect of the water in the Gurney stoves.

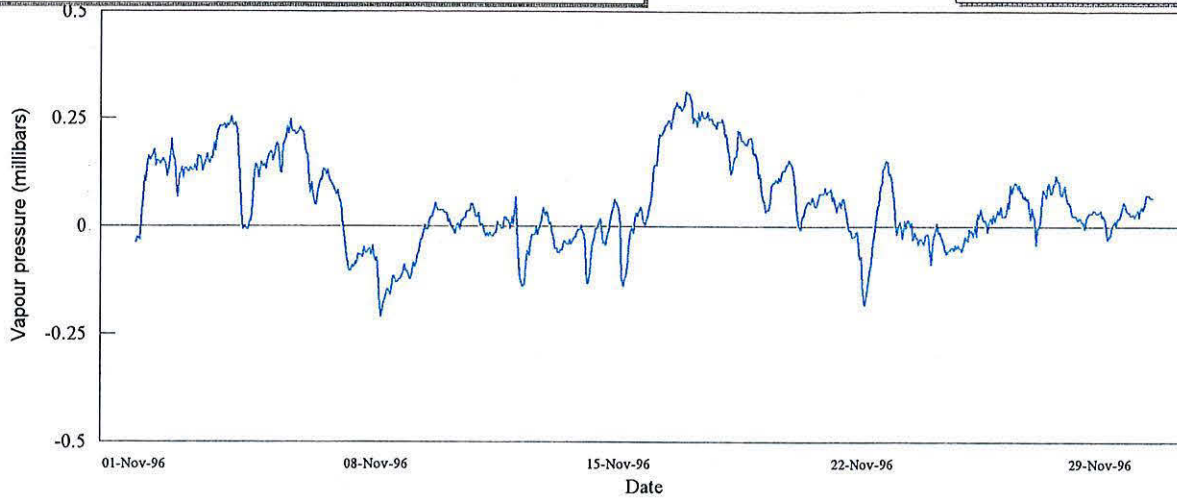
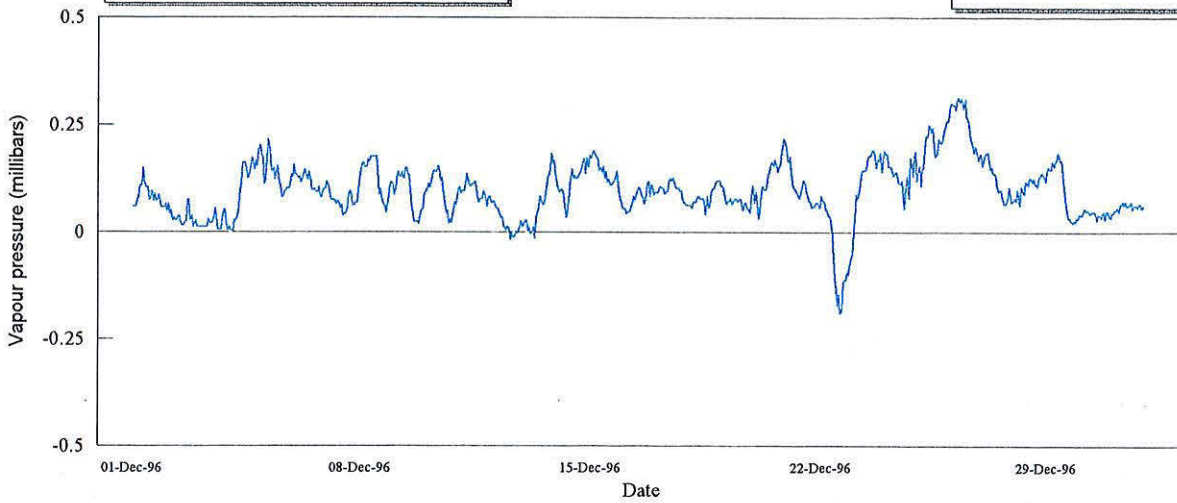
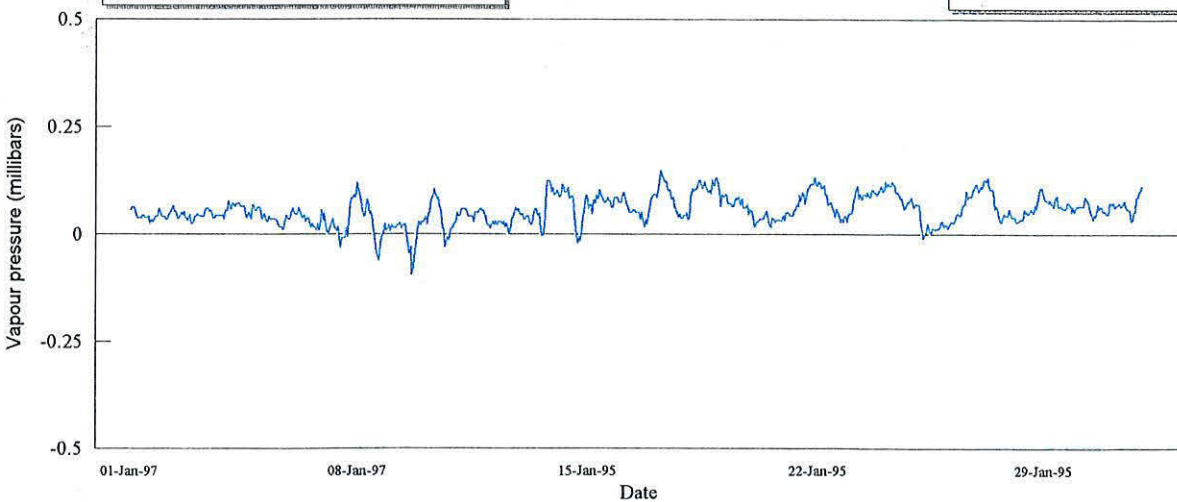
Moisture movement across the ceiling was generally from the cathedral to the roof space. This may have been caused by the extra moisture induced into the cathedral as in the previous monitoring period moisture moved backward and forward fairly evenly.

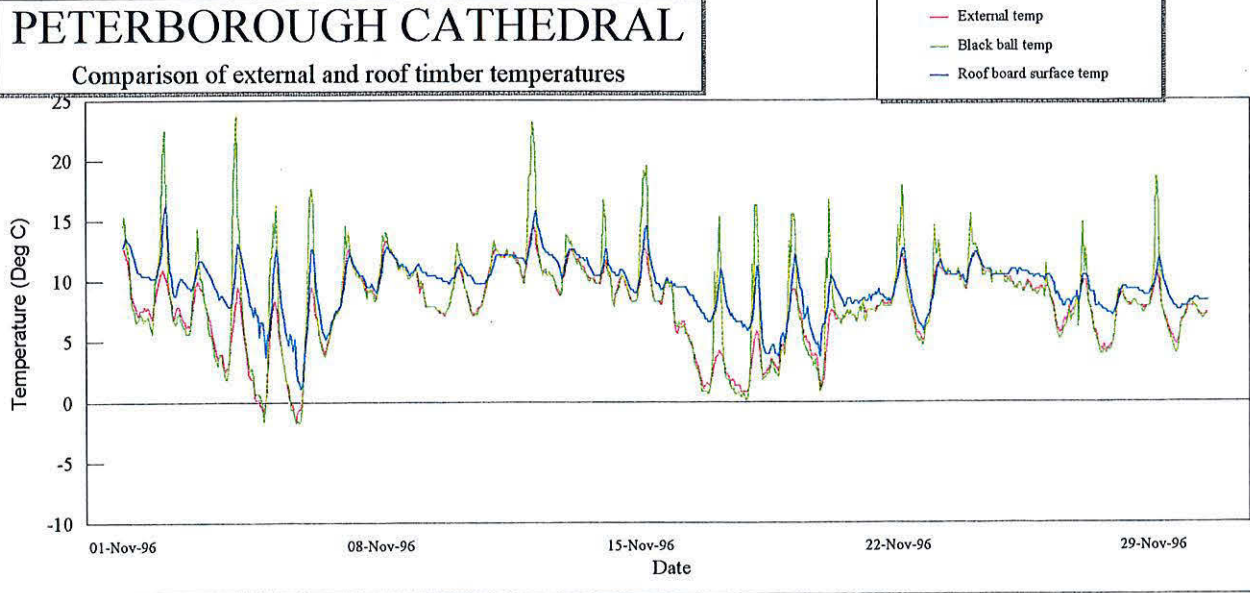
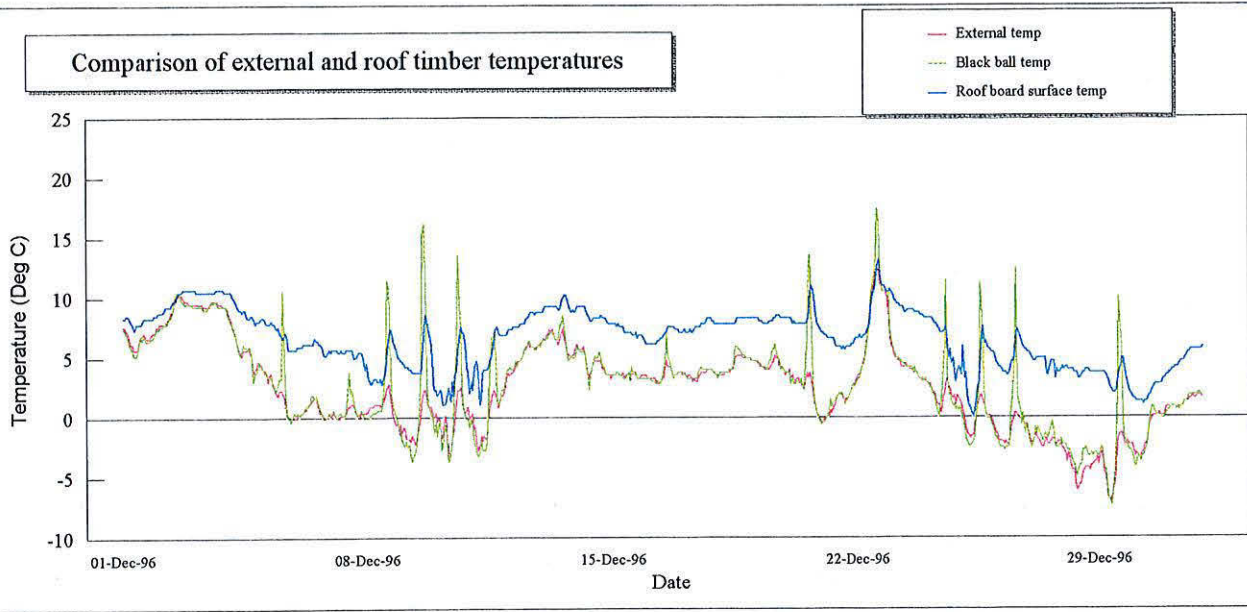
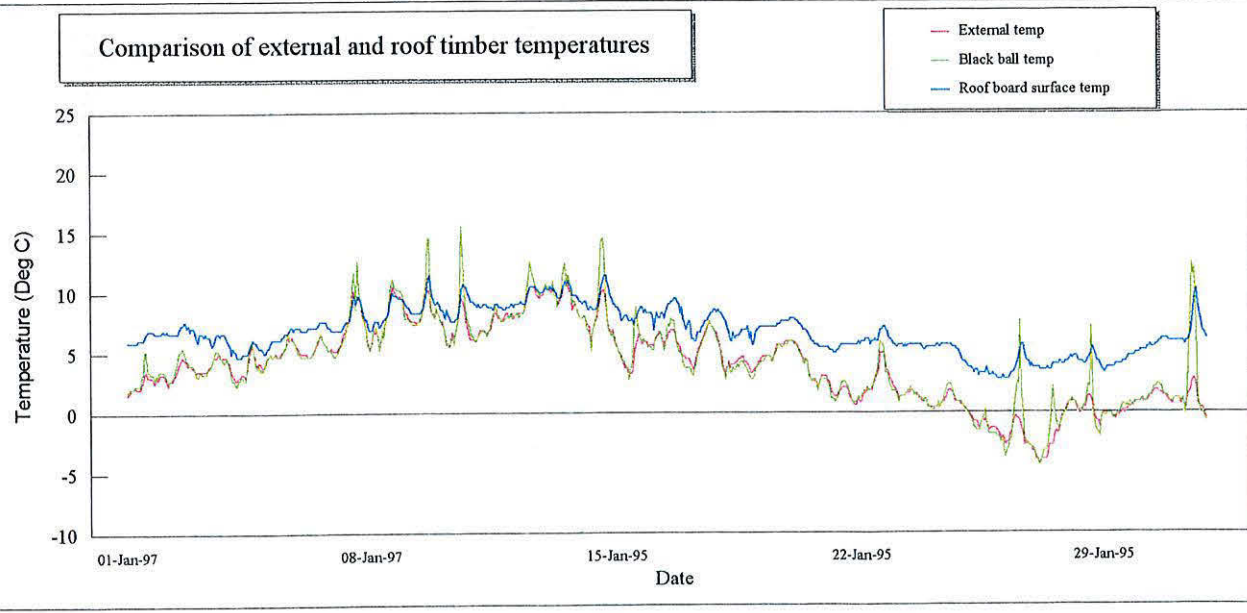
Comparisons of “black ball”, external temperature and inside roof timber temperatures are shown in graphs 30 - 33. The inside is generally well buffered from the external conditions, the only time the roof boards approached the external is shown in graph 33 and coincided with a sharp drop in external temperature. Calculations show that condensation will have occurred on the outside between the tiles and the roofing felt on a number of occasions, predictions indicate that there is a small possibility of condensation occurring on the inside between the felt and the boarding. A visual inspection of the roof boarding shows some staining but there is no evidence of moisture falling onto the top of the ceiling.
