**PETERBOROUGH CATHEDRAL
ENVIRONMENTAL MONITORING
1st FEBUARY TO 26th JUNE 1996.**

This report covers 5 months bridging winter/spring/summer. An analysis of temperatures across the painted ceiling has been included to assess the effects of solar gains in the roof space. The mid level temperature and humidity sensor had been disturbed around April 8th and humidity readings from that sensor are unreliable.

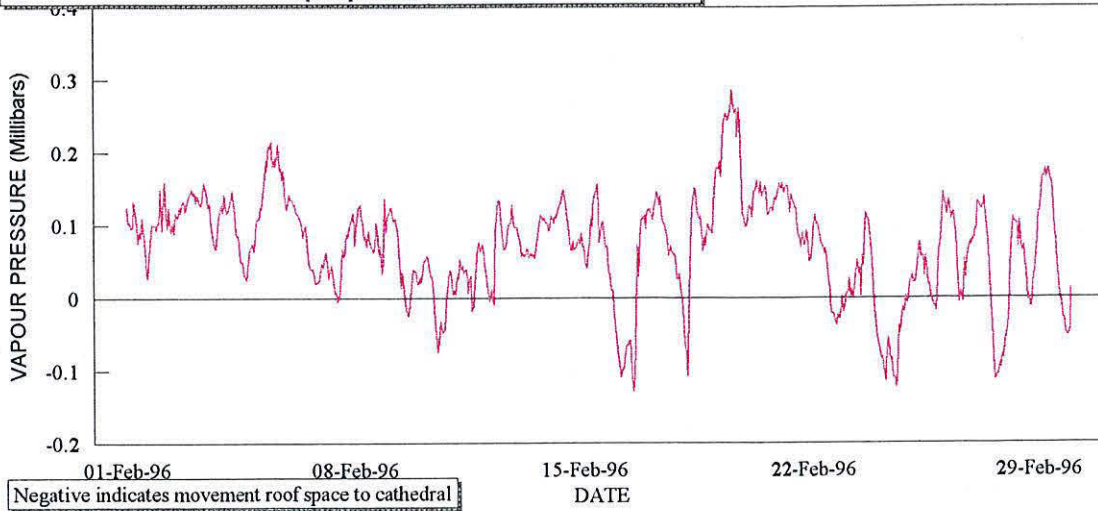
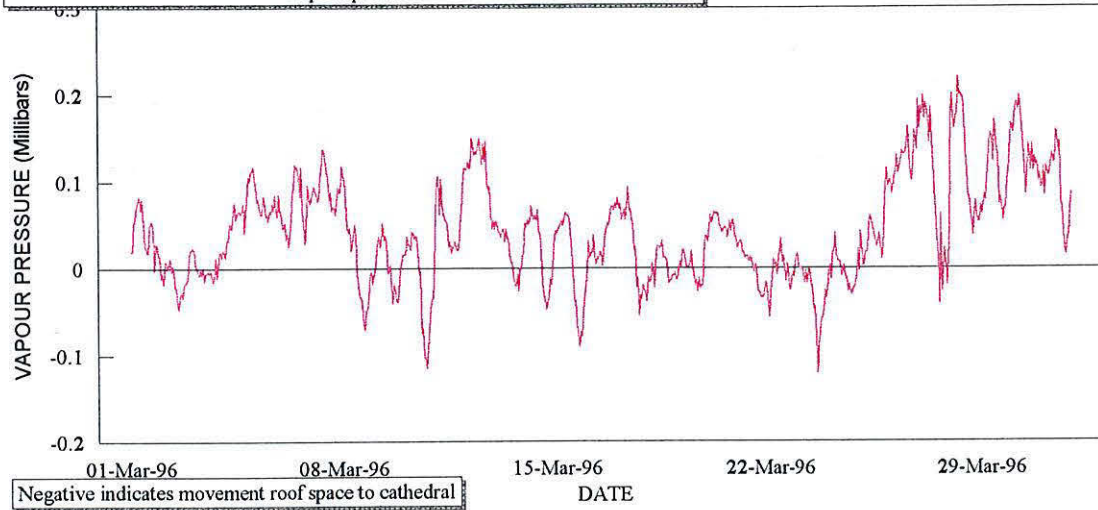
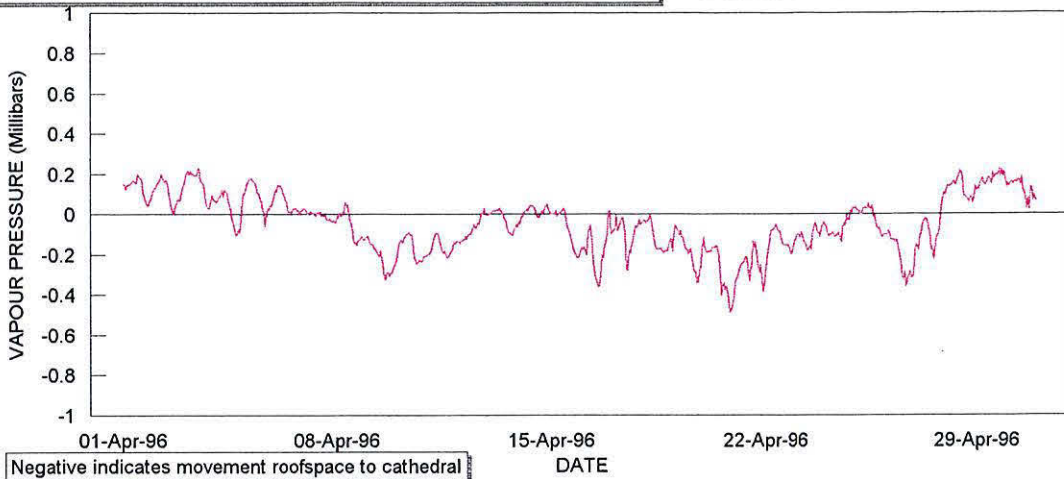
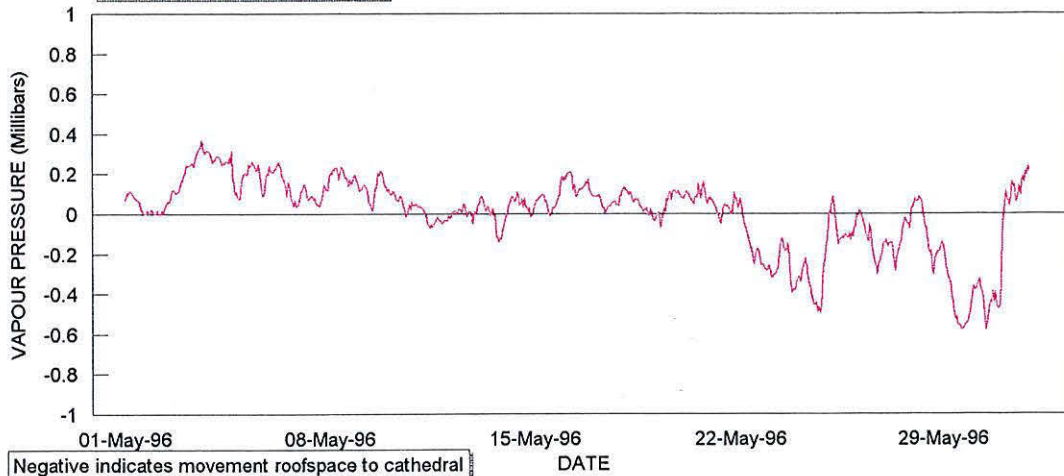
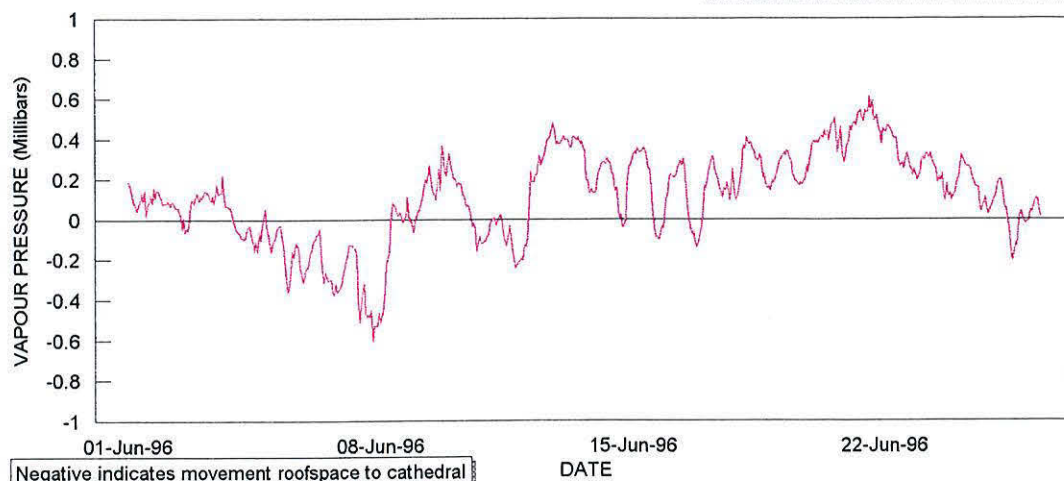
In February moisture movement was predominantly from the cathedral to the roof space, for the remainder of the period moisture moved either way on a fairly even basis.
