Building Record

18 Thames Street, Windsor

On behalf of Byron Hamburgers Ltd

October 2016

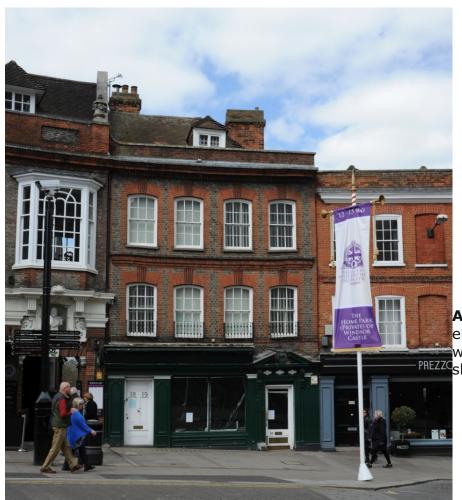
Appendix 3.1: Front elevation to Thames Street with, below, a detail of the PREZZC shop front. W
