A Report prepared for Mr. R. Bailey

HISTORIC BUILDING RECORDING AT DETACHED COACH-HOUSE , THE
OLD RECTORY, CHURCH ROAD, WADDINGHAM, GAINSBOROUGH,
LINCOLNSHIRE (Grade 2 Listed Building)

BBS Report No. : BBS/HBR/RB 1/17.

DETACHED COACH-HOUSE AT THE OLD RECTORY,
CHURCH ROAD, WADDINGHAM, GAINSBOROUGH, LINCOLNSHIRE.

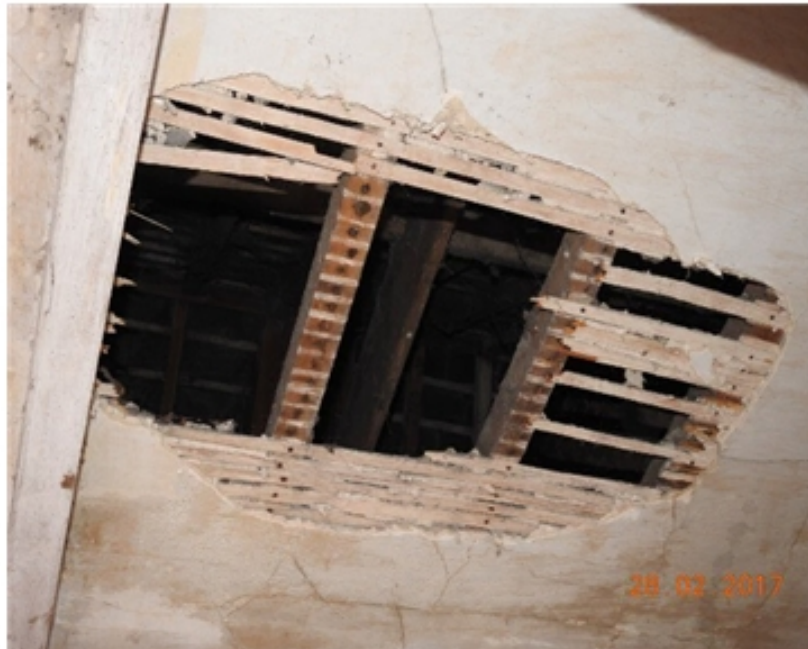
Plate 8 : Inside the Coach House : lath and plaster ceiling near roof beam...28.02.17.

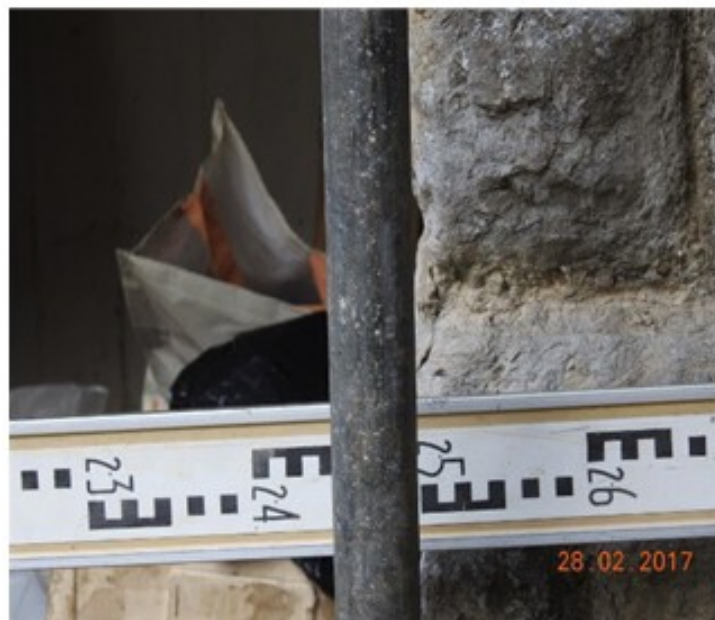
Plate 25 : width on outside of opening at entrance to lobby to Saddlery : 28.02.17.

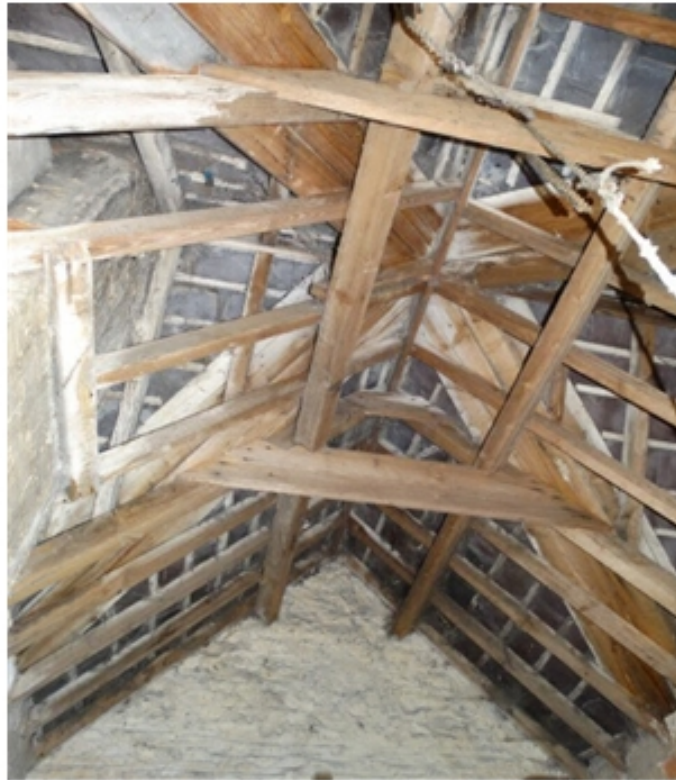
Plate 28 : Inside Hayloft looking north at valley boards at coach house (left) and stable roof (right) abutment : 01.08.16.

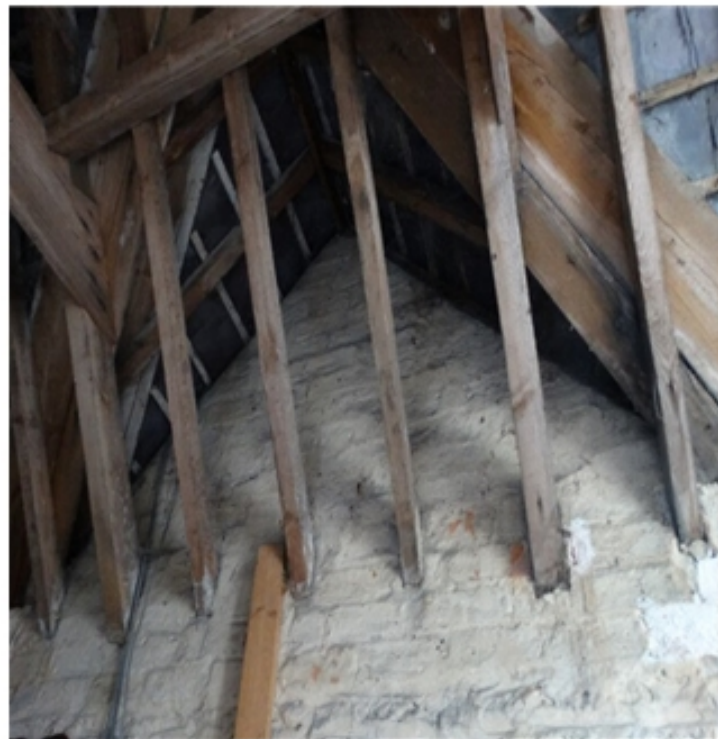
Plate 35 : inside the Hayloft showing the east facing wall roof timbers : 24.08.16.

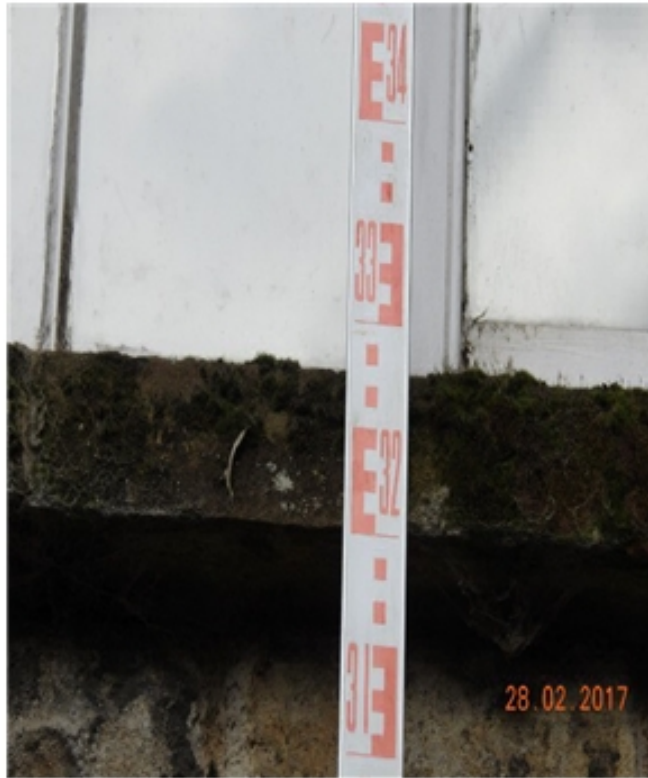
Plate 38 : Outside height of stone cill to Hayloft south facing window : 3.2metres aboveground level...28.02.17.

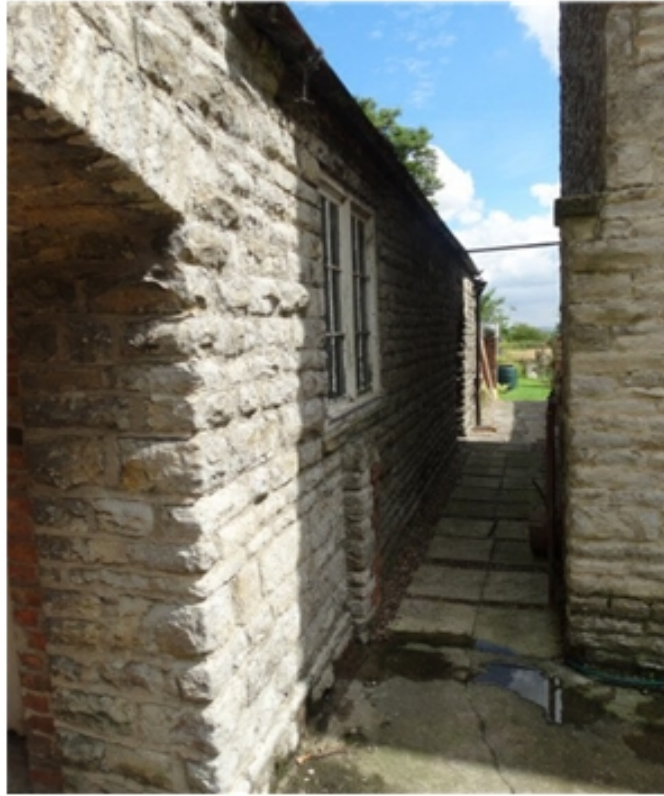
Plate 41 : South side wall of the Stables showing window and path leading to Coalhouse

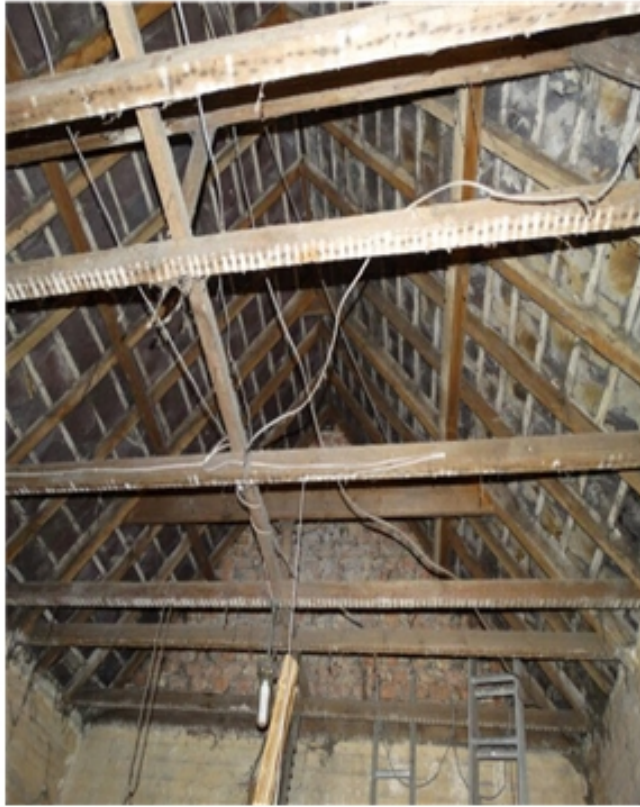
Plate 43 showing the Stables roof timbers looking east towards the Coalhouse :01.08.16.

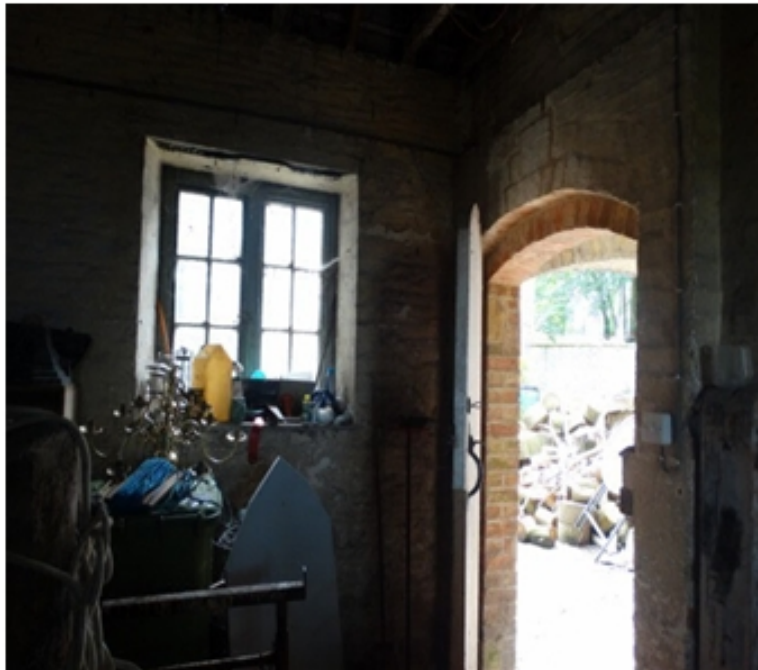
Plate 46 inside the Stables looking south : showing the entrance door and window : 01.08.16.

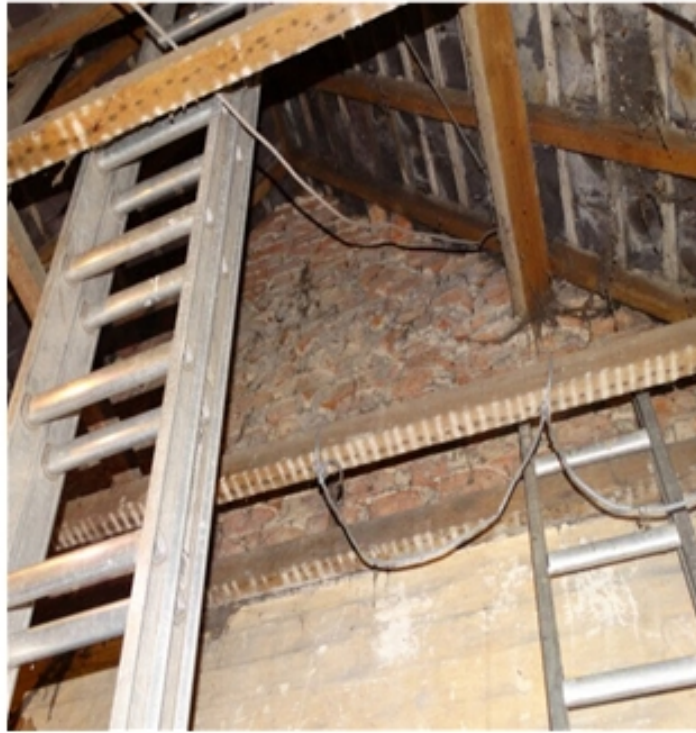
Plate 49 inside the Stables looking at the east division wall with the Coalhouse...24.08.16.

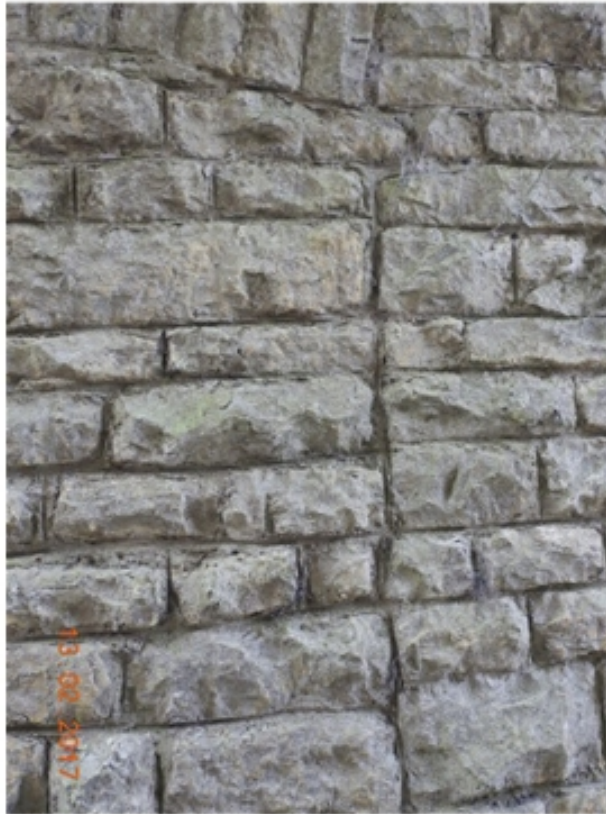
Plate 55 Outside the Stables showing former window opening in south wall...13.02.17.

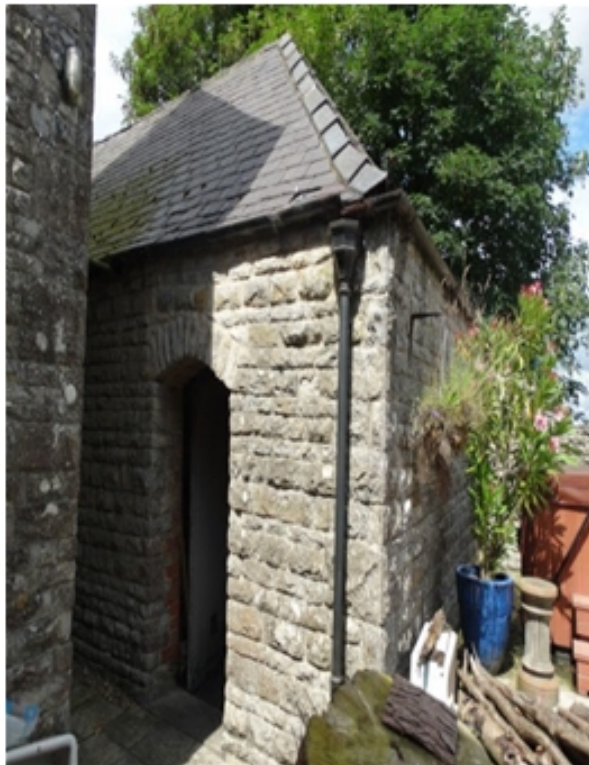
Plate 61 : Entrance to Coalhouse at the south -east corner ...01.08.16.

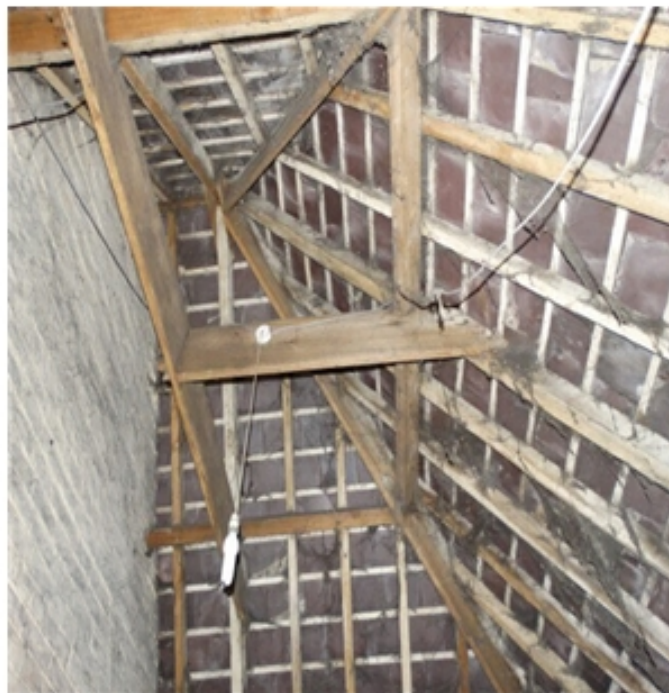
Plate 63 : Inside the Coal House looking at the roof timbers...01.08.16.

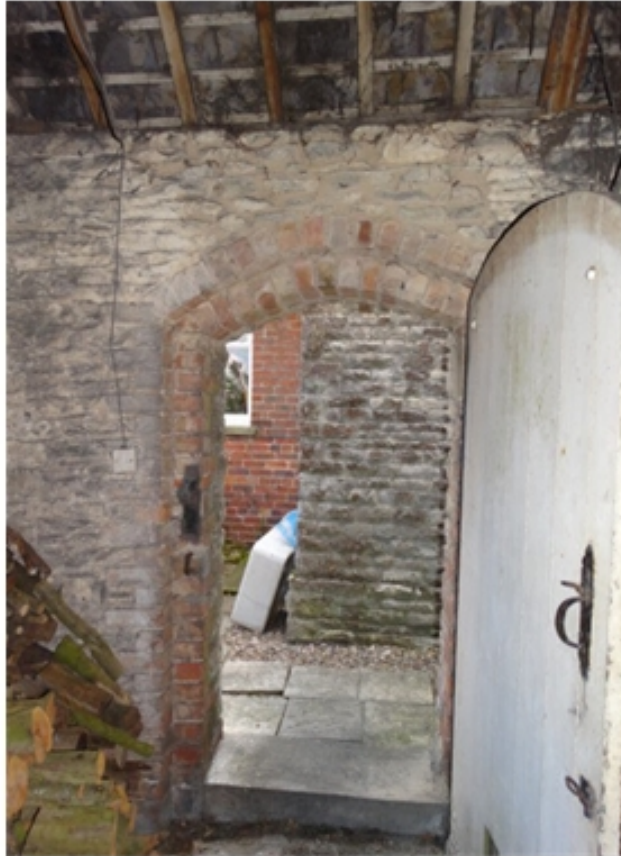
The Coalhouse is accessed by a timber hand door of framed, ledged and braced and boarded construction. There is no ceiling present which may have been removed. There are signs of timber seating in the west facing internal wall. The north facing boundary wall has a small hinged access door at high level framed and boarded and mounted on cast iron crooks and bands. The roof is hipped and pitched at 45 degrees and is well supported with collars and ties and valey boards. The timbers are sawn softwood and in good condition. The entrance door is set in a brick lined reveal with an arched head. The walls are whitewashed. The floor is red brick tiles.

Plate 64 : Inside the Coal House looking south at the entrance door brick rebate...01.08.16.

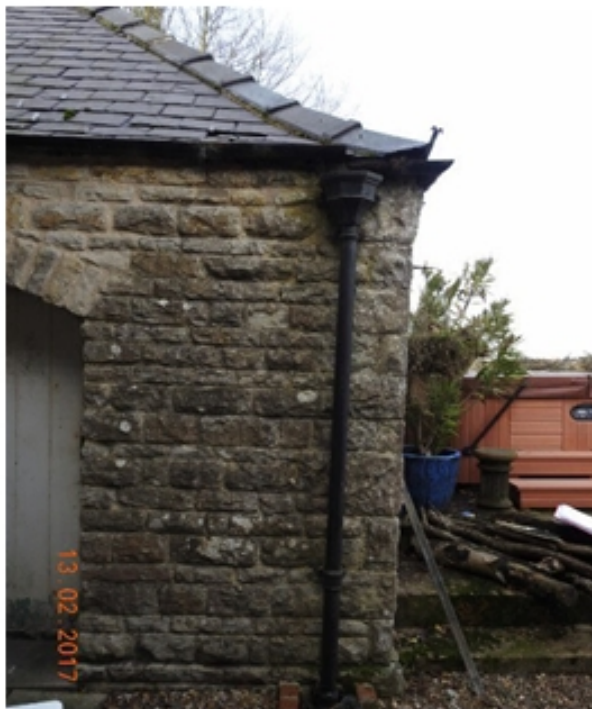
Plate 67 :south east corner of the Coalhouse : cast-iron rainwater downpipe ...13.02.17.

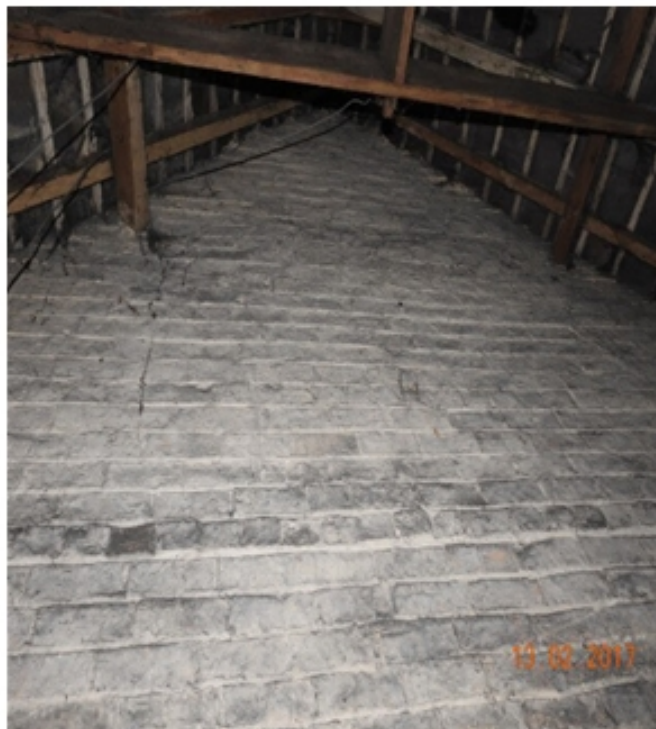
Plate 69 :inside the coalhouse looking at the division wall and roof next to the Stables...13.02.17.
