REPORT: MAPPING AND MONITORING CRACKS IN THE STANDING IGUANODON IN CRYSTAL PALACE  
PARK

India Carpenter

Post Graduate Diploma in Conservation  
Conservation Department 2017

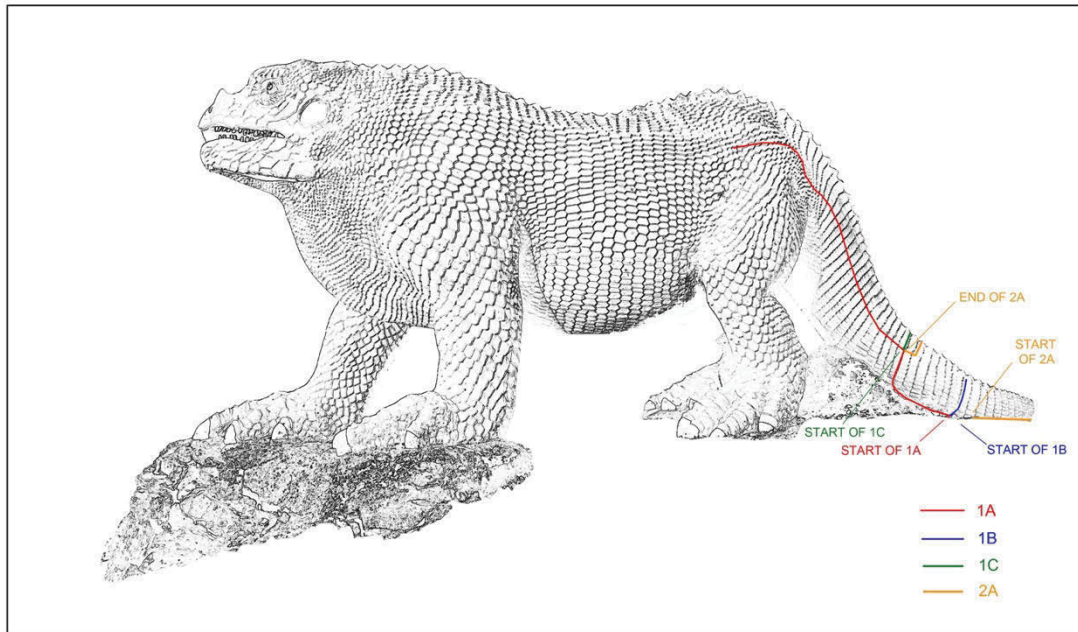
Plate 1. Diagram depicting the location of the cracks 1a,1b,1c and 2a.

- The tail has 2 primary cracks, identified as 1a and 2a. Emanating from these are numerous secondary cracks, identified as 1b,1b1,1b2,1c, 2b,2c,2d.
- Between 14.12.2016 and 10.03.2017, both primary cracks increased *at points* in both width and depth – see graphs/tables 1.0 and 2.0.
- Crack 1a between points 470mm-1000mm and Crack 2a between points 3680-4850mm, indicate a crack created due to shear force, see plate 17. This crack has increased in width and depth between 14.12.2016 and 10.03.2017.
- Between 14.12.2016 and 10.03.2017, Crack 1a has developed a loss at 540mm, with a disassociated fragment measuring 60x25x18mm. See plates 2,3,4.

- Crack 2a, between points 1300mm and 2300mm displays a complete detachment between the tail and the concrete raft on which it sits. See graph 2.0 and plate 17.
- There was no change in the dimensions of the secondary cracks; 1b,1b1,1b2,1c,2b,2c,2d.

Results from the monitoring of the tail cracks between 14.12.2016 and 10.03.2017 indicate a series of cracks formed due to shear stress as the ground beneath the lower section of the tail subsides. This is causing progressive cracking. The crack across the width of the tail has formed in the original concrete, not in the 2015 repair. The 2015 repair treatment included the insertion of a steel dowel (Cliveden 2015). It is likely that the rigidity of the steel dowels is preventing a crack forming at this point and the stress is transferring further up into the tail where the new crack has developed in the original concrete.

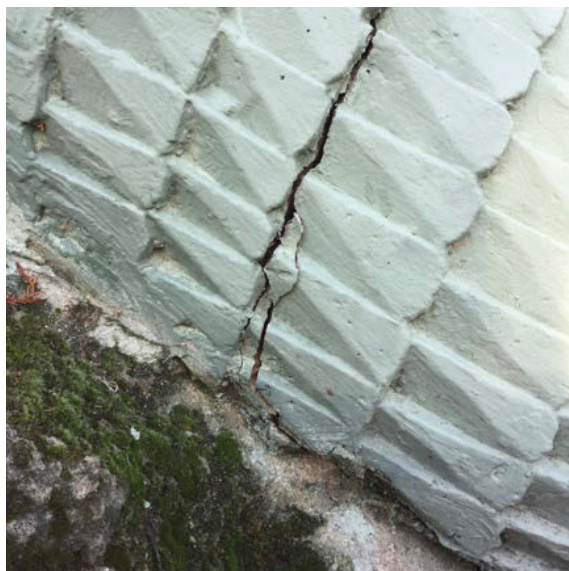
Plate 3. Photographed 14.12.16.

Crack 1A. Detail images depicting the progressive deterioration related to cracking. Numbers refer to the measurement points along the length of the crack in millimetres.

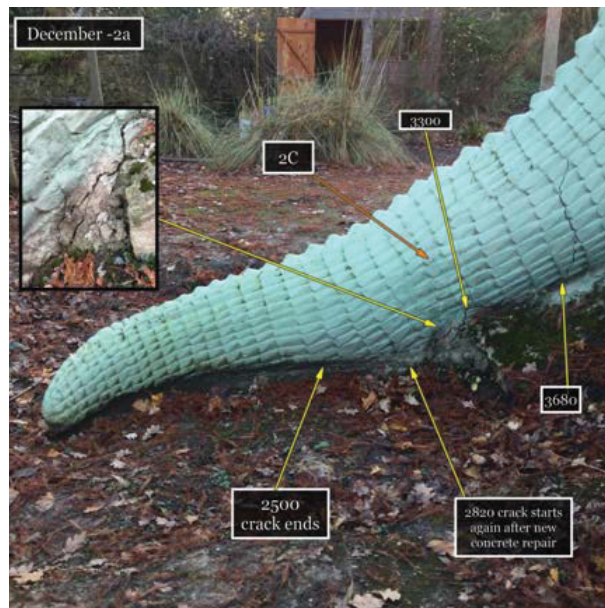
**Plate 11.** Photographed 14.12.16.

**Crack 2A.** Detail images depicting the progressive deterioration related to cracking. Numbers refer to the measurement points along the length of the crack in millimetres.

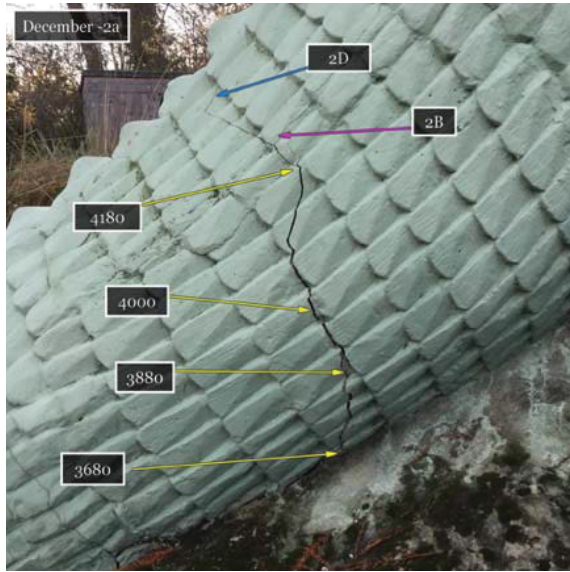
**Plate 14.** Photographed 14.12.16

Crack continues from base and over to the left side of the tail where it meets crack 1a. Crack 2a has formed in the original concrete, not in a historical repair.

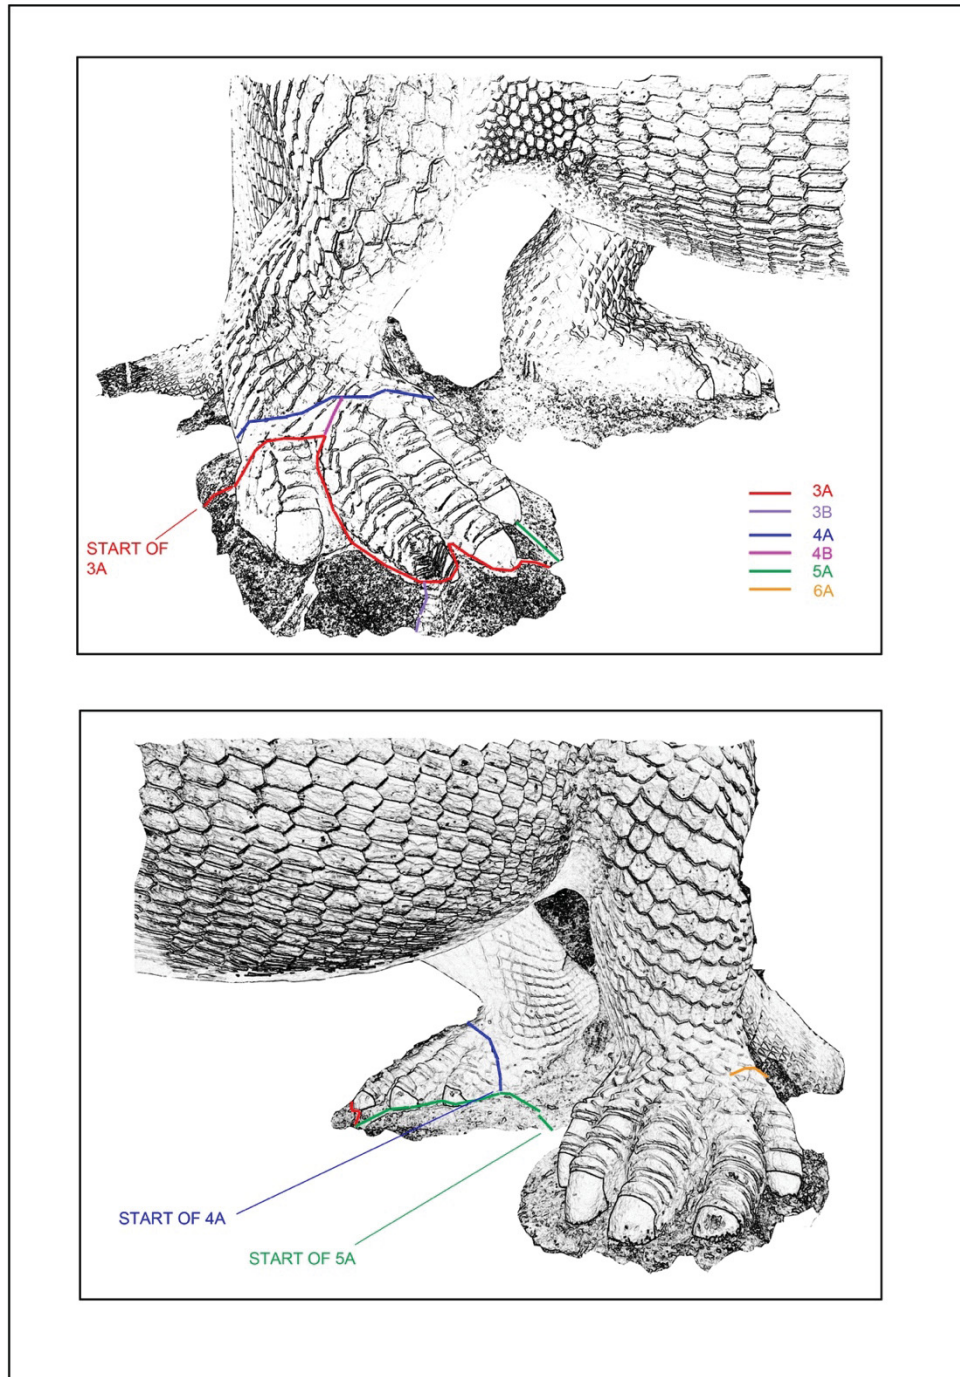
Plates 18 and 19. Diagrams depicting the location of the cracks.

- The back right foot has three primary cracks, identified as 3a,4a and 5a. Cracks 3a and 4a both start in the concrete base and extend over the foot, both cracks have secondary cracks, identified as 3b and 4b.

- Crack 5a does not extend into the foot and is limited to the concrete base, following the site of a repair made in 2015.
- Between 15.12.2016 and 15.03.2017, primary cracks 3a,4a,5a have increased *at points* in both width and depth – see graphs/tables 3.0, 4.0 and 5.0.

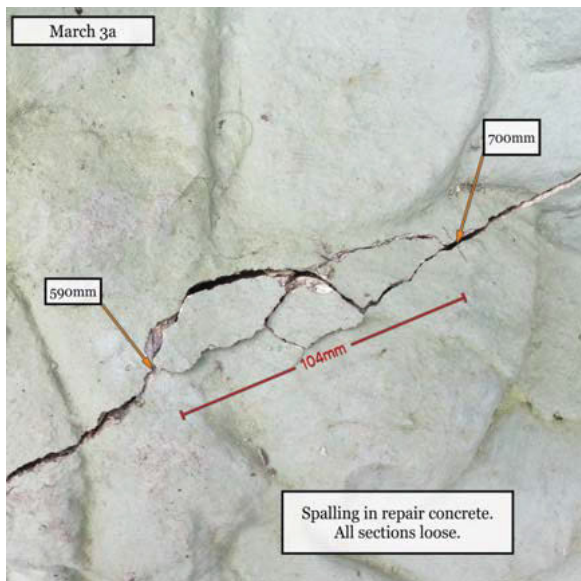
**Plate 22.**

**Plates 22-25-** photographed 15.03.17. Details of cracking and spalling in the concrete, including visible losses and detached fragments since 15.12.16.

- Crack 3a, between points 590-1100mm, displays an almost continuous length of spalling concrete, with numerous losses and disassociated fragments. Losses at points 950mm and 1050mm have occurred between 15.12.16 and 15.03.17. See plates 20-25.

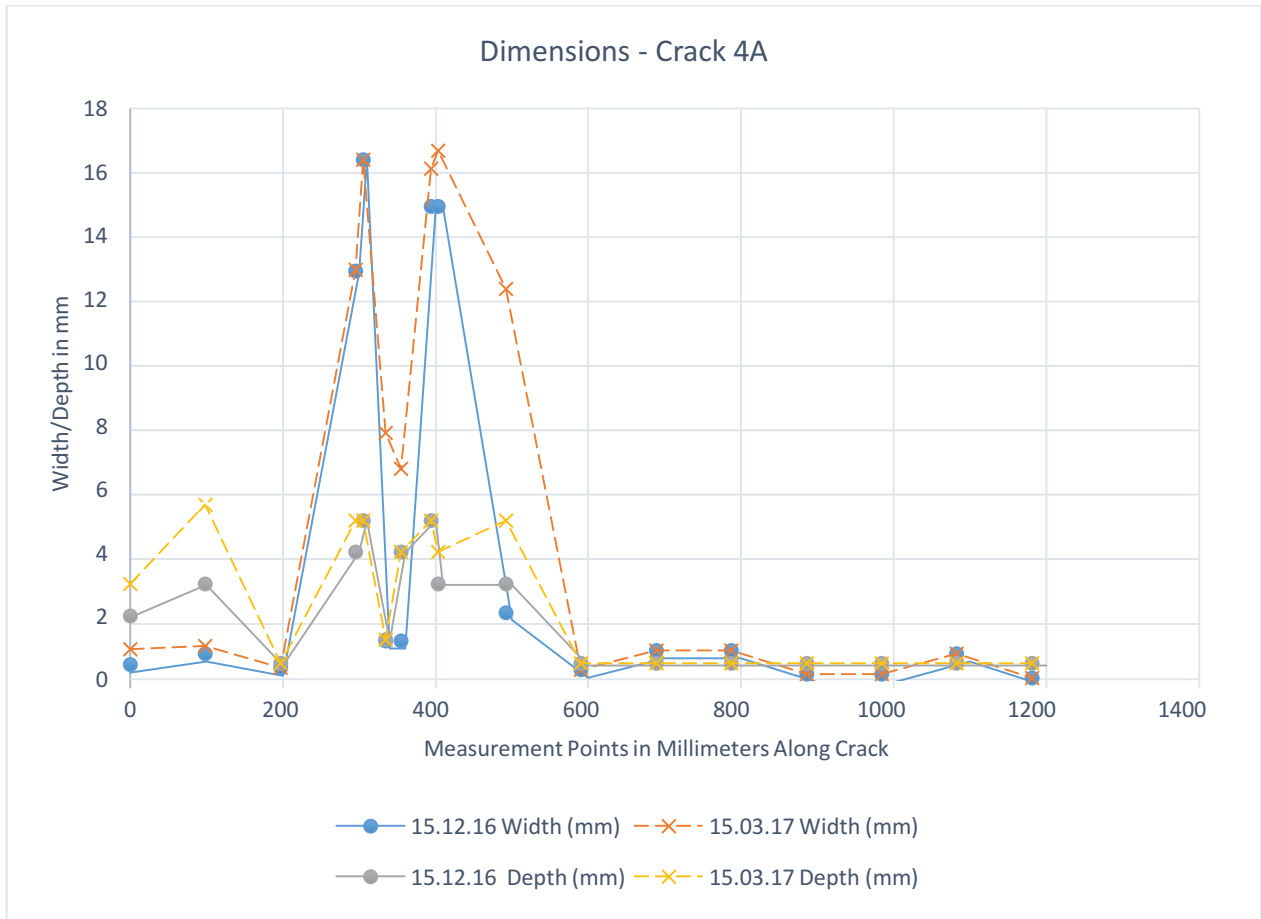
Graph 4.0

- Crack 4a follows the site of a 2015 repair. Point 290-510mm along the crack displays delaminating repair concrete, with total disassociation of fragments occurring between 15.12.16 and 15.03.17. See plates 26,27,28.

Results from the monitoring of the back left and right feet between 15.12.16 and 15.03.17 indicate a series of cracks, forming and increasing in width and depth at points, along the top of the back right foot and in the concrete base of the foot. These cracks are occurring at the sites of the previous 2015 repairs, indicating that these are progressive cracks caused by ground subsidence. The back right leg, formed around a 9ft (274cm) cast iron pipe which extends down into the ground, shows no evidence of cracking. Cracking appears at the point of stress where the apparently hollow foot meets the ridged leg. The back left leg displays only one short hairline crack, which has not increased dimensions between the two dates, suggesting that the ground is more stable on the left hand side of the dinosaur and subsiding on the right hand side. The numerous losses along crack 4a are the result of delaminating concrete applied during the 2015 restoration. The concrete has not adhered sufficiently to the concrete substrate and further delamination is developing.

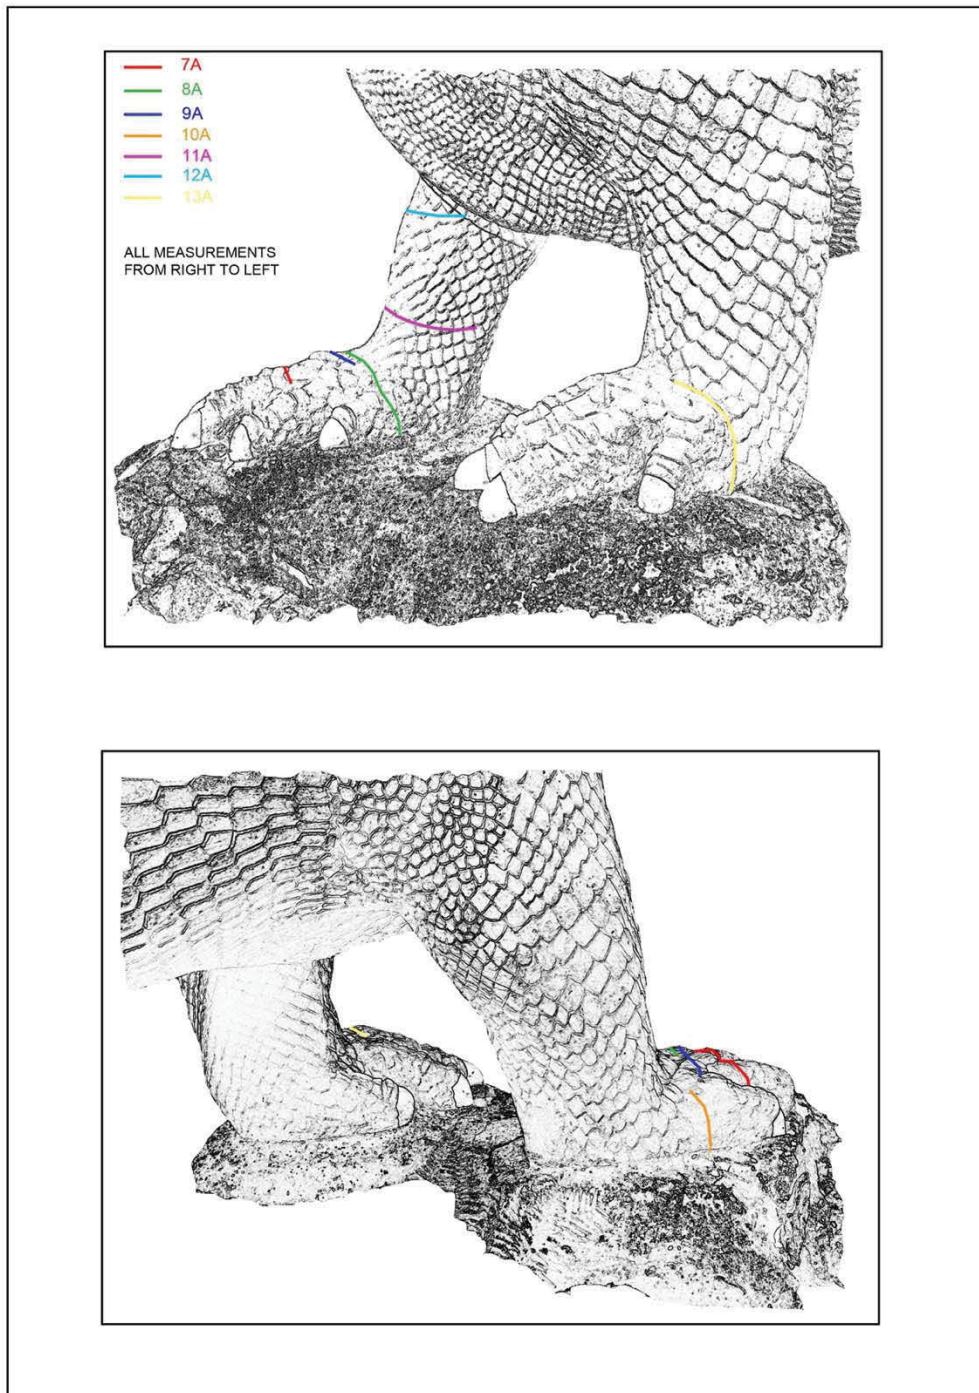
Plates 30 and 31. Diagrams depicting the location of the cracks.

- The front right foot has six hairline cracks, identified as 7a,8a,9a,10a,11a and 12a. There are no secondary cracks.
- The front left foot has one hairline crack, identified as 13a and no secondary cracks.
- Between 15.12.2016 and 15.03.2017 crack 7a increased in width and depth between points 400mm-600mm. This increase is due to a loss in the paint layers, along the site of a 2015 crack restoration. See plate 35 and graph 7.0.
- Cracks 8a-13a have seen no increase in dimensions between 15.12.2016 and 15.03.2017.

Results from the monitoring of the front right and left feet between 15.12.16 and 15.03.17 indicate a series of hairline cracks. These cracks have formed since the 2015 restoration (Cliveden, 2015.) Crack 7a is the only crack to have increased in dimensions between 15.12.16 and 15.03.17. This increase is due to a loss in the paint layer, not due to increased cracking in the concrete. The delamination of the paint is possibly due to water ingress, facilitated by the hairline crack. All the cracks appear to be on the sites of previous restorations.

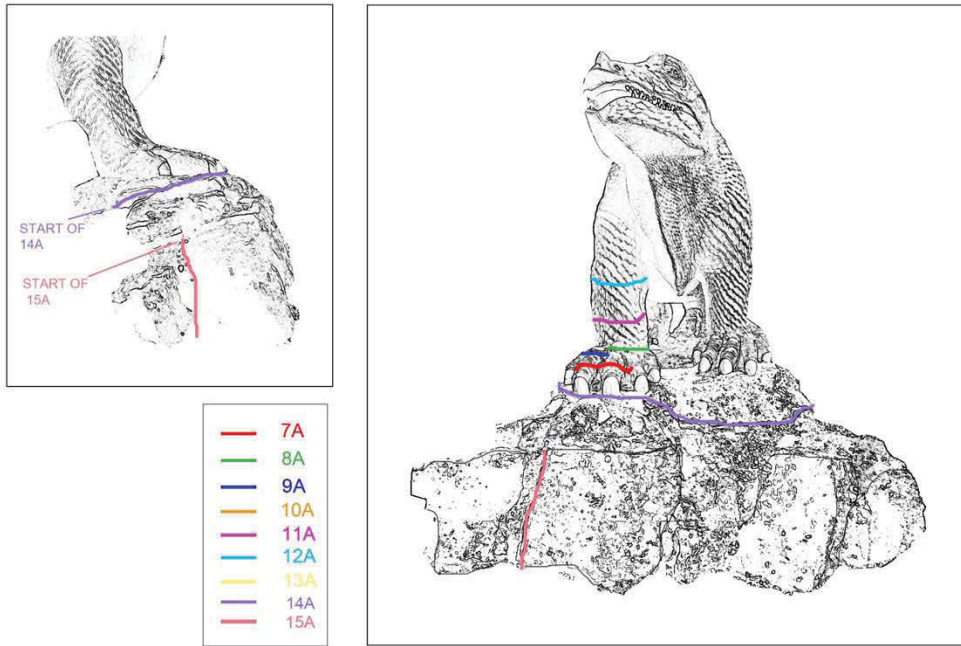
Plates 36 and 37. Diagrams depicting the location of the cracks 14a and 15a.

- The front plinth displays an extensive network of cracks. The two most prominent cracks were identified for monitoring, one horizontal 14a and one vertical 15a. See plates 36 and 37 for location.
- Crack 14a runs horizontally, through the site of previous concrete repairs, many of which are undocumented restorations.

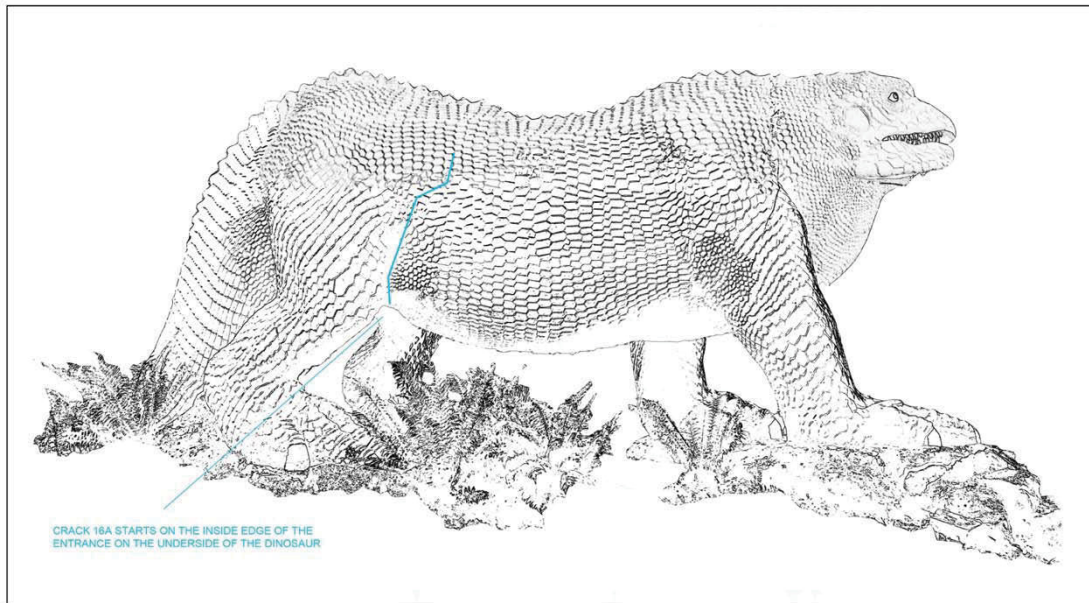
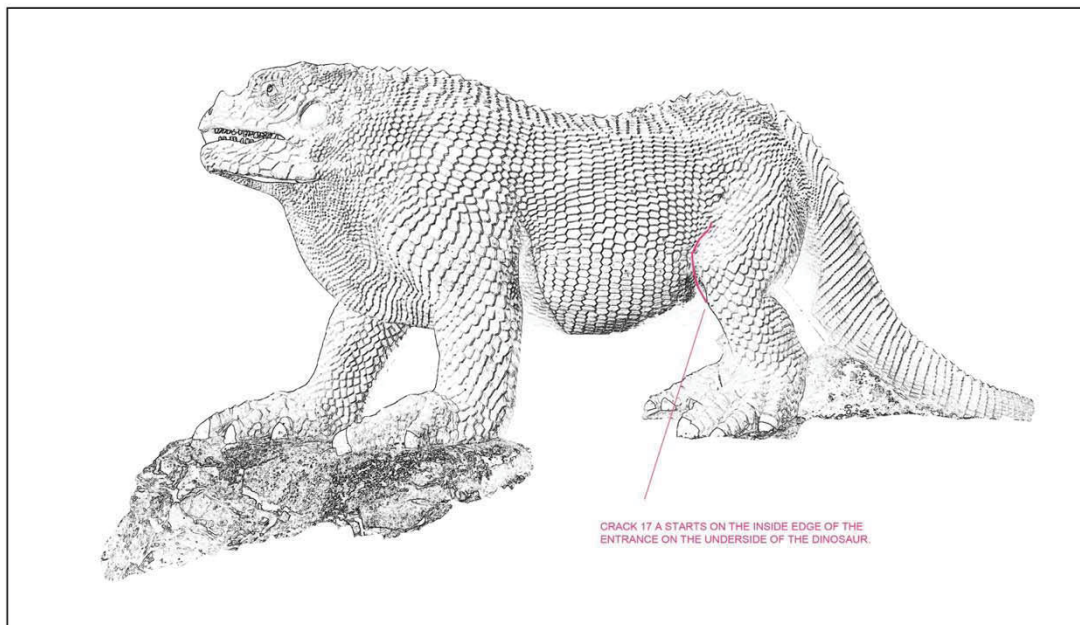
Plates 46 and 47. Diagrams depicting the location of the cracks 16a and 17a

- The body has two primary cracks, identified as 16a and 17a. See plates 46 and 47.
- Both cracks start on the inside edge of the entrance to the dinosaur (on its underside), 16a on the right and 17a opposite on the left. The location of the cracks is fairly symmetrical. See plates 48 and 50.
- Both crack's widest and deepest points are on the underside of the dinosaur, emanating from the entrance. Both cracks then taper to a hairline from point 500/600mm onwards.
- Crack 16a increased in both width and depth between points 200mm-600mm between the dates 15.12.16 and 15.03.17. See graph 16.0.
- Crack 17a increased in both width and depth between points 100mm-500mm between the dates 15.12.16 and 15.03.17. See graph 17.0.
- Neither crack increased in length between 15.12.16 and 15.03.17.

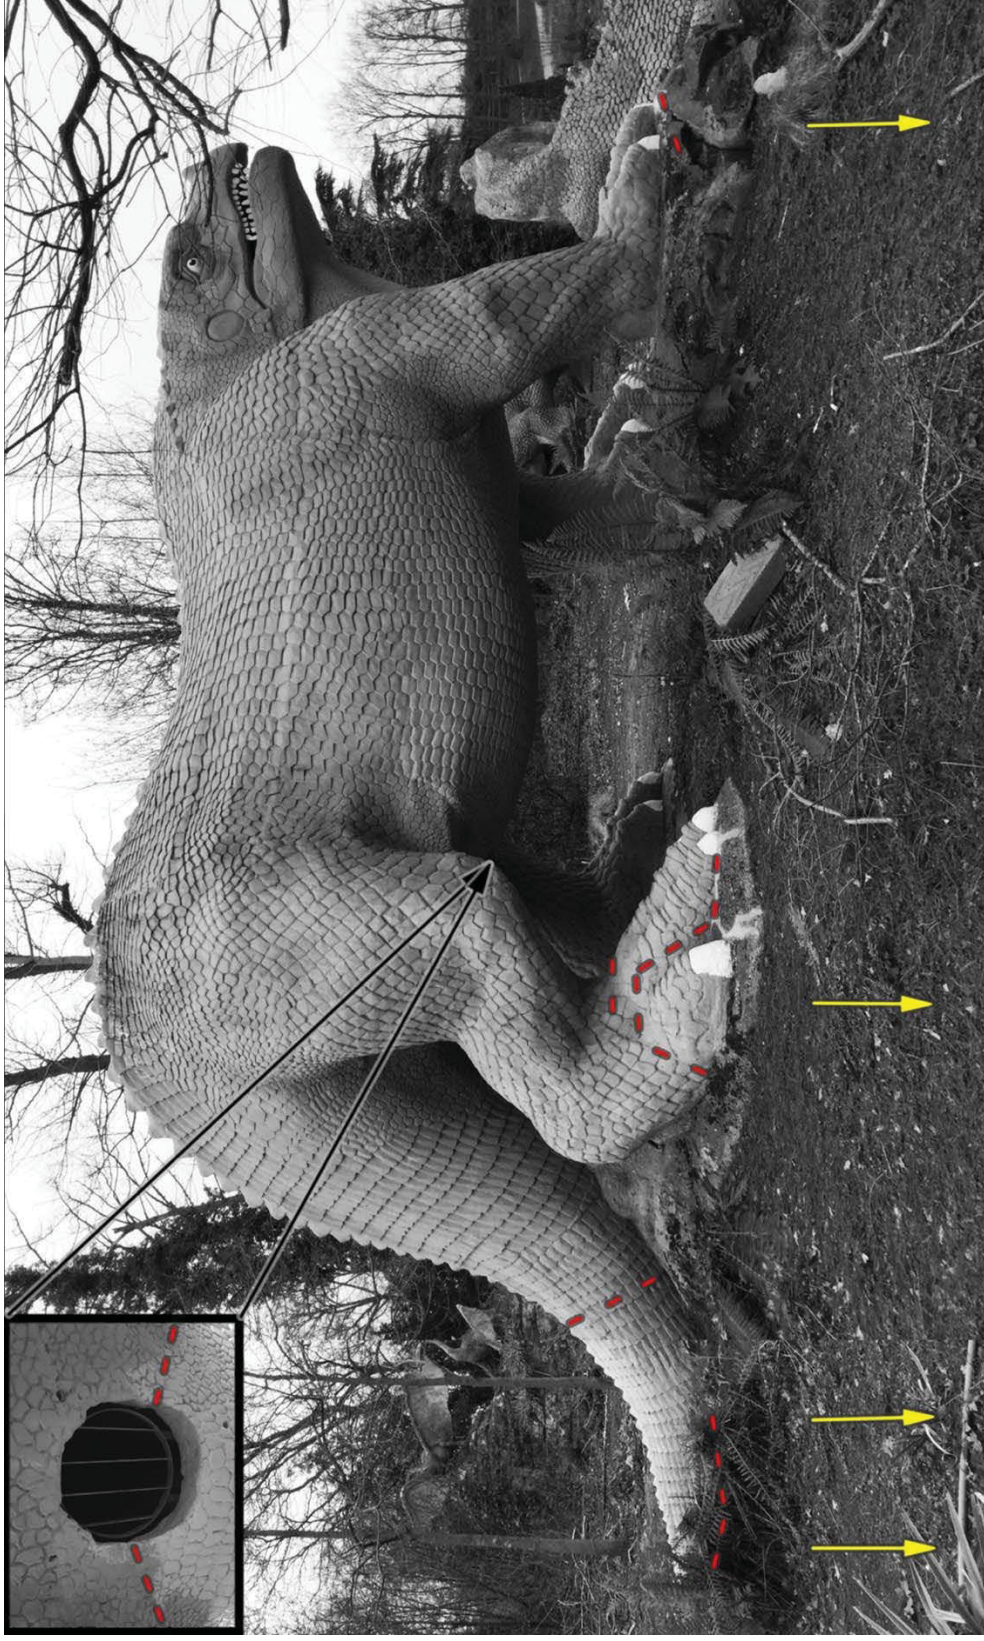
Plate 53.

**Red dotted lines** - Cracks that have developed since the 2015 restoration and have *further increased* in width and depth between 15.12.16 and 15.03.17.

The identification of cracks formed after the 2015 restoration reveals that the Iguanodon is subject to progressive cracking. Over the three-month monitoring period, many of the cracks saw an increase in dimensions and have subsequently incurred losses, both to original concrete, restoration concrete and restoration paint layers. Such deterioration *may* have been exacerbated by water ingress over the Winter period. The position and location of the cracks, the vast majority starting from a point at the ground, to the proper right and at the site of previous restorations, clearly indicate that the cracks are a result of the ground subsiding to the right and tail end of the Iguanodon (see plate 53).

Results show that without stabilisation of the ground to the right, tail end and front plinth, further ground subsidence and further structural deterioration of the Standing Iguanodon is most certainty inevitable.
