### A DEVELOPMENT OF A NEW METHODOLOGY FOR MAPPING AND MONITORING THE CONDITION OF 3DIMENSIONAL CULTURAL HERITAGE.

CASE STUDY: The Standing Iguanodon in Crystal Palace Park. Using Photogrammetry and 3D Digitalisation to Record Condition and to Map and Monitor Deterioration. Engaging Open Access as a Means of Digital Preservation and Project Outreach.

India Carpenter

Final Year Research Paper  
PG Diploma in Conservation  
Conservation Department 2017

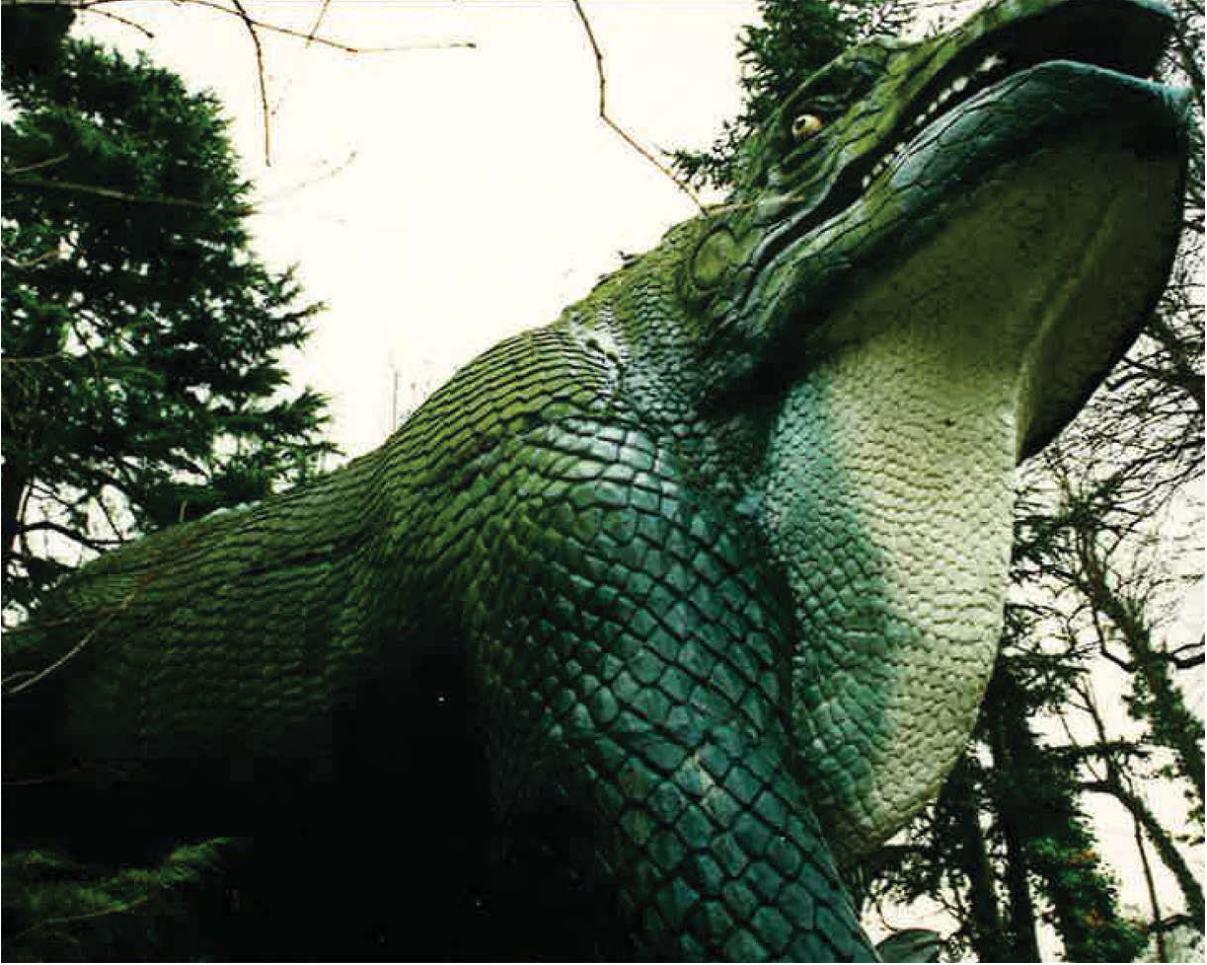
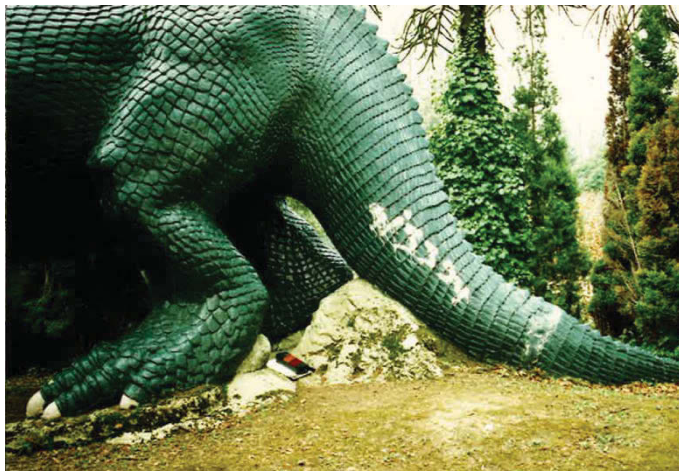
Plates 7 and 8. The Standing Iguanodon in the late 1990's. Note the green gloss paint and graffiti<sup>9</sup>

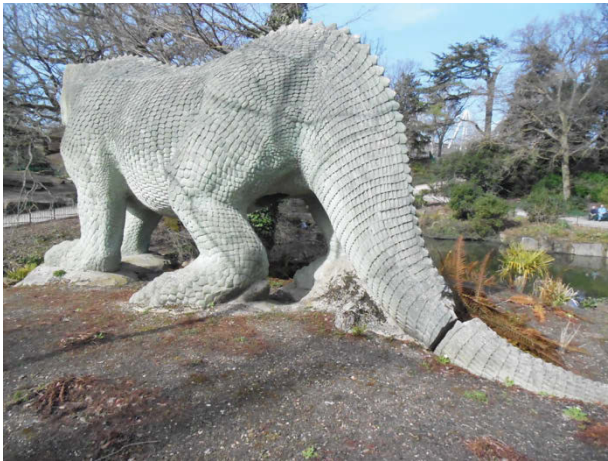
**Plate 10.** Iguanodon pre 2015 restoration<sup>11</sup>.

By 2015 cracks in the Standing Iguanodon had reopened (up to 100mm in width), the front feet were severely cracked, the tail had completely detached and the surface displayed extensive paint loss and biological growth (Cliveden, 2016). See plate 10. After campaigning and fundraising, the most iconic of the dinosaurs, the Standing Iguanodon was

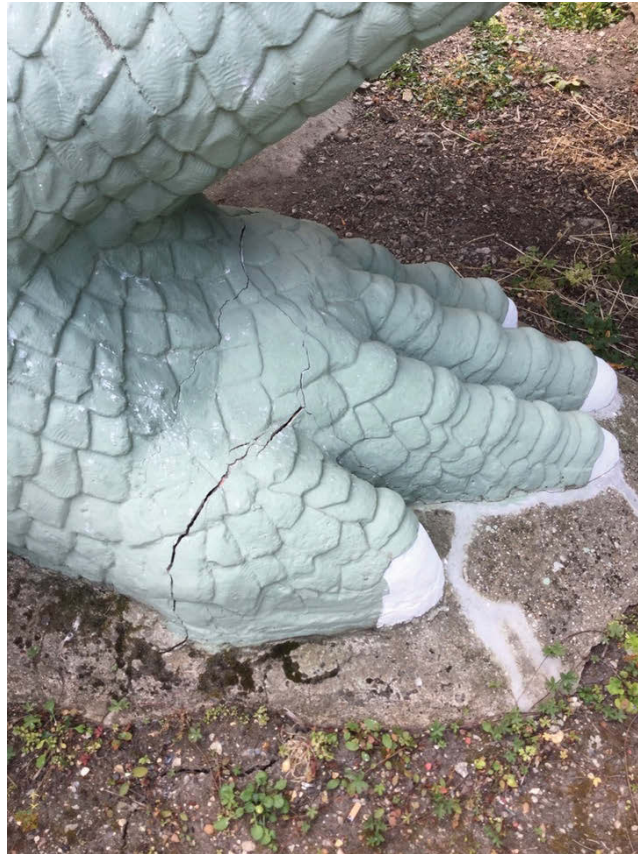
selected for re-treatment; the painted surface was cleaned, micro piles were inserted beneath the tail, cracks were again filled, losses remodelled, teeth were replaced and another paint scheme was applied. The treatment was completed in January 2016, however, by May 2016 cracks were, once again opening up along the sites of the new repairs. By August 2016 many of the cracks had reopened, up to 5mm in width, and sections of the surface were spalling. See plate 11.

**Plate 11.** Back right foot of Standing Iguanodon Summer 2016.  
Cracks reopening<sup>12</sup>.

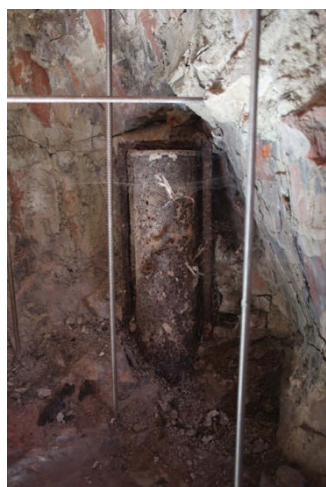
**Plate 17.** Cast Iron pipe, running through each leg<sup>14</sup>.

each of the legs are 4 cast iron pipes, see plate 16. The interior is intersected by lengths of 12-15mm stainless steel studding, inserted during both 20<sup>th</sup> century restorations, presumably to structurally support the work. Numerous stainless steel wire ‘staples’ have been affixed on either side of filled cracks and adhered with resin. Patches of stainless steel mesh have been used to bridge large gaps before being filled with concrete, these are 2015 additions.

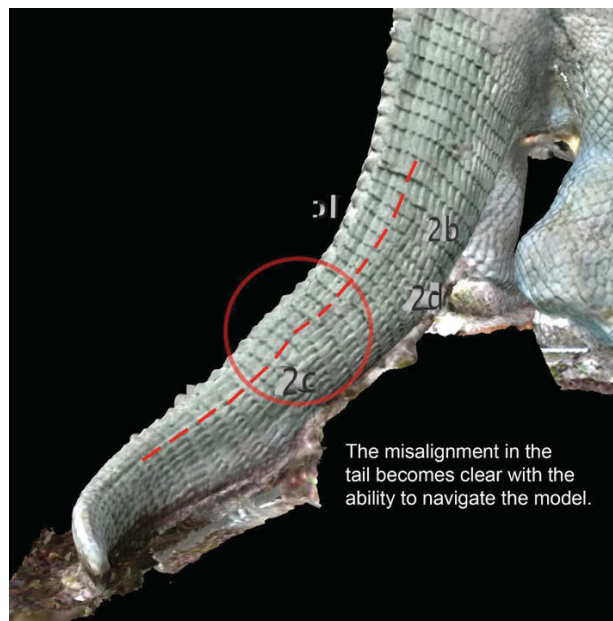
Plate 37 – Distortion of the tail revealed with the ability to navigate the tail and observe from numerous angles<sup>36</sup>.

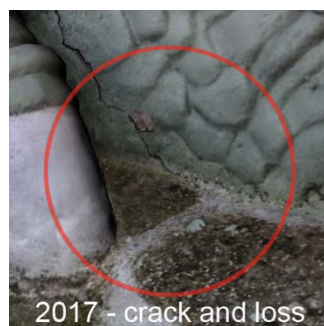
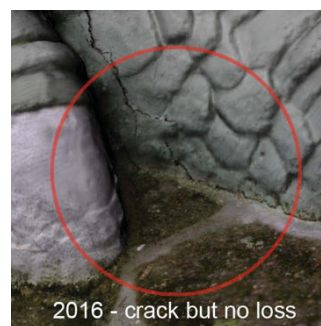
**Plates 37,38,39** –Images of the digital model comparing data from 2016 and 2017, red circles identifying concrete loss.<sup>37</sup>

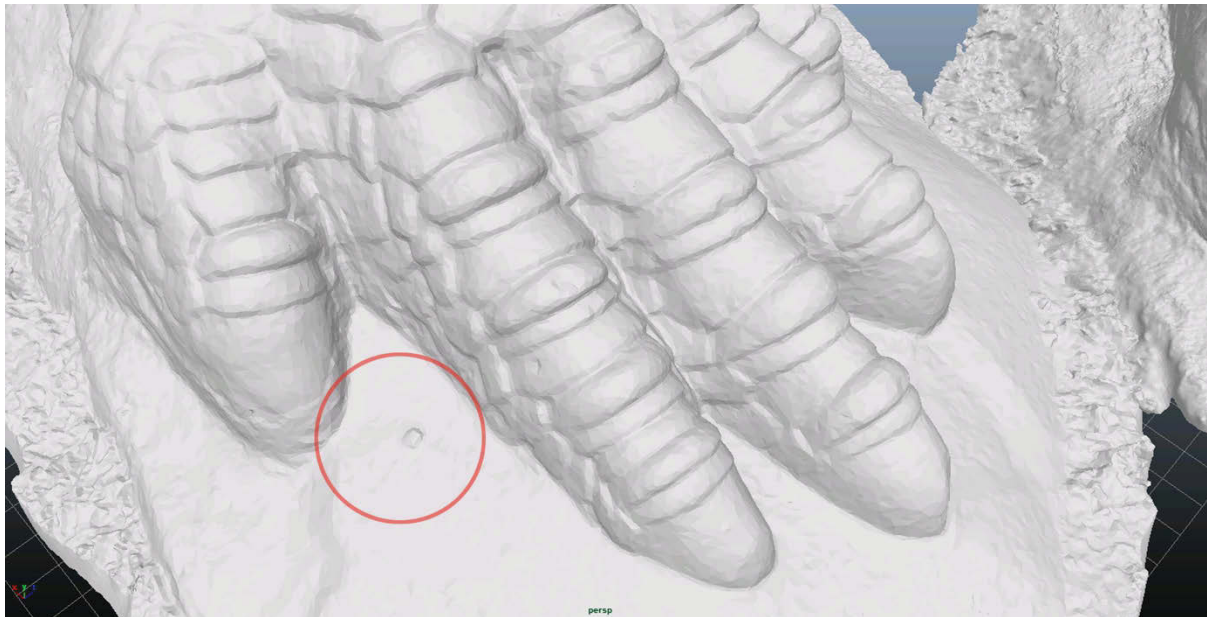
Experimenting with the view settings of the model can facilitate in identifying areas of loss. In plate 44, by eliminating colour, the surface relief is emphasised. This area of surface loss becomes clearly identifiable.

Plate 44 – Loss highlighted by change in view settings<sup>42</sup>.

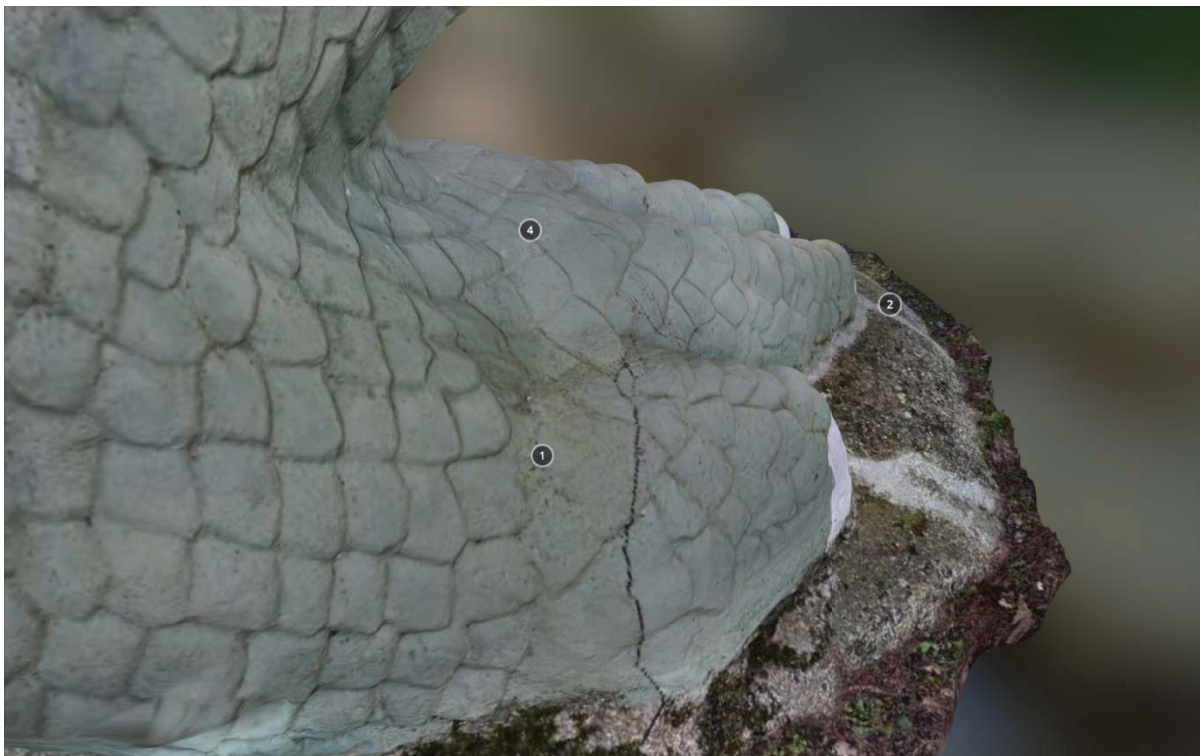
**Plate 49** – Screen capture of the back-right leg (detail of crack 3A) Sketchfab model<sup>47</sup>

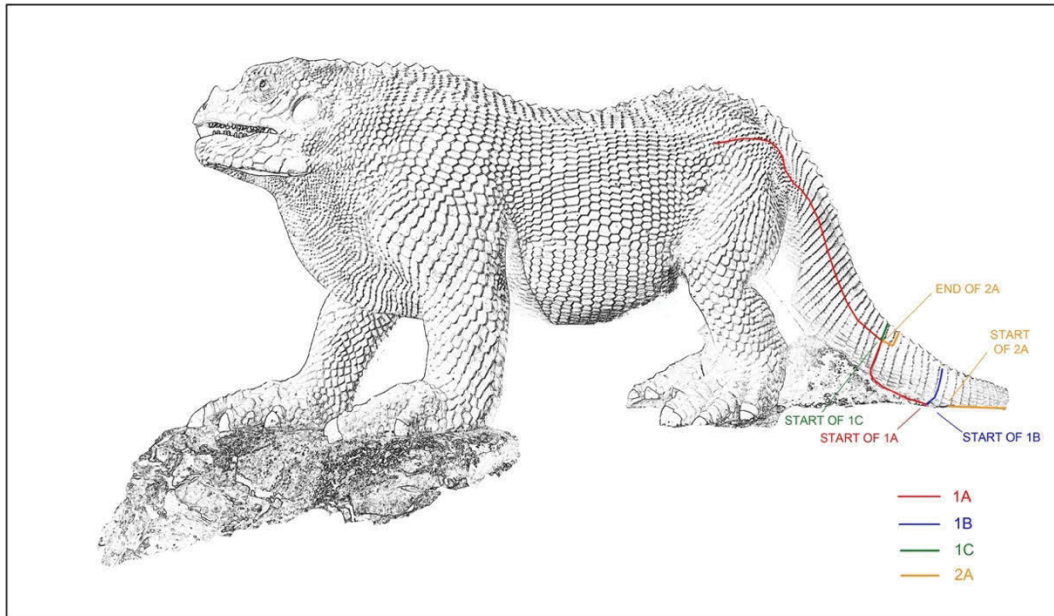
**Plate 54-** Diagram depicting the location of the cracks 1a,1b,1c.

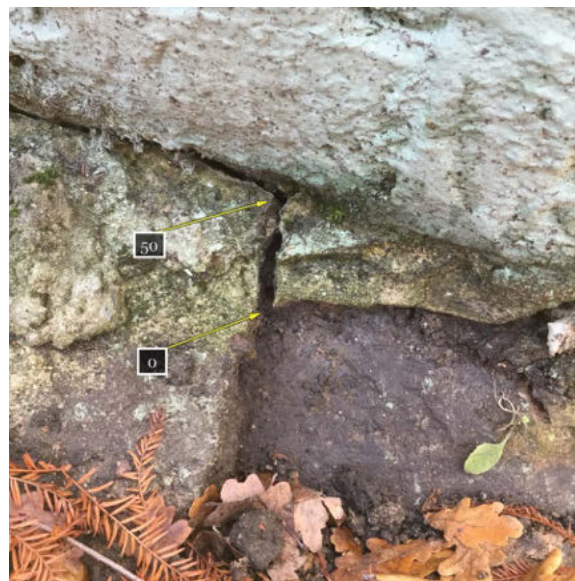
Crack 1A. Detail images depicting the progressive deterioration related to cracking. Numbers refer to the measurement points along the length of the crack in millimetres.

**Plate 55-** Photographed 14.12.16 – 0 identifies the origin and the first measurement point of 1A<sup>51</sup>.

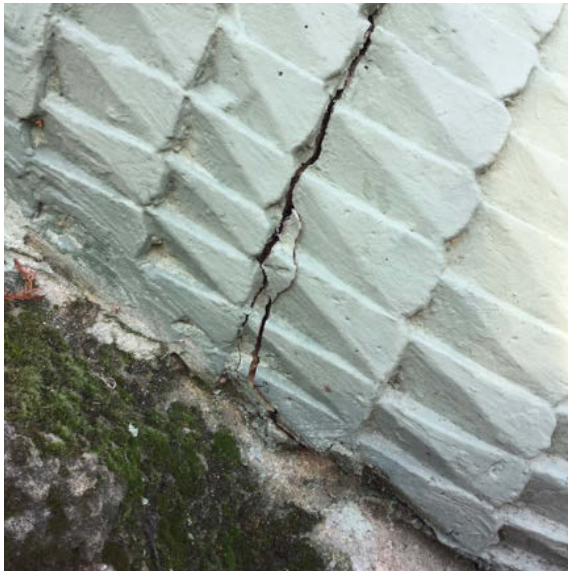
Plate 56-. Photographed 14.12.16<sup>52</sup>  
total

- The tail has 2 primary cracks, identified as 1a and 2a. Emanating from these are numerous secondary cracks, identified as 1b,1b1,1b2,1c, 2b,2c,2d.
- Between 14.12.2016 and 10.03.2017, both primary cracks increased *at points* in both width and depth – see graphs/tables 1.0 and 2.0.
- Crack 1a between points 470mm-1000mm and Crack 2a between points 3680-4850mm, indicate a crack created due to shear force, see plate 65. This crack has increased in width and depth between 14.12.2016 and 10.03.2017.
- Between 14.12.2016 and 10.03.2017, Crack 1a has developed a loss at 540mm, with a disassociated fragment measuring 60x25x18mm. See plates 56,57.

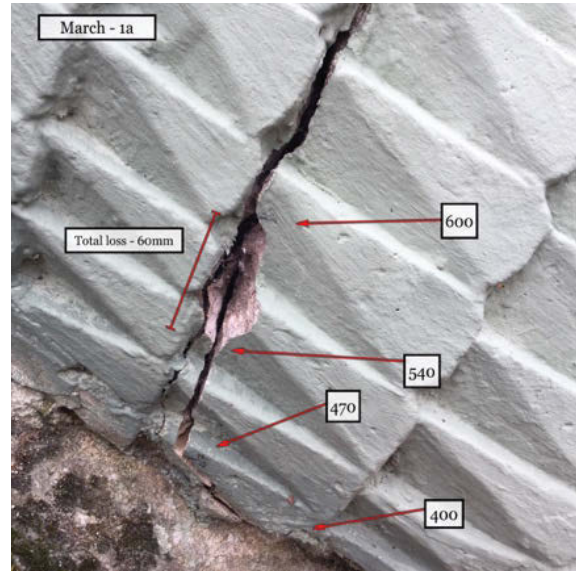
Plate 57-. Photographed 10.03.17 – Indicating  
loss to crack 1A<sup>53</sup>

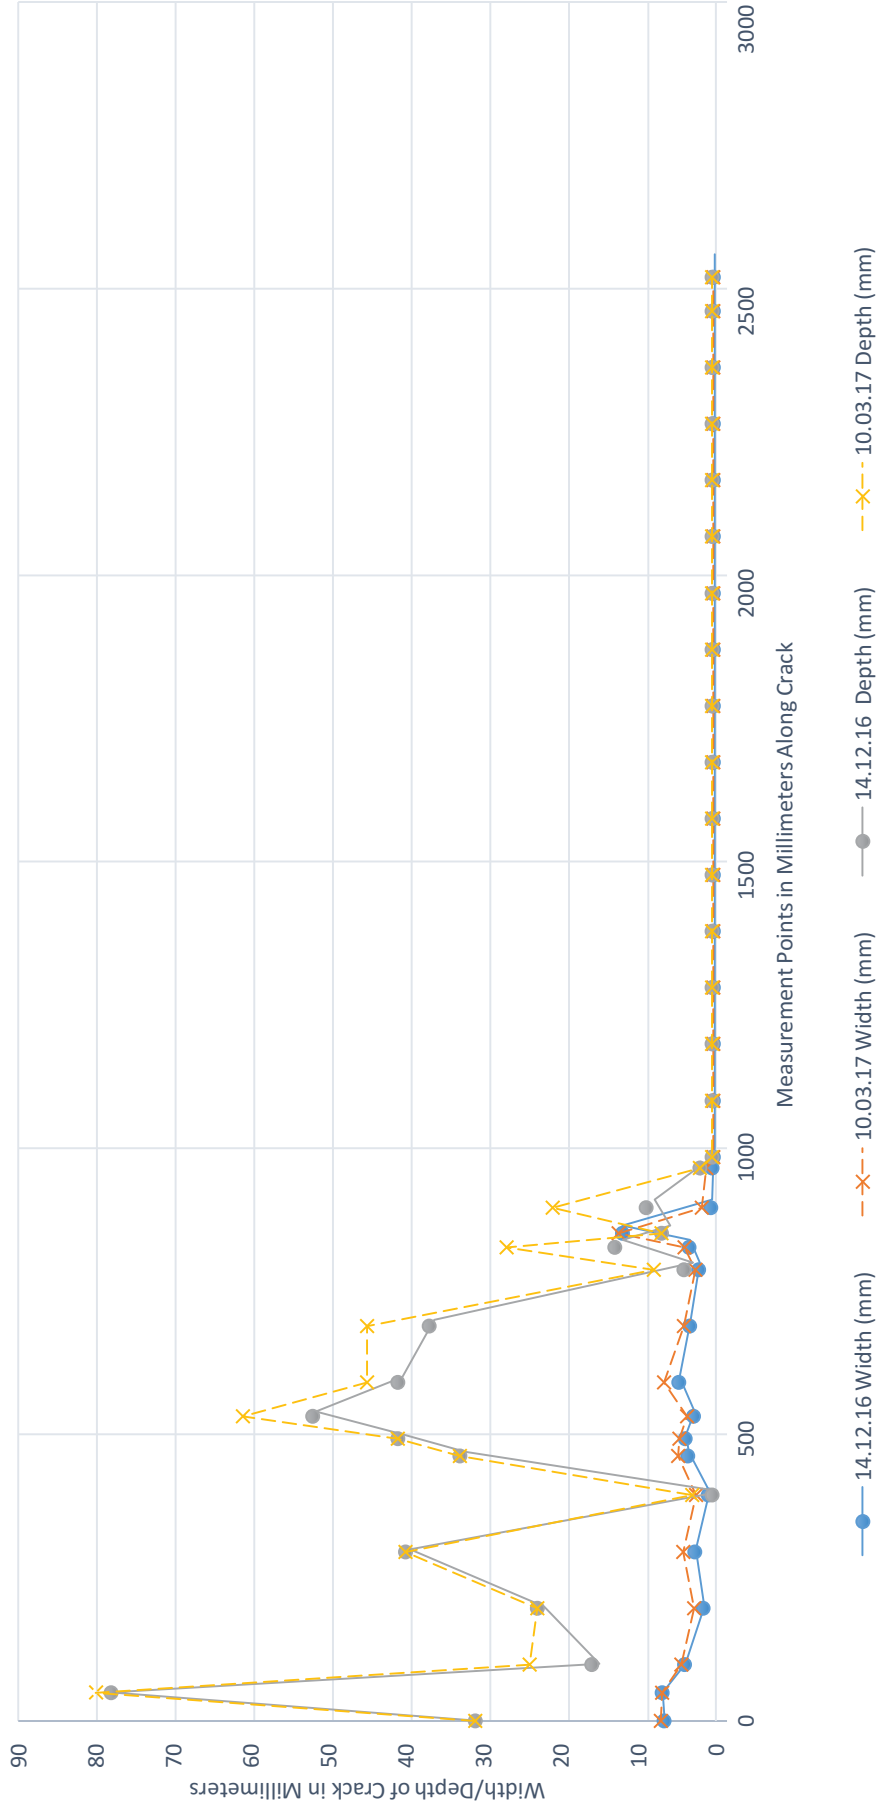
Graph 1.0

Measurement Points Along Crack (mm)	14.12.16 Width (mm)	10.03.17 Width (mm)	△ Width (mm)	14.12.16 Depth (mm)	10.03.17 Depth (mm)	△ Depth (mm)
0	6.67	7.05	0.38	31	31	0
50	6.9	6.91	0.01	78	80	2
100	4	4.4	0.4	16	24	8
200	1.6	2.79	1.19	23	23	0
300	2.7	4.15	1.45	40	40	0
400	1	2.5	1.5	0.5	3	2.5
470	3.6	4.86	1.26	33	33	0
500	3.94	4.68	0.74	41	41	0
540	2.83	3.69	0.86	52	61	9
600	4.79	6.68	1.89	41	45	4
700	3.36	4.12	0.76	37	45	8
800	2.17	2.6	0.43	4.1	8	3.9
840	3.44	4.05	0.61	13	27	14
865	12	12.56	0.56	7	7	0
910	0.64	1.8	1.16	9	21	12
980	0.45	1.2	0.75	2	2	0
1000	0.3	0.3	0	0.5	0.5	0
1100	0.3	0.3	0	0.5	0.5	0
1200	0.3	0.3	0	0.5	0.5	0
1300	0.3	0.3	0	0.5	0.5	0
1400	0.3	0.3	0	0.5	0.5	0
1500	0.3	0.3	0	0.5	0.5	0
1600	0.3	0.3	0	0.5	0.5	0
1700	0.3	0.3	0	0.5	0.5	0
1800	0.3	0.3	0	0.5	0.5	0
1900	0.3	0.3	0	0.5	0.5	0
2000	0.3	0.3	0	0.5	0.5	0
2100	0.3	0.3	0	0.5	0.5	0
2200	0.3	0.3	0	0.5	0.5	0
2300	0.3	0.3	0	0.5	0.5	0
2400	0.3	0.3	0	0.5	0.5	0
2500	0.3	0.3	0	0.5	0.5	0

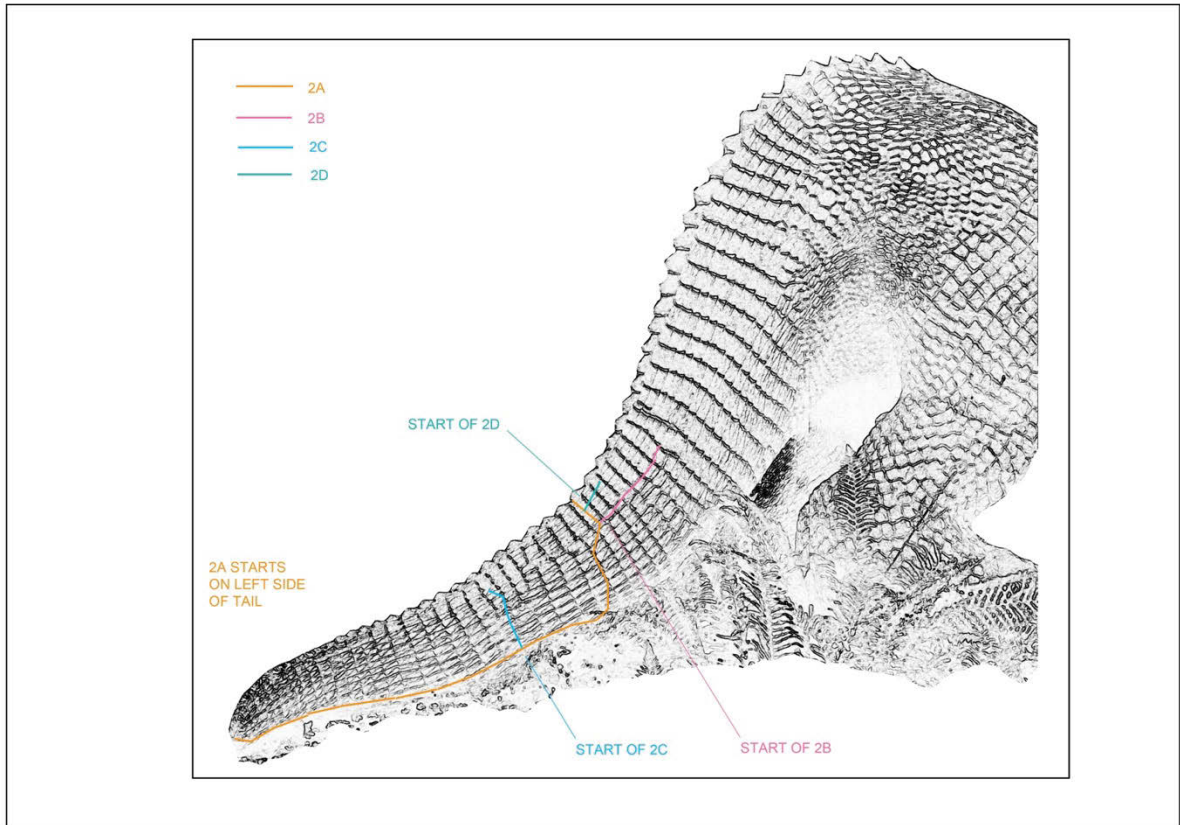
Plate 58-. Diagram depicting the location of the cracks 2A, 2B,2C,2D.

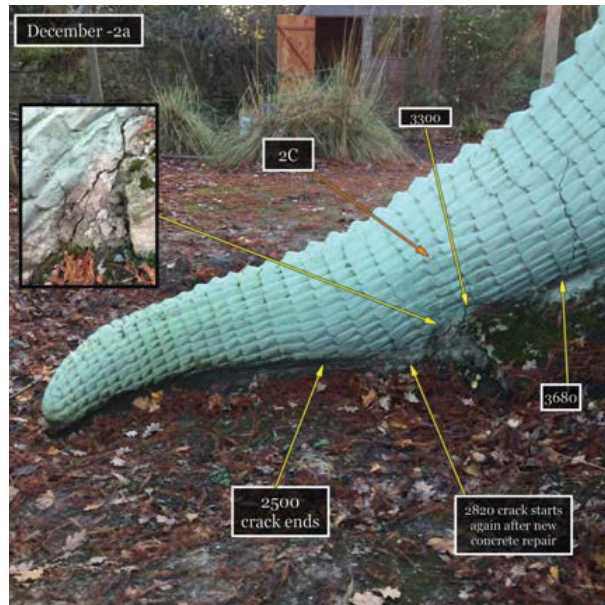
Plate 59-. Photographed 14.12.16<sup>54</sup>

**Crack 2A.** Detail images depicting the progressive deterioration related to cracking. Numbers refer to the measurement points along the length of the crack in millimetres.

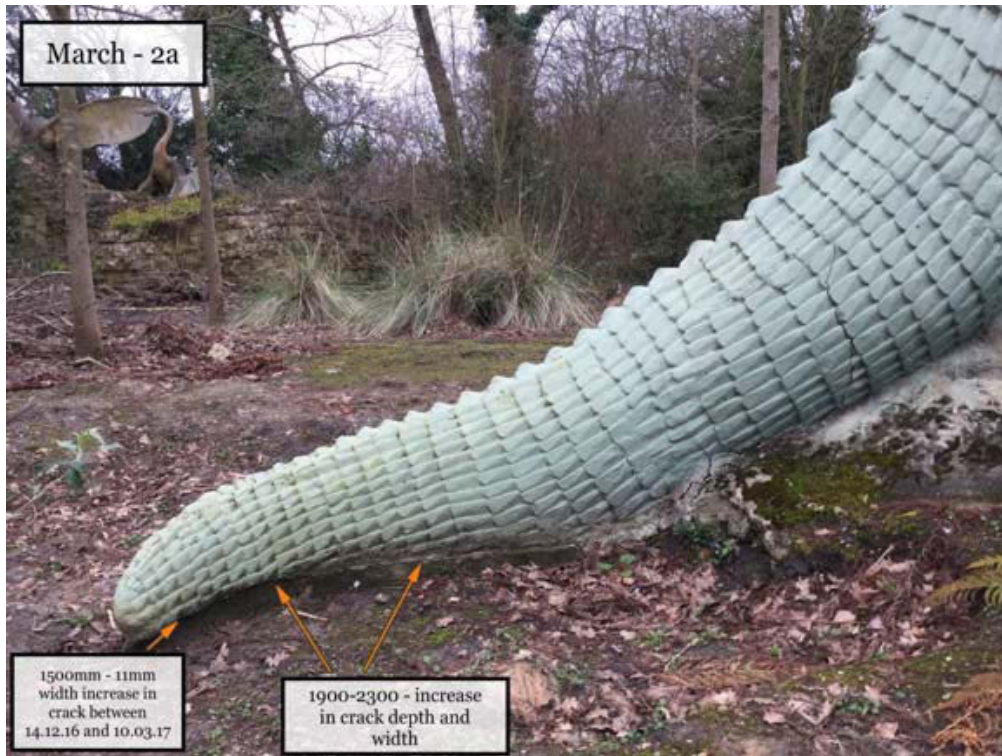
Plate 60- Photographed 10.03.17 - Locating the points of greatest crack depth and width increase<sup>55</sup>

- Crack 2a, between points 1300mm and 2300mm displays a complete detachment between the tail and the concrete raft on which it sits. See graph 2.0 and plate 60.
- There was no change in the dimensions of the secondary cracks; 1b,1b1,1b2,1c,2b,2c,2d.

Results from the monitoring of the tail cracks between 14.12.2016 and 10.03.2017 indicate a series of cracks formed due to shear stress as the ground beneath the lower section of the tail subsides. This is causing progressive cracking. The crack across the width of the tail has formed in the original concrete, not in the 2015 repair. The 2015 repair treatment included the insertion of a steel dowel (Cliveden 2015). It is likely that the rigidity of the steel dowels is preventing a crack forming at this point and the stress is transferring further up into the tail where the new crack has developed in the original concrete.

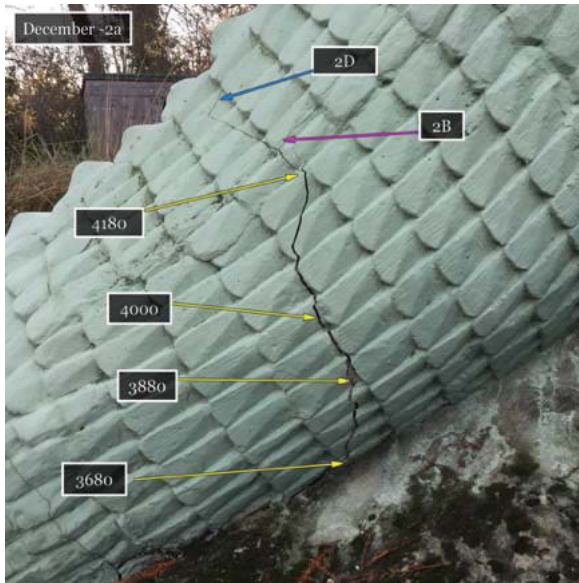
Plate 62-. Photographed 14.12.16<sup>57</sup>

Crack 2A continues from base and over to the left side of the tail where it meets crack 1a. Crack 2A has formed in the original concrete, not in a historical repair.

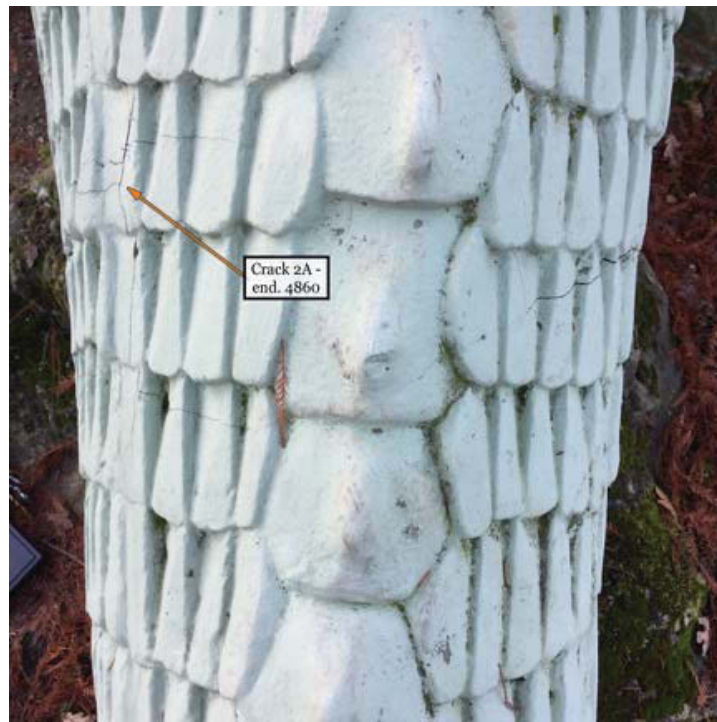
Plate 64-. Photographed 14.12.16 – End measurement point of Crack<sup>59</sup>

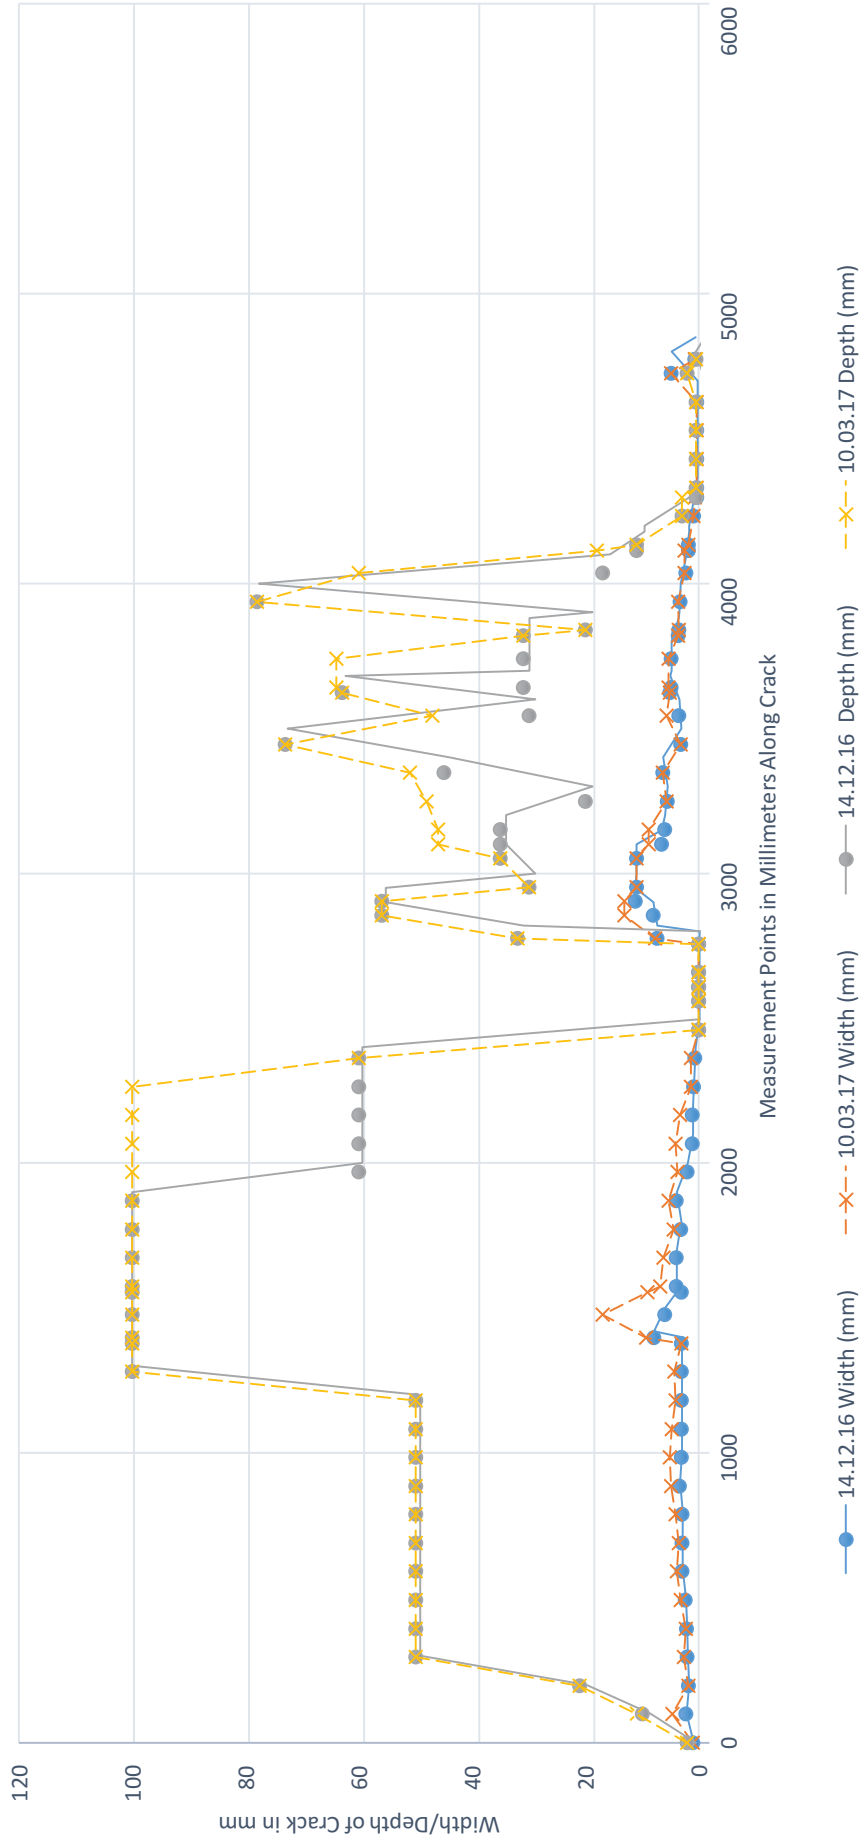
Graph 2.0

Measurement Points Along Crack (mm)	14.12.16 Width (mm)	10.03.17 Width (mm)	△ Width (mm)	14.12.16 Depth (mm)	10.03.17 Depth (mm)	△ Depth (mm)
0	1	1	0	2	2	0
100	2.3	4.7	2.4	10	11	1
200	1.8	1.8	0	21	21	0
300	2.1	2.64	0.54	50	50	0
400	2.2	2.3	0.1	50	50	0
500	2.4	3.2	0.8	50	50	0
600	2.9	3.8	0.9	50	50	0
700	2.9	3.5	0.6	50	50	0
800	2.9	4.1	1.2	50	50	0
900	3.4	4.85	1.45	50	50	0
1000	3.1	5.09	1.99	50	50	0
1100	3.1	4.8	1.7	50	50	0
1200	3.1	4.03	0.93	50	50	0
1300	3.1	4.35	1.25	100	100	0
1400	3.1	3.1	0	100	100	0
1420	7.9	9.3	1.4	100	100	0
1500	6	17	11	100	100	0
1580	3.1	9	5.9	100	100	0
1600	4	6.78	2.78	100	100	0
1700	4	6.2	2.2	100	100	0
1800	3.2	4.39	1.19	100	100	0
1900	4	5.3	1.3	100	100	0
2000	2.1	3.7	1.6	60	100	40
2100	1.09	4.03	2.94	60	100	40
2200	1.09	3.33	2.24	60	100	40
2300	0.89	1.36	0.47	60	100	40
2400	0.7	1.36	0.66	60	60	0
2500	0	0	0	0	0	0
2600	0	0	0	0	0	0
2650	0	0	0	0	0	0
2700	0	0	0	0	0	0
2800	0	0	0	0	0	0
2820	7.37	7.7	0.33	32	32	0

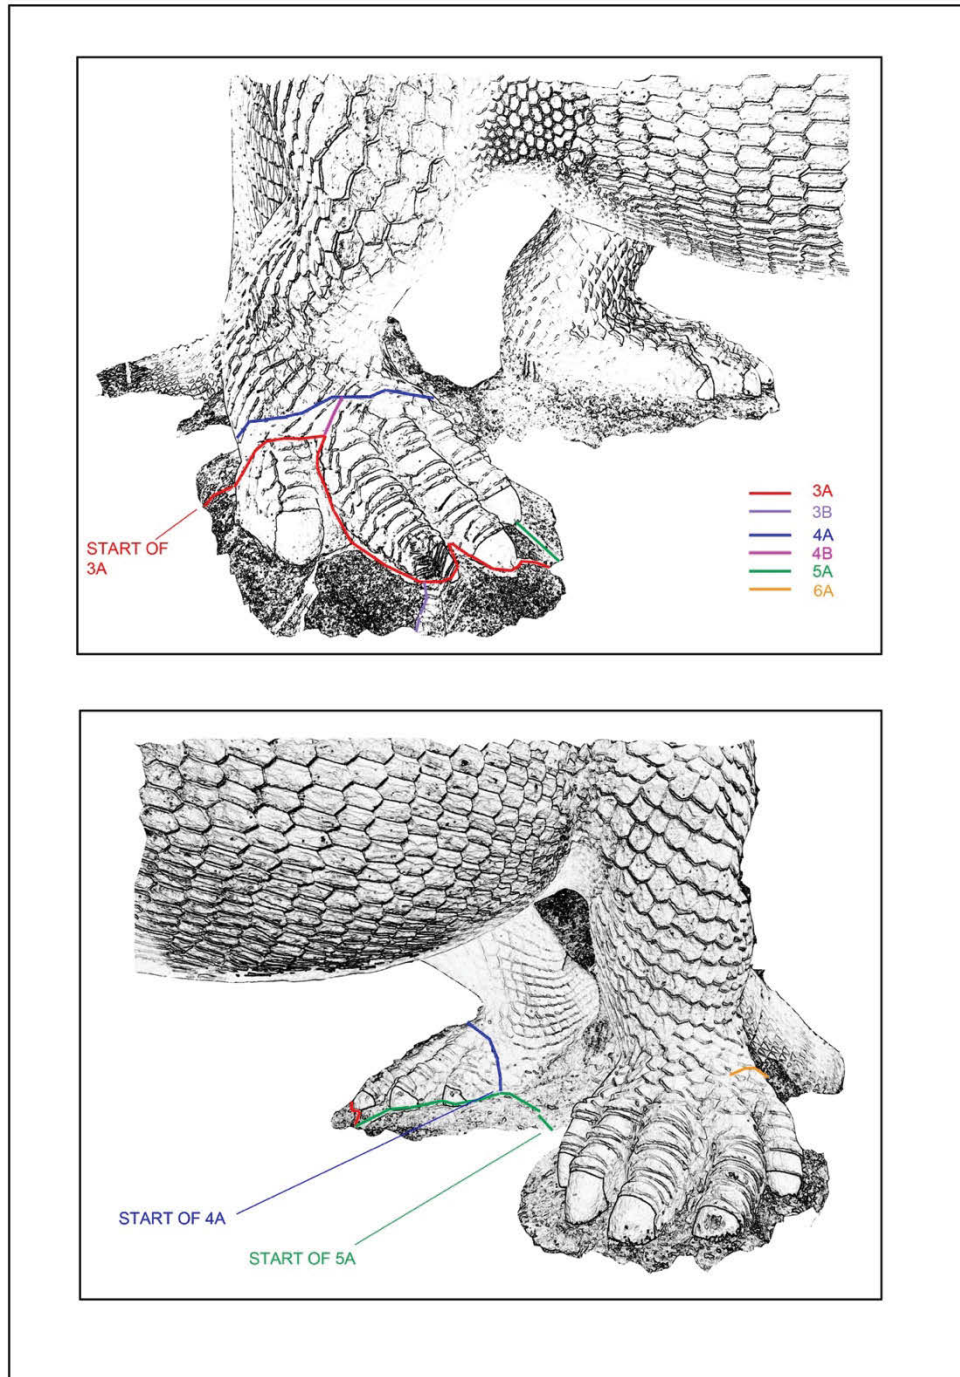
Plates 66 and 67- Diagrams depicting the location of the cracks.

- The back right foot has three primary cracks, identified as 3a,4a and 5a. Cracks 3a and 4a both start in the concrete base and extend over the foot, both cracks have secondary cracks, identified as 3b and 4b.

- Crack 5a does not extend into the foot and is limited to the concrete base, following the site of a repair made in 2015.
- Between 15.12.2016 and 15.03.2017, primary cracks 3a,4a,5a have increased *at points* in both width and depth – see graphs/tables 3.0, 4.0 and 5.0.

- Crack 3a, between points 590-1100mm, displays an almost continuous length of spalling concrete, with numerous losses and disassociated fragments. Losses at points 950mm and 1050mm have occurred between 15.12.16 and 15.03.17. See plates 85-88.

- Crack 4a follows the site of a 2015 repair. Point 290-510mm along the crack displays delaminating repair concrete, with total disassociation of fragments occurring between 15.12.16 and 15.03.17. See plates 90,91.

Results from the monitoring of the back left and right feet between 15.12.16 and 15.03.17 indicate a series of cracks, forming and increasing in width and depth at points, along the top of the back right foot and in the concrete base of the foot. These cracks are occurring at the sites of the previous 2015 repairs, indicating that these are progressive cracks caused by ground subsidence. The back right leg, formed around a 9ft (274cm) cast iron pipe which extends down into the ground, shows no evidence of cracking. Cracking appears at the point of stress where the apparently hollow foot meets the ridged leg. The back left leg displays only one short hairline crack, which has not increased dimensions between the two dates, suggesting that the ground is more stable on the left hand side of the dinosaur and subsiding on the right hand side. The numerous losses along crack 4a are the result of delaminating concrete applied during the 2015 restoration. The concrete has not adhered sufficiently to the concrete substrate and further delamination is developing.

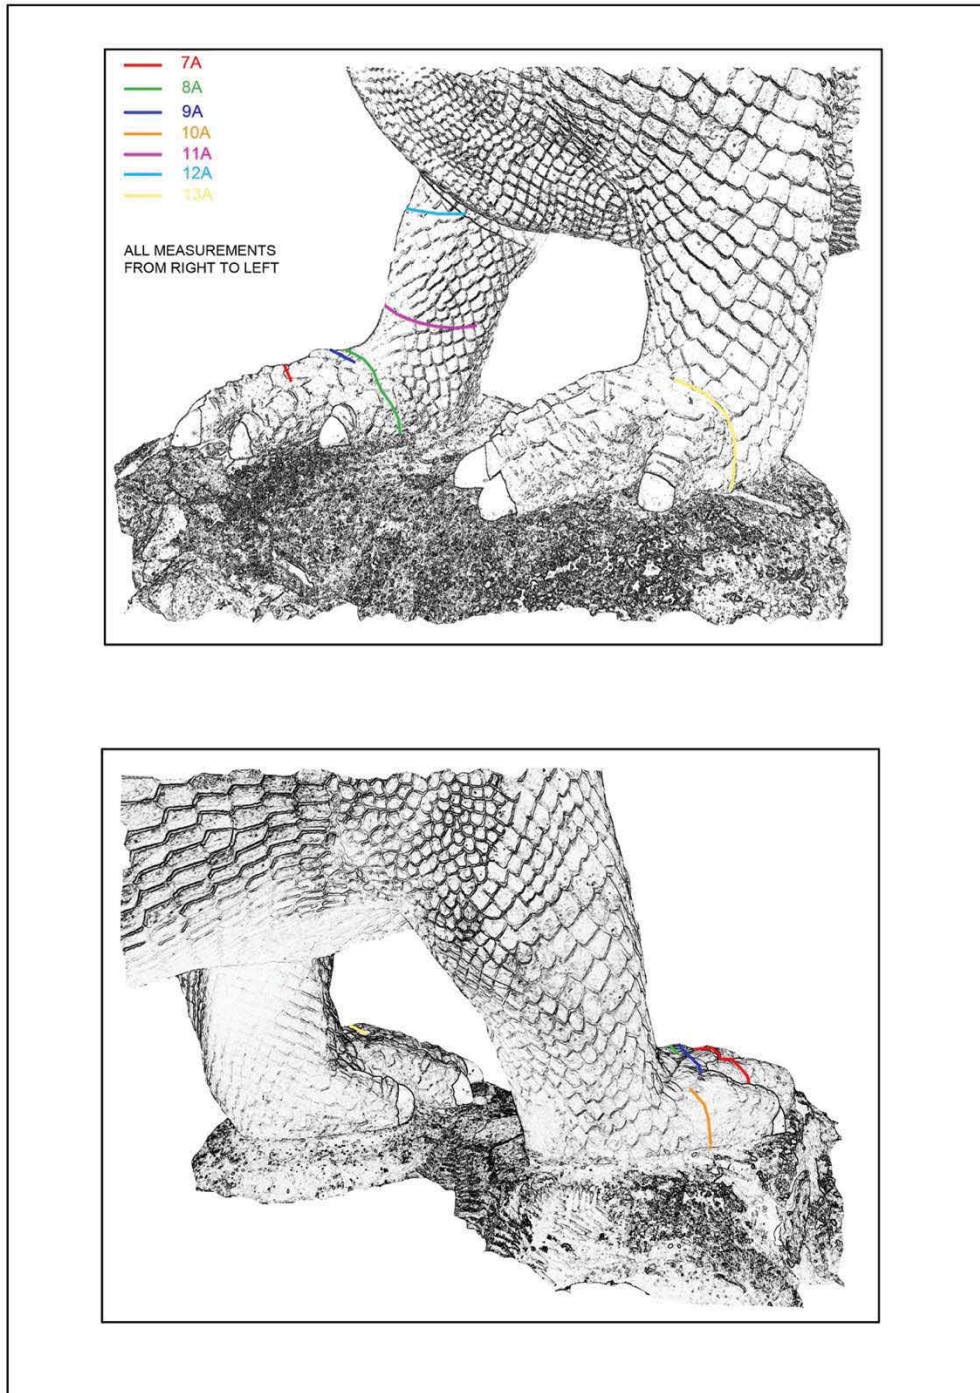
Plates 69 and 70. Diagrams depicting the location of the cracks.

- The front right foot has six hairline cracks, identified as 7a,8a,9a,10a,11a and 12a. There are no secondary cracks.
- The front left foot has one hairline crack, identified as 13a and no secondary cracks.
- Between 15.12.2016 and 15.03.2017 crack 7a increased in width and depth between points 400mm-600mm. This increase is due to a loss in the paint layers, along the site of a 2015 crack restoration. See plate 97 and graph 7.0.
- Cracks 8a-13a have seen no increase in dimensions between 15.12.2016 and 15.03.2017.

Results from the monitoring of the front right and left feet between 15.12.16 and 15.03.17 indicate a series of hairline cracks. These cracks have formed since the 2015 restoration (Cliveden, 2015.) Crack 7a is the only crack to have increased in dimensions between 15.12.16 and 15.03.17. This increase is due to a loss in the paint layer, not due to increased cracking in the concrete. The delamination of the paint is possibly due to water ingress, facilitated by the hairline crack. All the cracks appear to be on the sites of previous restorations.

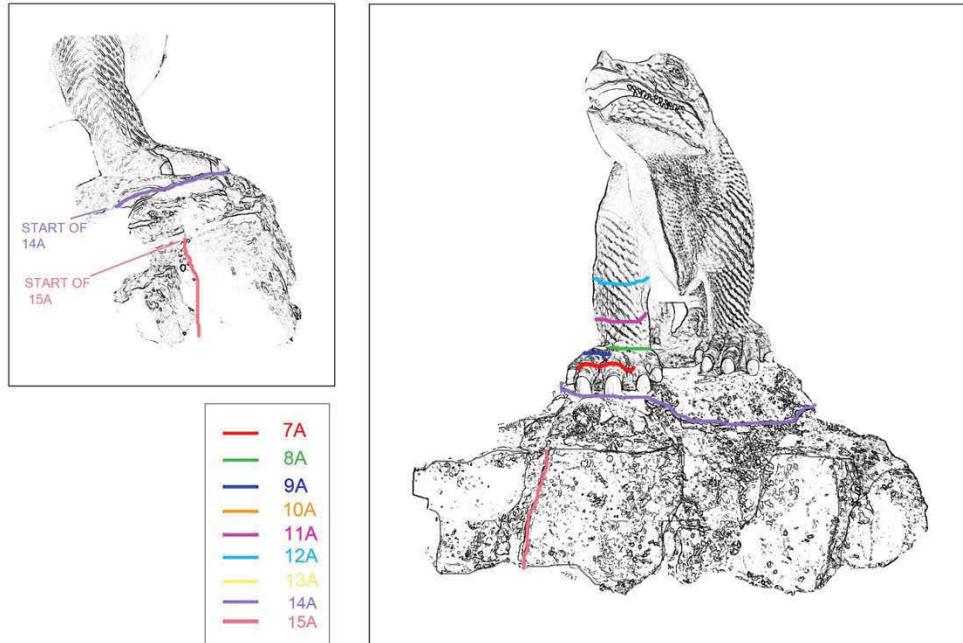
**Plates 71 and 72.** Diagrams depicting the location of the cracks 14a and 15a.

- The front plinth displays an extensive network of cracks. The two most prominent cracks were identified for monitoring, one horizontal 14a and one vertical 15a. See plates 71 and 72 for location.

- Crack 14a runs horizontally, through the site of previous concrete repairs, many of which are undocumented restorations.
- Points 400mm to 800mm of crack 14a run through concrete applied to fill a crack during the 2015 restoration (Cliveden 2015). This crack has increased in both width and depth between 15.12.16 and 15.03.17. See graph/table 14.0.

- Crack 15a runs vertically through historical repair concrete between two boulders as a result of shear stress due to ground subsidence.
- Apart from an increase in depth at point 0mm, crack 15a has not increased in width or depth between 15.12.16 and 15.03.17.

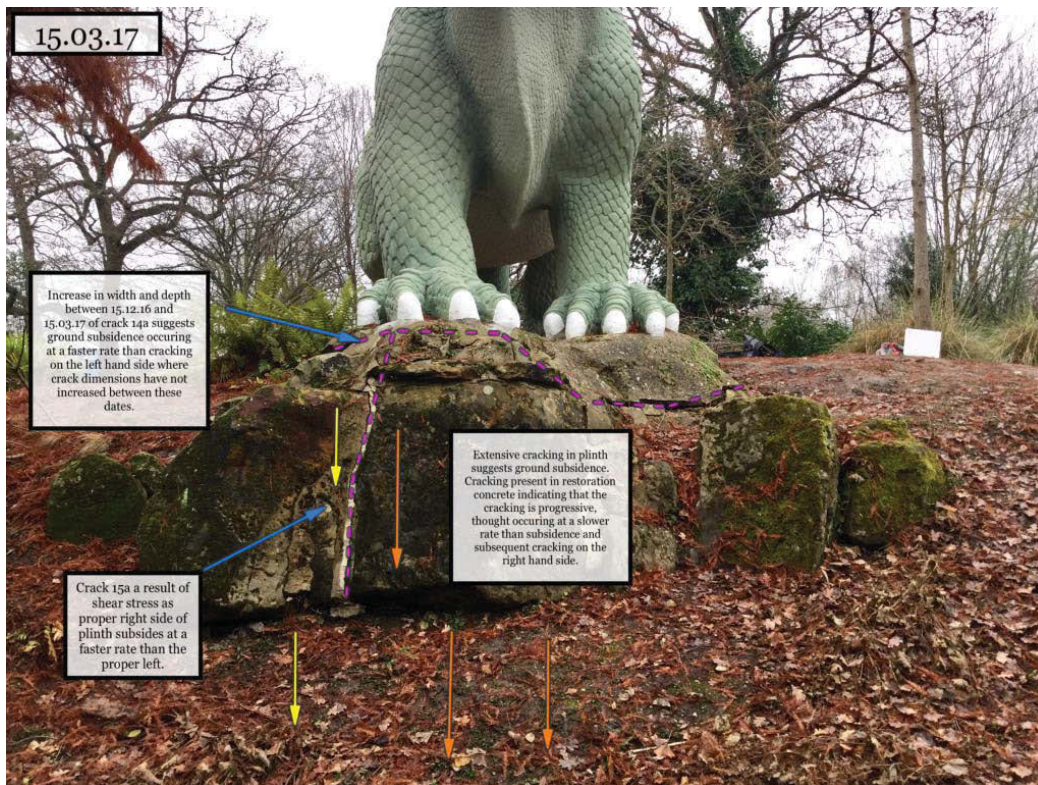
Plates 73 and 74 – Analysis of structural deterioration – Front Plinth<sup>62</sup>

The plinth beneath the front right and left feet consists of large boulders of Weald sandstone and concrete. The extensive cracking in the historical concrete repairs indicate the cracking is progressive and due to ground subsidence. The increase in the width and depth of crack 14a on its proper right hand side and the apparent stability of dimensions of the crack on the left hand side suggest that the ground is subsiding at a faster rate beneath the right side of the dinosaur. See plates 73 and 74.

Results show that without stabilisation of the ground to the right, tail end and front plinth, further ground subsidence and further structural deterioration of the Standing Iguanodon is most certainty inevitable.

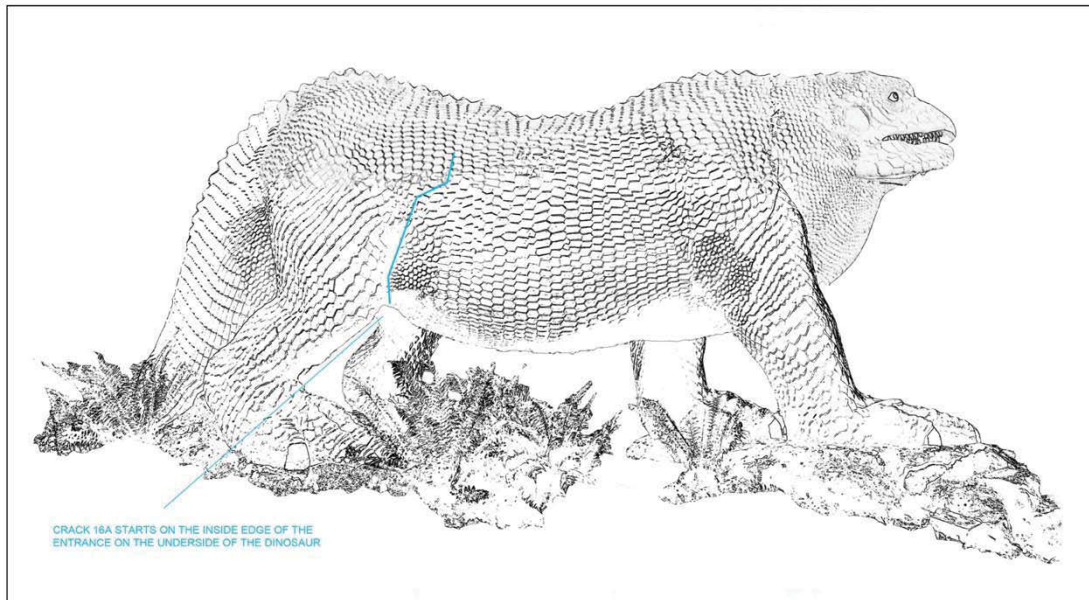
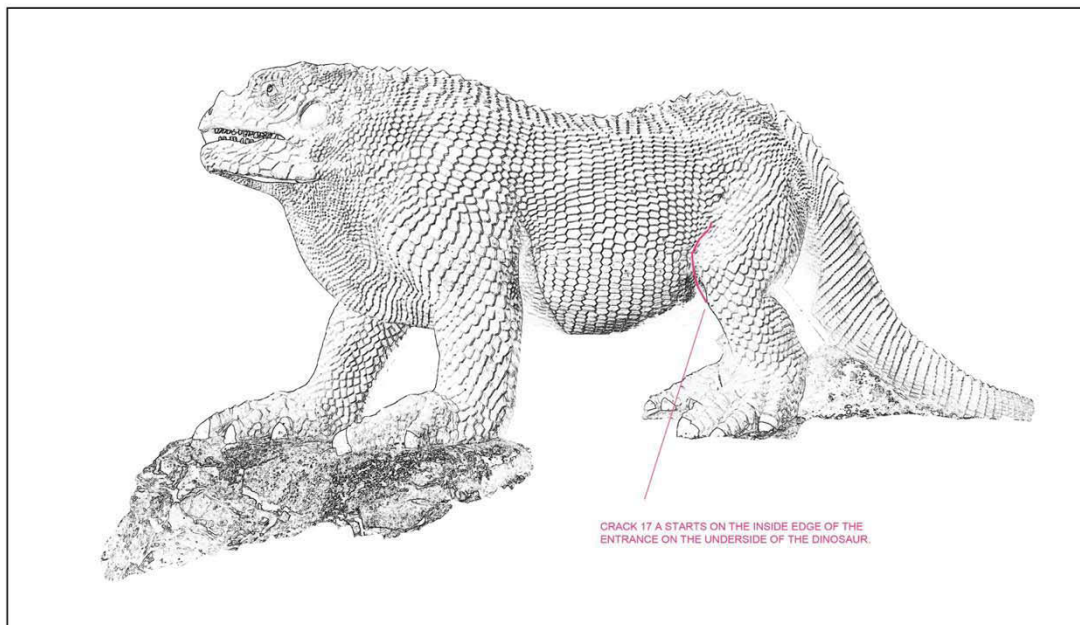
Plates 75 and 76-. Diagrams depicting the location of the cracks 16a and 17a

- The body has two primary cracks, identified as 16a and 17a. See plates 75 and 76.
- Both cracks start on the inside edge of the entrance to the dinosaur (on its underside), 16a on the right and 17a opposite on the left. The location of the cracks is fairly symmetrical. See plates 109 and 111.
- Both crack's widest and deepest points are on the underside of the dinosaur, emanating from the entrance. Both cracks then taper to a hairline from point 500/600mm onwards.
- Crack 16a increased in both width and depth between points 200mm-600mm between the dates 15.12.16 and 15.03.17. See graph 16.0.
- Crack 17a increased in both width and depth between points 100mm-500mm between the dates 15.12.16 and 15.03.17. See graph 17.0.
- Neither crack increased in length between 15.12.16 and 15.03.17.

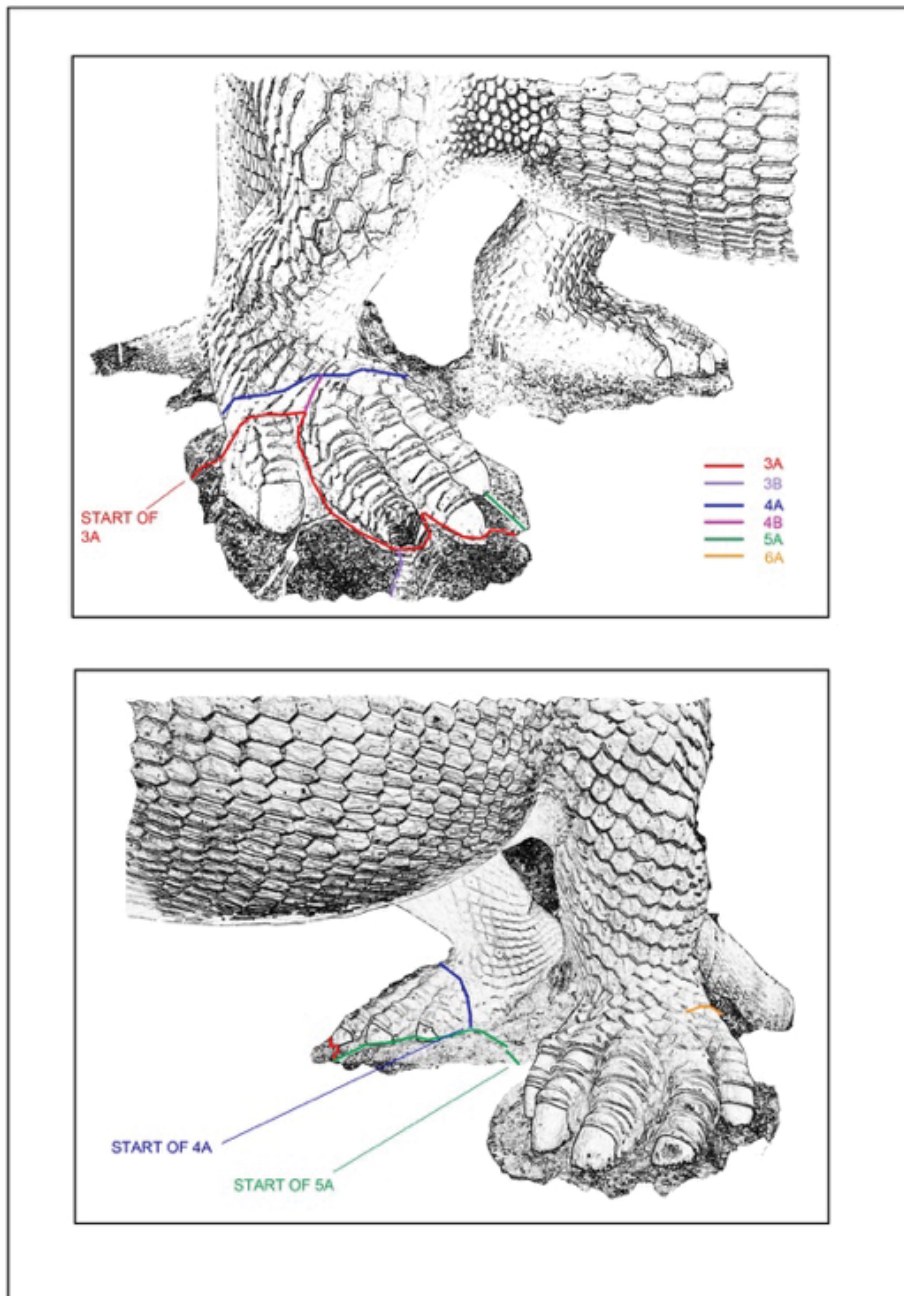
Plates 81 and 82 – Diagram of Back Feet.

Crack 3A – see plates 81 and 82- for location.
