### A DEVELOPMENT OF A NEW METHODOLOGY FOR MAPPING AND MONITORING THE CONDITION OF 3DIMENSIONAL CULTURAL HERITAGE.

CASE STUDY: The Standing Iguanodon in Crystal Palace Park. Using Photogrammetry and 3D Digitalisation to Record Condition and to Map and Monitor Deterioration. Engaging Open Access as a Means of Digital Preservation and Project Outreach.

India Carpenter

Final Year Research Paper  
PG Diploma in Conservation  
Conservation Department 2017

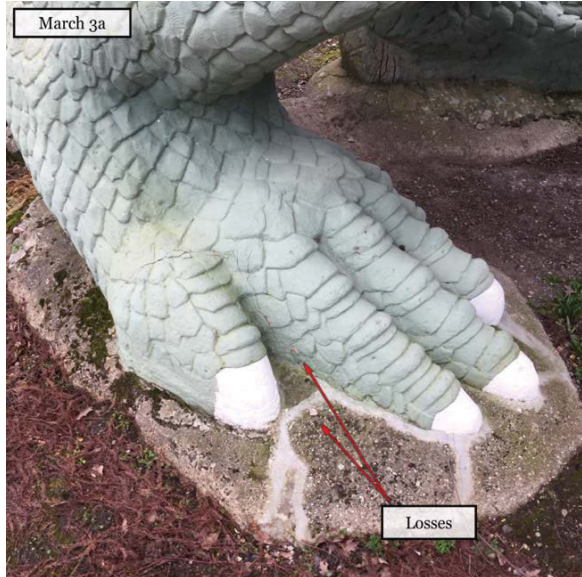
Plate 84- Photographed 15.03.17 – visible losses.

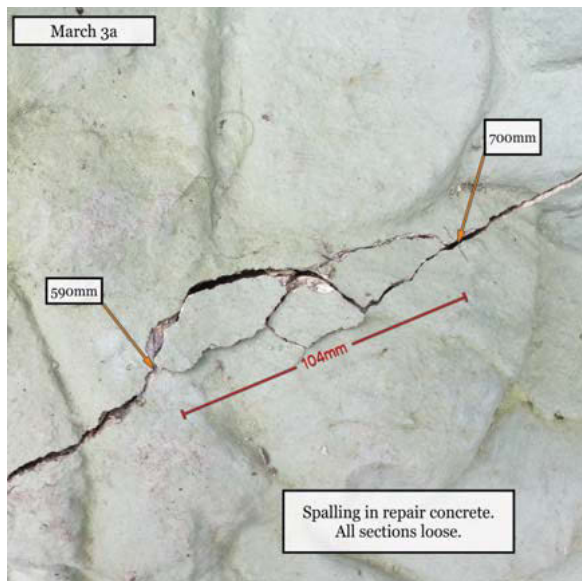
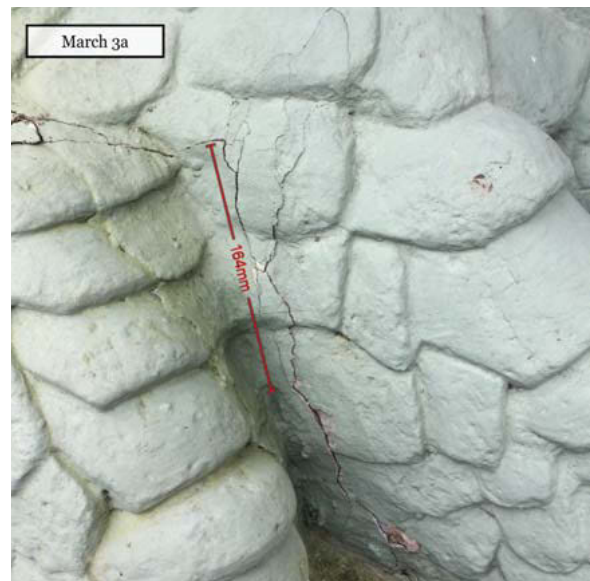
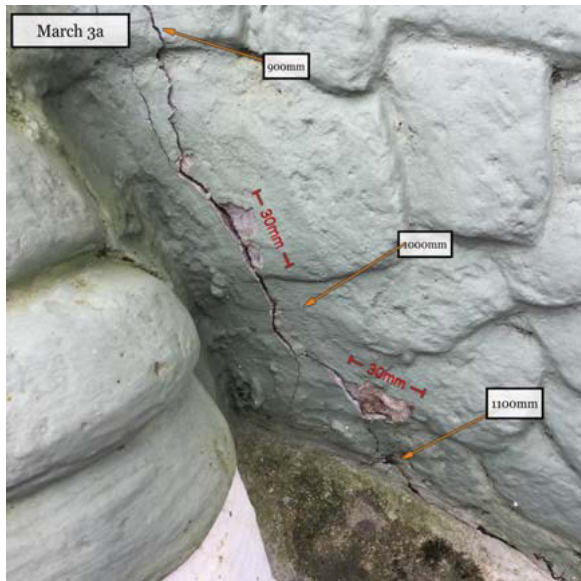
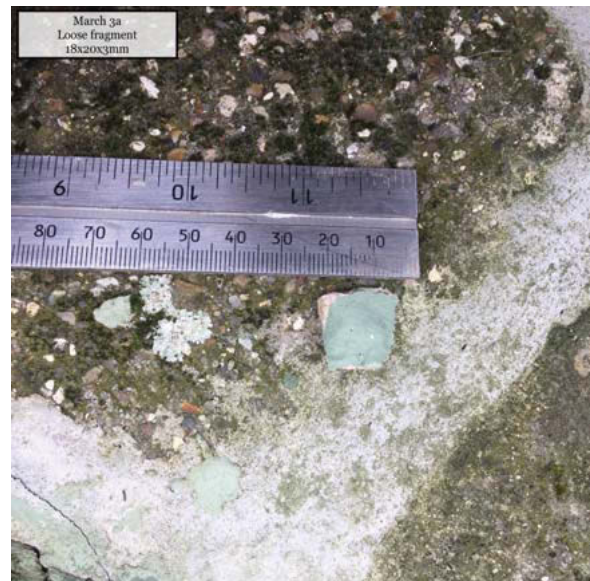
Plates 83-88- photographed 15.03.17. Details of cracking and spalling in the concrete, including visible losses and detached fragments since 15.12.16<sup>69</sup>

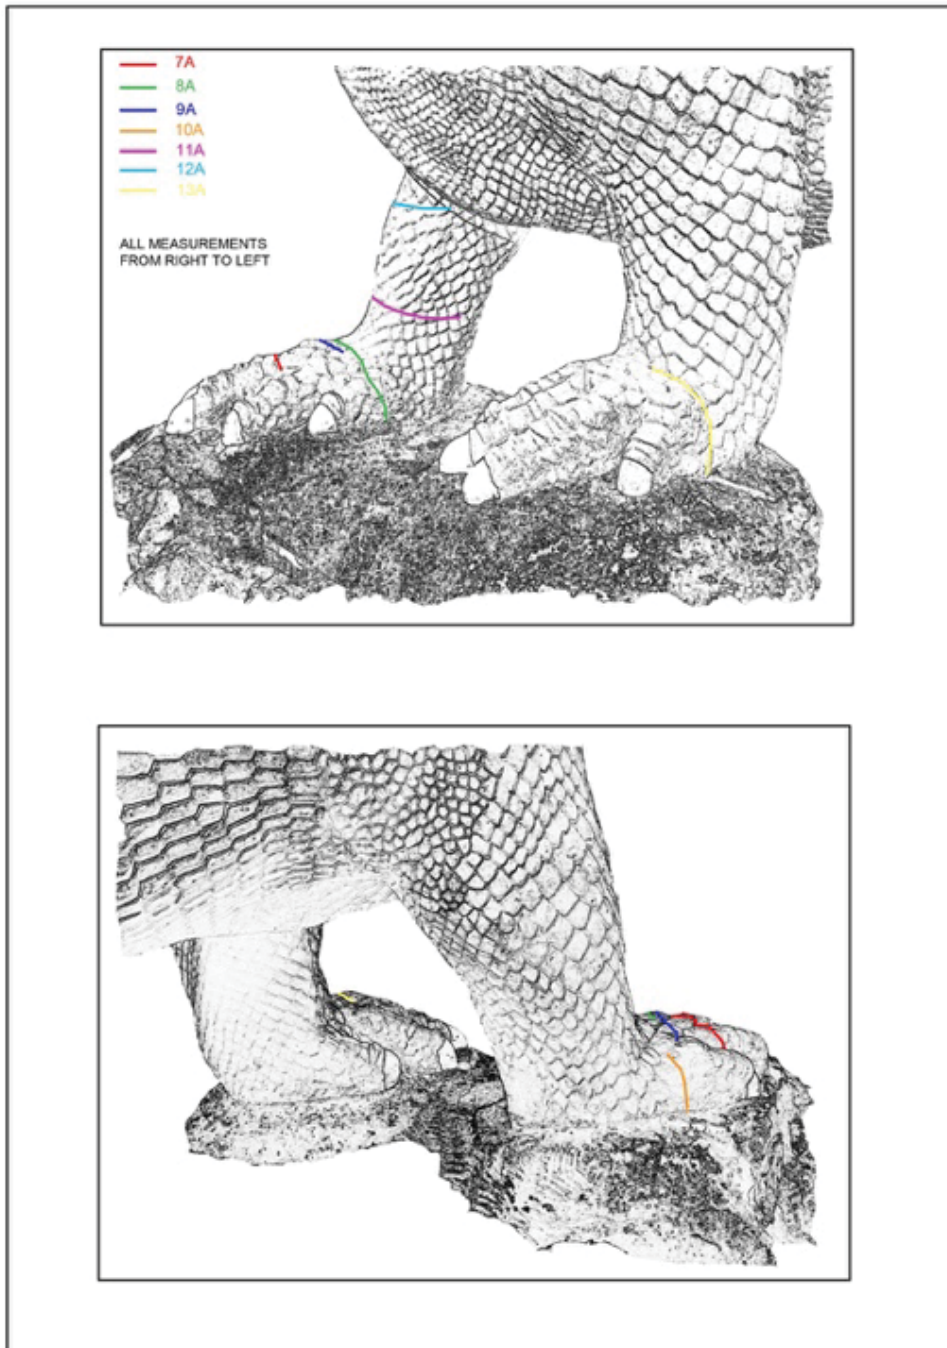
Plates 92 and 93. Diagrams depicting the location of the cracks.

Cracks 7a - 13a – see plate 92 and 93 for locations. Numbers refer to measurement points along the length of the crack in millimetres.

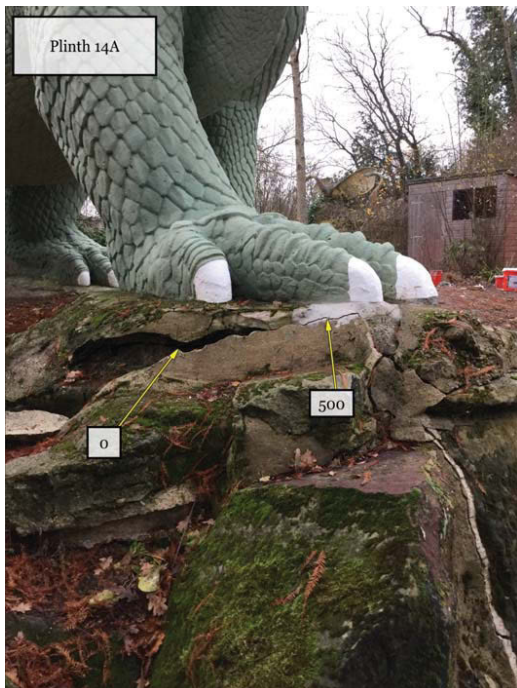
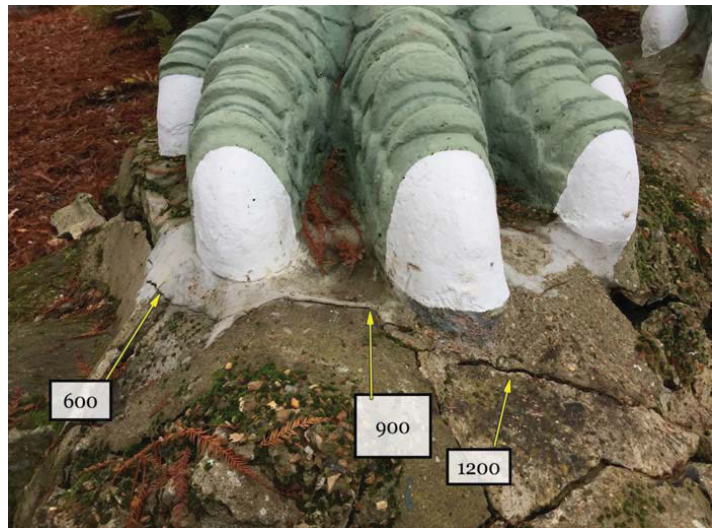
Plates 100 and 101.

- Points 1400 to 3900mm is an areas comprising of numerous restorations, with many loose and disassociated fragments and large sections of concrete. See plates 102 and 103 - particularly points 1800mm and 2700mm.

Plates 100 and 101 – Photographed 15.12.16 - Crack 14a<sup>76</sup>
