**Granary & Cart Lodge at
Mulberry Farm,
Risby, Suffolk
RBY 045**

Heritage Asset Assessment

**Leigh Alston MA (Oxon), Architectural Historian
on behalf of
Suffolk County Council Archaeological Service**

January 2013

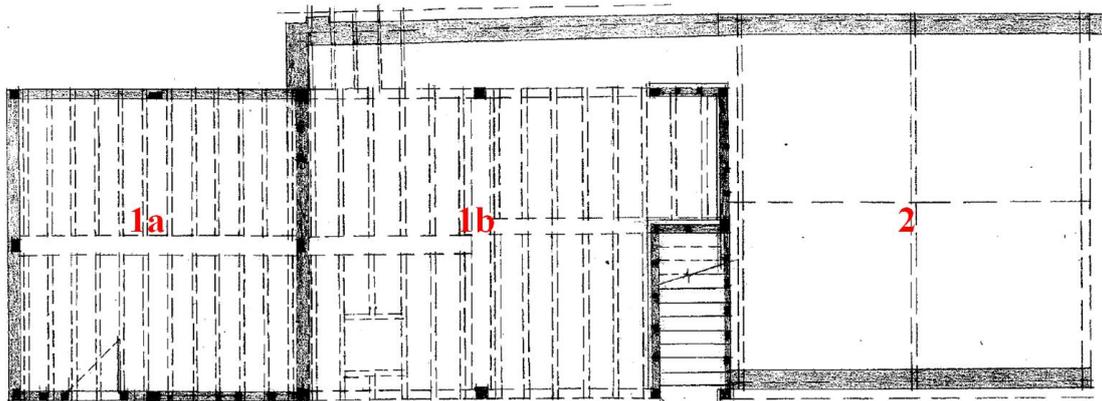
Figure 8

Ground plan of the granary and cart lodge identifying each area with a number for ease of reference in the text and photographic record.

1. A late-18th century timber-framed structure in four bays with a grain store on its upper storey reached by an enclosed internal stair against its eastern gable. The lower storey divided into a two-bay enclosed shed (1a), possibly designed as a small stable for cart horses, and an open-sided cart lodge (1b) to the east. The cart lodge originally open to both front and rear but the rear wall now enclosed by a mid-19th century flint-rubble wall forming a narrow lean-to extension. Now roofed with corrugated asbestos and clad in corrugated iron and weatherboarding, but with substantial fragments of 19th century lath-and-plaster with herringbone pargeting to the gables. Pegged mortises in both western corner-posts suggest the original building continued further to the west and has been truncated.

2. A mid-19th century single-storied vehicle shed of flint-rubble with red-brick dressing and a pantiled roof, now with an open eastern gable but possibly provided with doors initially. The rear (northern) wall continuing along the adjoining earlier cart lodge to form a narrow lean-to extension now roofed with corrugated asbestos.

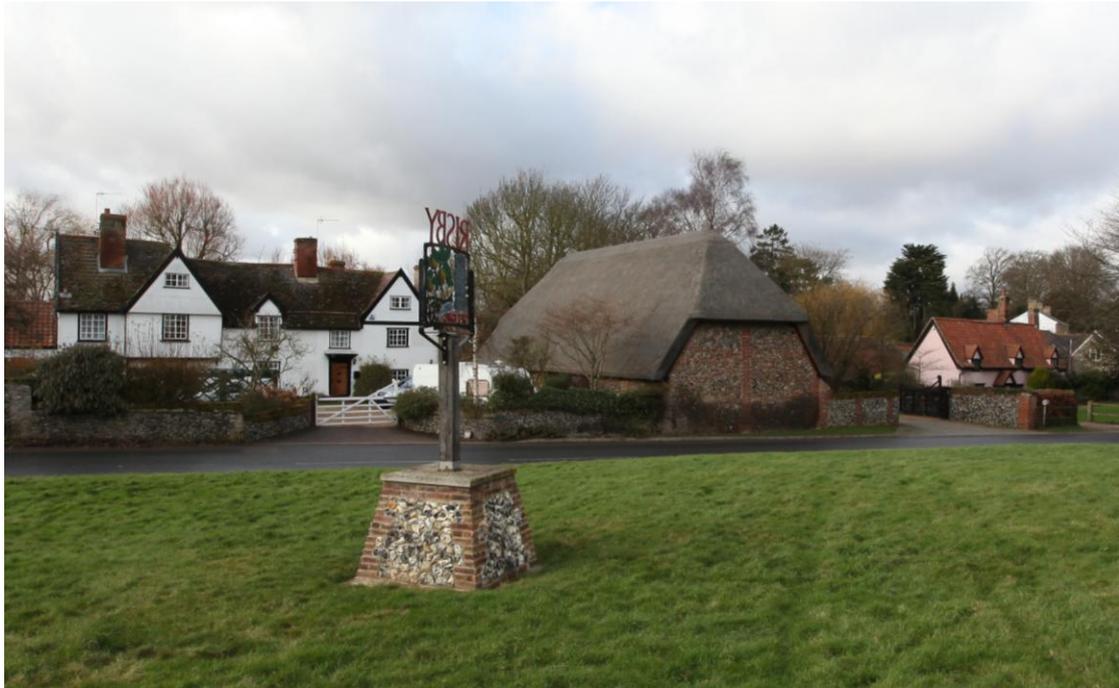
Illus. 1. A general view of the site from Risby green to the south-east showing the three grade II-listed buildings adjoining the granary: Lower Farm on the left (to which the granary belonged), the thatched aisled barn in the centre and Dove Cottage on the right – respectively dated by English Heritage to the 15th, 16th and 18th centuries. The granary itself is hidden behind the barn.

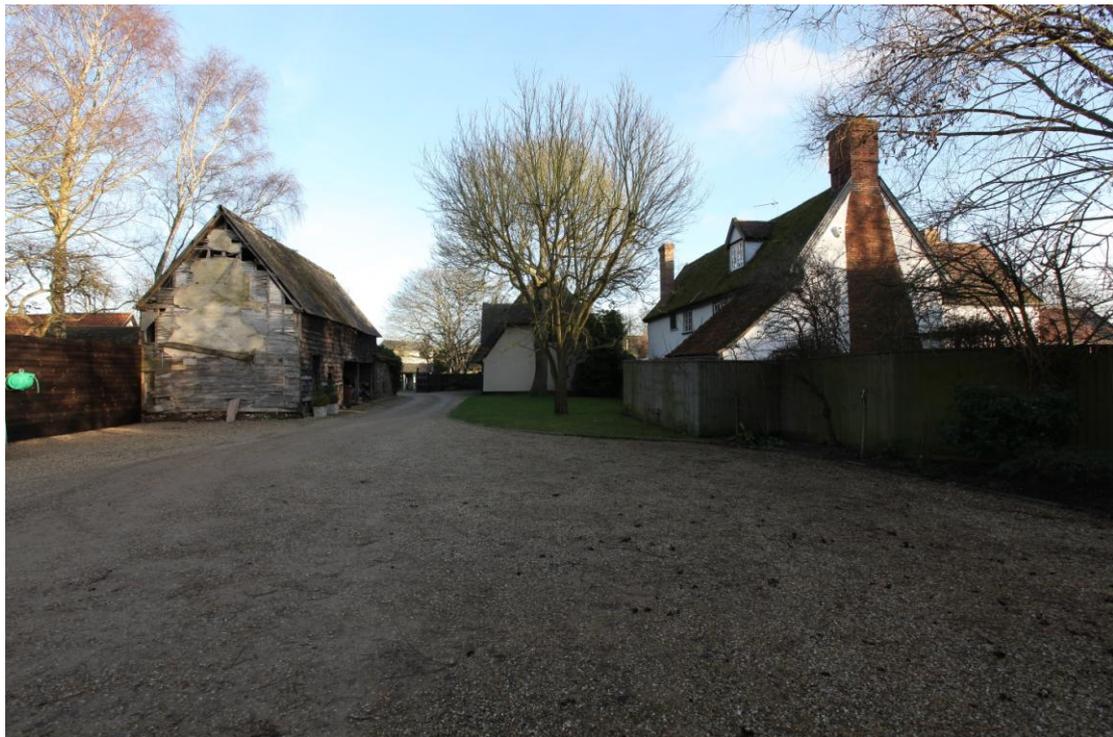
Illus. 2. A general view from the modern house known as Mulberry Farm to the west showing the rendered gable of the granary to the left with aisled barn in the centre and Lower Farm to the right.
