Date of report: 1st April 2008

Client: Landmarc Support Services Ltd (for Defence Estates)

## Barry Buddon training camp; a baseline condition survey of archaeological sites

# Barry Buddon training camp: a baseline condition survey of archaeological sites

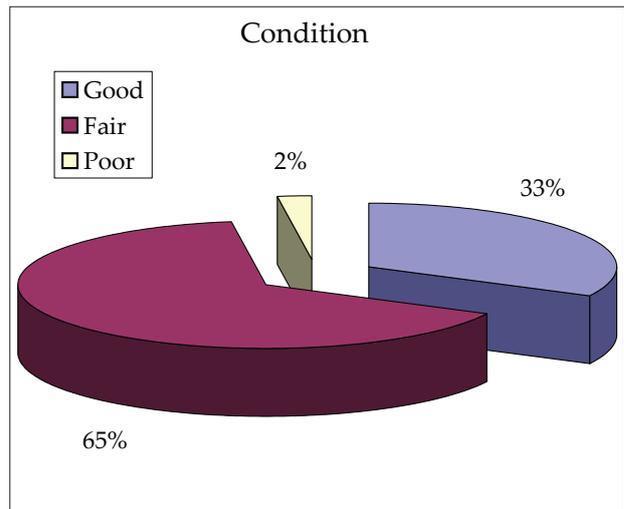
**Illus 11: Pie chart of condition of sites and monuments**

**6.16** The condition of each site was rated as one of three categories: 'Good', 'Fair' or 'Poor' based on the degree of survival of the existing remains. Of the 46 sites 15 (33%) were found to be in Good condition, 30 (65%) were Fair and only 1 site, the building remains at Site 57, was found to be in a Poor condition (Illus 11).

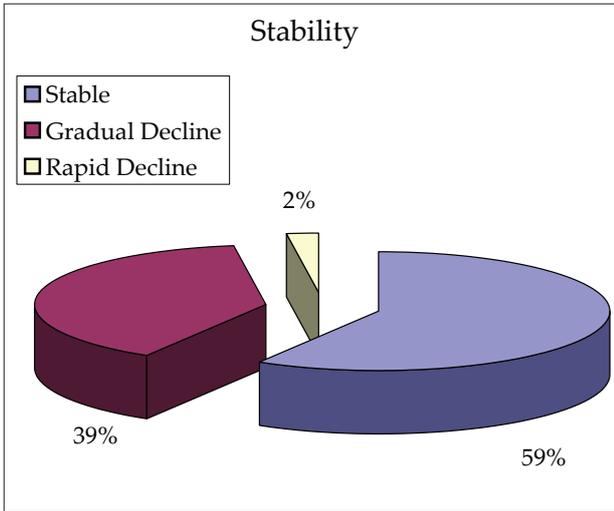
Illus 12: Pie chart of stability of sites and monuments

**6.17** The stability of each site was assessed based on visible signs of deterioration. Considering the nature of a number of sites, like the trenches dug into sand, the current stability of the sites were surprisingly good. Most evidence of degradation of the sites seems to have occurred in the past. The major threat of coastal erosion on the east side of the camp has been addressed, and the current activity in the camp has had little impact on most of the historical sites. A total of 27 sites (59%) were found to be Stable, 18 (39%) were in Gradual Decline and only one site (2%) appeared to be in a state of Rapid Decline (Illus 12).

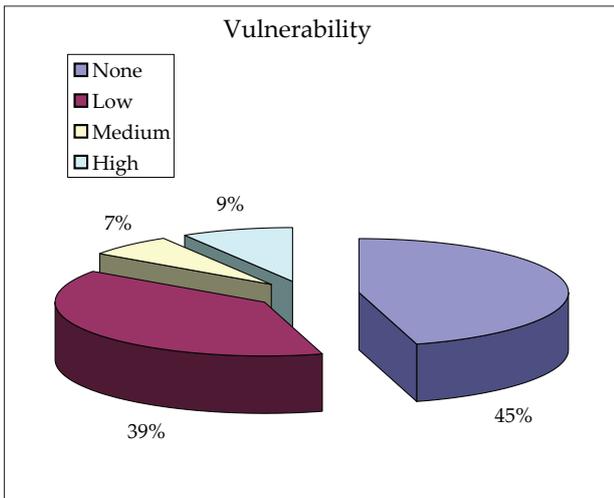
Illus 13: Pie chart of vulnerability of sites and monuments

6.18 Despite being situated in an area of relatively unstable ground, the majority of the sites appeared not to be very vulnerable. Of the 46 sites, 39 (84%) were deemed to have none or Low risk, 3 (7%) were recorded at Medium risk, and only 4 (9%) were at High risk (Illus 13).

6.19 The sites at high risk were the Allan Williams Turrets (Sites 29, 37 and 48) and the former keeper’s cottage (Site 57) at the Low Lighthouse. The turrets appeared to originally have had some form of protective coating which is now largely weathered away leaving the iron exposed to the salt spray from the sea. As a result the metal is corroded through in places (Illus 14) and part of the structures has become detached. The door from the turret at Site 29 was found on the ground 300 m to the SSW, and the top plate of the turret at Site 37 was lying loose on the ground (Illus 15). Whether this is caused by vandalism or just high winds, the detachment is made easier by the general decay of the metal.
