# Glastonbury Abbey South Nave Aisle

## Archaeological Survey of the standing fabric - 2004

Jerry Sampson

13 December 2004

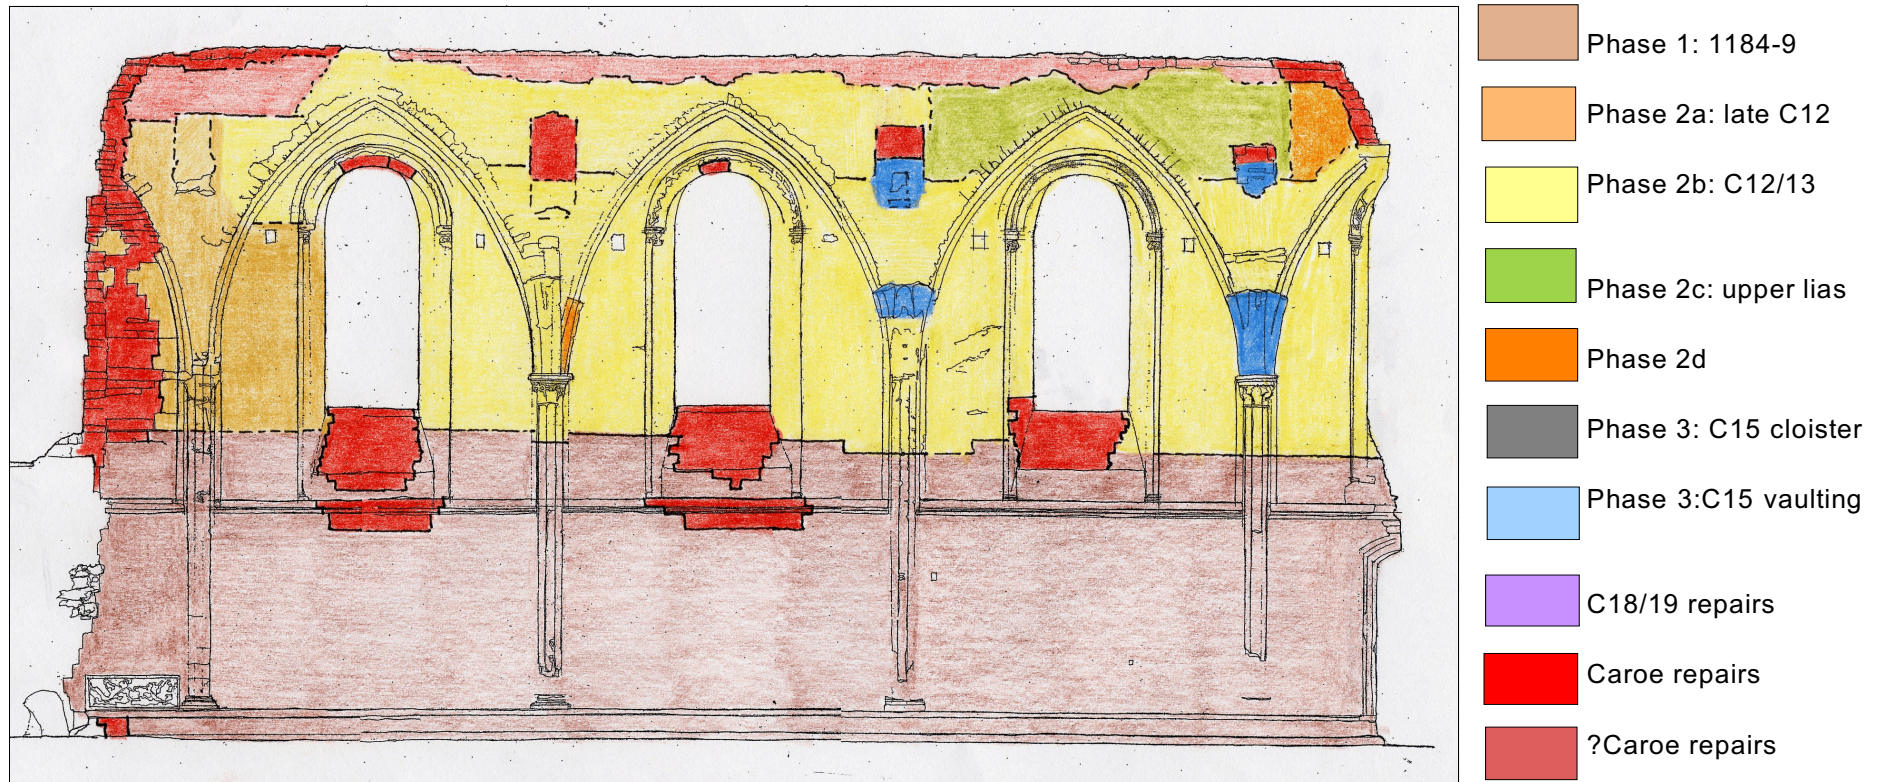
South Nave Aisle: North elevation phasing

north elevation for the course immediately above the break to have decayed much more than the rest of the surrounding masonry. This could be the result of the exposure of the core-work during the hiatus in building having allowed the lime mortar of the wall top to carbonate much more effectively than usual, forming a more impenetrable horizontal layer within the wall. This would then present a barrier to water-borne salts within the wall during the period of the ruination of the abbey, encouraging their deposition in the course above the building-break. This pattern of decay holds true across the eastern bays, but the decay tends to occur just **below** the projected line of the break in Bay 6, where the line of the break is less easy to identify.

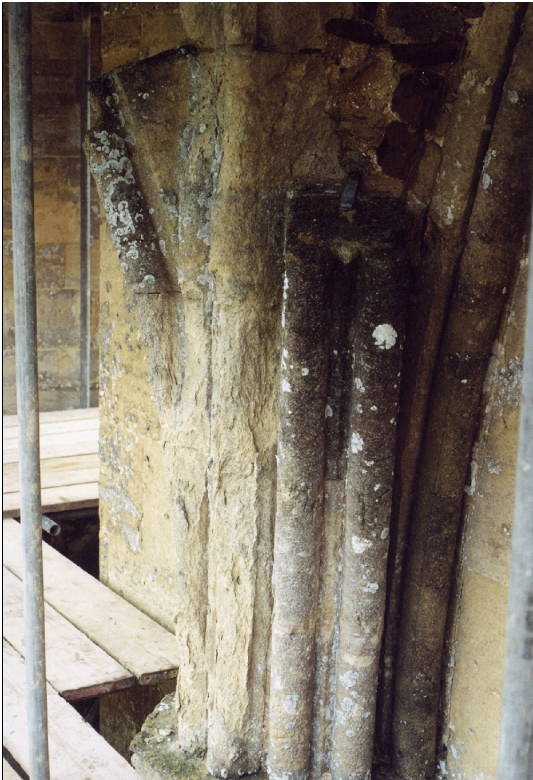
Above left: the late twelfth or early thirteenth century vaulting springer of Bay 4/5 looking South-East, showing the apparently vertical rise of the transverse rib.

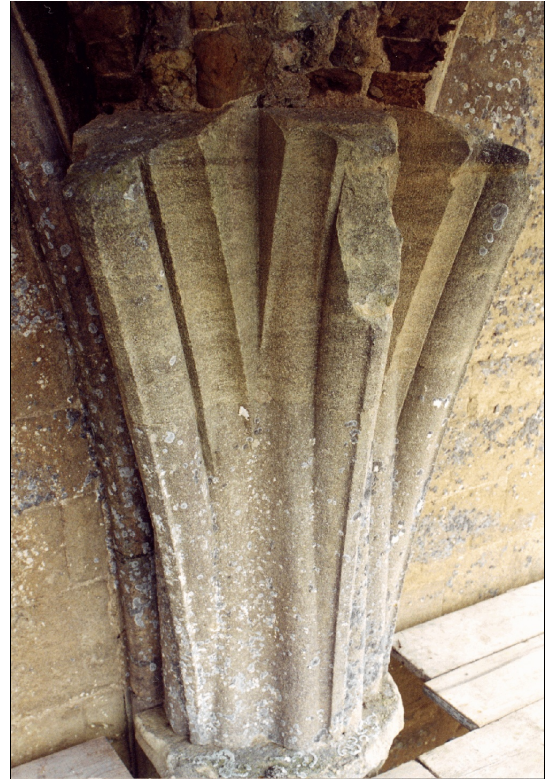
Above right: the fourteenth century vaulting springer of Bay 6/7 looking South-West.

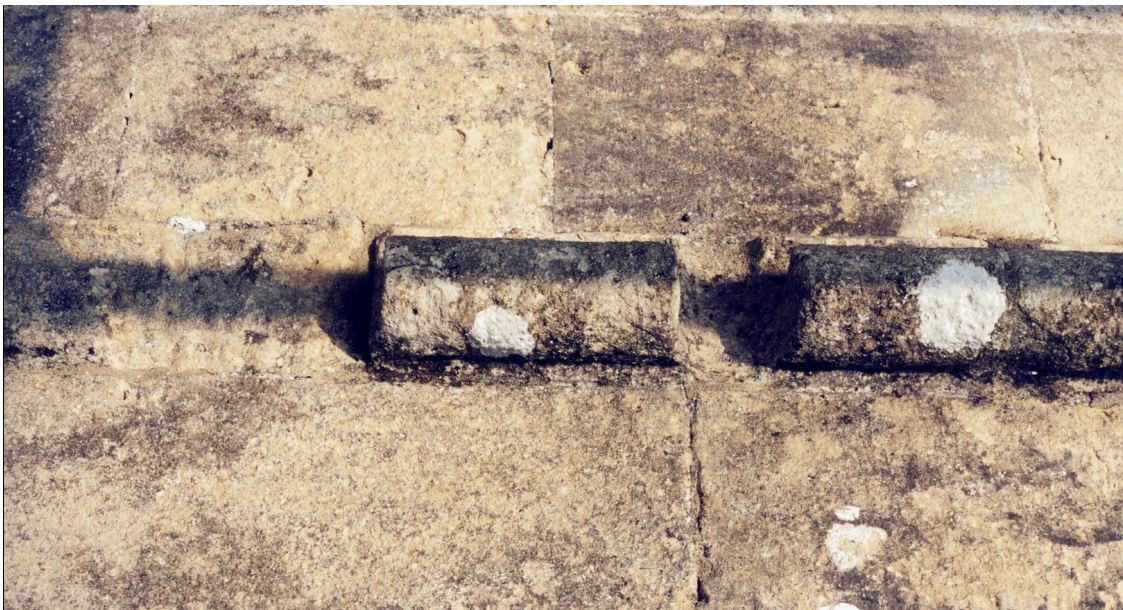
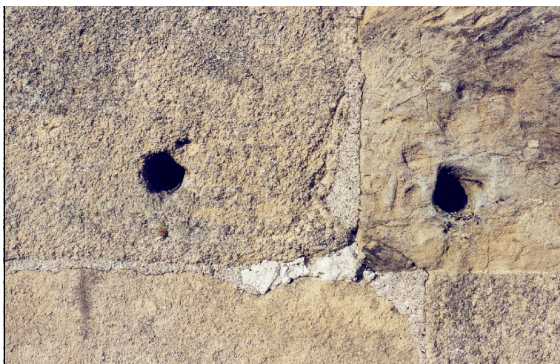
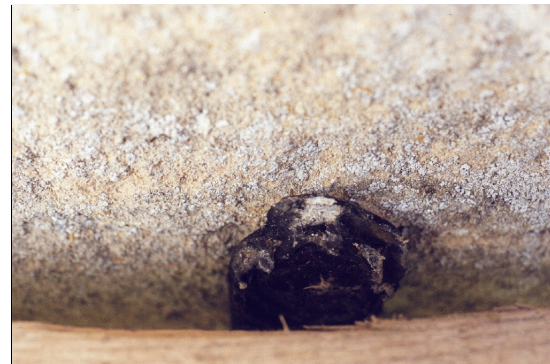
Left: The rain-water chute at the wall-head, closed off with Caroe period repairs

Below: The two cuts through the window-springer level string-course - that to the left for the first down-pipe; that to the right to accommodate the pipe after it was moved eastwards to avoid the new flying buttresses.

Bottom left: the lead straps securing the down pipes were held by two iron nails in wood plugs, only one of which still survives (bottom right), retaining a fragment of the lead strap beneath the round head.

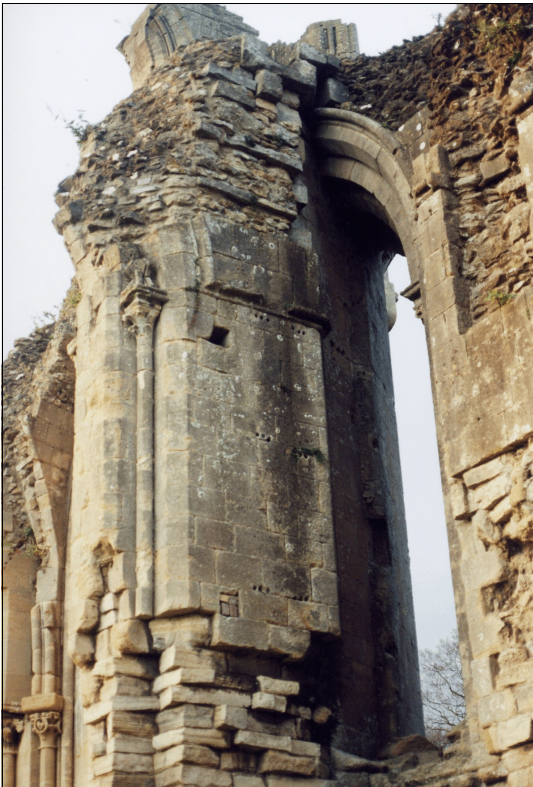
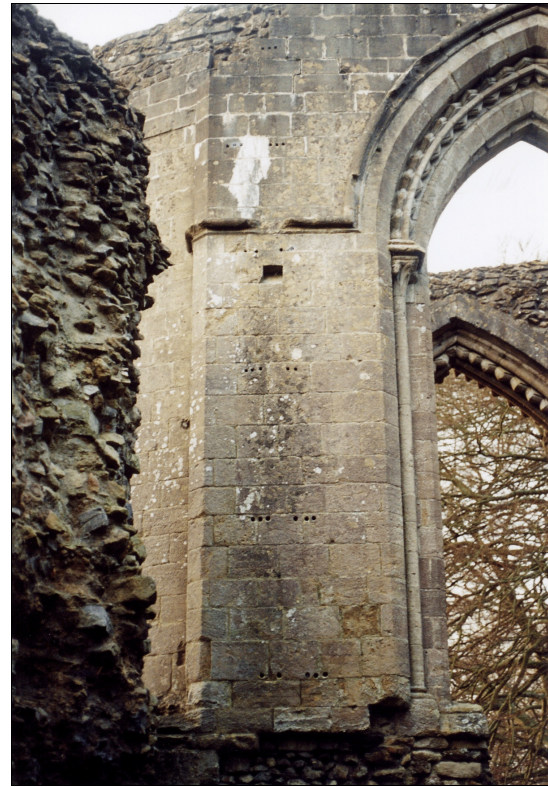
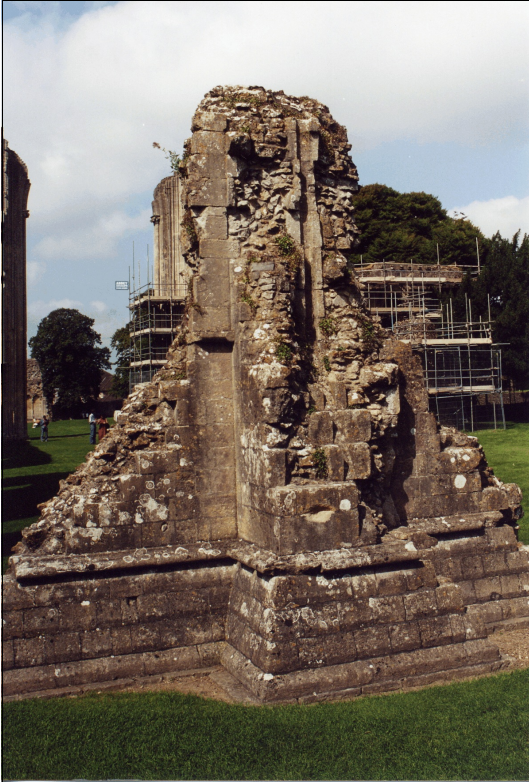
**Rainwater management elsewhere on the great church.**

Above: the north (right) and south (left) transepts had lead downpipes fixed to the wall adjacent to the side walls of the choir, each strap having three fixings to either side, the sets of six holes still clearly visible, with slots cut through the string-course. Above the south transept downpipe the curved water channel carrying off the water from the SE angle of the tower is preserved.

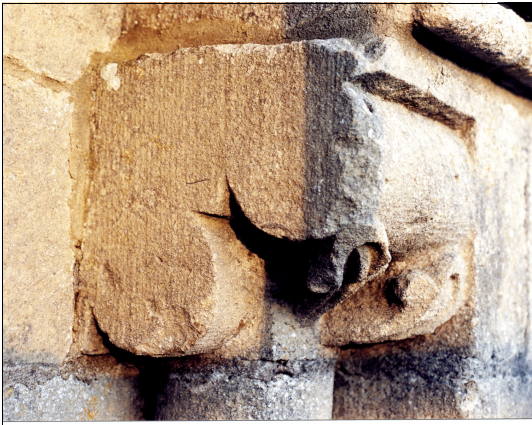
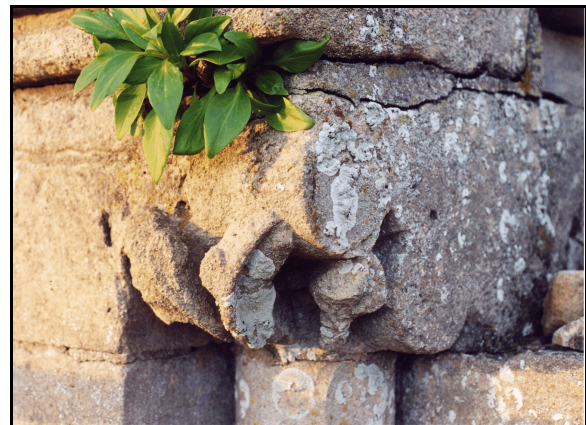
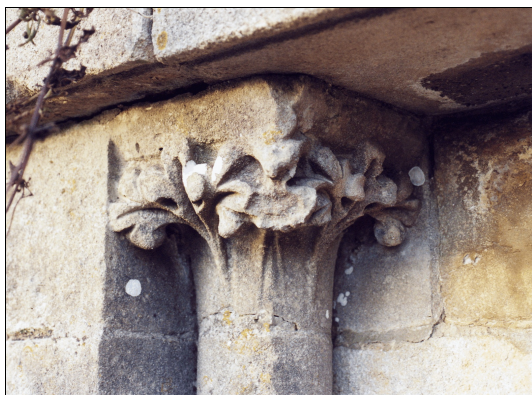
The change in the form of the capitals at the base of the parapet: in the eastern bay the foliate capital has merged with the form of the corbel-table (above); further to the west conventional capitals are used, the foliage similar to that of the north porch at Wells (left).

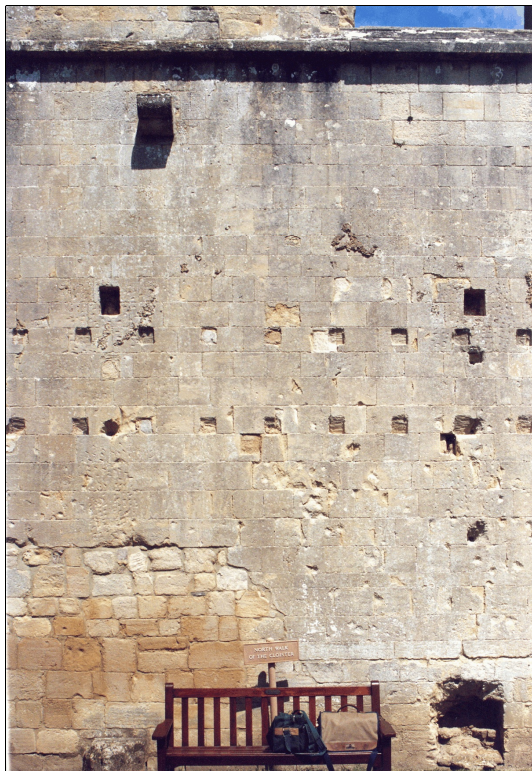
Left: the ends of the beams forming the early cloister ceiling were seated in shallow rectangular recesses in two rows.

The heavy corbels to support a wall plate (just below the drip-course) are later, but the early roof must have been seated at the same height. The two rectangular recesses relate to the cloister of Abbot Chinnock. The area of masonry at lower left is a post-medieval repair post-dating the destruction of the cloister, since it does not bear the pecking for fixing the cloister's attached shafts.

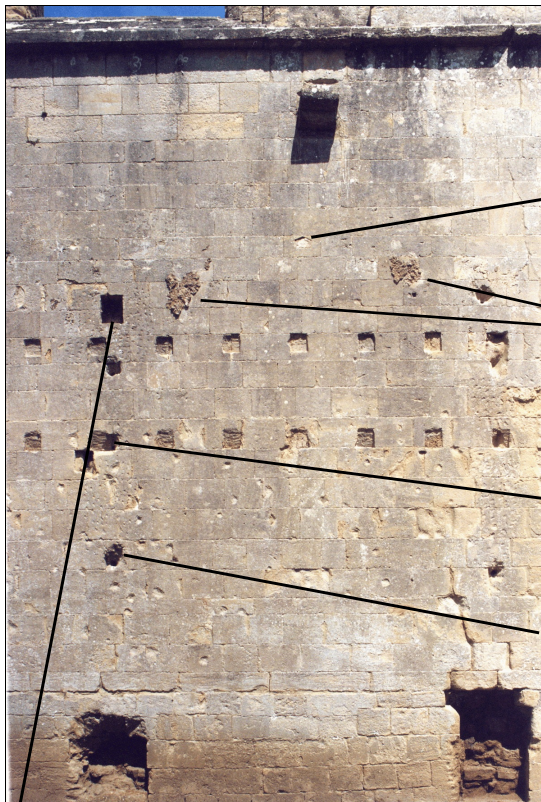
Marks of the C15 Cloister

Socket for ridge rib of vaulting

Fixings for wall-shaft

Socket for upper vault member

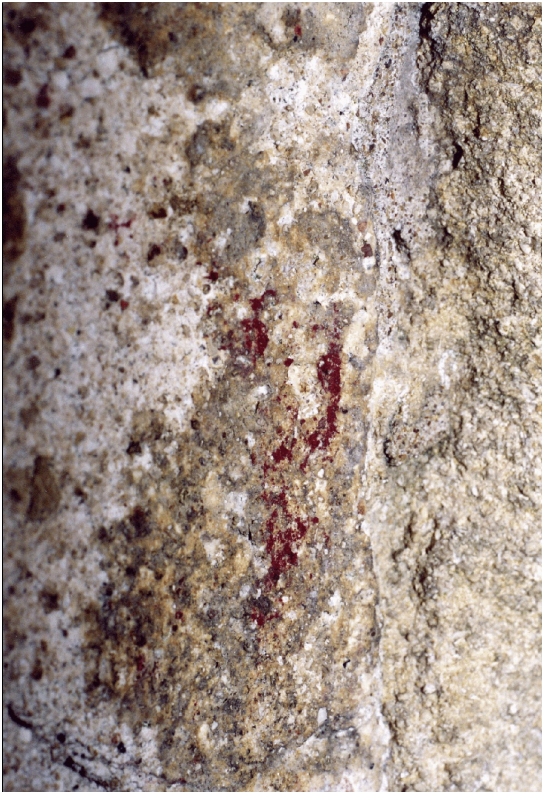
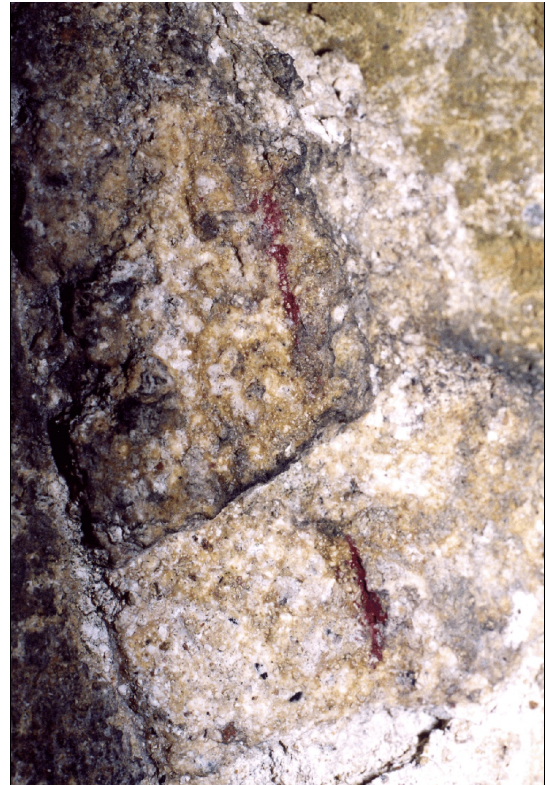
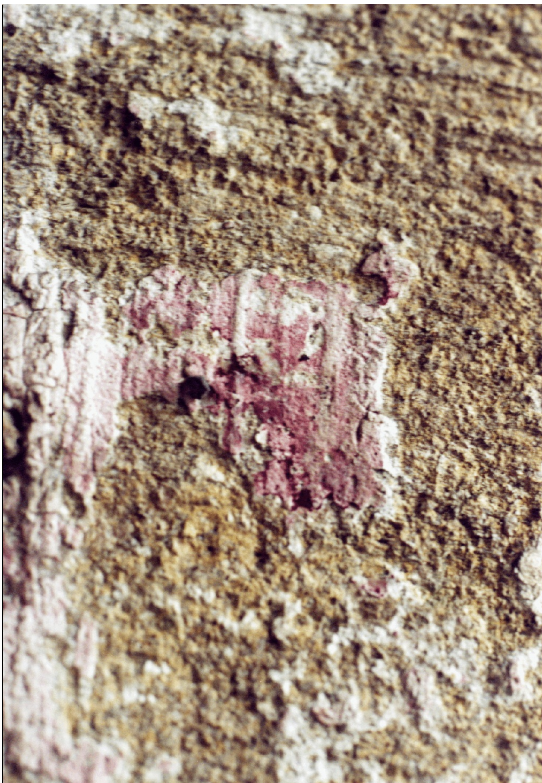
Above: two details of Area 11 (Bay 4/5, vault springer) - possible traces of red ashlar-lining on the vault web. Left, a more diffuse patch; right, a possible (discontinuous) ashlar line.

Left: detail of Area 15 (Bay 4, soffit of window head) - residue of red paint on white ground.

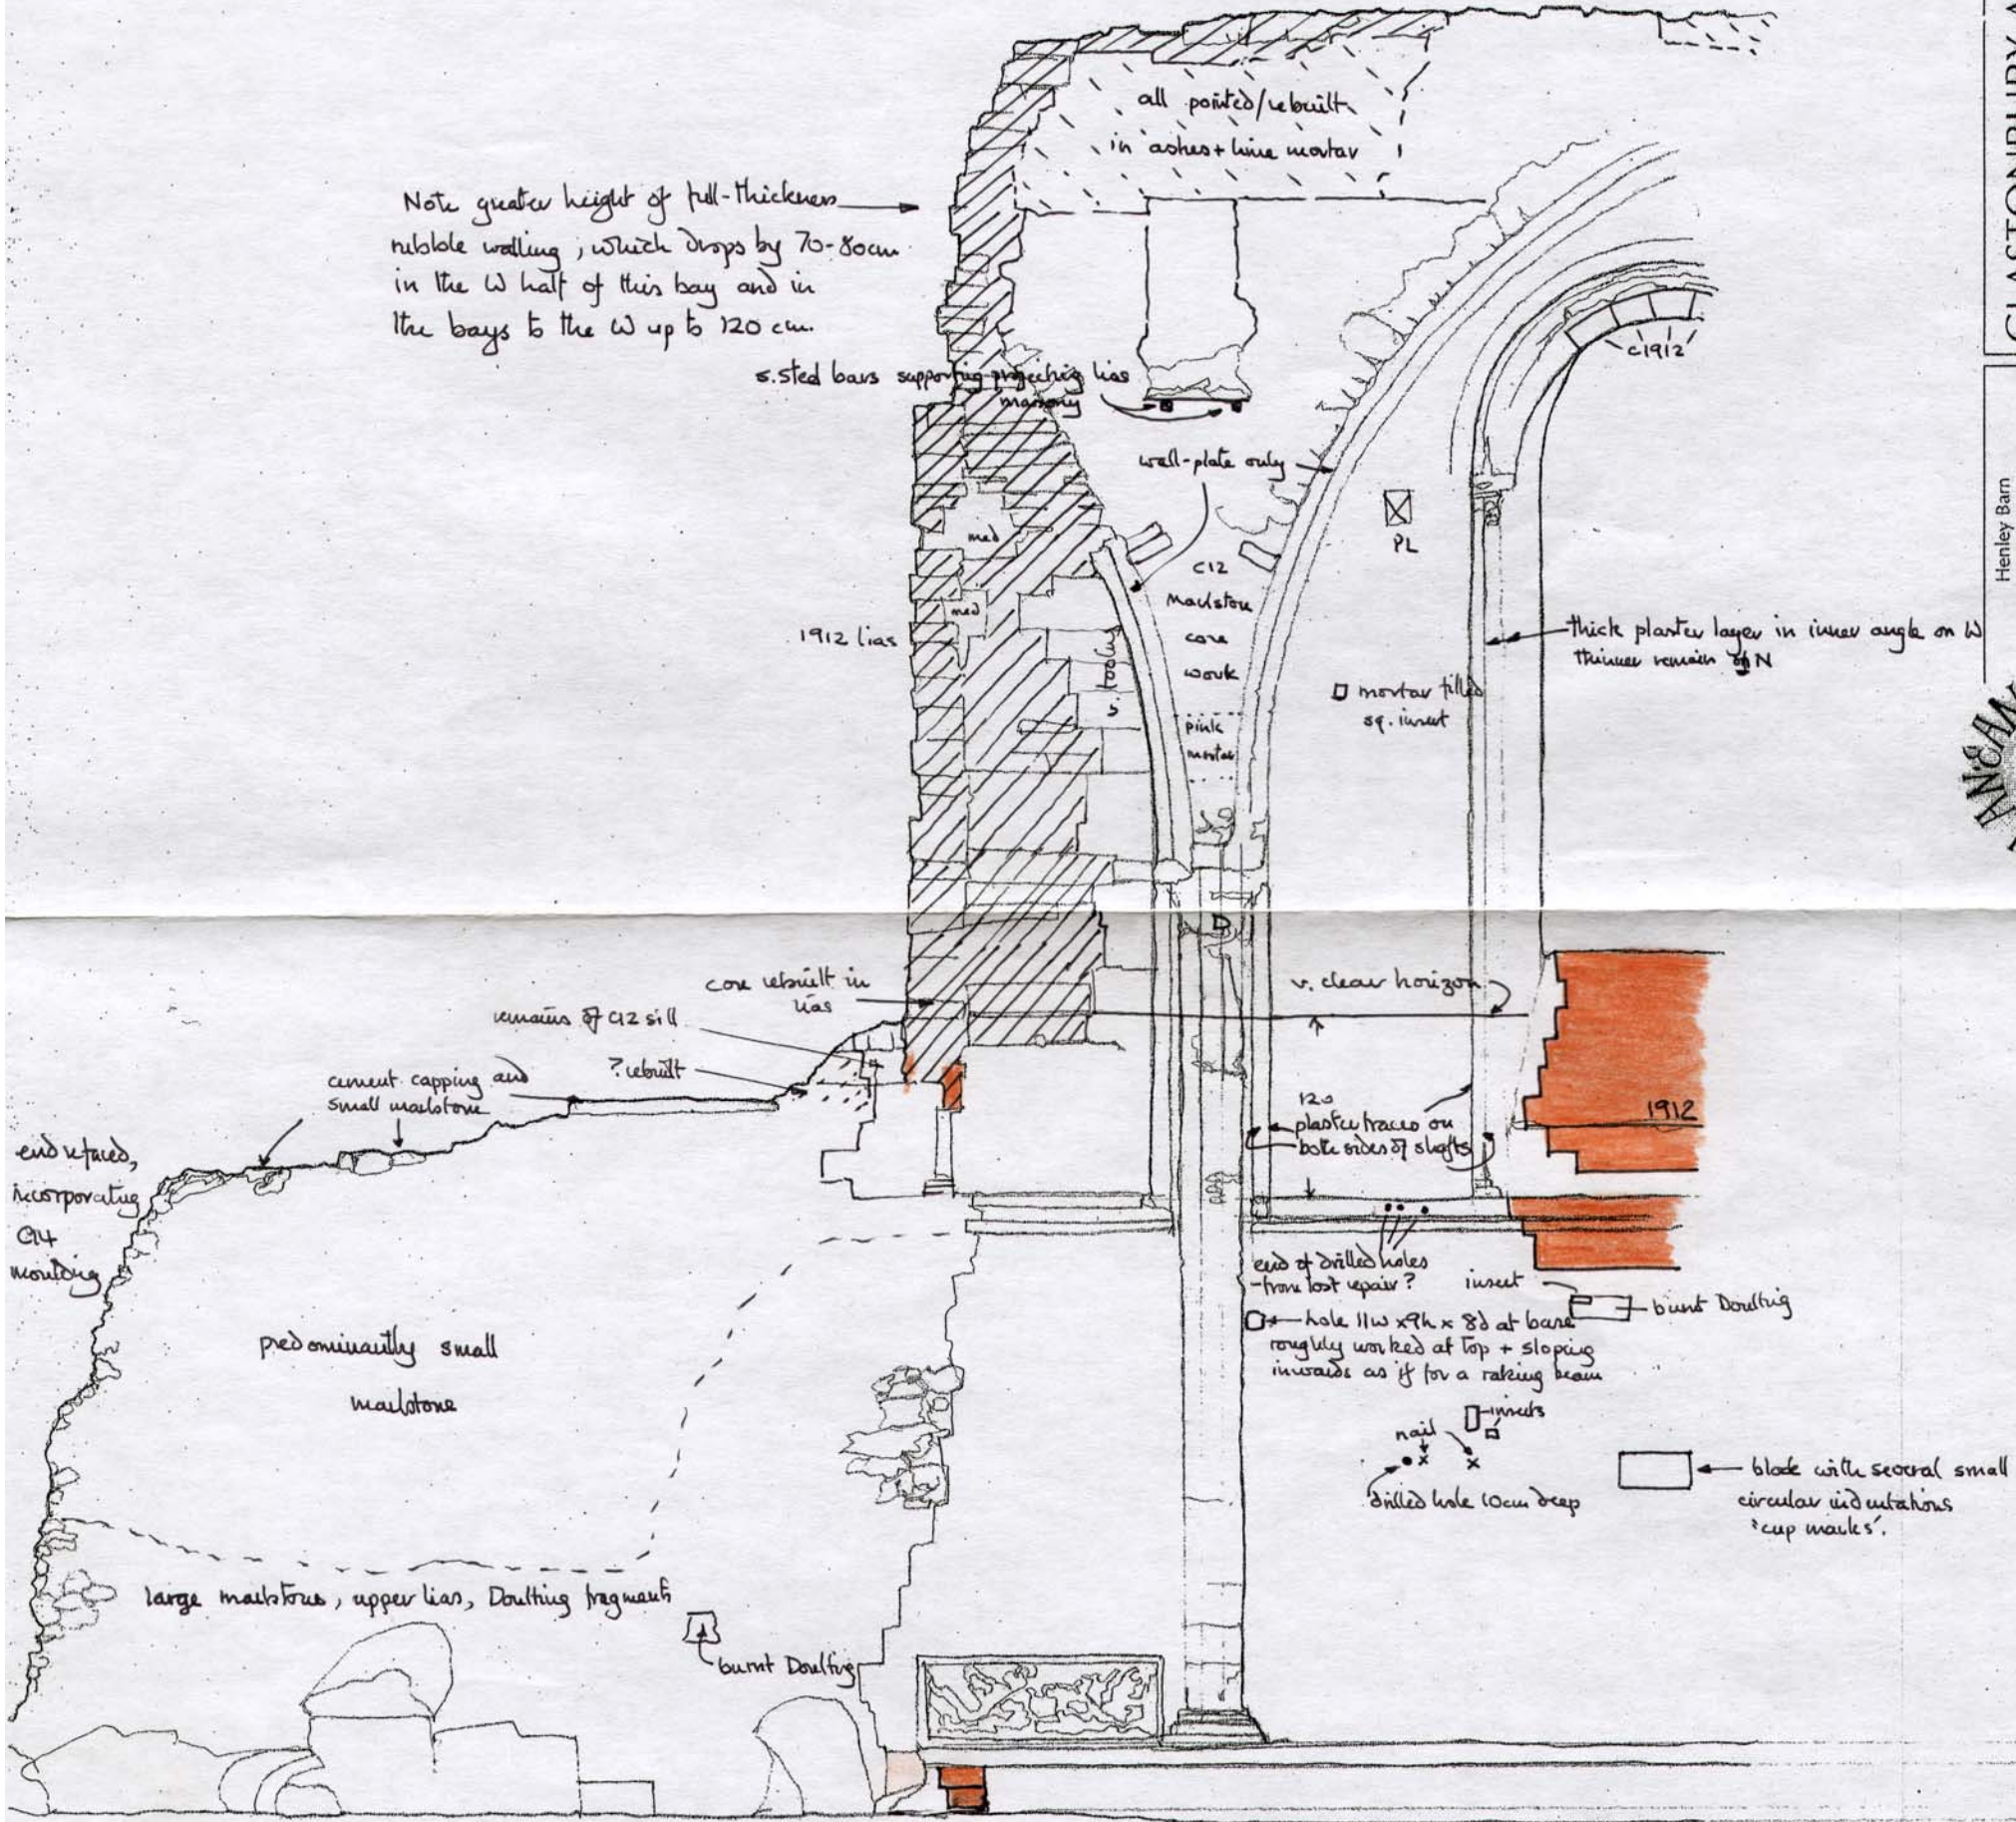
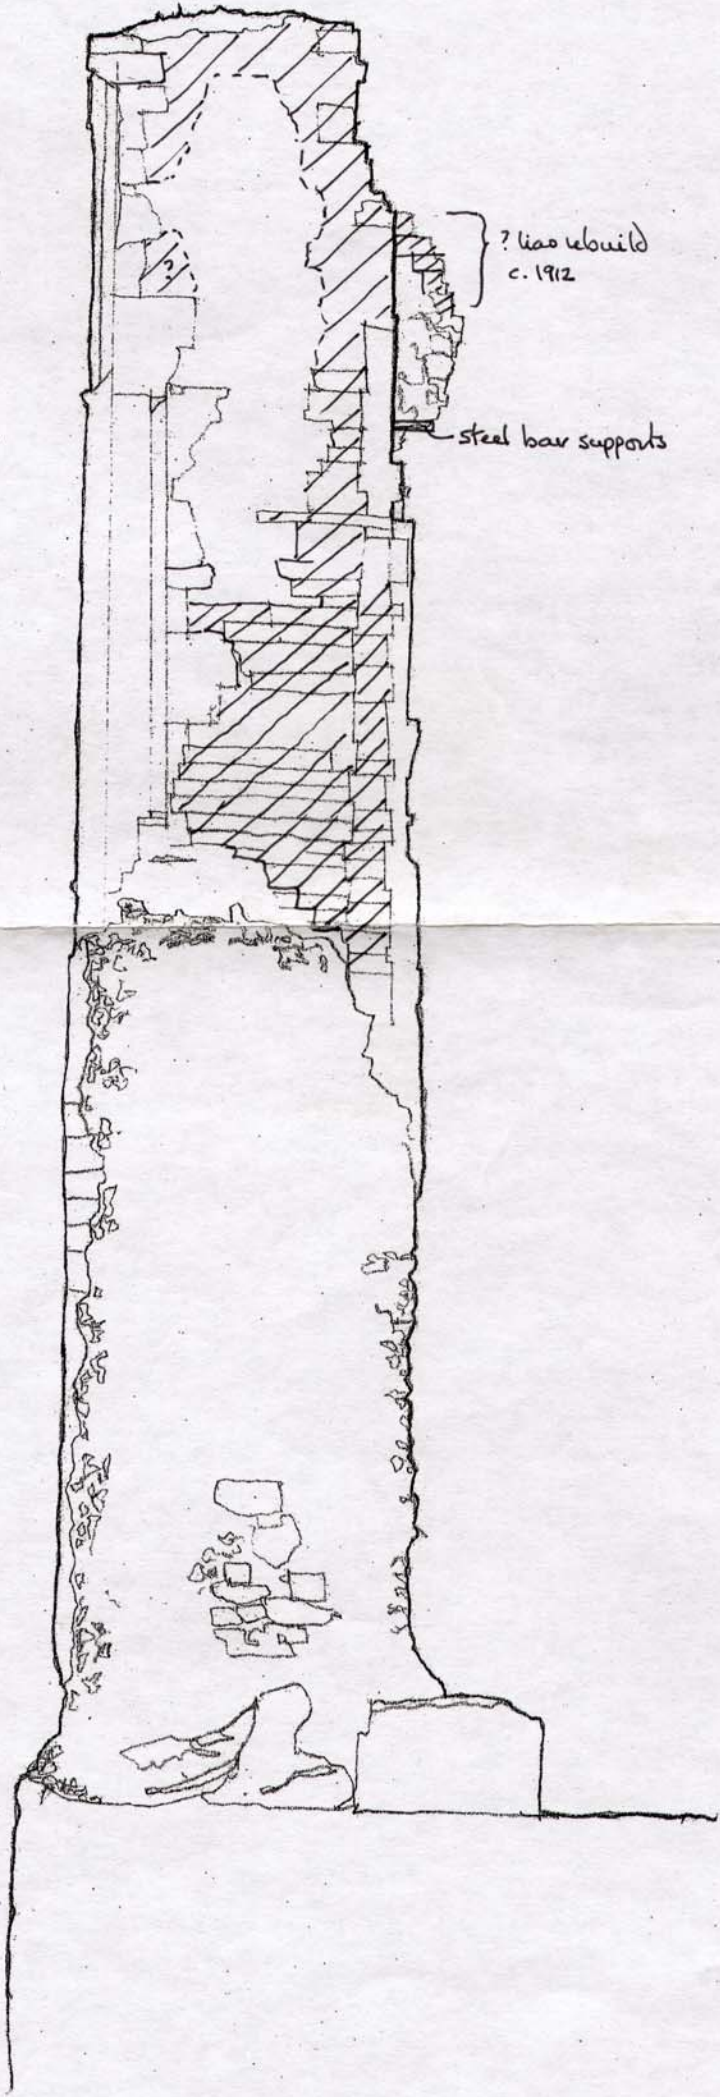
EAST ELEVATION  
 Scale 1:50  
 May 2004  
 262/53

- ④ Squared hole for saddle bar  $4\frac{1}{2}$  sq + ring .14 in deep. Poss. trace of a subsidiary hole just to the N, though v. uncertain; however, at the N end of the springing course for the S arch is a square mortar patch similar to those detected in ② & ③, and another sq patch with stone + mortar infill on the N arch's springing course base bed beside the angle with the N facing chamfer.
- ⑤ Much paint remaining slate with red overlaid with white with pink (or wash of red spread over limestone?) and black.

lower and quite different form of parapet, the capitals feiate adaptations of the corbels fr. the corbel table, but apparently genuine since the keel of the attached shaft beneath is carried up onto the neck. The water-chute on the central stone immediately beneath the string-course is correct for the down-pipe beneath, but it appears to be closed by the string. However, the stone over the chute is v. narrow - just the width of the opening - and is probably inserted, perhaps when the down-pipe was moved E or perhaps later. There is rather opening w/o chute for an eastern pipe. What is the status of this feature?

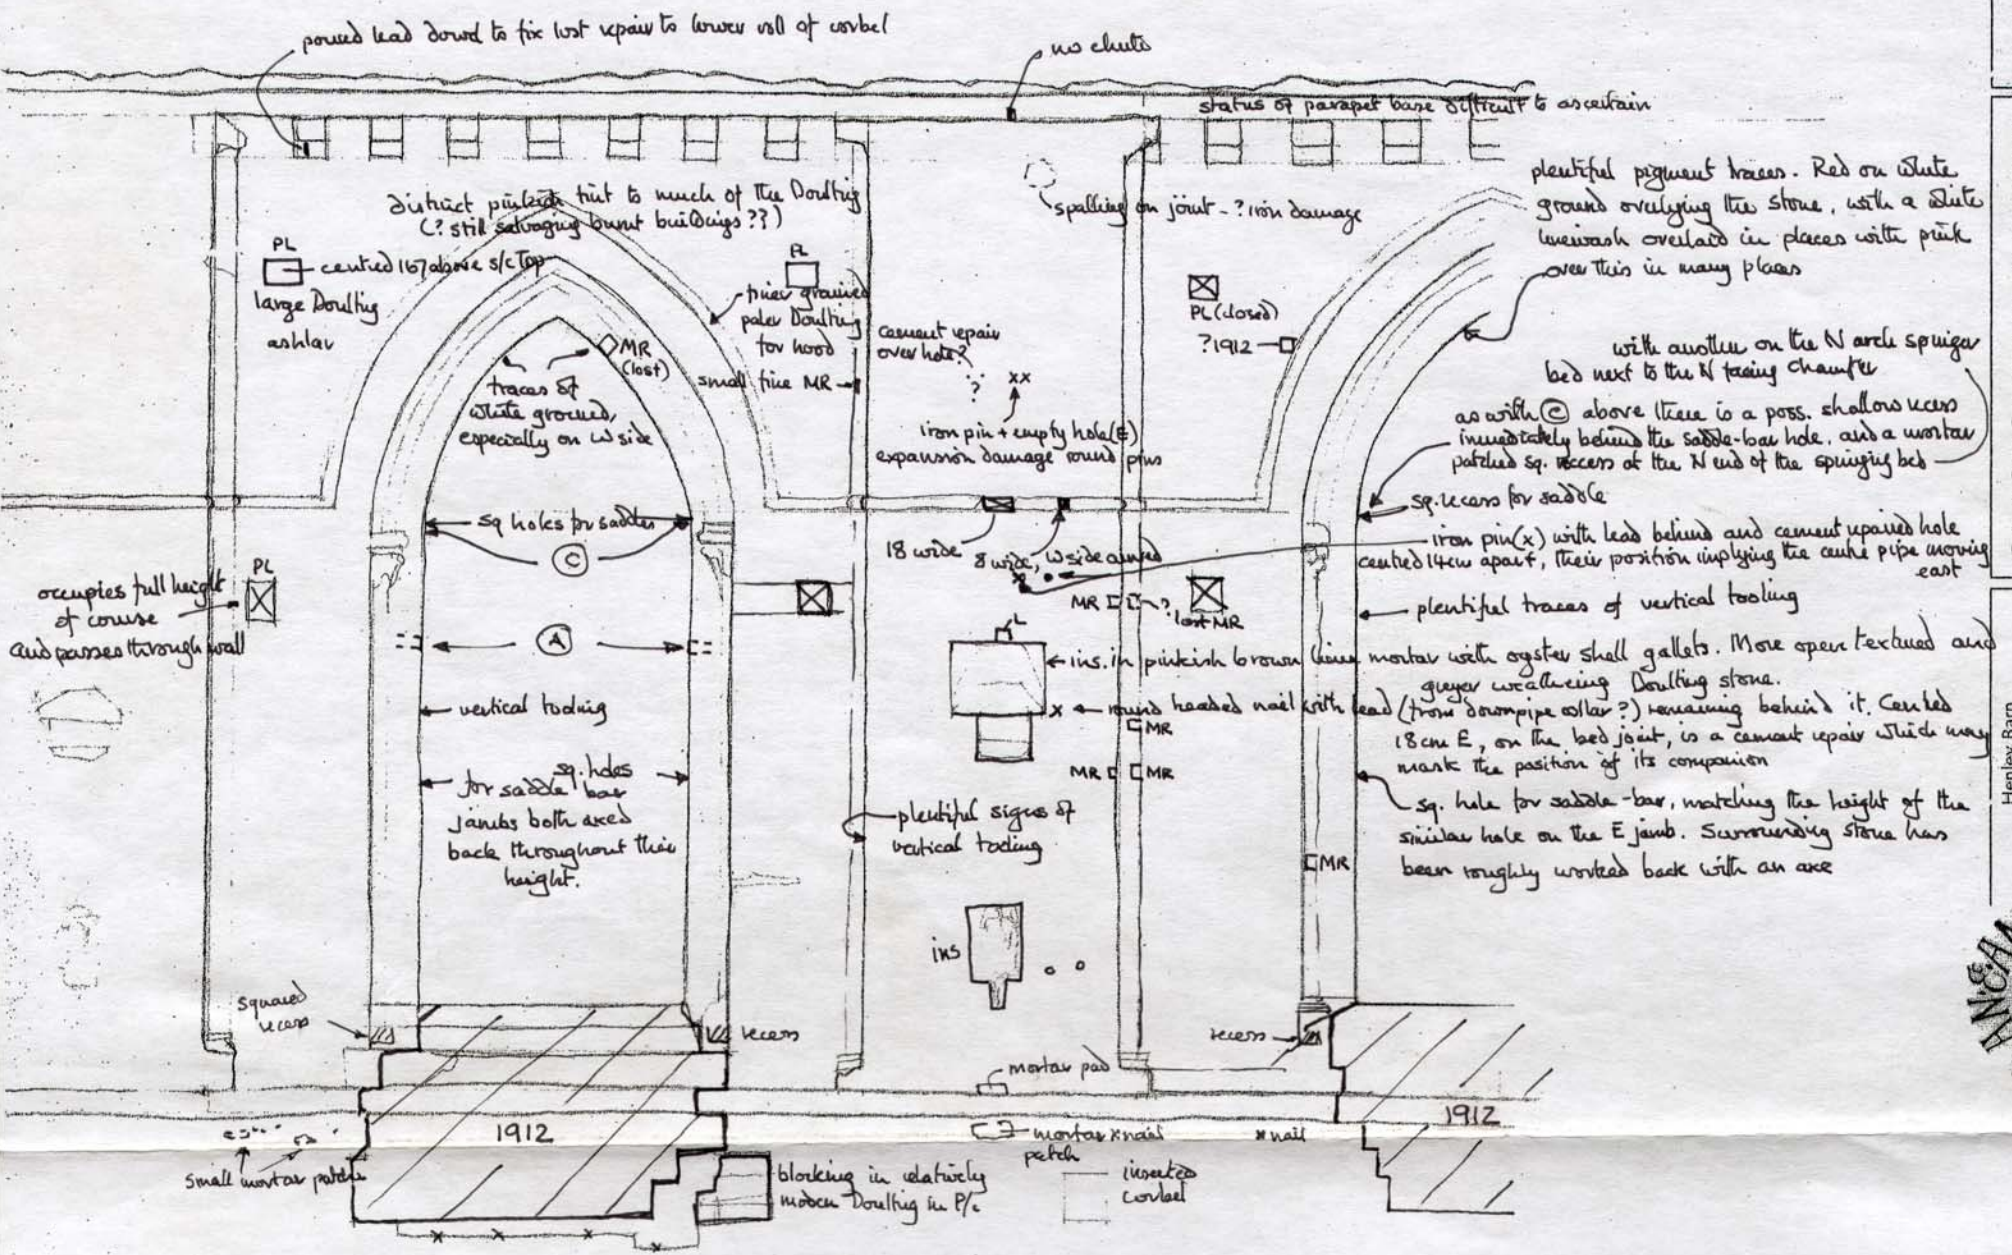
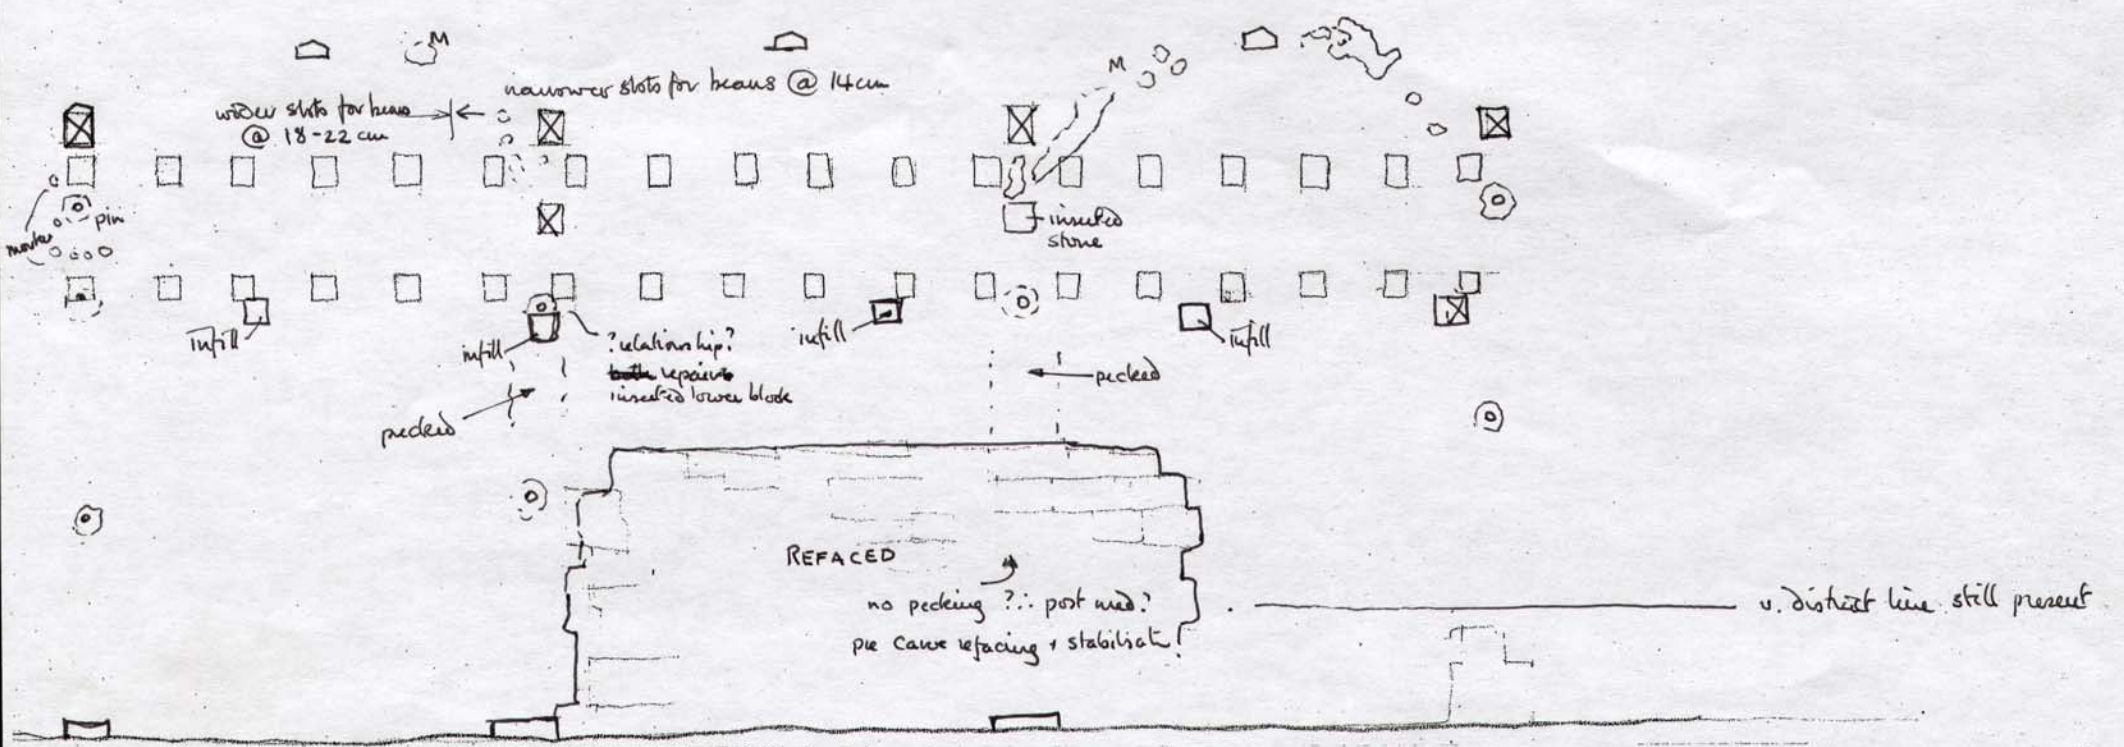
SOUTH ELEVATION (3 of 3)  
Scale 1:50  
May 2004

- (A) 3 sq. holes on each jamb between 11 + 15 cm and roughly square, up to 36 cm deep - 4 are filled with squared fragments of tufa (the 2 on the west fixed with a pale lime mortar, those on the W base; the other two with loose weathered fragments of Dorling stone mouldings. The use of tufa, and the mortaring-in of the E pair suggests a med. (or Dissolution?) date.

- (C) Centred 14cm back from the centres of the saddle-bar holes, and a little lower (being on the base bed of the arch springer) are two semi-circular recesses,  $5\frac{1}{2} \times 3h \times 4\frac{1}{2}d$  (orig) to W and  $6\frac{1}{2} \times 3\frac{1}{2}h \times 4\frac{3}{4}d$  (orig) to E. This course-line dies out as it approaches the N edge of the jamb and at this point on each side is a square mortar (E) or mortared stone (W) patch. @ the springing course of the N arch, at the angle with the inner chamfer, on each jamb is a further square mortar patch. Cf. (B) - to do with anchoring centring for the 2 arches?

(B) On the bed rising back from the top of the spacing abacus are 2 areas of mortar infilling on each jamb, centred 23 + 63cm back from the inner face of the saddle-bar hole (W - the E is 26 + 58 cm). Their infilling shows that they went out of use in the middle ages - the mortar is similar to the construction mix so they may belong to the centering for the arch. The same is suggested by the presence of pairs of square mortar-filled holes on the lines of the top of the N facing abaci on each jamb, the northern on the face of the jamb next to the chamfer, the southern centred 44 (E) and 58 (W) cm back from the angle. Each pair lies on the springing of its respective arch.

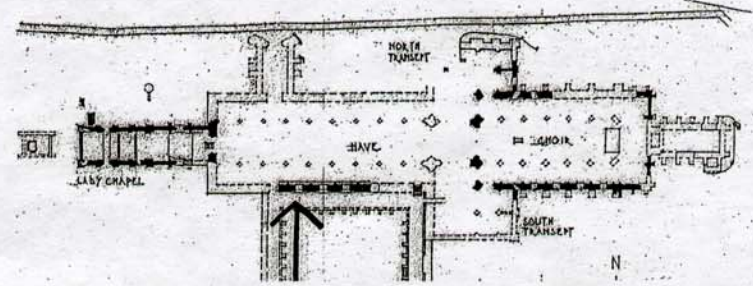
WEST ELEVATION  
Scale 1:50  
May 2004  
262/57

- ① blocking of hole left by withdrawal of corbel for wall plate
- ② mortar patches adhering to block below s/c (? associated area of carbon accumulation) - to do with roof?
- ③ blocking of destroyed label stop includes a piece of moulded ?Dundry with lime wash on the surface. Blocking initially fixed in a rich brown ?roman cement, with later P/c pointing

Lies forming the N edge of the rebuilt face, with (large) pieces of marble and some upper lies (generally in the top course) All with cement haunching.
