## ***Hanover protected wreck***

*Marine assessment for possible de-designation*

Historic England

May 2017

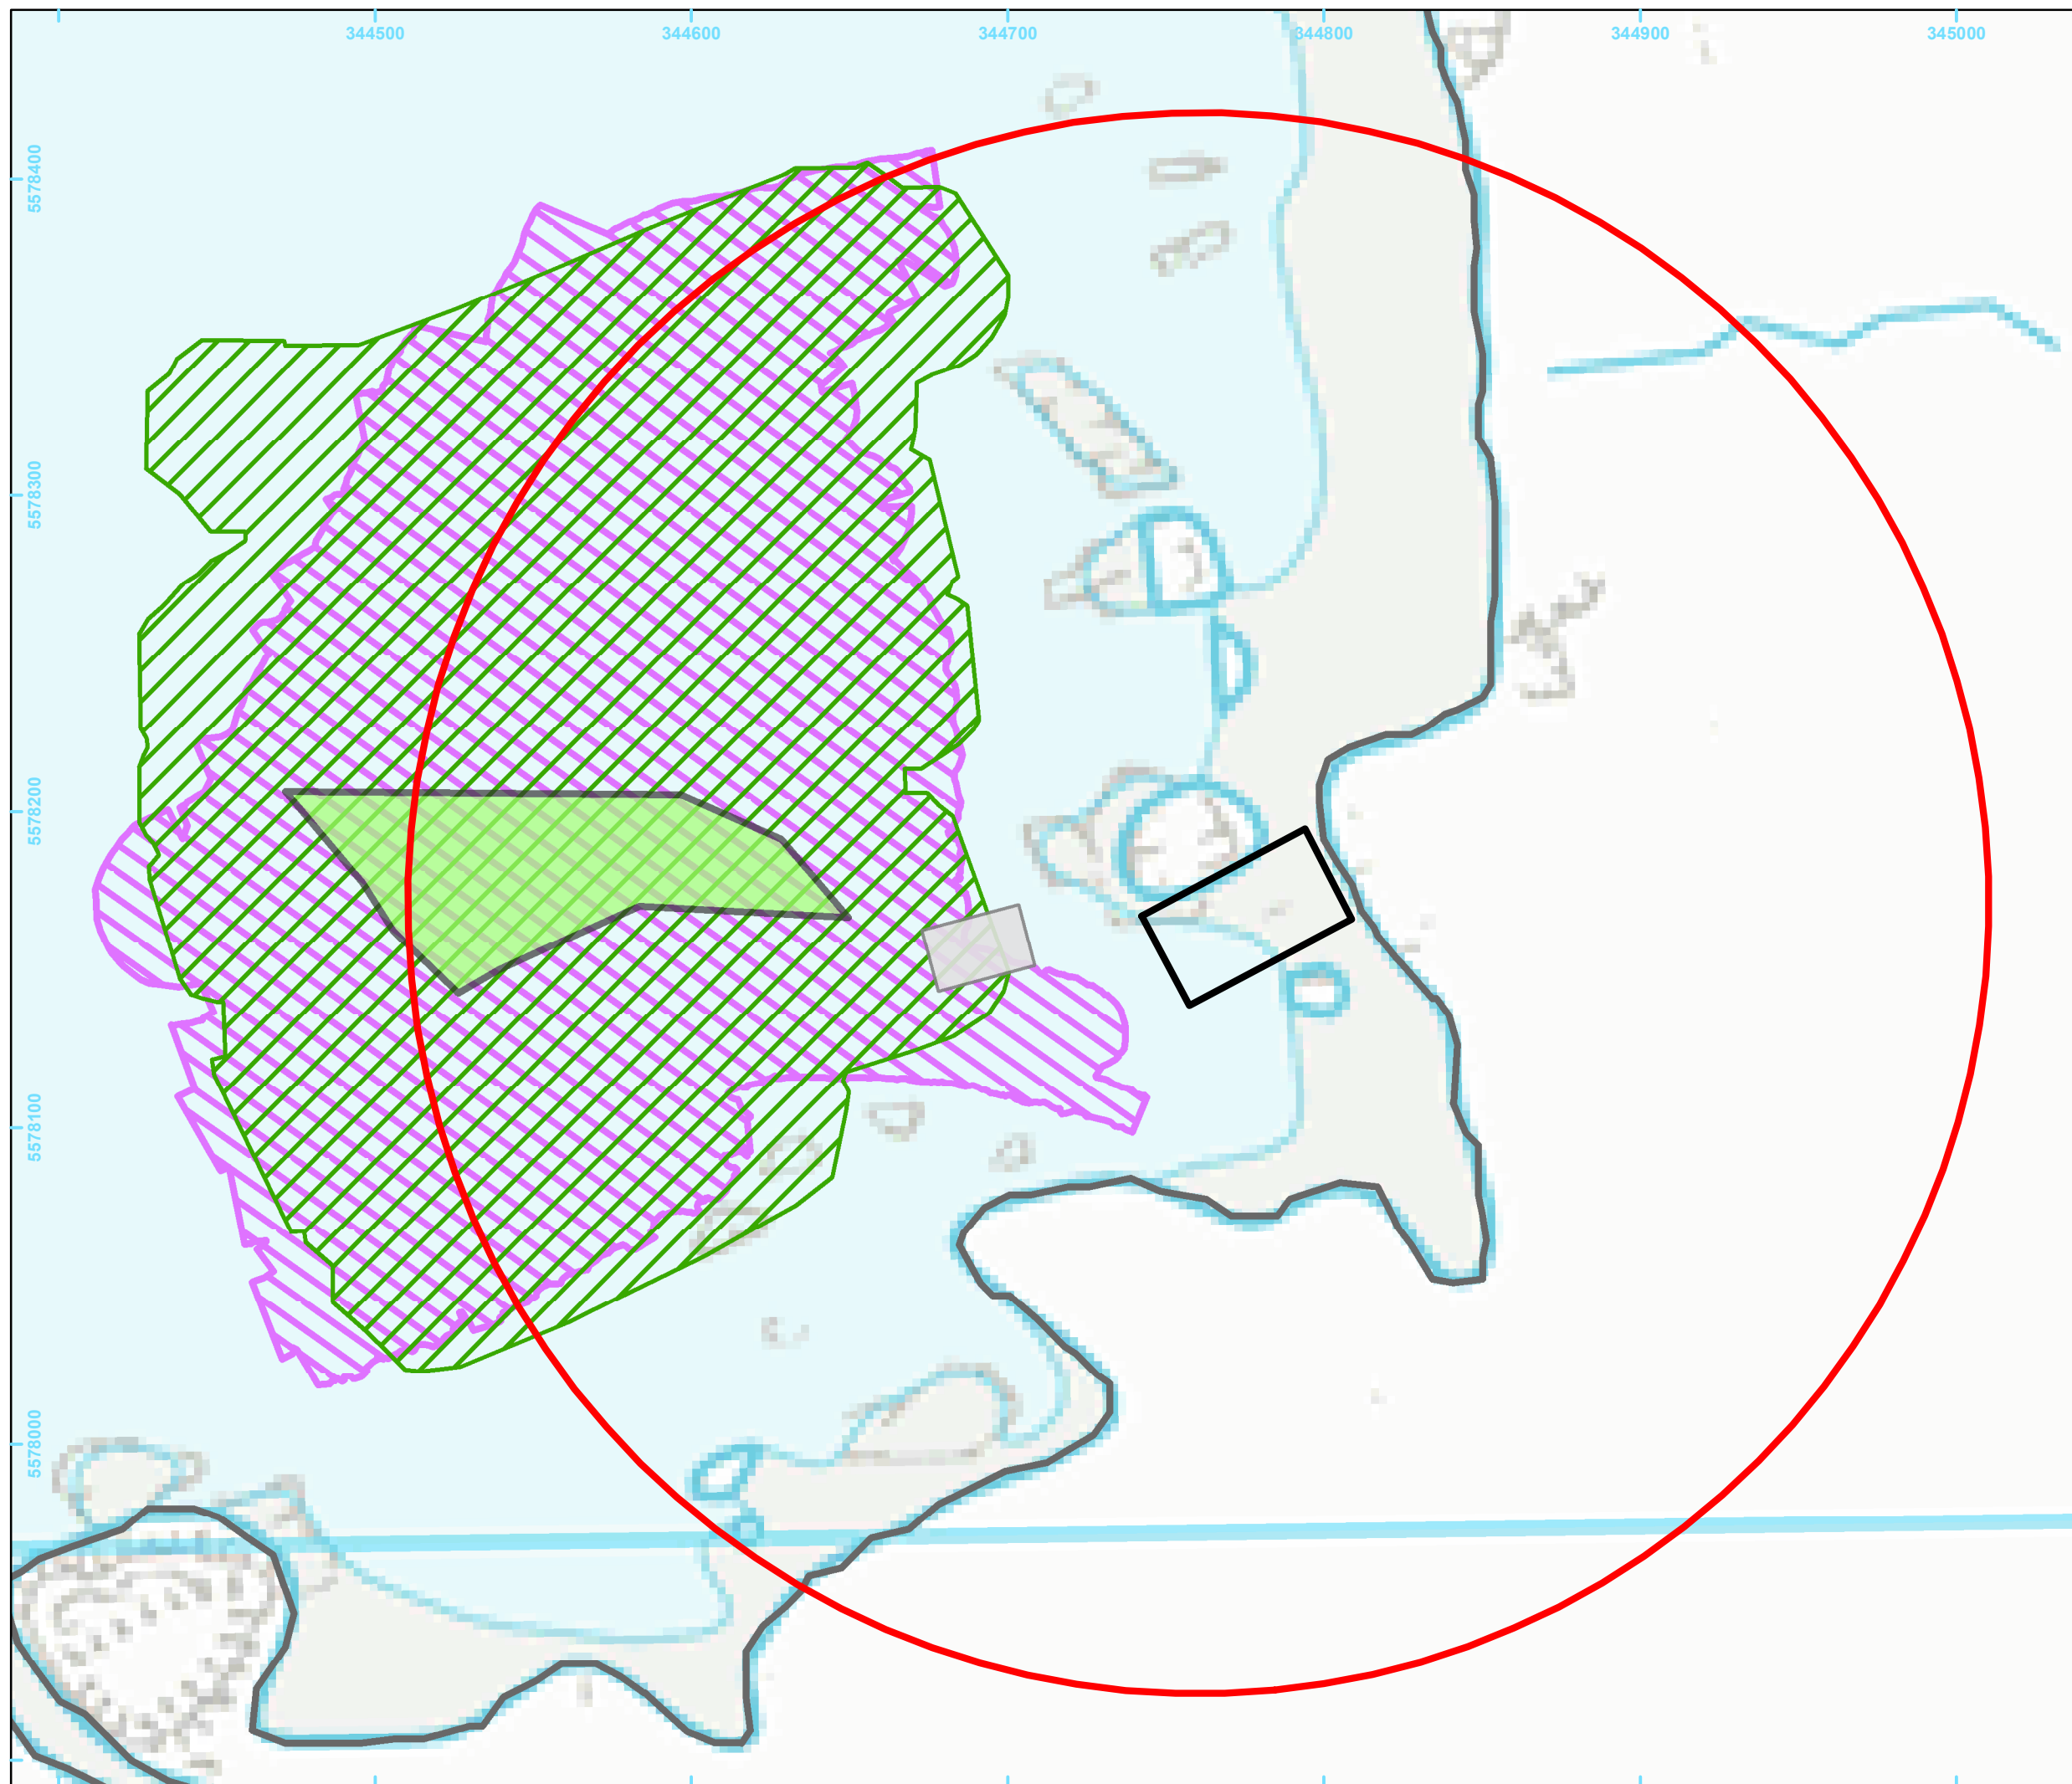
**Hanover designated area location  
and 2016 marine survey coverage**

- 7.4. The cluster of magnetic anomalies covers an area measuring c. 180m east-west by c. 70m north/south. It is located c. 100m west of where the salvage operations (Figure 1) were recorded as having taken place (Parham, *et al.*, n.d.), and c. 30m west of the position of the jack-up barge as estimated from photographs (Figure 1 and Figure 7). The nature of these objects cannot be determined without intrusive investigation, but the absence of magnetic anomalies in other locations within the designated area would suggest that these may be an associated group for which there are several possible explanations.

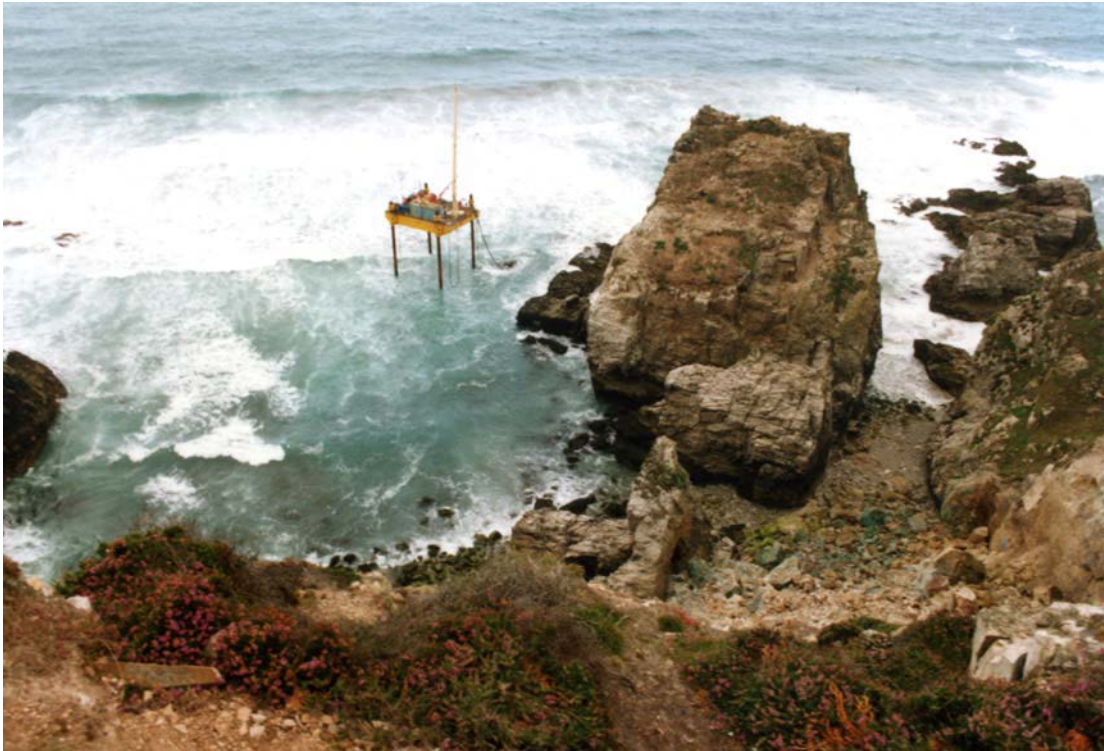
Figure 7 Hydrasolve jack-up barge in position in Hanover Cove (Parham, et al., n.d.). Note that part of the beach is exposed near the cliff

- reports that the site was under 3-4m of water at low tide (Parham, et al., n.d.) when in fact the reported area of the wreck was dry during the recent foreshore survey and also appears dry in the photograph of the jack-up barge (Figure 7); and
- the photograph of the jack-up barge appears to place it some distance from the reported location of the site (Figure 7).

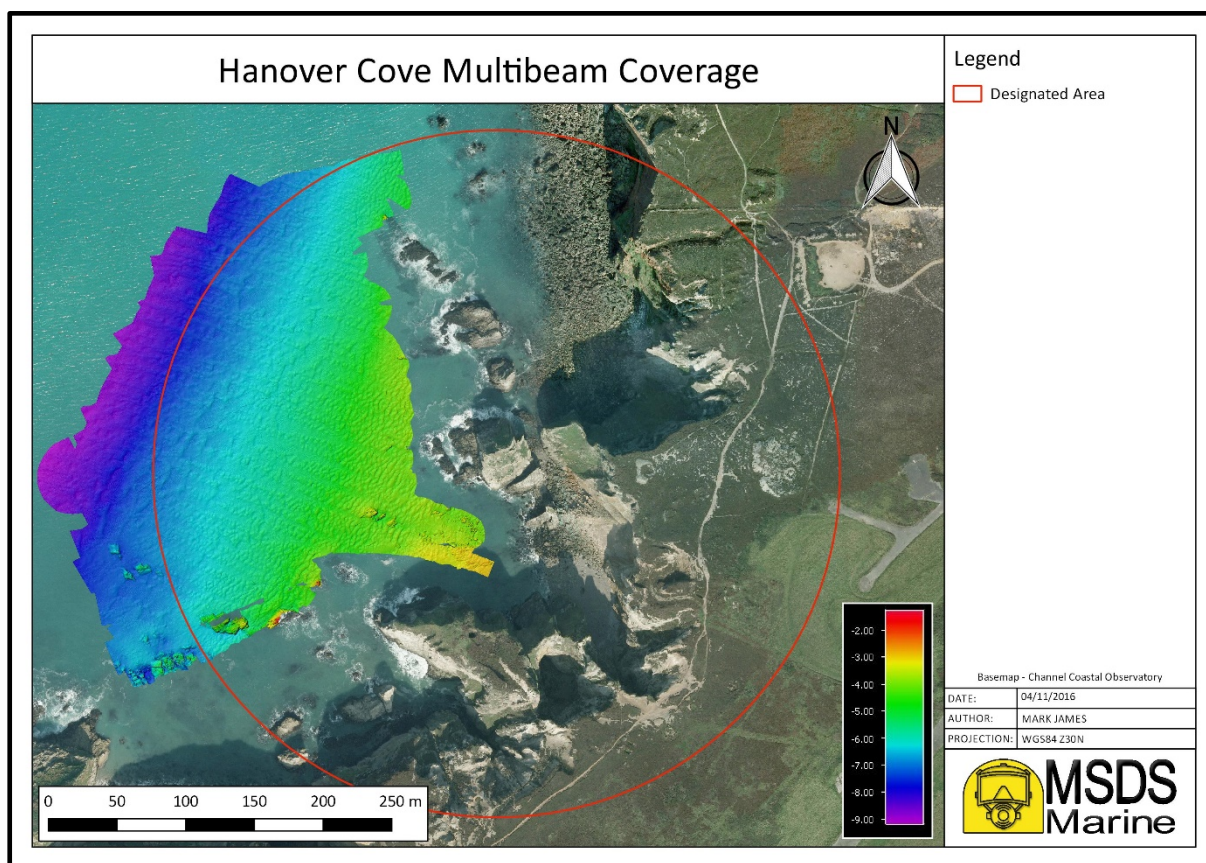
Figure 5: Hanover Cove multibeam coverage

4.1.1 Shallower areas were surveyed when the tide was highest to ensure that as much of the designated area as possible was surveyed. The presence of large and submerged hazards prevented the coverage of all underwater areas.

4.1.2 Two anomalies of potential archaeological interest were identified in the multibeam data, however it is highly likely that these features represent rocky outcroppings that have been partially uncovered due to sand movement.

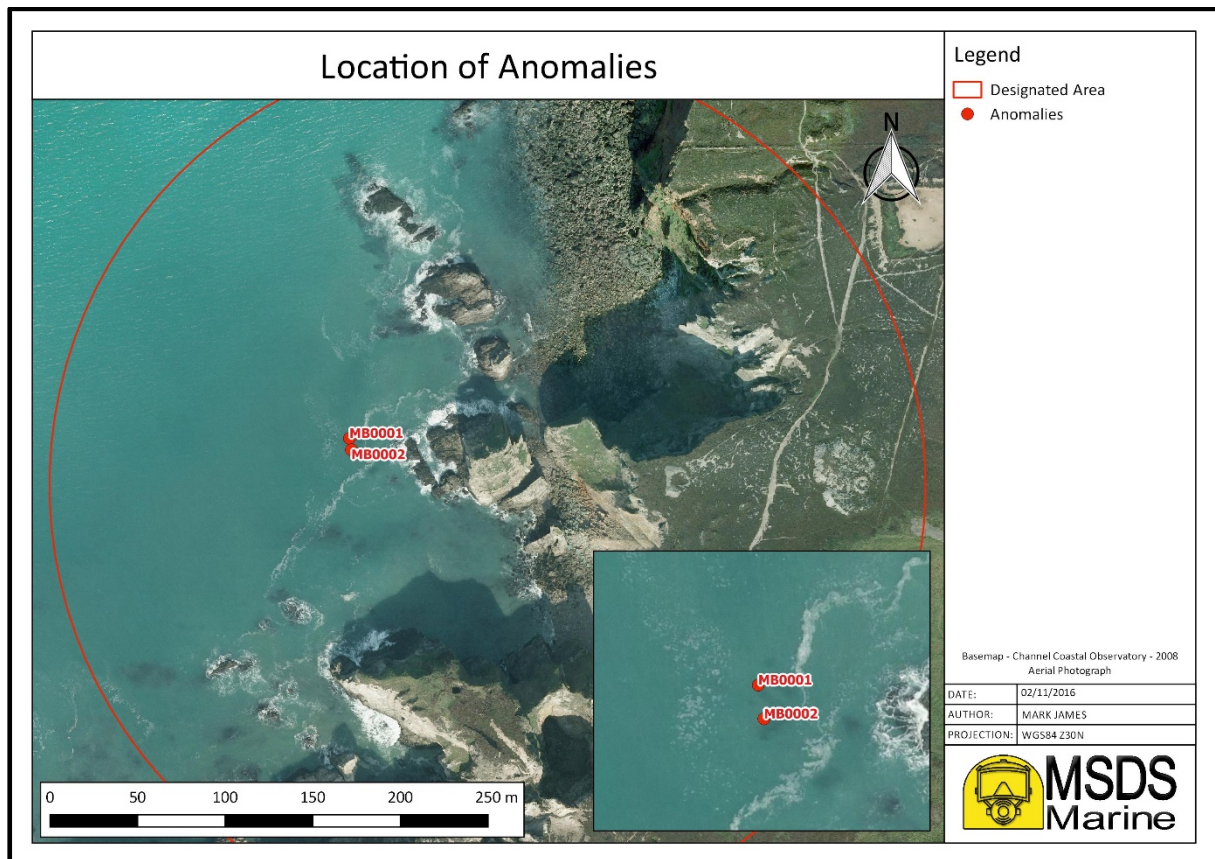
Figure 6: Location of anomalies

344685.863	5578192.009	Anomaly MB0002 is a feature made up of a linear anomaly 4.7m in length with another linear feature 2.5m in length at the northern end. The smaller linear feature has a curved element to the eastern end.
--------	---	------------	-------------	--

4.1.3 The identified anomalies are in very shallow water, between 1m and 4m. Aerial photography from 2013 shows these locations almost dry although the state of the tide is unknown. Local boat skippers have indicated that it is possible to walk out 'quite far' on a low spring tide.
