Western Breakwater, Granton Harbour, Edinburgh

Archaeological Watching Brief & Standing Building Survey

Report No. 1581

December 2008

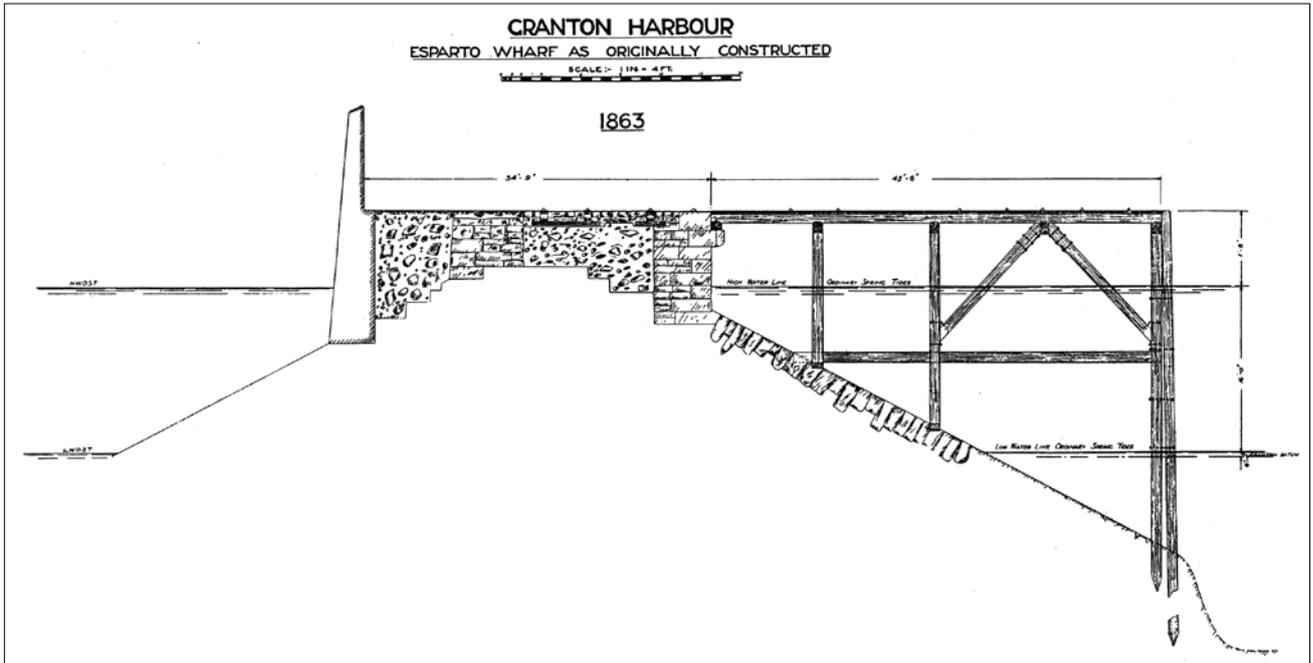
3A

- 3.1.10 A large mass of angular rubble infill was noted to the interior of the ashlar wall (**006**). This deposit corresponds with the central infill of the internal and external ashlar walls in Fig. 3a.
