**Chedworth Roman Villa**

**Conservation Management and  
Maintenance Plan Gazetteer**

**September 2007**  
**Revised November 2009**

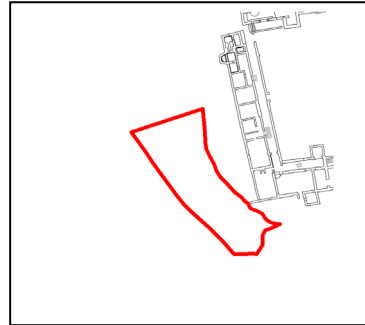
**Reference no:** 002.001  
**NT SMR:**

Sloping gravel trackway, leading up to flattish area adjacent to woodland boundary. Trees and brush to west of trackway, include ash and whitebeam, and non-native Western Red Cedar. Track is steep, woodland is managed but not planted.

Short-term cyclical: Brush needs managing, trees and shrubs trimming on a regular basis. The path needs regular gravel replacement, as it moves downhill and is washed away.

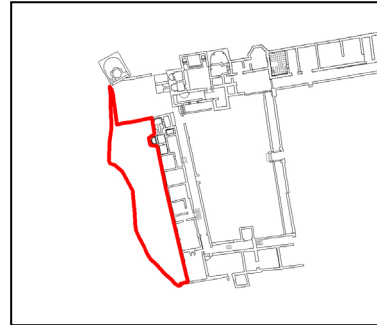
**Reference no:** 002.003  
**NT SMR:**

Sloping grassy bank, with clear break of slope where Roman boundary wall runs under turf; several humps are modern spoil heaps.

Short-term cyclical: Regular grass-cutting to keep down any tree regeneration and keep tidy.

Long-term: remove spoil heaps to return to smooth slope profile, keep to grass.

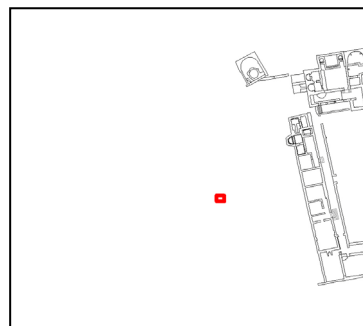
Small shed with planked exterior, single-pitched felted roof, surrounded by trees (Western Red Cedar). Contains water tanks and pumping gear.

Remedial: Clear tree debris from roof, treat walls with preservative and/or stain to soften aesthetic appearance.

Short-term cyclical: Survey every 3 years, repair as necessary

Long-term: If water system remains as is, there will be a need to house the pump equipment and header tank(s). This shed will be maintained through a regular cycle of survey and repair until it requires replacing or removal. Long-term aim would be to remove for aesthetic reasons. The Western Red Cedars surrounding the shed will need to be felled, as they will grow too large if left long-term. This may require a new planting screen of smaller native species.

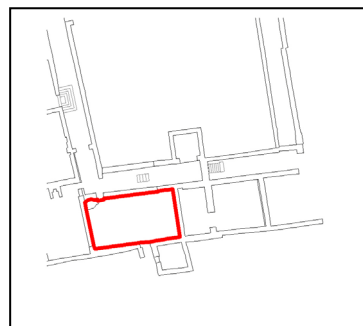
**Reference no:** 003.001  
**NT SMR:** 75481  
**Type:** Part of building

Large rectangular room identified as Roman kitchen, with reconstructed base of Roman oven in north-west corner of room, made of concrete kerbing. Crossed by visitor pathway, ground level slopes down to east; Low walling capped by flat concrete slabs and in south-east corner by irregular stone slabs. Trial pits revealed make-up deposits or demolition debris and a well-preserved section of mortar floor overlain by charcoal lenses.

Remedial: Path at north end of room has concrete kerbs, which need lowering to provide a level access to the garden court. Blockwork around oven needs repairing.

Short-term cyclical: Re-point walls with appropriate lime mortar, cut grass regularly. Signs need to be re-coloured.

Long-term: Path needs to be levelled if this remains the visitor route between the reception building and the site. Resurface with gravel. Walls need re-capping to ensure a uniform style. Oven could be laid out in more sympathetic materials.

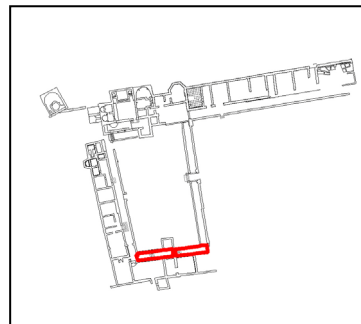
**Reference no:** 003.005  
**NT SMR:** 75520  
**Type:** Part of building

Long narrow corridor running west-east, linking Rooms 1, 1a, 1b, 2 and 3. On two levels, a modern wooden staircase joins the two parts. The ground level is laid to tarmac.

Not much known about archaeology below tarmac (no mosaics present); north wall of lower part also acts as retaining wall for garden court, and is the tallest area of wall surviving on the site - requires more careful monitoring and repair regime. Used as visitor route. Link to east portico blocked by a blank wall (see 010.003). Width of corridor differs above and below wooden steps. Unclear whether concrete steps reflect an original change of levels.

Remedial: Ensure paths are repaired, and staircase sound.

Short-term cyclical: Wooden staircase needs to be surveyed regularly and repaired as necessary. Grass needs to be cut regularly.

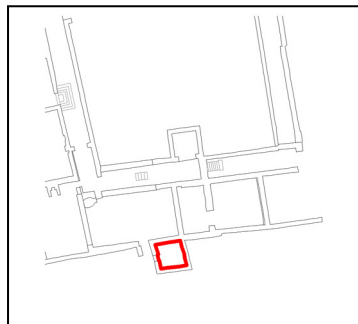
**Reference no:** 003.007  
**NT SMR:** 75482  
**Type:** Part of building

Small square room with exposed surviving features of Roman latrine. Part laid to gravel, sections of stone water-channels and flag flooring are visible. This has clearly been largely reconstructed, following excavation in the 1950s, but general layout of latrine is shown. On interior of east wall, top section of an arch visible, more visible from east side (outside room). Wall cappings have recently (2006) been renewed with flat rough limestone flags. Other stone architectural fragments are present.

Remedial: Stonework which is not part of latrine layout will be removed; existing stonework which is split will be repaired.

Short-term cyclical: All stonework will be inspected as part of regular site monitoring. Continue with winter covering to avoid frost damage.

Long-term: Attempts will be made to elucidate the structure of the latrine, by careful excavation to remove gravel fill and delineate sewer. This will be followed by a proper programme of consolidation and improved presentation. Wall cappings to be replaced to ensure uniform style.

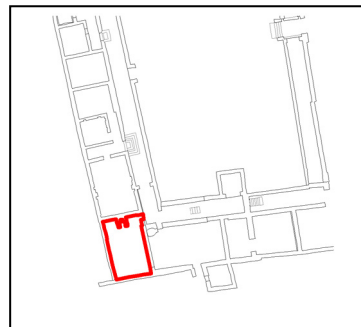
Southernmost room of west wing, contains hypocaust stoke-hole on north wall. Rest of floor area is covered with grass. Small section of wall with herringbone bonding. Walls capped with thick concrete slabs.

Exposed to the elements; wall-capping is unattractive and loose; grassy turf is uneven, detracts from understanding of room as an internal space; underlying archaeology not known.

Remedial: Cut turf away at wall junctions, repair wall-cappings.

Short-term cyclical: Grass needs to be cut regularly, walls need to be inspected as part of regular site monitoring. Environmental condition to be monitored and controlled using the Hanwell controller linked to BMSS.

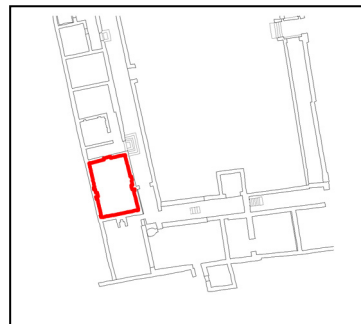
Dining room of Roman house, with partially preserved 4th-century mosaic floor; hypocaust exposed below floor, built on bedrock showing all earlier archaeological strata removed in 4th century; swill drain in south-east corner; mosaic has been partly relaid; whole room covered by 19th-century wooden shed.

Wooden shed provides weather cover but not good access for viewing; mosaic needs regular monitoring and cleaning, as capillary action brings moisture to surface causing efflorescence;

Remedial: Environmental monitoring system needs to be serviced to ensure accurate calibration of humidistat. Mosaic will be inspected daily for any dropped items or litter such as blown-in leaves, which will be removed.

Short-term cyclical: Mosaic will be inspected regularly for surface dust, salt efflorescence, and algal growth, as part of regular monitoring regime of site. Mosaic surface needs dry cleaning twice annually, or more frequently as necessary (depending on dust deposits). Wet cleaning required annually. Condition survey by qualified conservator required annually. Environmental condition to be monitored and controlled using the Hanwell controller linked to BMSS.

Long-term: The existing wooden shed, although it has been modified from the original, does not provide a fully controllable internal environment (especially as the windows are opened to allow public viewing). In the long term the mosaic needs better protection, and improved access for viewing and maintenance. The cement lacunae will be removed, and replaced with a softer lime-based mortar, to help 'wick the soluble salts away from the mosaic itself. The edges around the hole at the north end need to be consolidated.

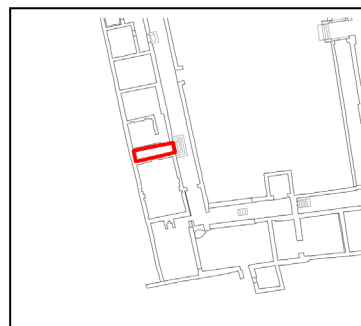
Internal corridor or ante-room to the dining-room (Room 5); has 4th-century geometric mosaic floor, originally part of larger mosaic but with signs of repair on north edge; steps down to corridor/portico; mosaic is re-buried under soil layer, geotextile marker, and coarse gravel.

Buried mosaic not accessible to view; mosaic not easily accessible for monitoring and condition recording.

Short-term cyclical: The walls and cappings need to be inspected a part of regular site monitoring programme, and repaired as necessary. Gravel needs to be kept free of plant growth. Buried surface temperature monitor needs to be regularly checked and serviced as part of environmental monitoring system service. Consideration will be given to a regular cycle of limited excavation and uncovering to assess condition, probably on a 10-year cycle, but advice will be sought from a qualified conservator.

Long-term: A long-term management aim to ensure the proper care of, and access to, the mosaic, would be to enclose the room within a suitable shelter building, and expose the surviving Roman features. Otherwise, regular condition survey must determine the effectiveness of the burial regime, which will be maintained or adjusted as necessary.

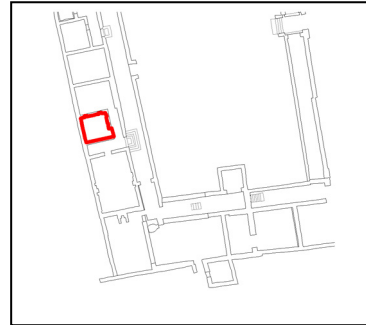
Small room next to corridor 5b, with hypocaust flues visible in wall faces; incomplete 4th-century mosaic floor with geometric pattern survives around edges of room; post-Roman 'squatter' hearth survives on top of mosaic; surviving archaeology is re-buried under soil layer, geotextile marker, and coarse gravel.

Buried mosaic and other features not accessible to view; mosaic and other features not easily accessible for monitoring and condition recording.

Short-term cyclical: The walls and cappings need to be inspected as part of regular site monitoring programme, and repaired as necessary. Gravel needs to be kept free of plant growth. Consideration will be given to a regular cycle of limited excavation and uncovering to assess condition, probably on a 10-year cycle, but advice will be sought from a qualified conservator.

Long-term: A long-term management aim to ensure the proper care of, and access to, the mosaic and the other intact archaeological features, would be to enclose the room within a suitable shelter building, and expose the surviving Roman features. Otherwise, regular condition survey must determine the effectiveness of the burial regime, which will be maintained or adjusted as necessary.

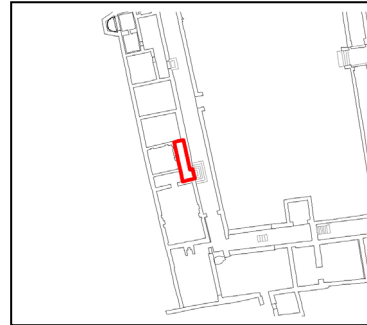
Short passageway joining 3 rooms of the west wing of the Roman house. Has a simple geometric mosaic floor *in situ*, re-buried under soil layer, geotextile marker, and coarse gravel.

Buried mosaic and other features not accessible to view; mosaic and other features not easily accessible for monitoring and condition recording

Short-term cyclical: Gravel needs to be kept free of plant growth. Consideration will be given to a regular cycle of limited excavation and uncovering to assess condition, probably on a 10-year cycle, but advice will be sought from a qualified conservator.

Long-term: A long-term management aim to ensure the proper care of, and access to, the mosaic, would be to enclose the passage within a suitable shelter building, and expose the surviving Roman features. Otherwise, regular condition survey must determine the effectiveness of the burial regime, which will be maintained or adjusted as necessary.

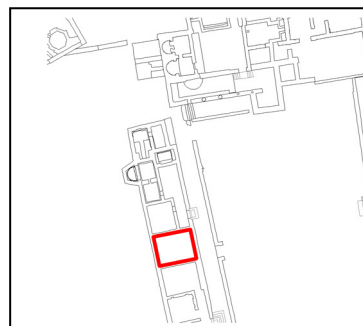
### Room 8

Rectangular room with archaeological features re-buried under soil layer, geotextile marker, and coarse gravel; known to have partial survival of *opus signinum* floor, and earlier make-up layers below; also contains earlier phase stokehole to bath-house to north.

Buried archaeological features not accessible to view; and features not easily accessible for monitoring and condition recording

Short-term cyclical: The walls and cappings need to be inspected as part of regular site monitoring programme. Gravel needs to be kept free of plant growth. Buried surface temperature monitor needs to be regularly checked and serviced as part of environmental monitoring system service. Consideration will be given to a regular cycle of limited excavation and uncovering to assess condition, probably on a 10-year cycle, but advice will be sought from a qualified conservator.

Long-term: A long-term management aim to ensure the proper care of, and access to, the archaeological features, would be to enclose the room within a suitable shelter building, and expose the surviving Roman features. Otherwise, regular condition survey must determine the effectiveness of the burial regime, which will be maintained or adjusted as necessary.

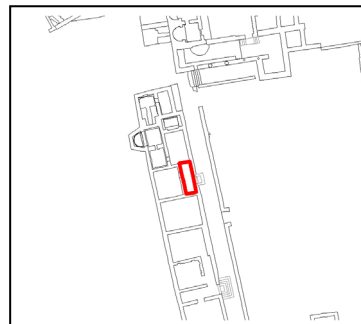
Small rectangular area onto which main door of bath-house opens. Access to Rooms 10 and 14. Incomplete geometric mosaic floor *in situ*, covered with geotextile and heavy-duty matting.

Used as main visitor viewing point for bath-house, so vulnerable to damage from visitor traffic.

**Short-term cyclical:** If the current system is to remain, the mat and geotextile cover need to be frequently monitored for build-up of dirt and debris, and the area vacuum-cleaned as necessary. Complete removal of mat, dry and wet cleaning of mosaic, condition survey, and replacement of the geotextile barrier is to be carried out annually. The faces of the walls needs to be inspected as part of regular site monitoring, and repaired as necessary. Walls will be dry-cleaned annually, but may require more frequent vacuum cleaning or brushing depending on level of cobwebs, dust, etc. Environmental condition to be monitored and controlled using the Hanwell controller linked to BMSS.

**Long-term:** The presence of visitors directly on the mosaic must be removed, and the mosaic either better protected within the existing shed, or housed within a new suitable shelter building. Ideally, the mosaic will be exposed for visitor access and better monitoring access.

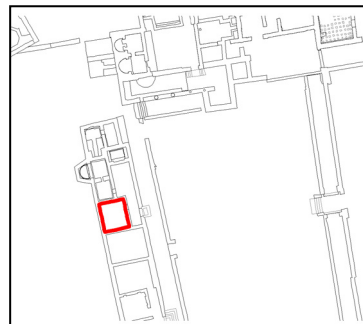
### Room 10

Rectangular room with incomplete mosaic floor, and ceramic hypocaust flues surviving *in situ* in walls; identified as changing room of bath-house; mosaic has been lifted and relaid using cement; also contains truncated coppice stool rooted in wall, left *in situ* after 19th-century excavation.

Short-term cyclical: Mosaic will be inspected regularly for surface dust, salt efflorescence, and algal growth, as part of regular monitoring regime of site. Mosaic surface needs dry cleaning twice annually, or more frequently as necessary (depending on dust deposits). Wet cleaning required annually. The faces of the walls needs to be inspected as part of regular site monitoring, and repaired as necessary. Walls will be dry-cleaned annually, but may require more frequent vacuum cleaning or brushing depending on level of cobwebs, dust, etc. Condition survey by qualified conservator required annually. Environmental condition to be monitored and controlled using the Hanwell controller linked to BMSS.

achieved through major modification to the existing shed, or replacement with a suitable shelter building, providing an improved environment and visitor access.

There will be a long-term aim to separate mosaic from cement base and re-lay a porous surface to allow ventilation to hypocaust.

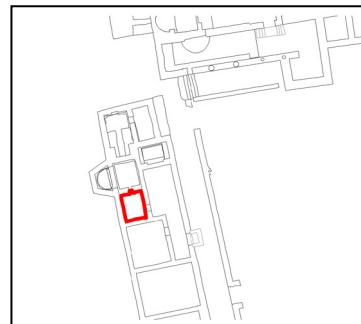
### Room 11

Small rectangular room with incomplete (80%) geometric mosaic floor; has best survival of ceramic hypocaust flue tiles along south wall, and quarter-round plaster moulding at wall/floor junction; ceramic tile hypocaust *pilae* support most of floor, but 2 acroprops and planking help support north end, which has suffered damage. Identified as warm room of bath-house.

Remedial: Environmental monitoring system needs to be serviced to ensure accurate calibration of humidistat. Mosaic will be inspected daily for any dropped items or litter such as blown-in leaves, which will be removed. The ceramic flues and plaster moulding will be inspected daily to ensure there is no debris building up, or any animal damage visible.

Short-term cyclical: Mosaic will be inspected regularly for surface dust, salt efflorescence, and algal growth, as part of regular monitoring regime of site. All of the ceramic and plaster features will also be inspected as part of regular site monitoring regime. Mosaic surface needs dry cleaning twice annually, or more frequently as necessary (depending on dust deposits). Wet cleaning required annually. The ceramic features require a specific cleaning and repair regime to be established with a qualified conservator. The faces of the walls needs to be inspected as part of regular site monitoring, and repaired as necessary. Walls will be dry-cleaned annually, but may require more frequent vacuum cleaning or brushing depending on level of cobwebs, dust, etc. Condition survey of all features by qualified conservator required annually. Environmental condition to be monitored and controlled using the Hanwell controller linked to BMSS.

Long-term: The existing wooden shed, although it has been modified from the original, does not provide a fully controllable internal environment (especially as the door is opened to allow public viewing). In the long term the mosaic, and its associated features, need better protection, and improved access for viewing and maintenance. This could be achieved by major modification of the existing shed, or construction of an appropriate new shelter building. This mosaic also needs investigation of the support system beneath the floor, to ensure it is effective, and this will be modified/replaced as necessary.

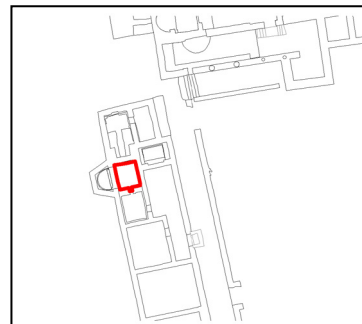
### Room 12

Small rectangular room with no surviving floor, contains ceramic tile hypocaust *pilae*; arched furnace entrance to north, leading to Room 16, and flue leading to hot bath Room 13 at base of west wall; some *pilae* reconstructed, arch over furnace flue rebuilt in 1960s. Identified as hot room of bath-house.

Ceramic tiles and interstitial mortar vulnerable to efflorescence, microbial decay, and freeze/thaw cycling; extent of 1960s rebuilding not fully known; access for monitoring, cleaning and repair is difficult; currently not visible to visitors, although with Room 11 gives excellent understanding of how hypocaust system works.

**Remedial:** Environmental monitoring system needs to be serviced to ensure accurate calibration of humidistat. Hypocaust floor and *pilae* will be inspected daily for any dropped items or litter such as blown-in leaves. Any extraneous material will be removed from the lower part of the hypocaust, but care must be taken to ensure no damage is caused during access. It is recommended that a suitable ladder be kept on the raised area above the furnace, so that it is always available for access, and the ladder set point marked in chalk at the top.

**Short-term cyclical:** *Pilae* will be inspected regularly for surface dust, salt efflorescence, and algal growth, as part of regular monitoring regime of site. Floor surface needs thorough dry cleaning twice annually, or more frequently as necessary (depending on dust deposits). Condition survey by qualified conservator required annually. Environmental condition to be monitored and controlled using the Hanwell controller linked to BMSS.

**Long-term:** The existing wooden shed, although it has been modified from the original, does not provide a fully controllable internal environment (especially as the door is opened to allow public viewing). In the long term the Roman features need

better protection, and improved access for viewing and maintenance. This could be achieved by major modification of the existing shed, or construction of an appropriate new shelter building.

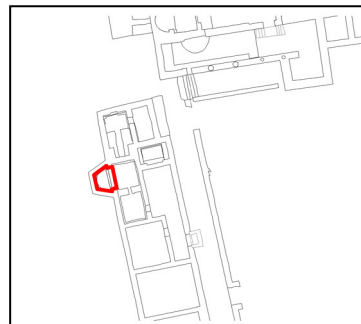
### Room 13

Small polygonal chamber containing remains of hot bath, with elements of hypocaust system at base; bath was lined with stone flags, plastered over. Identified as hot bath of bath-house.

Surviving elements vulnerable to efflorescence, microbial decay, and freeze/thaw cycling; access for monitoring, cleaning and repair is difficult; currently not visible to visitors.

**Remedial:** Environmental monitoring system needs to be serviced to ensure accurate calibration of humidistat. Bath area will be inspected daily for any dropped items or litter such as blown-in leaves. Any extraneous material will be removed but care must be taken to ensure no damage is caused during access.

**Short-term cyclical:** The surviving features will be inspected regularly for surface dust, salt efflorescence, and algal growth, as part of regular monitoring regime of site. Surfaces need thorough dry cleaning twice annually, or more frequently as necessary (depending on dust deposits). Condition survey by qualified conservator required annually. Irradiation of microbial growths. Environmental condition to be monitored and controlled using the Hanwell controller linked to BMSS.

**Long-term:** The existing wooden shed, although it has been modified from the original, does not provide a fully controllable internal environment (especially as the door is opened to allow public viewing). In the long term the Roman features need better protection, and improved access for viewing and maintenance. This could be achieved by major modification of the existing shed, or construction of an appropriate new shelter building.

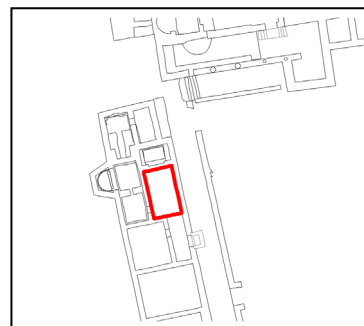
### Room 14

Rectangular room with incomplete geometric mosaic floor *in situ*. Mosaic has hard cement infill to lacunae, and the stumps of 4 metal tubes, originally part of a metal barrier around the central area. Also quarter-round plaster moulding survives at junction of wall and floor on west side. Floor is solid (no hypocaust), identified as cold room of bath-house.

Mosaic vulnerable to efflorescence, microbial decay, and freeze/thaw cycling; also vulnerable to mechanical wear, so not part of visitor route; metal tube stumps set into mosaic substrate, hard to remove without damage.

**Remedial:** Environmental monitoring system needs to be serviced to ensure accurate calibration of thermostat. Mosaic will be inspected daily for any dropped items or litter such as blown-in leaves, which will be removed. The heavy wooden barrier between this room and the vestibule will be replaced with an opening gate secured to the east wall.

**Short-term cyclical:** Mosaic and plaster mouldings will be inspected regularly for surface dust, salt efflorescence, and algal growth, as part of regular monitoring regime of site. Mosaic surface needs dry cleaning twice annually, or more frequently as necessary (depending on dust deposits). Wet cleaning required annually. The faces of the walls needs to be inspected as part of regular site monitoring, and repaired as necessary. Walls and plaster mouldings will be dry-cleaned annually, but may require more frequent vacuum cleaning or brushing depending on level of cobwebs, dust, etc. Condition survey by qualified conservator required annually.

**Long-term:** The stubs of the metal uprights will ideally be removed, but not if there is any likelihood of damage from the operation. The cement areas will be removed. The existing wooden shed, although it has been modified from the original, does not provide a fully controllable internal environment (especially as the door is opened to allow public viewing). In the long term the mosaic needs better protection, and

improved access for viewing and maintenance. This could be achieved through major modification to the existing shed, or replacement with a suitable shelter building, providing an improved environment and visitor access.

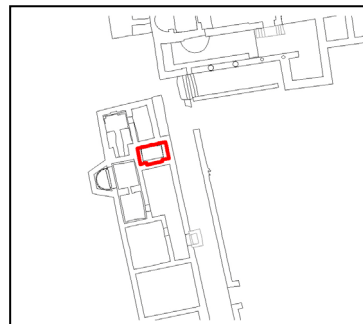
### Room 15

Rectangular cold plunge bath, with steps down into bath from Room 14 on south side. Lined with hard *signinum*, with some *faux marbre* painted decoration on plaster surface. *Opus signinum* is missing from floor, which is of stone flags. A drain leads out to the corridor on the east side.

Painted wall-plaster very vulnerable to damage by salt efflorescence and microbial attack. Not visible to visitors.

**Short-term cyclical:** all surfaces will be inspected regularly for surface dust, salt efflorescence, and algal growth, as part of regular monitoring regime of site. The flag floor can be thoroughly dry-cleaned annually, but the vertical painted plaster surfaces will only be touched by a qualified conservator. Condition survey by qualified conservator required annually.

**Long-term:** The existing wooden shed, although it has been modified from the original, does not provide a fully controllable internal environment (especially as the door is opened to allow public viewing). In the long term the bath and its delicate surfaces need better protection, and improved access for viewing and maintenance. This could be achieved through major modification to the existing shed, or replacement with a suitable shelter building, providing an improved environment and visitor access. It will be essential to roof furnace room 16 to remove the source of water ingress.

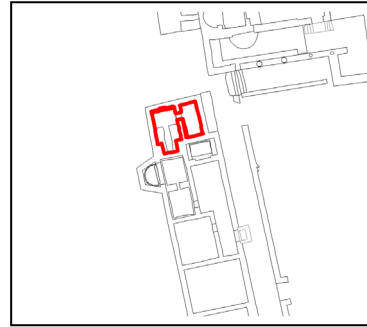
### Room 16

Pair of linked rooms outside area of bath-house covered by modern shed, but integral to original design. Chamber to west has furnace setting *in situ* (reconstructed in 1960s) and gravel obscuring other surviving features (including a drain or air flue); a doorway joins this chamber to the room on the east, which has no distinguishing features, and has gravel on the floor. The two rooms are interpreted as the furnace/'boiler room' for the bath-house hypocaust and hot water system, and its fuel store.

Short-term cyclical: The walls and cappings need to be inspected as part of regular site monitoring programme, and repaired as necessary. Gravel needs to be kept free of plant growth.

The north wall of shelter-building/south wall face of furnace rooms needs better protection to stop moisture penetration to painted plaster in Room 15.

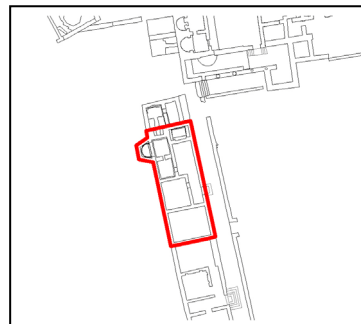
### 19th-century shed

Shed with wooden frame resting on restored Roman walls, with steeply-pitched, double-pitched slate roof; covers whole of rooms 8, 10-15, and small vestibule. Several small windows allow limited daylight entry; entrance is via door from corridor/portico in south-west corner of bath-house complex; no insulation in roof, but provided with overhead radiant heating system controlled via thermostat.

Remedial: Door will be replaced with easier-opening type.

Short-term cyclical: Shed will be inspected as part of regular site monitoring programme, to ensure it remains sound (e.g. any loose roof tiles noted and repaired). Shed needs full survey on 5-yearly cycle, and repair as necessary. Exterior will be re-stained every 10-years. Interior requires regular inspection as part of regular site monitoring, and through cleaning of all surfaces annually to remove dust, bat faeces, etc. This may be carried out more regularly if necessary, depending on level of build-up.

Long-term: Although it has been modified from the original, it does not provide a fully controllable internal environment (especially as the windows are opened to allow public viewing), or good access for viewing or maintenance. Long-term this shed will require extensive modification, or replacement with a building that can provide demonstrably better internal environmental control, and visitor access.

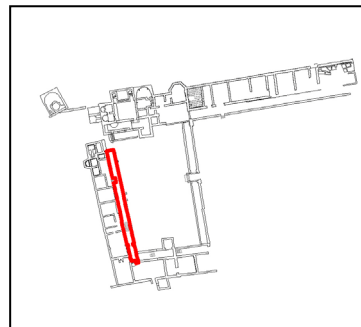
Long, narrow corridor/ portico running length of west wing from Room 5 to Room 15. Low wall on the east side also forms boundary of garden court, and is capped with a pitched cap comprised of re-used Roman limestone roof tiles, with a modern stone coping. There is an entrance in the centre of this wall which leads into the garden court to the east.

**Remedial:** The capping along the east wall, which consists of re-used Roman roof tiles, with a modern coping, needs to be repaired. Either the Roman tiles need to be more effectively fixed, or replaced with a different capping system.

**Short-term cyclical:** Regular removal of plant growth required. Tarmac surface and stonework of steps and walls will be inspected as part of regular site monitoring, and repaired as necessary. Consideration will be given to a condition survey using limited excavation to expose a sample area of the mosaic, to assess the impact of visitor traffic and the effectiveness of the burial regime. The cycle of this will need to be agreed with a qualified conservator. The wooden walkway will be professionally surveyed every 5 years, and repaired as necessary.

**Long-term:** The corridor will be removed from the visitor route, especially if condition monitoring shows that the mosaic is deteriorating due to traffic. An ideal aim would

be to expose the mosaic for visitor access, but this would have to be within a suitable shelter building. The cappings will be replaced to ensure a uniform style across the site, and also to conserve the remaining complete Roman roof tiles.

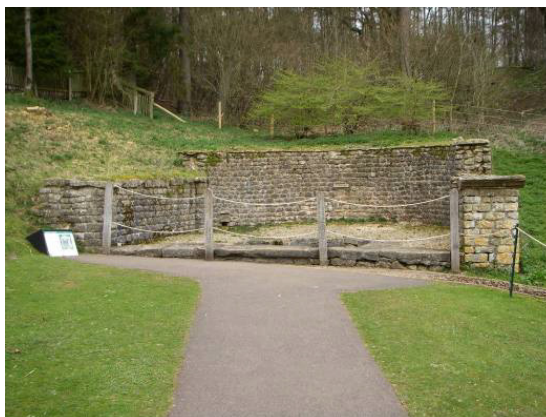
The open cistern suffers from freeze-thaw damage in the winter, and the modern cement lining is falling apart.

Remedial: Plant growth will be removed from the gravel. The cistern edges will be repaired. The cistern will be drained, cleaned, its condition surveyed, and repairs carried out as appropriate. Mole hills in the grassed area could be levelled.

Short-term cyclical: The wall surfaces and stonework of cistern and conduit need to be inspected as part of regular monitoring of site, and repaired as necessary. The gravel area will be cleaned of fallen leaves and other debris on a daily basis. Frost protection will be carried out as present on an annual basis during the closed period. Maintain rope and post barriers. Remove coins from pool.

Long-term: A system of frost protection as at present is required during the winter months. The surface treatment of the interior needs to be the same as the other internal rooms. Consideration will be given to lifting turf and laying a gravel base of geotextile barrier to deter moles; the drainage from the cistern could also be better controlled, through the provision of a formal soakaway, or piping. This would require excavation and exposure of the sub-surface features.

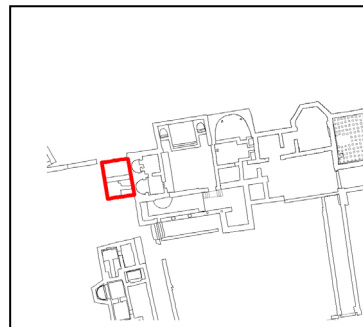
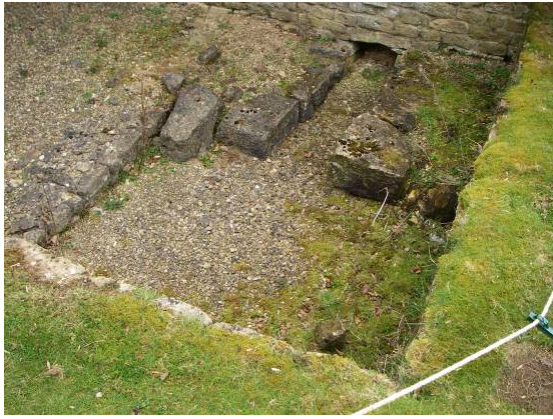
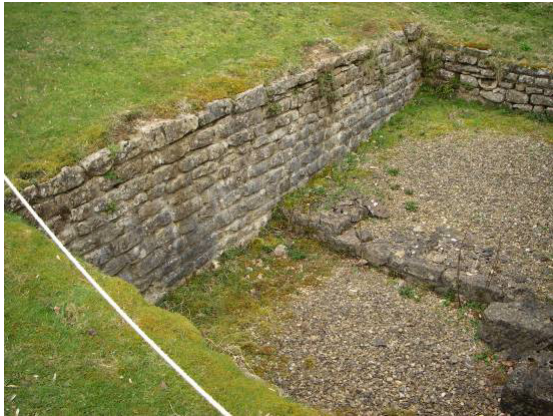
006.001

Rectangular room containing remains of stokehole at south end of east wall, with aperture (blocked) leading into hot rooms in room 22. Stokehole "cheeks" composed of very large ashlar blocks.

Short-term cyclical: The gravel needs to be kept free of plant growth. Gravel will be removed and replaced with turf. Walls need inspecting as part of regular site monitoring, and repair as necessary. The stokehole will remain filled and sealed, as long as it is exposed outside.

Long-term: In order to protect the archaeological features, and aid interpretation, it would be an ideal aim to include this area in any shelter building that covered the rest of the bath-house to the east. This is only necessary if it enables the bath-house to be interpreted as a complete entity. Otherwise, the current regime will suffice into the long-term.

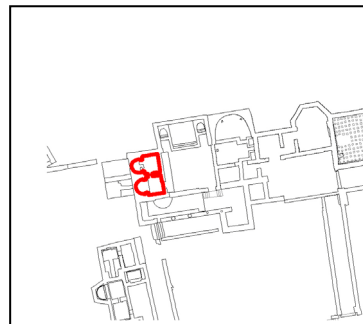
The lowest-lying parts of the hypocaust (ceramic tile *pilae*) are subject to microbial attack and are decaying; floors are fragile and will not be walked on.

Short-term cyclical: The whole interior and all surfaces will be inspected as part of the regular monitoring regime. Dry brush cleaning will be carried out to remove dust from the mosaic near the door, as necessary. Condition survey, and thorough cleaning, by dry brushing/vacuum cleaning of all surfaces, and wet cleaning of mosaics will be carried out annually, by a qualified conservator. Removal of the microbial growth, and prevention of re-growth, will be carried out by a qualified conservator to an agreed cycle.

existing shelter, or replacement with a new shelter. The main microbial growth occurs where the interior of the room is connected to the stokehole in Room 19 to the west. Consideration will be given to unblocking the stokehole in Room 1a to improve ventilation. Some investigation of how drainage could be improved in this area will be considered – a horizontal north-south drain could drain water away into space 20.

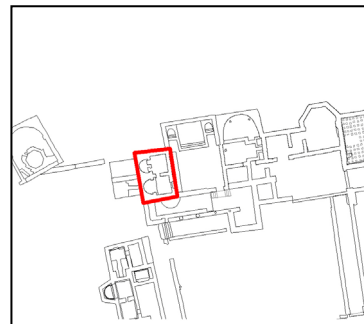
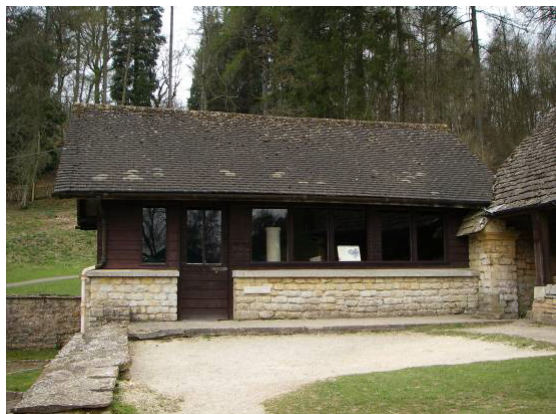
006.003

The shed was built in 1959 to protect the recently-excavated remains of the north bath-house found in Room 22. Stones from the east end of the north wing were used to reinforce the walls of Room 22. Originally the shed was glazed all round, but three sides were boarded over in 2002 to reduce the effects of incident sunlight on the interior.

**Remedial:** An electric fan will be installed in the south gable of the shed, to improve ventilation. Consideration of installing frost-protective heating will be made. Consideration of making at least one window an opening type for visitor viewing will be made. The windows need to be cleaned.

**Short-term cyclical:** The windows need to be cleaned regularly, and lamp bulbs replaced. Blackout covers will be placed over the windows during the closed season. The fabric of the shed will be inspected as part of the regular monitoring regime of the site, so that any defects such as loose tiles can be repaired. The shed will be professionally surveyed on a 5-yearly cycle. The interior of the shed will be thoroughly cleaned annually, or more frequently if necessary following observation. The exterior will be treated/stained every 10 years.

Long-term: The shed needs to be modified or replaced to provide adequate environmental control, visitor access, and access for cleaning and conservation.

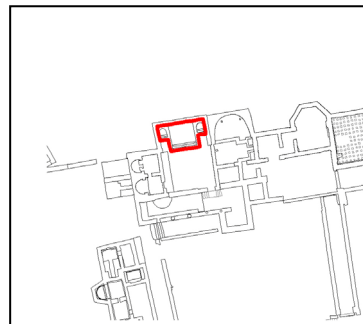
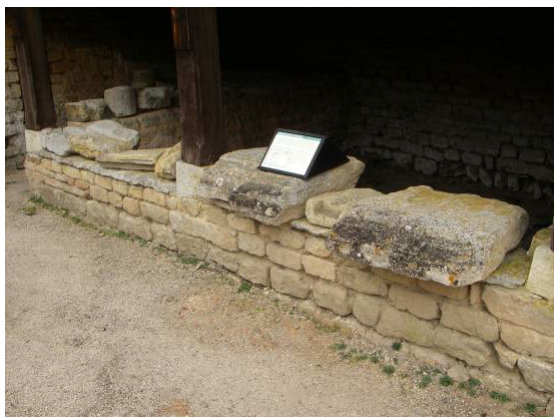
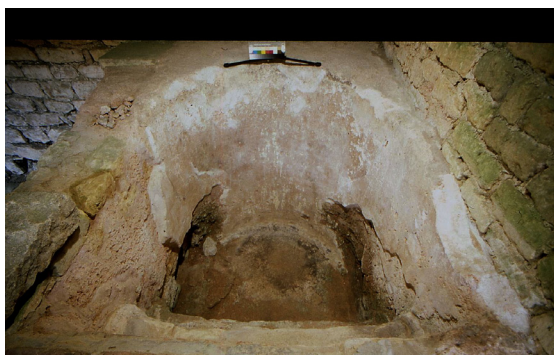
006.004

*Opus signinum* is vulnerable to climatic effects and visitor damage, as covered by open-fronted shed. Stored architectural fragments are vulnerable, untidy, and confusing. The structure is a bat roost.

Remedial: The stone artefacts will be removed and stored elsewhere. Simple visitor barriers will be erected to prevent access into the baths, and any damage to the *opus signinum*. Leaves and other debris will be cleared from the baths. .

Short-term cyclical: all surfaces will be inspected regularly as part of site monitoring regime, and repaired as necessary. Surfaces can be dry-brushed with care, and will be done so at least annually. Leaves, bat faeces and other debris need to be removed more frequently. Environmental condition to be monitored and controlled using the Hanwell controller linked to BMSS.

Long-term: Consideration needs to be given to a method of protecting the baths during the winter, by enclosing the front of the open shelter in some way. The baths,

and especially the surviving *opus signinum*, need better protection, and this may best be achieved by major modification of the existing shelter, or building of a new one.

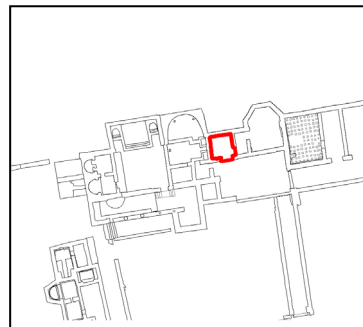
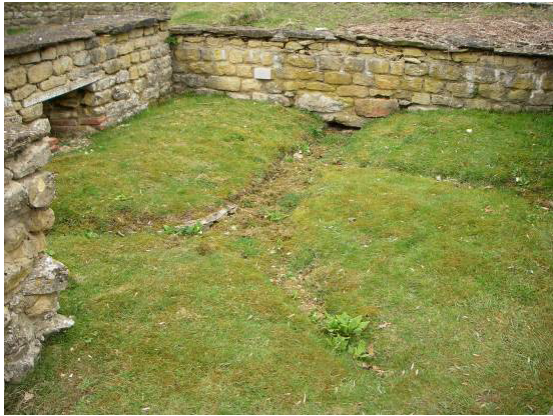
006.010

Small rectangular room (subdivision of earlier larger room), with doorway on south side. Stokehole to Room 21a in west wall. Survival of shallow channelled hypocaust. Laid to grass.

Remedial: Hypocaust needs clearing out and repairing.

Short-term cyclical: If grass retained, needs to be cut regularly. Walls, cappings and hypocaust stonework need to be inspected as part of routine site monitoring, and repaired as necessary.

Long-term: Hypocaust to retain soft capping.

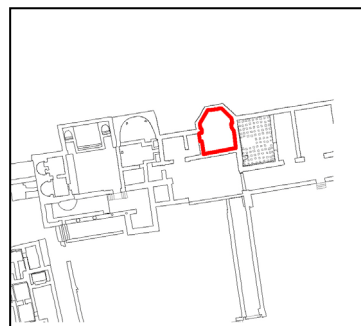
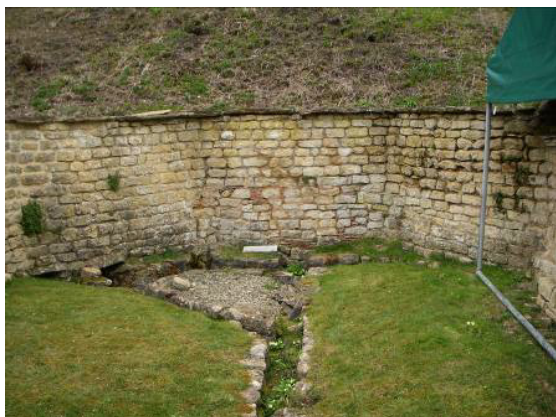
006.012

The stonework of the hypocaust has suffered damage and requires repair.

Vulnerable to weather - wall plaster has had some repairs/consolidation in the past but is falling off. Redesign of capping does not overhang enough to prevent rain drip onto plaster. Hypocaust vulnerable to plant growth and human traffic. Vulnerable to rabbit burrowing.

Remedial: Wall plaster needs urgent condition survey and remedial conservation. Hypocaust needs clearing out and repairing.

Short-term cyclical: Grass needs to be cut regularly. Walls, cappings and hypocaust stonework need to be inspected as part of routine site monitoring, and repaired as necessary.

Long-term: Retain turf-capping of hypocaust *insulae*. The capping overhang needs to be addressed, as it provides no protection for the wall-plaster. The long-term

protection of the wall-plaster needs to be addressed, and a solution sought in conjunction with a conservator.

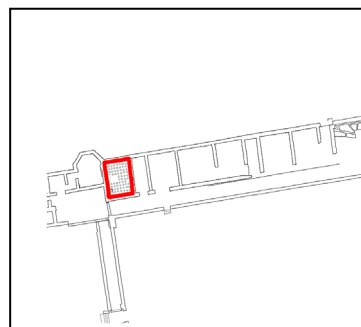
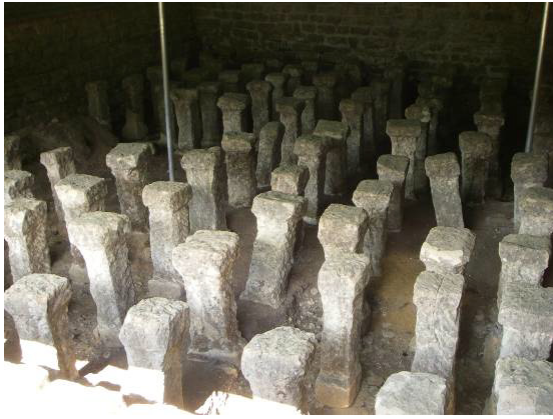
007.001

Several of the stone *pilae* have been repaired following major splitting. Frost spalling is visible on the upper parts of many of the *pilae*.

Marquee does not provide appropriate environmental conditions for the *pilae*, and looks unsightly. Vulnerable to plant growth where damp.

Remedial: Plant growth needs to be removed from between *pilae*. Top of south wall (where visitors stand) needs consolidation or capping in keeping with rest of site, as it is becoming loose and the mortar is crumbling.

Short-term cyclical: All walls, cappings and hypocaust *pilae* need to be inspected as part of routine regular site monitoring, and repaired as necessary. The effects of the winter protection regime need to be monitored, and adjusted if necessary. Hypocaust *pilae* will be subject to annual condition survey and cleaning of loose material from ground surface between *pilae*.

Long-term: The hypocaust *pilae* will be protected properly from the weather, either by construction of a rigid permanent shelter, re-burial, or suitable seasonal covering. Consideration needs to be given to treatment of flooring between *pilae* – this could be a camomile or sedum planting.

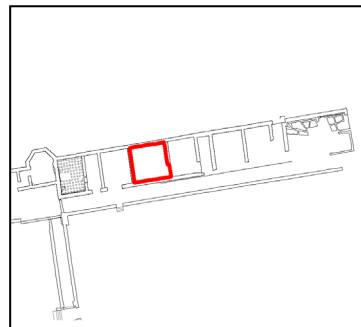
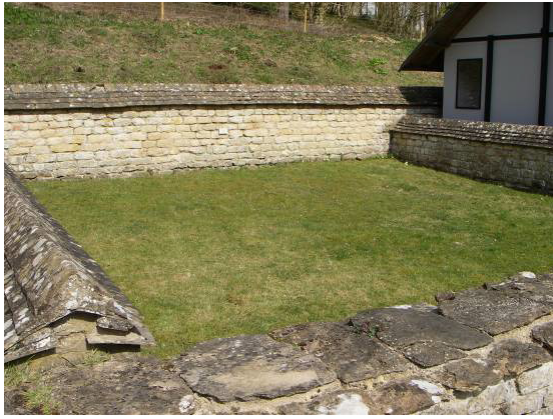
007.006

Roughly square room, with connecting gap to Room 29 to east, but not to corridor in current layout. Laid to grass, but presence of *in situ* late 4th-century mosaic known from sample excavation. Walls with pitched concrete tile caps, caps are in poor condition.

No system for monitoring condition of buried mosaic; grass inside room does not add to interpretation, and plant growth (roots) may damage mosaics. Wall caps are failing. Vulnerable to rabbit burrowing.

Remedial: Wall-capping on north side will be repaired/replaced immediately.

Walls will be inspected as part of regular condition monitoring, and re-pointed as necessary.

The mosaic fragments need to have an agreed cycle of condition monitoring, via sample excavation and inspection, to be agreed with a qualified conservator.

Long-term: Grass/turf will be raised to protect mosaic fragments.

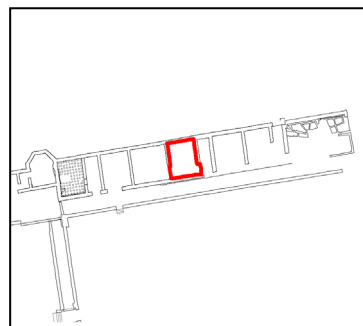
Walls with pitched concrete tile caps, caps are in poor condition, especially on north wall.

Wooden shed obscures access to surfaces. Wall caps are failing. Vulnerable to rabbit burrowing.

Remedial: Wall-capping on north side will be repaired/replaced immediately.

Walls will be inspected as part of regular condition monitoring, and re-pointed as necessary.

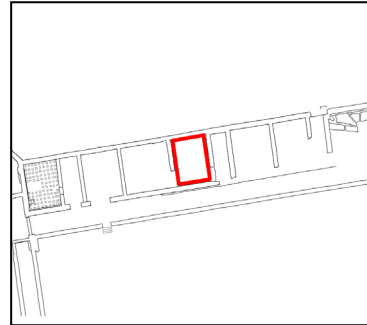
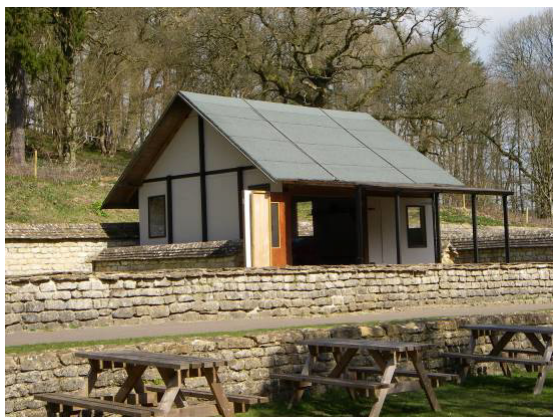
007.008

Wooden shed filling Room 29, with a double-pitched felted roof and painted plywood walls. Shed is laid on wooden sleeper beams resting directly on the ground. The front opens to admit visitors, and it is currently used as an education and demonstration space.

Short-term cyclical: Shed will be inspected as part of routine site monitoring, and repaired as necessary. Shed will be inspected structurally every 5 years. Exterior paintwork will be renewed every 5 years or sooner if weathered.

Long-term: Shed will be removed, and activities transferred to a permanent building.

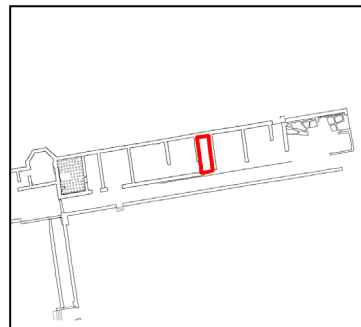
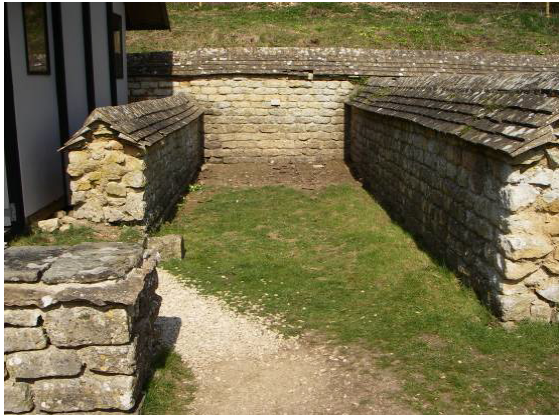
007.009

Wall caps are failing. Vulnerable to rabbit burrowing. Grass inside room does not add to interpretation, and plant growth (roots) may damage archaeology.

Remedial: Wall-capping on north side will be repaired/replaced immediately.

Walls will be inspected as part of regular condition monitoring, and re-pointed as necessary.

Long-term: Grass/turf will be raised to protect archaeology.

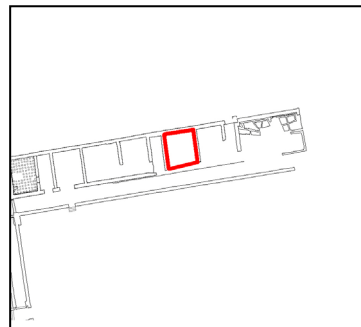
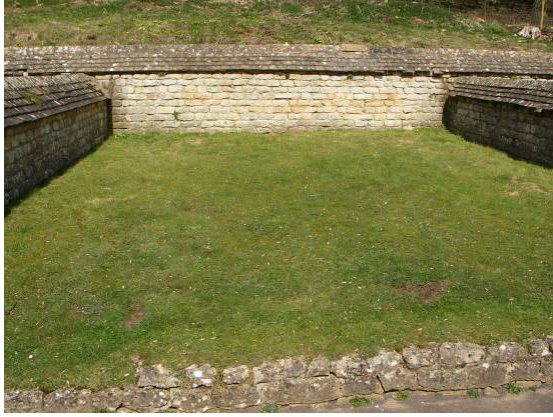
007.010

Wall caps are failing, especially on north wall. Vulnerable to rabbit burrowing. Grass inside room does not add to interpretation, and plant growth (roots) may damage archaeology.

Remedial: Wall-cappings, especially on north side, will be repaired/replaced immediately.

Walls will be inspected as part of regular condition monitoring, and re-pointed as necessary.

Long-term: Grass/turf will be raised to protect archaeology.

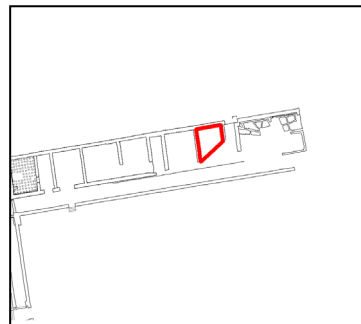
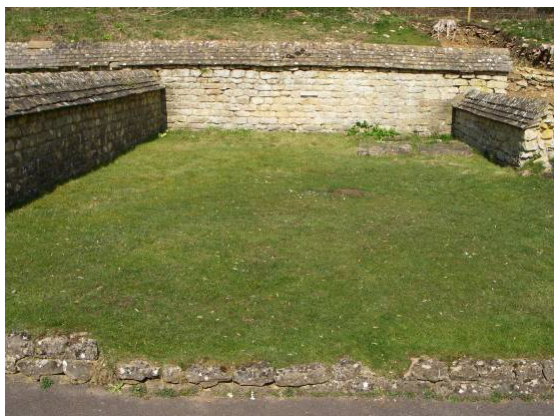
007.011

Wall caps are failing, especially on north wall. Vulnerable to rabbit burrowing. Grass inside room does not add to interpretation, and plant growth (roots) may damage archaeology.

Remedial: Wall-capping on north side will be repaired/replaced immediately. Hypocaust *pilae* will be removed and stored elsewhere.

Walls will be inspected as part of regular condition monitoring, and re-pointed as necessary.

Long-term: Grass/turf will be raised to protect archaeology.

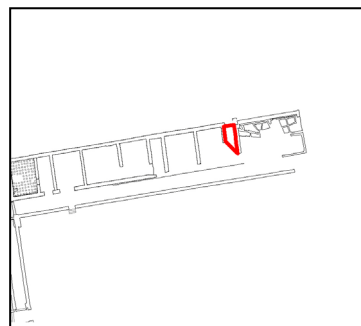
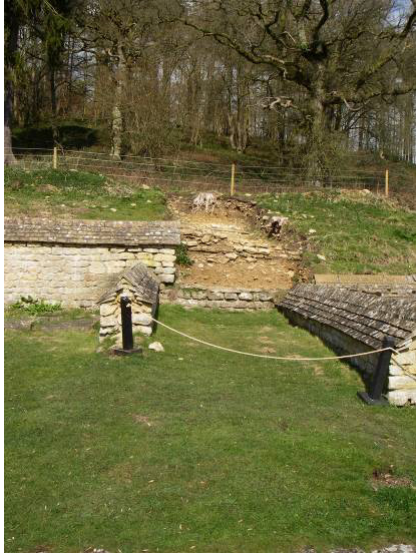
007.012

Wall caps are failing. Vulnerable to rabbit burrowing. Grass inside room does not add to interpretation, and plant growth (roots) may damage archaeology, especially mosaic.

Remedial: Wall-cappings will be repaired/replaced.

Walls will be inspected as part of regular condition monitoring, and re-pointed as necessary.

Mosaic will be subject to periodic condition monitoring, via a cycle of sampling by excavation and exposure, to be agreed with qualified conservator.

Long-term: Grass/turf will be raised to protect archaeology.

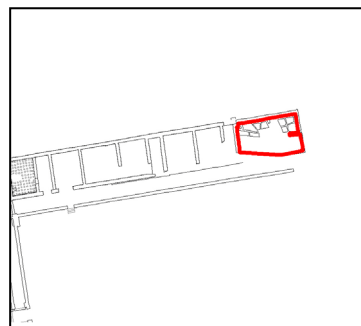
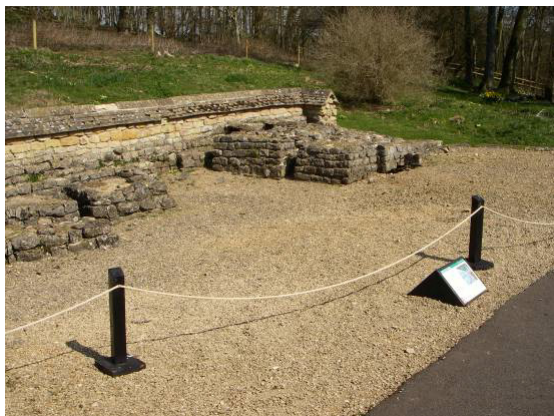
007.013

These western *insulae* have been demonstrated as founded on *in situ* Roman masonry, but built up post-excavation. The turf caps have been removed but not replaced, and they are in process of repair.

Another set of *insulae*, surviving to a higher level, lies in the north-east quadrant of the room, and appear to be in better repair, but bonded with a hard cement.

The south half of the room is featureless by contrast, although the wall around the south-east corner has been repaired and bonded with a hard modern cement.

Reconstruction not documented, and not clear; hypocaust *insulae* not in good repair. Wall capping is failing, especially along north wall.

Remedial: Wall-capping will be repaired/replaced. Hypocaust *insulae* will be repaired.

Short-term cyclical: Walls, cappings and hypocaust stonework will be regularly inspected as part of routine site monitoring, and repaired as necessary. Gravel will

be replaced if it becomes silted up. Plant growth will be regularly removed from all stonework.

Long-term: Hypocaust *pilae* to be soft-capped. Otherwise, this room could remain without major change.

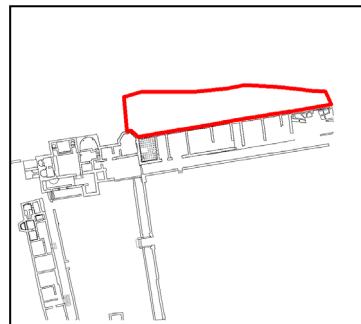
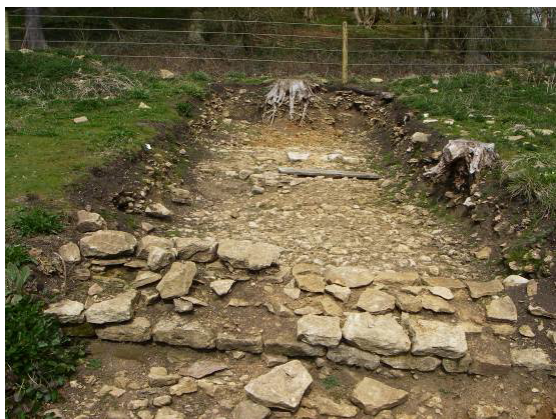
008.001

Where seen, the east-west (boundary?) wall is not in good condition, with most of the bonding mortar leached away over time.

Short-term cyclical: Area needs to be trimmed regularly, especially close to walls. Cycle of trimming to be agreed with wardens.

Long-term: The Roman ground-level and gutter is very close to the internal floor levels within the north wing rooms, so excavation of material to improve drainage is not really practical. This area may have to be preserved as it is.

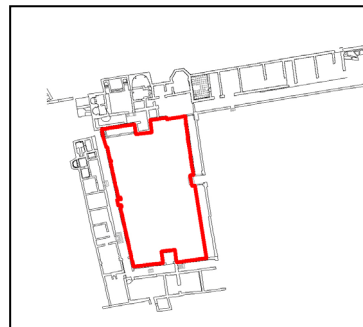
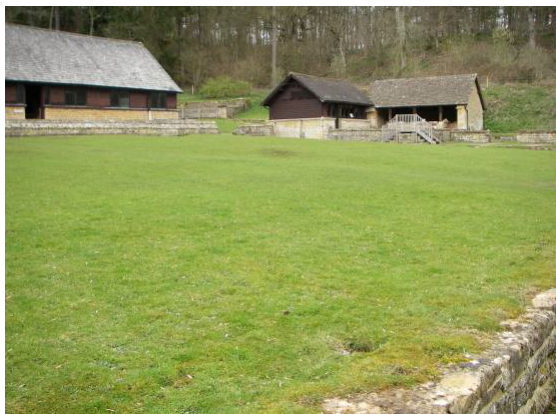
009.001

Grass needs to be cut. Some wear around wooden benches sited on grass - worse when not moved regularly.

Part of visitor route, but with no marked paths. Can lead to wearing away of grass and production of muddy patches.

Long-term: Area will be retained as grassy courtyard. Grass surfaces will be capable of carrying visitors, particularly in wet weather. If wear and tear occurs on

the areas of highest impact, consideration will be given to the use of different forms of harder wearing turf.

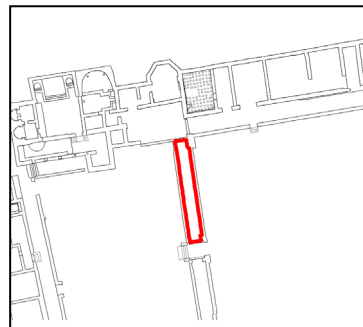
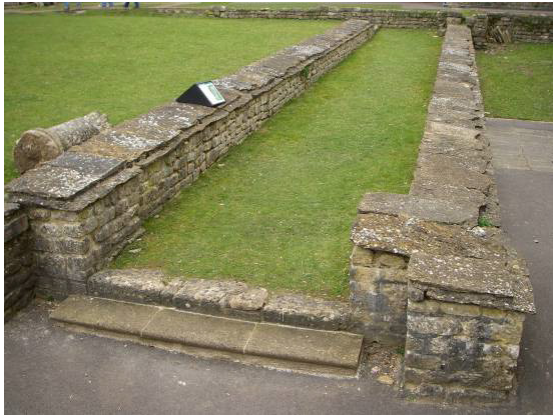
010.001

Extent of rebuilding not certain; relationship of thicker pier at north end to original walls not certain, and pier in poor condition; steps at south end are in poor condition.

Remedial: Wall pointing will be inspected and repaired as necessary.

Short-term cyclical: Grass will be cut regularly, and turf at base of walls re-cut annually. Walls and cappings will be inspected as part of regular site monitoring.

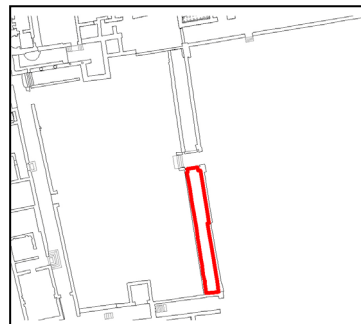
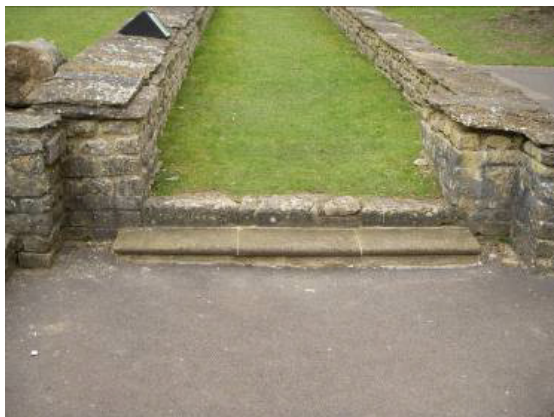
010.003

Walls not all in good condition.

Remedial: Pointing of walls needs to be inspected and repaired as necessary, any fallen stones need to be replaced.

Short-term cyclical: Walls and cappings need to be regularly inspected as part of routine site monitoring, and repaired as necessary. Grass needs to be cut regularly, and turf at base of walls re-cut annually.

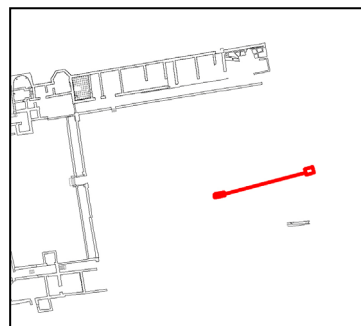
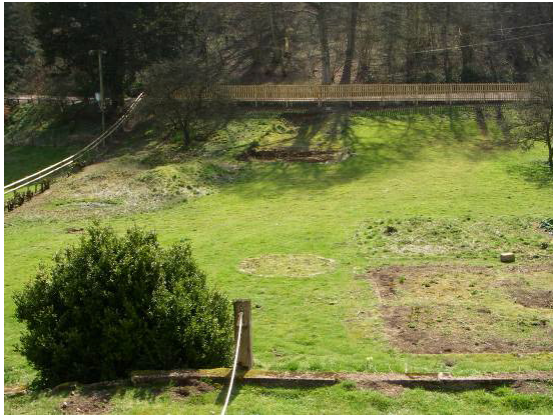
012.002

A pool of sewage was observed on the ground surface above this soakaway.

System is inefficient and causes visible pollution, preventing use of lower garden as part of visitor amenities; and creating visual blot, as well as potential health hazard.

Short-term cyclical: Regular cycle of septic tank emptying will be established. Regular inspection of pipework and remedial cleaning will be carried out frequently.

Long-term: This system will be replaced, or will revert to serving the Victorian house only. Effluent from the visitor centre will not be routed here.
