**Chedworth Roman Villa**

**Conservation Management and  
Maintenance Plan Gazetteer**

**September 2007**  
**Revised November 2009**

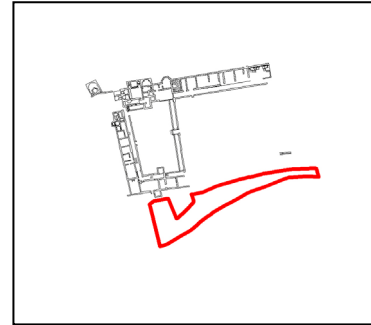
Area of car-park, sloping to east. Tarmac/chipping surface. Contains no features apart from 2 large mature Western Red Cedar trees just outside the entrance gate to the house drive.

Remedial: Ensure holes in car-park surface are repaired.

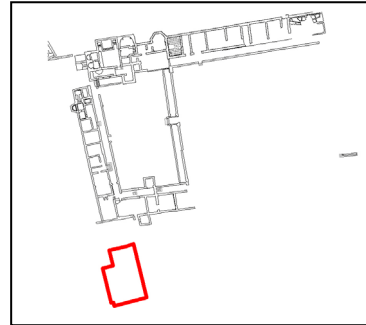
**Reference no:** 017.001  
**NT SMR:** 75540  
**Type:** Building (20th-century)

No major issues at the moment, in the sense of the building being unsafe or failing. The 2003 alterations changed the entrance to provide better access, and the addition of a glazed entrance brought much-needed light into the interior.

Short-term cyclical: Building fabric needs professional survey every 5 years; regular inspection as part of site monitoring, and repair as necessary. The bat population will be regularly surveyed, on a cycle to be agreed with the Nature Conservation Advisor.
