BUCKFAST METHODIST CHURCH ARCHAEOLOGICAL WATCHING BRIEF

**STEWART BROWN ASSOCIATES
FEBRUARY 2014**

METHODIST CHAPEL AT BUCKFAST ABBEY, DEVON ARCHAEOLOGICAL WATCHING BRIEF, DECEMBER 2013

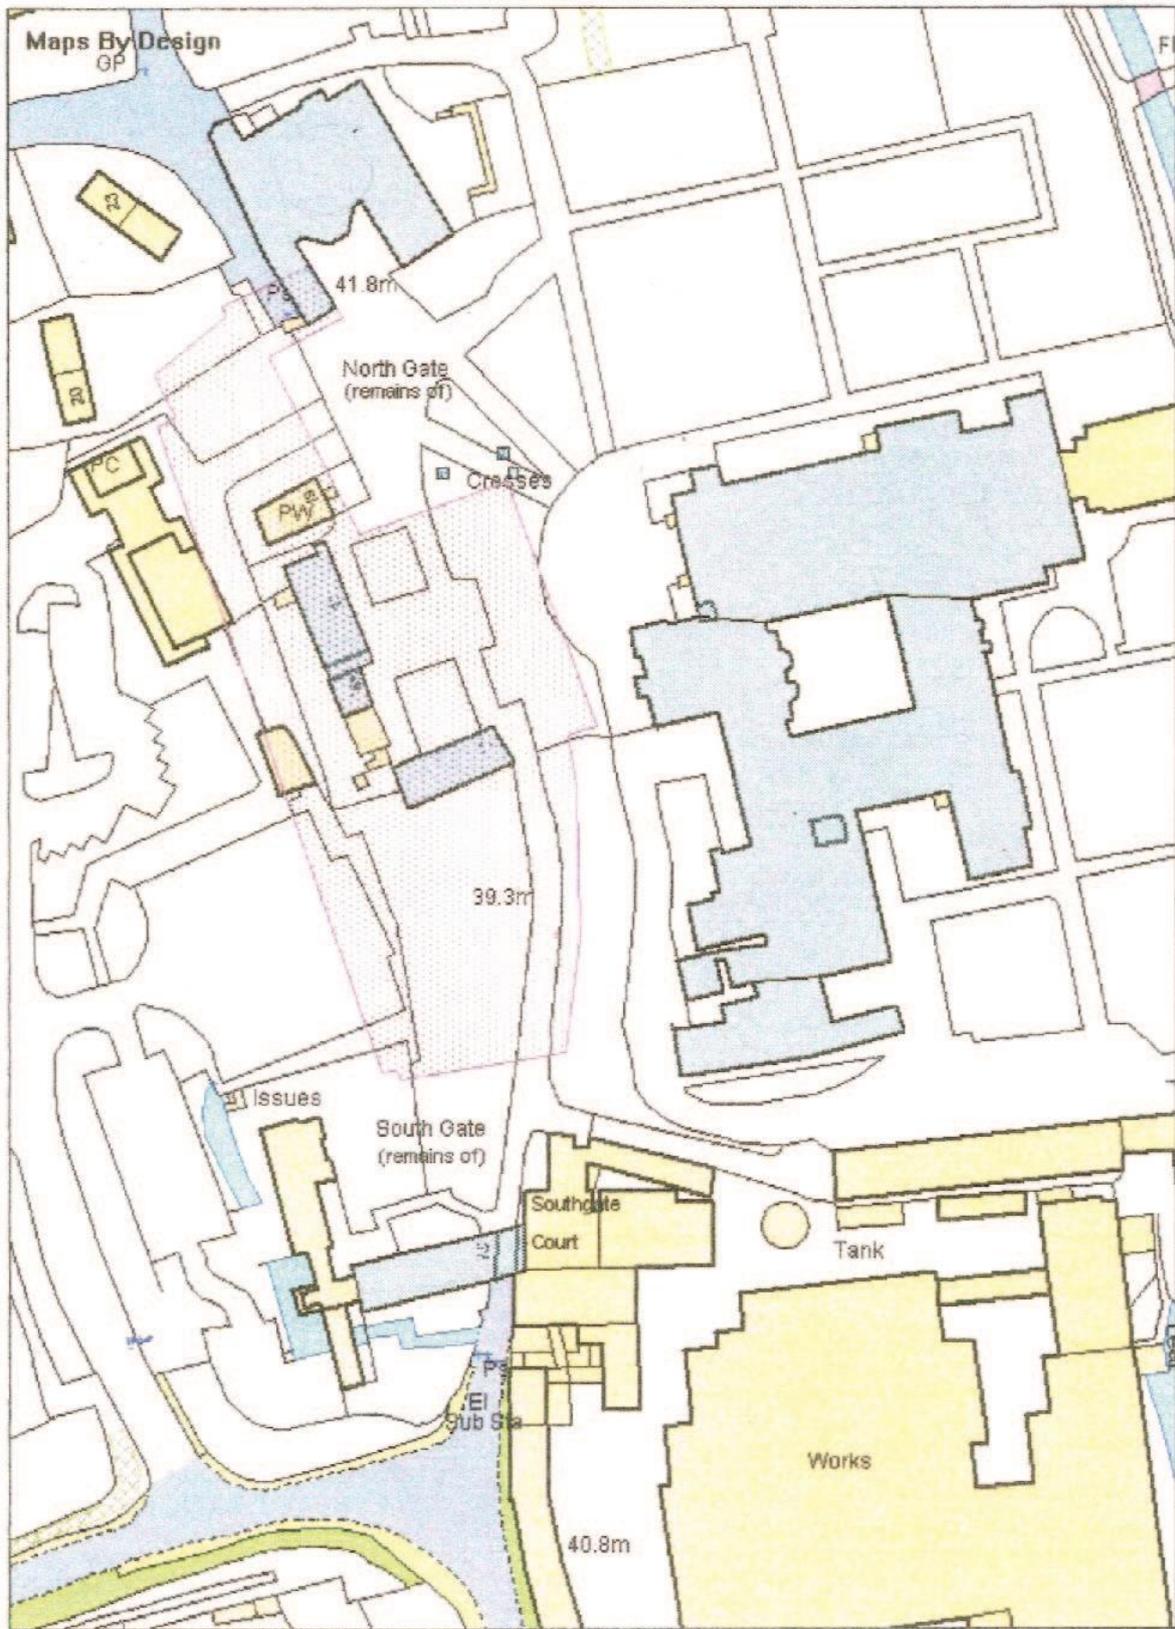
Fig. 1 Plan showing scheduled area (source Dartmoor National Park).

1.2 The ground beneath the chapel and its porch is scheduled (Fig. 1). The ground falls within the scheduled area known in the National Heritage List for England as 'The North Gate and part of the precinct area of Buckfast Abbey' (Monument number 1266782; NGR SX 7412 6738). The standing structure of the chapel is not listed.

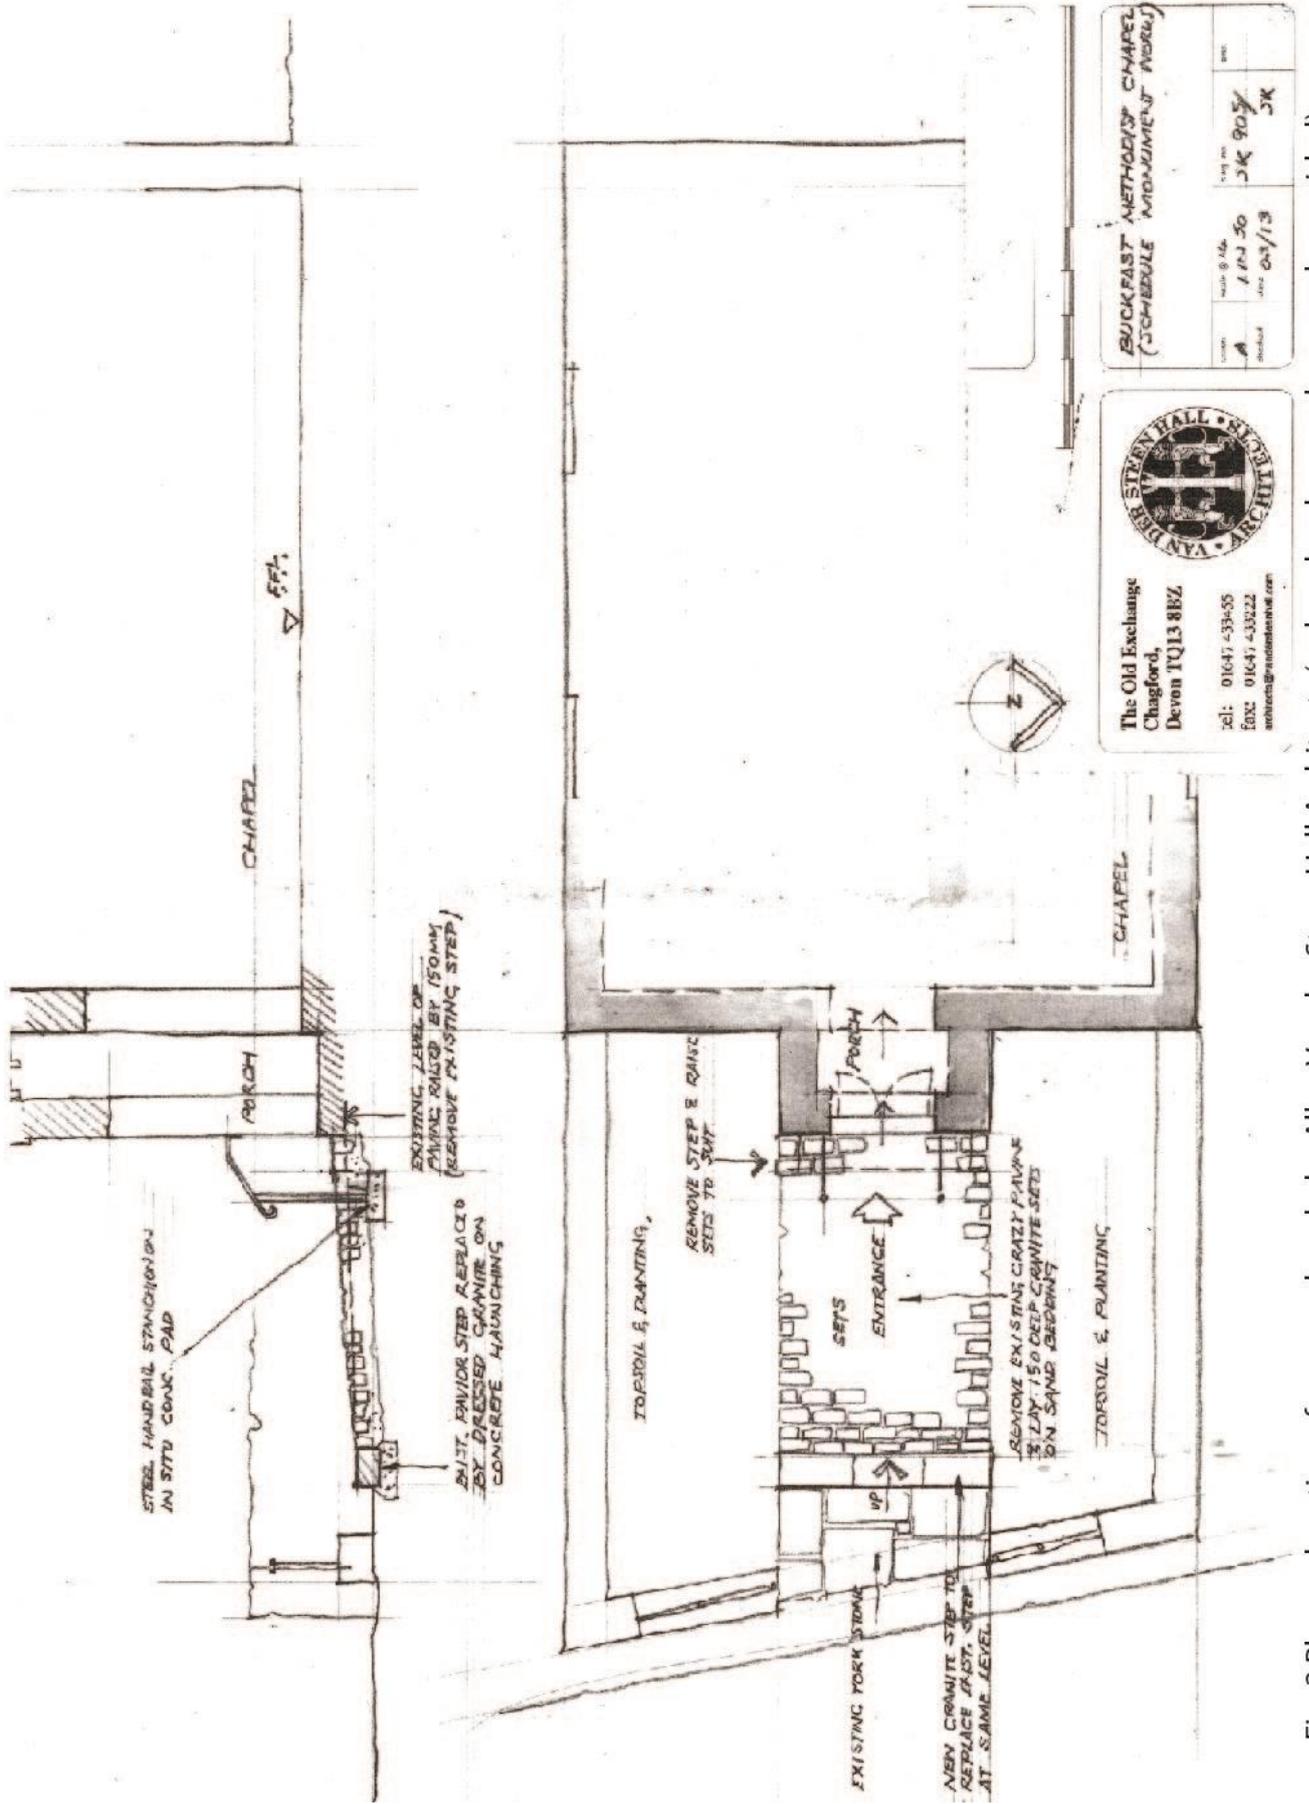
Fig. 2 Plan and section of proposed works by Allen Van der Steen Hall Architects (reduced scale - see drawn scale provided).

1.4 The proposed ground works which might uncover archaeological features and/or deposits are shown in drawings by Allen Van der Steen Hall Architects (Fig. 2). The present paving of the path leading to the porch (Fig. 3) is to be taken up and replaced with granite sets. The present step inside the porch is to be lifted and replaced at a higher level.
