**Building appraisal  
at The Sladd  
Kinver Road, Caunsall  
Kidderminster  
Worcestershire**

WSM 41860

10th September 2009

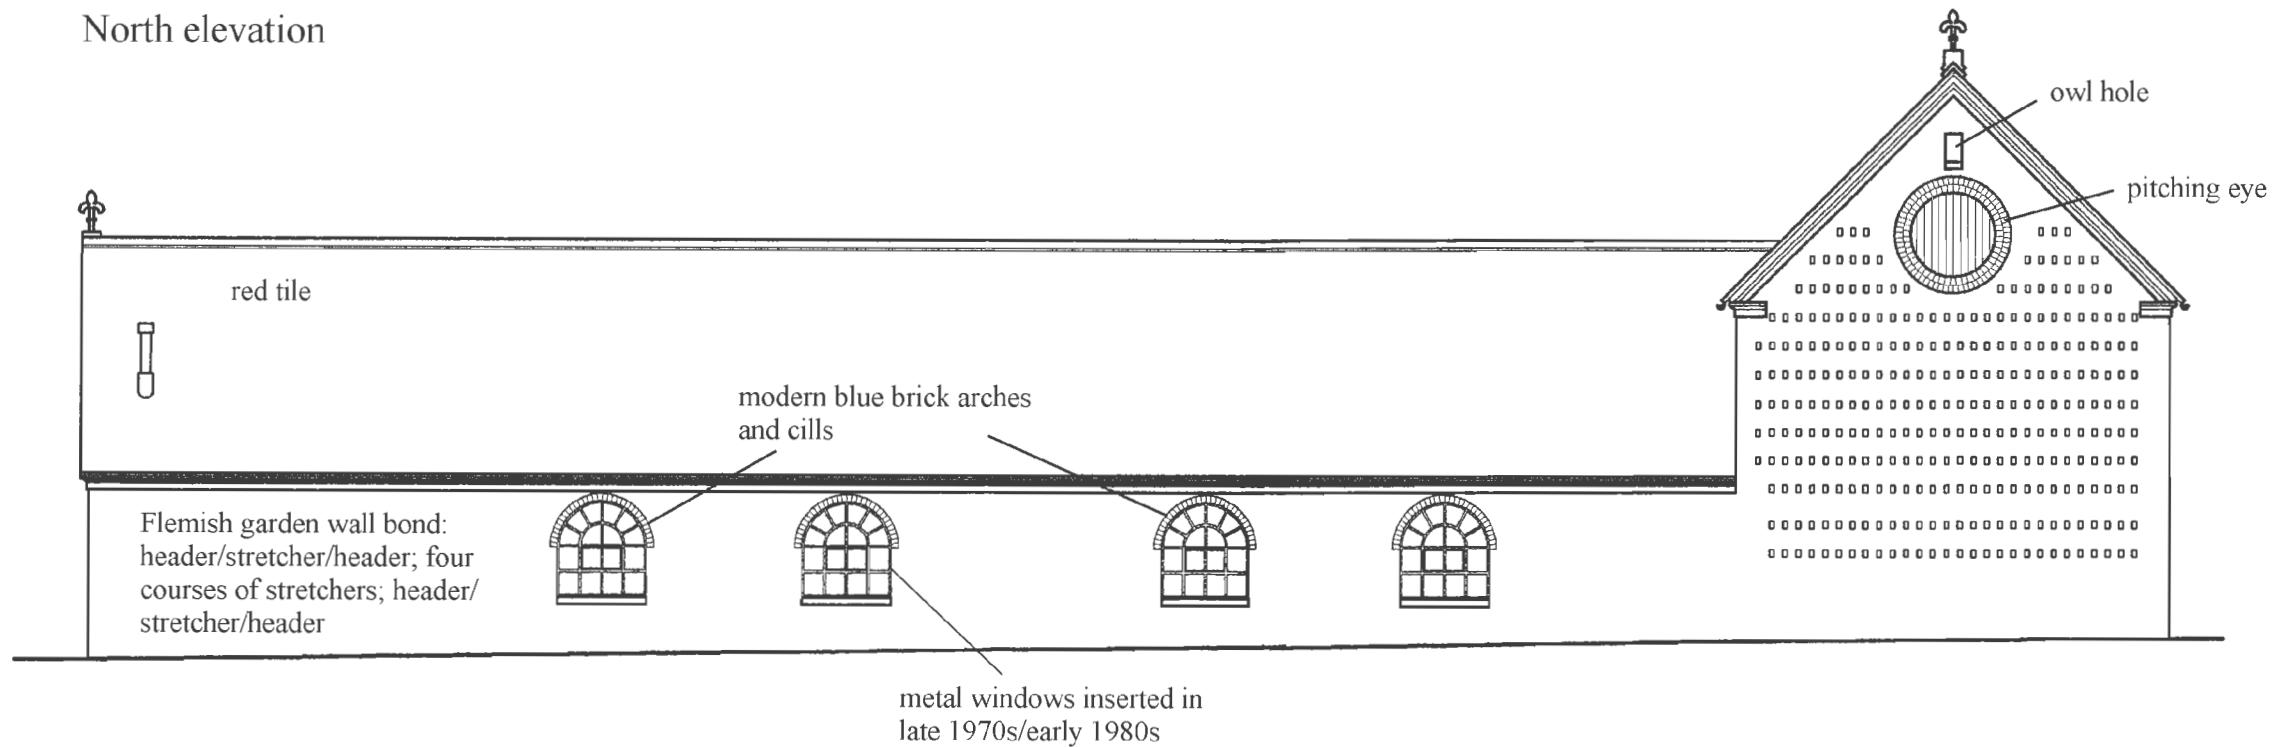
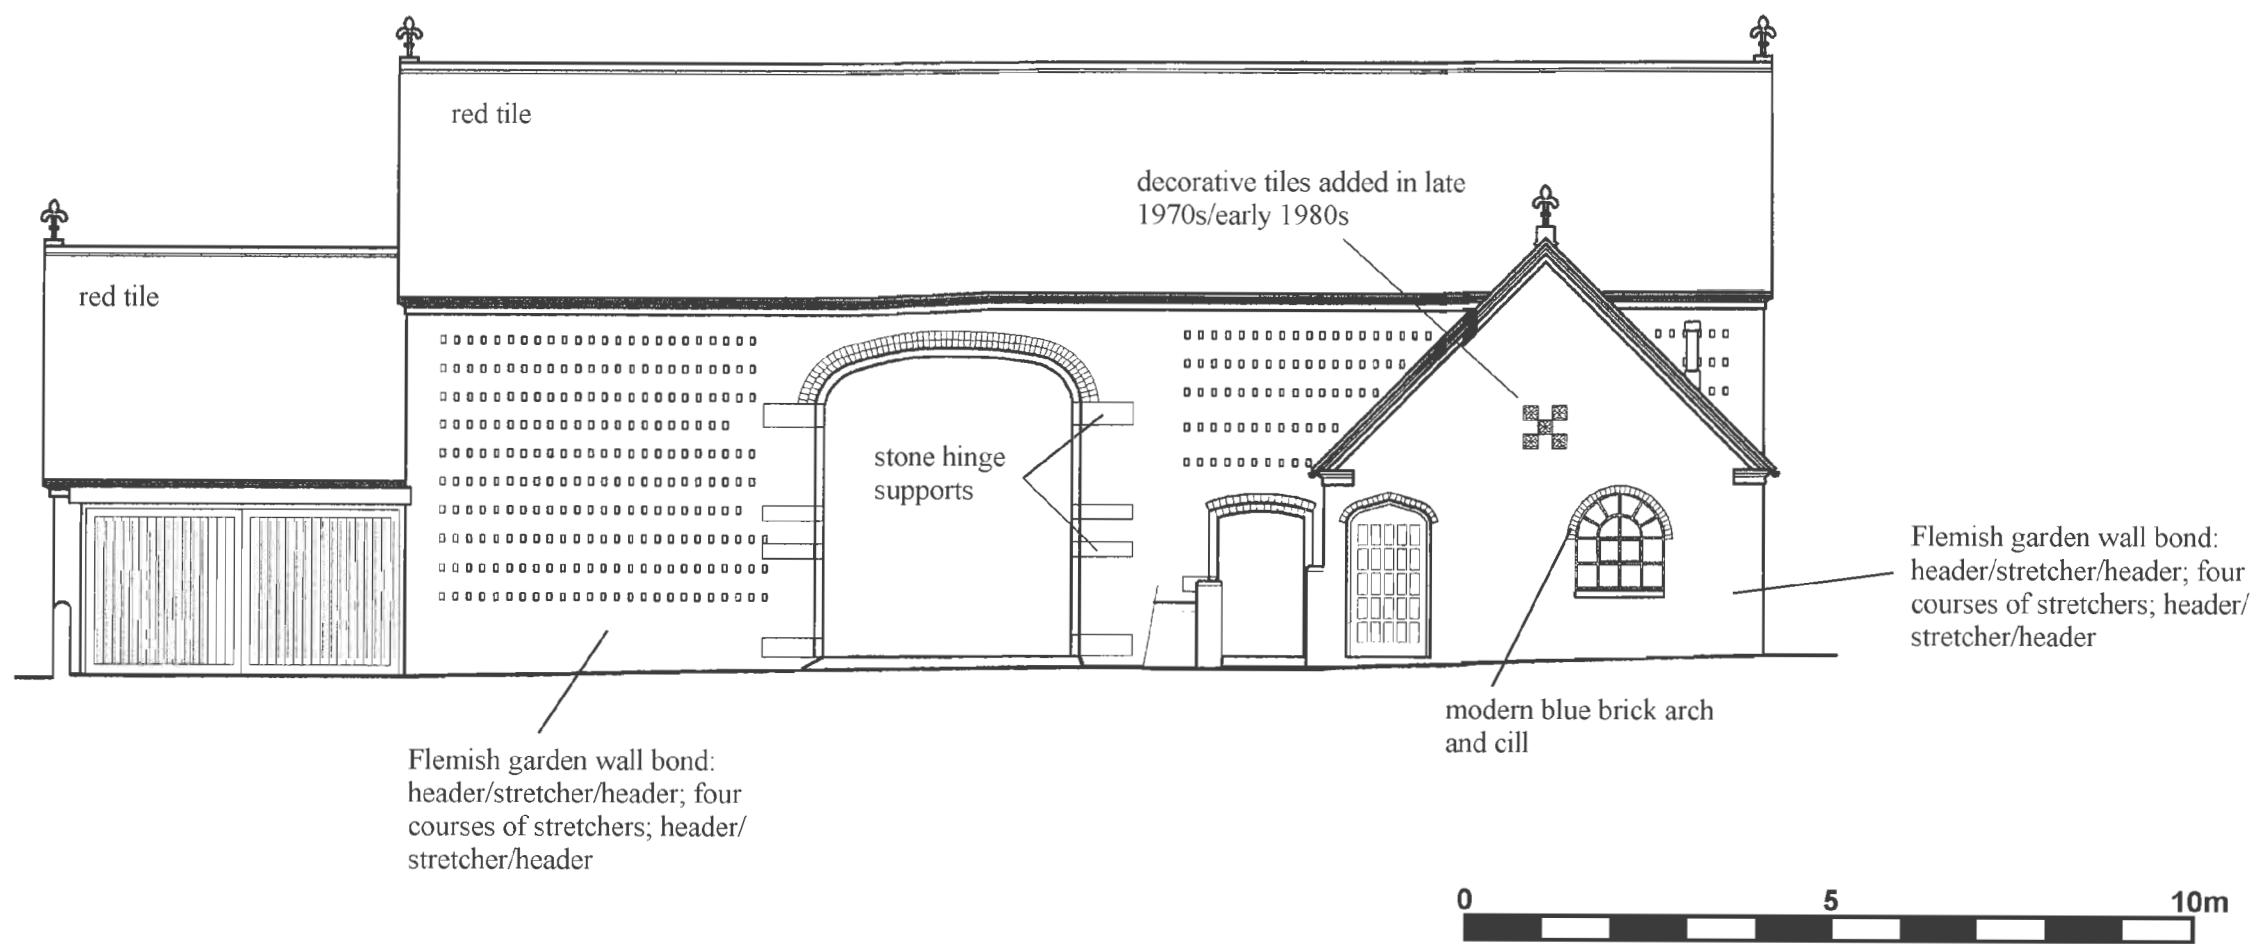
Fig 3.1: Elevations

The barn falls into Peters' (Peters 1969) Type 2 classification (Figs 3.1, 3.2, 5, 6, 7, and 10), which comprises barns in which the threshing floor is neither in the middle nor at the end, there being either an unequal number of bays on either side of it, as in the case at The Sladd, or, if it is a three bay barn, a difference in length of more than 15%. In both cases the difference is sufficient to be intentional.

The size of the doors opening onto the threshing floor was related to the way in which the barn was used. The example at The Sladd falls into Peters' Type I classification with high doors on both sides of the threshing floor (Figs 3.1, 3.2, 6 and 7). This style makes up nearly three-quarters of the examples, varying in date from the 16th century to 1880. They owed their popularity to their fitness for purpose and their adaptability. They not only permitted laden carts or wagons to enter from either side, but provided light for flail threshing and a flow of air for winnowing.

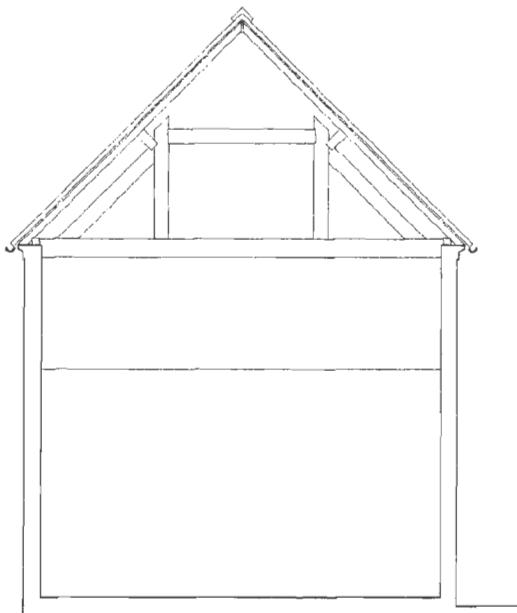
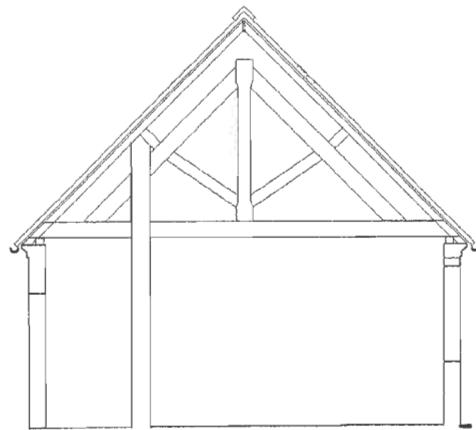
Fig 4: The roof trusses

the barn: queen post roof truss

the cattle shed: king post roof truss

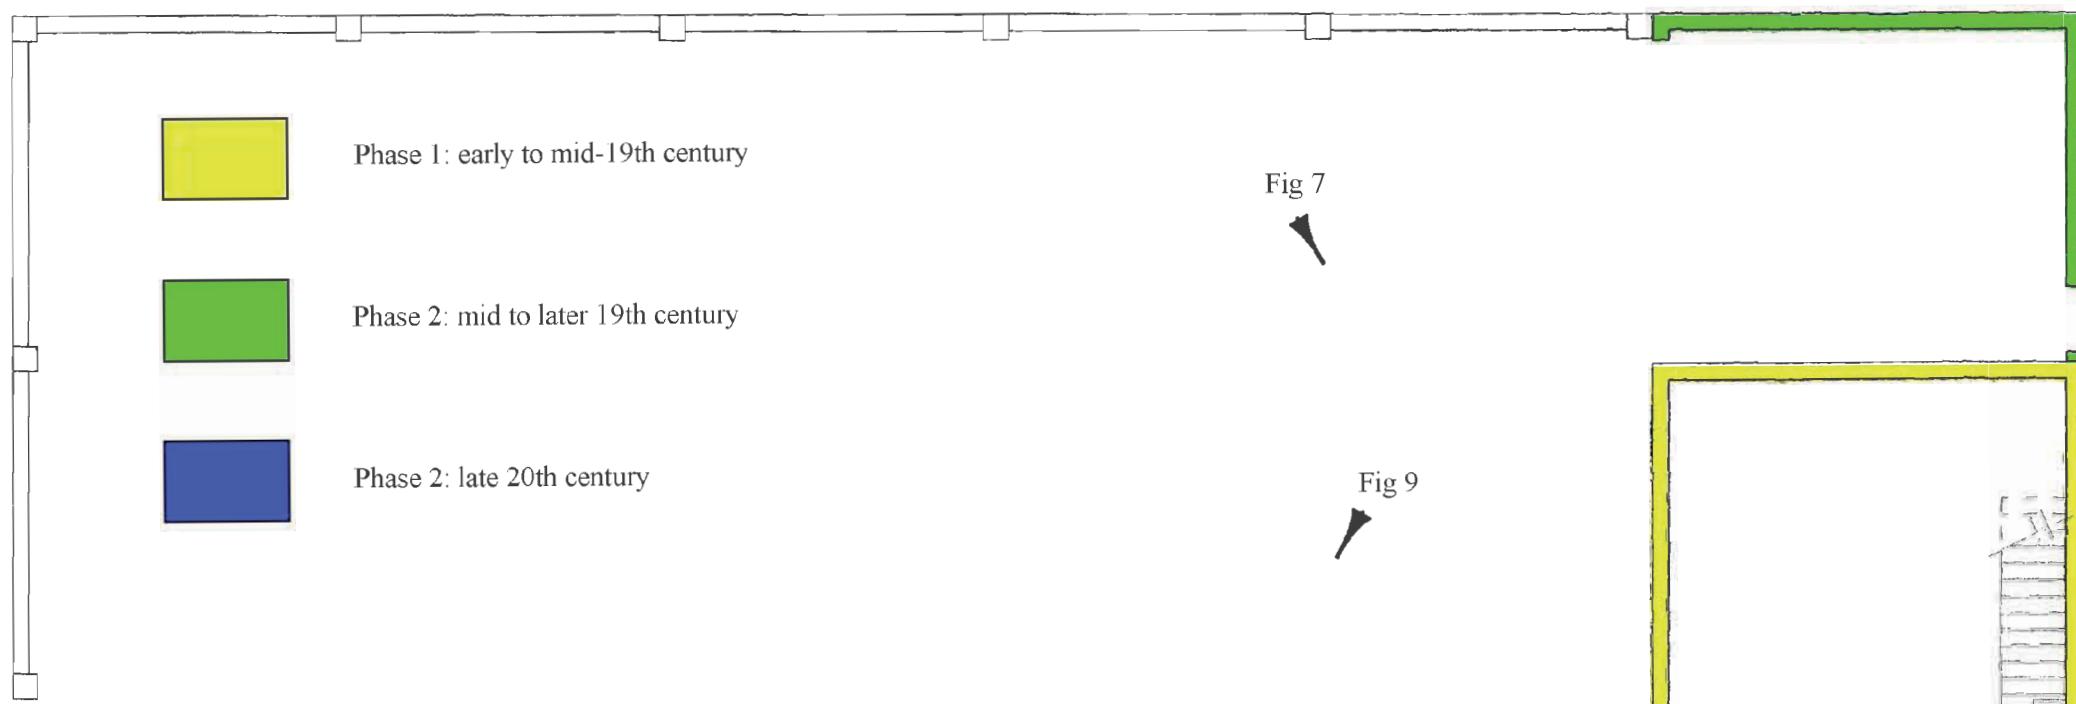
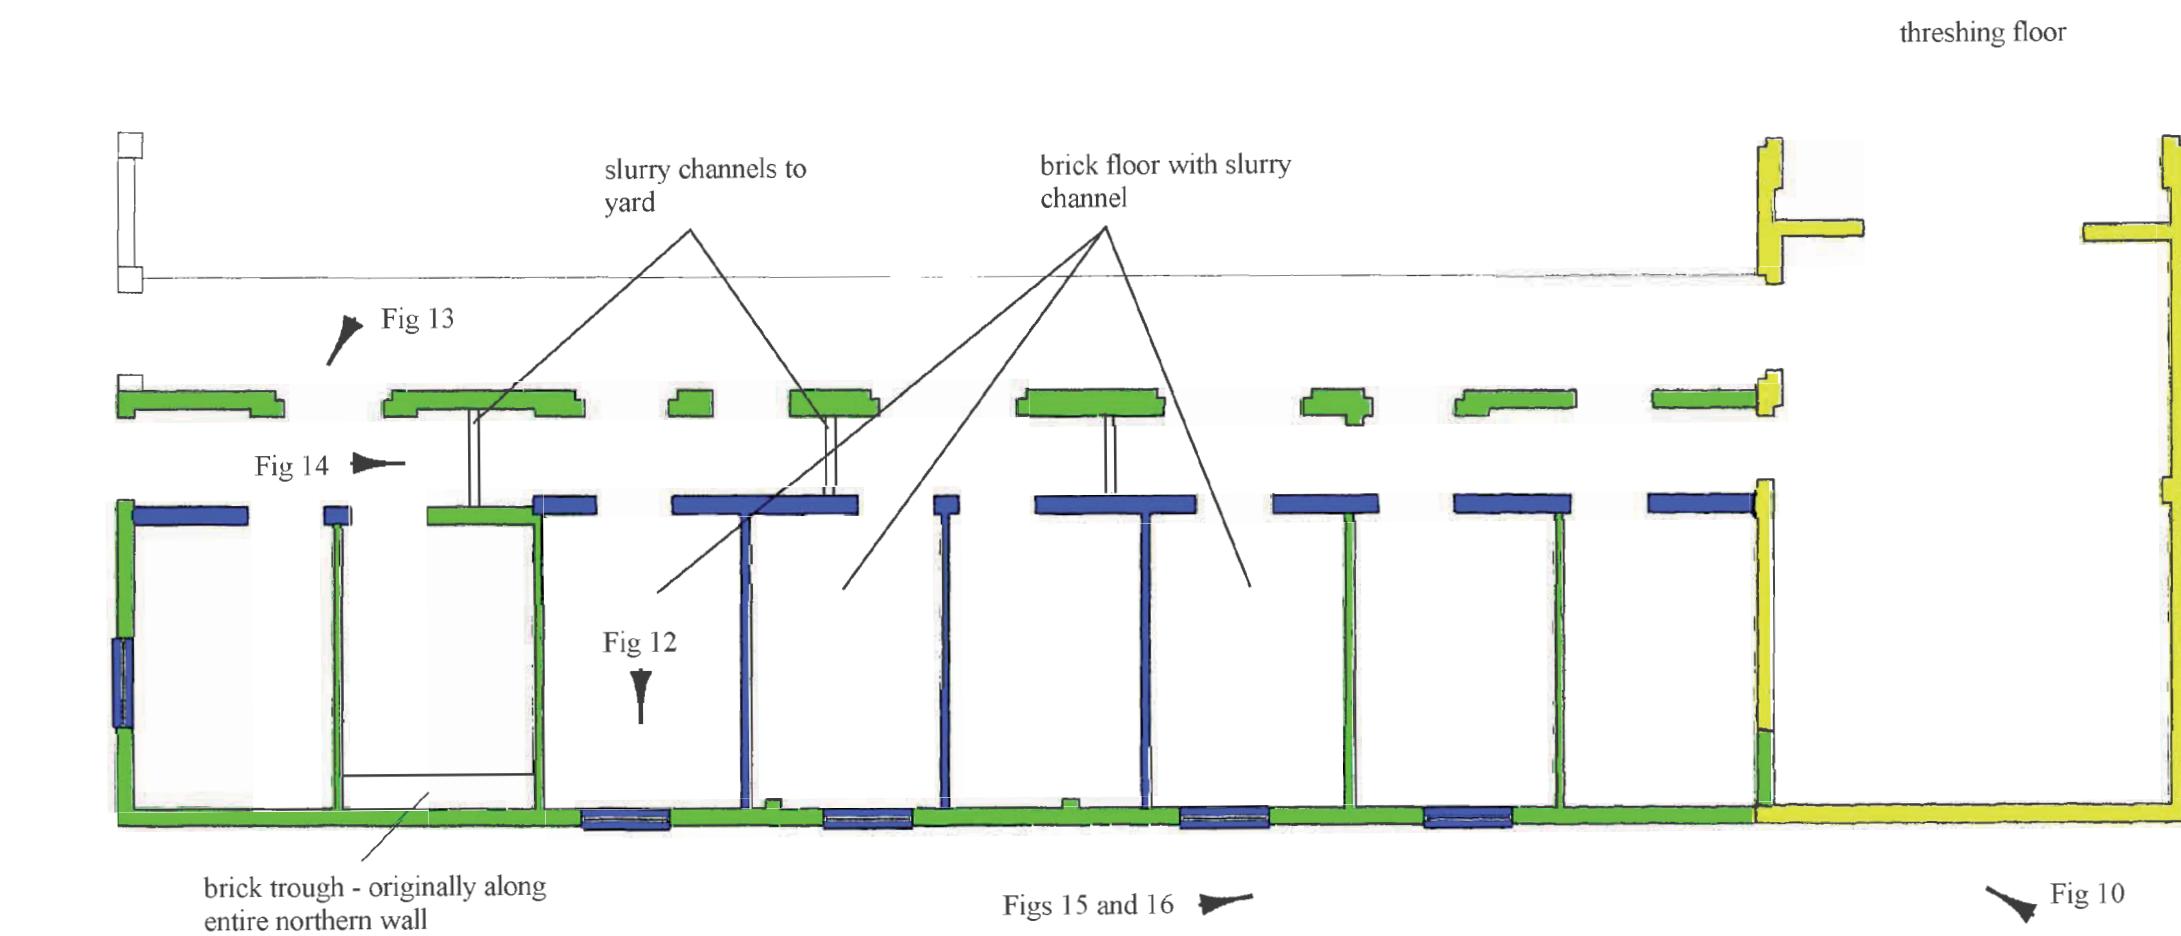
Fig 5: Phased plan

Fieldwork took place on the 24th August 2009. Although the complex is clearly composed of three separate elements (barn, cattle shed and a single cell addition on its southern end; Fig 5) there are no obvious joins in the masonry, differences in the size of the bricks or character of the brickwork. The only indication that the complex was built in stages are the ventilation holes in the north-west wall of the barn, which were subsequently blocked by the construction of the stable/cattle shed. The barn must have been constructed first, leaving masonry tails for the subsequent extensions, which were built when resources became available or when they were required.

The manger or trough (Fig 5) was always placed low-down for cattle, as at The Sladd, unlike that for horses. Parkinson suggested that it should be sufficiently low for the cattle to feed lying down, a height which Dean put at 18 inches. Stephens, however, considered that they should be about 2 inches higher.
