**DUNSTER CASTLE
ROOF REPAIRS**

archaeological watching brief

2006-2008

Archaeological Watching Brief

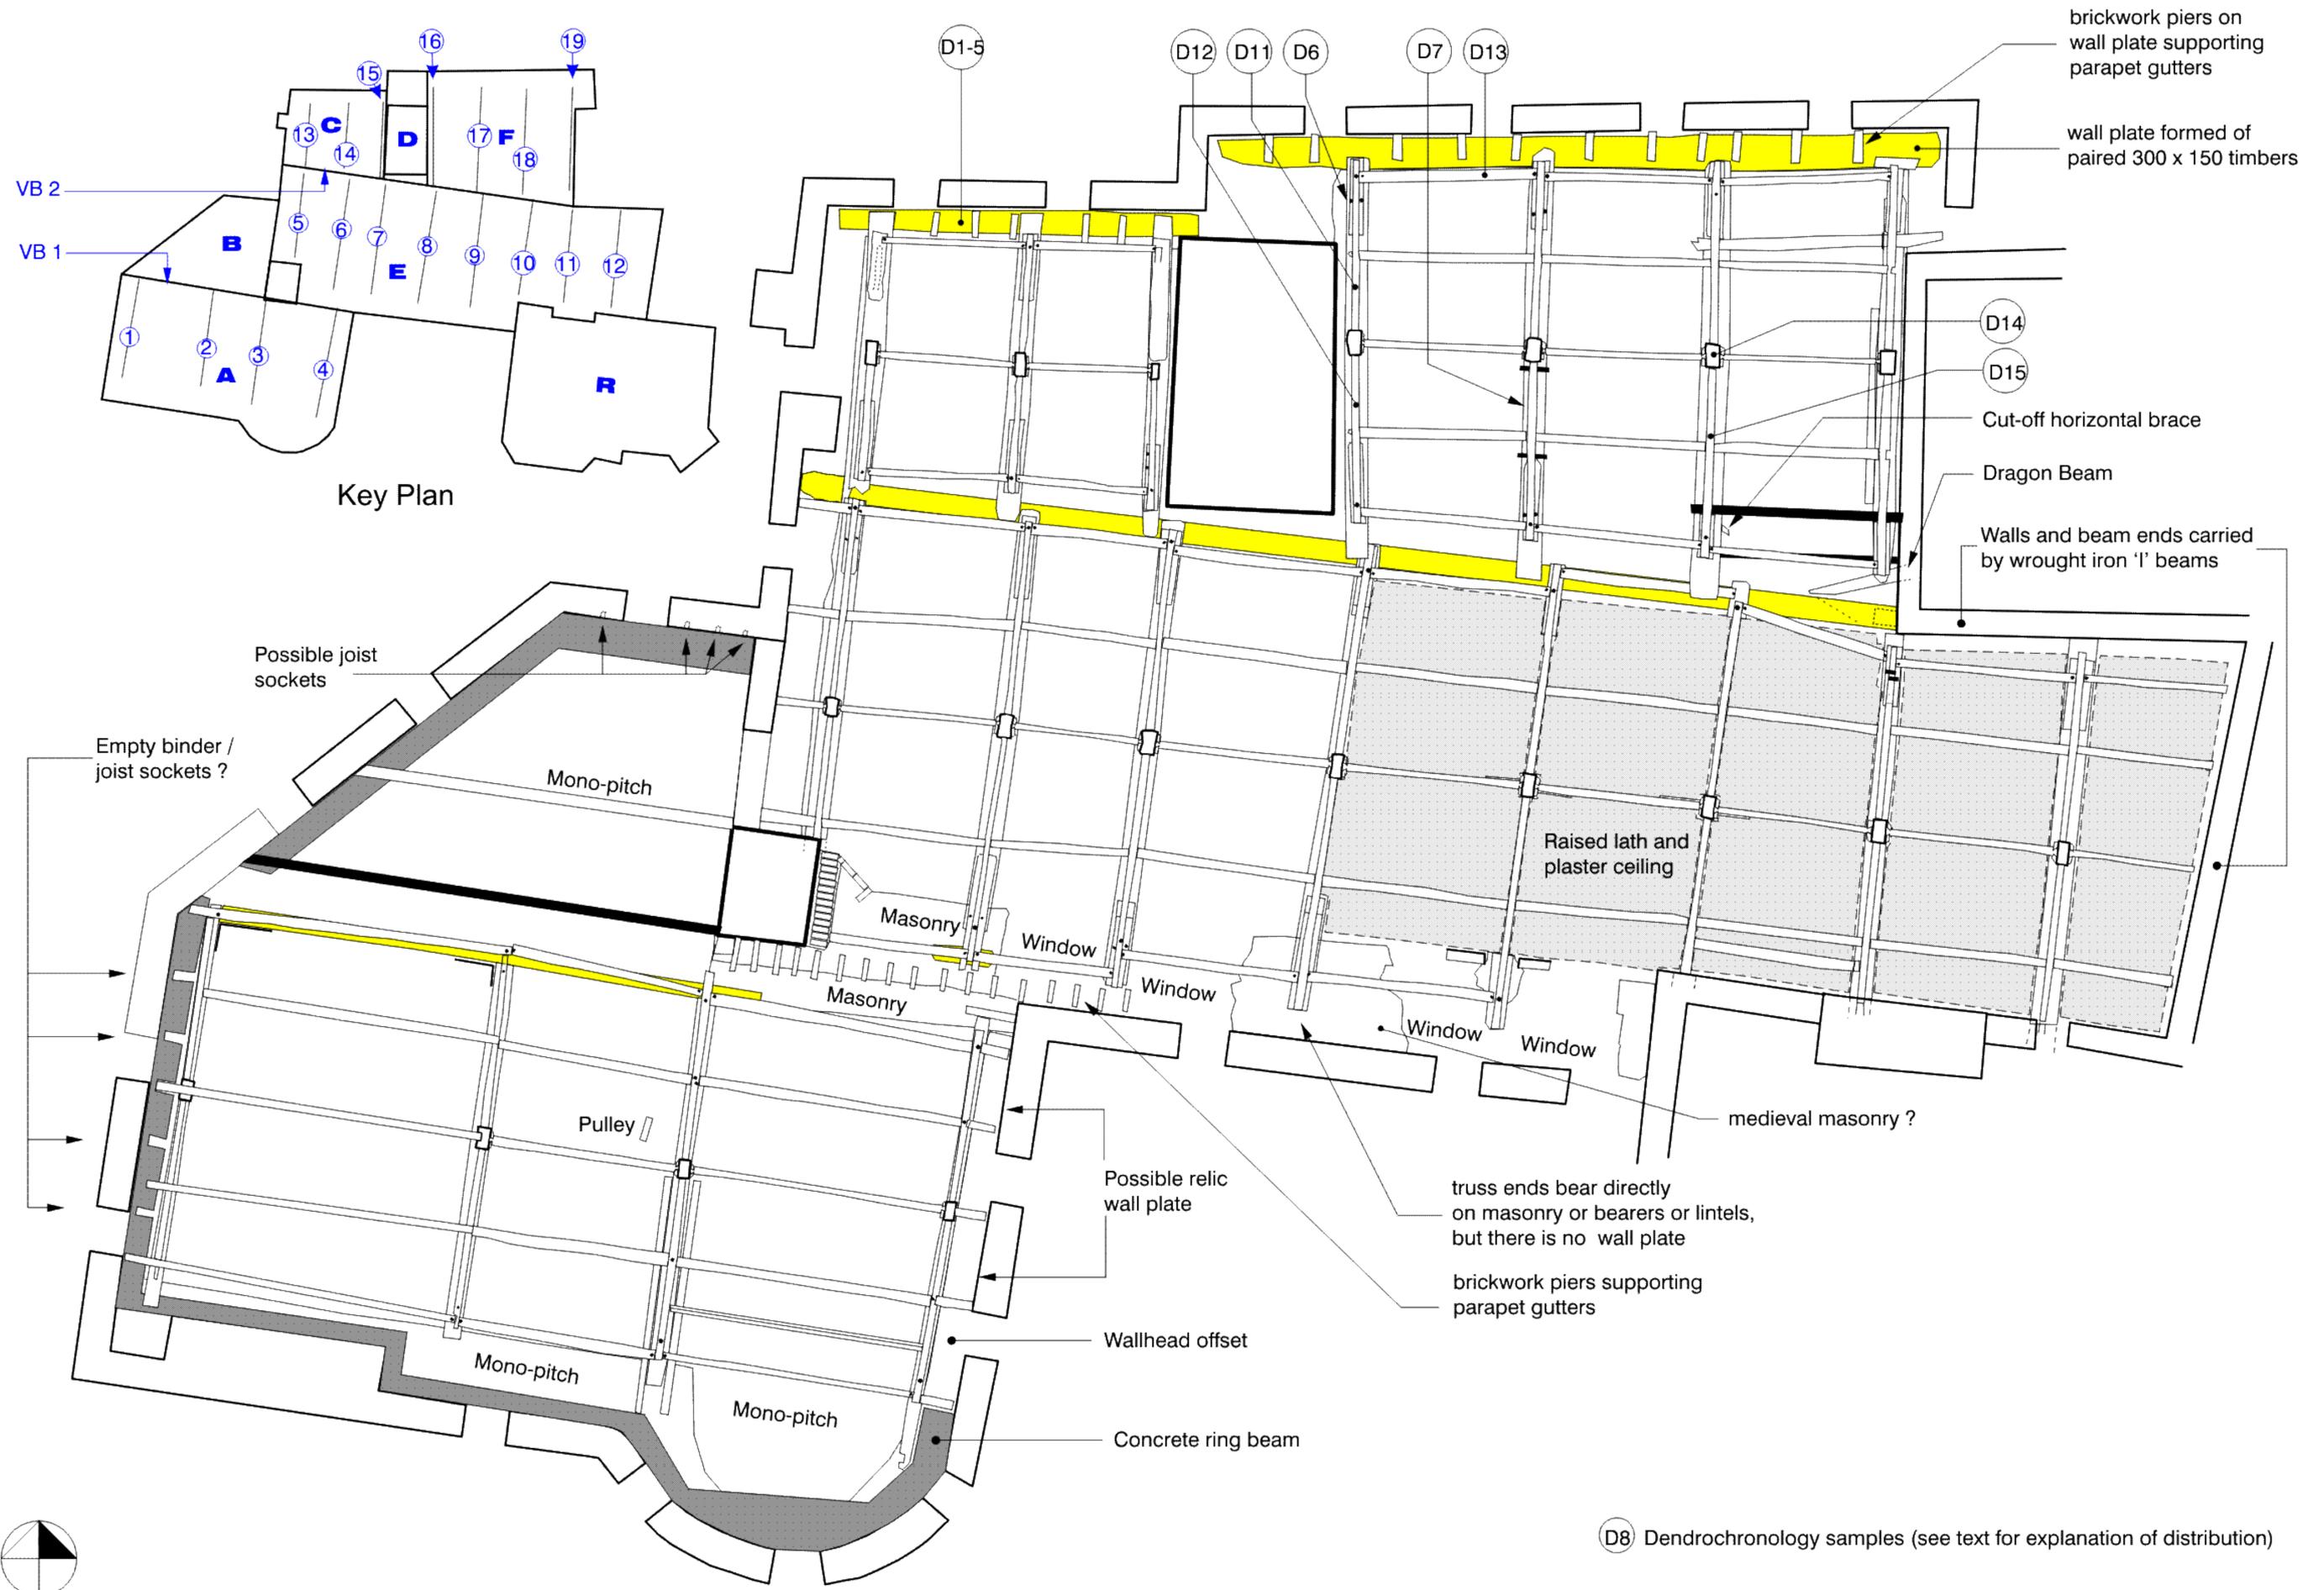
Figure 2. Roof plan showing structural elements

- 3.1.1 Eight separate structures are comprised within Roofs A-F and R; Roof 'A' comprising a pitched roof and a mono-pitch apron along its south side that is not distinguished by the National Trust's nomenclature. For the purposes of this report, the mono-pitch is referred to as Roof 'A1'. Roof 'D' surmounts the masonry turret situated between Roofs 'C' and 'F', shown blank on Figure 2 for reasons explained below.
- 3.1.2 All eight structures share a common W-E orientation (relative to site north), but with a slight divergence towards the east.

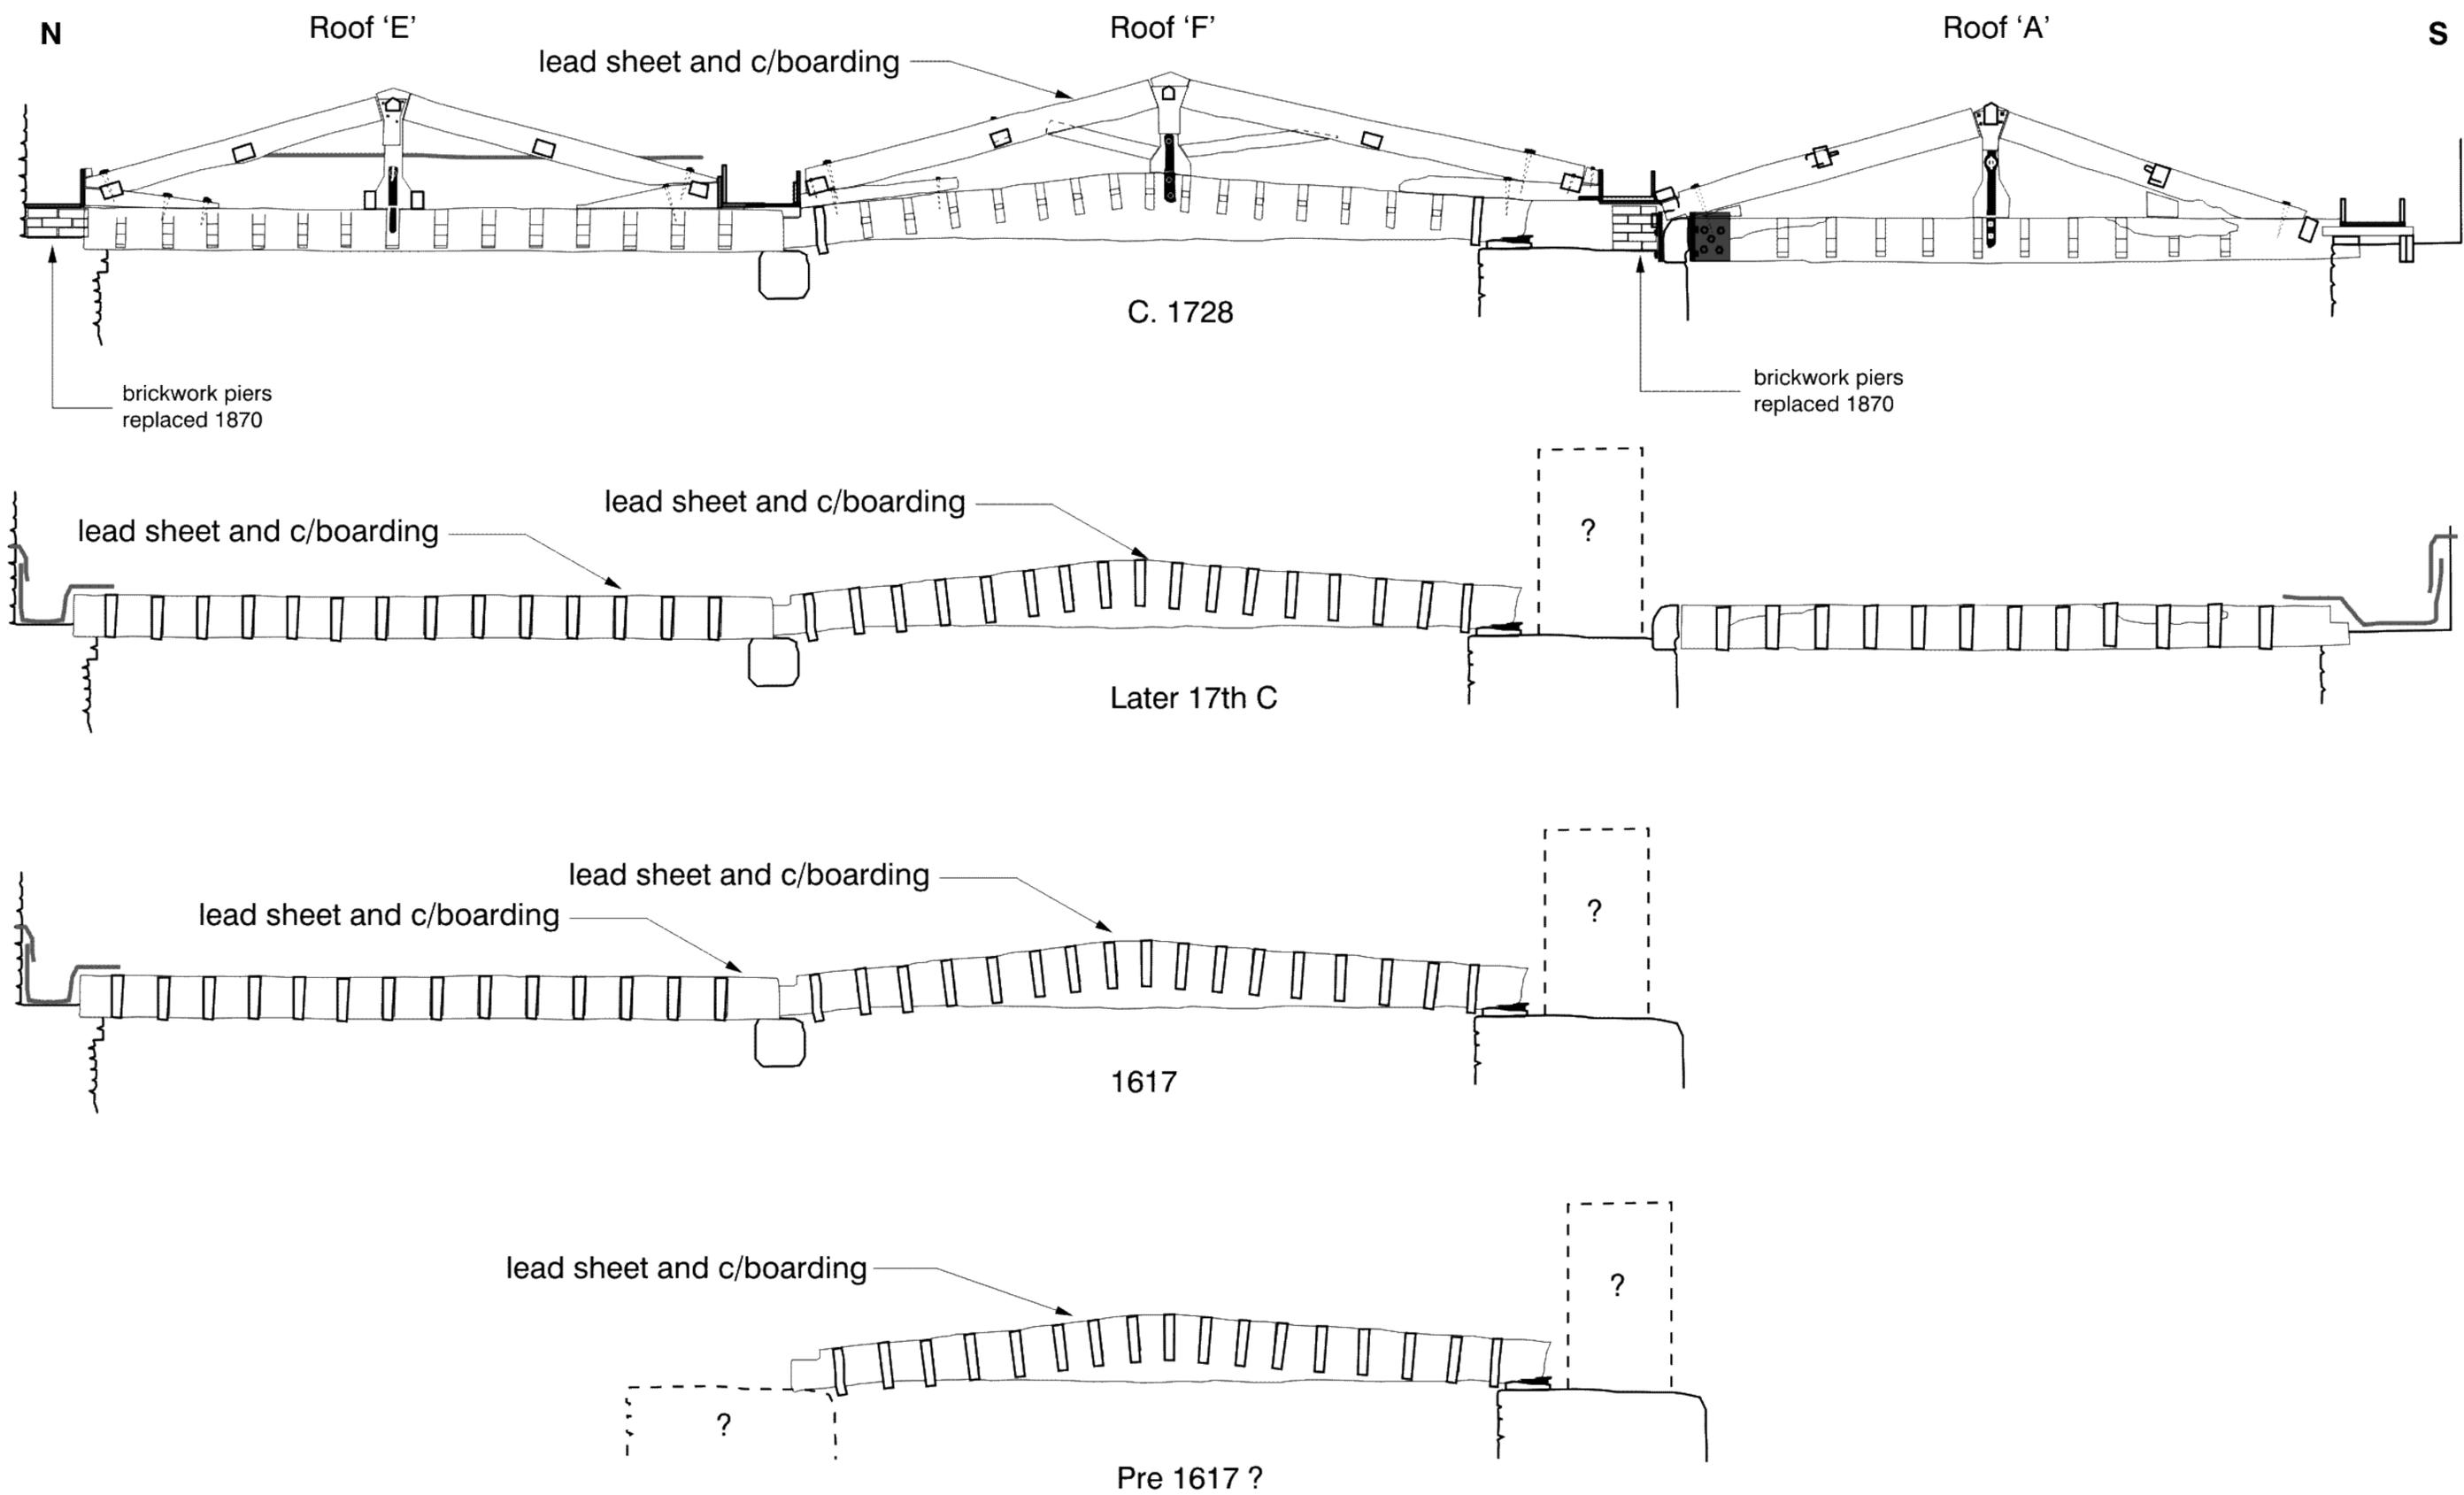
Figure 5. Suggested roof development

- c. The report concludes with an archaeological interpretation of the observations and an assessment of their significance, cross-referenced to a suggested chronological development of the roof structure illustrated by Figure 5.
