JOHN MOORE HERITAGE SERVICES

HISTORIC BUILDING ASSESSMENT

CHILDWICKBURY MANOR WATER TOWER

SEPTEMBER 2013

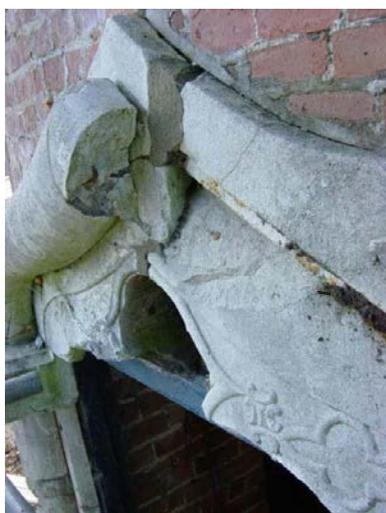
Plate 7: Door Detail

The materials utilised for the door mouldings is stone reinforced with narrow iron rods (Plate 7). Further decoration can be seen in the remains of a quatrefoil above the centre of the doorway and a stylised leaf motif to either side (Plates 8 and 9 below)

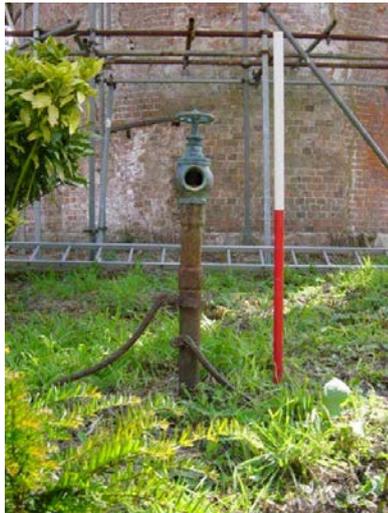
Plate 13: The Standpipe

There is a standpipe situated some 4.80 m from the blocked door of the tower (Plate 13). This pipe comprises early and recent metalwork. The date of origin for the pipe is unknown. A secondary structure, now demolished was situated adjacent to the blocked doorway on the western external face of the tower. The footings (Plate 14) are to the north of the doorway and measure c. 2.00 m by 1.55 m. Traces of the roof of this structure are still visible on the external face of the towers indicating a height of c. 1.3 m for the later build.

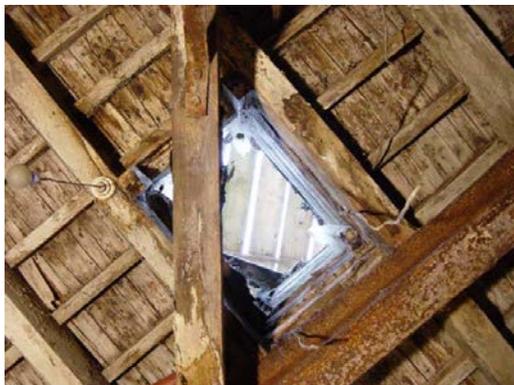
Plate 24: The Hatch Access Viewed from the Floor of the Tower

The ceiling supporting the underside of the cistern is an oak construction comprising main beams and joists; the hatch through to the tank is also clearly visible (Plate 24). The main beams include four that are recessed into the tower walls (Plate 25-26) and the joists are housed within the main beams. Later support was added in the form of iron I-beams in turn supported on vertical I-beams set into concrete footings. The iron supports are a much later addition to the tower: one is situated in front of the bricked up doorway, the other adjacent to a window.

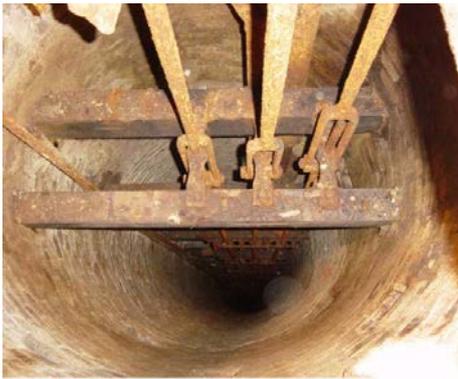
Plate 27: The Interior of The Well

The well, situated in a central position within the tower is currently encased in a wooden box-like structure of plywood construction and is believed to be over 100 foot deep. The well is brick lined and there are putlock type holes let into the walls probably to aid in the construction. The well houses an iron pump mechanism: a wheel that would have held a drive belt is clearly visible as are the pistons and a large cogwheel. Iron joists are also *in situ* within the well, which may have been inserted to provide additional support at a later date in conjunction with the addition of the I-beams supporting the roof and tank.

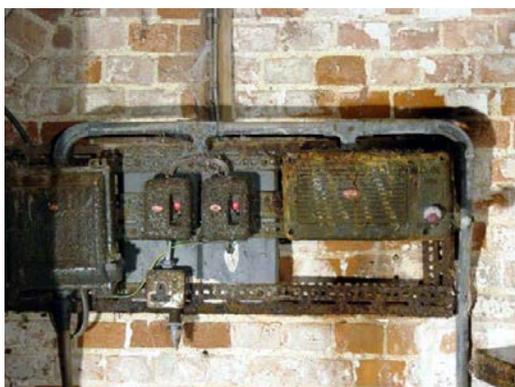
Plate 31: The Electric Supply

The fixtures and fittings *in situ* within the tower are predominantly later in origin than the construction itself. The conversion of the facility to electric power (Plate 31) with the addition of a large motor driven mechanism situated to the north of the current doorway (Plate 32-35) made some of the original

fittings redundant, resulting in their replacement with larger diameter pipes, taps and the addition of a modern water softening tank.
