Standing Building Survey
Ayton Farm mill cottage and mill system,
Aberargie, Perth and Kinross

Mill cottage/dam house looking South

24th January 2011

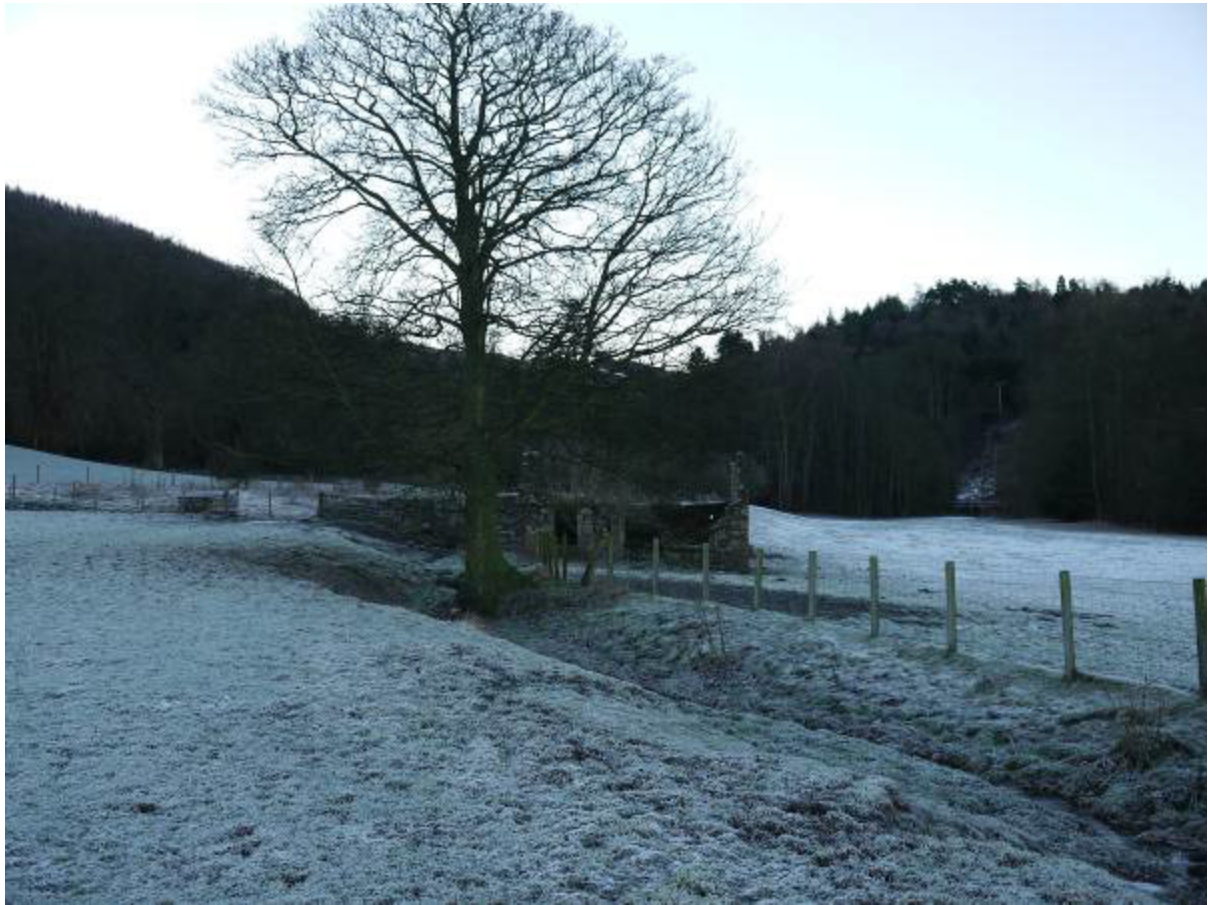
Illustration 5 General view of mill cottage/dam house looking South

The roofless remains of a single storey building that represents the former mill cottage/dam house at Ayton Farm lie to the South of the farm at 22m OD. This building is aligned East to West and lies on the west side of the former mill lead, it is accessed by a small arched stone bridge (Illus 6).

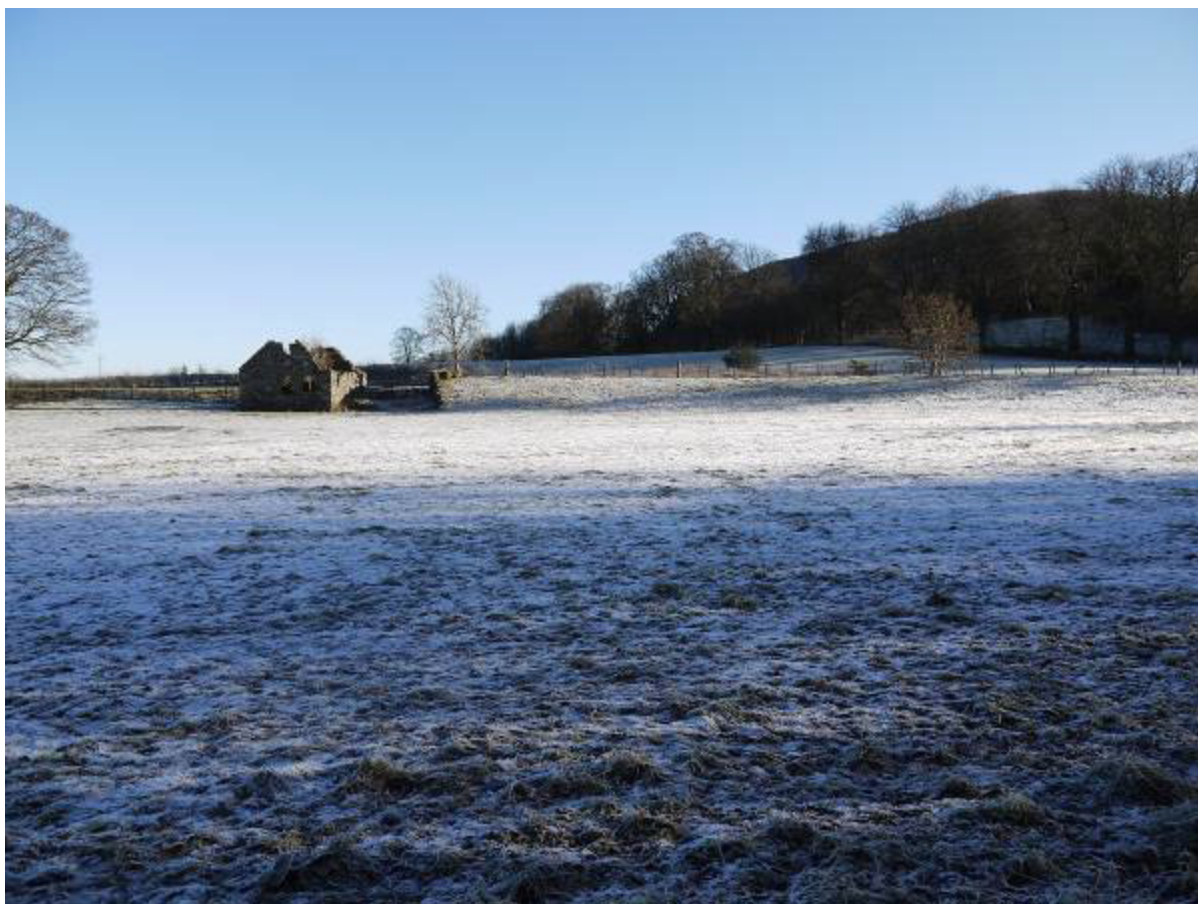
The most visible element of the mill pond is the substantial earthwork that formed its western boundary, this still runs up to the field boundary to the south. The eastern side of the pond is less well defined and a small stream still flows sluggishly through its entire length and feeds into the former mill lead to Ayton Farm.

Illustration 22 General view showing relationship between mill cottage/dam house and mill dam and pond looking East

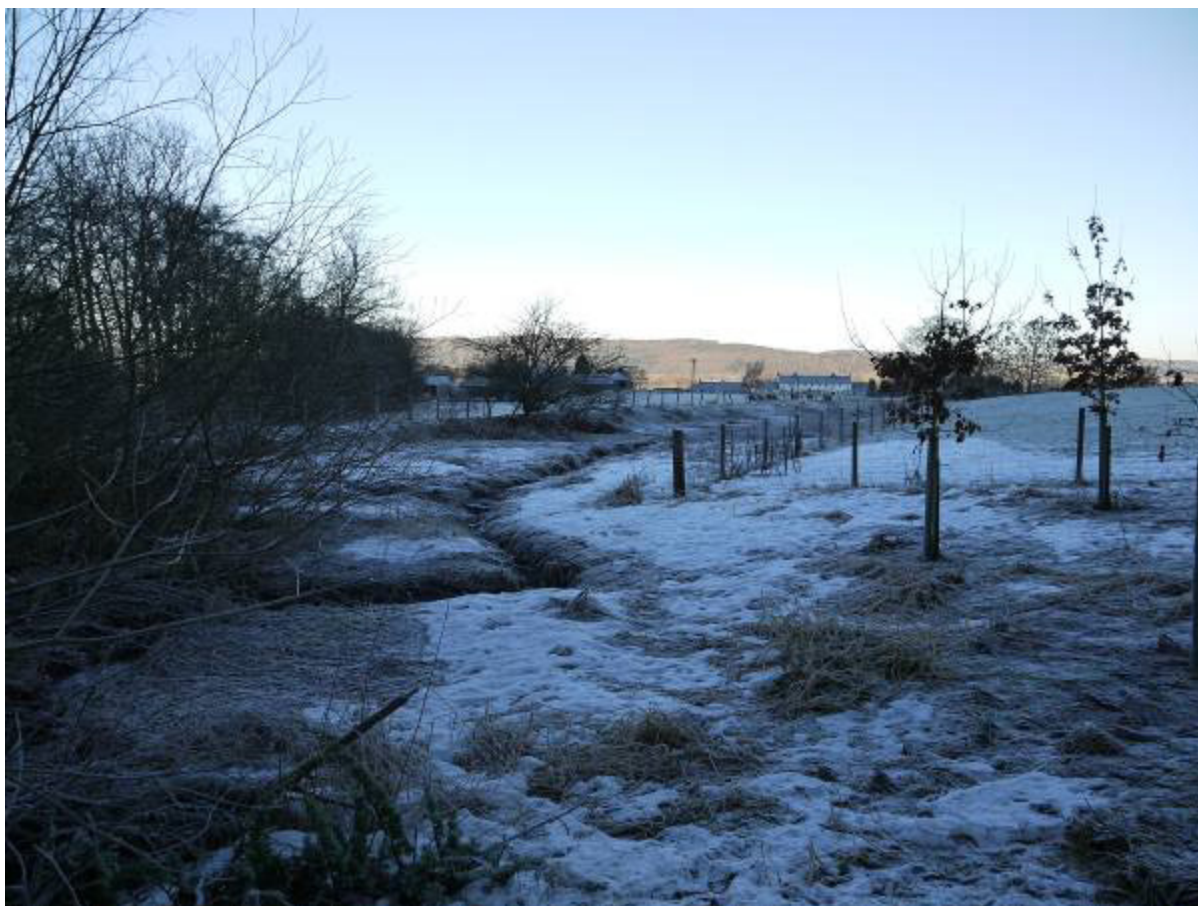
Illustration 23 Mill pond looking North

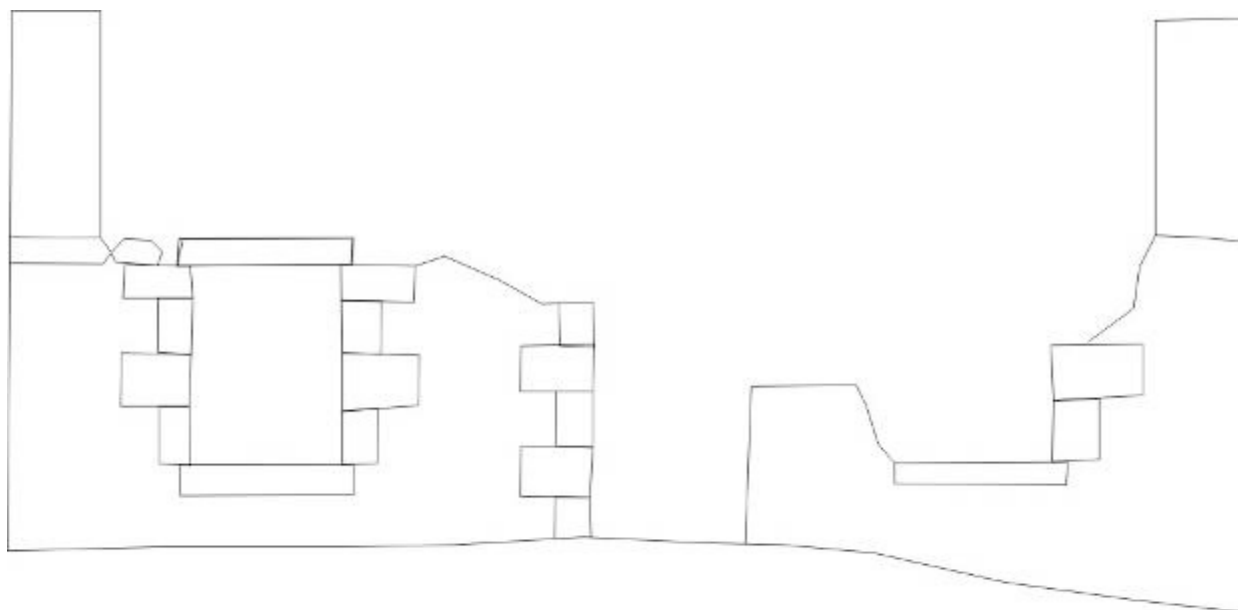
Illustration 26 (Top) Northern elevation of Mill cottage/Dam house

This elevation has a central doorway with a window on either side and is constructed of rough rubble (river cobbles and sandstones) bonded with lime mortar. The windows and doorway are defined by shaped sandstone blocks. The eastern end of this elevation survives to roof level whereas the western end has collapsed to a height of 1.6m. Its wall is 0.60m thick.

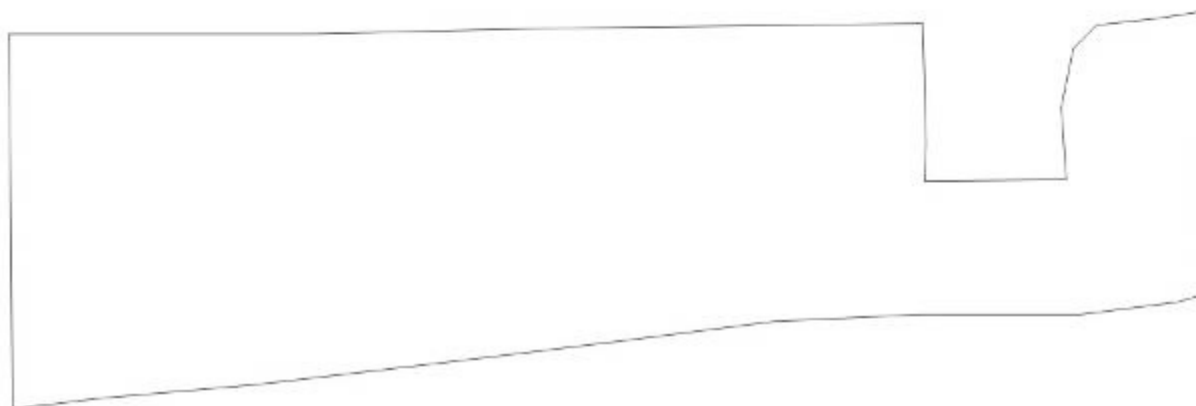
(Bottom) Southern elevation of Mill cottage/Dam house Scale 1:50

This elevation has a window at its eastern end and is constructed of rough rubble bonded with lime mortar.

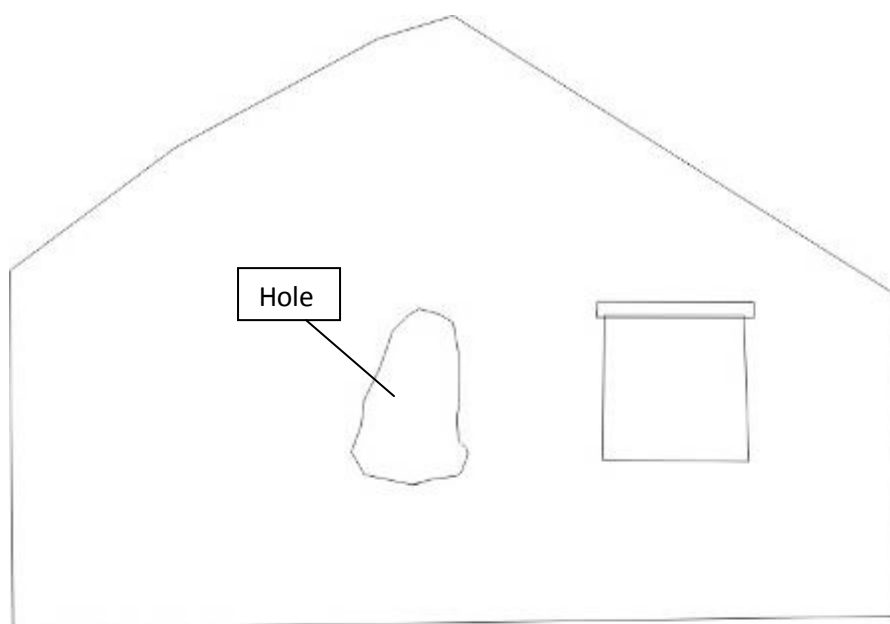
Illustration 27 (Top) Western elevation of mill cottage/dam house

This elevation has a window at its southern end and a central hole through the wall behind the fireplace. It is constructed of rough rubble bonded with lime mortar. The window has a wooden lintel but is not defined in the same way as the windows in the front Northern elevation, its wall is 0.60m thick.

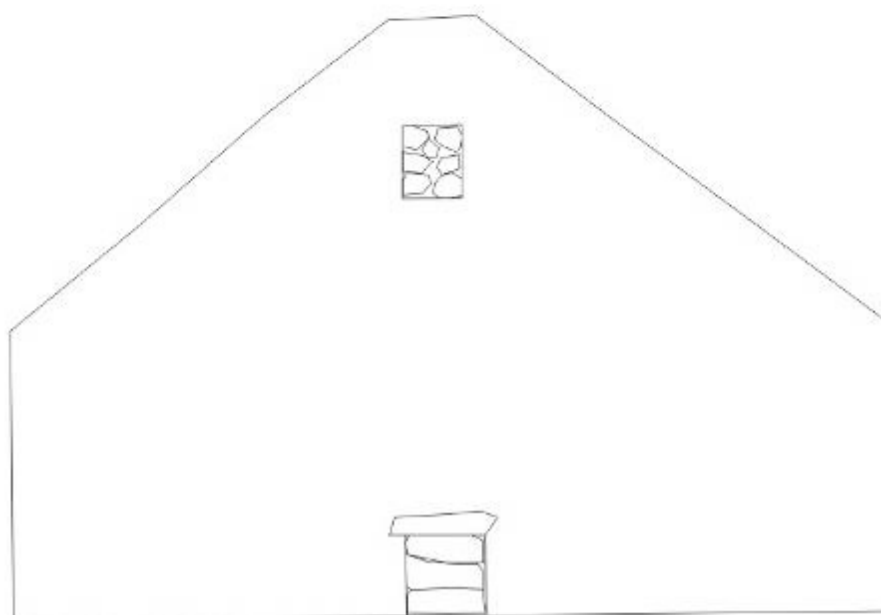
(Bottom) Eastern elevation of mill cottage/dam house (Scale 1:50)

This elevation has a blocked small window just below the apex of the gable and a blocked narrow access point at ground floor level. It is constructed of rough rubble bonded with lime mortar.
