# Archaeological Investigation: Excavation and Recording

Fishpool Valley,  
Croft Castle,  
Yarpole,  
Herefordshire,  
HR6 9PW

Report by Stephen Wass MA, MCifA (7651)  
Polyolbion Archaeology  
For  
Imogen Sambrook, Project Manager,  
Janine Young, Archaeologist,  
The National Trust

October 2017

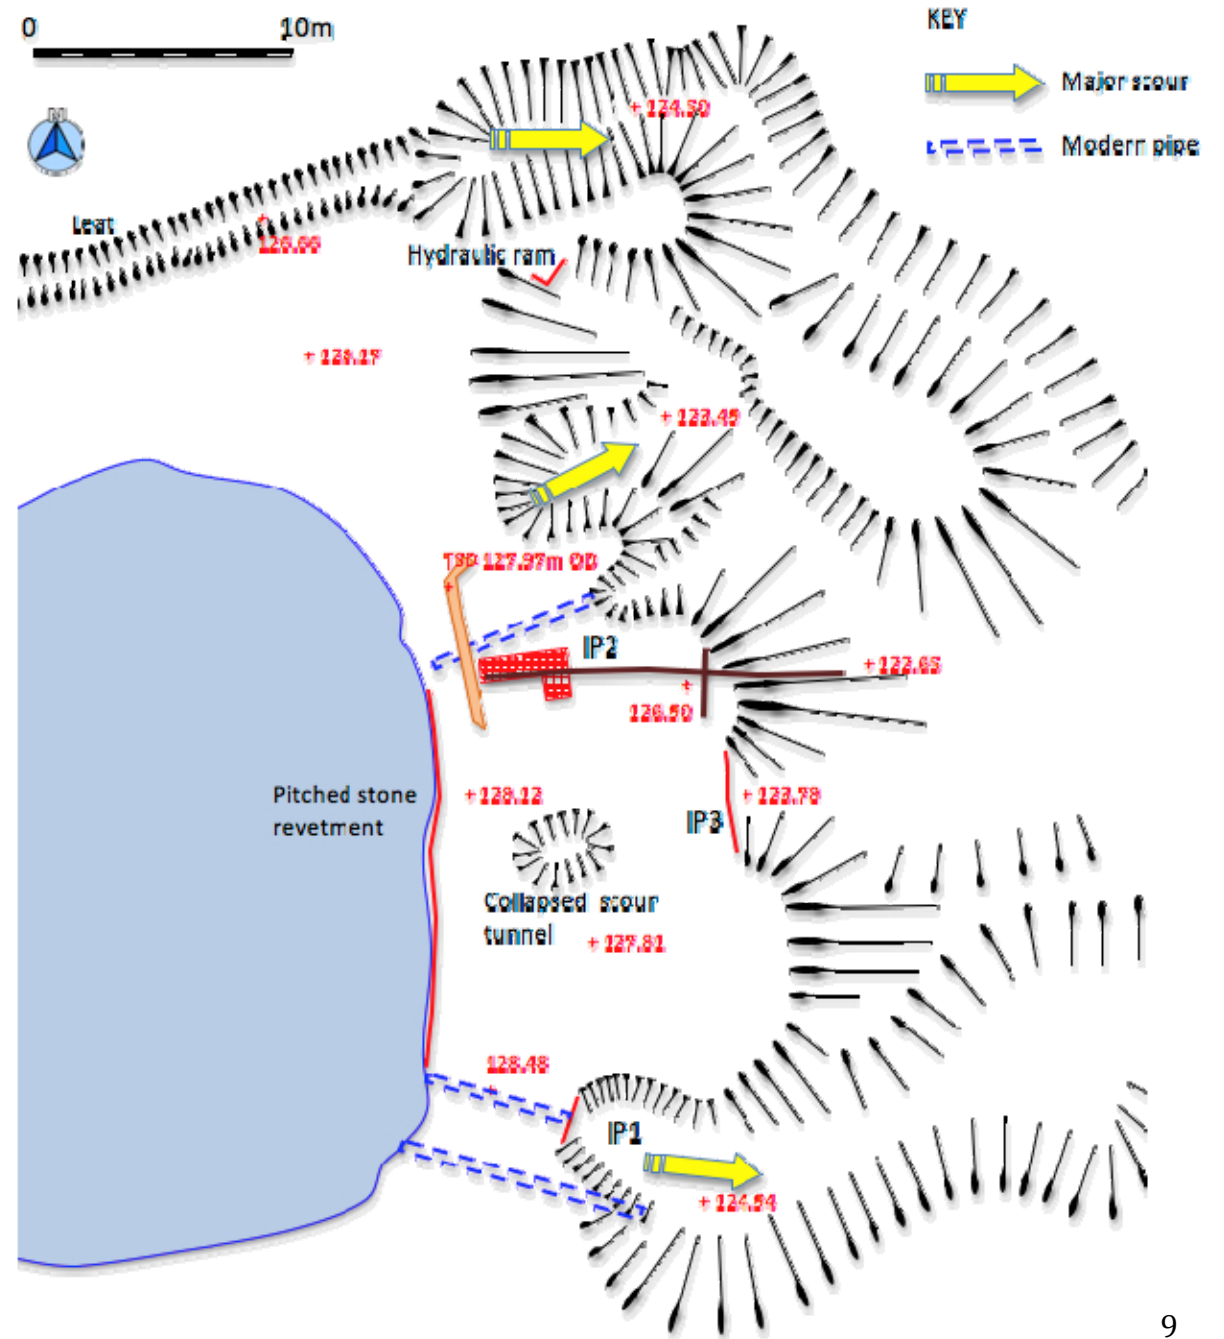
**4.1 POOL AND DAM 1.** Work began at this location with three IPs as it appeared to be the dam in most urgent need of attention. Given that it is the final pool and dam in the series it is clear that when heavy flooding does occur the full force of the accumulated water will be expressed here. Indeed the topographical survey and observations on the ground suggest that there are at least three large scour channels resulting from flood episodes (Fig. 5). The dam is unusual within the valley as it is rather broad with a shallow sloping top, in contrast to the narrower steeper dams seen up stream. The pool side face of the dam has a pitched stone revetment which appears to be in quite good condition. To the north of the dam is a shallow leat which originated at dam 2 and judging by the small amount of stonework surviving further west could have been used either to divert water into pool one or function as a by pass channel around it. To the north east is a hydraulic ram, now inoperative, in a brick and concrete housing. South of the centre is a major depression caused by the partial collapse of the roof of the scour tunnel. Recent control measures include ceramic pipes: a pair set just north of the centre and another set to the south where the pipe emerges high in a stone retaining wall. Close to this is the large modern plastic pipe installed after the most recent partial collapse of the dam (Fig. 6).

Fig. 6 Southern scour channel, looking west towards IP 1 and overflow pipes.

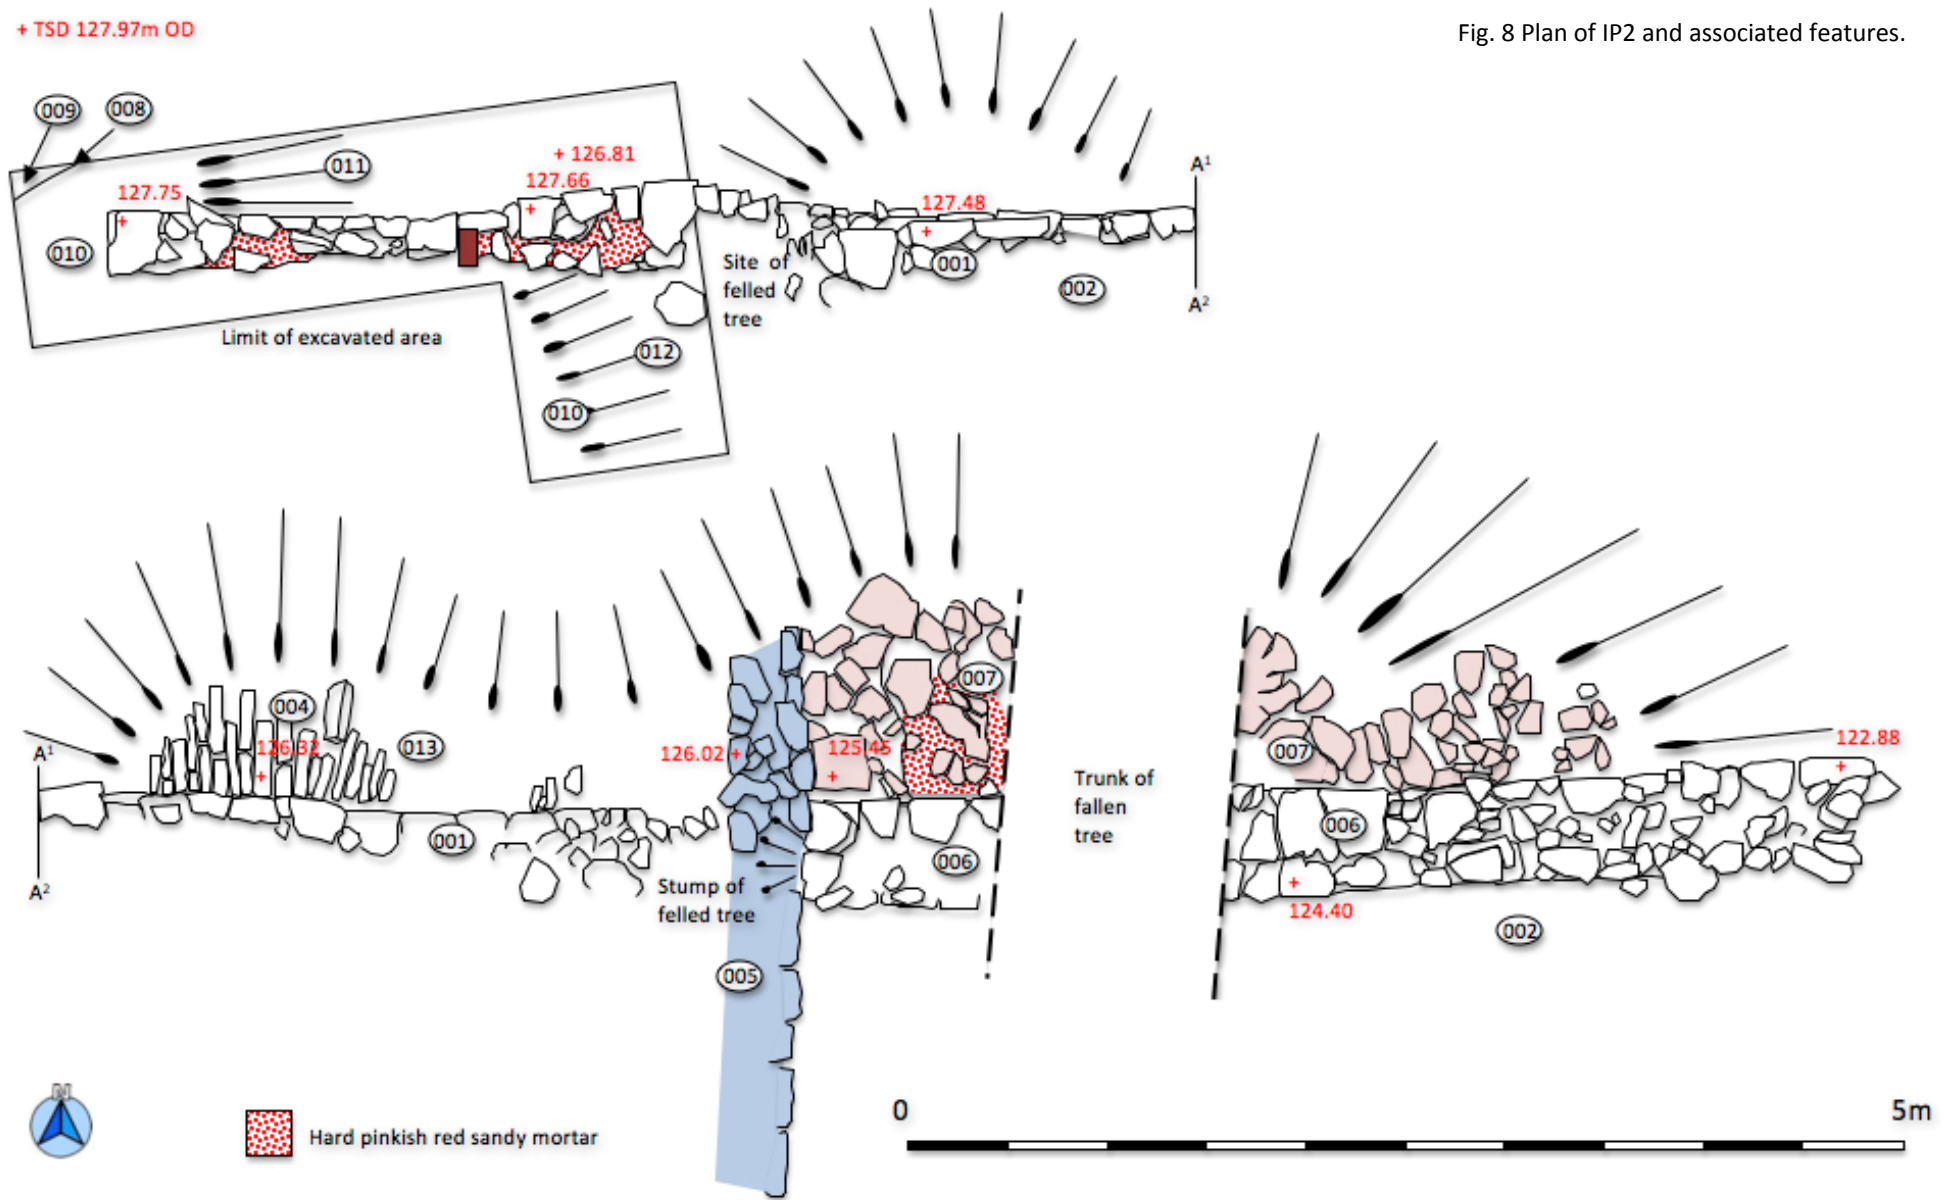
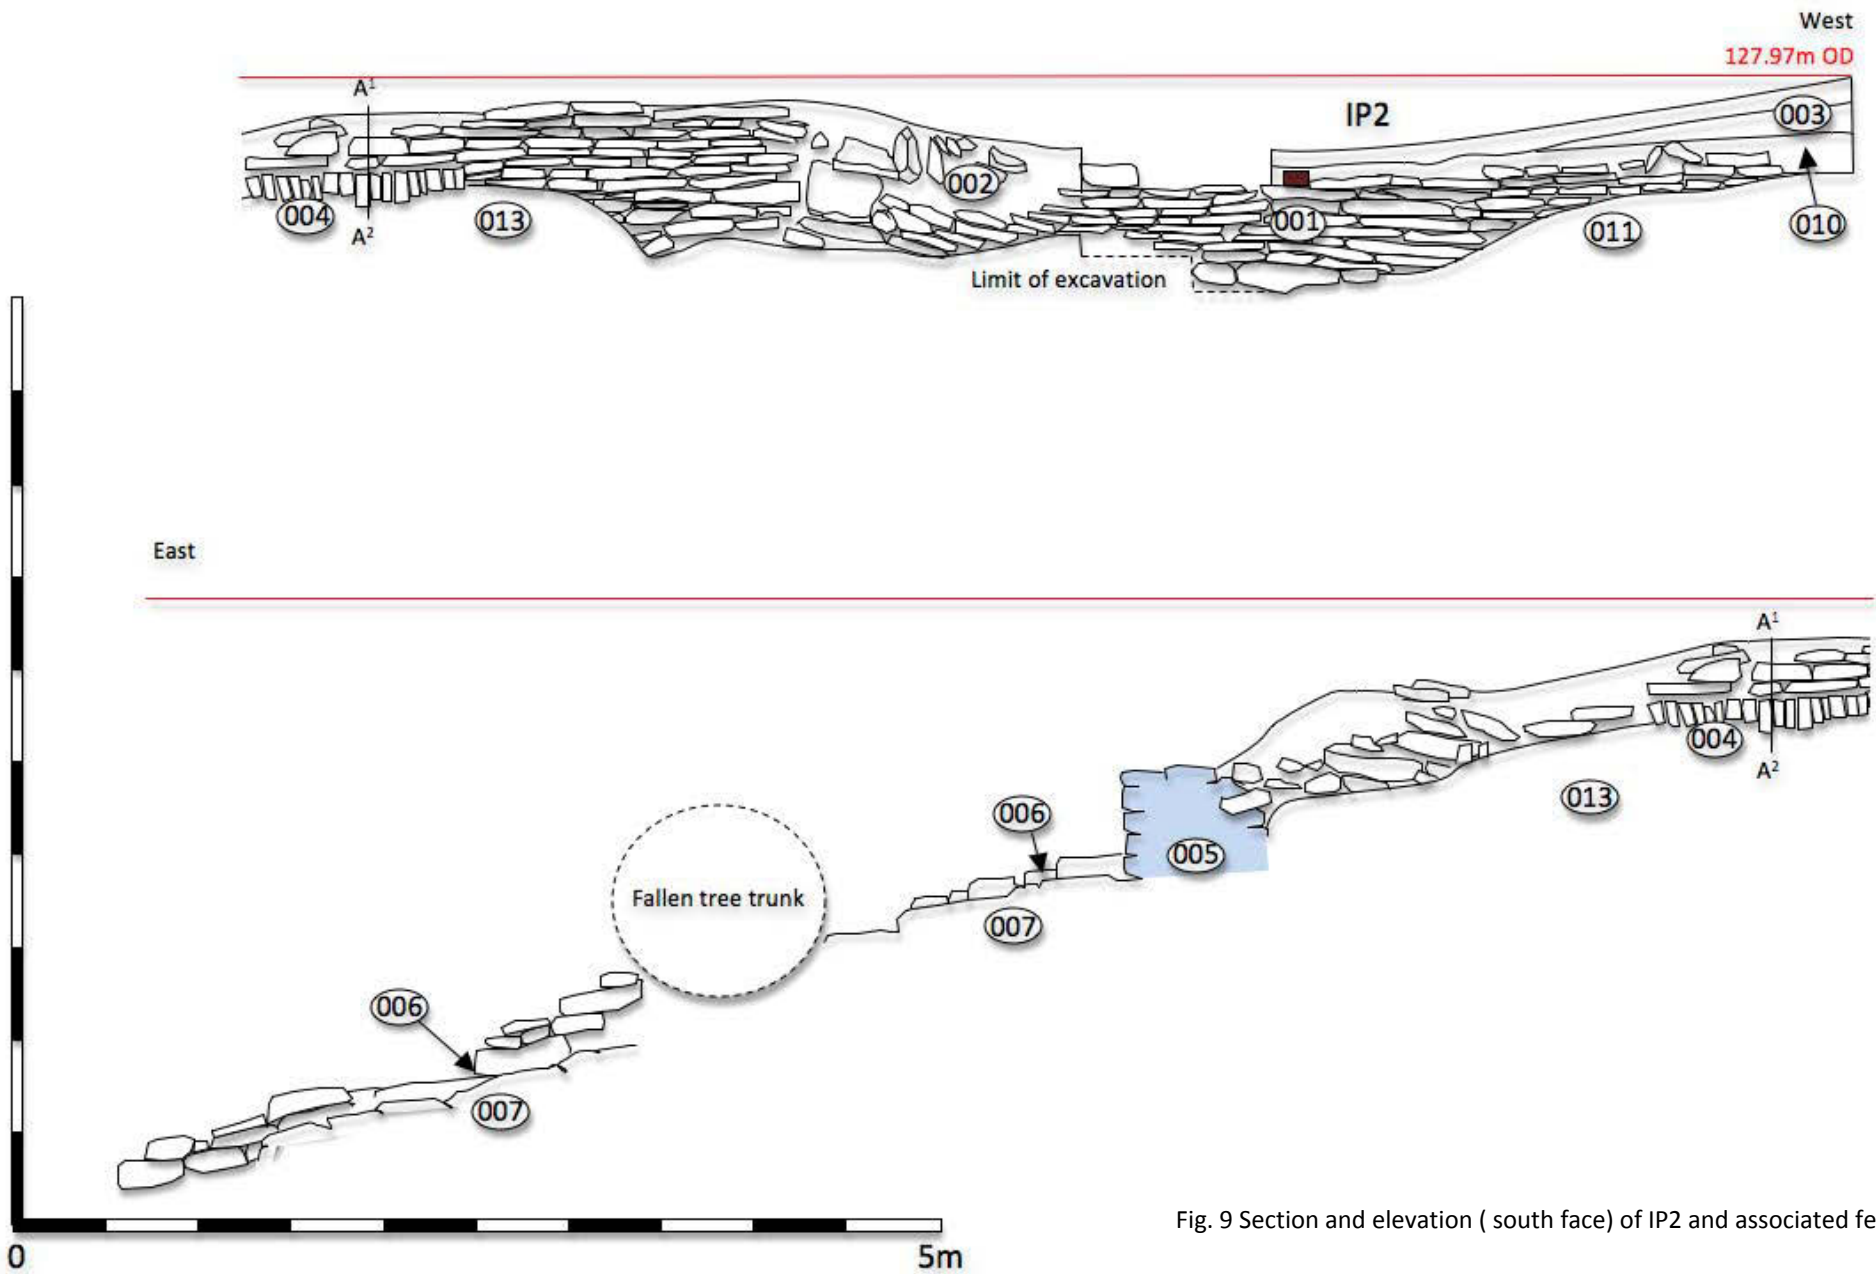
Fig. 9 Section and elevation ( south face) of IP2 and associated features.

As the north face is well finished but the south face is rough and irregular the structure was clearly built partially as a revetment wall. Whilst appearing to be dry built removal of some stones revealed a hard gritty reddish mortar. In places the wall has been all but reduced to a scatter of rubble by the action of tree roots. Immediately adjacent to its northern face is a small area of pitched stone paving (004) roughly 1.2 x 0.8m (Fig. 13) and bedded in a light grayish brown clay (013). This is assumed to be a small surviving section of a water channel or spill way leading down from the crest of the dam, the rest having slipped into the scour channel to the north.

The eastern end of the wall 001 appears to butt up against an earlier, although similarly constructed, wall (005) running north - south and so partially revetting the east face of the dam (Fig. 12). The east face of this wall stands in places to a height of 0.6m but when drawn as part of the 2006 survey its northern end was much higher, up to 1.2m. Most of this part of the wall has also collapsed down into the scour channel to the north. Below and beyond 005 to the east is an area of flat shallowly stepped flagstones set in a hard reddish gritty mortar (007). This extends further east below the trunk of a fallen tree and runs out around 2.5 m further down the slope (Fig. 14). It is flanked by the remains of a low wall (006) which butts up against 005 yet maintains the line of 001 for a further 6m (Fig. 9). There is no trace of a similar wall on the north.

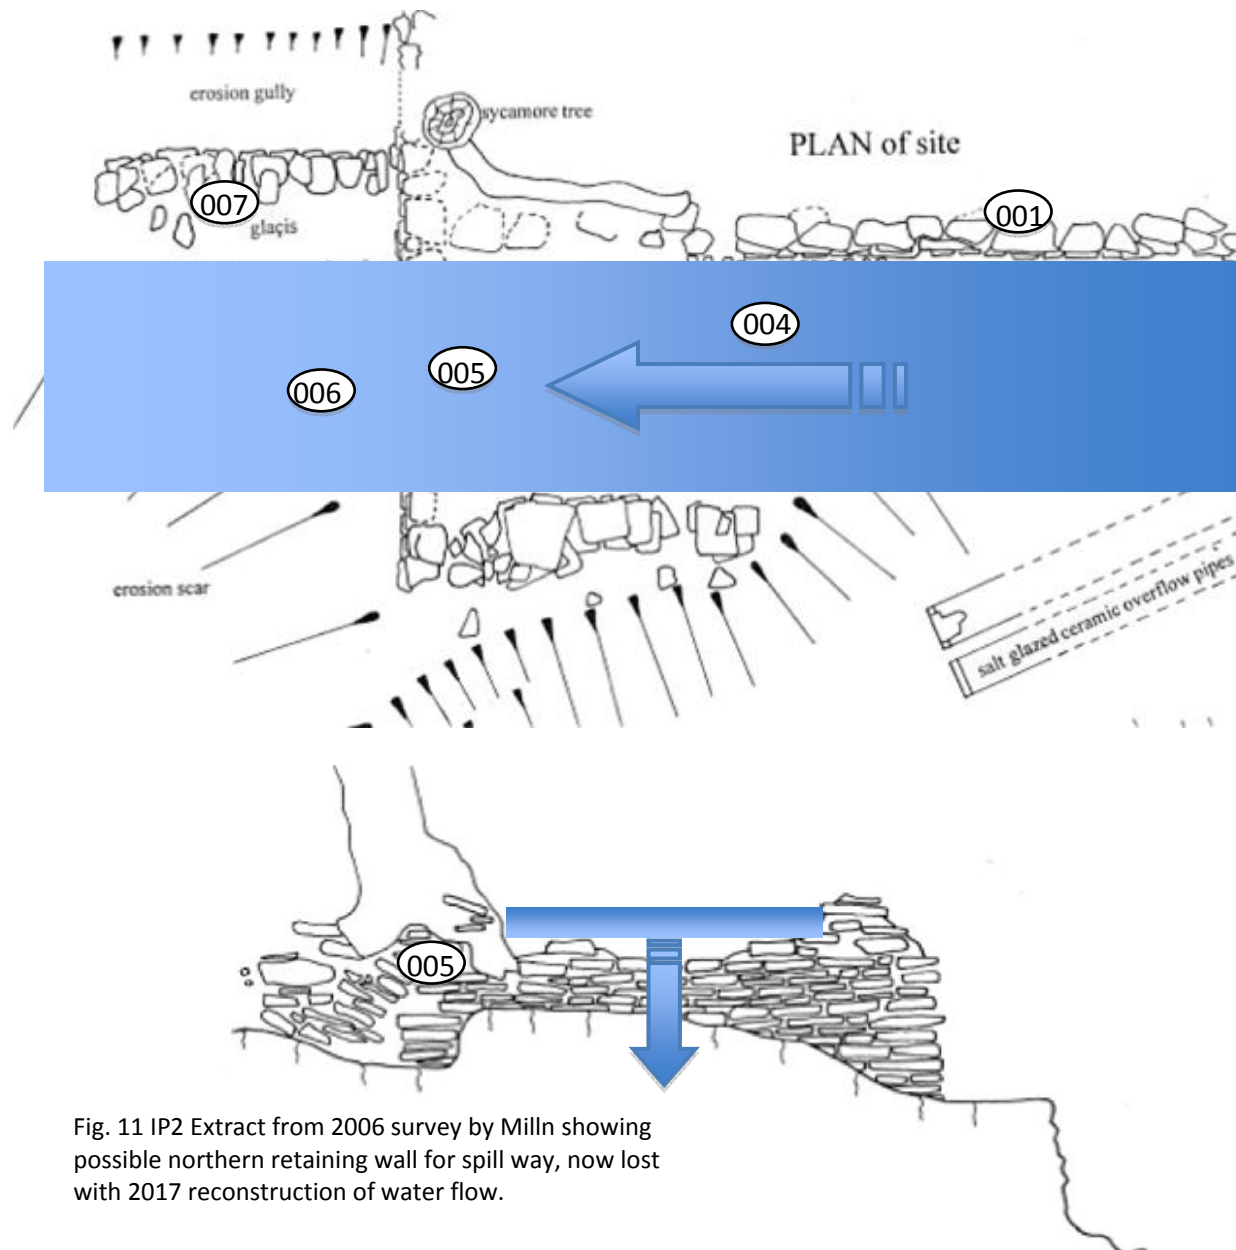
Fig. 11 IP2 Extract from 2006 survey by Milln showing possible northern retaining wall for spill way, now lost with 2017 reconstruction of water flow.

Conclusions. Although badly damaged and largely eroded away enough remains to tentatively reconstruct the arrangement here for a long shallow spill way. The observations made in 2006 give us an idea of the possible width (Fig. 11) indicating that the whole structure was around 10m x 1.2m. The spill way terminated in a vertical plunge of around 0.7m and the water then flowed out along a gently sloping cascade made a several shallow steps. It is possible that at some point this arrangement failed catastrophically, this and the subsequent insertion of pipes and a drainage gully to the north has removed all traces of the northern retaining wall of the structure. The weak point in the dam left after the spill way was abandoned was made good with a dump of clay and gravel and later by the addition of a concrete beam.

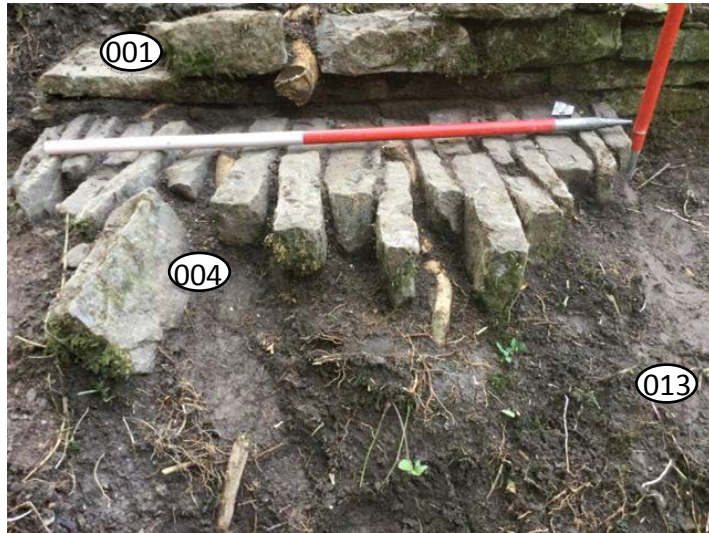
Fig. 13 IP2 Surviving portion of pitched stone surface

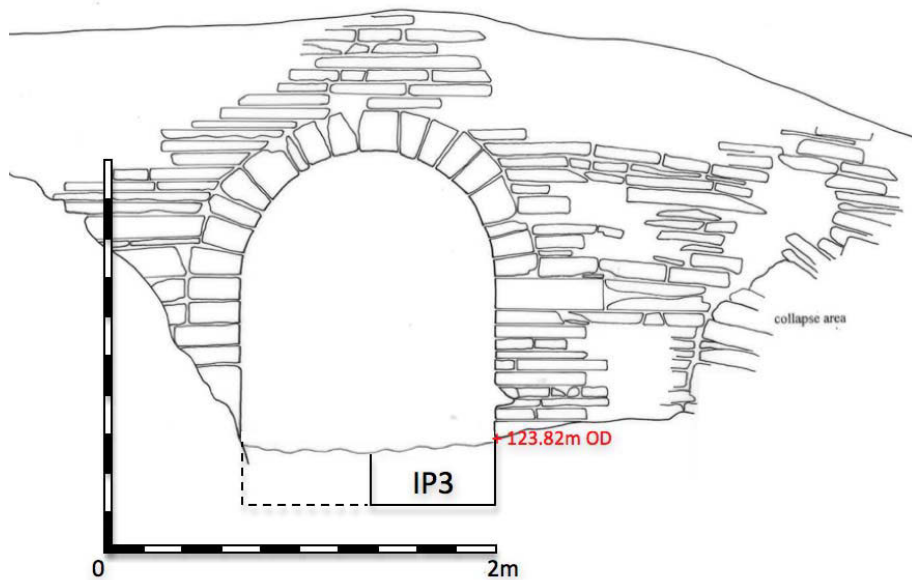
This task was initially left in the hope that the flow of water out of the tunnel (estimated at around 2 litres/minute ) would partially dry up. This did not happen and so a small trench was eventually dug through liquid mud and silt to determine where the bottom of the tunnel lay. A section roughly 1m x 0.5m adjacent to the south jamb of the retaining wall that framed the tunnel (001) was excavated much of the time under water. The top 10cm consisted of partially decayed leaf mould and twigs (002), below that was a more compact layer of very dark grey organic rich silt (003) around 25cm deep. This became increasingly gritty until it transformed in the lowest level of silting (004) which was a coarse sandy gravel 15cm in thickness above stone slabs (005). These felt fairly solid but it was not possible to determine whether they were part of a laid surface of just rubble fallen from above (Figs. 15 and 16).

Fig. 15 IP3 Elevation from 2006 survey with location of trench.

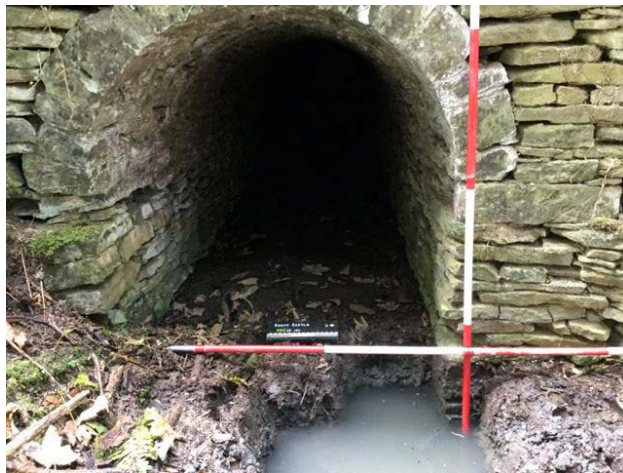
Fig. 16 IP3 view of tunnel entrance and trench looking west.

Conclusions. Scour tunnels are generally employed when the need arises to completely drain a pool. The idea that fully opening these tunnels in order to use a vigorous flow of water to partially scour out accumulated silts and sediments has been largely dis-credited.<sup>v</sup> However the character of the lowest silt indicates an initial fairly lively flow of water whether by accident due to a faulty sluice or managed for ornamental effect is uncertain. At some point a 6m section of the tunnel collapsed and this clearly restricted the water flow allowing the accumulation of an organically rich silt. The tunnel exit appears well built. The voussoirs are reasonably well formed and dressed but the retaining wall is of roughly coursed random rubble and has suffered from a partial collapse on its northern end.

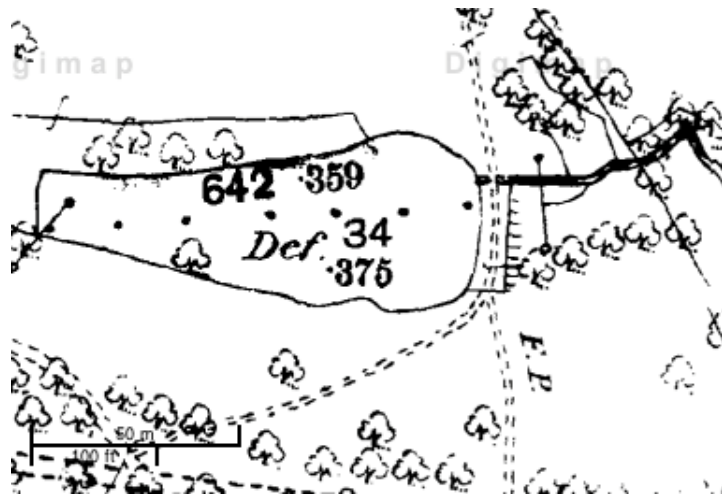
4.1.4 Dam 1 - Discussion. The overwhelming impression at dam 1 is that of chaos: fallen trees and massive gullies eroded by flood waters contrast with the orderly arrangement charted in the Ordnance Survey map from the 1880s (Fig. 17) which presumably most closely reflects the original picturesque layout. The broad top of the dam with a footpath crossing the spill way is clearly shown as is the small trickle of water presumably emerging from the scour tunnel. Particularly interesting is the line which appears to indicate that the dam crest was fenced or walled to create a small enclosure. Evidence for a continual run of walling along the east side of the dam is lacking, the cross wall which is part of the spill way and cascade does not line up with the retaining wall to the tunnel mouth so it seems most likely that the area would have been fenced. By 1900 (Fig. 18) the fence has been pushed out to the north from the spill way and for the first time water is shown to be exiting from the southern end of the dam. In both instances the leat along the northern side of the pool is shown entering at a midpoint but its continuation to the east is not marked nor does the hydraulic ram appear on any of the maps.

Fig. 17 Pool and dam 1 OS map 1:2500 1880s.

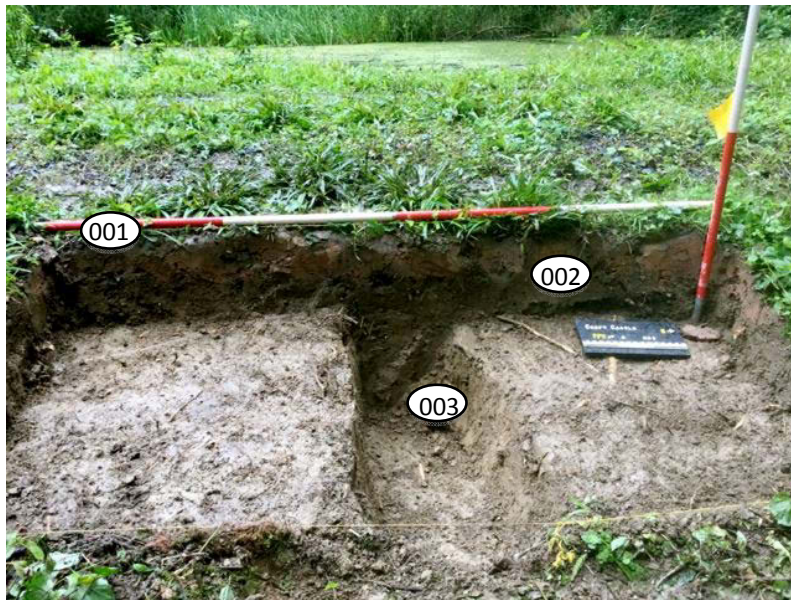
A trench 2m x 1m was laid out just above the break of the slope at the top of dam 2 and once the thin layer of turf and topsoil (001) had been lifted a dense band of red clay (002) was exposed capping the crest of the dam and tailing away to the east. Below this was a light brown clay (003) which appeared to be making up the main body of the dam at this point. This was examined to a depth of 0.5m without any further contexts becoming apparent. The slopes below what appears to be a scour point were examined for evidence of stonework but nothing was picked out as being significant (Fig. 24).

Conclusions. No evidence for a spill way or cascade was found, however, the possibility of a low level pipe whose outflow has been obscured by silting cannot be discounted and could not be confirmed without a much larger exploration of the down stream face of the dam.

Fig. 24 IP6 Looking west.

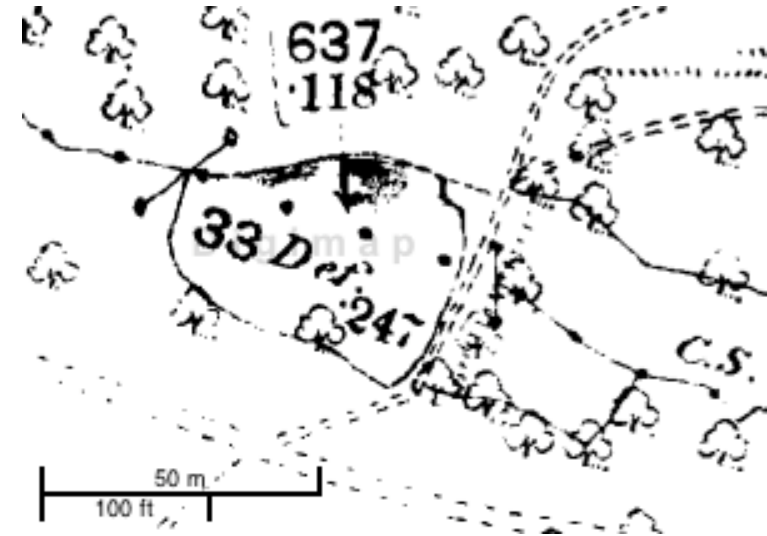
Fig. 25 Pool and dam 2 OS map 1:2500 1880s

4.2.4 Dam 2 – Discussion. The first edition of the OS map (Fig. 25) shows water passing the dam at the southern and northern ends and apparently appearing through the dam just north of the centre. Milln has previously documented the modern concrete spill way and downstream from it a partially collapsed tunnel which allowed a footpath to cross over the by pass channel on the north end of the dam. More work is needed to confirm the presence of a low level pipe or tunnel at the southern end but it seems the most likely explanation for the large retaining wall. The irregular form of the dam as revealed by the topographical survey (Fig. 19) indicates a number of major flooding and scouring events and there is, possibly as a consequence of this, no obvious source for the central flow of water apart from leakage. These marked streams could originate from low level seepage through the dam and it is possible, especially as these streams are marked as boundaries, that they represent the line of the original stream through the valley

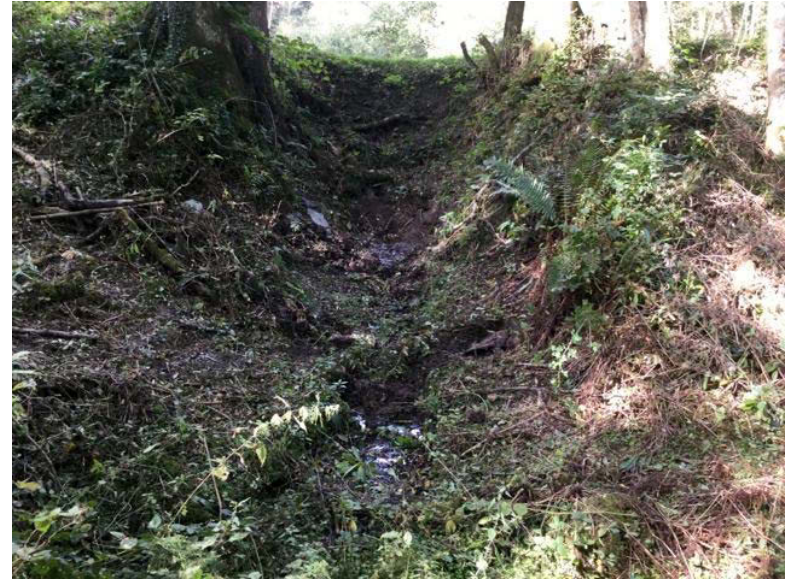
After on site discussion it was decided to locate a small trench 1m x 0.5m around 4m east of the dam's crest down in a steep sided gully. A combination of tangled tree roots plus rubble (001) and a dump of domestic debris from the twentieth century (002) meant that only limited progress was made here. The entire gully was searched both by visual inspection and probing with road irons but no traces of any stone structures or related debris were encountered (Fig. 26).

Conclusions. The regular form of the gully at this point and its being in line with a concrete bastion-like feature at the pool's side suggest

Fig. 26 IP7 Looking north west up the gully.

that the gully resulted from the collapse of a tunnel the remains of which, by comparison with other sites upstream, could be quite deeply buried, equally we could be seeing the effects of erosion with the added construction simply a measure to reinforce the dam.

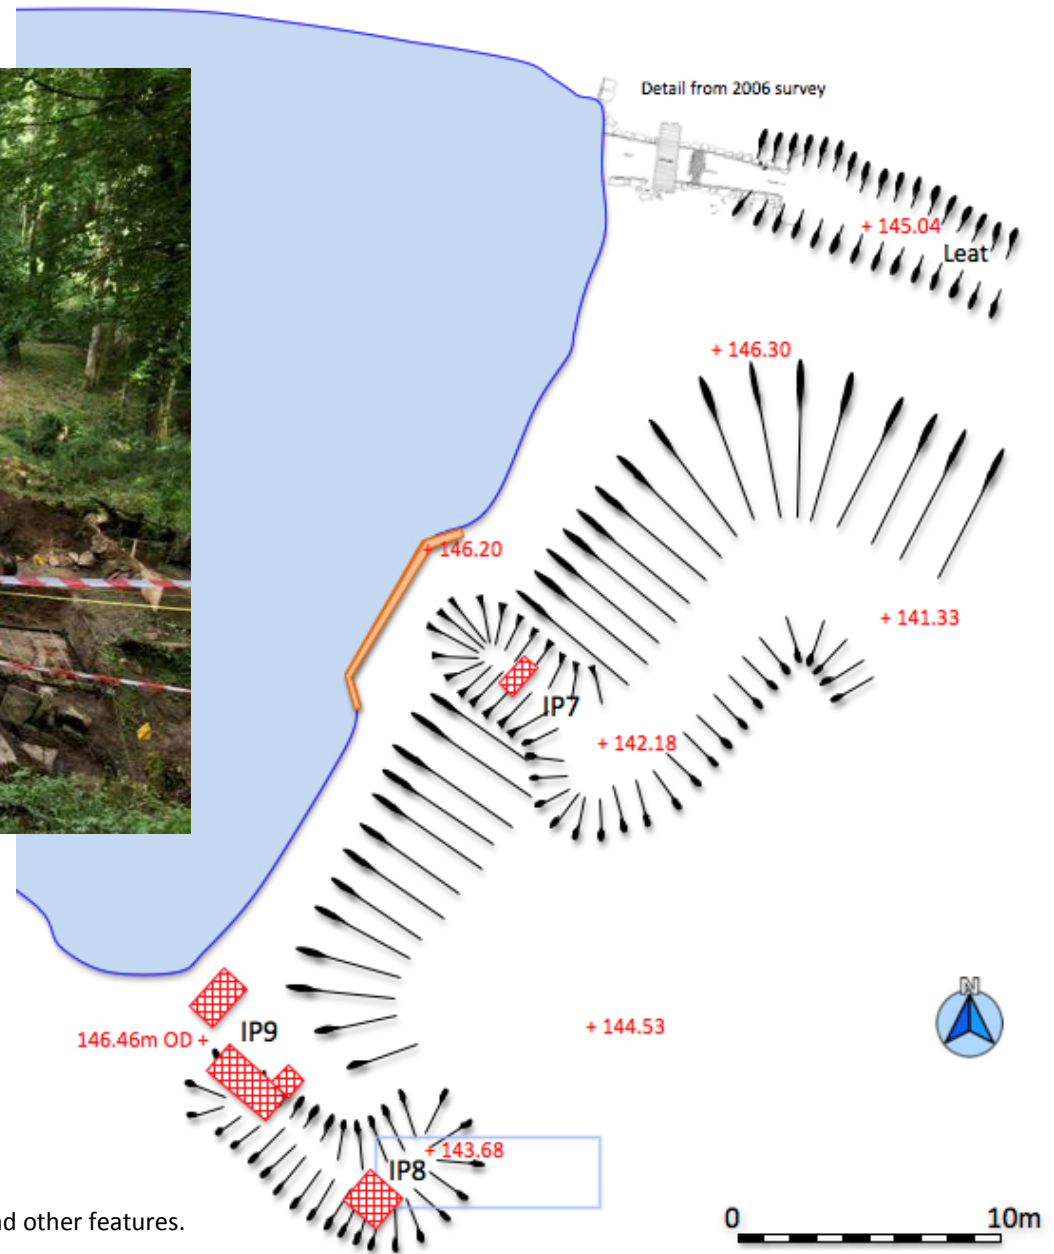
Earthwork remains (Fig. 28) indicated a deep channel emerging from the southern end of the dam which after proceeding down the valley for something over 10m makes a right angle turn towards the north east.

Fig. 28 Dam 3, location of IPs and other features.

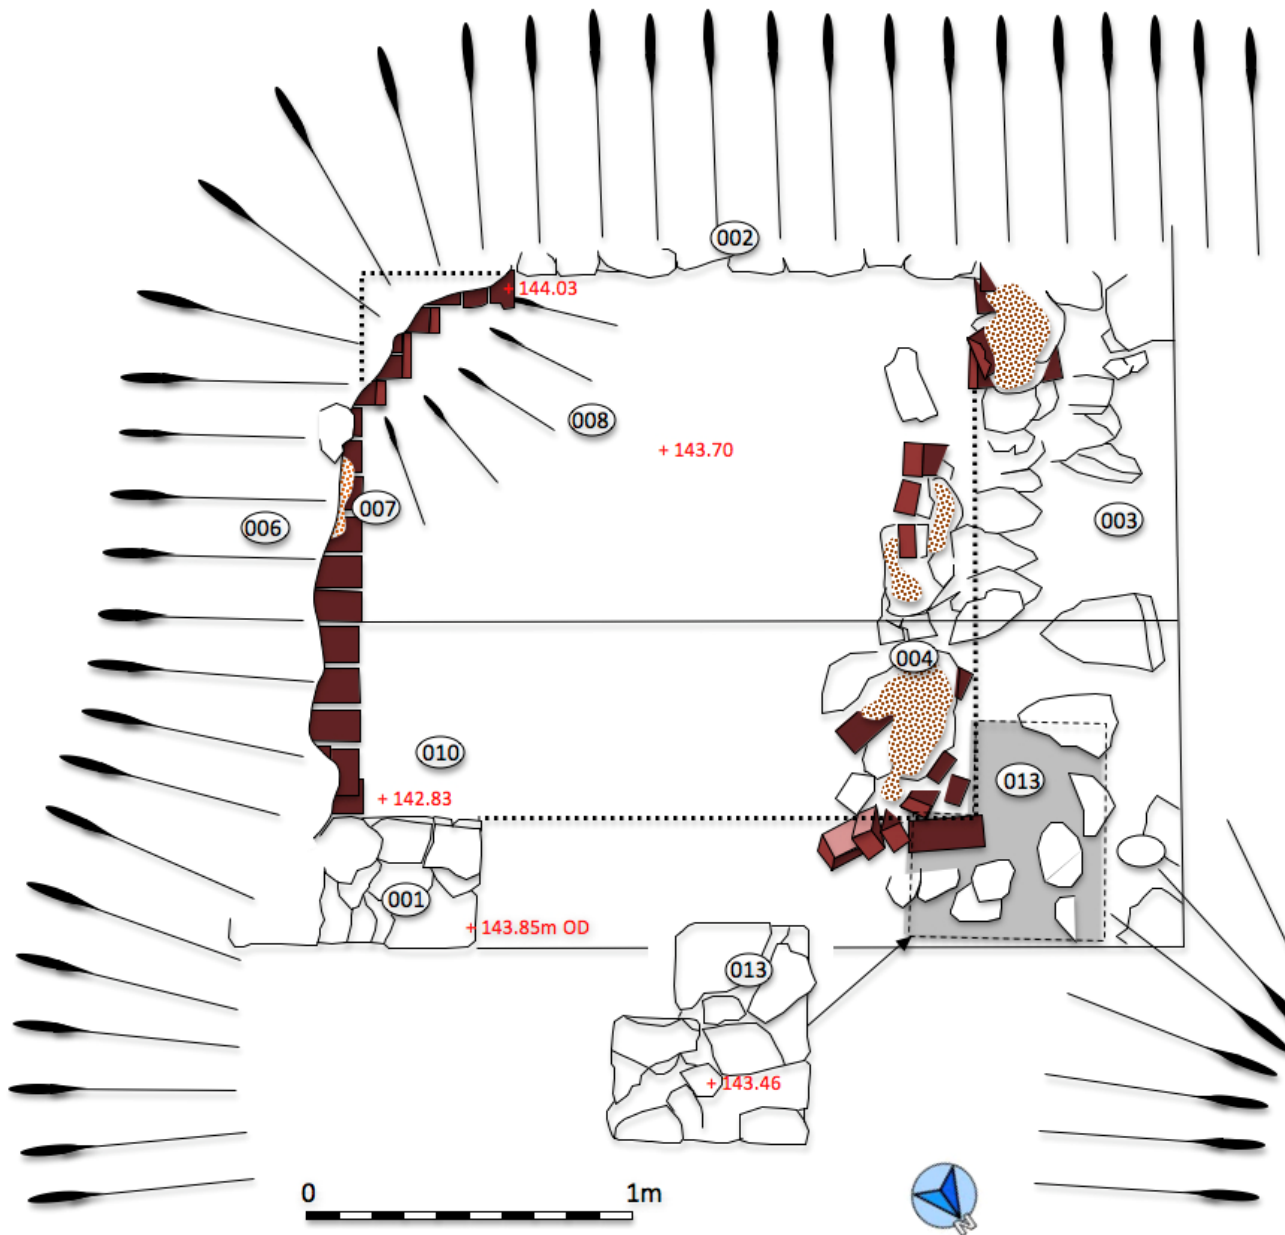
Fig. 29 IP8 'Sunken Building' Plan.

After clearance two structural elements were noted in the banks to the south west and south east. These were part of the same building so an area roughly 3m square was marked out for excavation. The topsoil, a shallow dark brown sandy loam (005), was removed but in places the slopes were so steep that there was little covering and the eroded face of the subsoil, a dense brown silty loam (006) was exposed. The full extent of the building was then revealed fitting neatly in to the corner of the channel. The structural elements comprised the south west and south east retaining walls (002) built hard against the rising scarps. These walls were built of roughly coursed rubble using a hard pinkish red sandy mortar. The eastern corner was marked by a similarly constructed pillar (001) bonded into the wall and viewed from the outset as a jamb for an opening. At this stage the location of the northern corner was not apparent and the line of the north west was marked by a mass of tumbled rubble including chunks of brickwork still mortared together with a whitish buff gritty mortar (004). Partial removal of this revealed full extent of the stub of wall noted earlier and the line of the west wall to be fixed. Upstream the channel was filled with a mixture of rubble in silty loam (003). Most significant was the survival, on top of the south east wall, of a course of bricks acting as the springing for a low vault. Remnants of this projected out for six courses in the south corner below which was a void (Figs. 29, 30, 31).

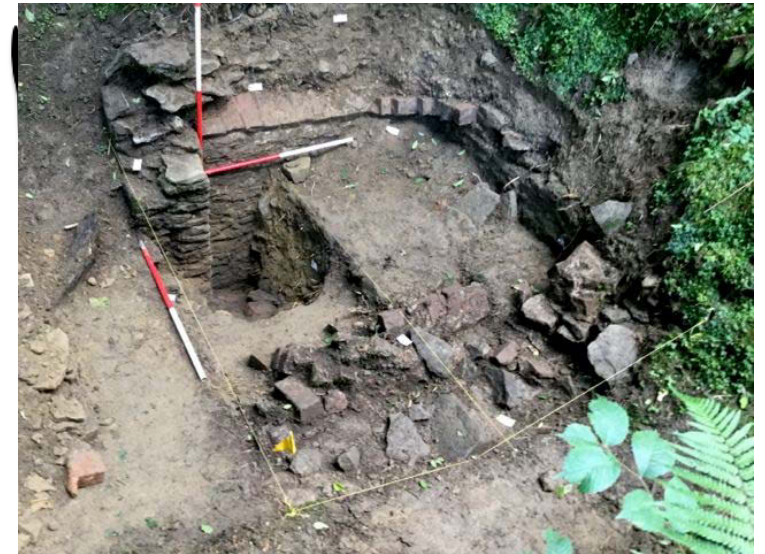
Fig. 30 IP8 'Sunken Building' looking south east.

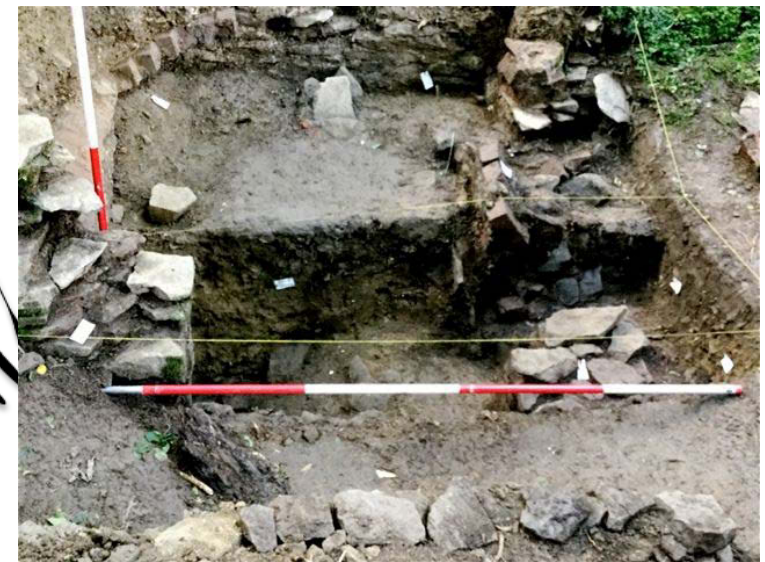
Fig. 31 IP8 'Sunken Building' section south west.

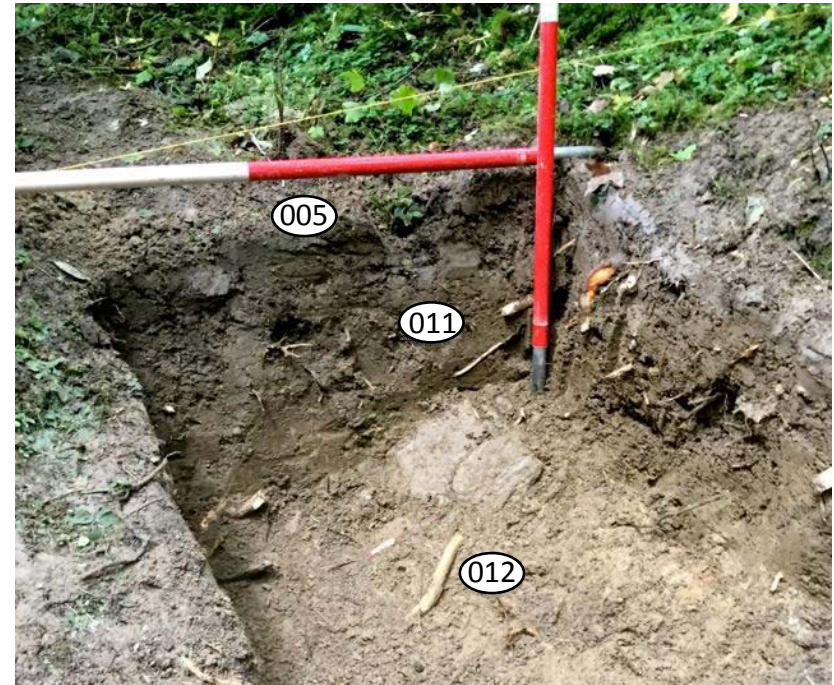
A test pit 2m to the north east of the main trench (Fig. 33) was opened up to determine if the channel had continued in a north easterly direction. Below the topsoil was a thick (40 cm) layer of firm brown clayey loam (011) above a light brown compact silty loam with some rubble (012) of an unknown thickness (excavated to a depth of 30 cm). At the time this was interpreted as undisturbed natural, however Later examination of deposits further up the valley suggest that this conclusion was wrong and the channel here shown on a number

Fig. 33 IP8 test pit looking north.

of sources must have been filled in at the point when it was no longer in use ( see IP9).

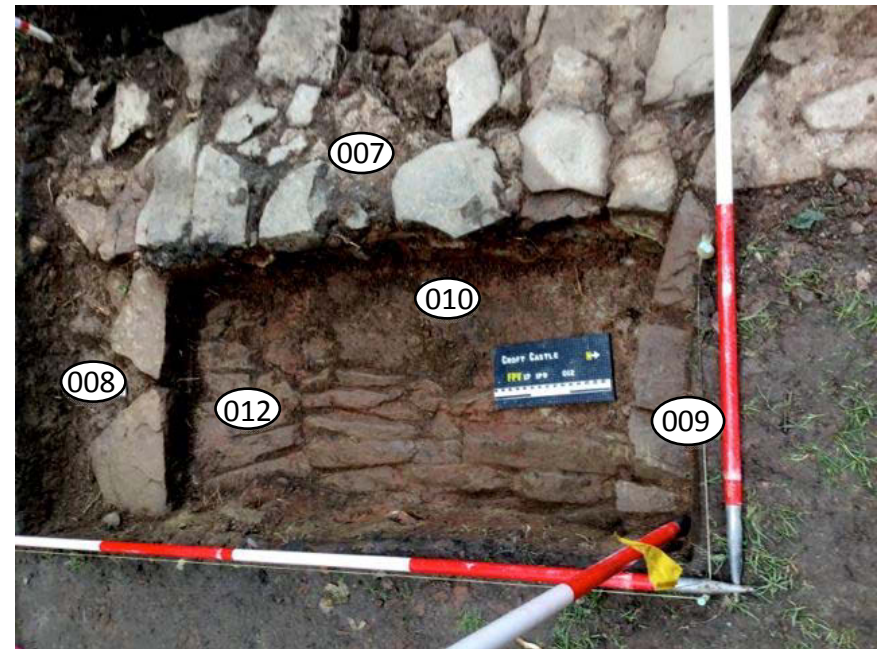
An extra trench was opened 1m to the west of the first trench (Figs. 27 and 34) the gap being necessary to maintain access for a public footpath. After the removal of a very shallow depth of topsoil the two flanking walls of the spill way were uncovered each standing to a height of 2 courses (009 to the north 008 to the south). The channel was blocked by a later cross wall (007) which would have formed an edging to the pool at this point. Remnants of the pitched stone base of the spill way were noted (012) although presumably some had been lost in the course of the later blocking. Significantly the pitched stones here were set across the channel whereas further down they were aligned longitudinally. A visiting hydraulic engineer commented that this pattern

Fig. 34 IP9 Additional trench, north to right.

Conclusions. There is no doubt that a well constructed spill way existed here and that it was taken out of action by careful blocking at the pool side. What remains puzzling is the digging of a channel which partly destroyed the southern edge of the spill way. This suggests that there was an additional overflow point from the pool a little further south. If so it in turn was filled in with dumps of brick rubble.

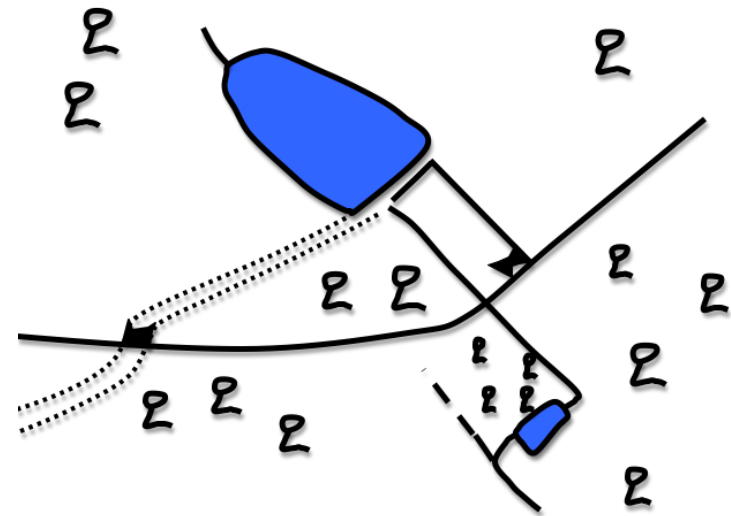
4.3.4 Discussion. The arrangements at dam 3 whilst perplexing are amongst the best surviving examples as there seem to have been no instances here of the kind of destructive scouring seen further downstream. The sequencing of events seems fairly secure but the explanation of those events and particularly the purpose of the sunken building remains obscure. It is perhaps worth considering the map evidence first. Although a number of early maps of the estate are available as photocopies their provenance is uncertain and in the case of the earliest, assumed to be from the 1790s<sup>vii</sup> errors have been made in pasting the sheets together so at the crucial point the parts do not match up. By making some adjustments a reconstruction of the original image can be made (Fig. 37 ). This indicates two parallel channels issuing from pool 3 although its possible that the uppermost could be a fence line. There is an interesting arrangement further downstream where the channel makes a fight angle bend before feeding into a small rectangular pool. The LIDAR image for the area (Fig. 38) illustrates some of the complexity of this area but shows no trace of the small pool. However the Somerset Davies map<sup>viii</sup> from roughly the same

Fig. 37 Pool and dam 3, reconstructed extract of map from late eighteenth century.

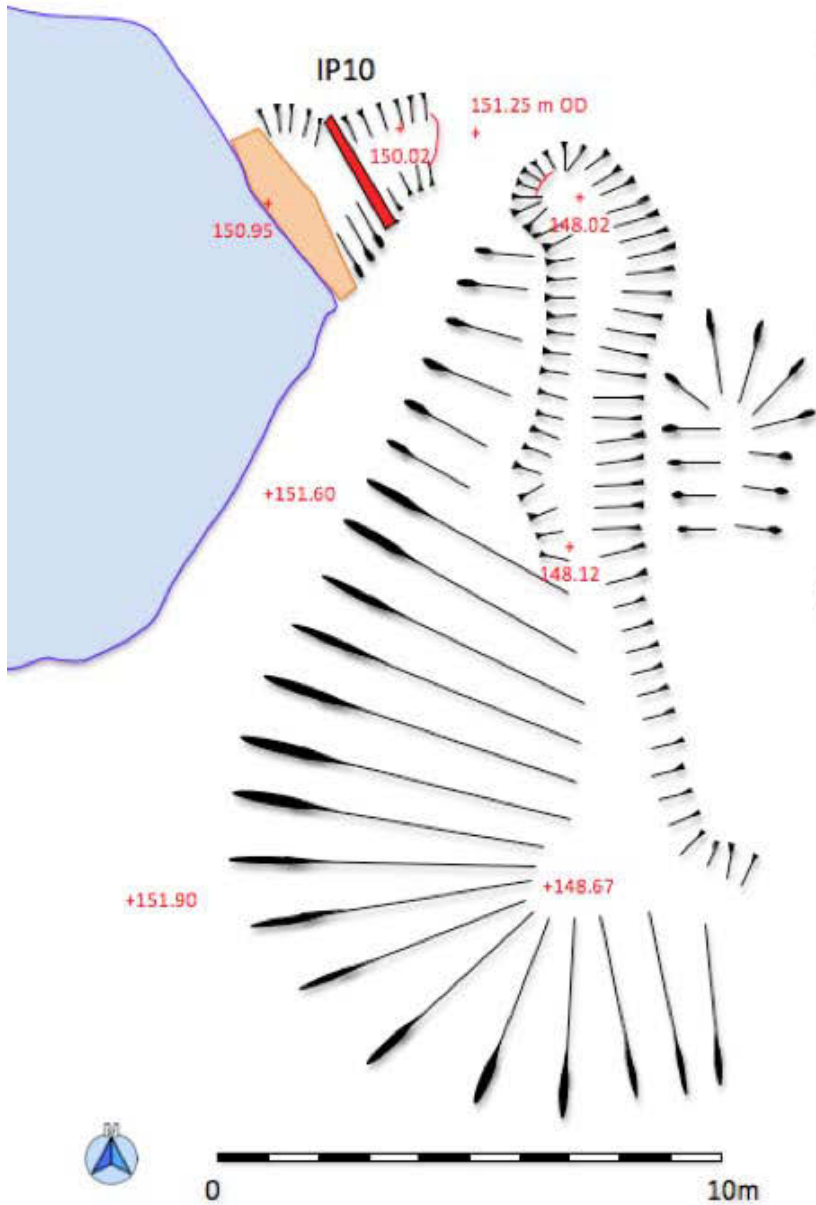
Fig. 45 IP 10 Drawings by Milln with amendments.

No excavation was required here. The volunteers cleared large quantities of fallen braches and the over burden of vegetation enabling access to and visual inspection of the concrete weir, the brick setting for the former sluice and both ends of the tunnel (Fig. 43).

Conclusions. Although what could have been earlier stonework lining the channel to the north was noted the brick setting for the sluice itself, on account of the bricks used, the pointing and the concrete rendering on the east face has certainly been heavily repaired in recent times. There was no evidence of an earlier arrangement here although, of course an

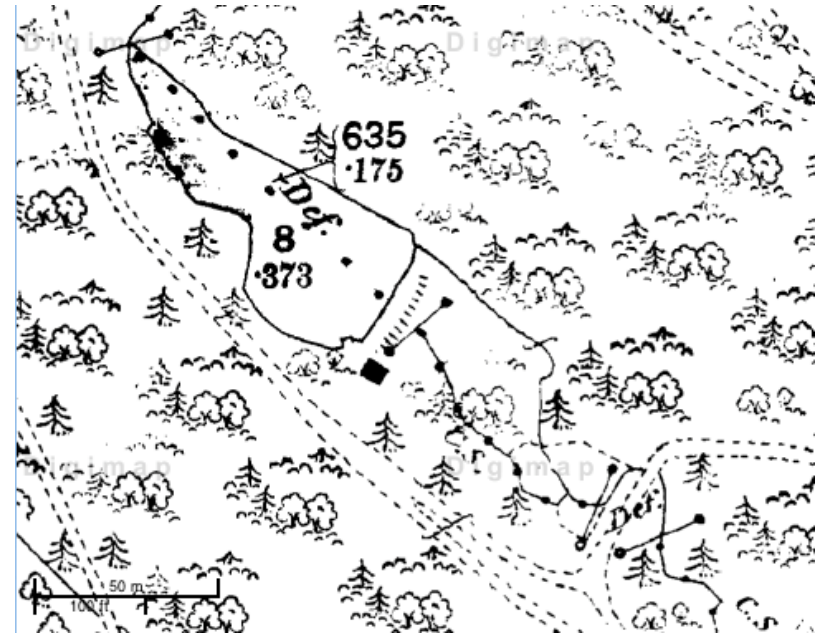
Fig. 48 Pools and dams 4 and 5 OS map 1:2500 1880s.

older weir at this point could have been swept away. However, it is also possible that what is seen today is simply a rebuild of the original construction. In this connection it is interesting that the 1880 OS 1:2500 map (Fig. 48) shows the pool as drained and it is not refilled until after 1970 suggesting the brick sluice is pre-1880 and the blocking and further addition of a sandbagged concrete weir is post 1970. The level of the base of the culvert drops by over a metre and by comparison with Milln's elevation from 2006 (Fig. 45) it is clear that this face is eroding back rapidly and drastically undercutting the culvert's side walls (Fig. 46). Presumably at some point this fall expressed itself as a cascade probably at the out fall from the culvert where it could be seen.

Early maps ( Fig. 48) again reflect the current situation with a high level by-pass channel to the north and a low level outflow to the south driving in this case the water pump. As noted elsewhere the central outflow may simply be the result of the survival as a boundary of the original stream.
