# Archaeological Investigation: Excavation and Recording

Fishpool Valley,  
Croft Castle,  
Yarpole,  
Herefordshire,  
HR6 9PW

Report by Stephen Wass MA, MCifA (7651)  
Polyolbion Archaeology  
For  
Imogen Sambrook, Project Manager,  
Janine Young, Archaeologist,  
The National Trust

October 2017

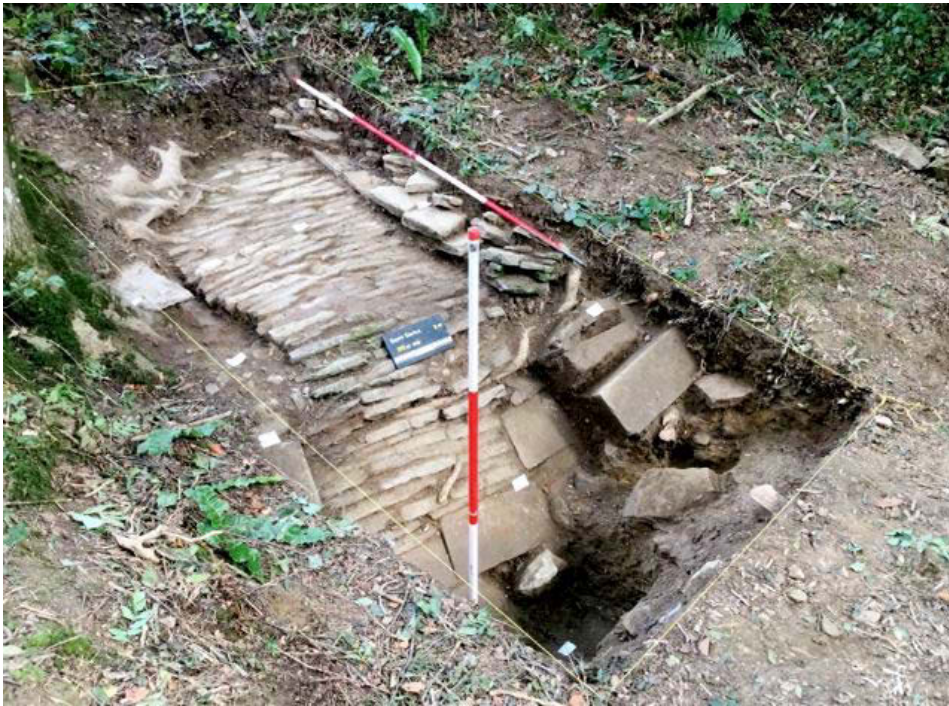
Fig. 52 IP16 looking north east.

A late addition to the roster, strimming of the undergrowth uncovered a small patch of pitched stones. This was examined and an area 4m x 2m was marked out for excavation. The thin covering of dark grey sandy loam (006) deepened towards the south but was generally just a thin covering over an expanse of pitched stone creating a spill way just over a metre wide and sloping down gently to the south for a distance of around 3m at which point it took a sudden downward turn and a face was exposed (003) which dropped over a metre at an angle of roughly 45 degrees. The lower parts of this section were constructed with irregularly placed but well dressed stone blocks. It bottomed out onto a large slab of water smoothed stone (009) although immediately to the east no similar stone could be found rather there was a layer of fine dark grey silty clay (010). Because of the depth only a small section of the base of the channel was cleared and it remains to be seen if it was more widely paved.

Conclusions. It seems likely that this is the lower section of a spill way and cascade that could have originated from an overflow channel across the top of the dam, possibly in a culvert as on dam 7.

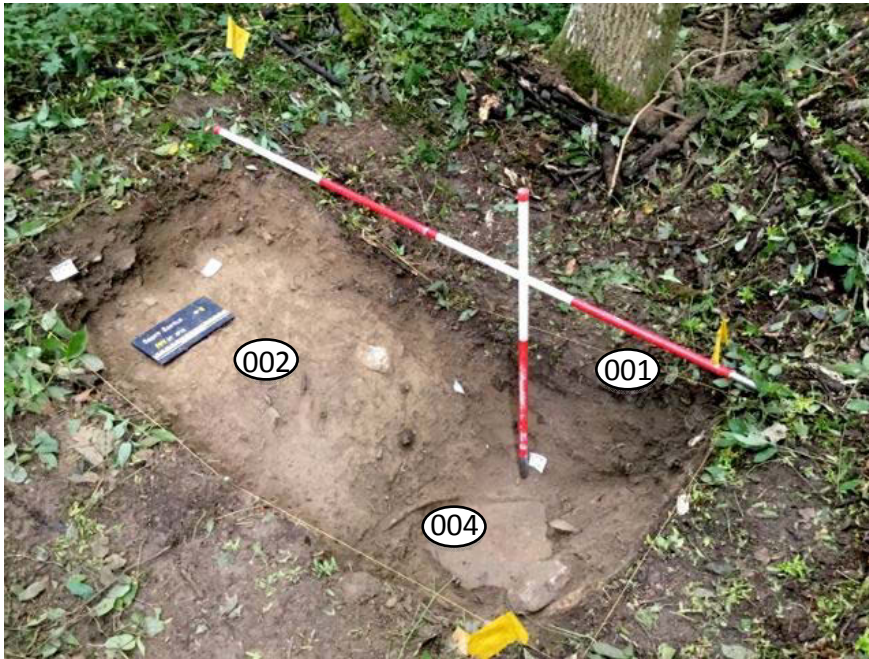
Fig. 54 IP12 looking north east.

A trench 2m x 1m was opened across the shallow earthwork that cut into the valley side south of the dam. A deep layer of silty loam (001) topsoil and leaf mould was cleared to reveal the profile of a 'shallow 'V; shaped ditch (003) cut into what appeared to be the natural silty clay. The lower part of the fill of the ditch was a slightly more loamy silty clay (004) and contained a few stone slabs which appear to have slid down into the ditch from the higher slopes to the south (Fig. 54).

Conclusion. Given the course of the ditch, from the south side of the dam round then into the valley below, and that the level of the bottom of the ditch is around 30 cm below the top of the dam there can be little doubt that this was a by pass channel designed to function as a release at times of very heavy rainfall. There was no evidence of a stone lining nor could the site of a possible sluice gate be identified on the surface. It's unusual positioning makes one wonder if it was an after thought perhaps a response to other changes to water flowing over the dam below,

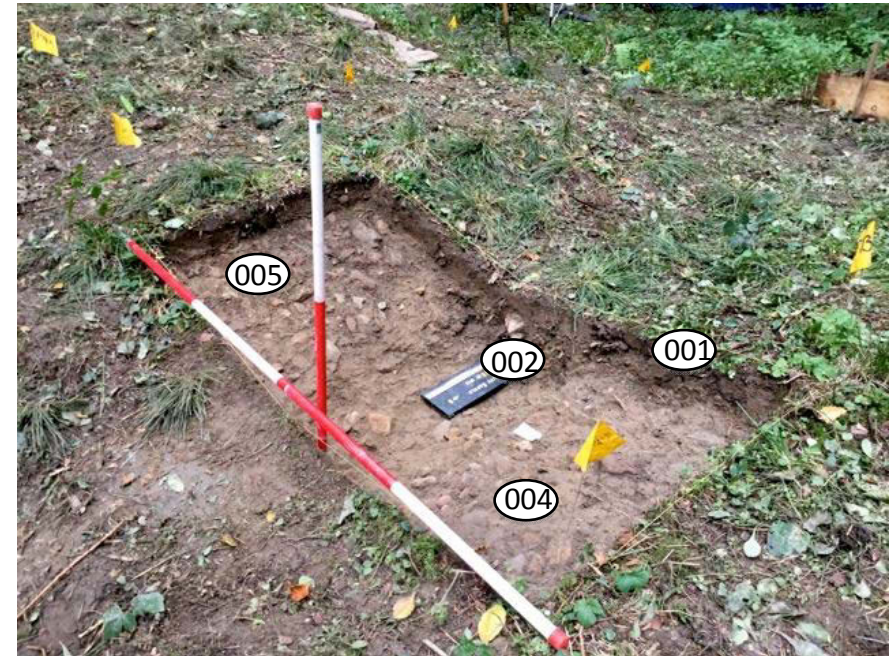
Fig. 55 IP13 looking north west.

deposits were a capping (10cm in depth) above a fine brown silty clay (006) making up the body of the dam. The base of the cut (003) was filled with a shallow deposit of firm brown silty loam (002) (Fig. 55).

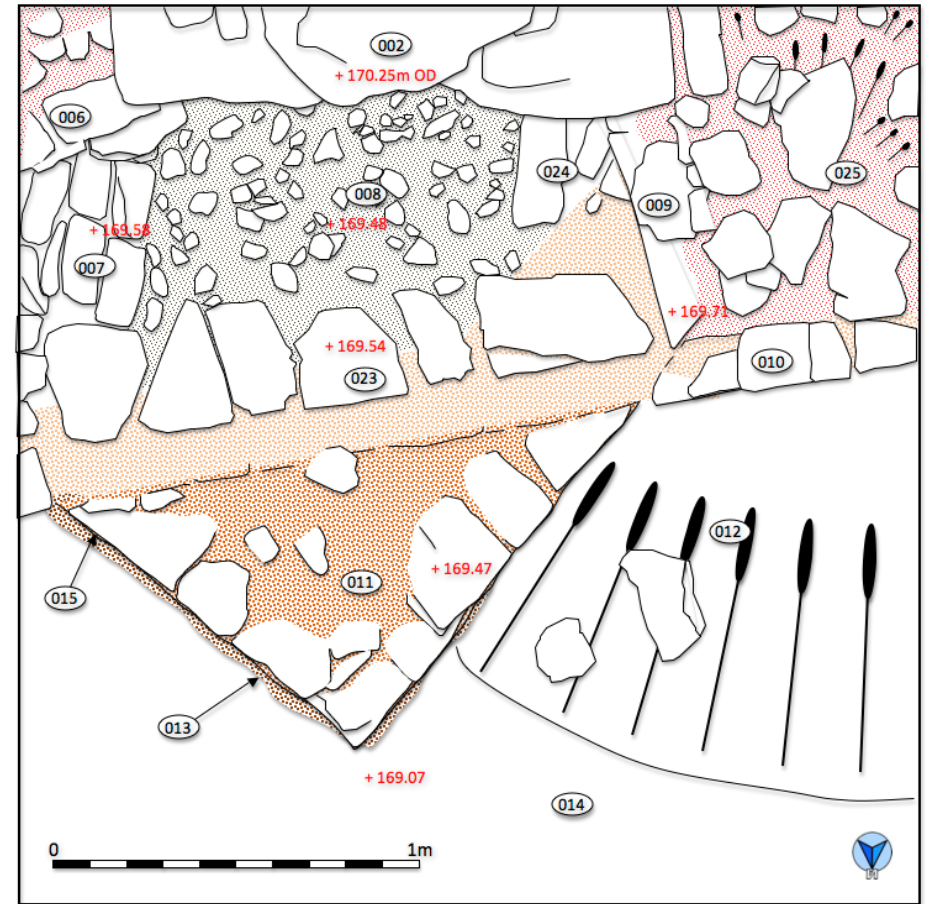
Fig. 56 IP14 Plan of upstream features.

The whole of the downstream cascade was excavated along with most of the flanking walling, however, as part of the clearance of the culvert on the up stream side it became clear that there were further structures here too and an additional area 2.5m square was opened up (Fig. 56). The dark grey sandy loam topsoil was present across the site at irregular depths ( up to 30cm. in some of the low lying areas, elsewhere it barely covered the stone work ). In places it was mixed with quantities of loose rubble. The most obvious element at the outset were the three very large capstones (002) which closed off the top of the culvert and enabled a walkway along the top of the dam. It is probable that there was a fourth stone, now broken and tumbled to bottom of the cascade (026).

The capstones were supported on two side walls flanking the culvert ( 004 to the south and 005 to the north). These were made with three courses of large blocks with some additional packing below the capstones themselves. The base of the culvert was lined with pitched stones (005) although at one point water had evidently eroded away the

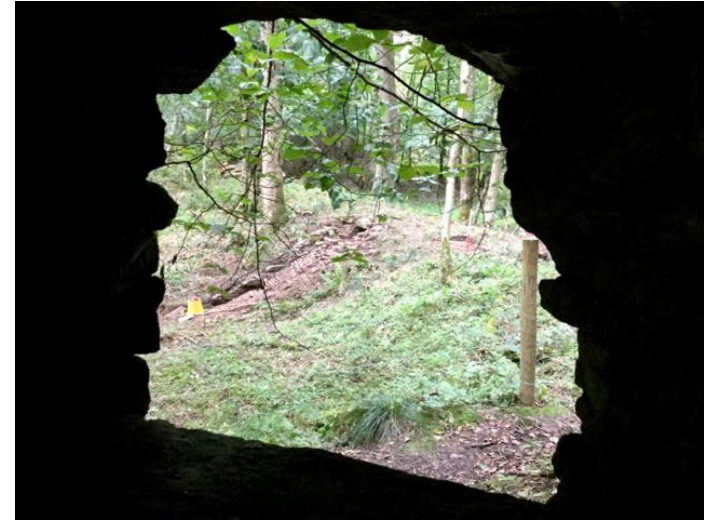
Fig. 61 IP14 the cascade viewed from the grotto looking north west.

Conclusion. This well preserved monument was obviously carefully designed and sited to be an attractive element within this 'picturesque' landscape. The view of it from the window in the grotto to the south east is particularly striking (Fig. 61) . It appears that a certain amount of repair was needed on the up stream side and it may be that the original pitched stone front was lost to erosion necessitating repairs and perhaps the addition of the base for a debris catcher which on the basis of parallels from Croome (Fig. 62) and Packwood would have been in the form of an upright fence like iron grid.

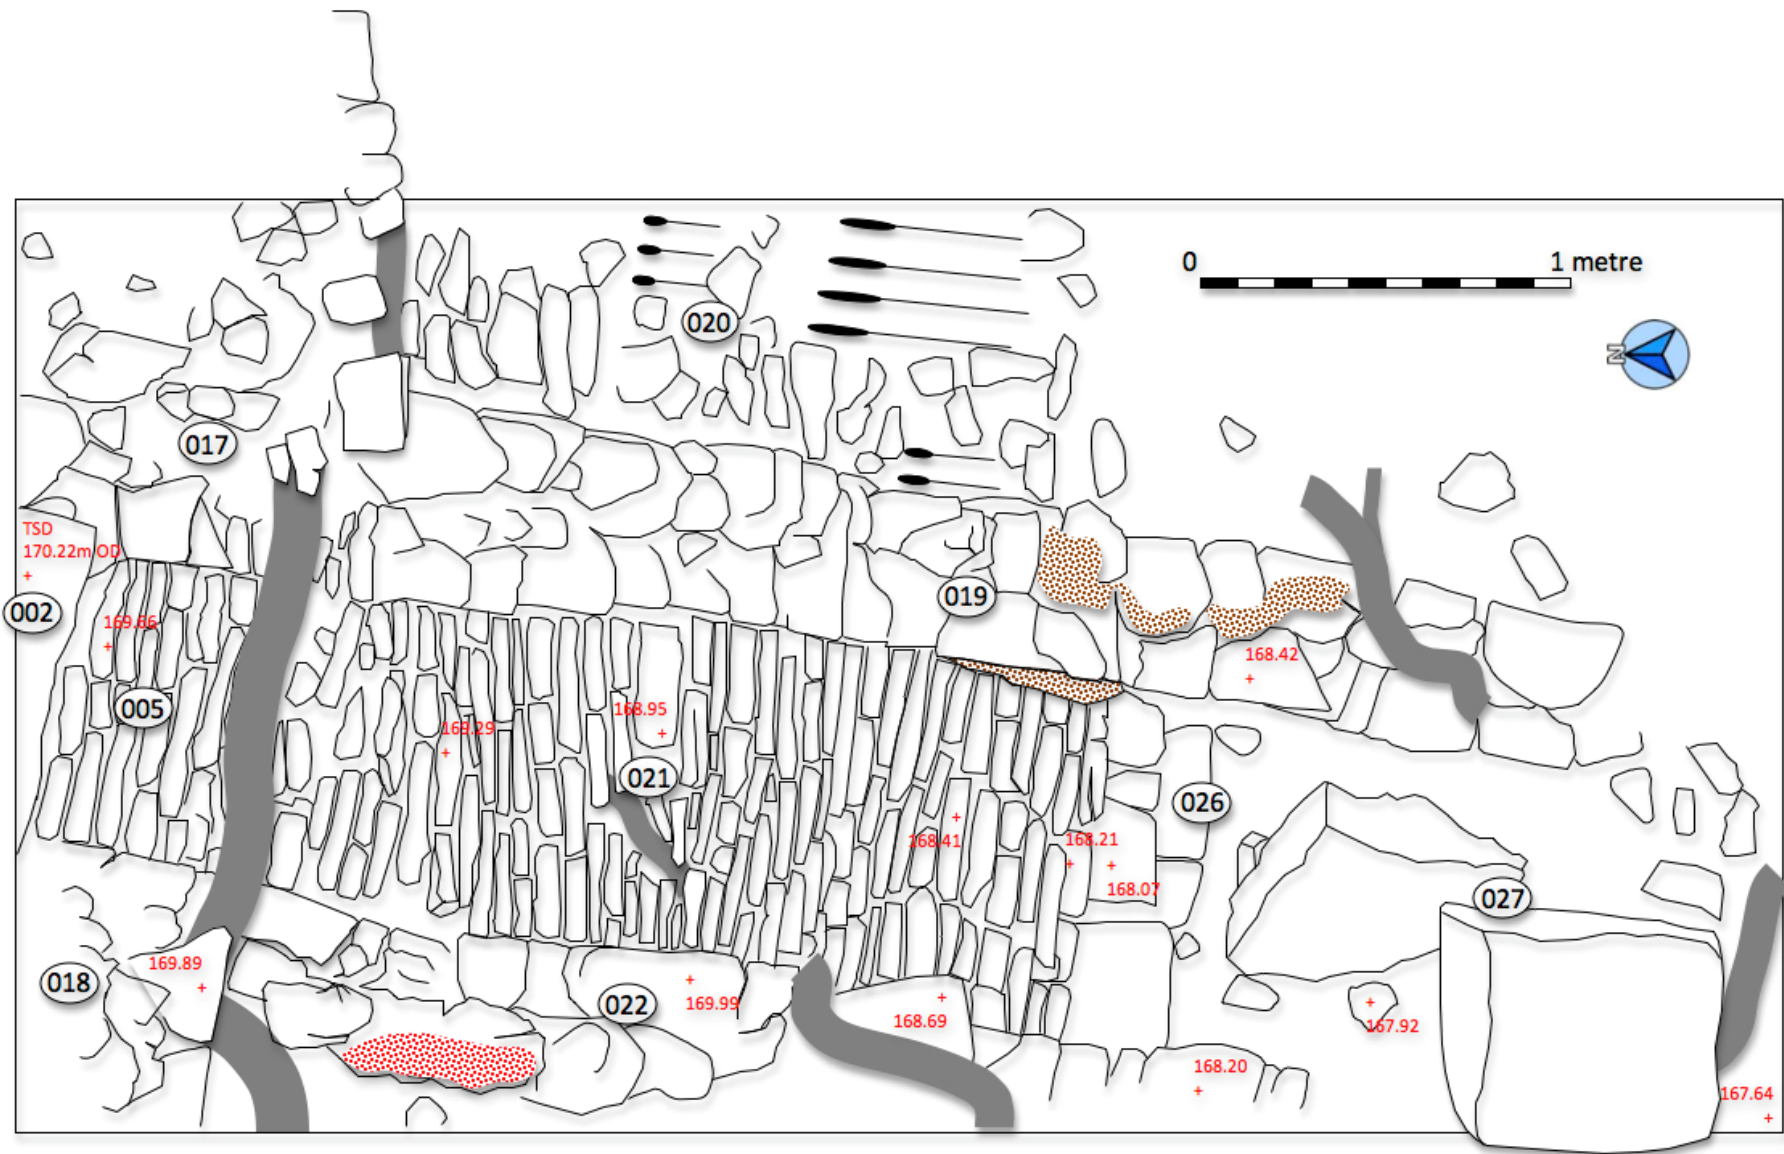
Fig. 63 IP14 Plan of cascade.

On the cascade side the situation was a little less complex (Fig. 60). The evenly sloping ( around 30 degrees from horizontal) pitched stone face of the cascade ( 021) has suffered some root displacement and there were a number of voids underneath where the substrate had been washed away but generally the condition was good. Roughly built walls edged the crest of the dam (017 to the east and 018 to the west) and may have partially supported the fallen capstone. The side wall to the cascade to the west (022) was particularly well preserved to the point where several examples of shaped stone blocks, cut to echo the line of the fall of the cascade, had survived. The eastern side wall was less well preserved (019). Beyond that a spread of rubble down the face of the dam (020 ) looked purposeful and may have been laid to enhance the rustic surroundings of the cascade. At the foot of the cascade the outgoing channel was lined with stone slabs (026) but much of it was filled by two large stone blocks (027) which on close examination proved to be the two broken halves of what appeared to be an additional capstone fallen down from above.

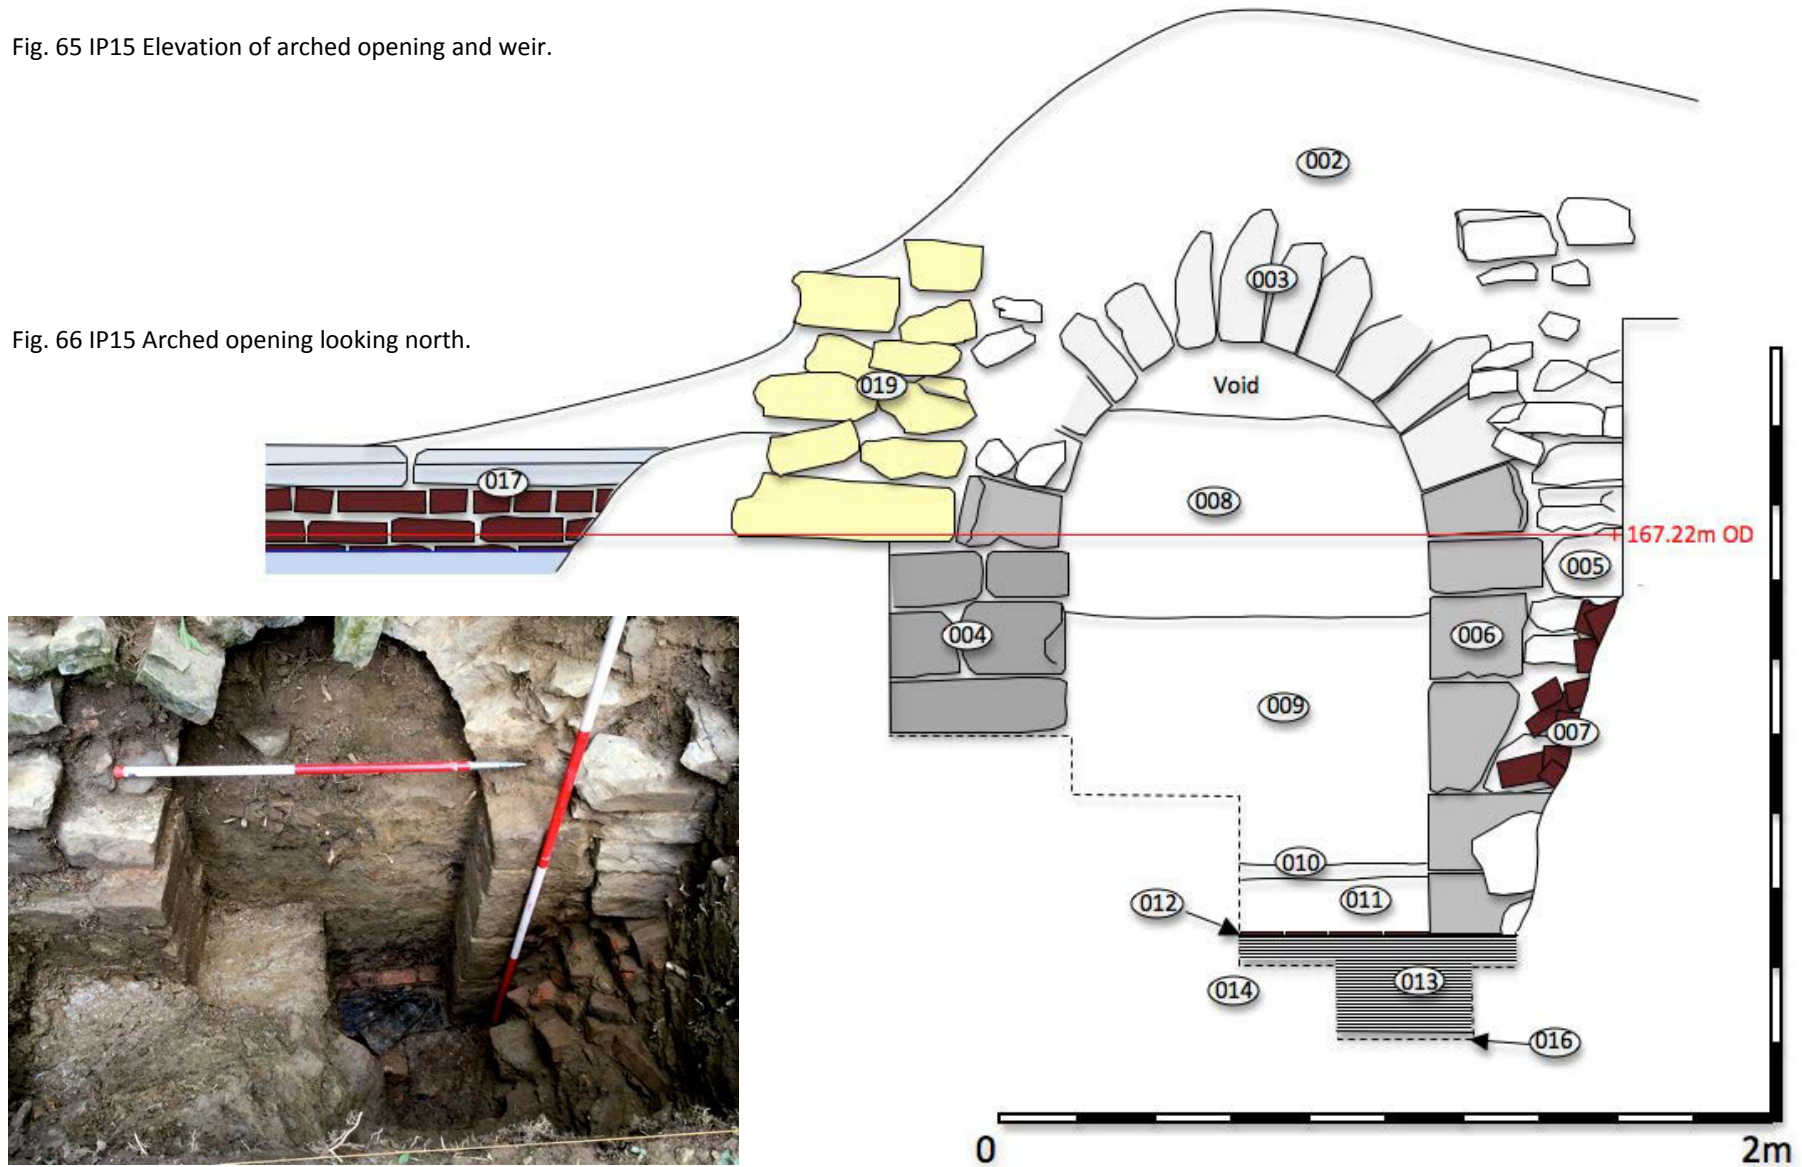
Fig. 67 IP15 Plan.

To the east of the opening was a tumbled mass of loose bricks piling in from the side (007) which rather curiously had then been used as the basis for rebuilding part of the retaining wall to the dam (005). Similarly a mass of rubble including a few brick fragments in a matrix of silty brown clay (015) formed a bank to the south west of the opening. These materials appear to be an attempt to fill the outgoing channel from the arched opening whilst at the same time maintaining its visibility, perhaps for ornamental effect.

Functionally it could have acted as a scour tunnel but the possibility exists, especially as it may have been plastered, that the water could have been expressed through some sort of ornamental mask or fountain head as seen at Hafod (Fig. 69).<sup>xii</sup> As the pool is currently drained the possibility exists that remains of the sluice controlling the up stream end of the scour tunnel may still be preserved below the silting in the pool. We may assume that at some stage the tunnel was partially closed and an alternate arrangement bringing the water over the dam via a spill way and small weir was instituted immediately to the west. This failed and has been largely swept away by later flooding.

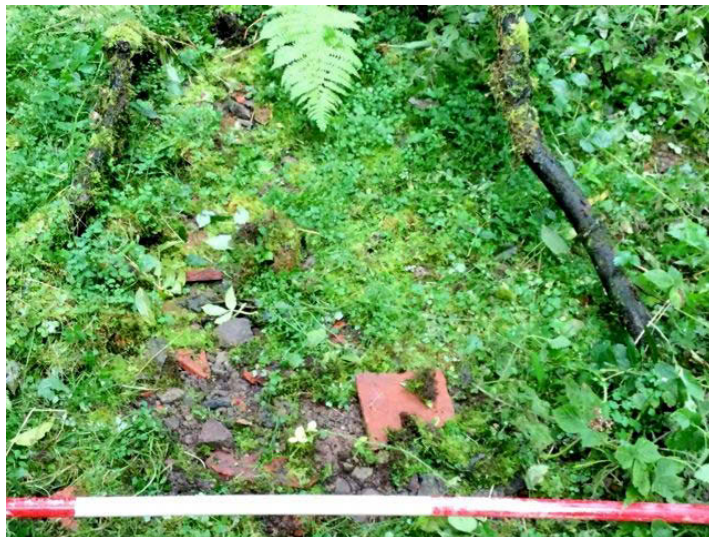
Fig. 71 Building debris on the site of the 'conduit'.

The earliest map we have, the demesne map from the late eighteenth century, shows the larger pool water filled but as well as the stream that supplies it approaching from the north it also shows a small feeder coming in from the north west which originates in a structure marked as ‘conduit’ (Fig. 72). By 1880 the OS map (Fig. 73) shows the pool to be dry but a small building is marked on the conduit’s site. This may have been a small building, possibly ornamental, built over a natural spring but whatever the case a spread of building debris mainly brick and tile fragments is scattered over the area (Fig. 71).
