A Historic Building Survey at the Britannia Works, Coleshill Road, Atherstone, Warwickshire

ULAS Report No. 2019-006 ©2019 A Historic Building Survey at the

For: Hazleton Homes

ULAS Report Number 2019-006 ©2019 Accession Number pending

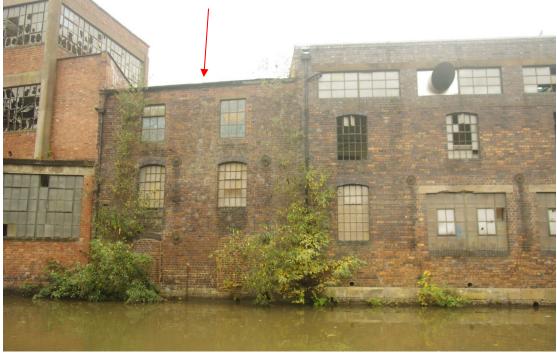
Only the blue-brick north-eastern wall facing out over the canal is fully visible (Fig. 49). This elevation has blocked windows (or possibly loading doors) at ground floor level which is almost at water level height. The segmental-arched heads of these former openings are made from blue bricks and match those on the first floor. The style of brickwork and window heads suggests a mid to late 19th century construction date. The first floor windows have multi-paned metal-framed windows but straight-line joints in the brickwork beneath them suggest that these openings have also been modified and may have been loading doors onto the canal. The second floor windows have also been modified and the flat parapet has been rebuilt which makes it possible that this Building once had a different roof profile. There is a joint in the brickwork between this building and Building O/P to the north which seems to wrap around and butt against Building N which indicates building N is the earlier of the two.

Figure 49 North-east facing elevation of Building N Building N is arrowed. Building F-L on left and O/P on right

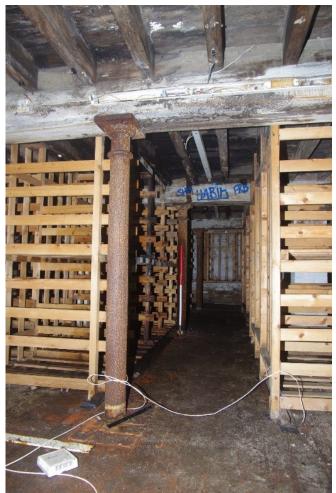
The low-ceilinged basement is reached via a doorway on the southern wall. Because it runs beneath Buildings N and Q it is L-shaped in plan. Although there are four steps leading into the basement area it is only partially below ground and corresponds with the blocked ground floor windows seen on the canal-side elevation. This basement/ground floor area has a red brick floor and a series of cast-iron columns supporting the floor above (Fig. 50). The space is filled with wooden racks which appear to have been used for storage of completed items as one label survives with the designation for top hats for Derby and Ascot. At the time of the survey the supporting timbers appeared to reasonably secure but rainwater was constantly running through the rotten floorboards so only a minimal amount of time was taken in this area. There is evidence of three blocked windows at the north-western end of Building Q which would have faced out onto Coleshill Road. A set of steps leads up to the north-east into the covered access way between Buildings O/P and Q.

Figure 50 Building N basement/ground floor Looking north-west from Building N to space below Building Q. 1m scale

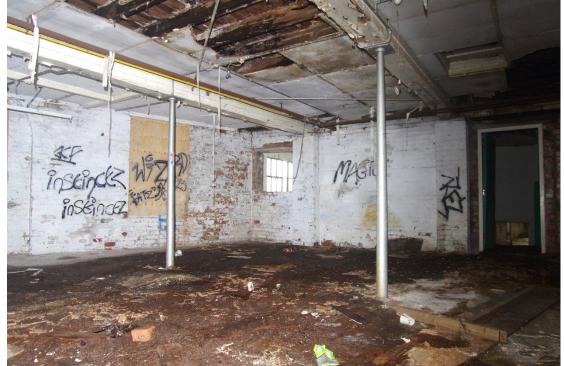
The first floor of Building N was not accessible due to the rotten floor boards but could be viewed from a doorway from the access way between Buildings O/P and Q (Fig. 51). It would appear that the first floor is divided into two equally-sized spaces to the east and west. The ceiling is supported by chamfered timber beams which are held by slim cast-iron columns. A doorway on the southern wall leads out to the wooden stairs which access the floors of Building F-L.

Figure 51 Building N, first floor Looking south-west towards doorway to Building F-L

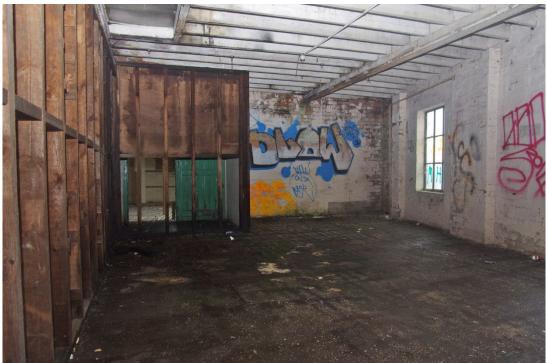
The second floor of Building was also too dangerous to enter but had also been divided into two. The partitions which were visible appeared to be made from timber and may therefore be a later addition. A partial inspection of this floor could be made from the northern end of Building F-L which showed the underside of the flat roof and part of a skylight. There are no supporting columns on this floor.

Figure 52 Building N, second floor Looking north from Building F-L

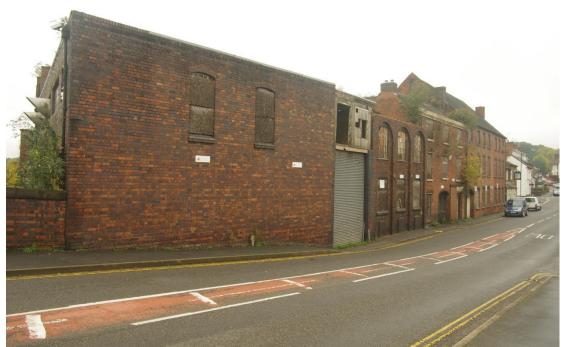
The north-west facing elevation on Coleshill Road is a very plain blue-brick frontage with only a pair of windows at first floor level (Fig. 53). The windows have been boarded over but have sloping brick sills and segmental brick heads. There is no evidence of a door onto the street or any other windows on this elevation. The top of the flat parapet wall is brick and has no copings suggesting that the building has been truncated in some way. Butting against the western edge of this face is a large roller-shutter door leading into the vehicle access area between Building O/P and Q.

Figure 53 Building O/P Coleshill Road elevation Looking south. Building O/P on left of roller-shutter doors to the vehicle access

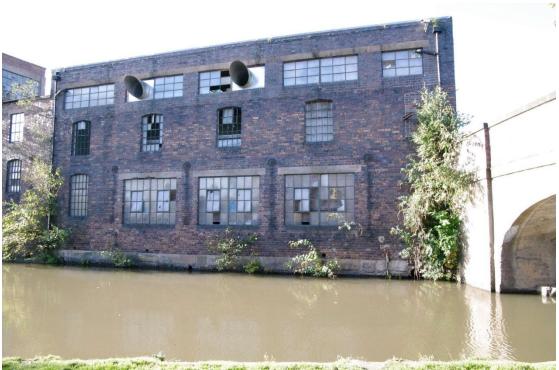
The north-east facing elevation onto the canal appears to show the building to be a three storey structure although in actual fact the upper two lines of windows both serve the first floor (Fig. 54). At water level there is a line of large limestone blocks set on top of blue bricks. At ground floor level is a metal-framed window with an arched segmental head which appears to be of late 19th century date. If this date is correct then this wall must belong to the earlier structure shown on the 1889 map. Also at ground floor level are three wide metal-framed windows with large concrete lintels which have replaced

Figure 54 Building O/P north-east facing elevation Looking south-west

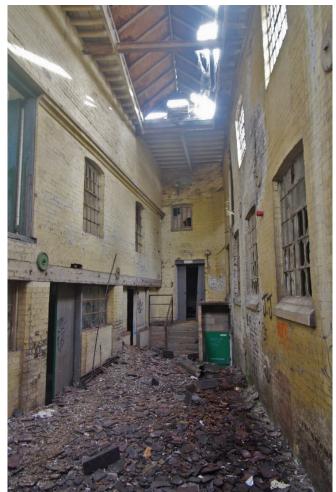
The south-east facing elevation is hidden by Building N so cannot be seen. The southwest facing elevation faces into the vehicle access passageway leading into the site from Coleshill Road (Fig. 55). Many of the roof tiles are still collapsing into the covered vehicle access passage so only a minimal amount of time was taken in this area. This area has a slightly odd shape being bound by Building O/P to the north-east, Building N to the south-east, Building Q to the north-west and the large roller-shutter door to Coleshill Road. The south-east facing elevation of Building O/P has only two rows of windows, some of which have been modified into loading doors at ground and first floor level. A long timber beam forms the window and door lintels at ground floor level. The beam is supported by brick piers but also has a single cast-iron column close to its southern end where steps lead into the north side of Building N. Large relieving arches spring from pier to pier. It is possible that this once formed an open arcade which has since been infilled with glazed windows and doors. On the same elevation, at first floor level, are multi-paned windows with segmental arched heads above which is what may be the remains of a projecting brick eaves course. If this is the original roofline of the pre-1924 rebuilt building then it must have had an extra floor, or increased height first floor, added later, possibly in the 1930s. This would explain the 1930s style second floor windows on the canal-side elevation.

Figure 55 Building O/P south-west facing elevation Looking south-east. Building O/P on left, Building N in centre, Building Q on right

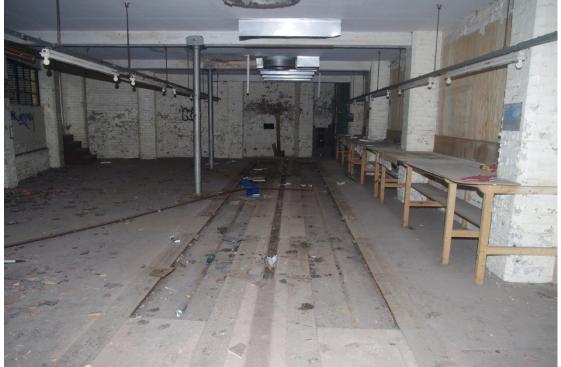
Inside Building O/P the ground floor is made of concrete with marks suggesting the presence of, now removed, machinery (Fig. 56). There is no basement to this building. The ceiling is supported by unchamfered timber beams supported at either end by brick piers and slim cast-iron columns in the centre. A small goods lift up to the first floor has been added into the north-eastern corner. There are no windows along the Coleshill roadside wall on this floor. There are no internal stairs within this building.

Figure 56 Building O/P ground floor Looking north-west towards Coleshill Road wall

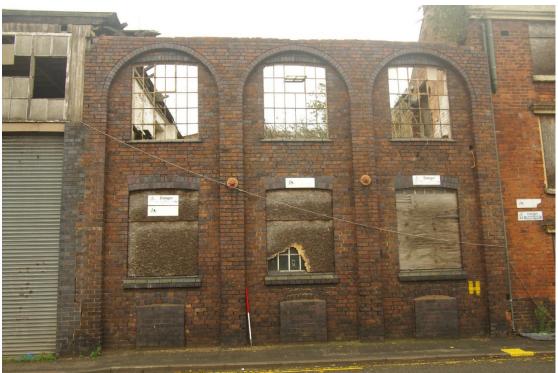
The north-west facing elevation is the principal elevation and faces out onto Coleshill Road (Fig. 57). The elevation is constructed from dark red bricks with window and arch details in blue bricks. There are three bays each set within a full-height blind arch. At pavement level are the three blocked windows which serve the basement/ground floor already discussed beneath this building and Building N. The windows above the basement have chamfered brick sills and have been boarded over. The top floor windows also have chamfered brick sills but the sills are not as wide. The brickwork for the vehicle access to the east of this elevation has been keyed into the side of Building Q and is especially noticeable as blue bricks have been used whereas Q has dark red/brown bricks. On the western side of Building R1. When the Morriss 2003 report was produced the building still had its hipped roof supported by a king post structure. This has since collapsed and lies in pieces spread across the top floor.

Figure 57 Building Q north-west facing elevation Looking south-east. 1m scale. Covered access to left, Building R to right

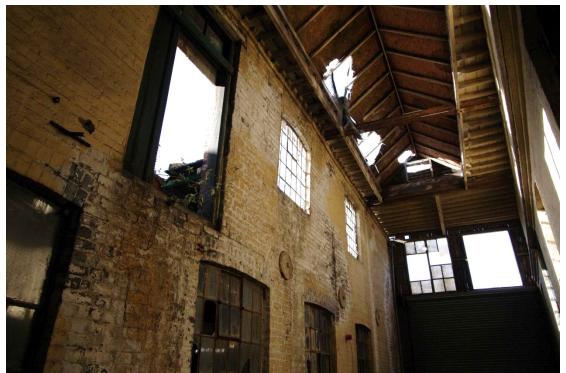
The north-east facing elevation of Building Q faces into the covered access to the side of Building O/P (Fig. 58 and also Fig. 55). At ground level a set of masonry steps leads down into the basement/ground floor below this building and Building N. A row of four multi-paned windows with shallow brick-arched heads and chamfered brick sills form the first floor and match those seen on the Coleshill Road frontage. At second floor level are two similar windows but without any sills. There is also a narrow loading door at first floor level. A dentilled eaves course runs along the top of the wall and now supports the covered roof of the access passage between O/P.

Figure 58 Building Q north-east facing elevation Looking north-west. Roller shutters to Coleshill Road on right

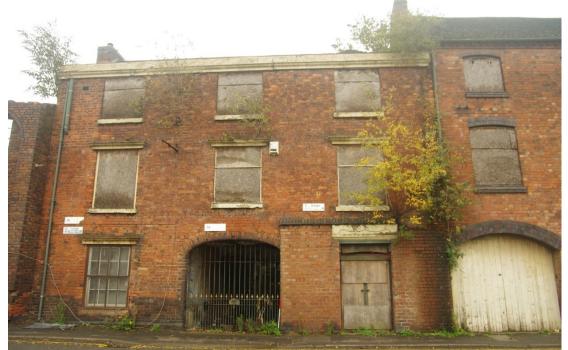
The main red brick elevation of Building R houses the only pedestrian entrance from Coleshill Road. The north-west facing elevation onto Coleshill Road consists of a threestoreyed structure with three bays (Fig. 61). At ground floor level is a 6 over 6 wooden framed sash window with a projecting moulded cornice and a stone sill. The top of the cornice shows signs of rusting and may be made from cast-iron. In the centre of the ground floor is a wide 3-centred vehicle archway leading to a wide passageway between the rear wings. This has a relatively modern wrought-iron gate fitted. To the east of the archway the ground floor elevation has been modified by adding a skin of later, possibly post-WWII, bricks which surround a wide doorway with a stone lintel decorated with a neo-classical scroll. It is not clear whether this skin masks an earlier modified window nor exactly why it has been added. The second-floor windows have been boarded over but have wooden frames and possibly the same cast-iron cornices and stone sills as on the ground floor. The same pattern can be seen on the second floor beneath the projecting eaves cornice. The tiled roof has a fairly low pitch and has a double chimney stack at each gable end.

Figure 61 Building R north-west facing elevation Looking south-east. 1m scale. Building U/T on right

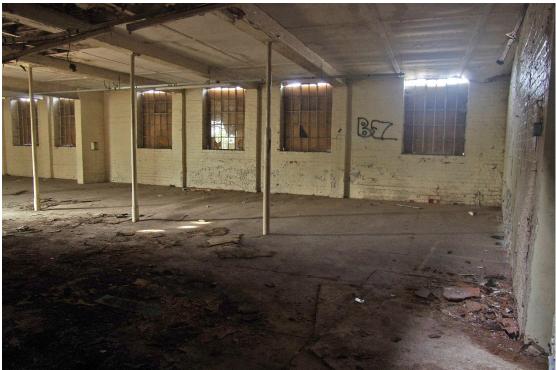
The first floor room of Building T has an unsafe floor so could not be entered. However it could be viewed from the doorway between Building V and this room which showed it to form a continuous long room stretching across both Building T and Building U (Fig. 78). Slender cast-iron columns support the ceiling. Where the wall between the two buildings has been removed a large I-section steel beam has been inserted as a support. A doorway on the east wall leads to the inserted corridor which runs behind Building R. No access could be gained to the second floor of Building T due to the unsafe condition of the top floor of Building V.

Figure 78 Building T first floor Looking north-west. The first floor of Building U is beyond the stub of wall to the left

Due to a very unsafe floor the first floor room of Building U is only visible from the eastern corner of Building T. As already noted the first floor of Buildings T and U have been opened to create a single room with the former supporting wall being replaced by a large steel beam (see Fig. 78). The second floor could not be reached due to unsafe flooring.

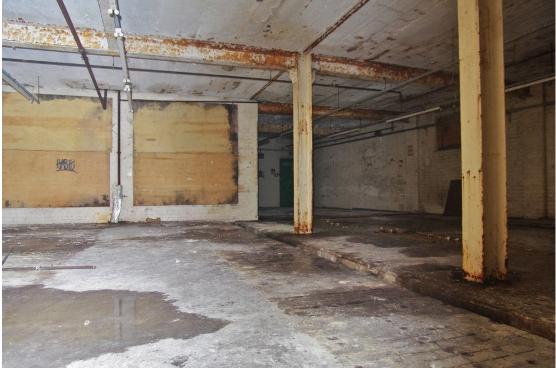
Figure 87 Building V ground floor Looking south

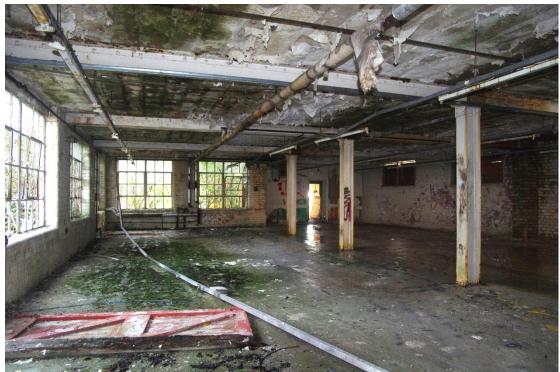
The first floor of Building V also consists of a large open space with enclosed steel stairs at the northern end of the room (Figs 88 and 89). Either side of the stairs are open doorways into the first floor rooms of Building T and U. Another doorway on the northeast wall leads to the partially collapsed corridor running across the rear of Building R. At the southern end of the room as well as the toilet block there is another set of steel stairs leading up to the second floor and also to the footbridge across to Building F-L. Close to the western foot of the stairs on this floor is the stub of remaining building with stairs leading down to the outside yard. These stairs appear to be the last surviving portion of the now-demolished structures which were located to the south-west of Building V (see Fig. 83).

Figure 88 Building V first floor Looking south. Stairs and toilet block centre right

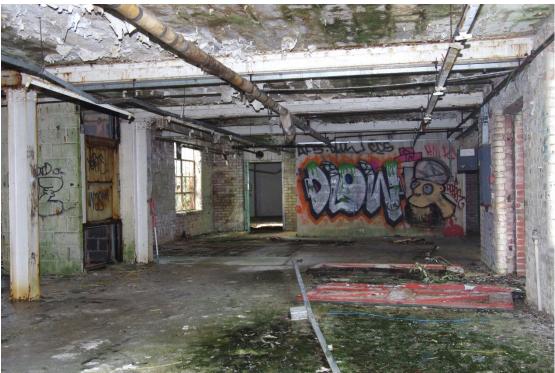
Figure 89 Building V first floor Looking north-east towards doorway in Building U (to right of window)
