LOCK COTTAGE, CANAL FOOT, ULVERSTON, CUMBRIA

Archaeological Building Recording

Client: Mr and Mrs White

October 2011

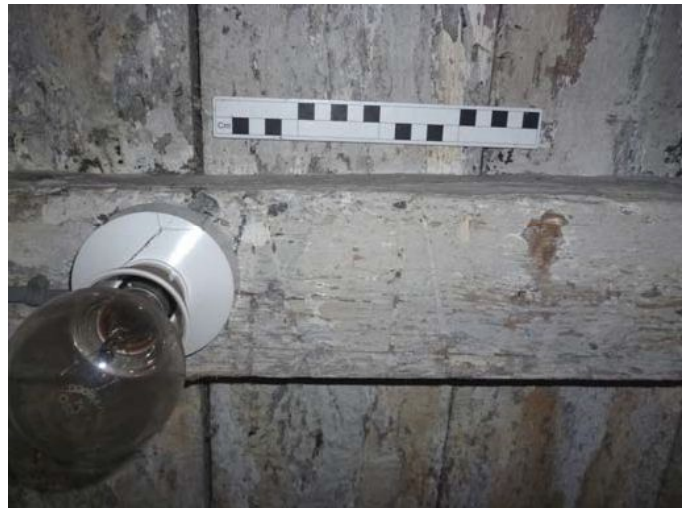
4.3.10 The ceiling on the west side of the room above Ground Floor Room 7 had the original rougher timbers (Plate 62); some were $\frac{1}{2}$ and $\frac{1}{4}$ round, one had Baltic marks (Plate 63). The floorboards on top were covered by modern chipboard. All of the flooring and timbers visible in the ceiling were whitewashed and rest on the top rail of the stud wall to the west and carry on above Ground Floor Room 6 to the west and onto the beam and slightly later joists which were added to form a lower ceiling over that room.

Plate 62 (left): Timber in the ceiling on the west side of the room above Ground Floor Room 7

Plate 63 (right): Detail of Baltic timber marks, Ground Floor Room 7

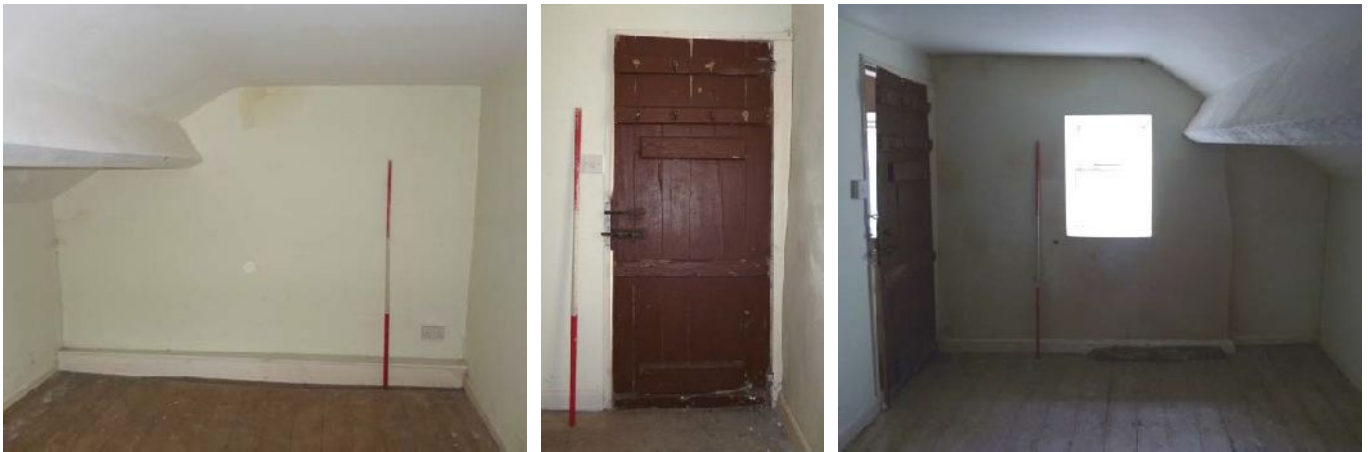
4.3.12 **First Floor Room 1:** this room has tongue and groove timber floorboards orientated east/west with narrower sections orientated north/south along the east elevation. It has a modern plaster ceiling, which slopes down on the north side and incorporates a central down-light. There is a single purlin along the north side, which is clad with modern boxing and painted (Plate 64). The walls are finished with modern plaster and paint and have a modern skirting board throughout. The north elevation is otherwise plain as is the east elevation apart from boxing along its base. The south elevation has a doorway on the west side with an early plank and batten construction door (Plate 65). The east side of the door has an early latch but has been cut back to fit the modern surround. The west elevation has a central two-light hinged casement window and the wall is thicker at this point (Plate 66), presumably to house the chimney, and there is a projecting stub of masonry at the base which corresponds to the chimney breast below (see Figure 4).

Plate 64 (left): East end of First Floor Room 1

Plate 65 (centre): Doorway in the south elevation of First Floor Room 1

Plate 66 (right): West end of First Floor Room 1

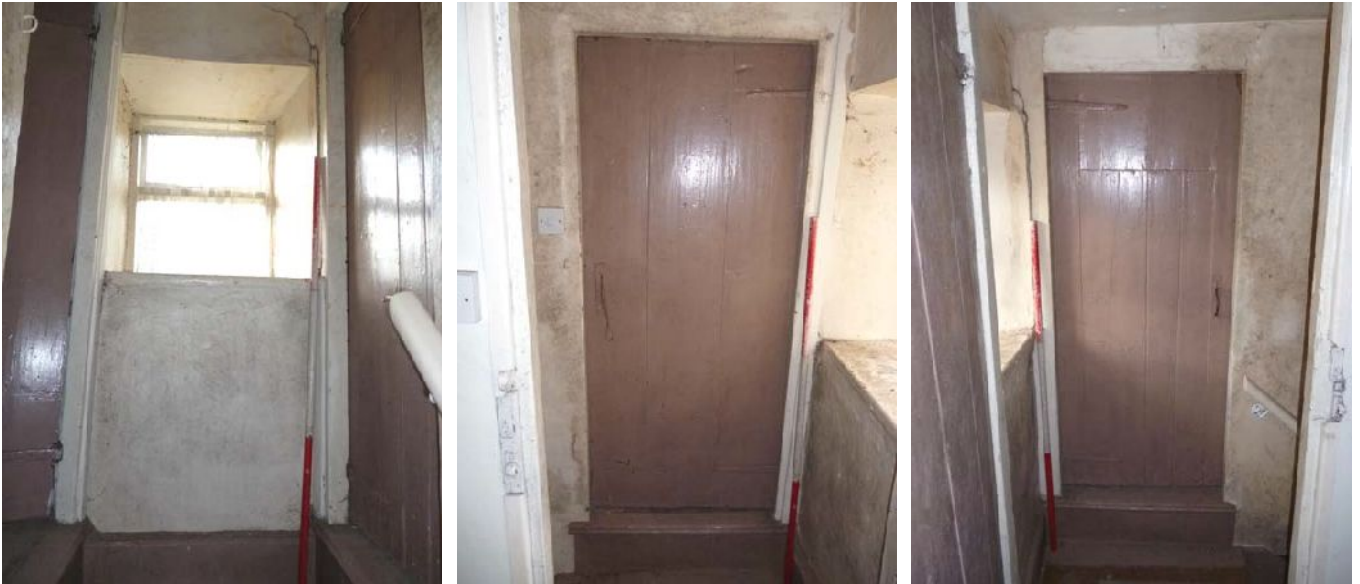
4.3.13 **First Floor Room 2:** this room forms the landing at the top of the stairs. It has a plank floor with east/west aligned floorboards as per First Floor Room 1. There is skirting along the west elevation (Plate 67) and a single step up into First Floor Room 1 and First Floor Room 3 through doors to the north and south sides of the room respectively. There is a two-light hinged casement window on the west elevation between the two doors. Both are early plank doors with long hung strap hinges and early latches and both have plain surrounds; wider planks have been used in the door to the south (Plate 68) and the north door has a cut section in the top (Plate 69), which perhaps used to open separately.

Plate 67 (left): West elevation of First Floor Room 2

Plate 68 (centre): South elevation of First Floor Room 2

Plate 69 (right): North elevation of First Floor Room 2

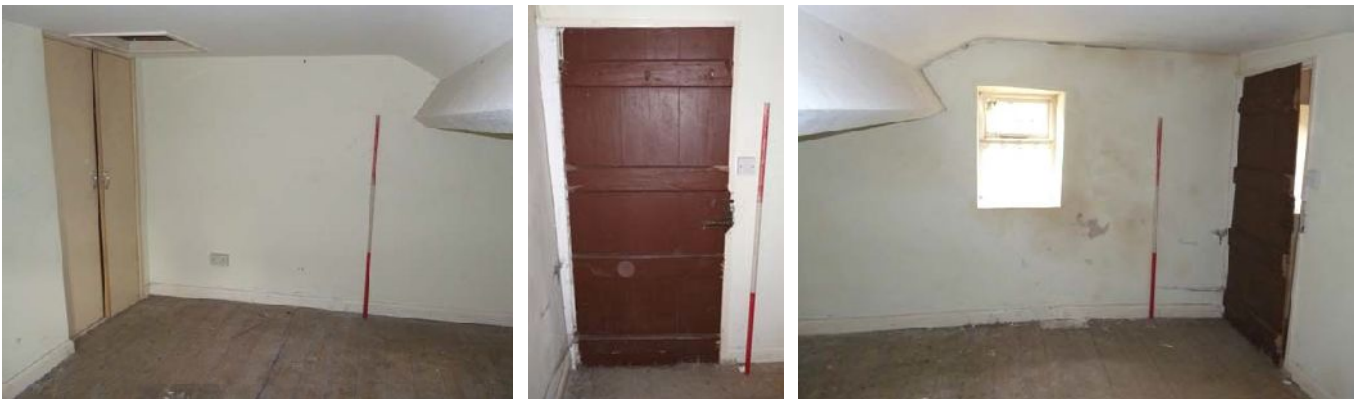
4.3.14 **First Floor Room 3:** this room has tongue and groove floorboards orientated east/west and a small panel of timber across two planks on the west side. It has a modern plaster ceiling, which slopes down to the south, with one boxed purlin, and there is a hatch in the north-east corner (Plate 70). The walls are finished with modern plaster and painted and there is skirting board throughout. The north elevation is a stud wall with an early plank and batten door on the west side, which has been sawn on the east side to fit the new surround (Plate 71). There is a double door on the east side (Plate 70) into the airing cupboard which houses the water tank and has modern hardboard walls and timber shelves. The south and east elevations are plain. The west elevation has a two-light hinged casement window, with a sill and lintel and plain surround (Plate 72).

Plate 70 (left): North-east corner of First Floor Room 3

Plate 71 (centre): Doorway in the north elevation of First Floor Room 3
