MOOR HOUSE FARM, BROUGHTON BECK, ULVERSTON, CUMBRIA

Archaeological Building Recording

Client: Neil Price Ltd

June 2012

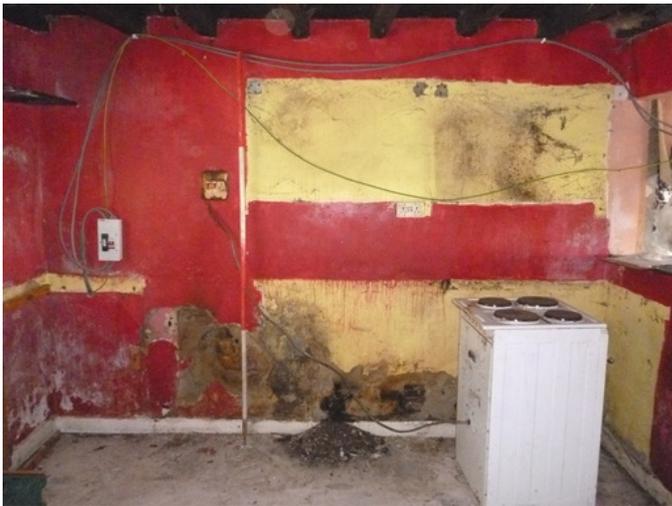
Plate 19 (left): North-east elevation in Room G4

4.3.4 Ground Floor Room 4: this too has a concrete floor, and the ceiling is supported by a single timber beam orientated north-west/south-east, which is hand-finished and chamfered and has had an old slot near the centre that has been filled with a piece of timber, suggesting that it is re-used and was perhaps originally a cruck blade. This beam is supported at the south-east end by a heavy and hand-finished timber post. The walls are all finished with a concrete skim or plaster and painted and there is a plain skirting board throughout. The north-east elevation is essentially plain, with numerous electrical fittings attached, although there is brick in the wall, which is evidently blocking a former fireplace, perhaps in two phases (Plate 19). The south-east elevation has been mostly removed to create a large opening and connect the room more fully with G5. A new beam has presumably been added to span this opening, but this has been plastered over, and part of the wall has been left on the north-east side and topped with a timber shelf to form a 'bar' (Plate 20). The post supporting the ceiling beam is incorporated into this section of wall. The south-west elevation is plain, apart from a doorway on the south-east side with a plain modern door and surround. The north-west elevation has a doorway on the south-west side, with a beaded tongue and groove plank and batten door the top part of which was probably glazed but is now covered by plywood (Plate 21). To the north-east is a window, with splayed jambs extending to the floor, within which is a modern UPVC two-light casement and a sink unit (Plate 21). A timber shelf is attached to the wall just below the ceiling to the north-east of this.

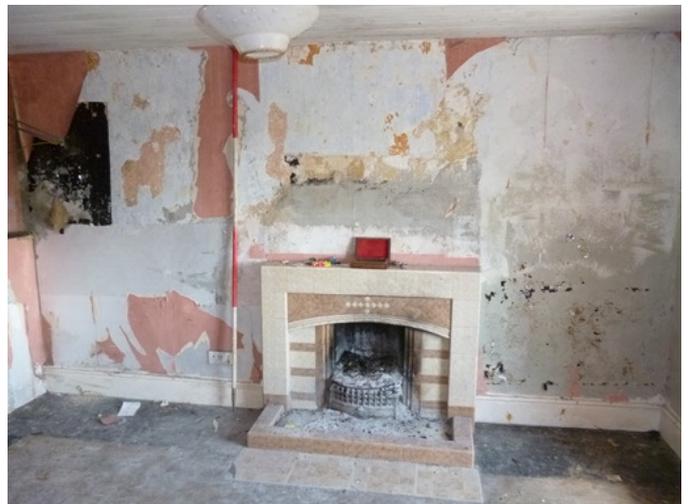
Plate 22 (right): Fireplace in north-east elevation of Room G5

4.3.5 Ground Floor Room 5: this has tongue and groove floorboards, which are stained dark brown around the edges of the room, and there is a tiled hearth corresponding to the fireplace on the north-east side. The ceiling is supported by a single central beam orientated north-west/south-east, which is considerably wider than that to the north-west, hand-finished and chamfered and supported at the north-west end by the same post supporting the beam in Room G4. The ceiling is finished with tongue and groove boards. The walls are finished with plaster or a concrete skim and wallpaper and paint and there is a roll-moulded skirting board throughout. The north-east elevation has a central fireplace with a mid-20th century tiled surround (Plate 22). The south-east elevation has a wide central window with splayed jambs and a concrete skim over the sill/seat and a modern UPVC three-light casement. The south-west elevation is plain, while the north-west has been partially knocked through and is open on the south-west side but retains a low wall to the north-east incorporating the post supporting the ceiling, as per Room G4.

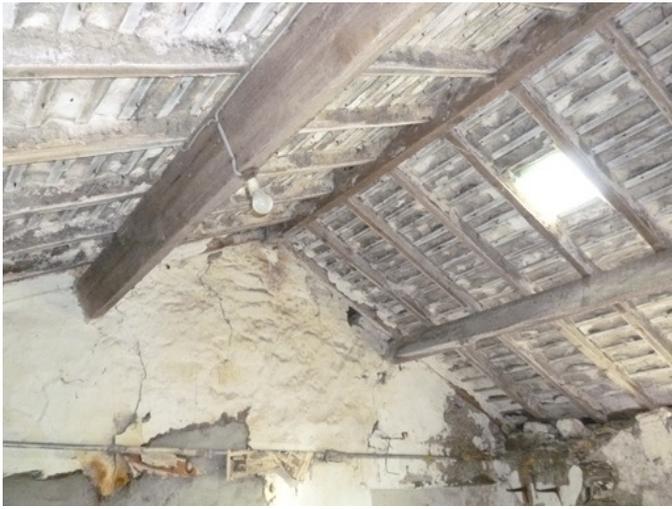
Plate 23 (left): Roof in Room G6

for a piece of machinery or similar. The room is open to the roof, which is supported by a single purlin per pitch plus a ridge purlin, all of which are machine sawn (Plate 23). There is a small skylight in the south-east pitch of the roof. All of the walls have slightly different finishes. The north-east elevation is finished with lime wash, but has been extensively patched with concrete render. There is an alcove on the south-east side with a slate lintel, and various water pipes are attached across the whole elevation (Plate 24). The south-east elevation is essentially exposed stone. There are two iron brackets and a broken off pipe going into the floor, evidently for a cistern and toilet on the north-east side, and a single window in the centre with a two-light timber casement and stone lintel and sill. To the south-west of this the low brick walls and concrete base are set against the wall (Plate 25). The south-west elevation was originally the external wall of the main house, and is covered by rough cast render that has been finished with lime wash, with a low plinth discernible at the base (Plate 26). The north-west elevation is almost entirely finished with concrete skim and has water pipes attached. On the south-west side there is a doorway, with a stone lintel and some of the surround remaining but no door.

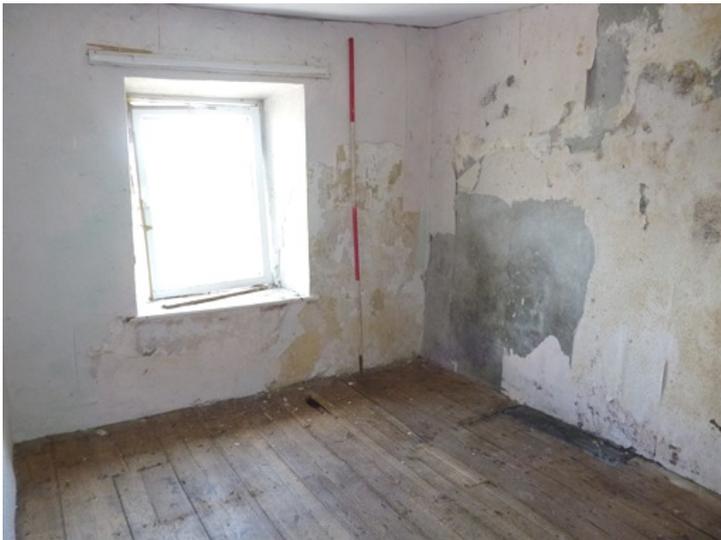
Plate 27 (left): South corner of Room F1

4.3.7 **First Floor Room 1:** this has wide floor boards, which have evidently been polished or sanded, and a shallow hearthstone against the south-west elevation (Plate 27). The ceiling is finished with plaster and there is a north-west/south-east orientated beam along the north-east elevation, which is also finished with plaster. The walls too are finished with plaster and paint, although there is also some concrete skim. The north-west and south-west elevations are plain. The north-east is a stud wall; the

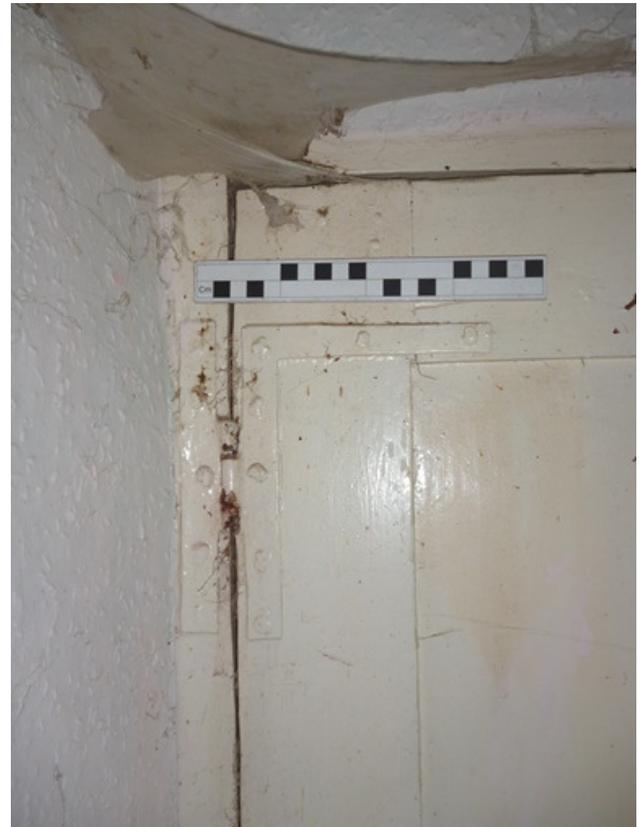
Plate 28 (right): Detail of hinge in Room F1

beam running along the top is actually the tie beam of the truss visible in the attic (see *Section 4.3.13* below) and there is a doorway at the north-west end with an early two panel door (as per those in Room G3, see *Section 4.3.3* above) with L-shaped hinges (Plate 28), a later latch, and plain surround. The south-east elevation has a central window with splayed jambs, a timber sill, and modern single-light UPVC casement.

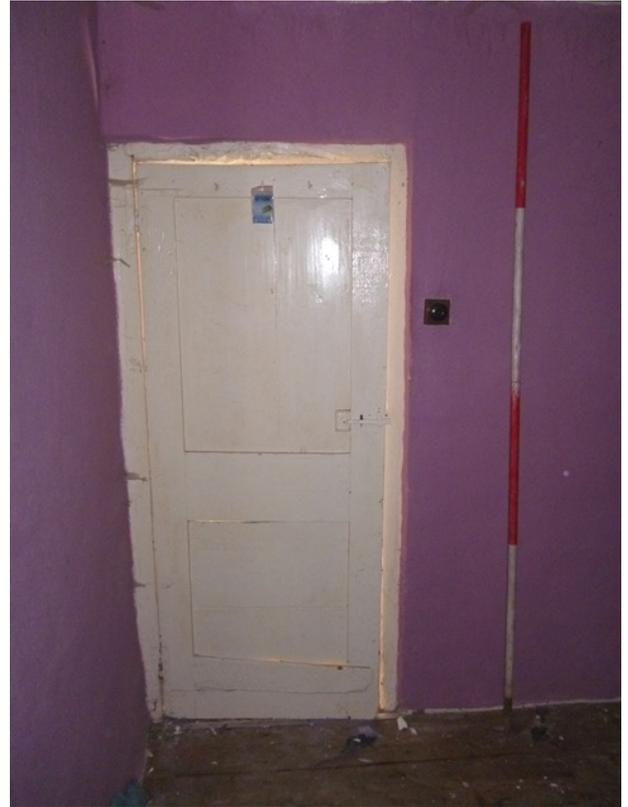
Plate 36 (right): Door, south-west elevation, Room F5

4.3.11 **First Floor Room 5:** this too has a wide plank floor and the ceiling is finished with plaster and supported by a north-west/south-east beam, which is also finished with plaster. The walls too are finished with plaster and wallpaper and mostly plain. There is a window in the north-west elevation, with splayed jambs, a timber tongue and groove board sill, and single-light UPVC casement (Plate 35). There is a doorway in the south-east side of the south-west elevation, with an early two-panel door with L-shaped hinges and a plain surround (Plate 36).

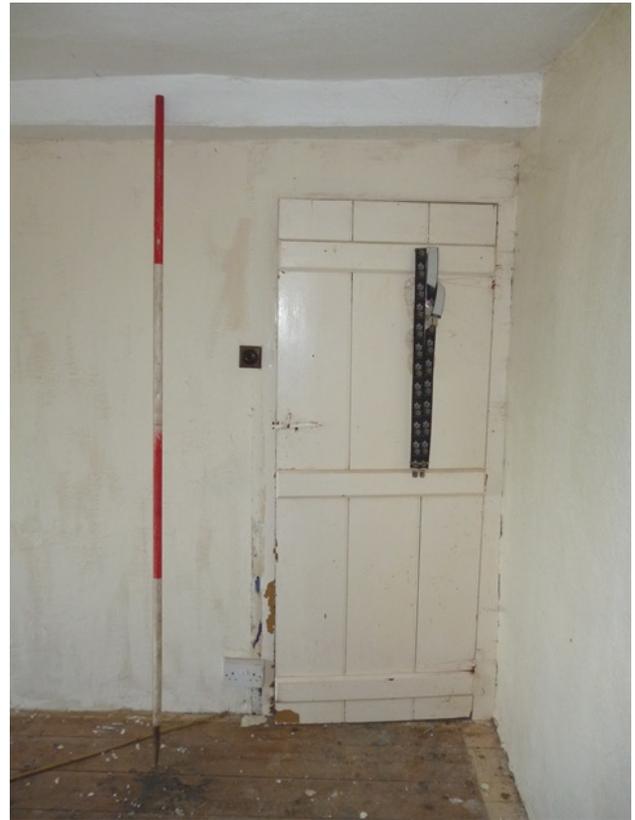
Plate 38 (right): Door, south-west elevation, Room F6

4.3.12 **First Floor Room 6:** this has narrower tongue and groove floorboards and the ceiling is finished with plaster and supported by a north-west/south-east beam against the south-west elevation, which is also finished with plaster. The walls are also finished with plaster and paint and generally plain. The south-west has a central window with splayed jambs and a UPVC single-light casement (Plate 37). The sill has been removed and stuffed into the gaps below and around the window are pieces of newspaper dated 2006. The south-west elevation has a doorway on the north-west side with a door constructed from three wide beaded planks and battens supported on strap hinges (Plate 38).

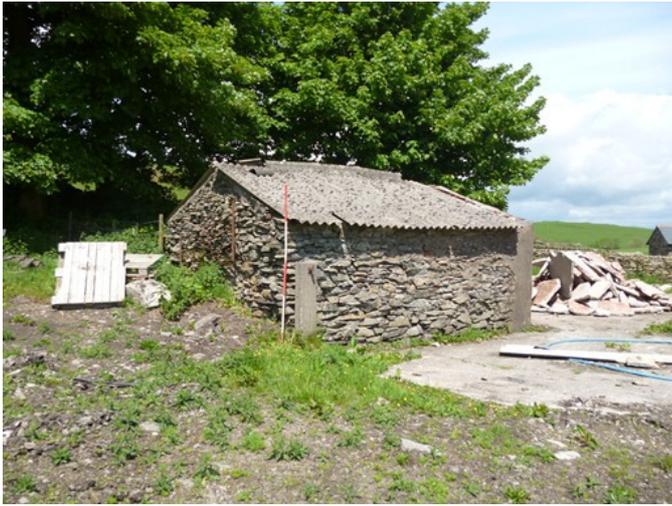
Plate 45 (left): South-east external elevation of the outbuilding

4.3.15 **Outbuilding:** although not specifically include in the building recording, photographs were also taken of a detached outbuilding. This was largely of stone construction (Plate 45) and rectangular in plan (and approximately parallel to the building and so orientated north-east/south-west) although the north-east end has been largely rebuilt in machine-made red brick, although externally it is finished with concrete render (Plate 46), with an iron girder for a lintel to provide a wider garage entrance. The roof is constructed from corrugated concrete sheeting, supported by a single truss constructed from L-shaped iron girders (Plate 47). Internally there is little of interest, although the doorway was closed by a large folding door on a rail that allowed it to be moved against the side wall (Plate 48).

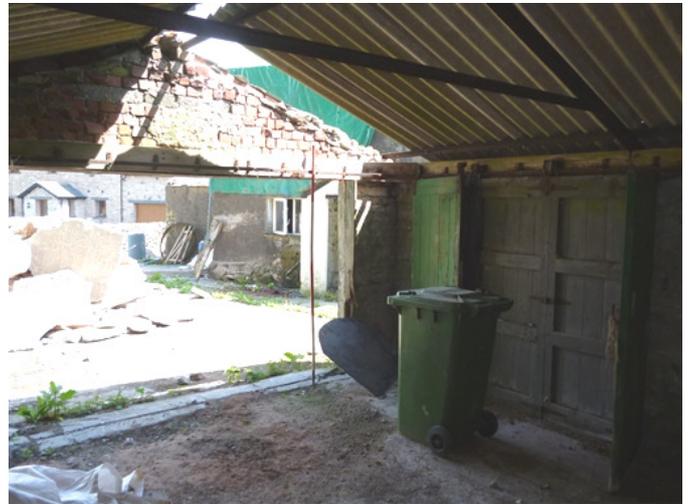
Plate 48 (right): Folding door within the outbuilding
