BARN ON LAND TO REAR OF ROSE COTTAGE, STANK LANE, STANK, CUMBRIA

Archaeological Building Recording

Client:
David and Kate Hornby

October 2012

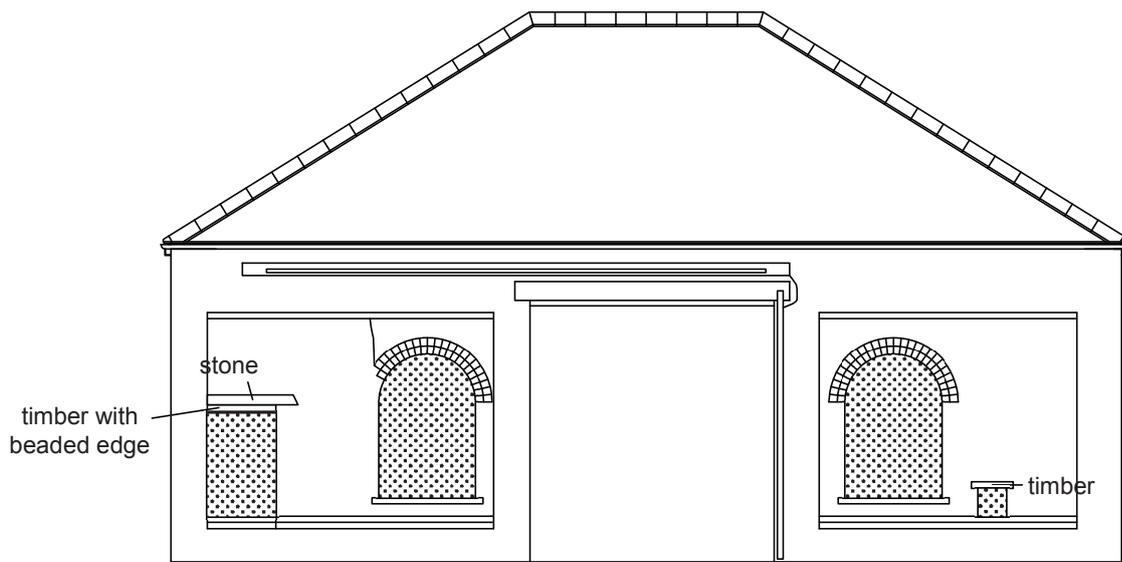
NORTH-WEST EXTERNAL ELEVATION

4.2.1 **North-west elevation** (Figure 2): this has two recessed panels either side of a central wagon doorway (Plate 11). The north-east of these panels, and probably the rest of the associated wall, has evidently been rebuilt in a similar type of brick to the original build, and this area includes a small doorway with a slate lintel. This has been blocked with concrete blocks, leaving a recess. To the south-west of the rebuild is a window with a round header arch and red sandstone sill, although this has been cut through on the north-east side by the line of rebuild, and the whole window has been blocked with brick, including some re-used yellow fire brick (Plate 12). The wagon doorway has the remains of a timber sliding door in front of it, with a long timber rail and iron fixture attached above. The doorway has a timber lintel, and there is apparent rebuild around the south-west end, evident as concrete patching. The jambs are also finished with concrete and it is apparent that this doorway is wider and differently arranged to that in the south-east elevation, suggesting that it has been inserted or widened. To the south-east of the doorway there is another recessed panel, also with a blocked window with a round header arch and red sandstone sill. A short distance to the south-east of this is a short timber lintel at low level below which is a small aperture, which cuts through the moulded plinth but is blocked with brick (Plate 13).

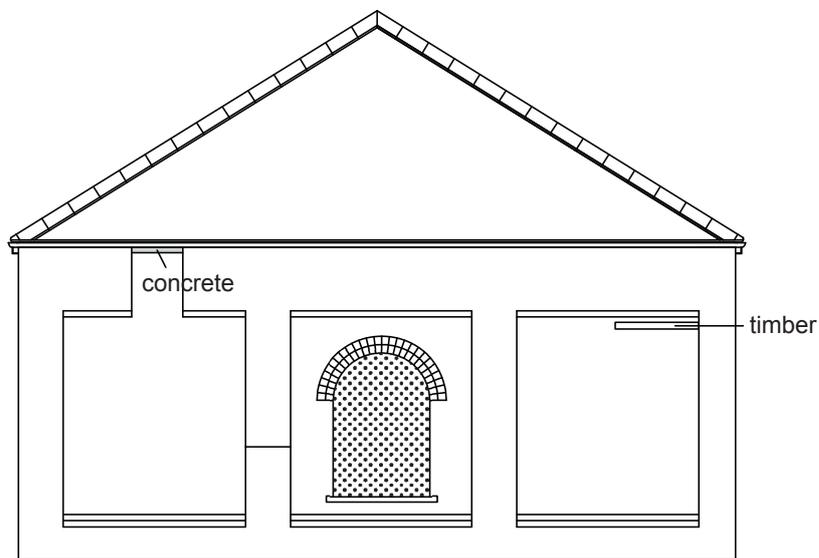
NORTH-EAST EXTERNAL ELEVATION

4.2.2 **North-east elevation** (Figure 2): as per the other elevations there are three recessed areas across the elevation, situated between a pair of columns either side of the centre and one at either end (Plate 14). The plinth has largely collapsed and is in places unrecognisable and the lower part of the south-east central column has also collapsed. In addition, there is a rectangular section cut out of the area above the south-east recessed area, which is topped with loose concrete blocks (Plate 15). The central recess has a window with a round header arch and red sandstone sill, which is blocked with bricks. The north-west recess has a horizontal piece of timber built in on the north-west side, which appears to be a lintel it does not correspond to any obvious opening. There are traces of limewash on the south-east side of the central recess and in the south-east recess.

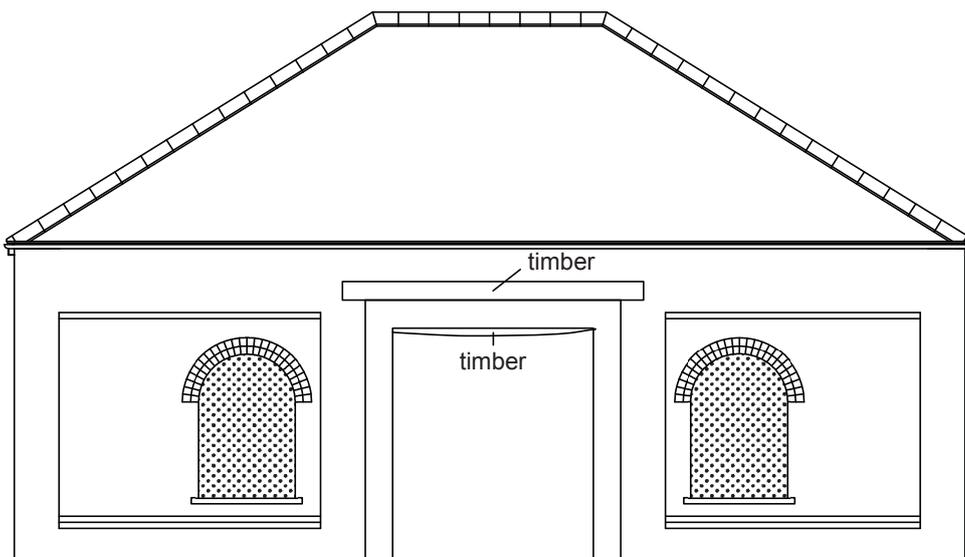
SOUTH-EAST EXTERNAL ELEVATION

4.2.3 **South-east elevation** (Figure 3): this is broadly the same as the north-west elevation, although it is partially obscured by vegetation (Plate 16). There is a recessed area either side of a central doorway, although the doorway is different in style to that to the north-west, with recessed areas on both sides and a lower timber lintel with projecting brickwork above. The remains of a timber plank and batten sliding door are positioned in front of the doorway and they are fixed to a timber rail above (Plate 17). In the recesses to either side there is a single window with a round header arch, blocked with brick (the north-east including some re-used yellow fire bricks) and with a red sandstone sill.

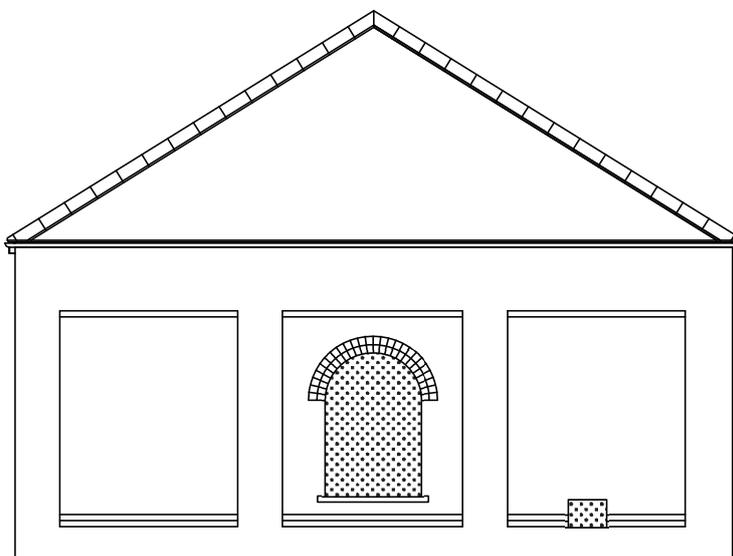
SOUTH-WEST EXTERNAL ELEVATION

4.2.4 **South-west elevation** (Figure 3): this is essentially the same as the north-east, although the plinth is better preserved. There are three recessed areas divided by projecting columns. The north-west is plain, while the central one has a window with a round header arch and red sandstone sill, which is blocked with brick (Plate 19). The south-east recess has a small low aperture with no lintel on the north-west side, which cuts through the plinth and is blocked with brick (Plate 20).

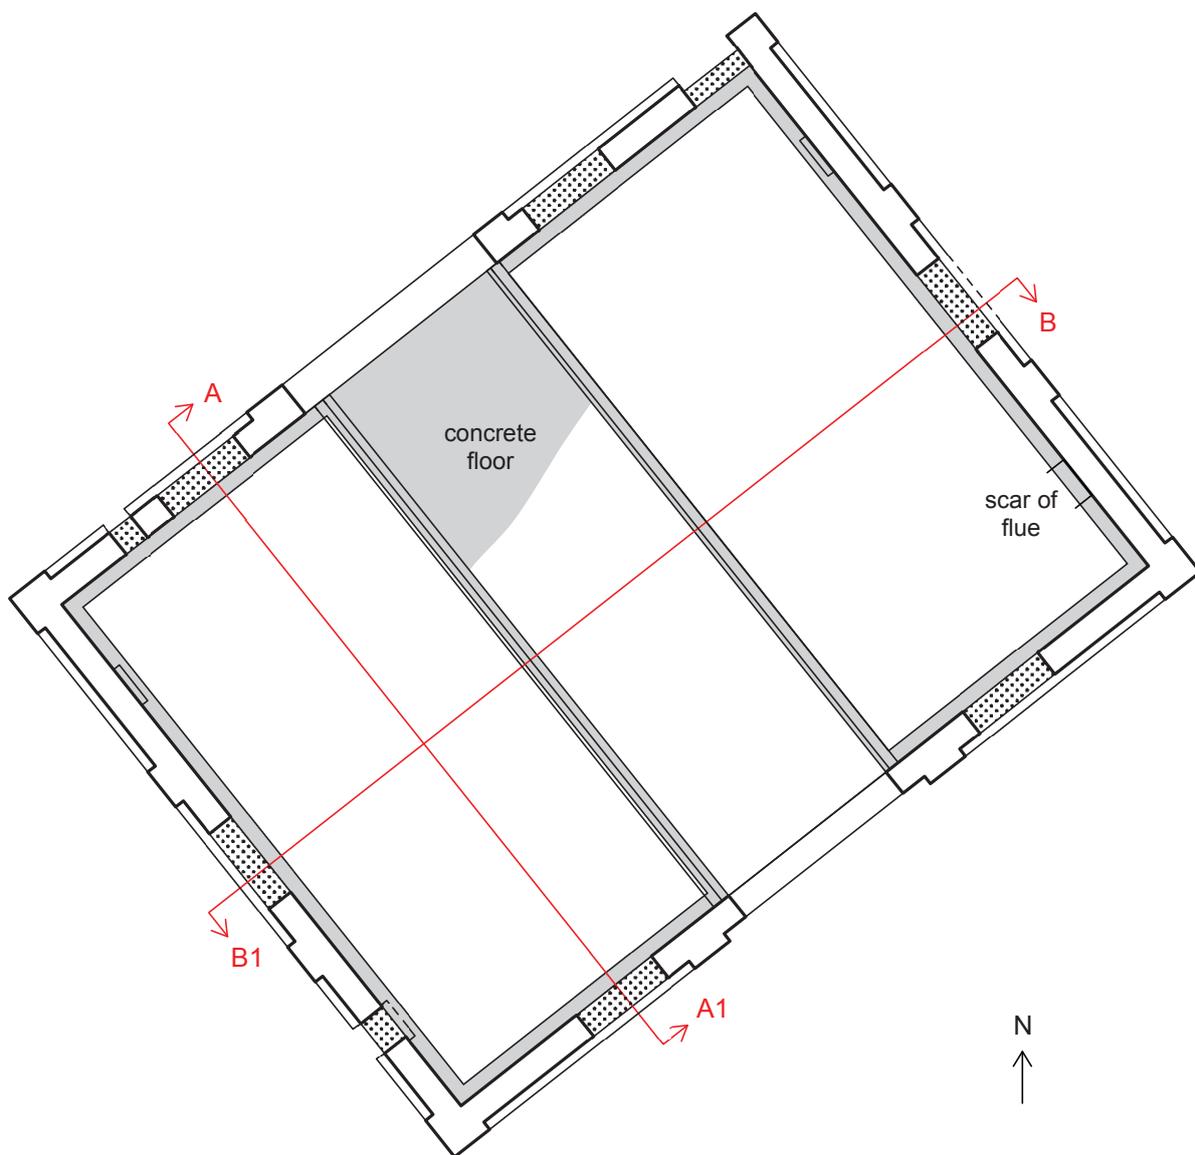
Figure 4: Floor plan

4.3.1 **Ground Floor Room 1:** the interior of the building comprises only a single room, although it is open to the roof structure, which extends well above ground floor level. The floor is covered with gravel, but there is a poured concrete section against the north-west doorway and a plinth made of concrete blocks around the interior and either side of a passageway running between the opposing central doorways in the north-west and south-east elevations (Figure 4). Slots within this plinth along the north-east and south-west elevations denote the position of joists that originally supported a raised floor. The roof structure is supported by two king post trusses orientated north-west south-east (Plate 21). Each truss has a pair of angled braces running between the joggled end of the king post and a flat joint with the principal rafters (Figure 5). The king post too forms a flat joint with the principals and is fixed with a bolt through the underside of the tie beam. There is a long iron bracket bolted to the south-west face of the north-west end of the south-west tie beam (Plate 22), and there are numerous other bolt holes across both tie beams, most of which are empty. The trusses support two purlins on all four sides and a ridge plank orientated north-east/south-west. There are additional timbers around the apex and this, plus the fact that the slates are not plastered in this area, suggests that there was originally a louvred opening (Figure 5). In addition there are two similar patches within the slates in each pitch, indicative of flues or skylights and similar patches above the pairs of former flues against the north-east and south-west elevations (see Sections 4.3.2 and 4.3.3 below). All of the timber in the roof is machine sawn.
