# FORMER METHODIST CHURCH, QUEEN STREET, MILLOM, CUMBRIA

Archaeological Building Recording

Client: Mark Tohill  
Planning Ap. Ref.: 4/06/2352  
NGR: SD 17593 80057

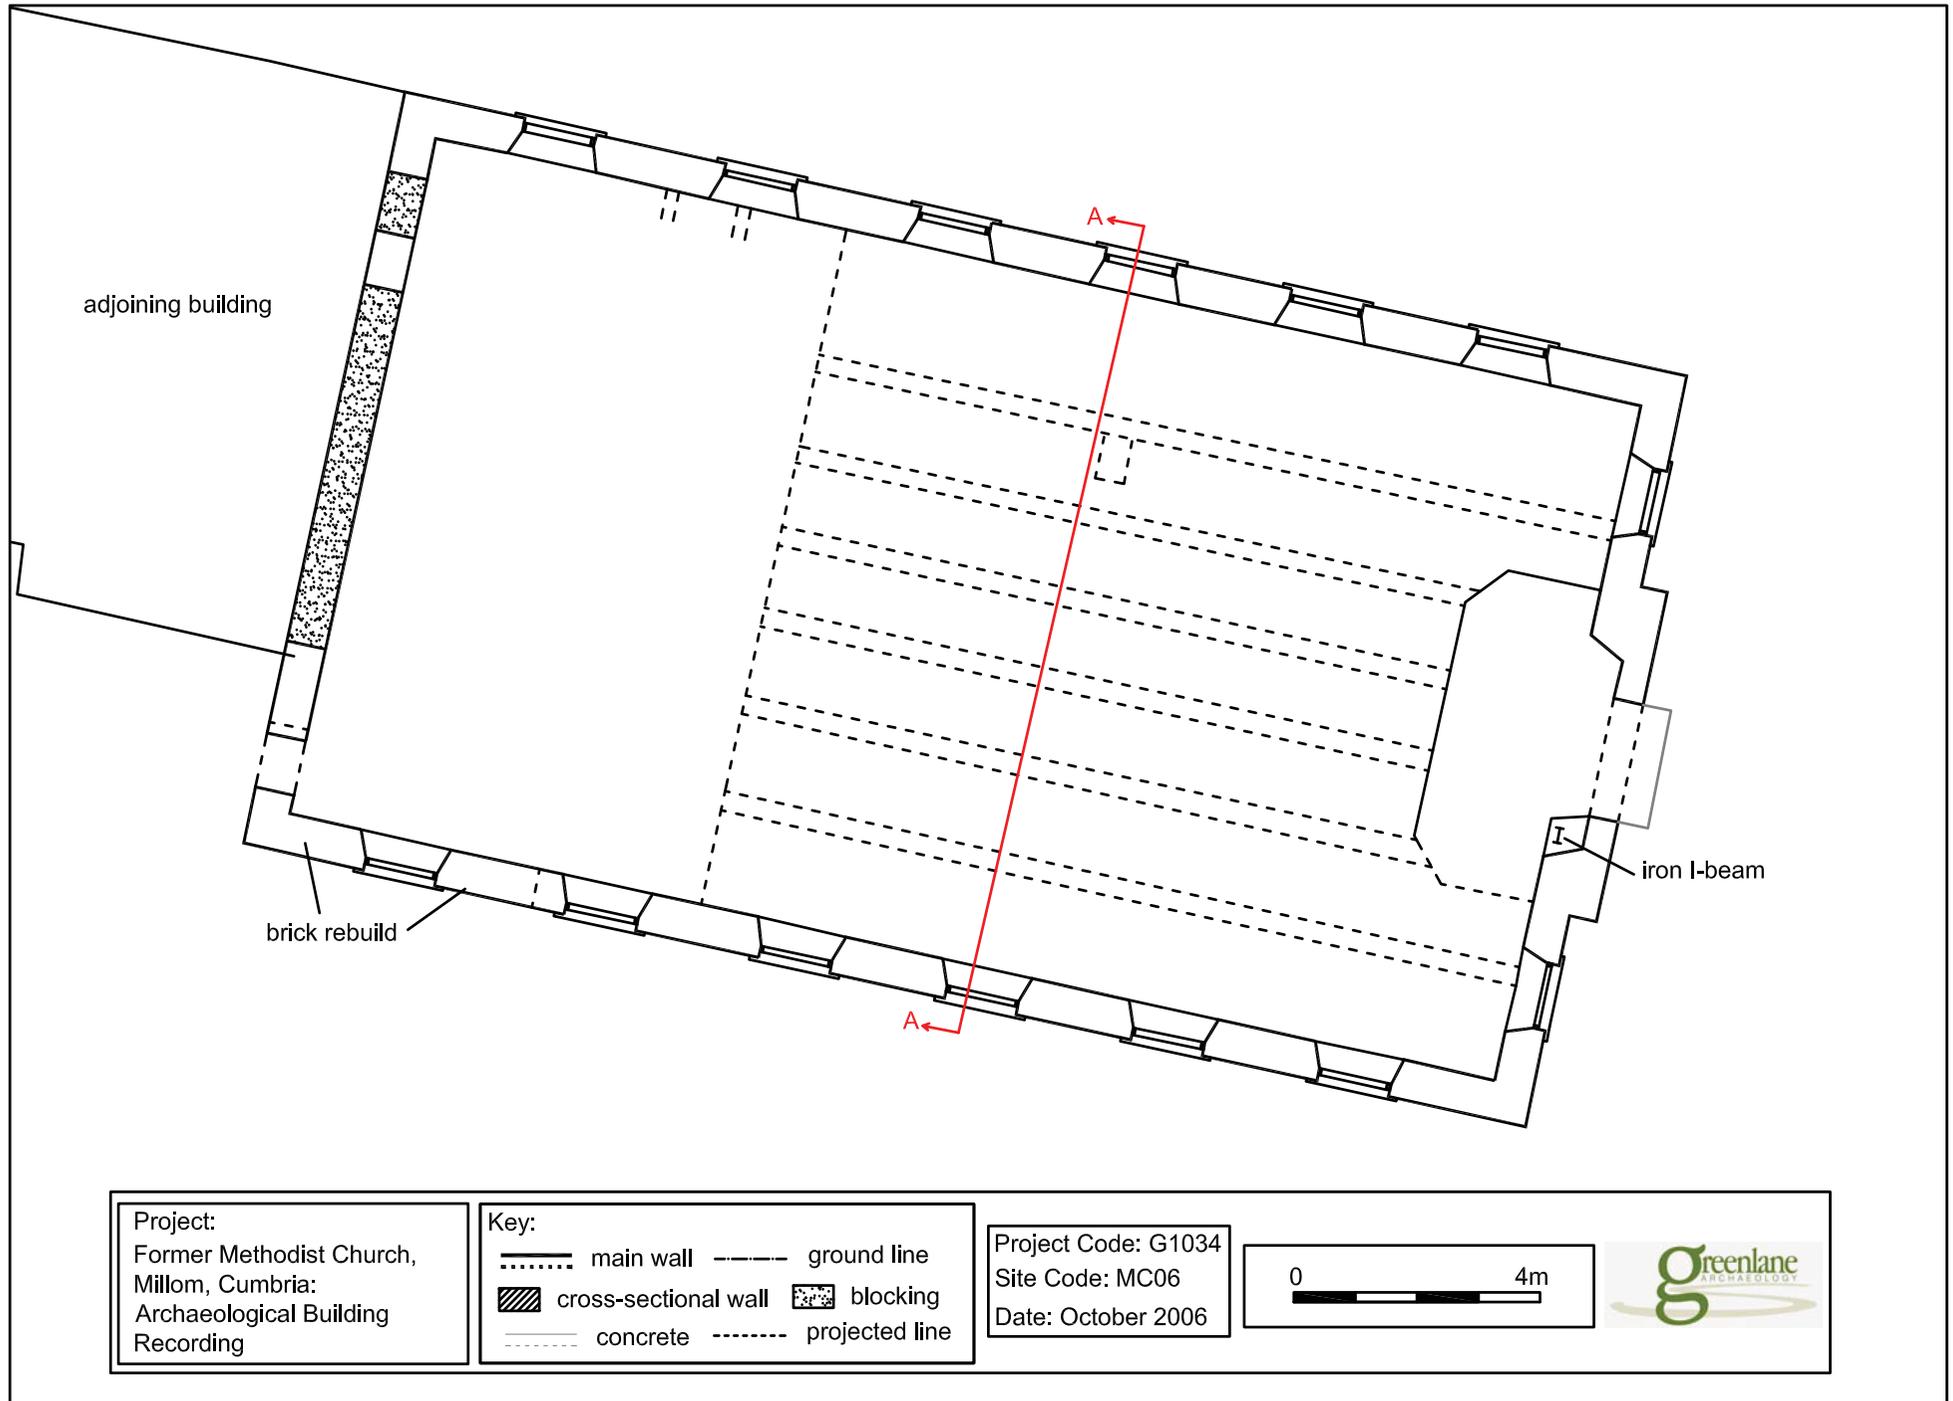
Figure 4: Ground floor plan

**4.4.1** The interior comprises a single large room, originally on two floors but now open to the ceiling (Figs 4-6; Plate 23). The floor is covered in rubble but no original surface survives – six low stone walls, presumably forming the bases of a timber floor, orientated east/west are present, although these end at a north/south wall at the west end with large amounts of concrete dumped on top. A small brick section is present on the north side of the centre, towards the west end. The roof is supported by five trusses, each sat on scrolled brackets set into the north and south walls (Fig 6; Plate 24). Each truss comprises a pair of queen posts supporting a collar, which in turn supports king-posts, which are notched and splayed to fit the principal rafters and have squared heads supporting the ridge purlin (Campbell 2000, 47). A three-way strap (*op cit*, 50) attaches the queen post to the collar and principal rafter and attached to the inside edges of the queen posts and the underside of the collar is a curved bracket. This is chamfered and originally supported the vaulted lathe and plaster ceiling, part of which survives at the east end and had an iron 'rose' boss set into it supporting the light fitting. There are three purlins per pitch, and the principal rafter is trenched to fit them, plus a ridge purlin, and there are two small finials on the underside of the tie beam. The walls in general comprise rough courses of slate, although the round arches over the windows are brick – some brick lying loose in the building is marked 'Whitehaven', although it is not known where in the building this originated, if at all. Some areas of the wall are finished with plasterboard.

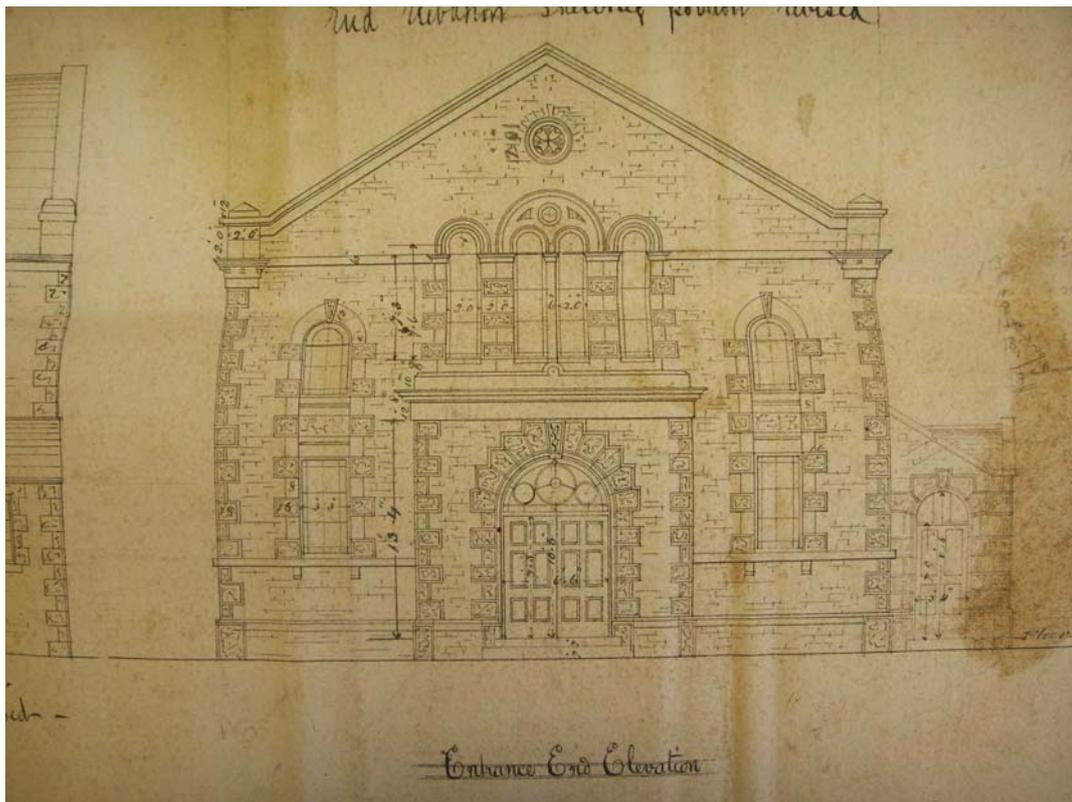
Plate 1: East external elevation as proposed in original drawings of 1872 (CRO (B) Z1099 1872)

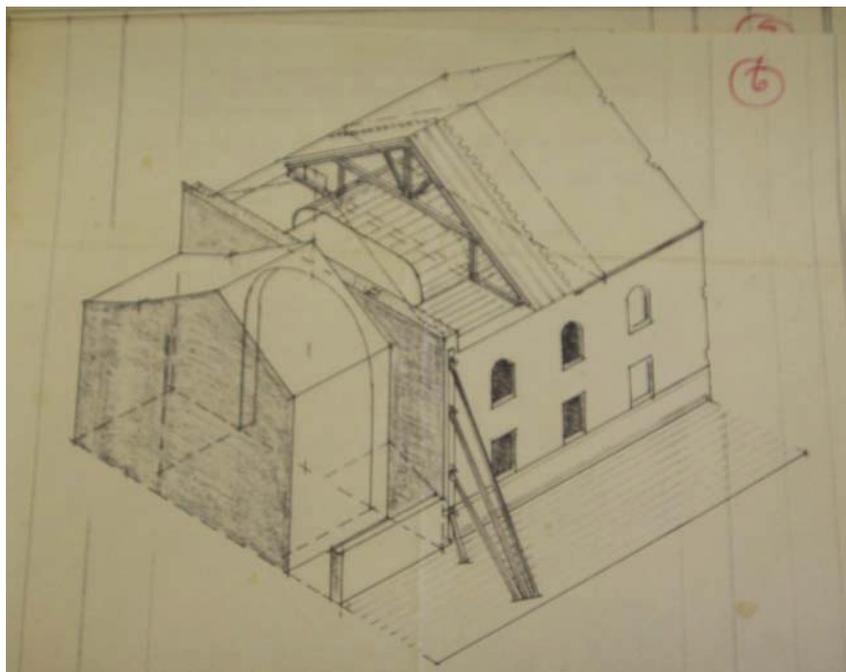
3.1.3 By the late 1950s the church was evidently in poor condition, and it was considered necessary to carry out some major repairs (CRO (B) BDF C/M/M/7/3/1-3 1958-1960). An inspection carried out on 26<sup>th</sup> June 1958 recorded that '*The church built about 80 years ago, with walls of stone 2'3" in thickness, is in quite good condition except for cross wall at the Chancel end which shows cracks in places; it has moved outwards back towards Wellington Street causing a bulge outwards at the corner and extending along the side wall for about 9'0 or so*' (*ibid*). The movement within the building was considered to be as a result of the damaged wall having been built on the line of a ditch, an area of filled ground, or area affected by water (*ibid*). The condition of the side wall was considered to be so poor that it was proposed that the building be demolished and a new church built in its place, but ultimately money was raised to carry out substantial rebuilding of the affected parts of the church (Plates 11-14). At this time some of the pews and the area around the pulpit were re-organised (Jack Giles pers comm.). The church remained in use for much of the 20<sup>th</sup> century after the renovation work (Plate 15), but was finally abandoned in 1993 (Jack Giles pers comm.), all the original fittings were removed and it was turned into a builder's store (Mark Tothill pers comm.), and the hall to the north was demolished (Jack Giles pers comm.).

Plate 11: Isometric view of the church and supports to south-west corner in 1958 (CRO (B) BDF C/M/M/7/3/1-3 1958-1960)

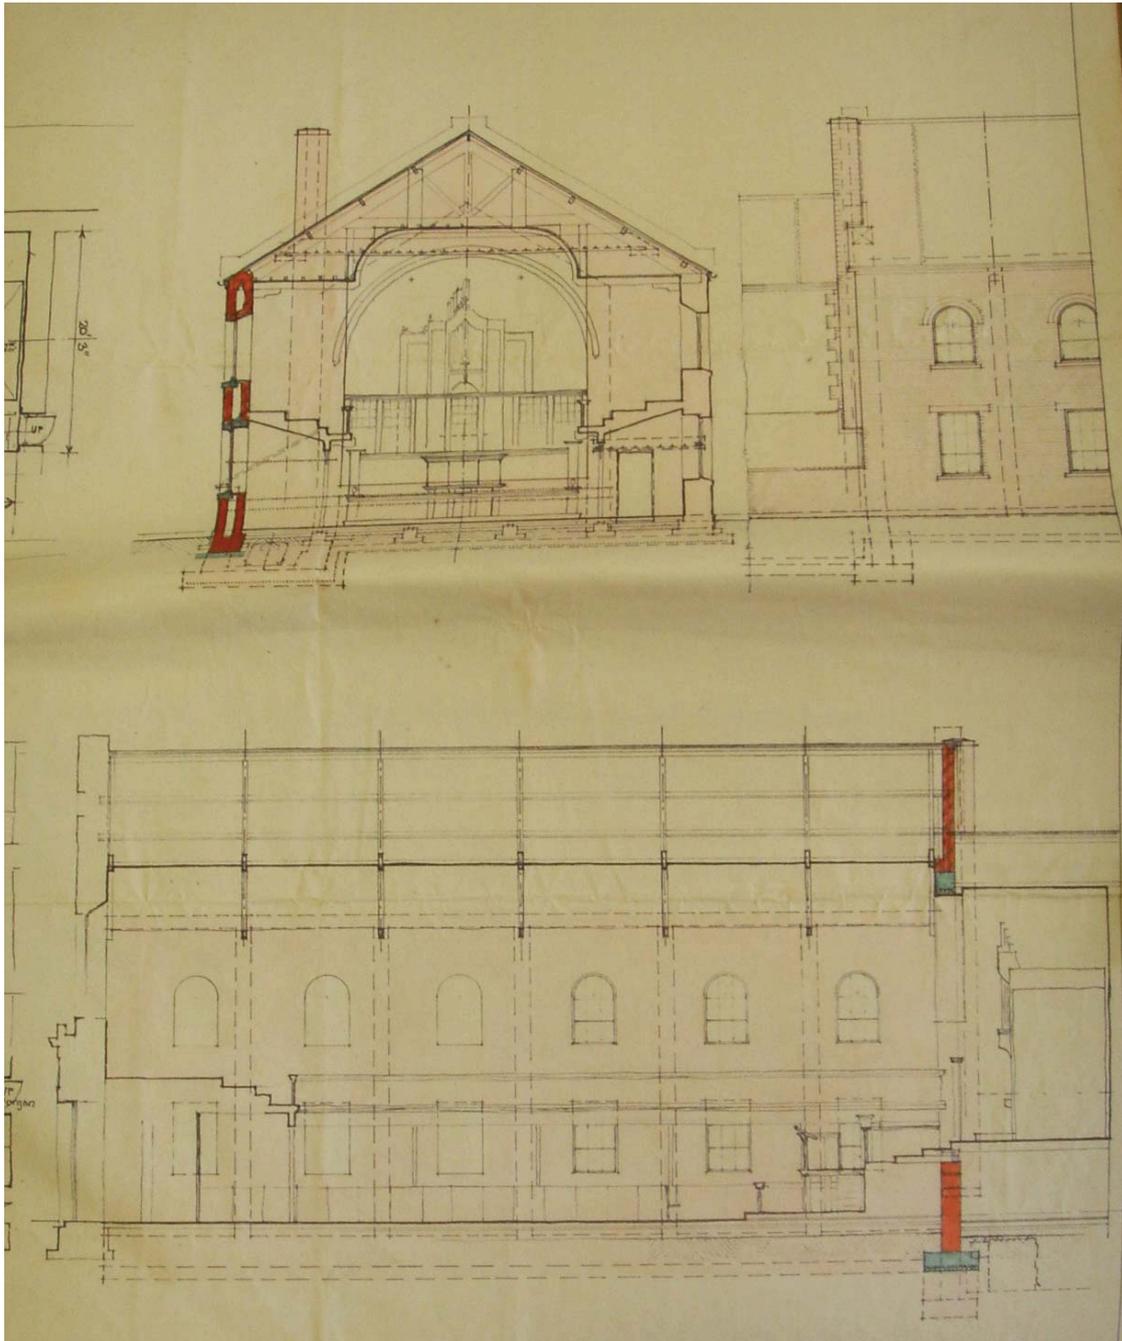
Plate 13: Cross-section and long-section of the church showing areas needing repair in red (CRO (B) BDF C/M/M/7/3/1-3 1958-1960)

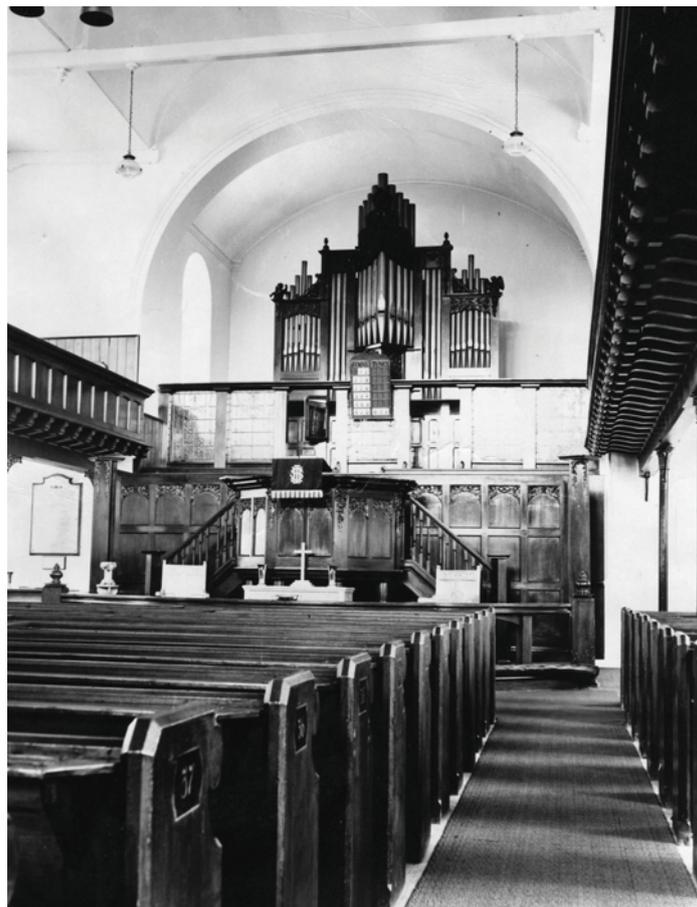
Plate 15: View of the interior in 1959, taken after the rebuilding work (provided by Jack Giles)

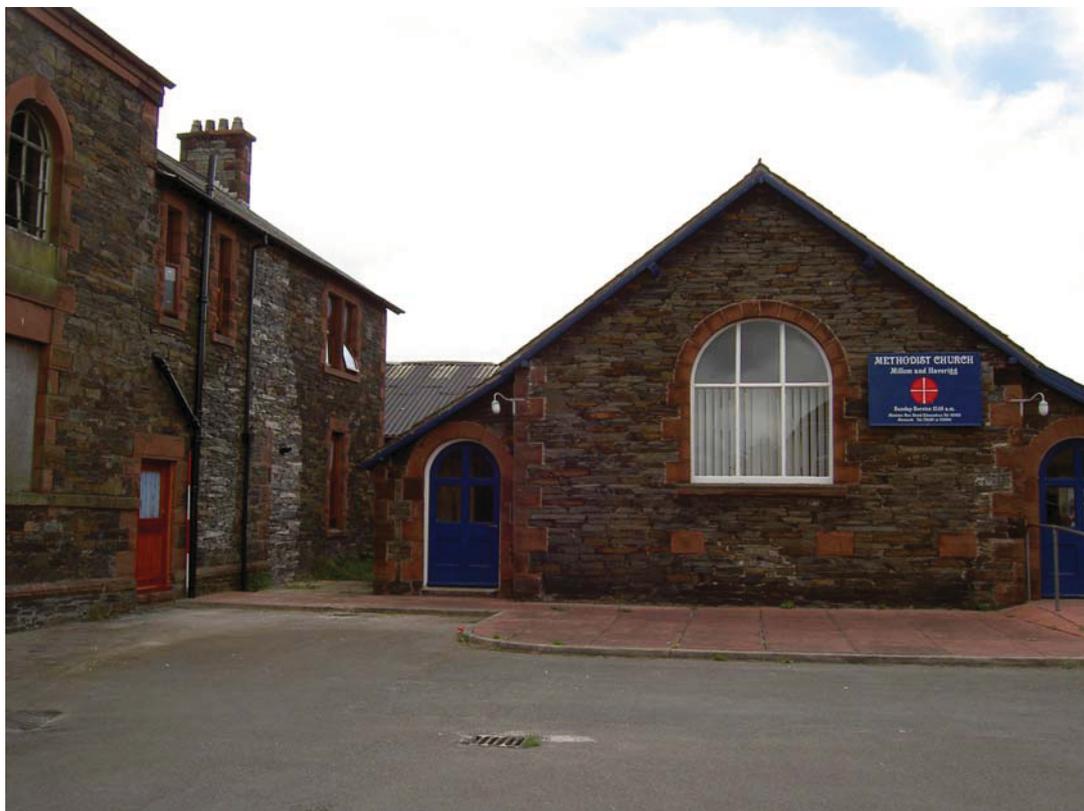
**4.3.4 West elevation:** this is largely obscured by the later extension and therefore could not be examined in detail (Plate 22). The elements that are visible have been covered by render and timber panelling and painted as part of the recent renovation of the west extension (Plate 21). A small square chimney is present, however, which has a flat coping around the top.

Plate 21: Extension to the west end of the church, and surviving church
