# HOUSE AT SLACKWOOD FARM, SILVERDALE, LANCASHIRE

## Archaeological Building Recording

Client: Adrian Waddingham

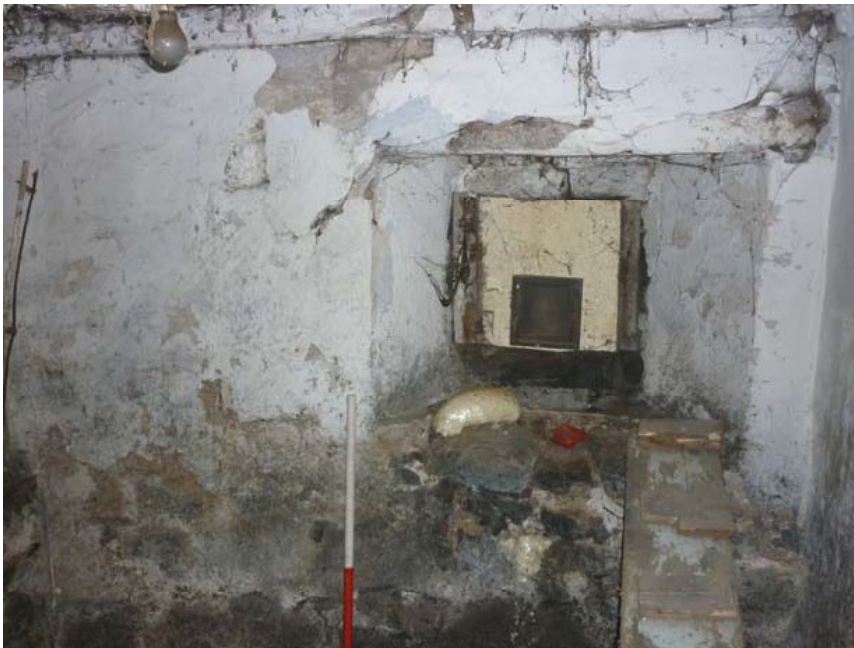
Plate 16 (left): North elevation of the cellar

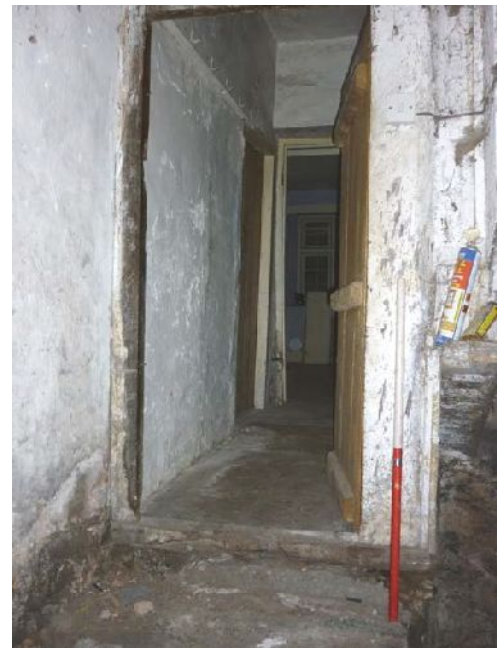
Plate 17 (right): Doorway in the south elevation of the cellar

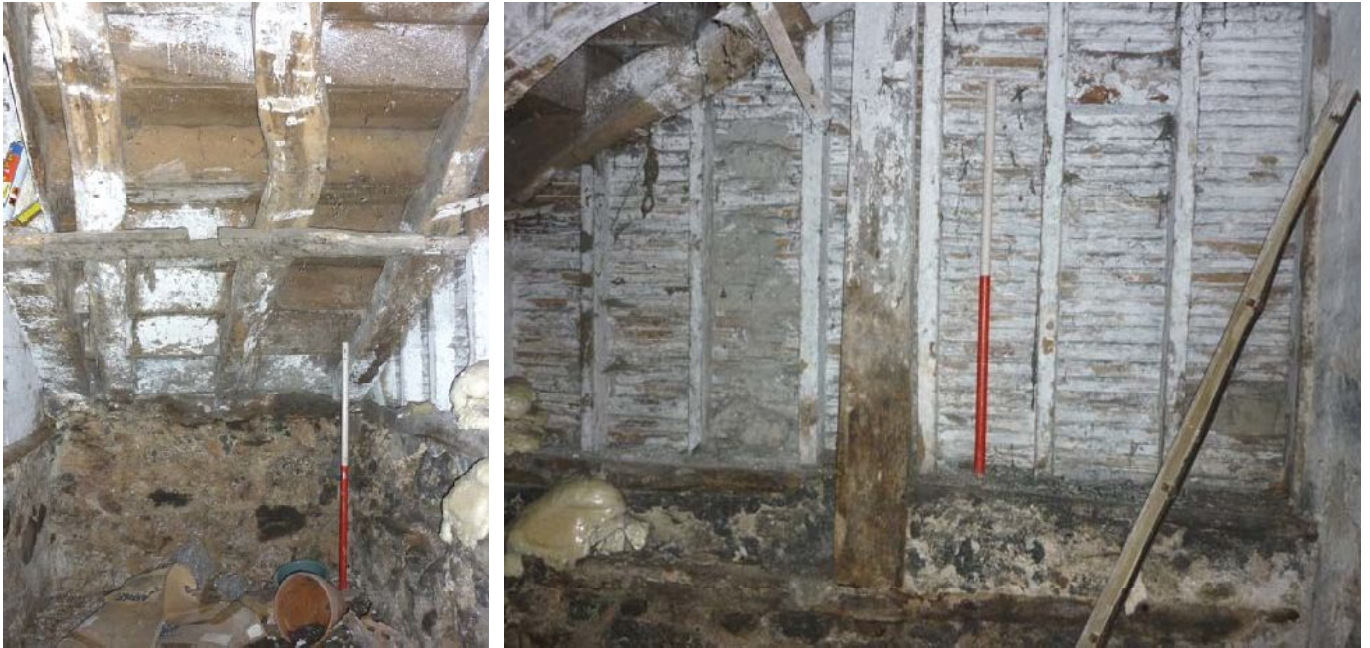
**Plate 18 (left): Underside of the stairs from in the cellar**

**Plate 19 (right): The west elevation of the cellar**

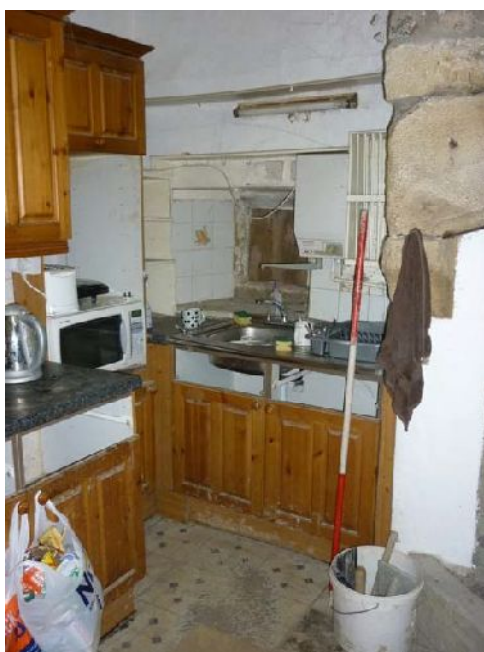
**Plate 24: South-west corner of Ground Floor Room 3**

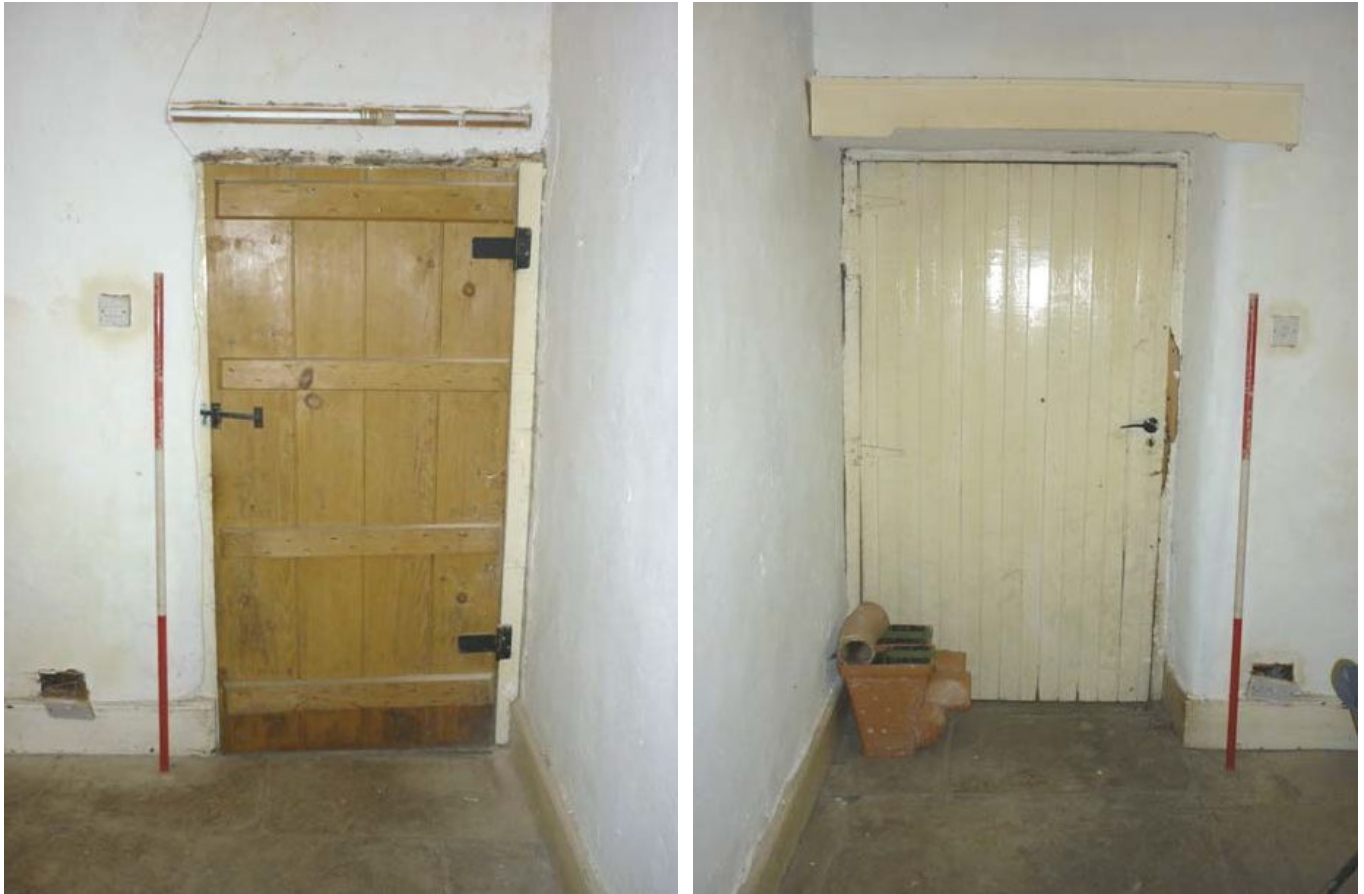
Plate 28 (left): Doorway in the north elevation of Ground Floor Room 4

Plate 29 (right): Doorway in the south elevation of Ground Floor Room 4

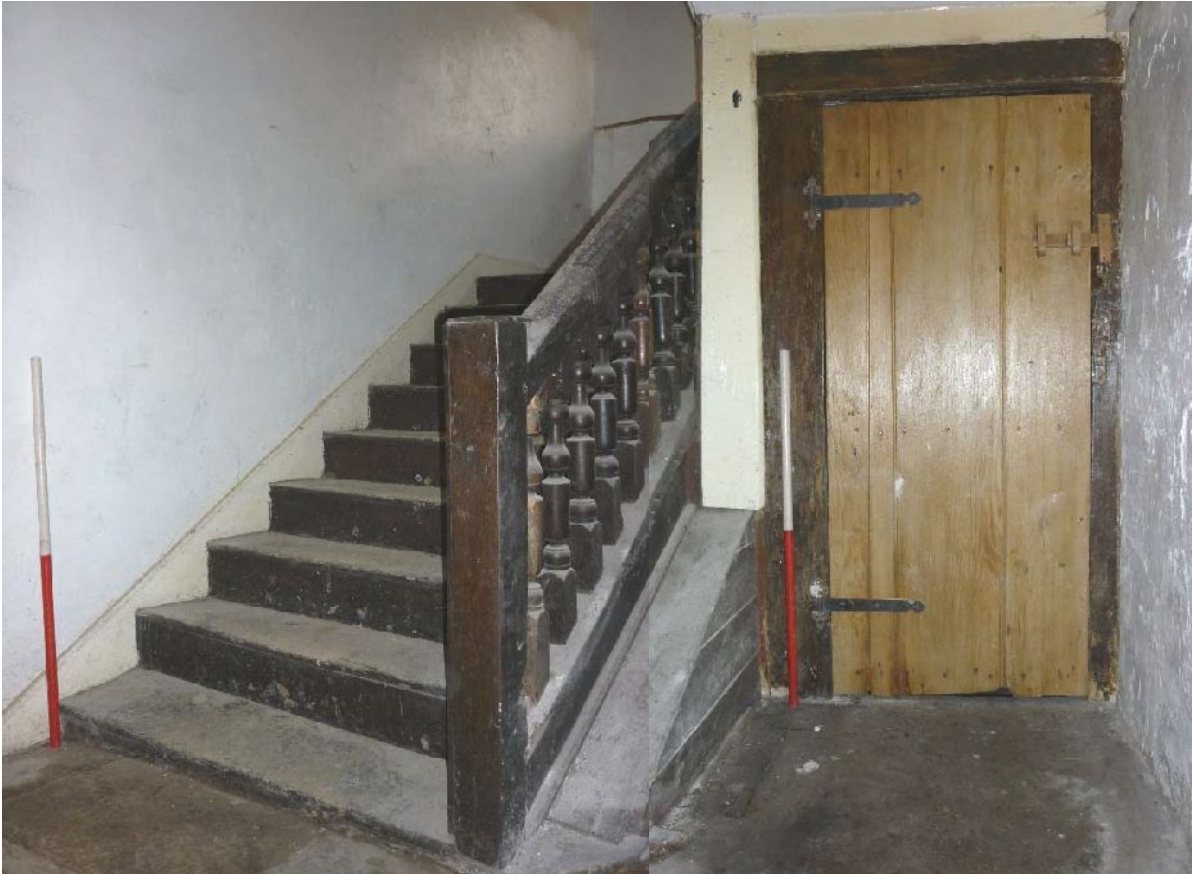
4.3.7 **Ground Floor – Room 5:** the hall and stairs were centrally located on the north side of the house. The hallway had a sandstone flag floor at ground level and was slightly raised relative to Ground Floor Room 3 to the east, where there was a timber threshold. The timber staircase had a half-hexagonal hand rail, turned balusters, and a newel post with a beaded fascia board on the west side, and was panelled on the east side (Plate 32). Above the landing on the north elevation there was a

three-part mullion window, with widely splayed jambs, each with six lights (Plate 33). There was a doorway on the lower level to the east of the stairs, which had a plain surround and housed a beaded plank and batten door, with modern “Gothic” strap hinges and possibly the original sliding timber lock (Plate 32). The east elevation was plain except for the beaded plank and batten door on the south side, which had an early latch and a plain surround that was pegged together. The south elevation had two doorways to the east and west of a dividing wall (Figure 9). The east doorway had a plain surround, the tongue and groove plank and batten door for which was loose in Ground Floor Room 5. This door had a later latch and hinges. The west door had a stop chamfered surround and pegged joints and was a beaded plank and batten type with a modern latch.

**Plate 32: Composite photograph of the stairs, viewed from the ground floor**

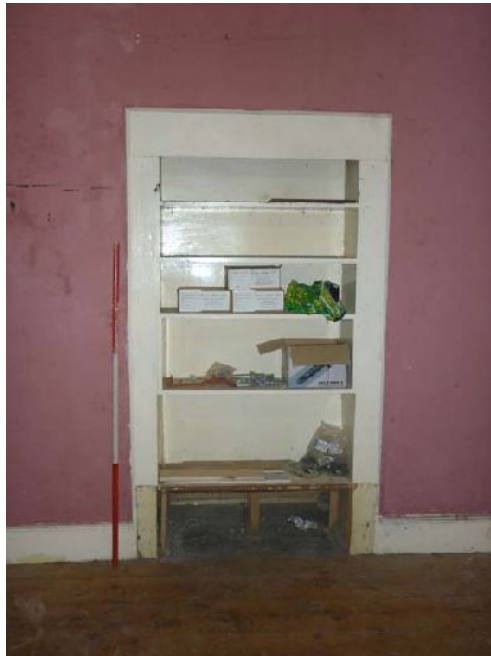
**4.3.8 Ground Floor – Room 6:** this room had modern floorboards and a plastered ceiling with one north/south beam, which was stop-chamfered at the north end and had a row of empty joist holes, conceivably for a stud partition wall, on the east side. The south end had two steel braces attached in the centre with bolts. The walls were all plastered and painted and there was beaded skirting throughout. The north elevation had a door on the west side with a rounded edge to the surround. There was a chimney breast central to the east elevation, which had the original dressed stone lintel with a flanged top with some inserted stone work below this and a raised tiled hearth on top of the possibly original stone or concrete hearth stone (Plate 34). The later stonework extended to the south to form a low shelf (Figure 7) with a slate top above which timber shelves were attached. The south elevation had two windows (Plate 35) which were the same as those in Ground Floor Room 4 (see *Section 4.3.6* above); these possibly had pegged joints and were ovolo-moulded. The west elevation was plain except for an alcove, which was filled with modern shelves, formed in a former doorway (Plate 36).

**Plate 36: Cupboards on the west elevation of Ground Floor Room 6**

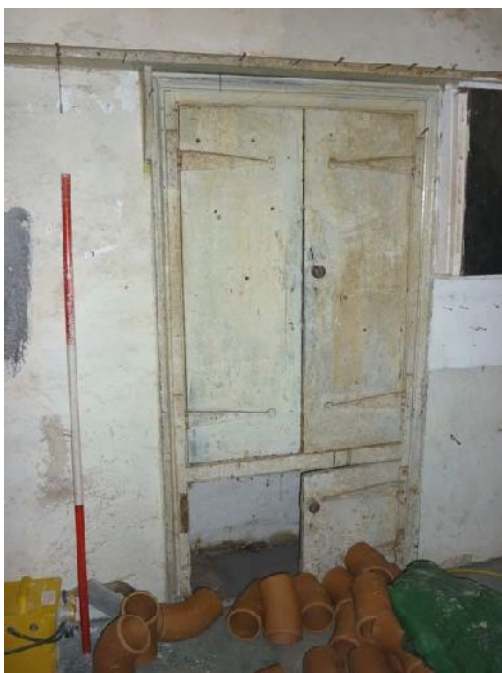
**Plate 39: Cupboard in the west elevation of Ground Floor Room 7**
