# YARD 143, STRICKLANDGATE, KENDAL, CUMBRIA

## Archaeological Building Recording

Client: Aquine Ltd  
Planning Ap. Refs.: SL/06/1324-5  
NGR: SD 5150 9309

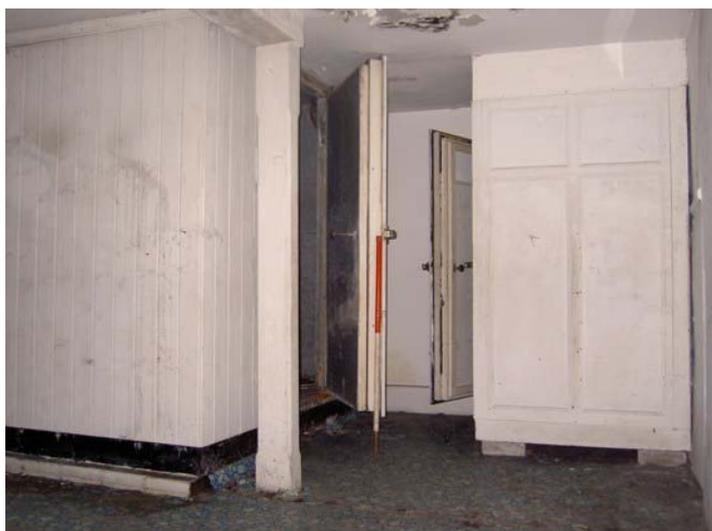
**Plate 20: Walk-in refrigerators, west room ground floor**

5.3.1 **West room, ground floor:** the walls were finished with plaster and painted white. There was a large fireplace in the west elevation just off-centre to the south which had been blocked. At some point a blue painted steel I-beam had been inserted to act as a lintel over the fireplace, it is possible that the fireplace once held a range that had been removed. In the north-west corner there was a large commercial fridge with the trade name Frostmaster, this measured 2.15m x 2.30m and was the height of the ceiling. In the north-east corner of the room there was another smaller commercial fridge manufactured by Frigidaire (Plate 20). The installation of this unit necessitated the removal of the ground floor staircase. The east elevation was a modern stud wall constructed of timber and hardboard with a sliding door at the south end that gave access to the east room. In the centre of the modern partition there were two large windows allowing more light to enter the west room from the lighter eastern room. The south elevation had an inserted doorway at the west end which held a white painted timber four panel door (Plate 21). The east jamb of the doorway appeared to have been completely re-built. To the east of the doorway there was a window which was built into a floor to ceiling recess in the wall and appeared to be in its original location. The ceiling was lath and white painted plaster and had a beam running south to north off centre to the west. This beam terminated 2m from the north wall, having been truncated to allow the door of the Frostmaster to open. The beam end was supported by a white painted rectangular timber column with chamfered edges. The floor was concrete with a linoleum covering.

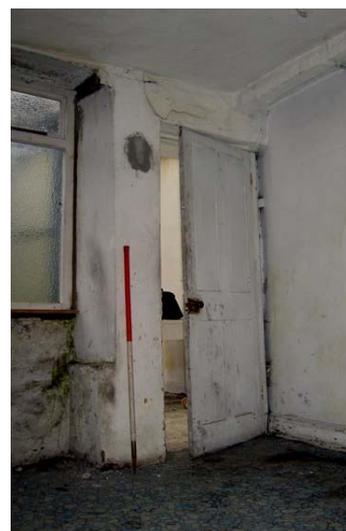
**Plate 21: West door, access via conservatory**

5.2.3 **South elevation, lower:** there were two doorways and three windows on the ground floor (Plate 18 and Plate 19). The doorway at the west end could only be accessed via the conservatory and would appear to have been inserted. The window just to the east of the conservatory had a blue painted timber window frame which held two fixed frosted lights arranged side by side below a shallow top hung ventilator. The casement stays and frosted glass suggested a 20<sup>th</sup> century date, and cement pointing around the window also indicated it was a replacement although probably in an original location. The sill was yellow sandstone and possibly original too. The doorway to the east of the window was probably the original entrance to the west cottage; this was just to the west of the downpipe that roughly demarked the original junction of the two cottages. The blue painted door was panelled and held a large frosted upper light; cement render on the door lintel obscured its fabric. The window just east of the downpipe had a modern blue painted frame with a large fixed frosted light below a shallow upper top hung ventilator again with a single frosted light. The sill and lintel were timber although once again the lintel had been rendered. This window had partly filled a blocked doorway which was the original entrance to the eastern cottage. The original window for this cottage, at the west end of this elevation, held a modern blue painted sliding sash window with four frosted lights. This window had a timber sill and a rendered lintel.

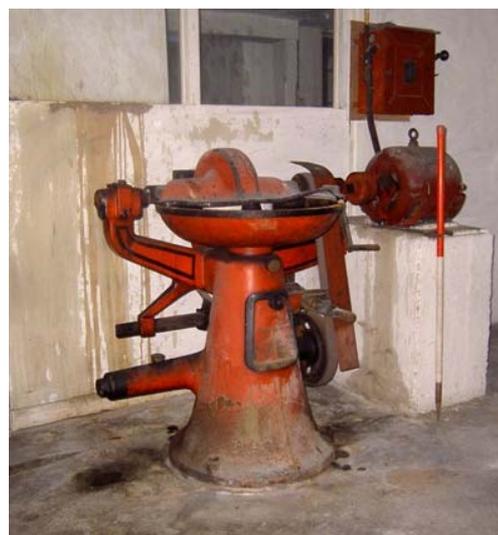
Plate 23: Mixing machine and electric motor

5.3.5 The floor itself was made of concrete and the deliberate and obvious slope would suggest an industrial function for the room presumably contemporary with the commencement of the pie manufacturing. Further evidence of pie making, or other meat processing, was suggested by a large industrial mixer which was located against the partition wall between the east and west rooms (Plate 23). The machine was manufactured by the Barwin Engineering Company of Wilmslow and was powered by an electric motor manufactured by the Electric Motor Construction Co Ltd; the motor was connected to a 400v switch box which was fixed to the partition wall.

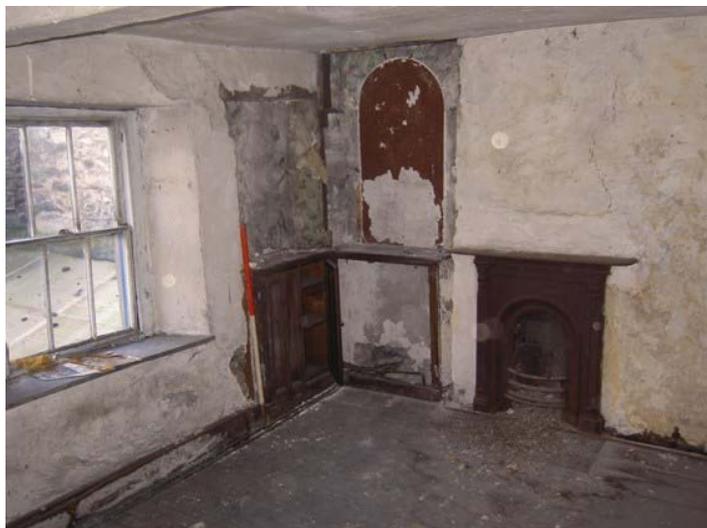
**Plate 24: South-west corner of south-west room, first floor**

5.4.2 **First floor, south-west room:** the north and east elevations were stud walls, constructed from lath and whitewashed plaster and appeared original. There was a doorway in the east end of the north elevation to allow access to the room from the staircase landing. There was a sliding sash window in the south elevation that had a timber board sill and splayed jambs, and while the window was a replacement the location was original. In the south-west corner of the room the wall was recessed to allow for fitted cupboards or cabinets and what appeared to be the outline of a mirror. It seemed likely that the part of the recess on the west elevation may have been an

original feature, while the part on the southern elevation had been formed by the partial blocking of an original doorway. In the centre of the west elevation there was a cast iron fireplace (Plate 24). The floor of the room was laid with softwood machine cut planks approximately 0.2m in width. On the south and east elevations there was 0.1m high beaded skirting boards. The ceiling was lath and plaster and either white-painted or whitewashed.

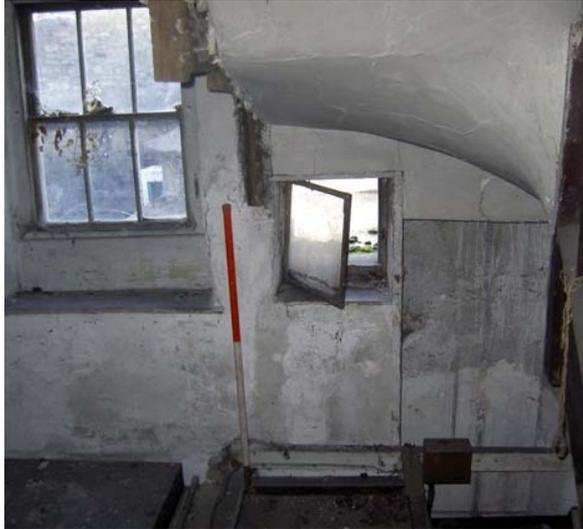
**Plate 25: Windows in north elevation, north-west room**

**5.4.3 First floor, north-west room** the elevations were all plastered and whitewashed. The north elevation had a window towards the west end that appeared to be in an original location; this was one of the six-light sliding sash windows (Plate 25). The jambs were splayed and there was a timber sill that was 0.20m lower than the external sill. Adjacent to the east side of this window there was a small square window with a rudimentary timber frame and a single perspex pane. There was a further window just to the east which was boarded over and would have been the stairlight. It would appear that the stairlight was blocked by the addition of newer buildings to the north, between 1833 and 1859 (see Plate 2 to Plate 4); the small window is its replacement at a higher level (Plate 25). This replacement stairlight must pre-date the removal of the stairs for the refrigeration units on the ground floor, and associated stud wall partition that enclosed the stair landing on this floor (see Fig 4). The floor had been completely removed from the west half of the room to allow space for the top of the large refrigerators on the ground floor (Plate 26). The tops of the refrigerators were effectively the floor surface on top of which sat the electric motors that powered them; the motor for the larger Frostmaster fridge was labelled 'Prestcold Refrigeration'. Once again the ceiling was plastered laths and was considerably bowed in the centre.

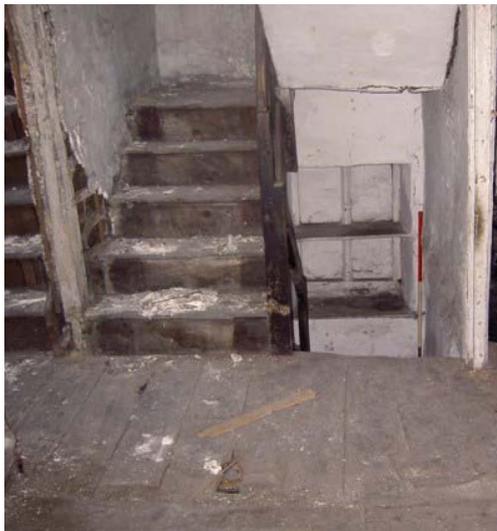
**Plate 27: First floor east staircase and blocked stairlight**

5.4.1 **Introduction:** the original form of this floor consisted of two rooms for the west cottage, the south-west room being the main living room. Both rooms were accessed from the stairway landing from which they were partitioned off (Plate 27). The east cottage had one large living room on this floor which was accessed directly from the top of the stairs.

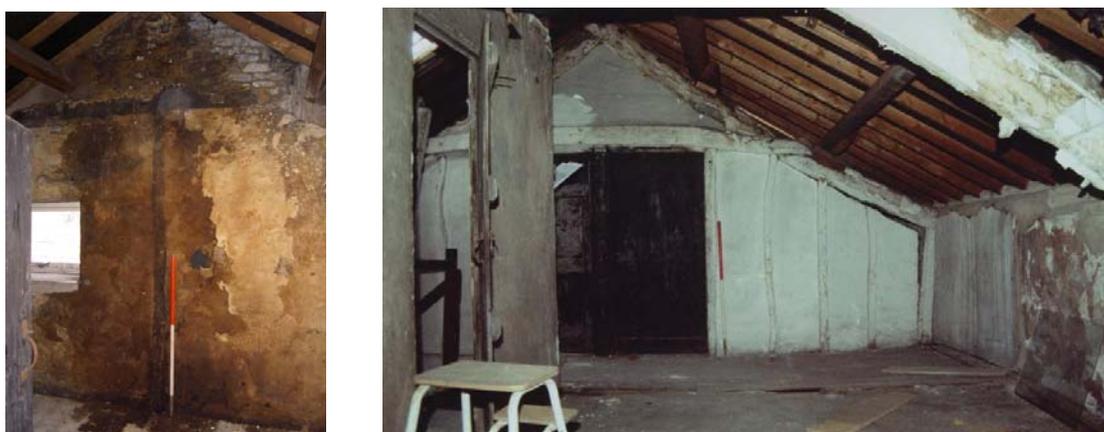
**Plate 29: Partition and ceiling scars, second floor east rooms**

**Plate 30: Roof truss and collar with partition wall and exposed staves. Partition scar on floor for east elevation of second floor north-west room**
