ELLEL HOUSE, CHAPEL LANE, GALGATE, LANCASHIRE

Archaeological Building Recording

Client: Ellel Healthcare Ltd
NGR: 348555 455805

© Greenlane Archaeology Ltd
July 2008

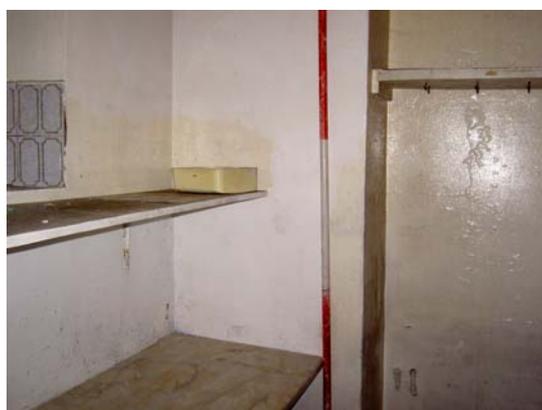
Plate 37: (right) Larder G4b looking west

4.4.10 **Room G4b:** this room was accessed from Room G4a and appeared to have been a larder attached to the main food preparation area. All elevations were plastered and had been painted white. The north-east, north-west, and south-east elevations were modern stud walls with a modern door and surround in the south-east elevation. The south-west elevation was the external wall that housed an early timber four-light window and fitted timber shelves (Plate 37). The ceiling was plastered and the floor was laid with quarry tiles.

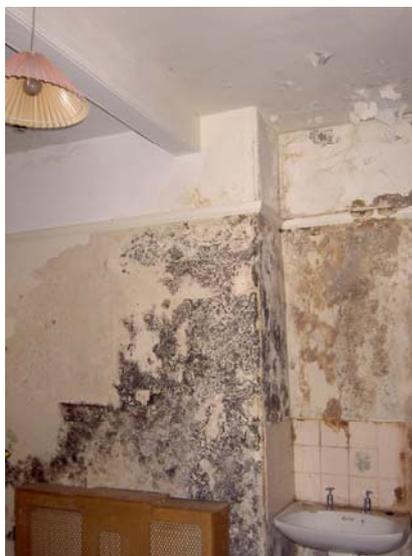
4.4.11 **Room G5a:** this room formed part of the southern half of the main wing and may have originally been the reception/living room for the servants of the household; the documentary sources show that there was originally no access between the two halves of the main wing although the room was most recently accessed from the rear corridor (G6). All elevations were wallpapered between the moulded and white painted skirting boards and picture rails, above which they were painted white in keeping with the plastered ceiling. The north-east elevation had been divided near the south-east end where a partition wall had been inserted to form corridor G6. The partition wall forming the south-east elevation had a doorway at its south-west end and made use of the original north-east/south-west beam line. The south-west elevation featured a central chimney breast in front of which a modern radiator with a perforated timber cover had been positioned suggesting that the original fireplace had been blocked. To the north-west of this chimney breast there was a small

Plate 38: (left) Chimneybreast in south-west elevation of Room G5a

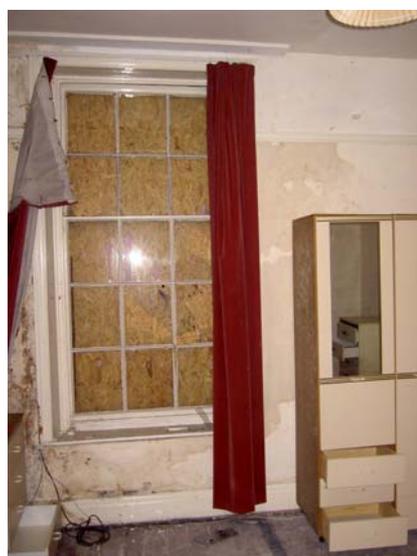
modern hand basin (Plate 38). The north-west elevation was the external wall with a tall 15-light timber sash window (Plate 39) to which a modern curtain rail and curtains had been added. There was no sign of the blocked door to the north-east of this window evident externally, which would have been the main access point for this part of the wing before the creation of corridor (G6) leading from the north half of the main wing. Two beams were visible in the ceiling which both had decorative beaded edging (Plate 40), and the floor was covered with modern carpet.

Plate 39: (right) Window in north-west elevation G5a immediately left of the blocked doorway evident on the exterior elevation

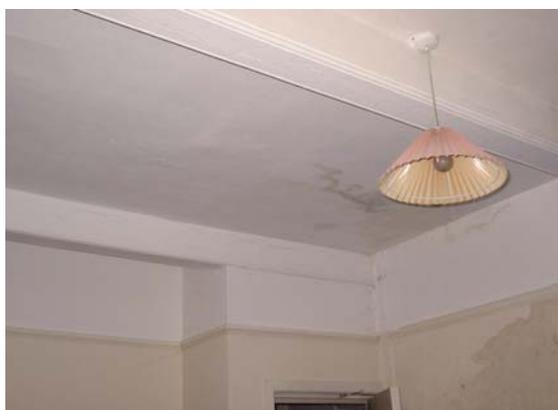
Plate 40: (left) Beams in ceiling of Room G5a

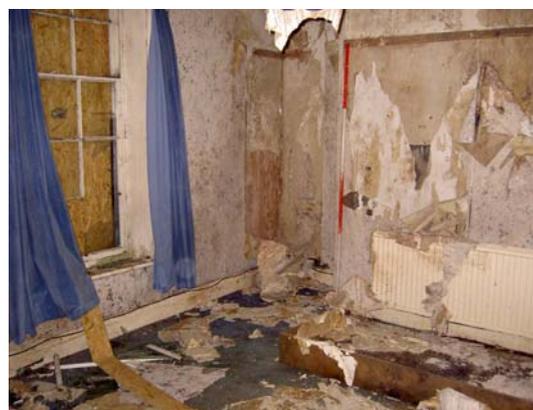
Plate 41: (right) Chimneybreast in north-east elevation of Room G5b

4.4.12 **Room G5b:** this room was probably the second living/reception room for the servants' part of the main wing. All the walls had woodchip wallpaper, skirting boards, and there were scars from a removed picture rail. There was a large chimney breast on the north-east elevation that corresponded with that in room G5a (Plate 41), and a modern radiator was fixed to the wall where the fireplace would have been. The south-east elevation was formed by a partition wall that originally separated this room from the stairway/hall which became now corridor G7. The south-west elevation was the external wall and had a small stud wall cubicle at the north-west end housing a toilet and hand basin. The interior of this cubicle was wallpapered and the floor was tiled. The north-west elevation had a window of the same design as that in room G5a. The ceiling was plastered and the floor carpeted.

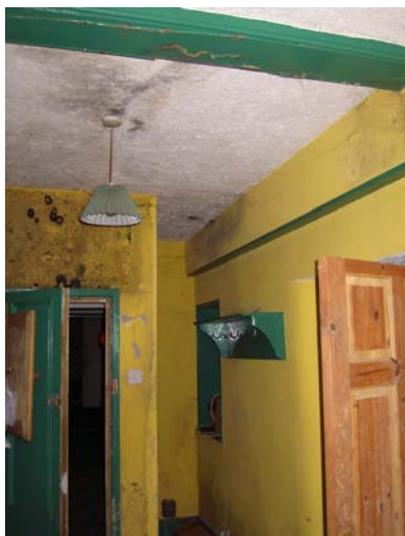
4.4.14 **Room G7:** the walls were plastered and painted yellow, and the beaded skirting boards, door frames, and other timbers were finished with green paint (Plate 42) The north-east end had a small partition that separated this space from G6 and the doorway into room G5b, which seemed to be a recent alteration and related to the change in function of this room into a kitchen. The south-east elevation was an external wall that had a central doorway to the kitchen extension, Room G8. This doorway, which had chamfered jambs, had a modern varnished six-panel timber door and surround and was a later addition. At the south-west end of the wall was the earlier or original doorway which had a chamfered jamb at the north-east and had been partially blocked with plasterboard creating a recess. At the north-east end of this elevation there was a small single-light window. The south-west elevation was an external wall and housed a doorway that led to porch G10, the door was painted green and held two frosted glass lights. The room had parquet flooring and the ceiling was finished in artex. A timber beam with rounded corners ran north-west/south-east from Room G5b.

Plate 42: (left) North-east elevation of Room G7

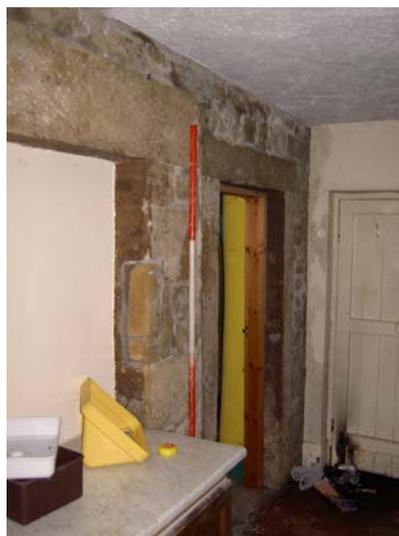
Plate 43: (right) North-west elevation of Room G8

4.4.15 **Room G8:** this room was an extension to the rear of the main wing. The walls were plastered and painted except for the north-west elevation that was plain stonework (Plate 43). The north-east elevation had a wide external doorway with a white-painted timber batten door and plain frame, this door led to the later porch (G9). There were sinks along the south-east elevation which were set below a window in the brick built wall which was otherwise plain. The south-west elevation had a doorway to the vestibule of the stable block extension (G12), which was formed from two square stone columns supporting a stone lintel. The north-west elevation contained two doorways. Both doorways are probably original and have substantial stone lintels and surrounds. The ceiling of the room was finished with

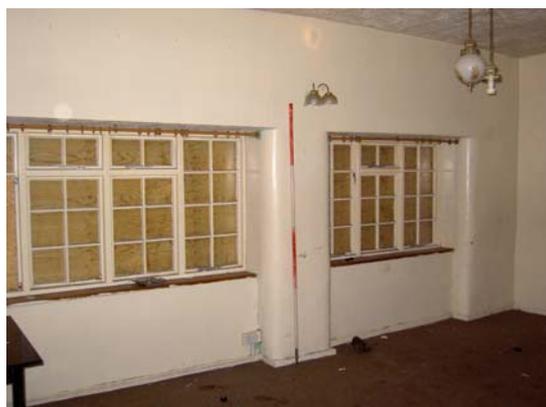
Plate 44: (left) Windows in south-east elevation of Room G11

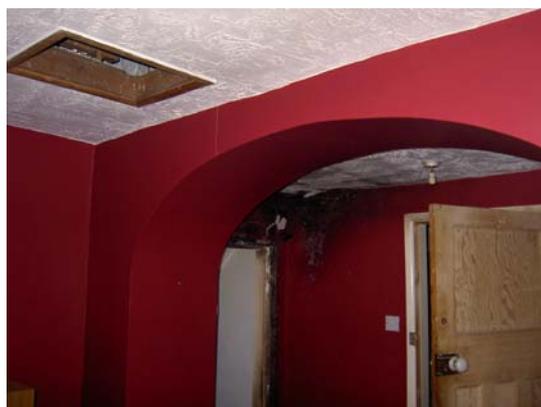
Plate 45: (right) Wide arched doorway in north-west elevation, Room G11

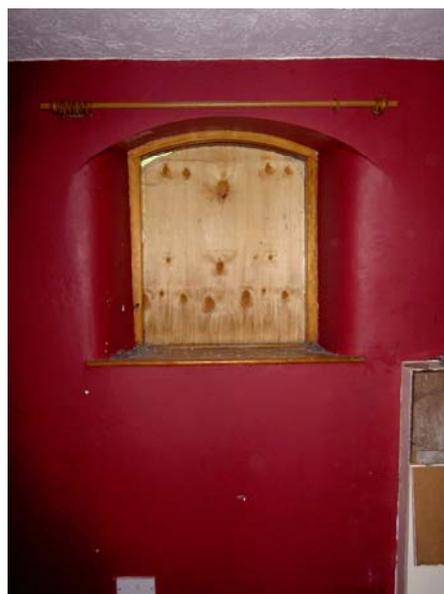
Plate 47: (right) Probable converted doorway in the north-west elevation of Room G12

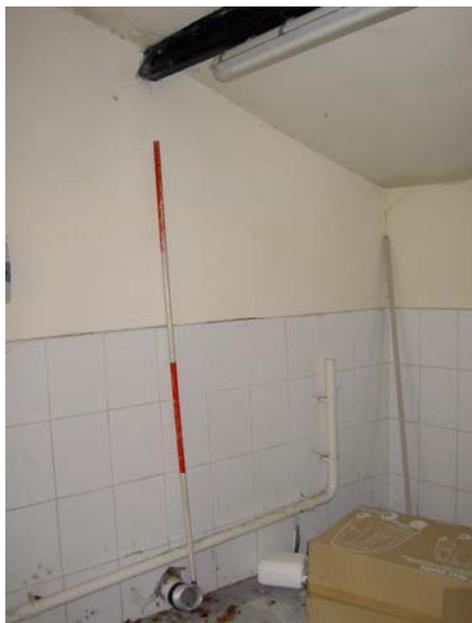
4.4.20 **Outbuilding G13:** this single room building was the former washhouse and had retained the function of utility room when recorded; containing a washing machine. The interior elevations were tiled to a height of approximately 1.5m with the remainder being plastered (Plate 48). The south-east elevation had worktops attached and the north-west elevation had a central window and door to the south. The roof sloped and the single central north-east/south-west beam was exposed. The floor was concrete and the adjacent brick built outshut housed a toilet.

Plate 48: Internal detail, outbuilding G13

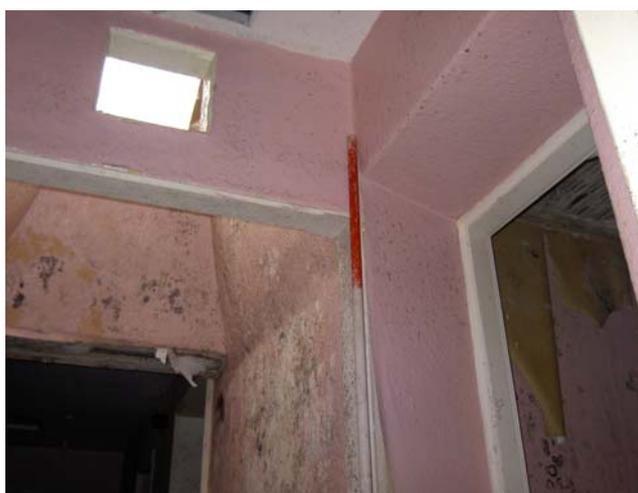
Plate 50: Skylight in passage F5 from the north-east showing doorway to F9

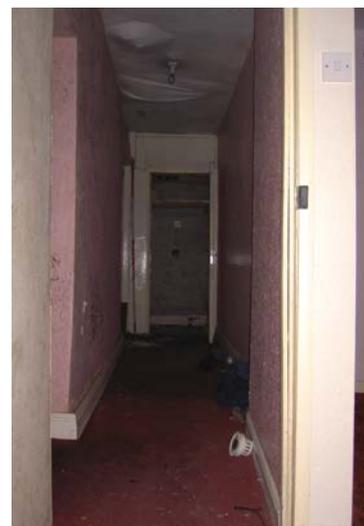
4.5.8 **Corridor F6c:** this comprised a long corridor running north-west/south-east, which had been made necessary by the more recent partitioning off that had occurred as the larger rooms were divided to create individual bedsits within the building (Plate 52). All the elevations were finished with woodchip wallpaper and had a modern beaded skirting board. The passage was created by partitions around the north-east side of the existing north-east stone central dividing wall. The south-east elevation was taken up by the modern door and surround allowing access to F6b. The stone south-west elevation has had two doors inserted to access the rooms on its south side, F8a and b, both these doors are unsurprisingly modern. At the north-west end of this passage there was an airing cupboard that filled the end. This had timber shelving and pipes for a hot water boiler. The ceiling of the corridor was plastered and had been finished with woodchip wallpaper, while the floor was carpeted.

Plate 52: (right) Corridor F6c from the south-east

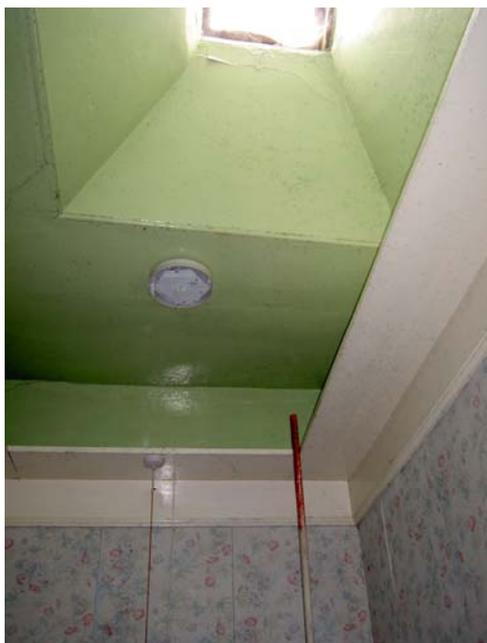
Plate 53: (left) Skylight in the bathroom of Room F9

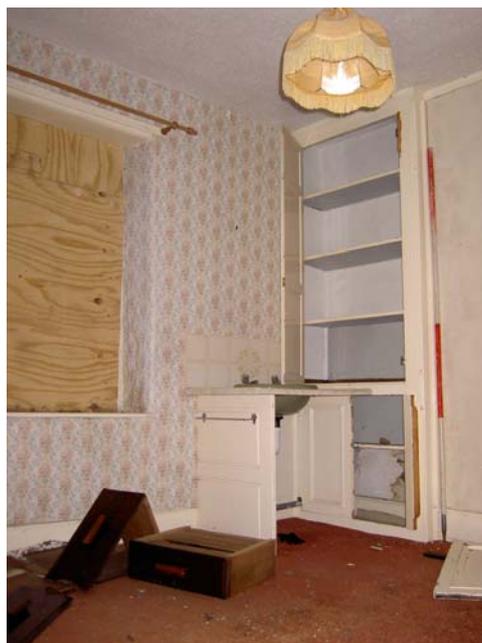
Plate 54: (right) Built-in cupboard in corner of Room F9

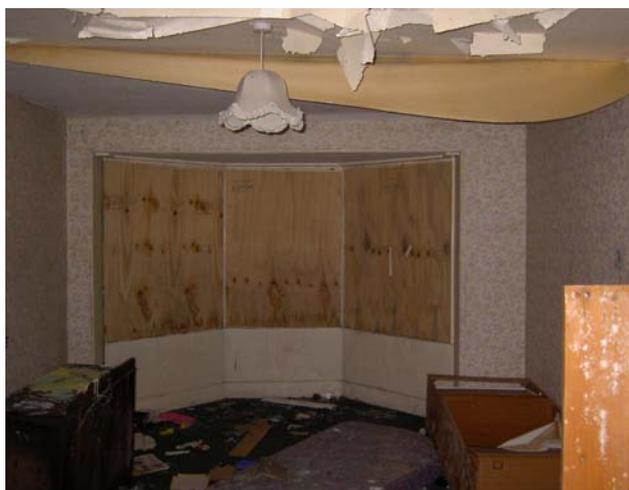
Plate 55: (left) North-west elevation of Room F10

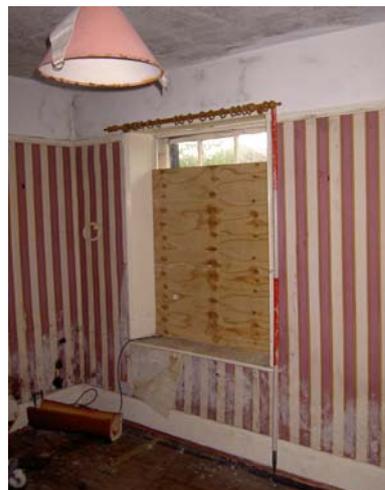
Plate 56: (right) North-west elevation of Room F11a

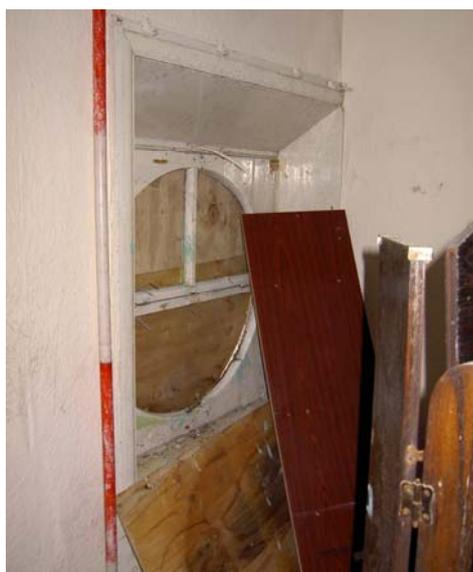
Plate 57: (left) Oculus, hallway F11b

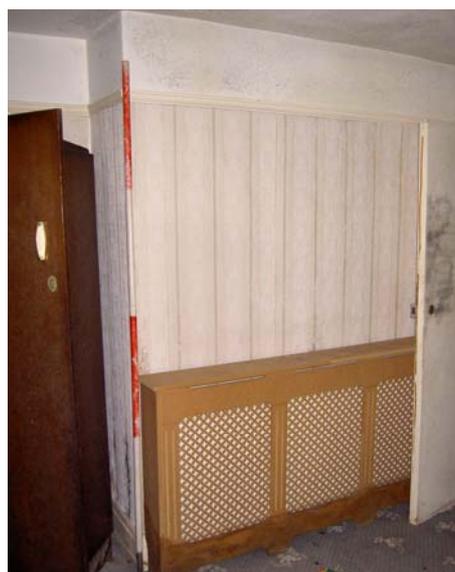
Plate 58: (right) Chimneybreast, Room F12a

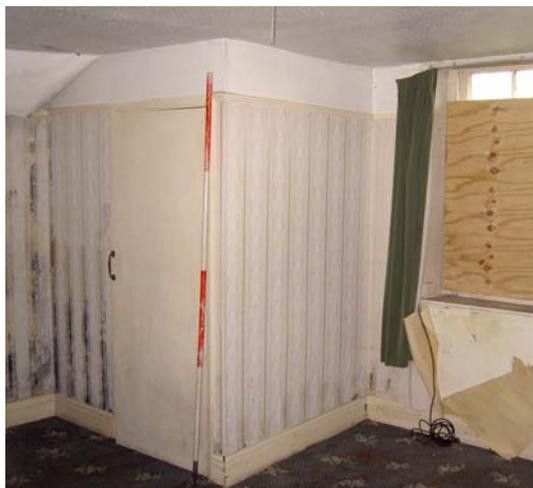
walls, containing a toilet and hand basin (Plate 59). The door to this cubicle was modern and the interior had been wallpapered, had a picture rail and skirting boards, and the floor was carpeted.

Plate 59: (left) Cubicle in south-west corner of Room F12a

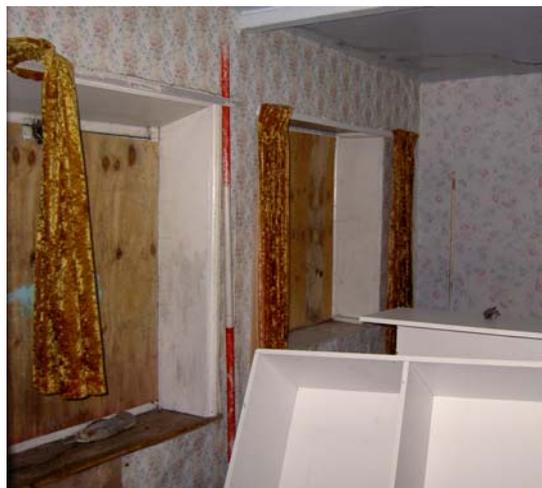
Plate 60: (right) Room F12b, windows in south-east elevation

4.5.17 Room F12b: the south-east elevation was the rear exterior wall of the main wing and had two windows, the oculus to the north-east matched the one in Hallway F11b (*Section 4.5.15*), and there was a more conventional square window to the south-east (Plate 60). The south-west and north-west elevations were plain and papered with modern plain skirting, the floor was carpeted. The ceiling was plasterboard and there was a beam running north-west/south-east.

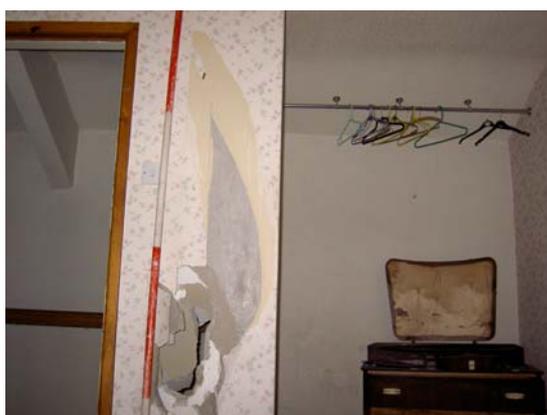
4.5.18 Rooms F13: this room had a recent partition to create two living quarters on the first floor of the stable block. The partition round the stairway also appeared to be modern (Plate 61), suggesting that this block had been heavily altered in recent times. The flooring of the south-western room was modern boarding indicating that this floor might have altered along with the addition of the stairs. The two windows in the south-east elevation had modern casements with top hung ventilators (Plate 62). A single central truss was visible over the stairway and the central partition.

Plate 61: (left) Landing partition, north-west of Room F13 looking north-west

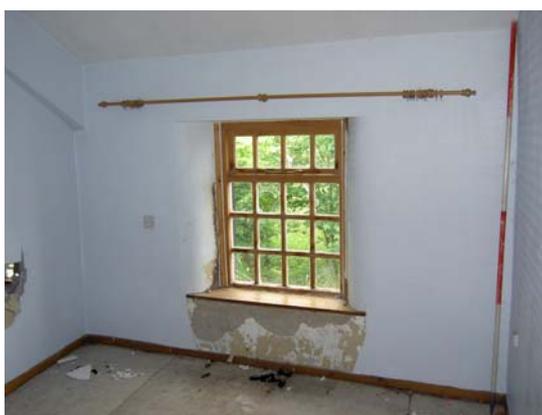
Plate 62: (right) Room F13, south-west window and inserted partition

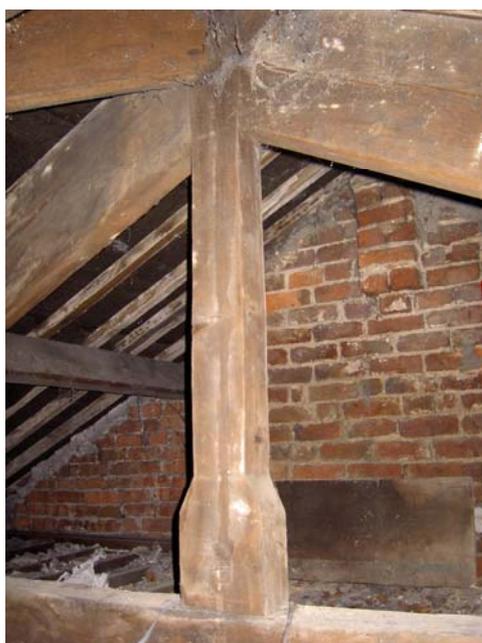
4.6.2 Roof space over main wing: only the space above Room F12b was accessible within the main wing, this enabled the recording of the building's south-western truss (Plate 63) and elements of the walls. The truss was a basic king-post type, splayed at the top to meet the principal rafters and at the base as if to house angled braces, although there were no evident signs of these having existed. Carpenters' marks in the form of chiselled Roman numerals were present: II at the junction between the king post and the tie beam and III at the junction between the principal rafter and the tie beam on the south-east side. There was a single purlin per pitch, and all of the timber was apparently sawn. Only the north-east and south-west elevations were visible; the south-west being plain masonry (Plate 64) with thick mortar and the north-east being filled by a chimney stack built of hand-made mid reddish orange bricks (Plate 63).

Plate 63: (left) King-post truss above Room F12b showing brick chimney stack to north-east

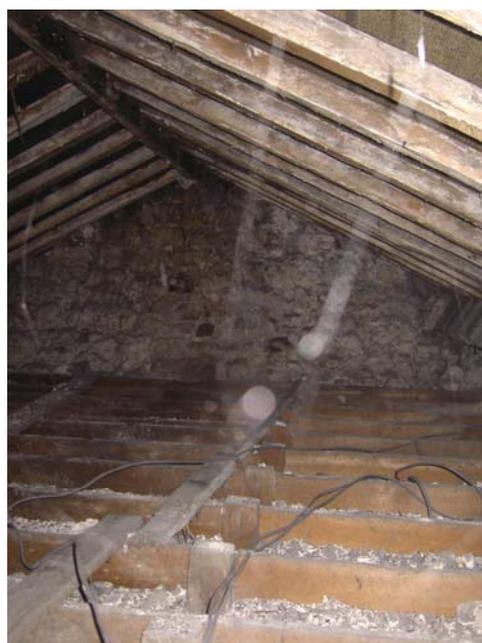
Plate 64: (right) General view of the south-west end of roof space over Room F12b

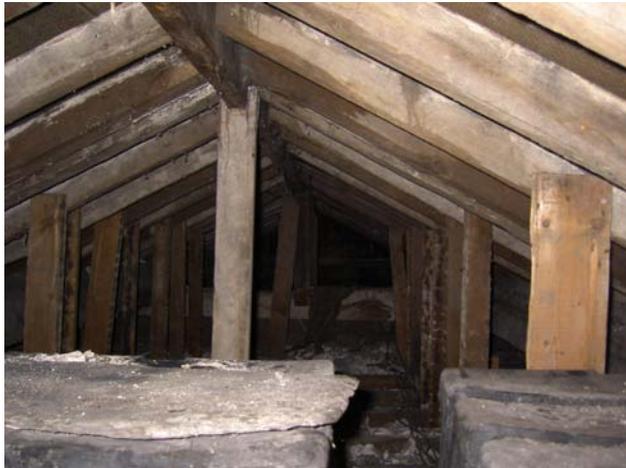
4.6.3 Roof space over south-east wing: only the space above the north-east half of this wing was accessible. The roof structure was very basic, comprising only a simple post, effectively a king post, beneath the ridge purlin and additional smaller vertical posts, one on each side (Plate 65). There was a single purlin per pitch, but the roof had apparently been raised slightly in height and extra purlins bolted to the originals as a result. The south-east elevation was plain masonry, apart from a stone corbel projecting from it supporting the ridge purlin. The north-west elevation had a small aperture connecting to the roof space of the main wing with a timber lintel, although this could not be accessed as it was blocked by a recessed skylight beyond

Plate 65: (left) General view of roof space above the south-east wing

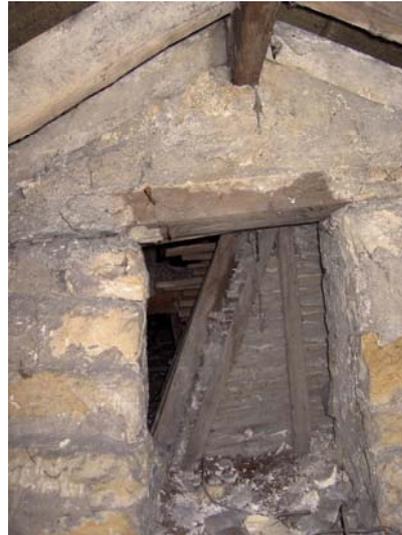
(Plate 66). Again the timber was evidently sawn and there were Baltic timber marks in the form of simple scored lines across one of the purlins.

Plate 66 (right) Opening connecting the south-east wing to the main part of the house in the north-west elevation
