PIEL VIEW FARM, BIGGAR VILLAGE, WALNEY, BARROW-IN-FURNESS, CUMBRIA

Archaeological Building Recording

Client: Storey Sharp
Construction

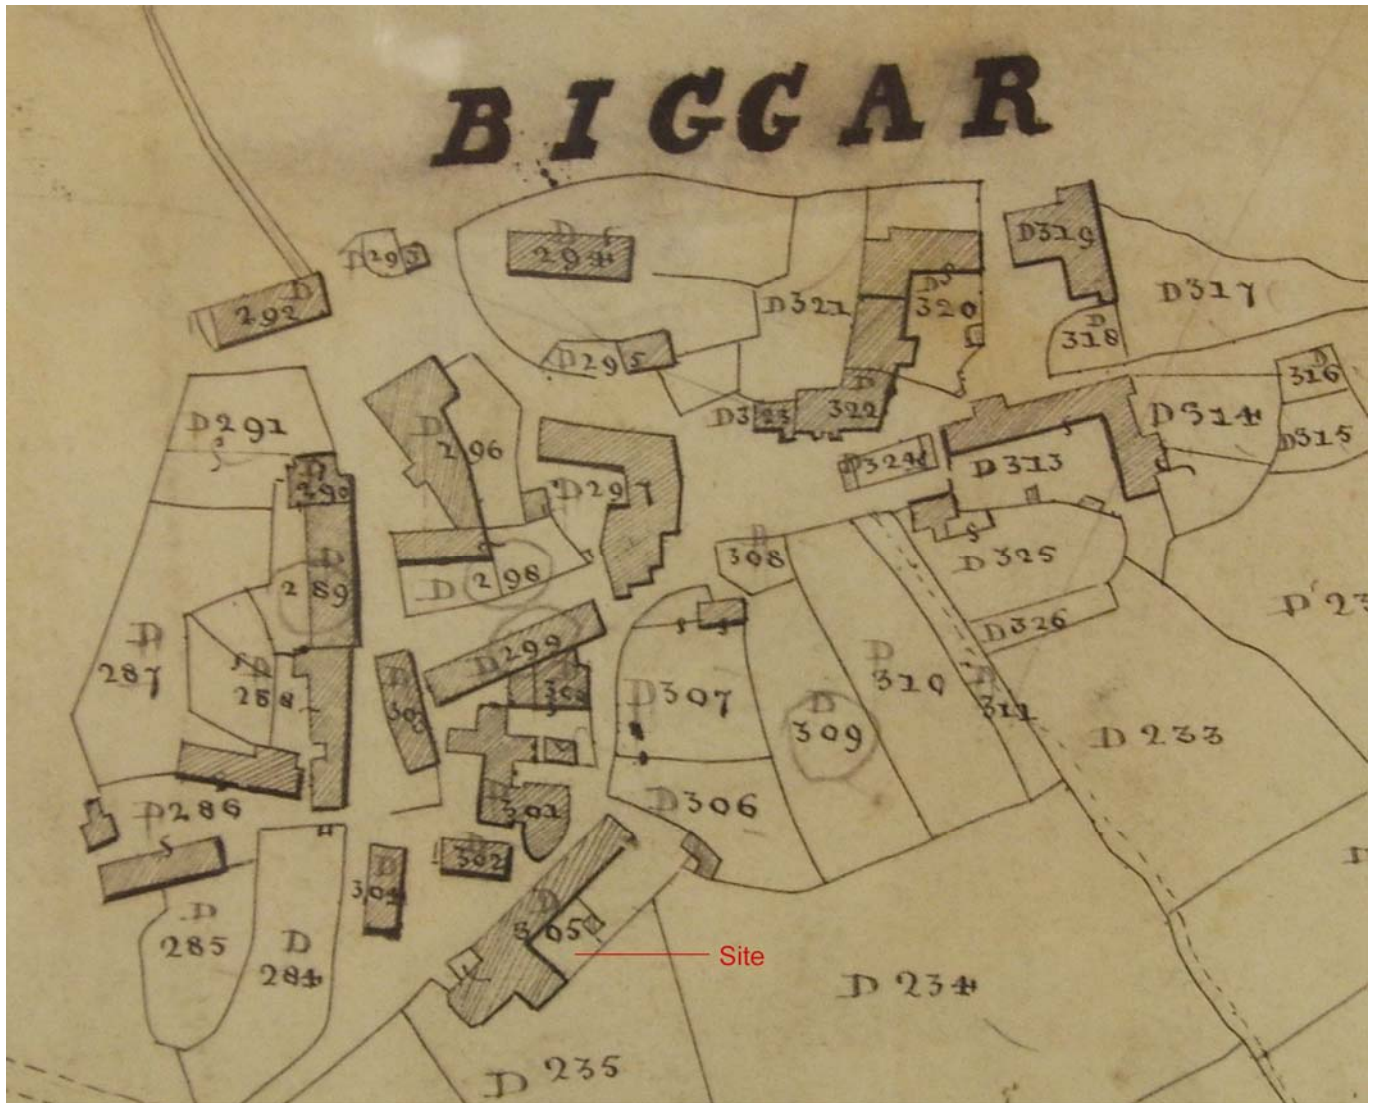
Plate 1: Extract from the Tithe map of 1843. The site is D305 at the south end of the village

3.3.3 **Tithe map 1843:** this map clearly depicts the barn (Plate 1), which appears to have a horse gin on the south-west end (CRO(B) BPR 1/I/3/2 1843). The internal divisions are not shown and it is unclear if there is an associated farmhouse at this time. The schedule lists the property rather unhelpfully as 'homesteads'.

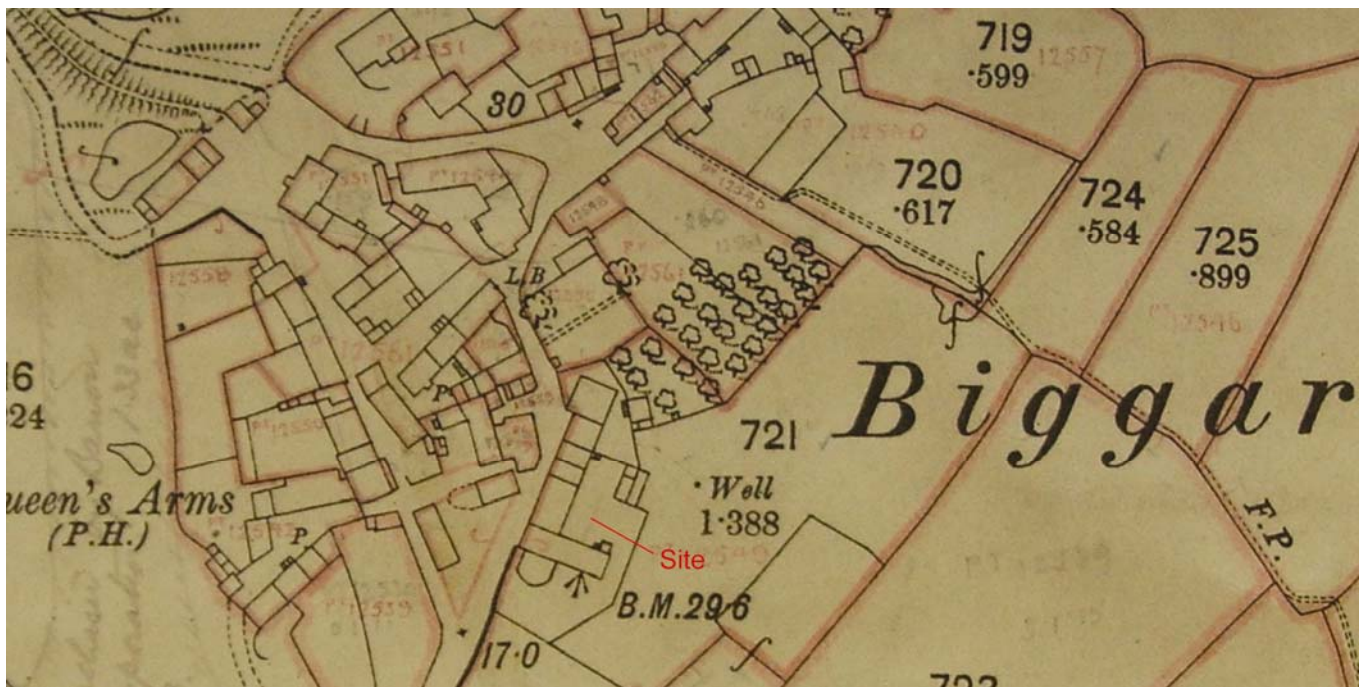
Plate 2: Extract from the Ordnance Survey map of 1891

3.3.5 **Ordnance Survey 1891**: this map, the first edition 1:2,500 scale, shows the buildings very clearly, and it is evident that the farmhouse has definitely been added at the north-east end of the range (Plate 2). Another small building has also appeared at the end of Building 3; this building was absent at the time of the building recording.

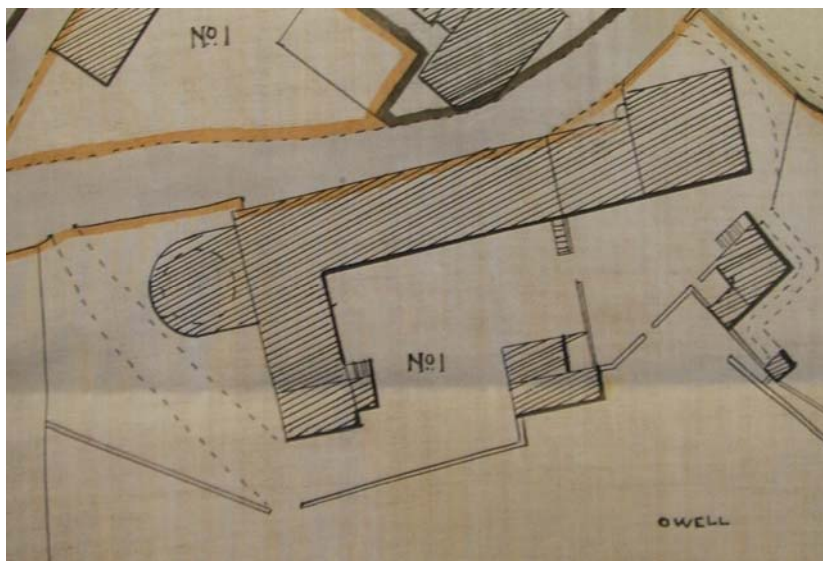
Plate 3: Extract from a Plan of Biggar village of 1893

3.3.6 **Village plan, 1893:** this plan (CRO(B) BD BUC 43/4/8 1893) shows the whole farm in good detail (Plate 3); it is evident from the external steps that the main barn probably has haylofts, and possibly a granary. The gin ring is also clearly depicted as well as various outbuildings.

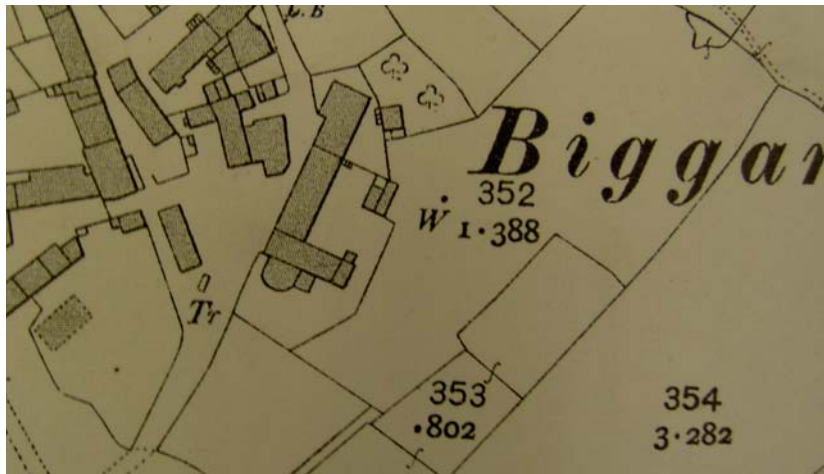
Plate 4: Extract from the Ordnance Survey map of 1913

3.3.7 **Ordnance Survey 1913:** this map shows that the shippon (Building 2) has yet to be built (Plate 4); however, a small addition is shown to the east of the horse gin (Building 4). The steps that access Building 3 also appear to have been removed by this date.

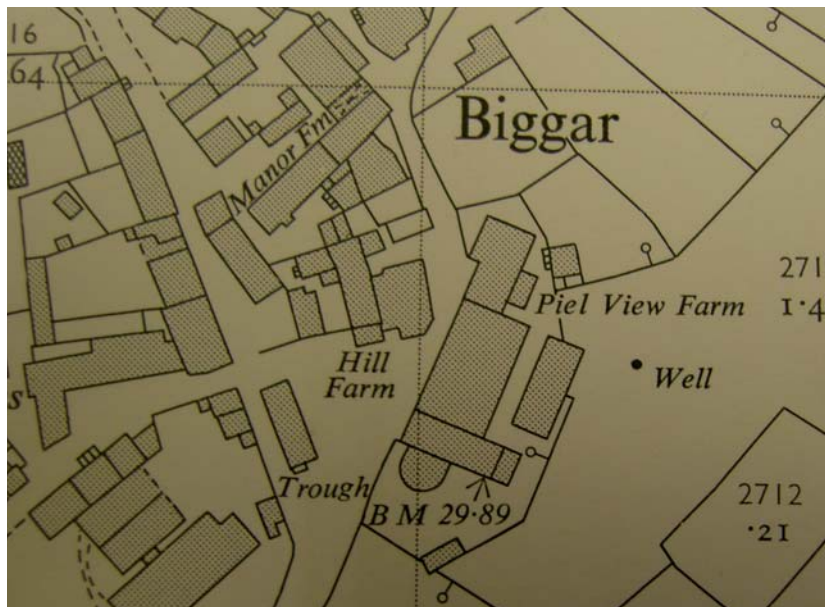
Plate 5: Extract from the Ordnance Survey map of 1959

3.3.8 **Ordnance Survey 1959:** this is the first map available that shows the new shippon (Building 2), although no internal divisions are shown. The shippon (Building 2) was probably added quite a lot earlier than this; it was unfortunate that no Ordnance Survey map from the 1930s was available. This map also illustrates that the horse gin was still rounded at this time, and that the building to the east of Building 3 was still standing (Plate 5).

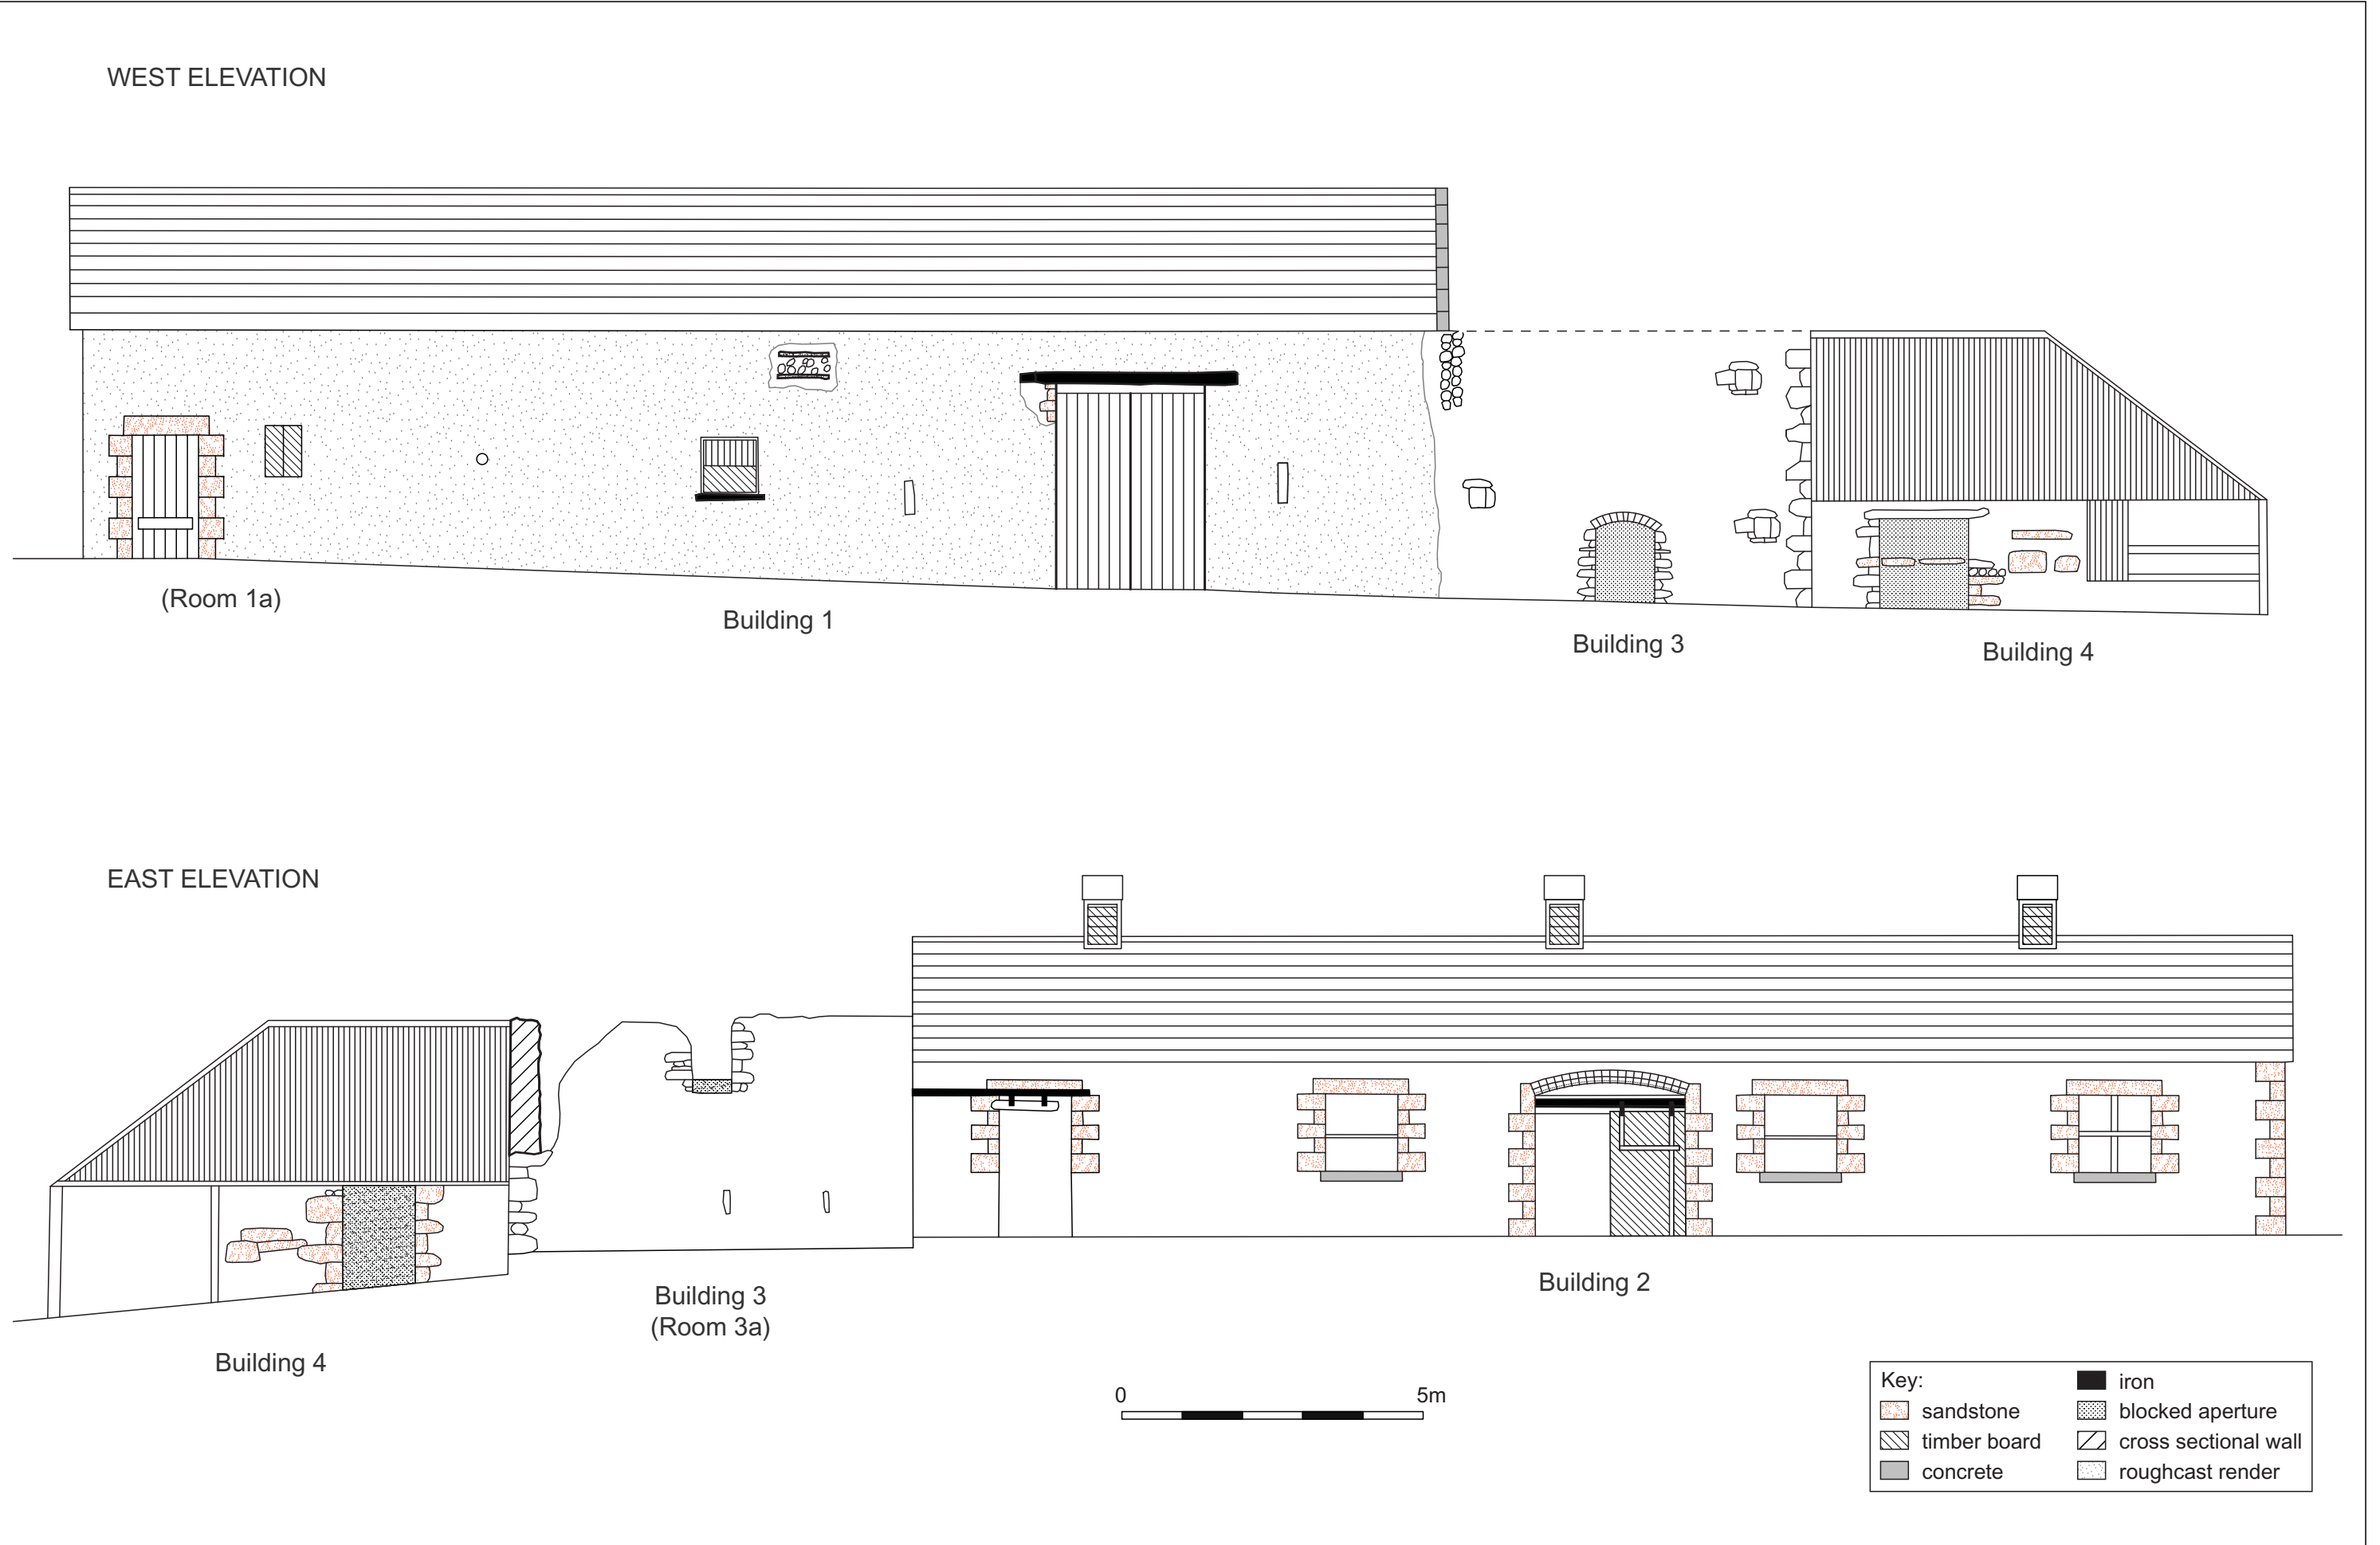
Figure 2: East and west external elevations

4.2.2 **West elevation:** this elevation begins with Room 1a, at the north end of Building 1, which sits between the current farmhouse, to the north, and the range of farm buildings to the south; the change in roof height indicated this junction which was obscured by external render (Figure 2). The two features that pertain to Room 1a are a doorway and a small window at the north end of the elevation (Plate 6). The doorway, which had been left un-rendered, had even-sized, roughly-dressed, red-sandstone quoins and lintel. The jambs and sill of the window were entirely rendered and the aperture had been boarded up within a rudimentary timber frame.

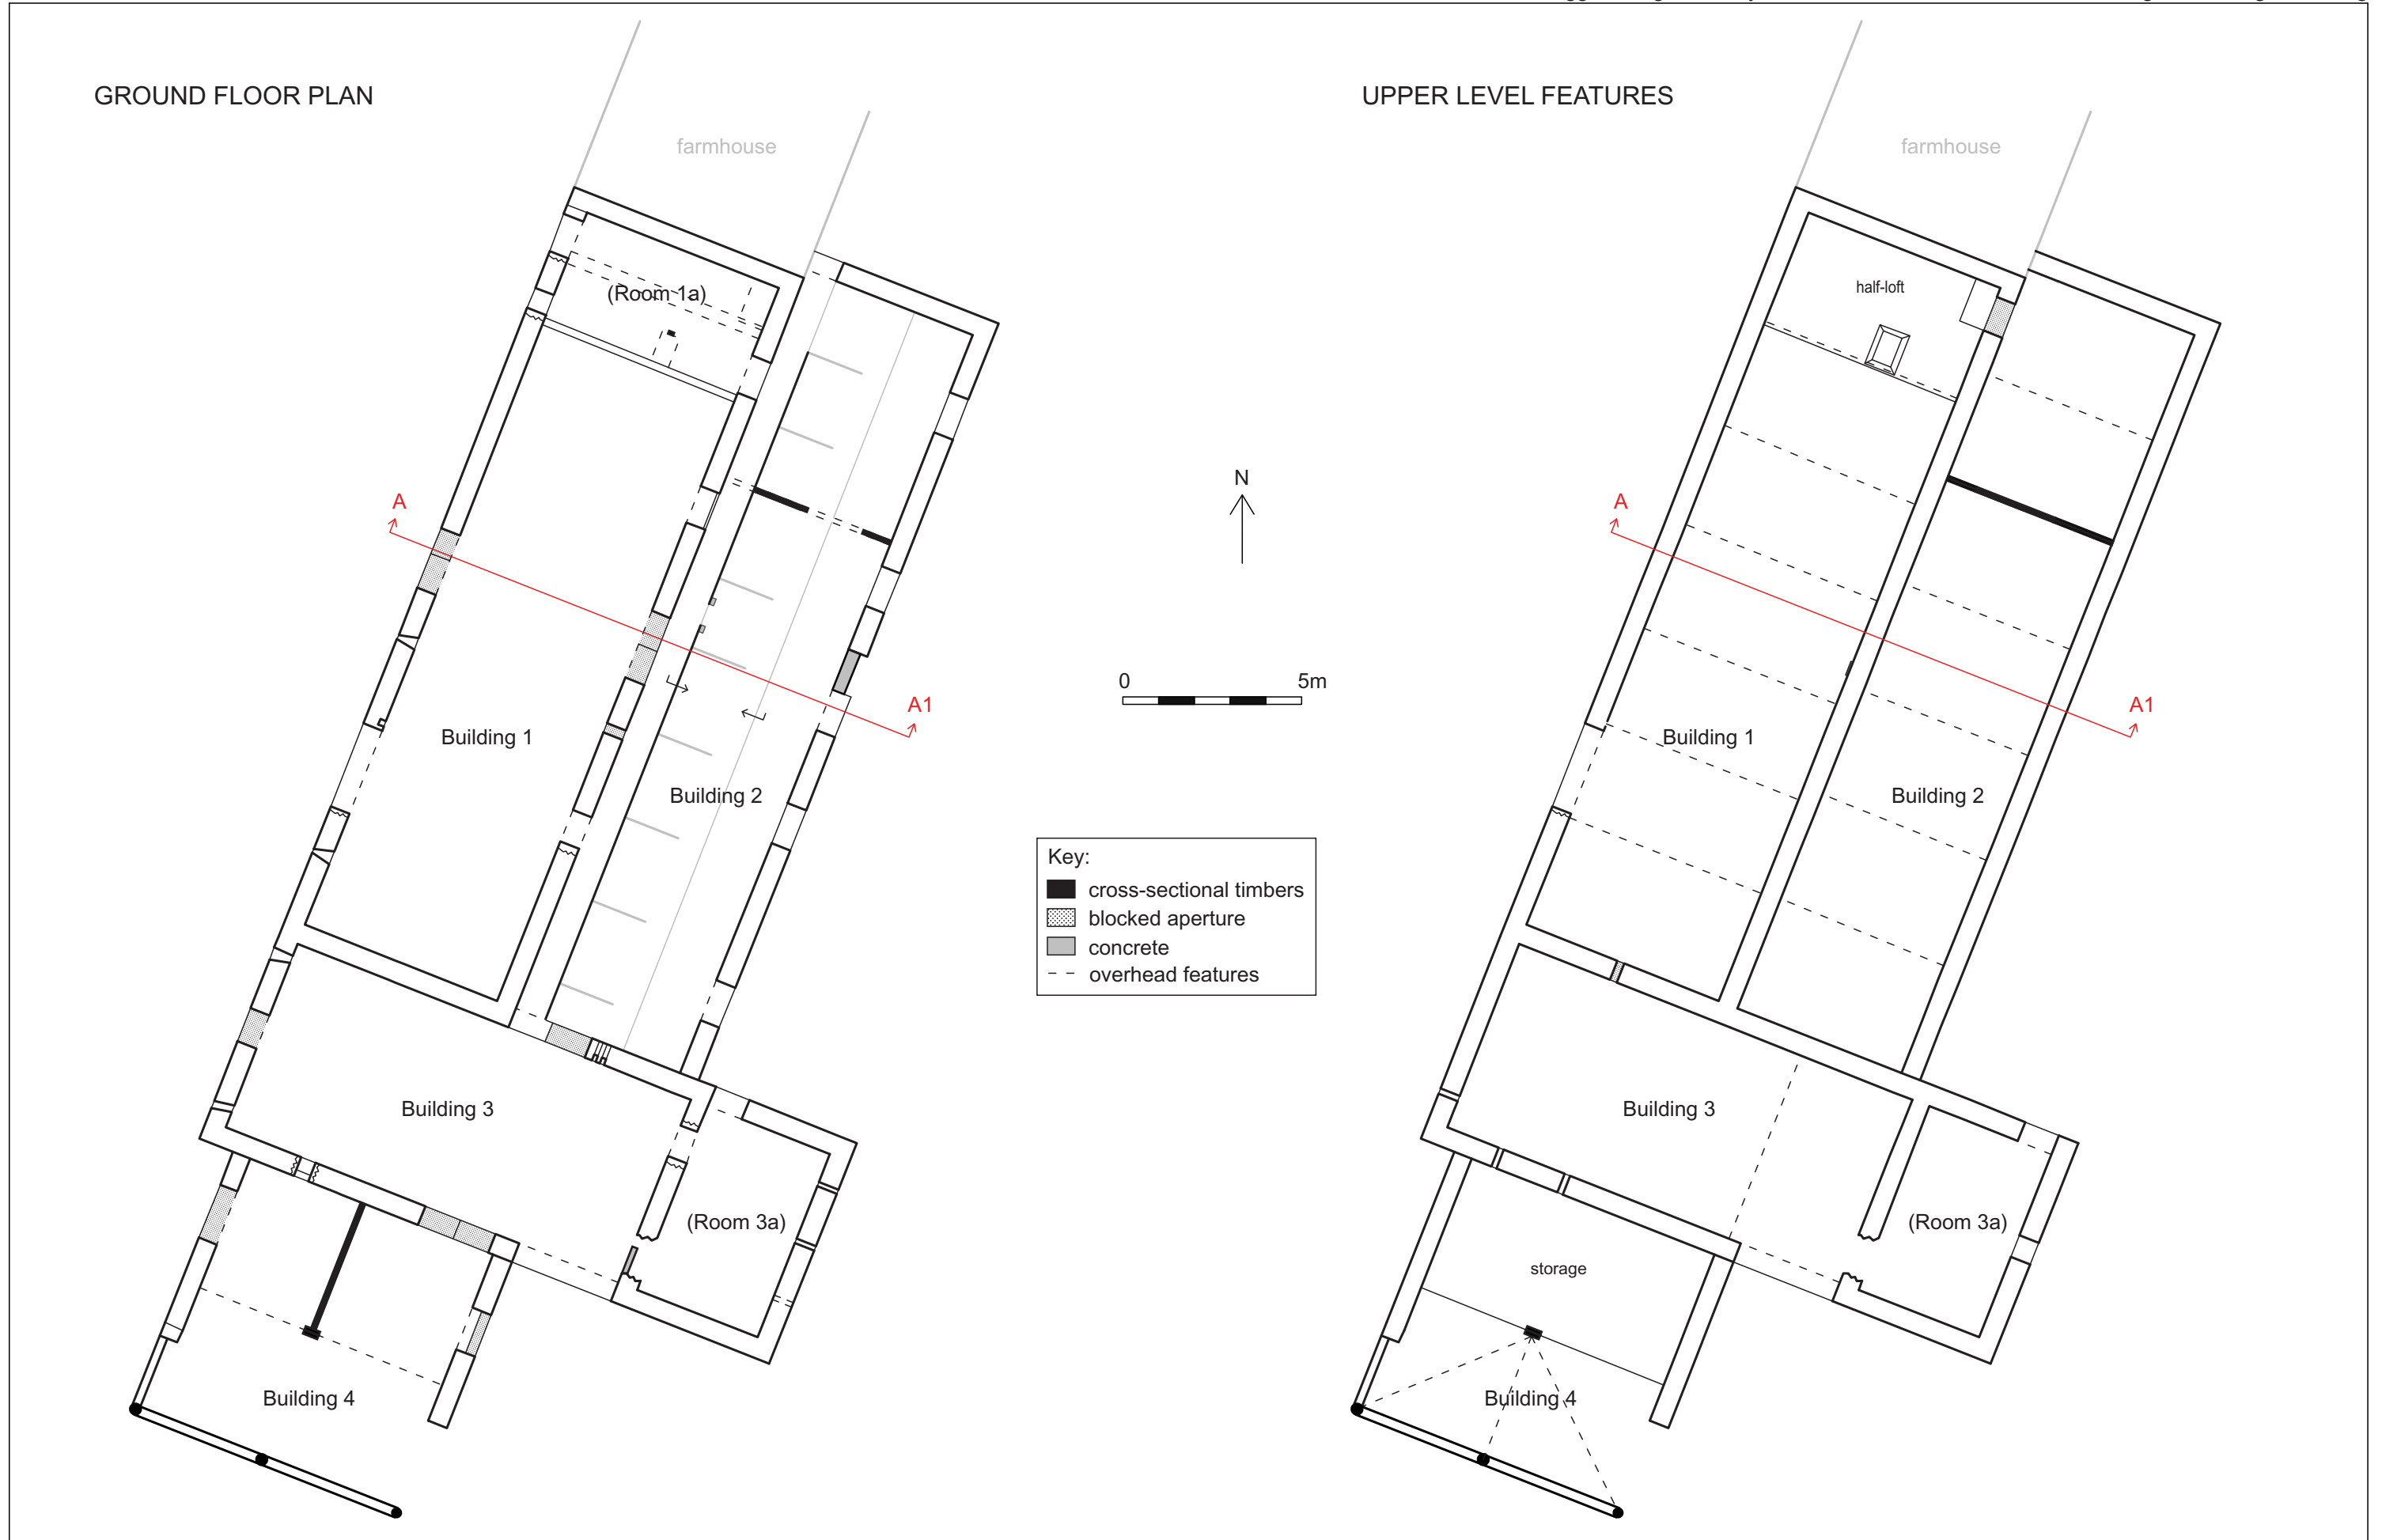
Figure 3: Ground floor plan and upper level features

4.2.7 East of the horse gin, the remaining part of the elevation, which was formed by Building 3, was set back several metres from the horse gin. There was a large wagon doorway at the west end of Building 3 (see Figure 3); this doorway had clearly been inserted as the blocked original wagon doorway with its neat red sandstone arch was evident just to the west of this doorway (see *Section 4.3.20* for full description). The later doorway was much higher, and had an iron beam lintel over ashlar red sandstone and red brick quoins (Plate 11). To the east of the wagon doorway (Building 3) the wall was very dilapidated and only a small section remained at the east end, where the beach cobble construction was evident as well as large irregularly shaped quoins.

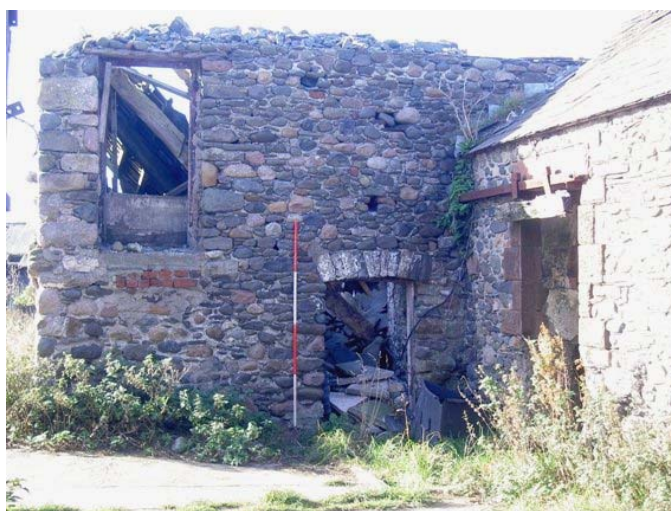
Plate 15 (right): Building 3 viewed from the north

4.2.11 **North elevation:** the east end of Building 3, corresponding internally to Room 3a, had an upper doorway at the east end which was set against the east wall; there were also quoins on the west side that showed it to be an original upper-level door. The doorway housed a basic timber frame under a timber lintel but there was no door left. A small area of blocking in concrete block and red brick at the base of the doorway probably indicates the location of an upper stone step; steps are indicated in this area on the 19th century maps (see Plate 2 and Plate 3), but appear to have been removed by 1913 (Plate 4). This elevation also housed a lower-level doorway at the west end that was flush with the wall that divides Room 3a within Building 3; this doorway had a neat arch of mixed stone that had been whitewashed (Plate 15). The arch was very similar to that in the west elevation of Building 3.

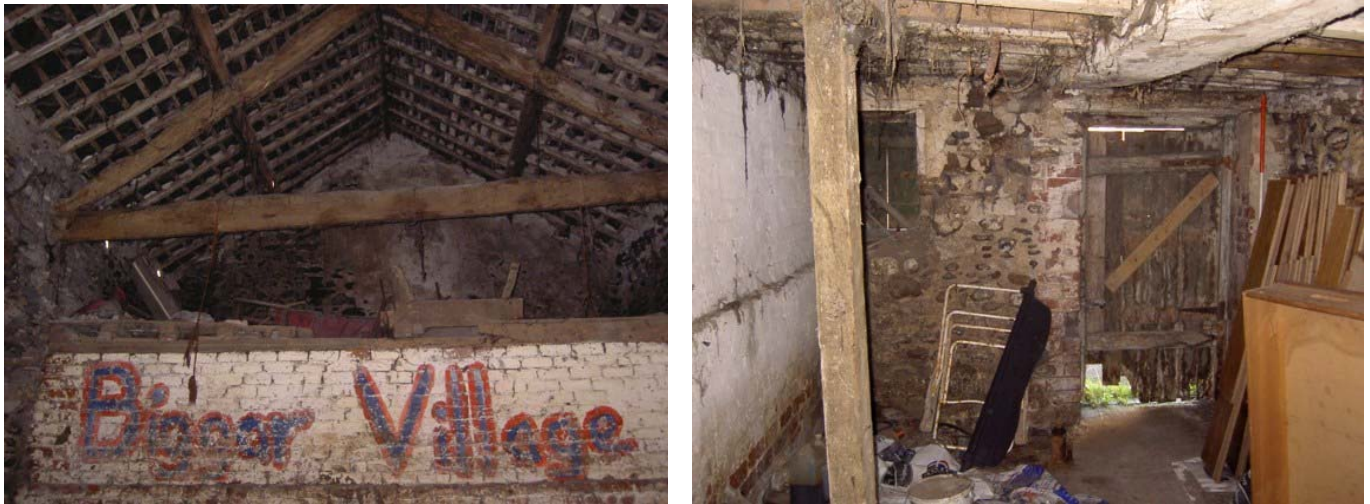
4.3.1 **Building 1, north elevation and Room 1a:** this building was undoubtedly part of the original phase of development at this farm, and was a purpose built threshing barn that formed part of a north-south range along with the small domestic building to the north. Room 1a was created by partitioning off 3m of the north end of the barn, the ceiling for which was provided by a timber half loft (Plate 16). Room 1a had an original doorway in the east elevation as well as one to the half loft level; the 1891 Ordnance Survey map seems to indicate that steps led to this upper-level door at that time (Plate 2). The partition at the south side of the room was plain, and constructed from red brick. It is possible that the underside of the half loft was originally open and supported on east-west timbers keyed into the walls; however, the two original doors at the north end of the east elevation suggest there was originally a partition in this area. The west elevation of the room housed a small window and a doorway, both of which had bricks built into their jambs and had probably been inserted later (Plate 17). The north elevation of Building 1 appeared to be entirely plain. The floor of this room had been concreted, whilst the concrete in the main barn had been removed to reveal bare boulder clay.

Plate 16 (left): Partition and half loft, Building 1

Plate 17 (right): Room 1a viewed from the east

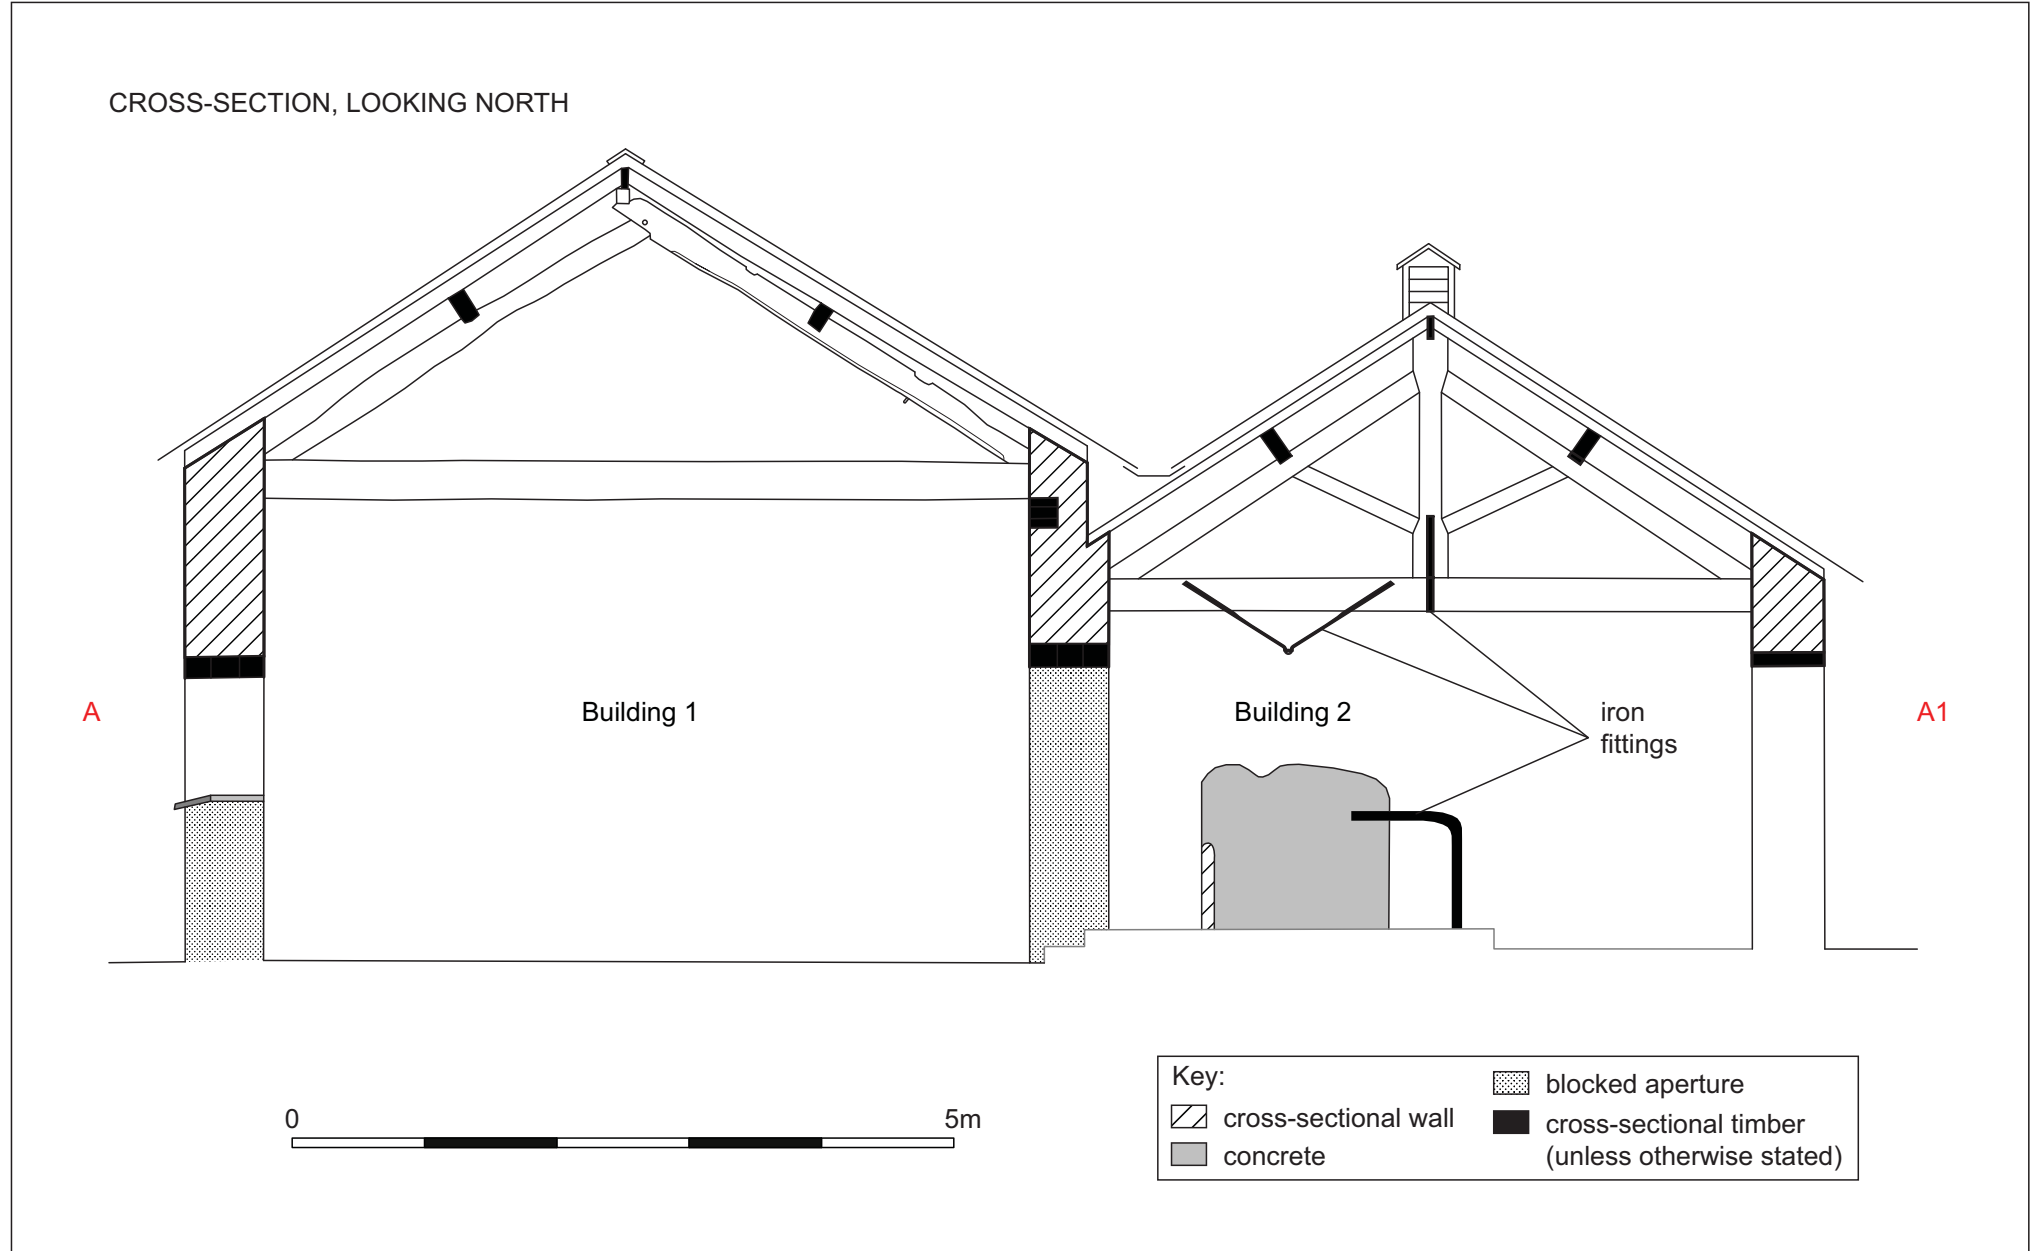
Figure 4: Cross-section, looking north

4.3.5 **Building 1, roof:** there were six trusses in the barn, four softwood king-post types with joggled braces, and two of the original oak tie-beam variety (Plate 22). One truss re-used an earlier timber (Figure 4). The re-used timber was the eastern principal rafter and had the scar of a lap joint on its lower north face; this contained at least one peg hole. This timber also had a stop-chamfered inside edge which distinguished it from the other oak timbers (Plate 23); all the purlins had been replaced and the two original purlin scars were also evident on this and the other earlier principal rafters. The square-cut softwood purlins tended to run two trusses before overlapping; it is probable that these replacement purlins were the same age as the replacement king-post trusses which were very similar to those found in Building 2. The roof was clad in slate which was capped by sandstone ridge tiles; these presumably had been salvaged from the earlier phase of roofing.

4.3.12 The roof comprised six identical king-post trusses with joggled arches (Figure 4; Plate 24) that supported a single purlin per pitch. All the roof timbers were softwood and appeared to be contemporary. This timberwork supported slates under ceramic bonnet tiles, and there were three timber louvers atop the roof for ventilation.

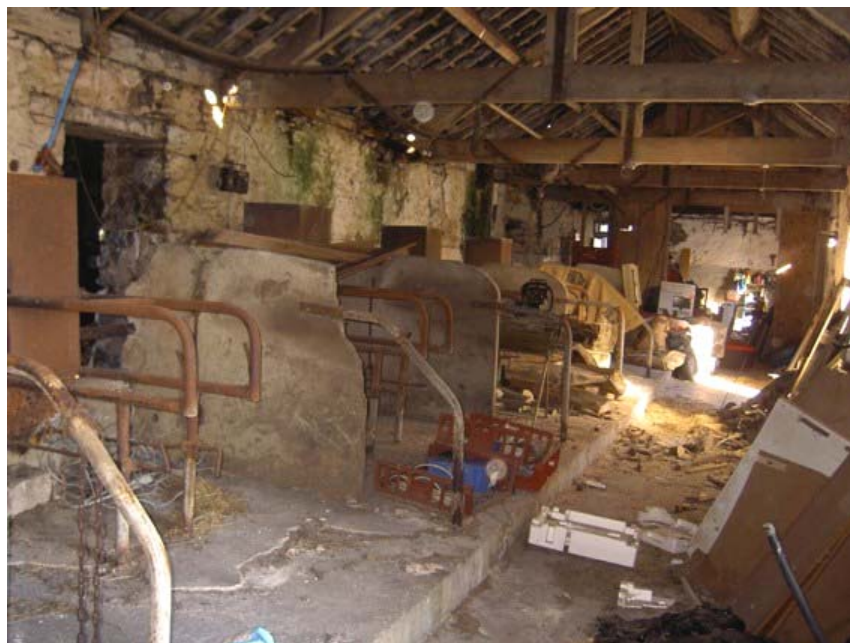
4.3.6 **Building 2:** this purpose built shippon was the latest addition to the farm buildings complex and first appears on the 1959 Ordnance Survey map, surveyed in 1958 (Plate 5). The building was a single room that had the remains of a simple timber partition near the north end, which had probably been added, and it housed eight cattle stalls and the remains of milking equipment were evident. The building was being used as a storeroom and workshop at the time of the building recording (Plate 24).

Plate 24 (left): Building 2 viewed from the south

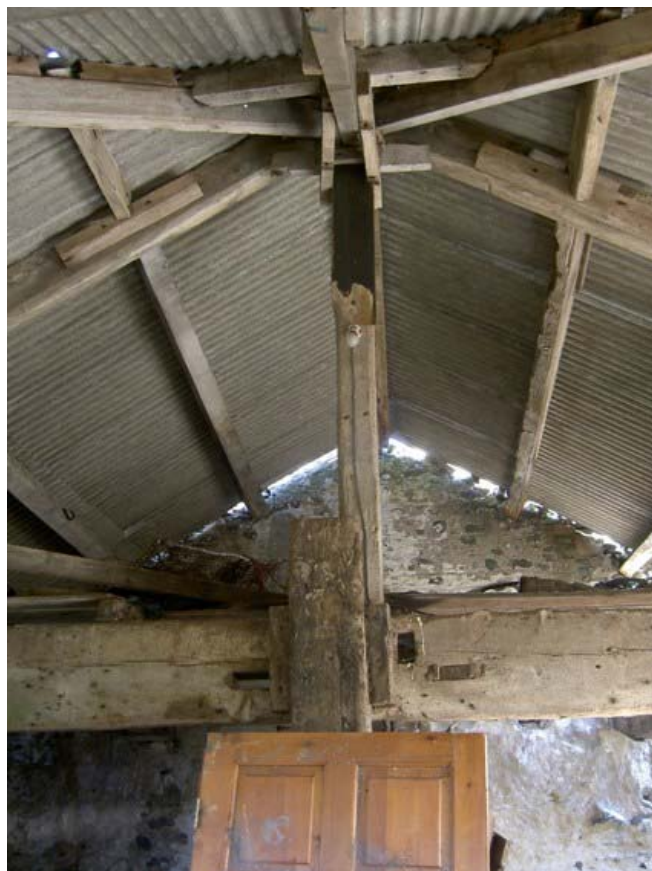
Plate 33 (right): Roof timbers in the former gin case, Building 4

4.3.24 **Building 4, floor and roof:** the floor in this building had evidently truncated the natural ground level to some extent, especially at the north end. This may have been necessary in order to construct a flat floor, or to position the overhead axle at the right level for the associated machinery housed in Building 3 to the north. The floor had been concreted and was rather featureless; however the quantity of dung present did suggest that it had been a stable quite recently. The roof timbers were constructed around an east-west king-post truss that had an enormous oak tie-beam which had evidently been re-used at least once. The truss formed the southern end of the roof's ridgeline that extended northwards to the rear of Building 3; three timbers extended from the top of the truss to each of the three timber posts located in the centre and at the corners of the south elevation. This arrangement formed a hipped roof
