BOLTON PERCY GATEHOUSE,  
BOLTON PERCY, NORTH YORKSHIRE

ARCHAEOLOGICAL OBSERVATION,  
INVESTIGATION AND RECORDING

Report no: 2009/346.R03  
Version: Final  
Date: February 2010  
Author: Shaun Richardson & Ed Dennison

The Vivat Trust  
20 Cowcross Street  
London  
EC1M 6EJ

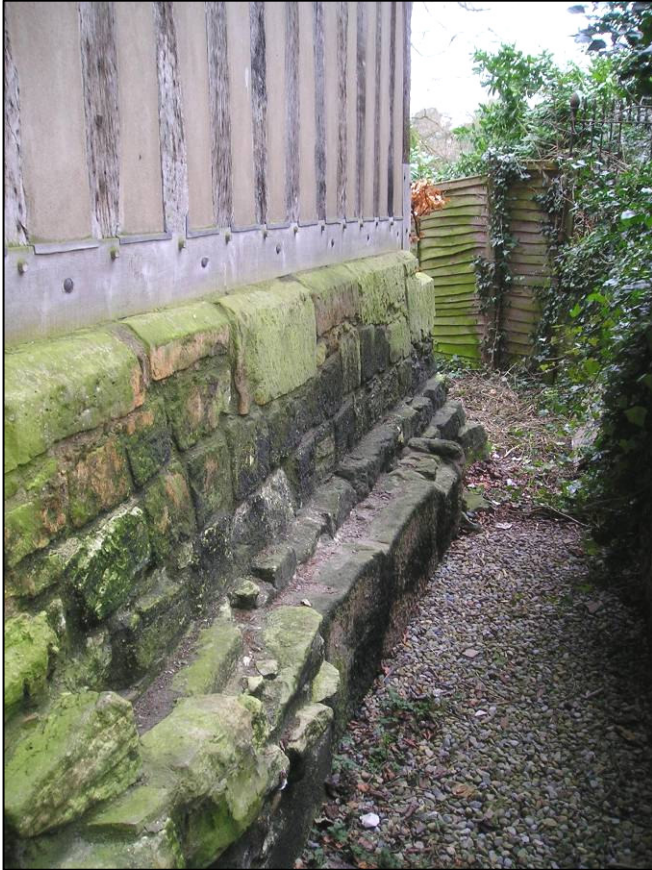
- 3.10 The top of the chamfered plinth of the east gable is set slightly higher than that to the south or north elevations. It is of coursed squared rubble, slightly stepped out to either end, and incorporating a rectangular dressed stone object towards the centre (see plate 7). The object is 2.10m long, stands 0.60m high and projects from the base of the plinth at a slight angle. The interior has been filled with rubble. The object appears most likely to be a trough, although given that the plinth of the west part of the gatehouse incorporates part of a grave slab (see below), the possibility that the object is a stone coffin cannot be totally discounted. It is not known when this object was introduced into the footings.

Plate 7: Chamfered plinth, east end of gatehouse, looking north.

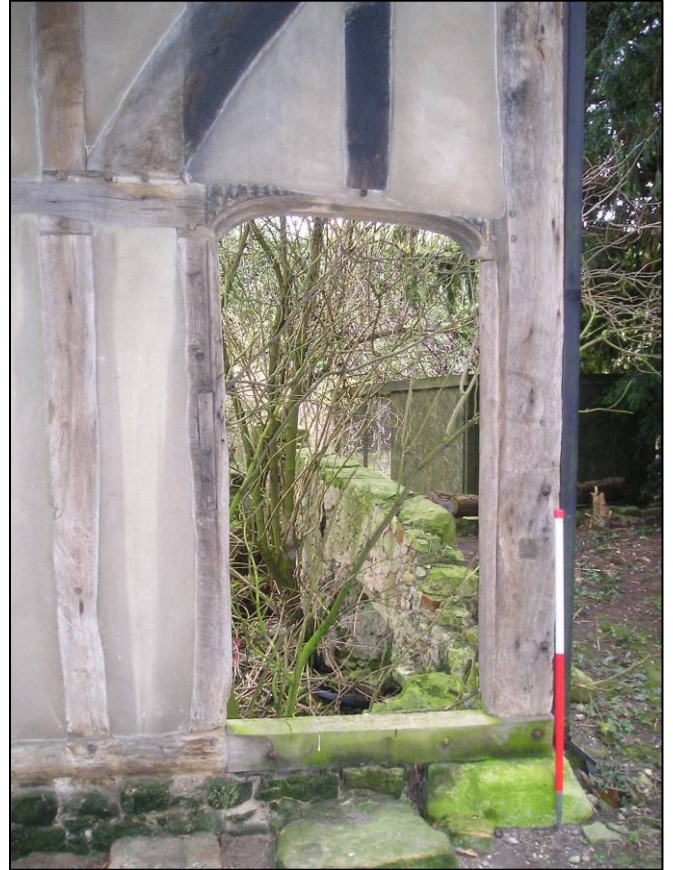
- 3.8 The passage itself is crossed by six timbers, joists supporting the floor of the first floor chamber above; some of these have wrought-iron bolts and wrought-iron eyes on plates fixed to them. The plinth to the base of the east side of the passage is not chamfered, and is much lower than the plinth around the rest of the building. Above the plinth, a sill beam supports close studding with downward braces to either end. The studs rise to a mid rail, above which there is further close studding and the same arrangement of downward braces as below. The west side of the passage is similarly constructed, but has downbraces only above the midrail, and a doorway towards the north end. This doorway has a very shallow arched head with spandrels to the passage enriched with foliate carving (see plate 8). It formerly lead into a staircase rising to the first floor of the west part.

Plate 8: Doorway at north end of west side of central passage, looking south-west.

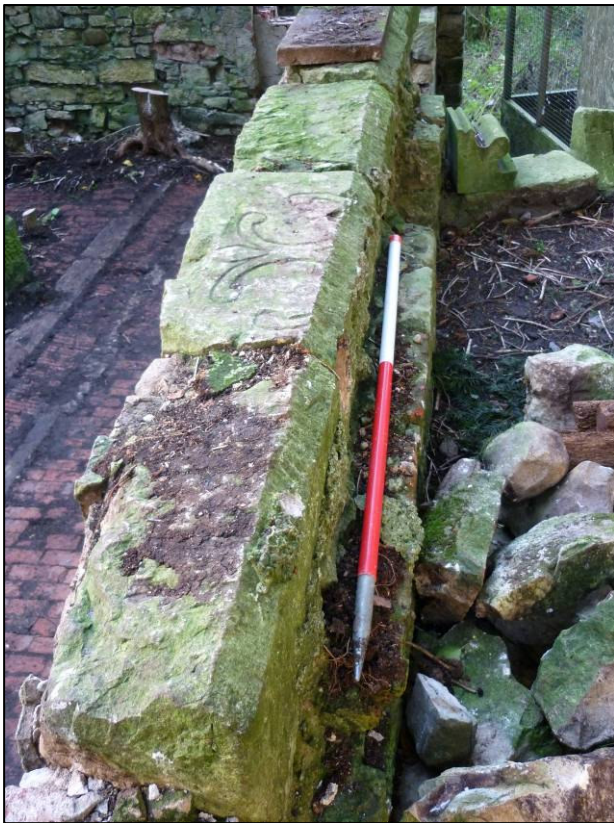
Plate 9: Reused grave slab on chamfered north wall of west cell of gatehouse, looking south-west.

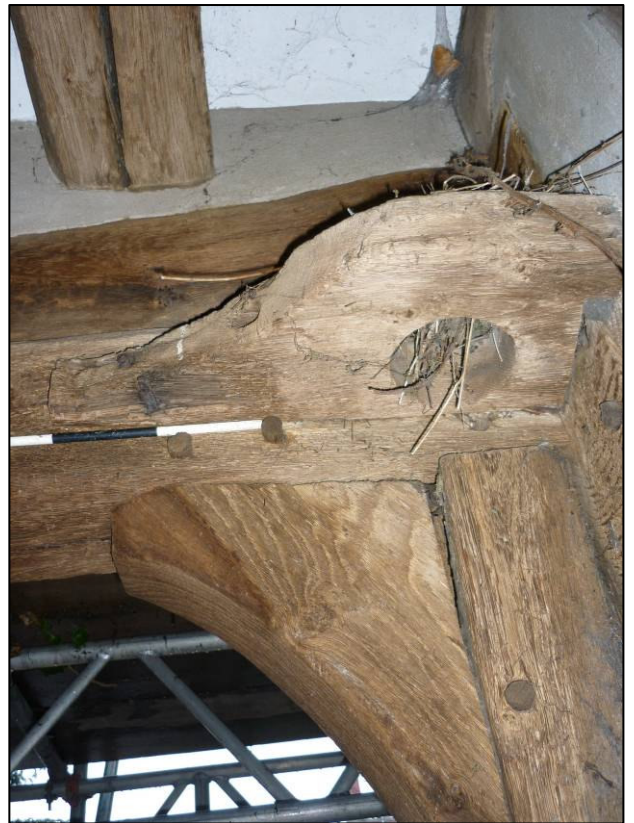
Plate 10: Harr for harr-hung gate over south-west corner of central passage.

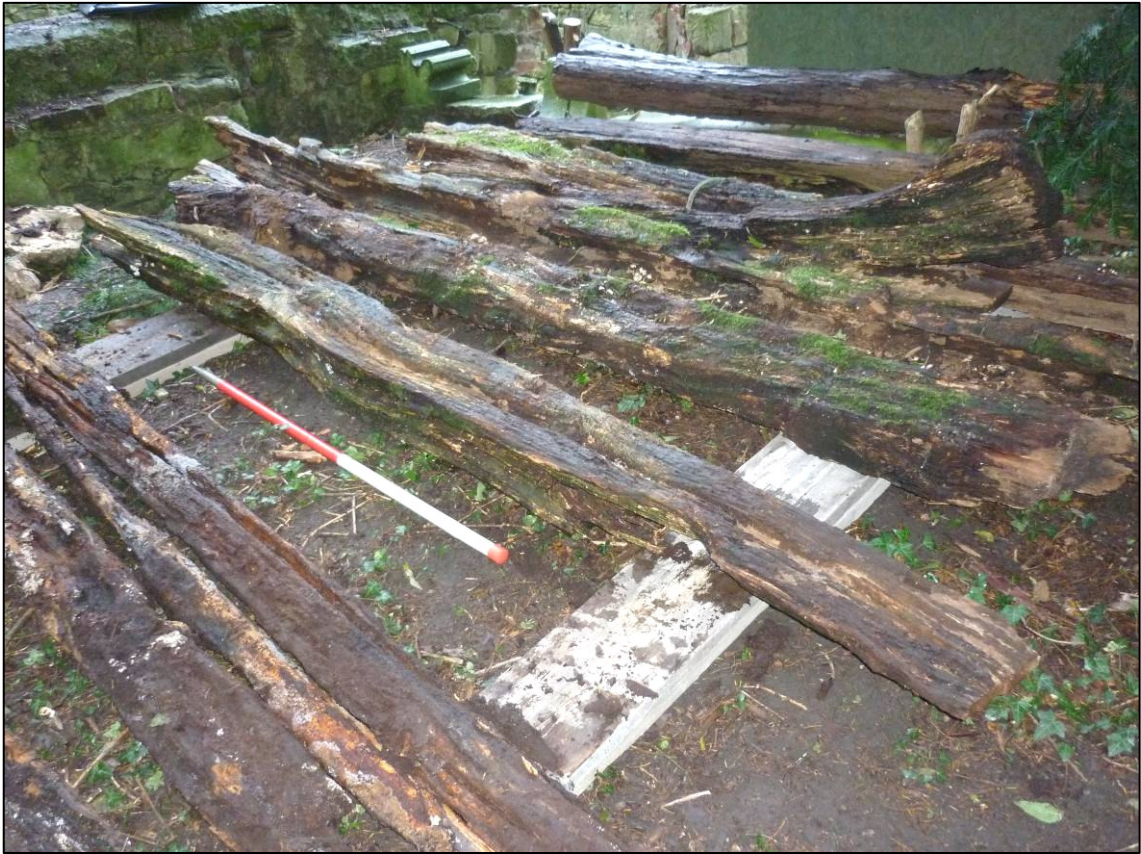
- 4.2 A total of 14 timbers that remained substantially whole during removal were recorded as part of the watching brief (see plate 11). Once these had been taken out of the west cell, it became clear that a significant proportion of the remaining detritus in this area had once also been whole timbers (probably of small scantling only) but that they had since rotted beyond recognition. During the clearance work, it was noted that further timbers, perhaps the heads of posts, had been placed on the clean brick floor of this part of the gatehouse and covered in polythene and then chicken-wire, presumably so that they could be re-used at a later date. Unfortunately, this protection had proved inadequate, and these too had rotted away to the extent that their original form was lost.

Plate 11: General view of old timbers after removal from west cell of gatehouse.

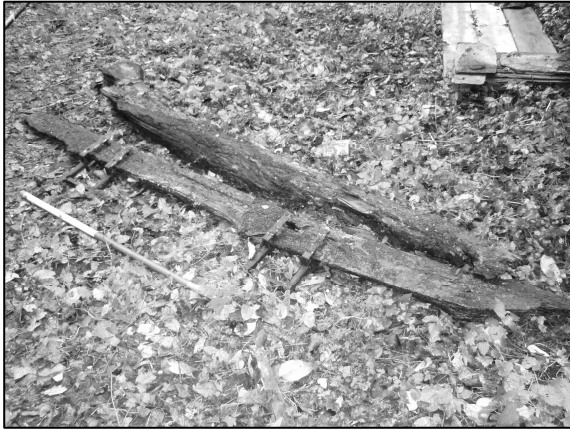
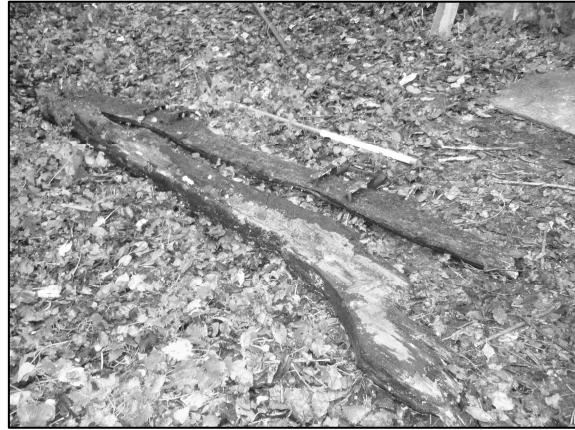
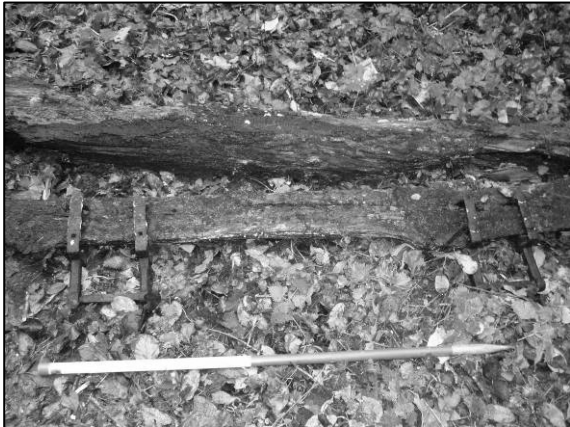
This timber measures 2.75m in length, 0.08m in width and 0.18m in depth. One end is slightly splayed or angled, and might form the remains of a scarf joint. There are two wrought-iron brackets attached to the timber. Each is formed by a pair of flattened straps, slightly raised from the surface of the timber, and once joined by bolts running through the timber; these are or were secured by square nuts. At their base, the straps joint to form a thicker (circular section) piece, which projects beyond the timber. The thicker pieces to both brackets have an eye at the project end, through which a thick wrought-iron bolt is placed. These brackets are sometimes seen where a timber has later timbers strapped on to it in order to provide extra support.

Photo 2/452: Timbers 1 & 2 - general view.

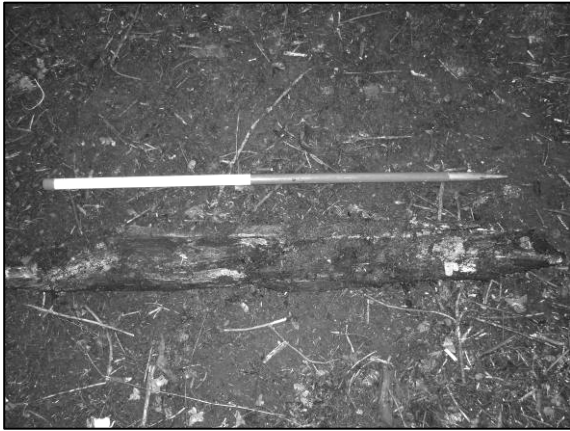
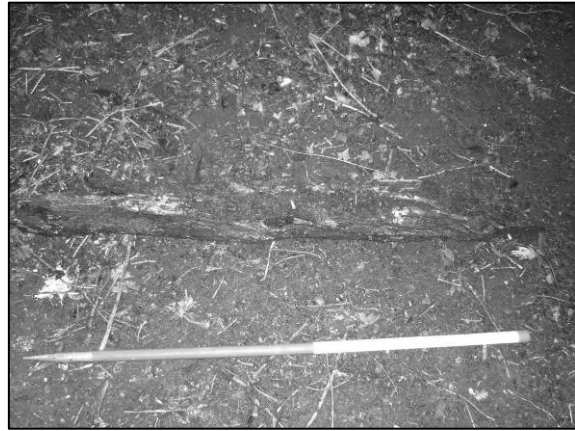
This timber measures 1.28m in length, 0.13m in width and 0.25m in depth. There may be the remains of a mortice to one surface.

Photo 2/473: Timber 4 - general view.

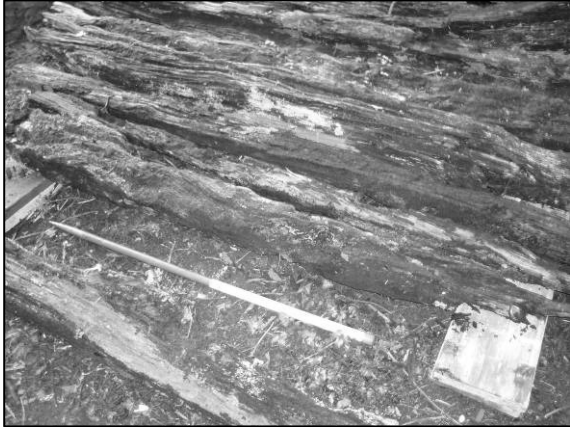
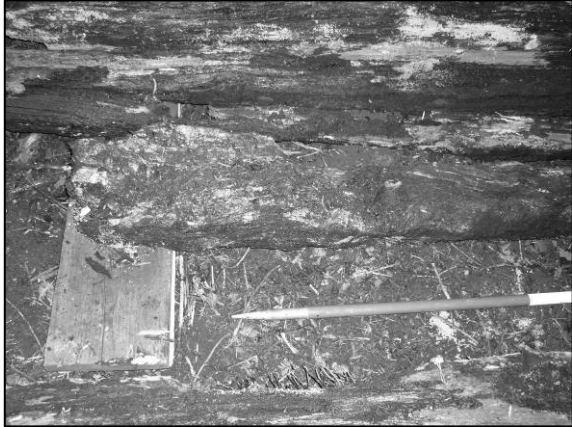
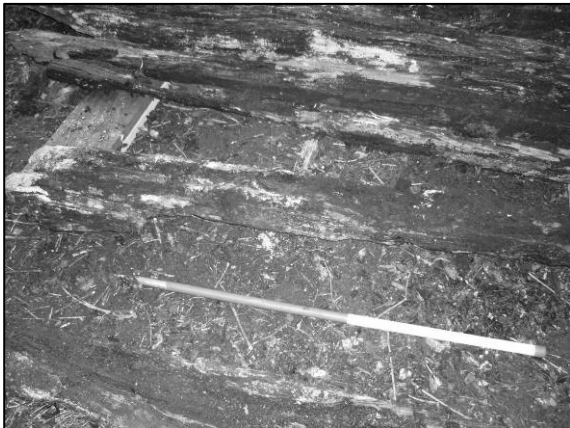
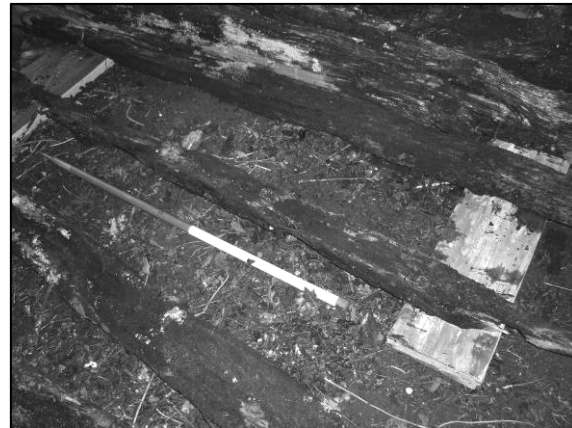
This timber measures 2m in length, 0.10m in width and a maximum depth of 0.25m, although for the majority of the length the depth is only 0.15m. The timber is slightly jowled to the wider end, and has a well preserved top and soffit. There are no other features.

Photo 2/478: Timber 6 - jowled end.

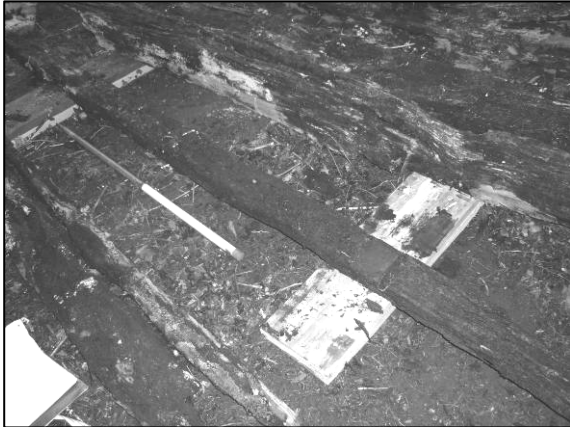
This timber measures 2.30m in length, 0.11m in width and 0.11m in depth. There are four mortices spaced at equal centres to one surface, averaging 0.05m in length. The timber resembles a stud or part of a common rafter; if so, then it seems to have been re-used from an earlier structure.

Photo 2/482: Timber 7 - general view.

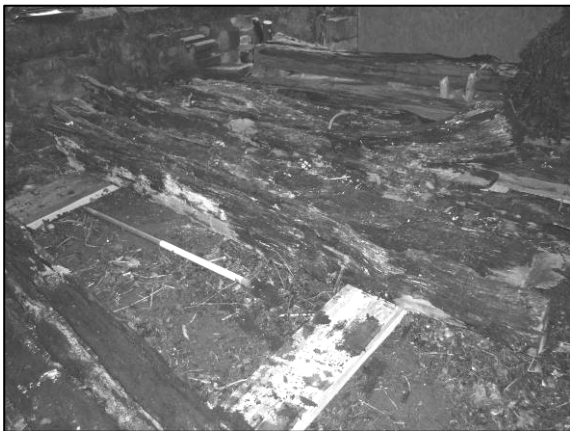
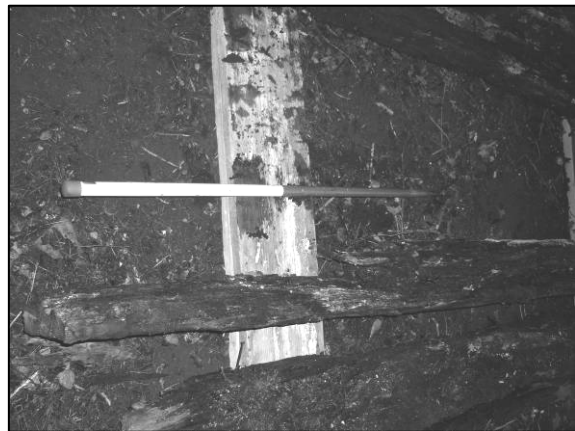
This timber measures 2.90m in length, 0.10m in width and 0.12m in depth. It may be a stud or part of a common rafter. There are no other features.

Photo 2/483: Timber 8 - general view.

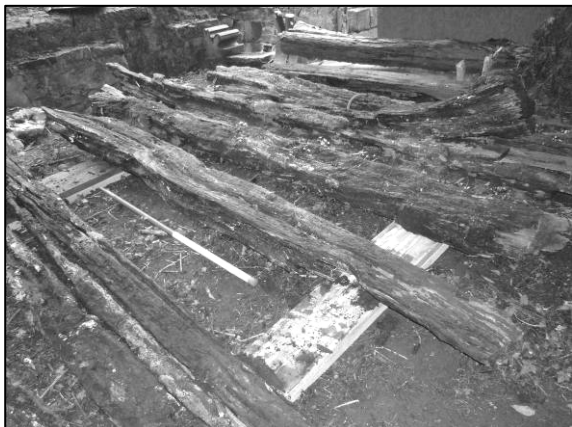
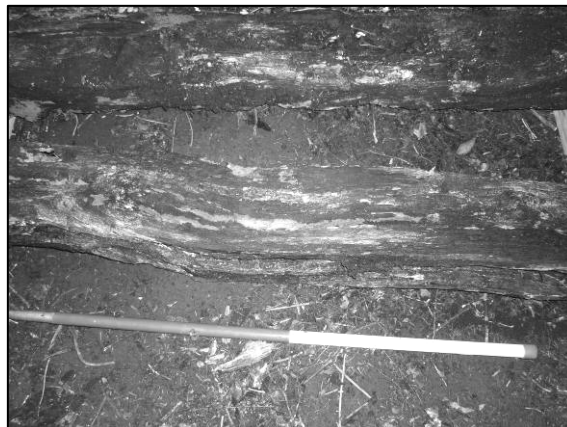
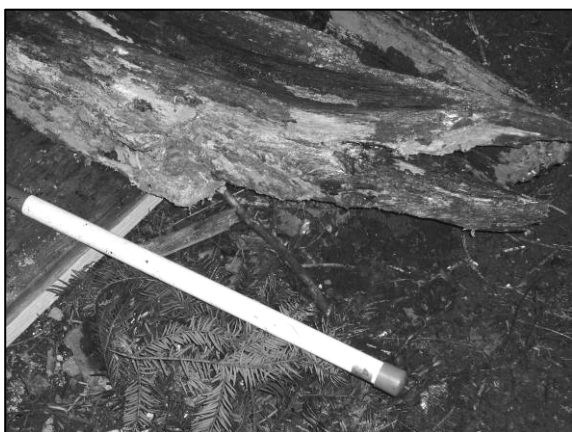
This timber measures 2.73m in length, 0.15m in width and 0.22m in depth. It may be part of a top-rail or a sill beam. There may be the remains of a stop-splayed scarf at one end, while the other end is sawn off (see figure A1/1). There are four peg holes to one end of one side, with a single peg hole at the opposite end of the same side; each peg corresponds with an empty mortice in the surface forming the top or soffit.

Photo 2/486: Timber 9 - detail of peg holes.

Photo 2/487: Timber 9 - detail of scarf.

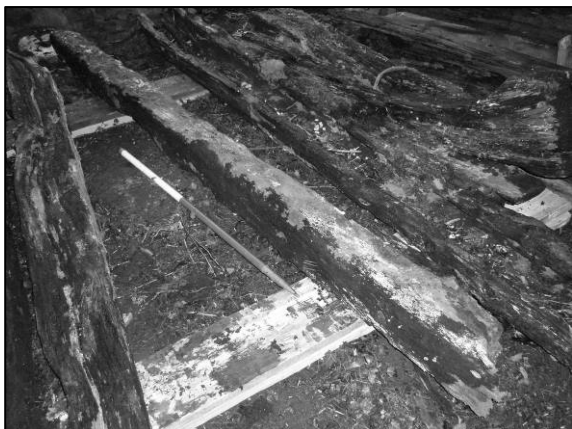
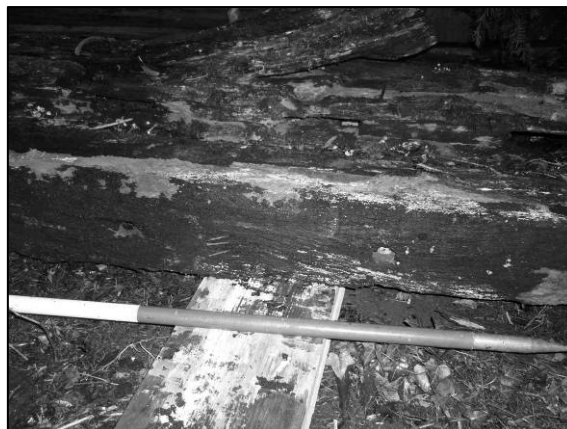
This timber measures 2.83m in length, 0.15m in width and 0.22m in depth. It may be a stud or part of a common rafter. There are no other features.

Photo 2/489: Timber 10 - detail of peg holes.

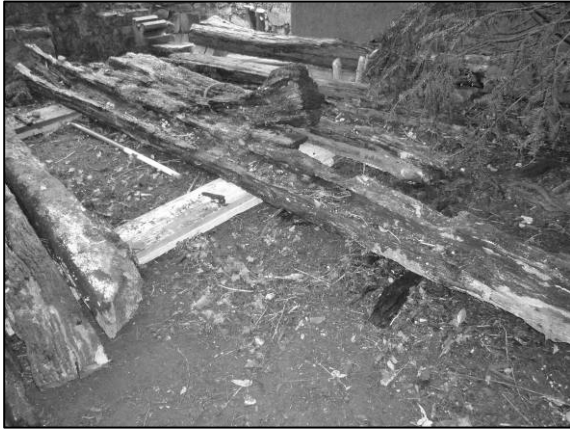
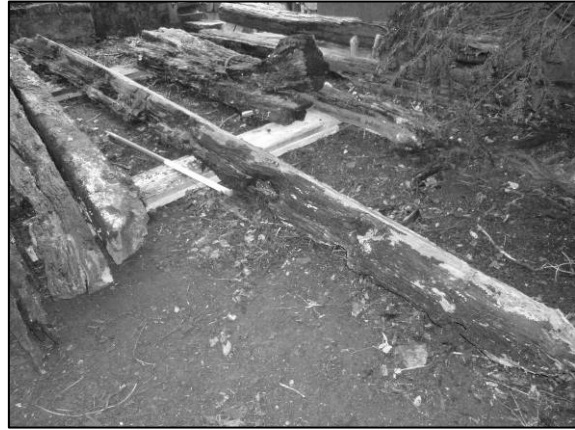
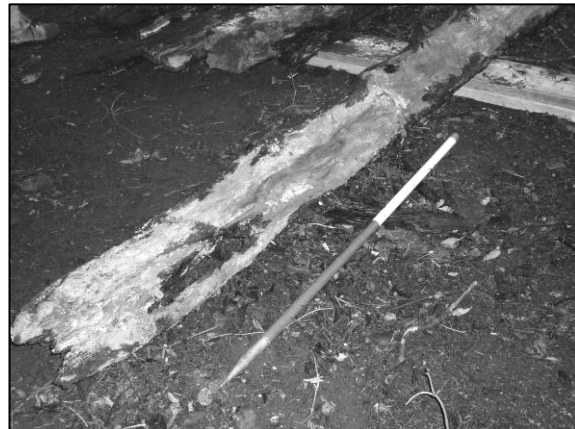
This timber measures 4.64m in length, 0.20m in width and 0.23m in depth. There are four mortices for studs in the top, spaced at equal centres and averaging 0.20m in length. There are a group of four peg holes to one end of one side, corresponding to the mortices, with a mortice of the same length to one end of the same side. At the opposite end, there are the remains of a much longer mortice or perhaps a slot (see figure A1/1).

Photo 2/493: Timber 11 - detail of mortices at one end.

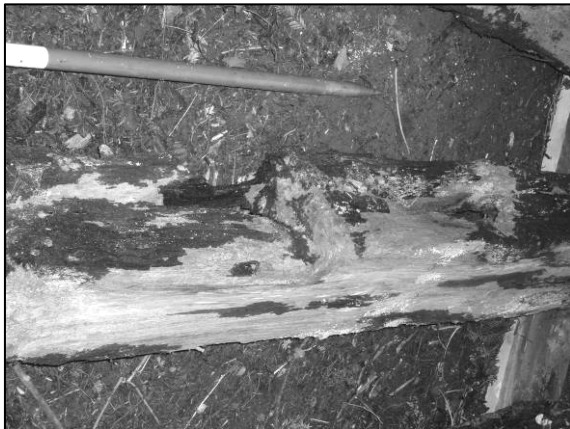
Photo 2/492: Timber 9 - detail of mortice and peg hole.

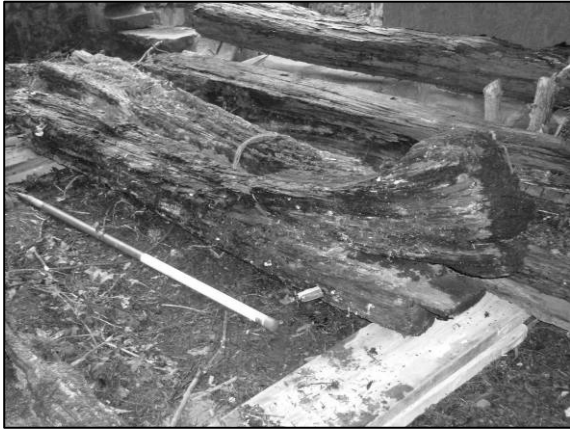
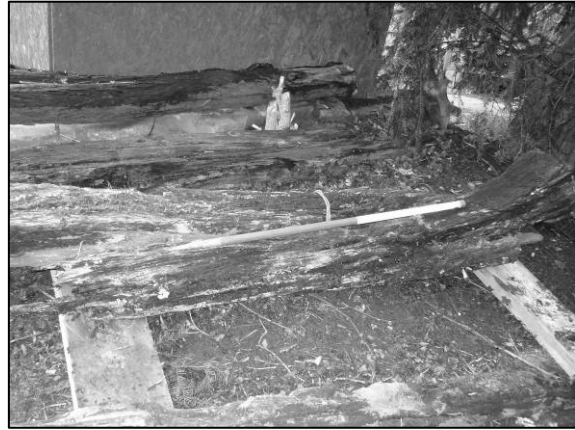
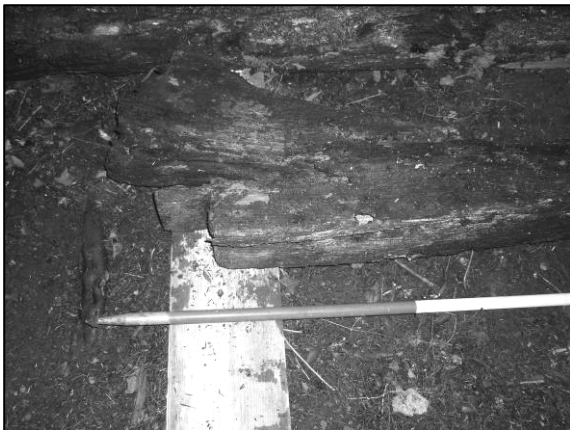
This timber measures 2.20m in length, 0.20m in width and has a maximum depth of 0.46m, although for the majority of its length it is only 0.18m deep. It forms the remains of the upper part and head of a post, presumably one of those shown here on the c.1974 photograph of the gatehouse reproduced by Kvarud (1991). On the top of the post, there is a cut-out for a horizontal timber, presumably the former jetty, with two peg holes and a corresponding mortice below (see figure A1/2). The position of the peg holes and the angle of the mortice suggest that an upward sloping timber such as an aisle principal joined the post here, although a brace to a jetty bressumer is more likely, given that such features are shown in this position on the c.1973 photograph reproduced by Kvarud (1991).

Photo 2/498: Timber 12 - detail of joint.
