Historic Building Recording  
Roof Repairs at  
Hamilton's Land  
Linlithgow

LL05

**HISTORIC BUILDING RECORDING  
ROOF REPAIRS AT HAMILTON'S LAND  
LINLITHGOW**

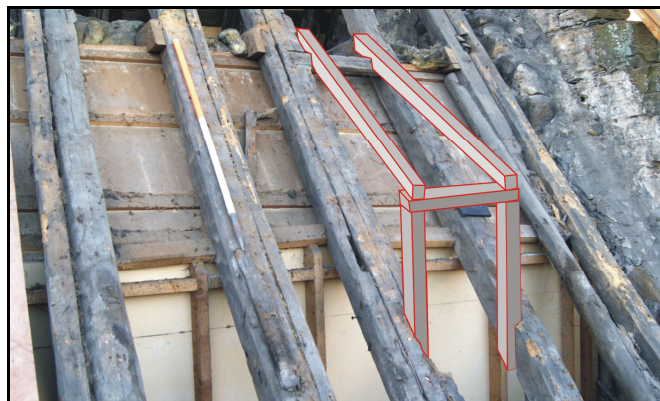
There are 4 sets of features which are interpreted as 'cat slides' – very small, simple low-angled dormer windows. These are represented by opposing vertical slots for uprights corresponding with small bridles or recesses for bridles further up the roof. Each cat slide is only as wide as a single rafter spacing. If the attics were originally intended for habitation - which is likely given the space they enclosed, it is likely that the cat slides were created soon after the roof was constructed. Their form, positioning and spacing suggests that they were probably all inserted at the same time in order to create roughly equal lighting across the two attics.

*Reconstruction of cat slide (rafters 2A & 3A)*

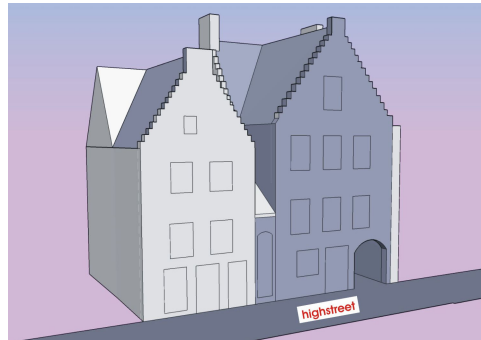
*Basic Model of Hamilton's Land as it stands today*

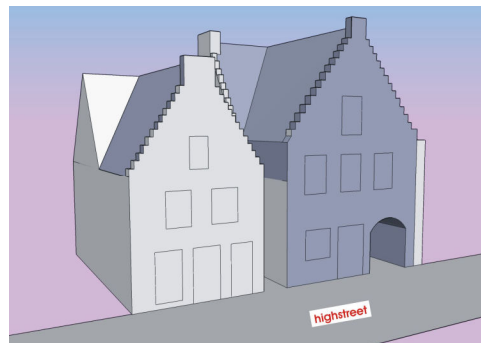
As discussed above under phasing, it has been difficult to ascertain if the N and S roofs are contemporary or whether the N roof was built first and the S added later. If the roofs were constructed at the same time, then perhaps in an earlier form Hamilton's Land was only two stories high, the current roofs being later additions when the structure as a whole was raised to incorporate a 3<sup>rd</sup> floor.

*Hamilton's Land as it may have looked in a previous two storey form*

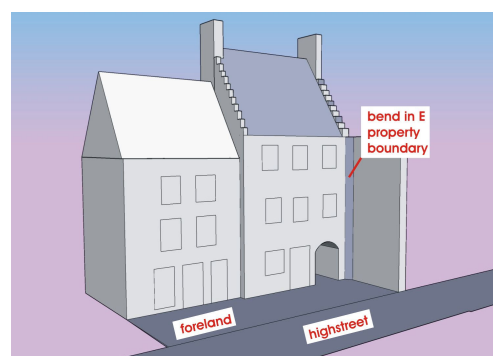
However, as outlined above in the phasing section, there is slightly more evidence for N roof having been built first, which would suggest that the property was at some stage set back from the High Street. This would mean that the original frontage was later enclosed within the building when the S roof/S projecting gable was added. This may well explain why steel I-beams were incorporated half way along the property later on: A necessary response to the removal of such a major wall.

*Hamilton's Land as it may have looked if the N roof was built before the S (prior to the construction of the forward projecting gable)*

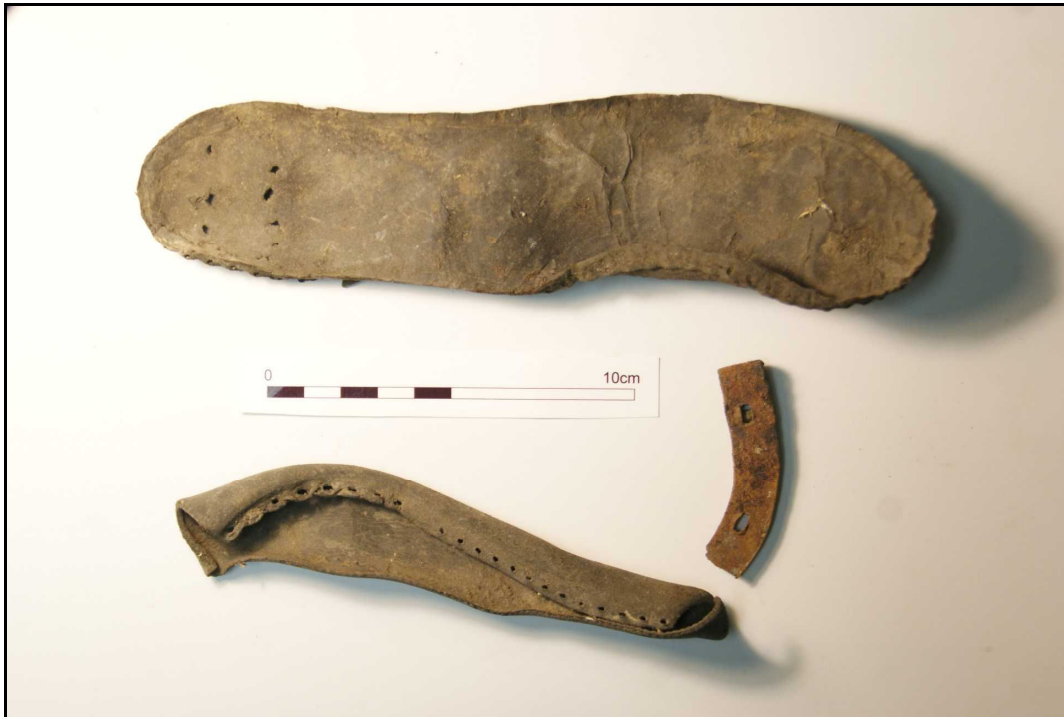
and 27 has been filled with general waste, stone debris and mortar creating a semi-firm false floor. While investigating this layer several leather scraps of shoe were found amongst the waste.

leather production after Cromwell's occupation in the mid 17<sup>th</sup> century, and became increasingly associated with shoe production. One wonders if a well lit space such as the S attic was perhaps associated with such a trade. Some evidence which may tentatively suggest that was the case are the fragments of shoes found in the S attic stuffed down between the party wall and bressumer beam 26. The fact that these are fragments rather than whole shoes, may point to them being waste from shoe repair work, rather than them simply being discarded footwear belonging to the tenants who resided in the building. Textile manufacture and tailoring also require good lighting, so this is another possible craft which may have taken place in this space.

*Fragments of shoes found stuffed down the gap between beam 26 and the party wall*

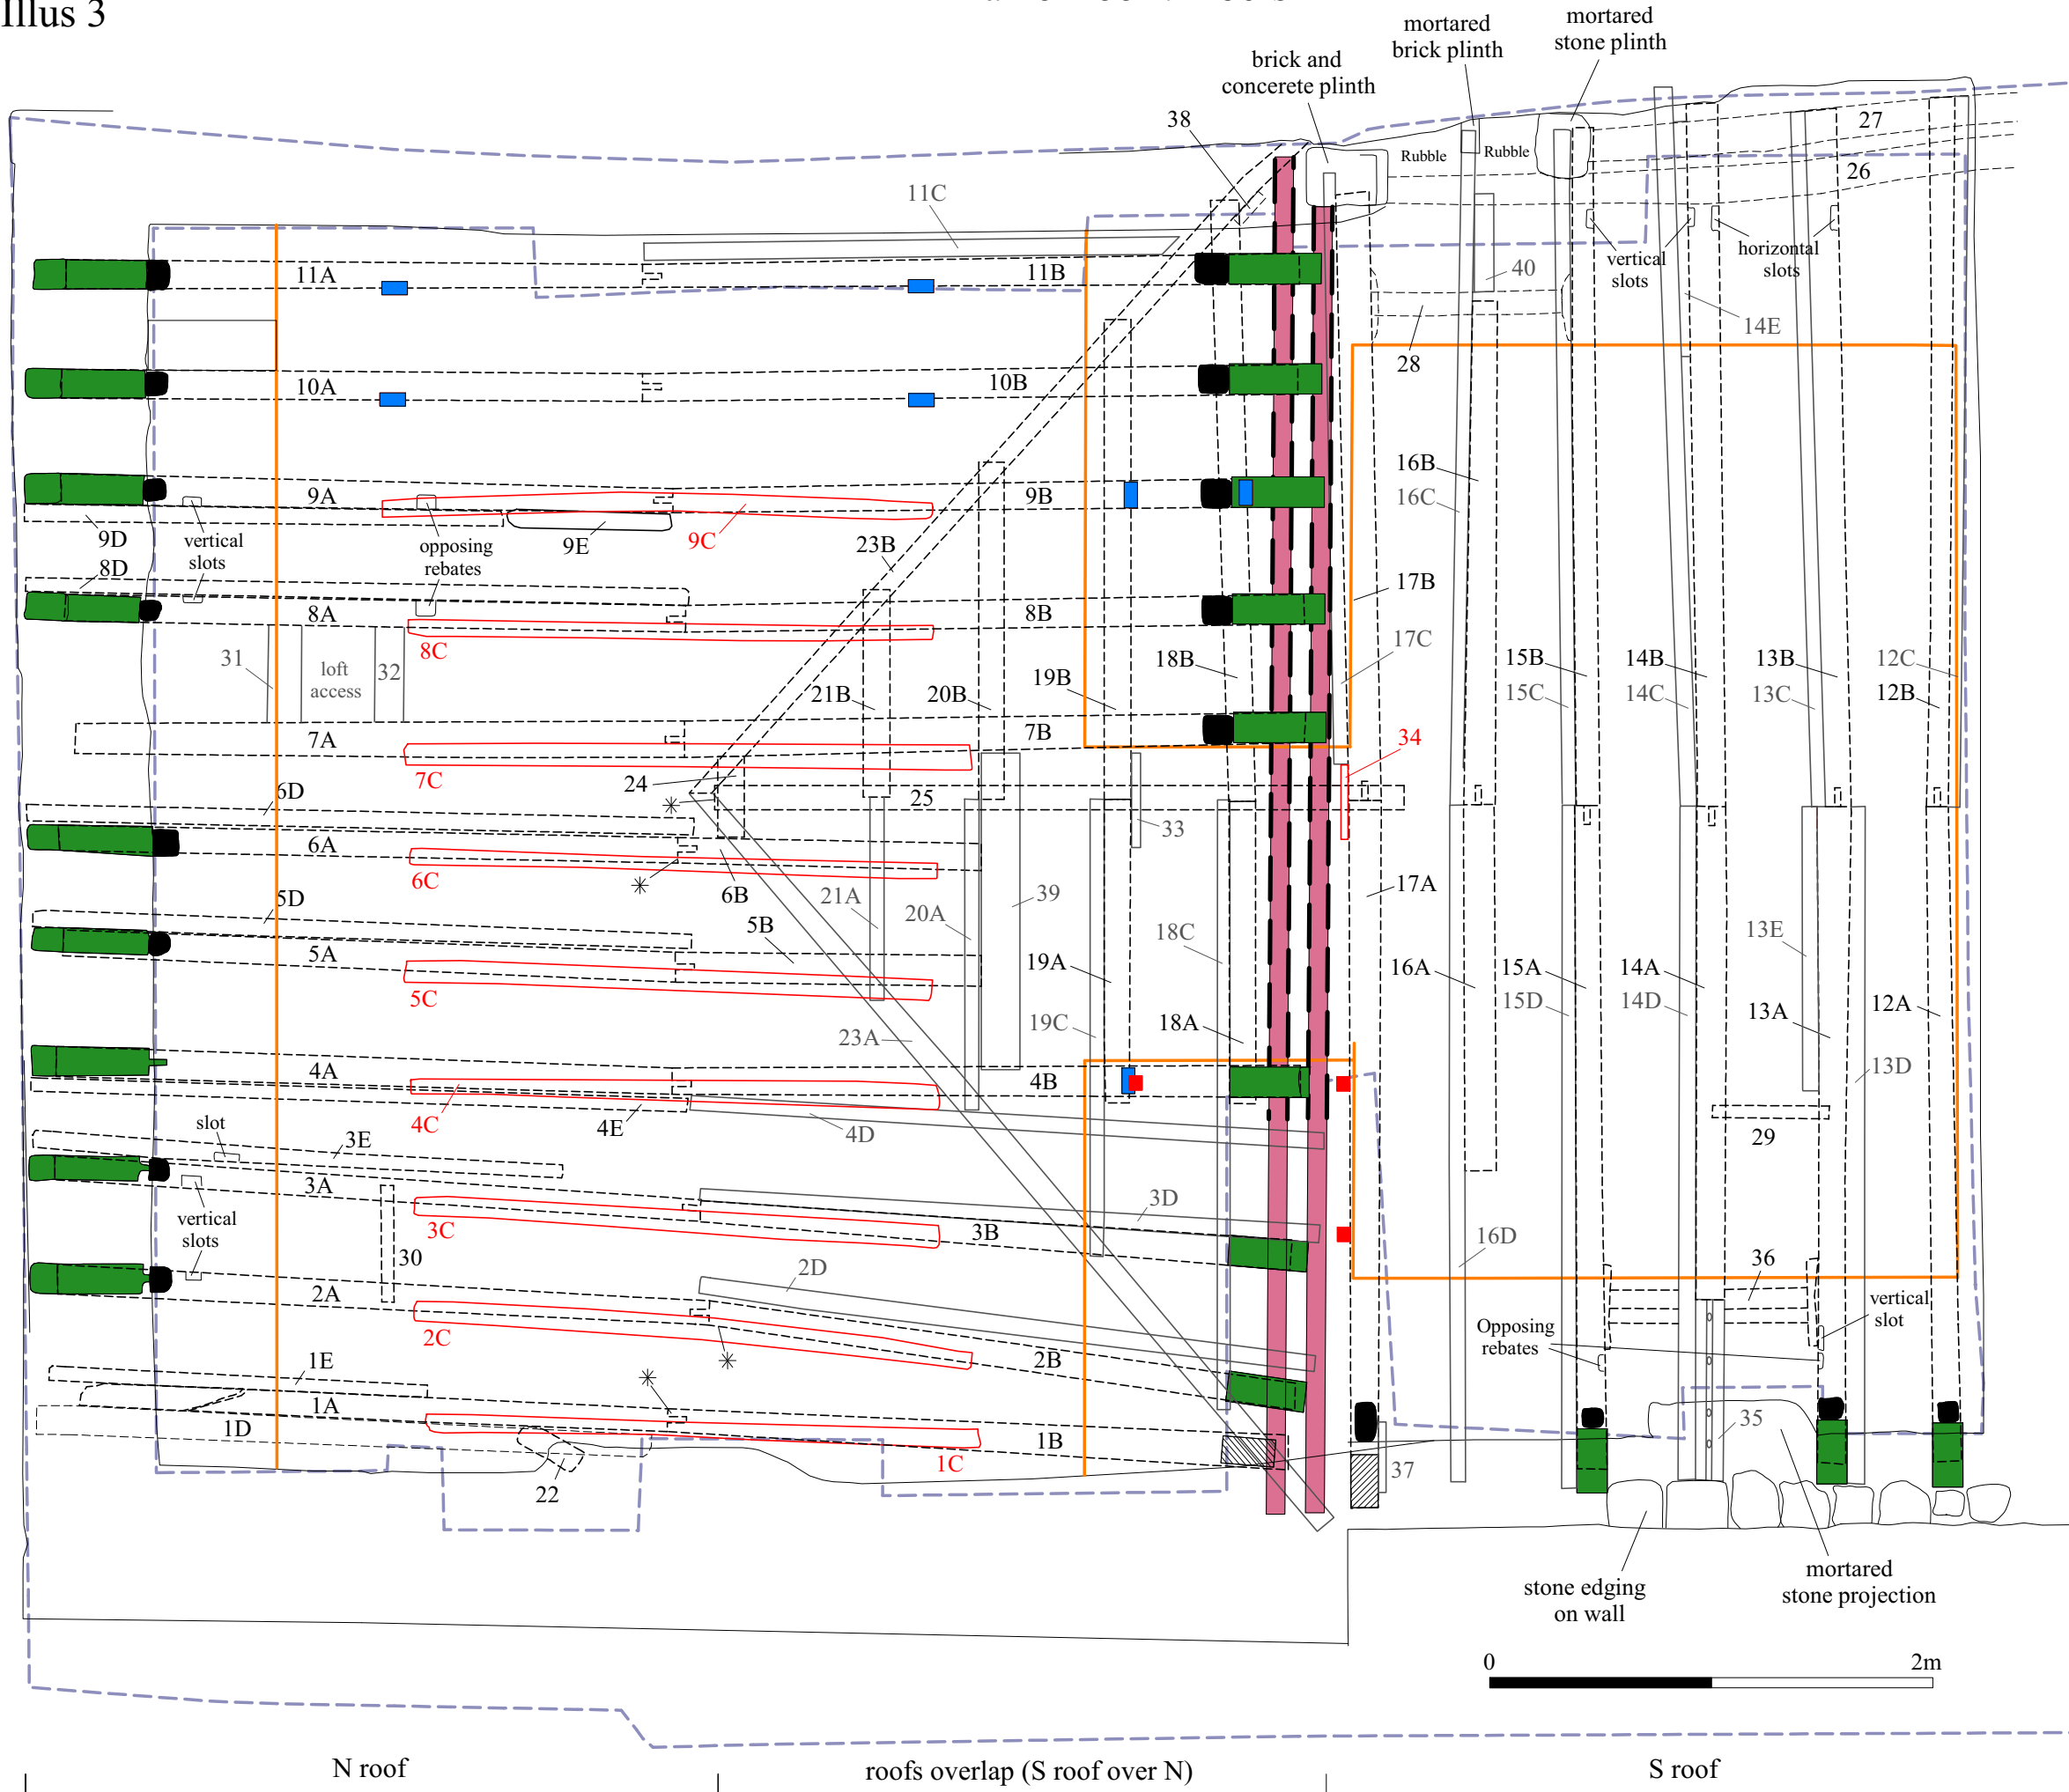
Illus 3

# Plan of roof timbers

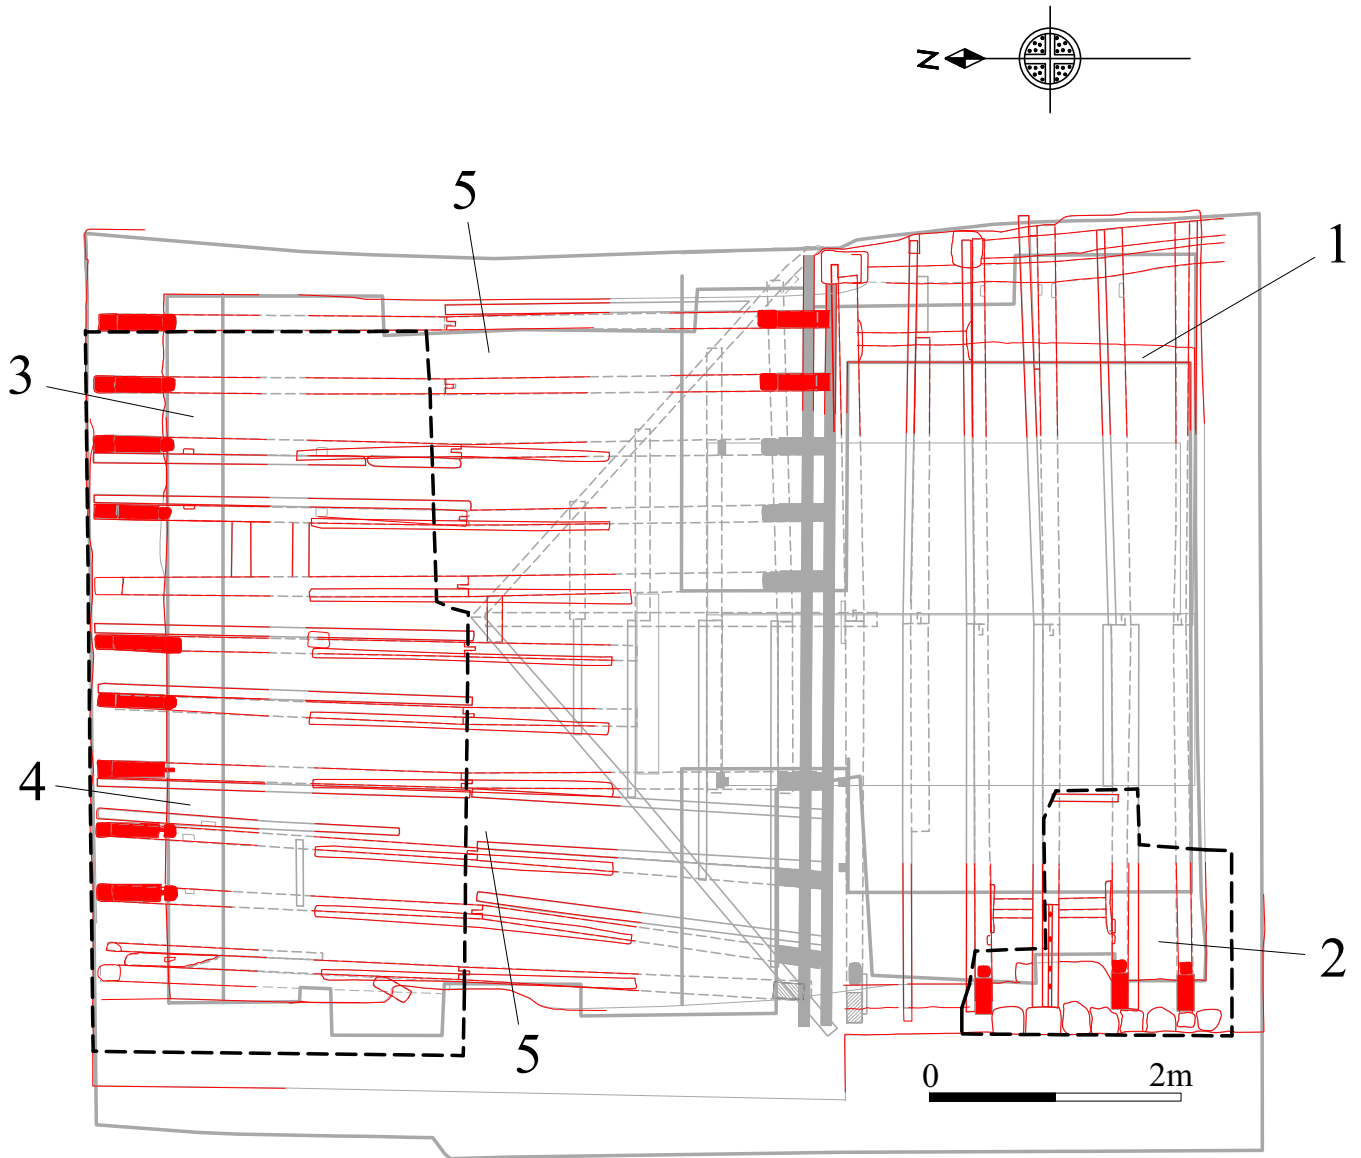
Illus 6

The 5 plans drawn on site and areas stripped of sarking that could be externally viewed

Areas stripped of sarking  
that could be externally viewed
