Archaeological Building Recording Former Steadings at Monzie Perth and Kinross

MN01

**ARCHAEOLOGICAL BUILDING
RECORDING
FORMER STEADINGS AT MONZIE
PERTH AND KINROSS**

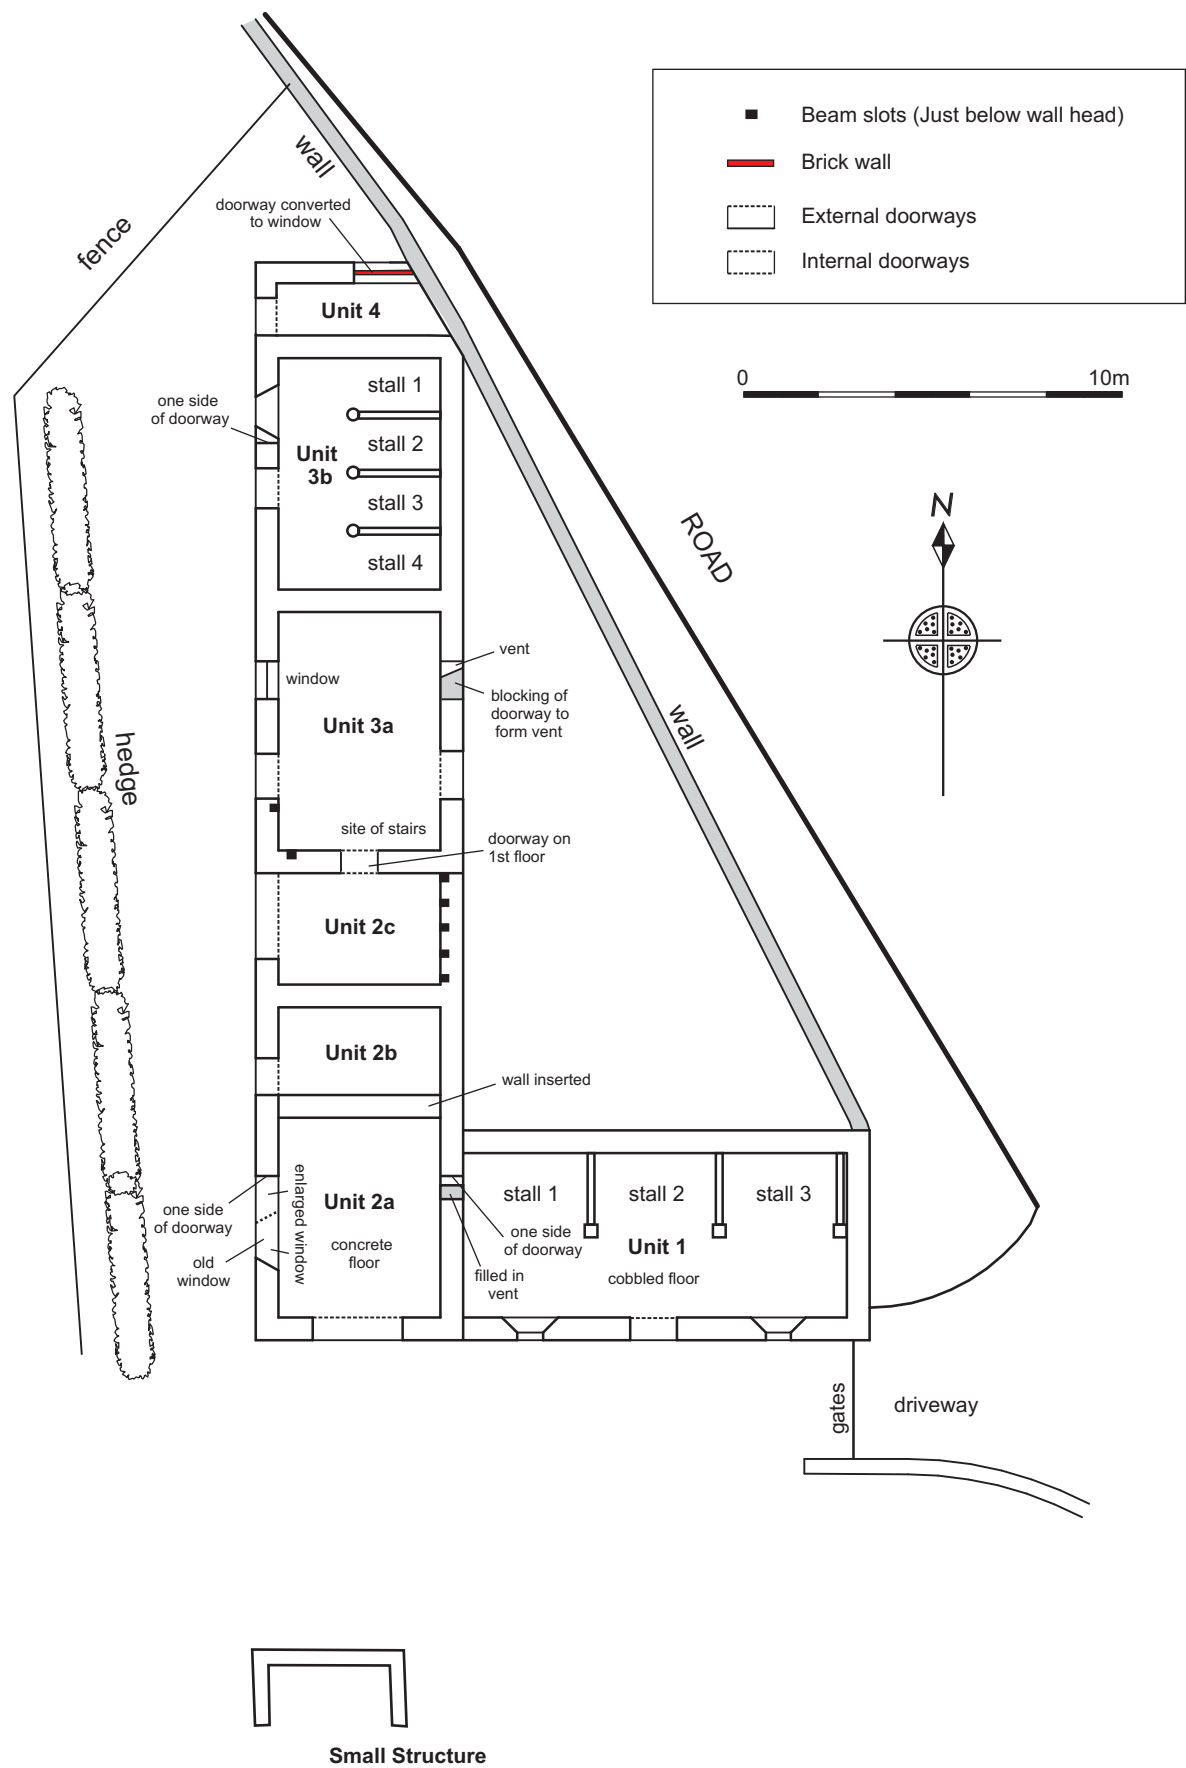
The front (S) elevation of Unit 1, looking N

The floor is cobbled and there are three square stone blocks supporting the posts for stall divisions. The stall divisions have been constructed using good carpentry skills - horizontal pine planks joined together, smoothed off and cut so that the upper edge is gently curved.
