Finavon Doocot Angus

Historic Building Recording for
The National Trust for Scotland

FF14

FINAVON DOOCOT
ANGUS
FF14

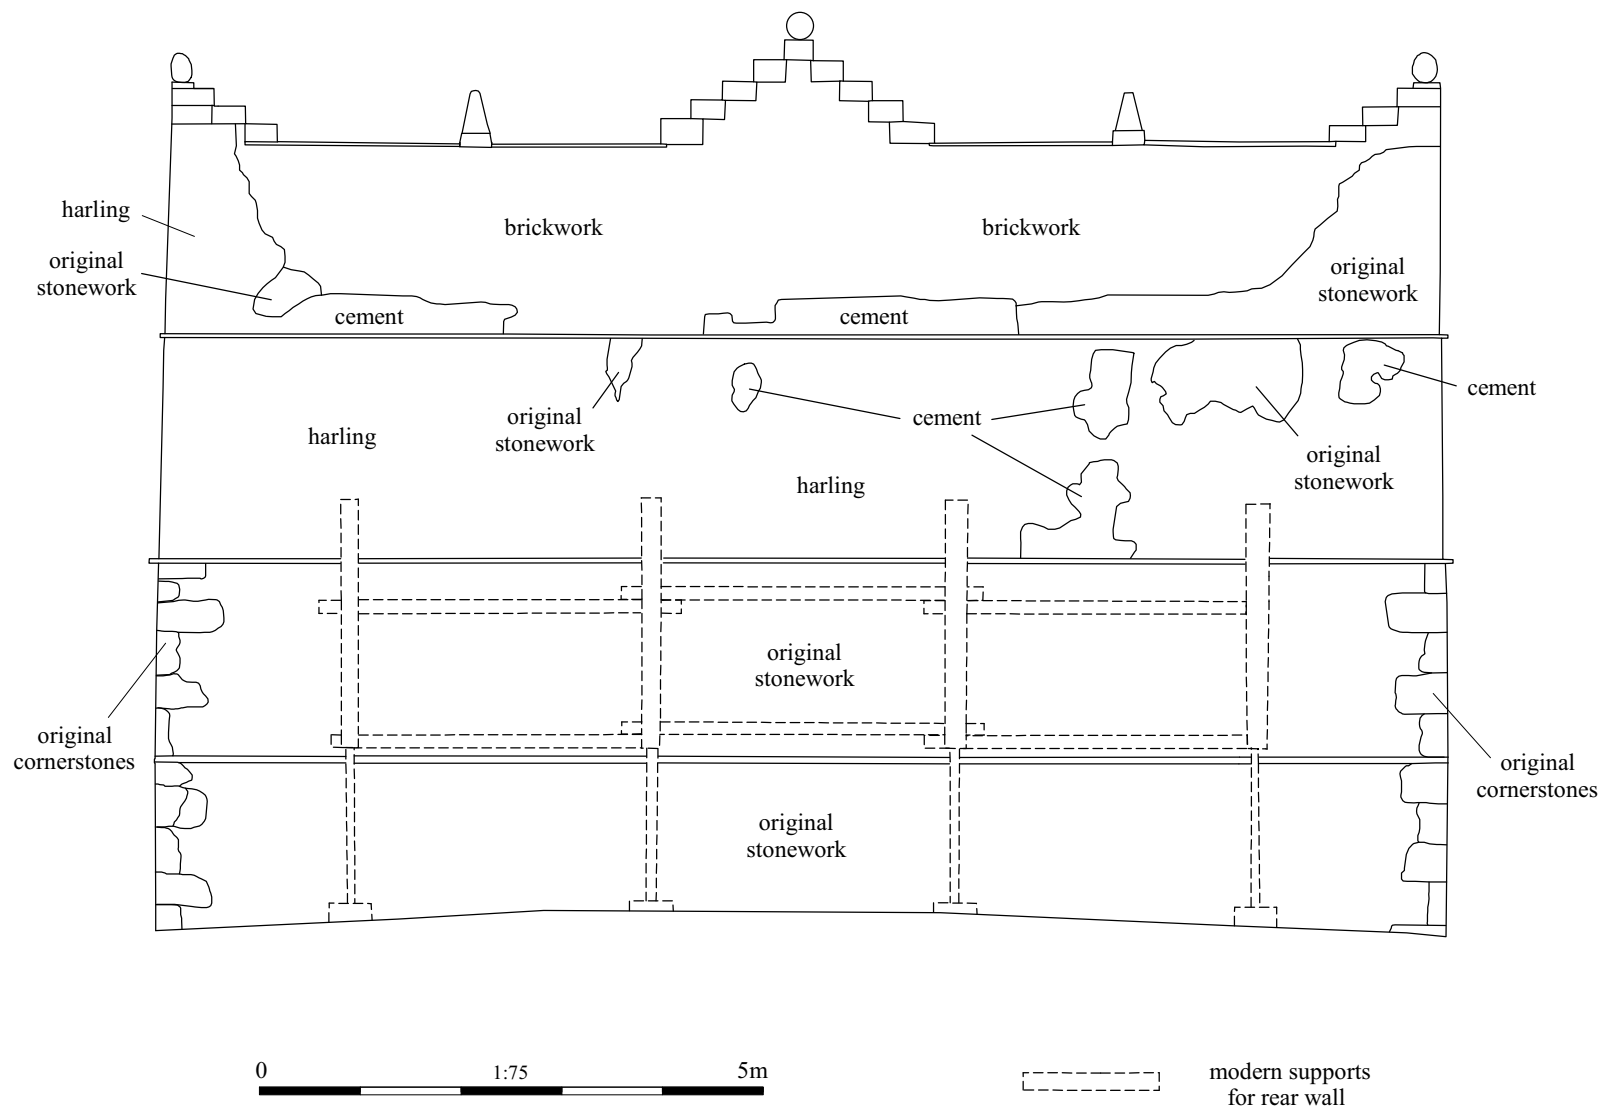
Rear Elevation

Three horizontal string courses are incorporated into the rear wall composed of rectangular sandstone slabs of a variety of widths and roughly uniform thicknesses. The lower course, which runs at head height, is broken off, but the middle course still projects some 12cm, though many of its stones are broken. The middle course continues around the E and W sides of the structure where it descends in steps towards the front elevation. This string course is entirely intact on the side elevations and is probably a replacement here. The lower course may also have once run around the E and W sides of the building, but was subsequently covered over with harling. This possibility was noted when closely inspecting photographs of the E elevation where it looks like there is a horizontal raised bulge giving away the former location the course. The upper string course on the rear elevation is largely intact and is likely to be a replacement.

The other major structural alteration was the partial dismantling of the upper part of the rear wall. Much of this repair was carried out in red brick and the upper string course was probably also replaced during this work. What remained of the W and E gablets was altered and stabilised in red brick; the central finial was completely reconstructed. The stone ledge just above the roof line towards the bottom of the rear parapet (see photo below) also seems to have been rebuilt as it fairly uniform. As already mentioned above, it is likely that the string courses along the W and E elevations were removed and new courses inserted during the restoration.
