Archaeological Building Record  
Billiard Hall, 108-114 High Street  
KINROSS

**ARCHAEOLOGICAL BUILDING RECORD**  
**BILLIARD HALL,**  
**108 – 114 HIGH STREET, KINROSS**  
**KR09**

*Alder Archaeology Ltd recorded a derelict Billiard Hall attached to the former Carnegie Museum and Library in Kinross High Street, site code KR09.*

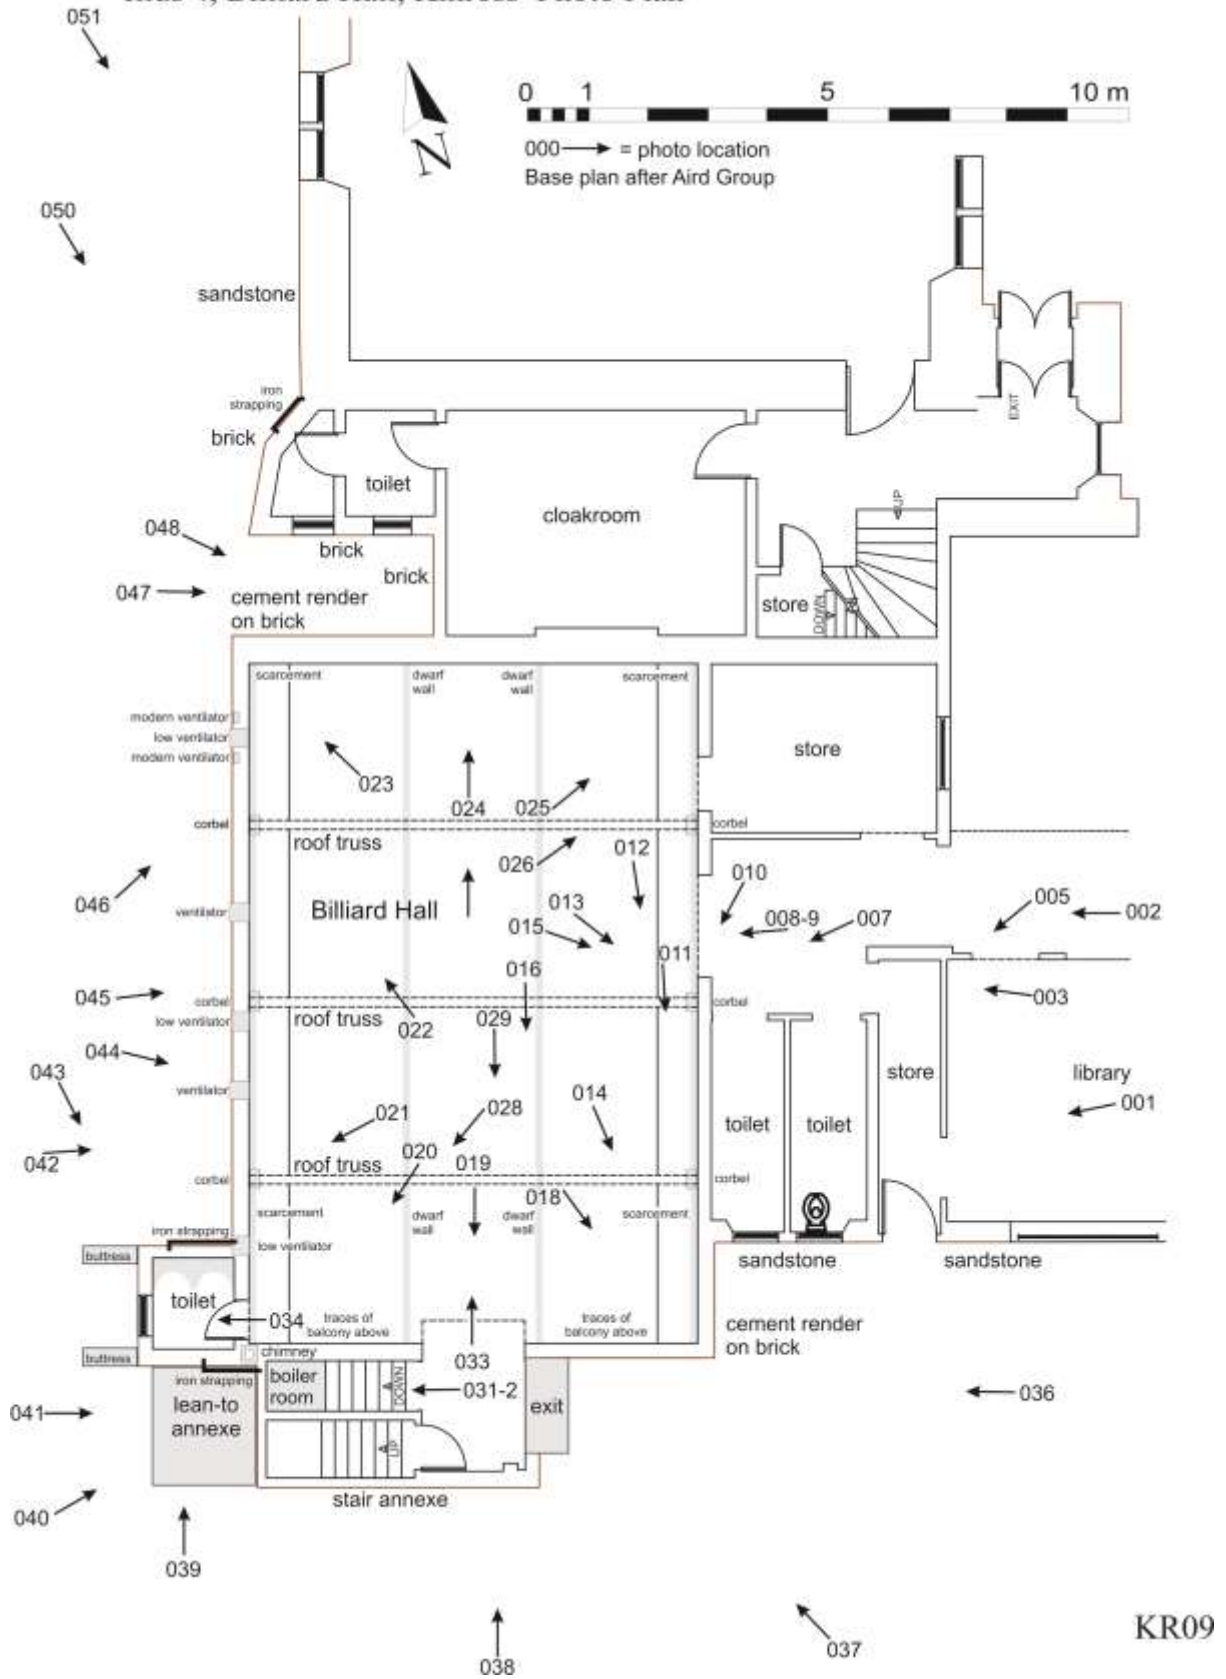
Illus 5, Billiard Hall, Kinross Internal Views

Internally, the building has been stripped almost entirely back to bare brick, perhaps as a result of attempts to cure a damp or dry rot problem, but there are traces of lath and plaster lining in some places.

It is evident from scarcements along the W and E walls, and two N – S dwarf walls, that the hall had a suspended wooden floor, with joists running E – W and boards presumably N – S, but this floor is now entirely missing. There are lengths of modern dpc roll draped over the scarcements in various places, obvious unused, indicating a very recent abortive plan to replace the flooring.

It appears from traces of cement or plaster, that the walls, and also the balcony, were lined to waist height, probably with boards. This was a common arrangement in sports halls, dance halls, school rooms, etc, because the lower part of the wall tends to be kicked and scuffed, requiring a robust covering, while the upper part of the wall could be plastered and painted to reflect more light. Often the boards were separated from the wall with a layer of asbestos-reinforced plaster, to reduce the effects of condensation and dry rot behind the boards.

The doorways where visible seem to have been formed with rolled steel lintels, with a shallow relieving arch in the brickwork above. The lintels are of a very shallow section, with thin flanges, of type not generally seen today. They seem to be in very poor condition, severely corroded, and in many parts of the building have been replaced with precast prestressed concrete lintels.
