# Archaeological Historic Building Record Grundcruie Water Treatment Works Methven MV05

DPB/MV05 08 January 2019

# ARCHAEOLOGICAL HISTORIC BUILDING RECORD GRUNDCRUIE WATER TREATMENT WORKS METHVEN MV05

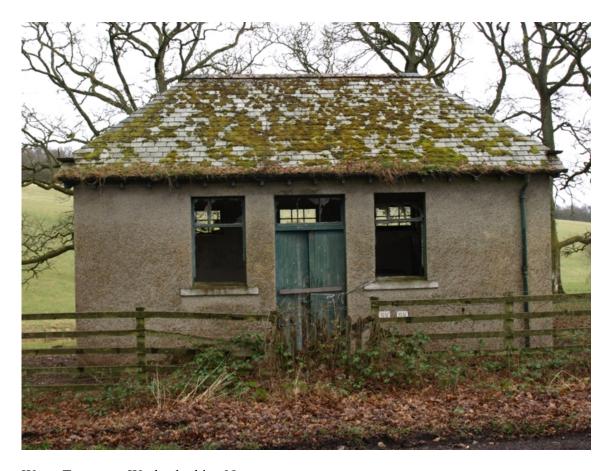
Water Treatment Works, looking N

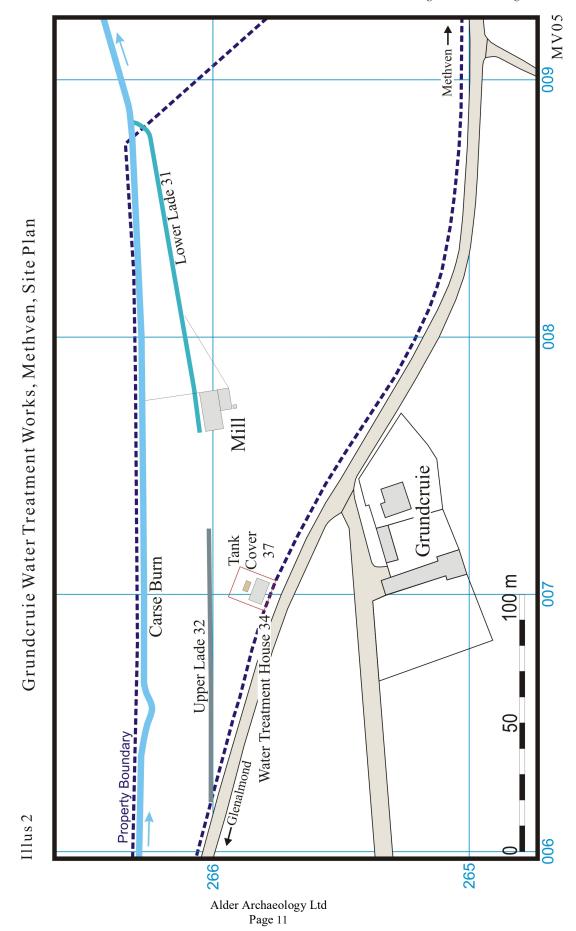
# Illus 3 Grunderuie Water Treatment Works, Methven Plan

About 3 m to the N of the Water Treatment House 34 is a mainly concrete deck 37 over what appears to be a reservoir or perhaps a settling tank, about 3.8 m x 3.2 m, its edges formed by red colliery bricks. A loose example bore the stamp AIRDRIE. The E end of the deck was covered with wooden planks.

Tank Cover 37
