Archaeological Watching Brief
West Mains of Huntingtower
Perth
HR02

07 April 2020

**ARCHAEOLOGICAL WATCHING BRIEF
WEST MAINS OF HUNTINGTOWER
PERTH**

HR02

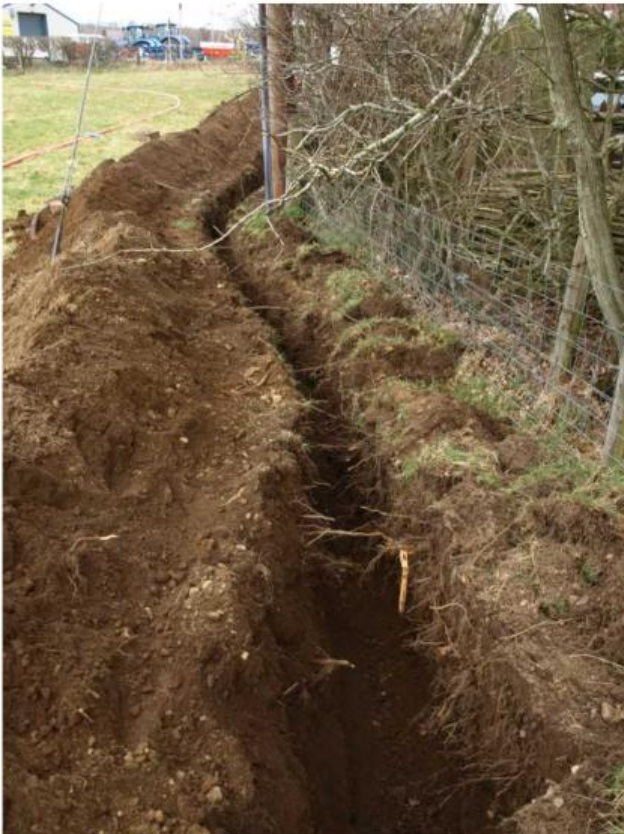
7 View N from
Post 3 to Post 13.

Illustration 7: View N from post 3 to post 13.

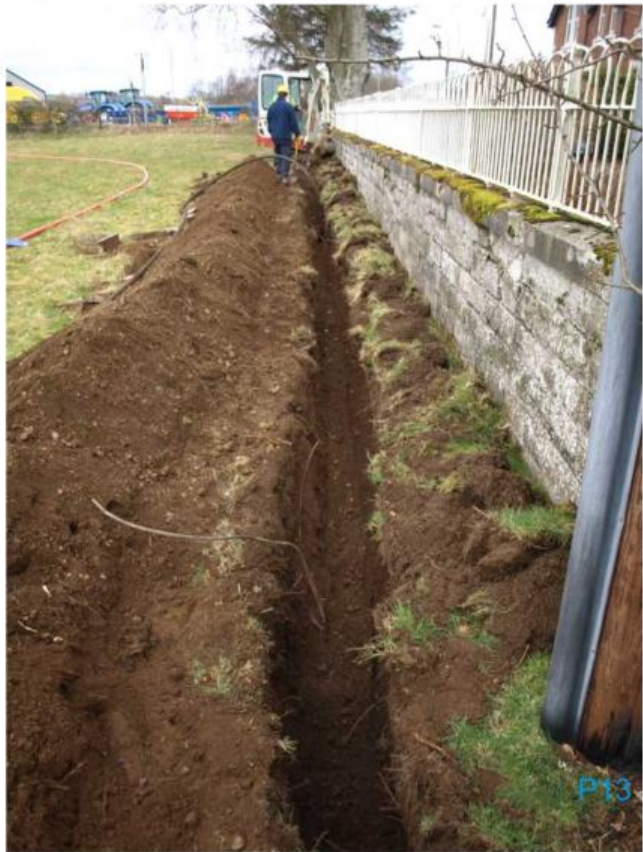
8 View N from
Post 13.

Illustration 8: View N from post 13.

From the bend at post (13) northwards, a two-strand copper earthing wire was found in the upper fills of the trench, connected at intervals to vertical lead-tube earth spikes. This was related to the low-voltage supply carried on post (13), not the 11 Kv supply being replaced.
